# The Treachery of Images: Redefining the Structural System of Havana's National Art Schools

**Abstract:** This paper illustrates the contribution that on-site survey and graphical documentation offer to the structural comprehension of 20th century architectural and civil engineering heritage and, therefore, to its sustainable conservation. The research herein presented has identified the true structural system of Havana's National Art Schools, an internationally well-known architectural masterpiece that was recently investigated within the drafting of a comprehensive conservation management plan. This iconic complex was built right after the Castro's revolution and was meant to embody Cuba's newfound freedom. To this end, the complex was supposed to be built using Catalan vaulting, a technique loaded with significance due to its provenance, affordability, and flexibility. While most of the literature, the architectural features, and the very designers assert that no concrete nor steel were employed during construction, recent studies suggested that a reinforced concrete core might be hidden behind the masonry-like appearance of the five buildings. The structural analysis performe

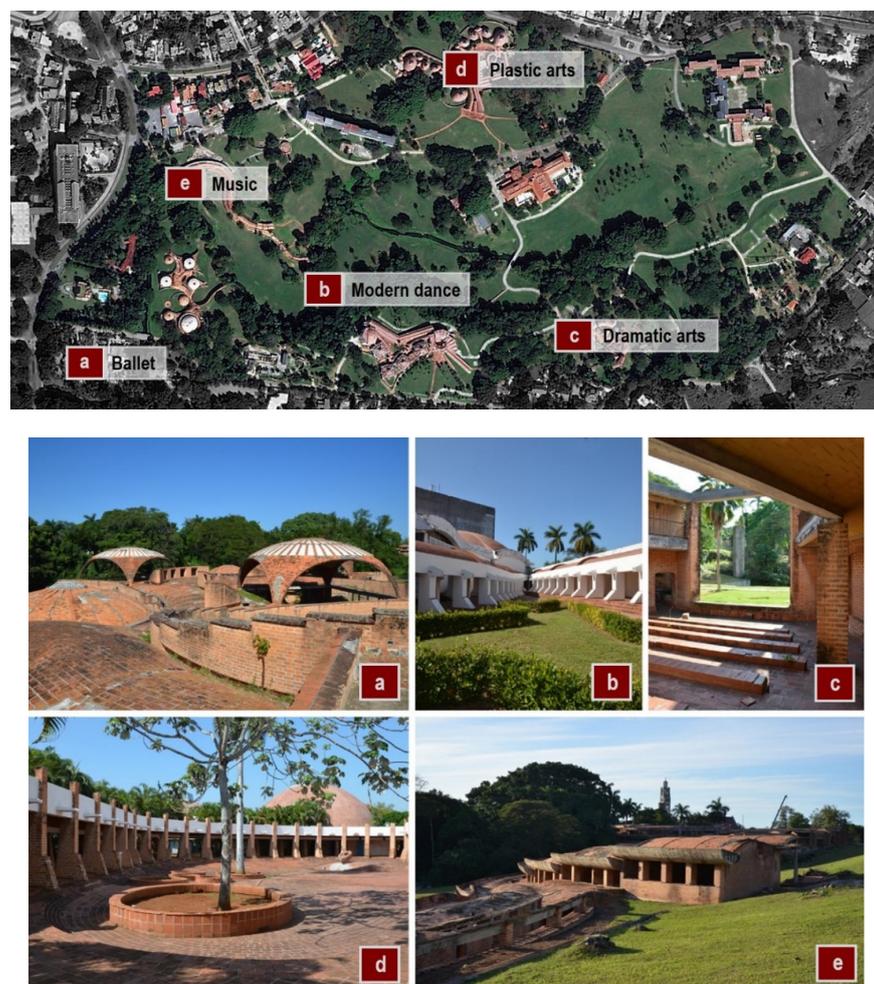
**Figure 1.** Satellite map of the campus and overview of the five schools: (a) School of Ballet; (b) School of Modern Dance; (c) School of Dramatic Arts; (d) School of Plastic Arts; (e) School of Music (photos by the authors).

Given the extent of the task and the limited time available, work was split between the three architects, and each one of them was put in charge of one or two buildings: Garatti oversaw the construction of the Schools of Ballet (Figure 1a) and Music (Figure 1e), Gottardi of the School of Dramatic Arts (Figure 1c), and Porro of the Schools of Plastic Arts (Figure 1d) and Modern Dance (Figure 1b). As the aim was however to create a homogeneous complex, to overcome physical distance between the pavilions and style differences owed to the architects' diverse education, the designers sought unity in architectural and structural features. From the very beginning, they identified a few shared principles to follow throughout construction, such as formal freedom, integration with nature, and the employment of the same construction systems and building materials. With regard to the latter, they also agreed to avoid the use of concrete and steel, arguing that such materials were lacking in the postrevolution phase, in favor of locally sourced materials and workmanship and, especially, of bricks and Catalan vaulting [1,2].

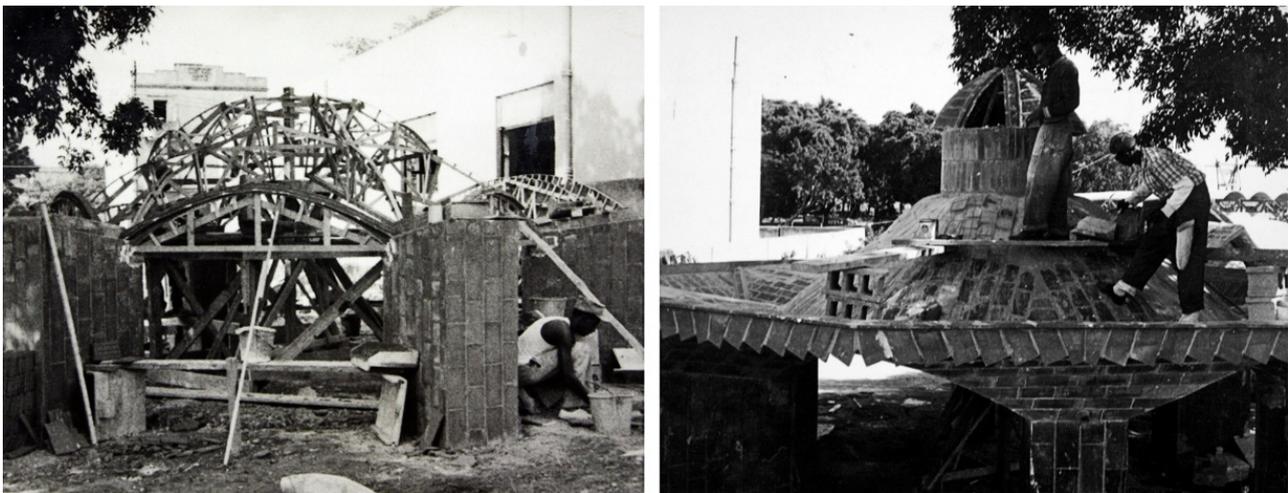
**Figure 2.** Photographs stored in the Universidad de las Artes de Cuba (ISA) archive showing a teaching workshop and small-scale testing of the Catalan vaulting technique. The original caption by José Mosquera reads: “Banco de pruebas. Escuela para aprender la tecnica constructiva” [“Test bed. School for learning the building technique”].

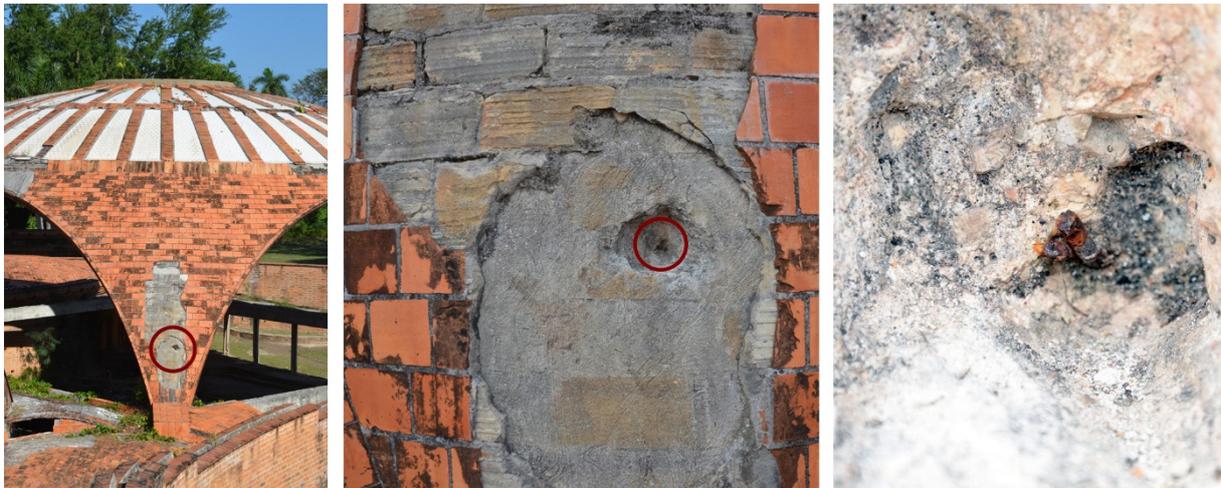
**Figure 3.** The pendentives of the dance pavilion's dome. The loss of the outermost layer of tiles unveiled the presence of reinforced concrete. The picture on the right shows the visible tie wire.

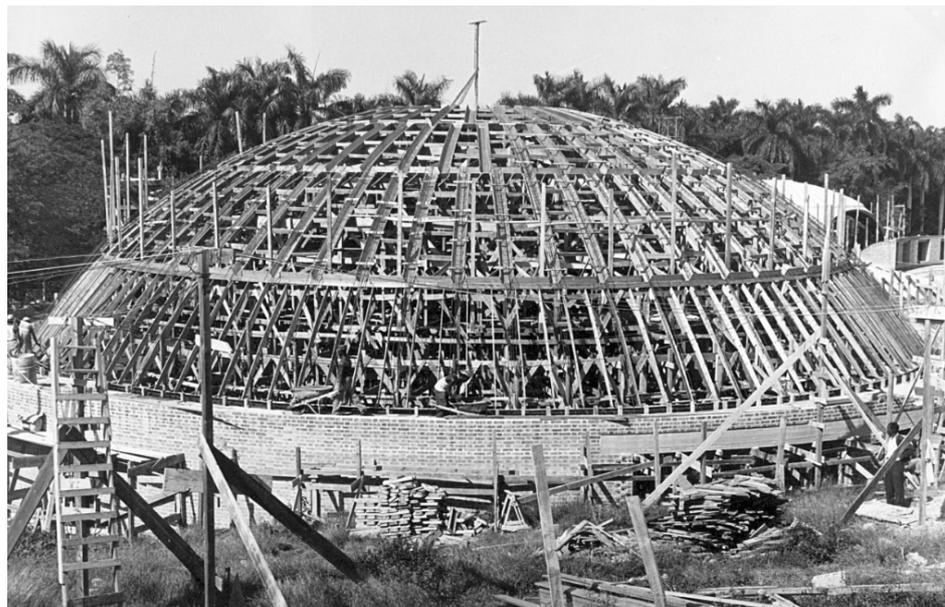
**Figure 4.** The School of Ballet's choreography theater during construction. The photograph depicts the wooden formworks for the casting of the dome's concrete ribs and rings (ISA archive).

As emerged from an attentive study of Mosquera's pictures, the main criterion adopted throughout the building site was that of covering the inside of the wooden formworks with one or more layers of clay tiles before placing rebar and pouring the concrete inside of them (Figure 4).

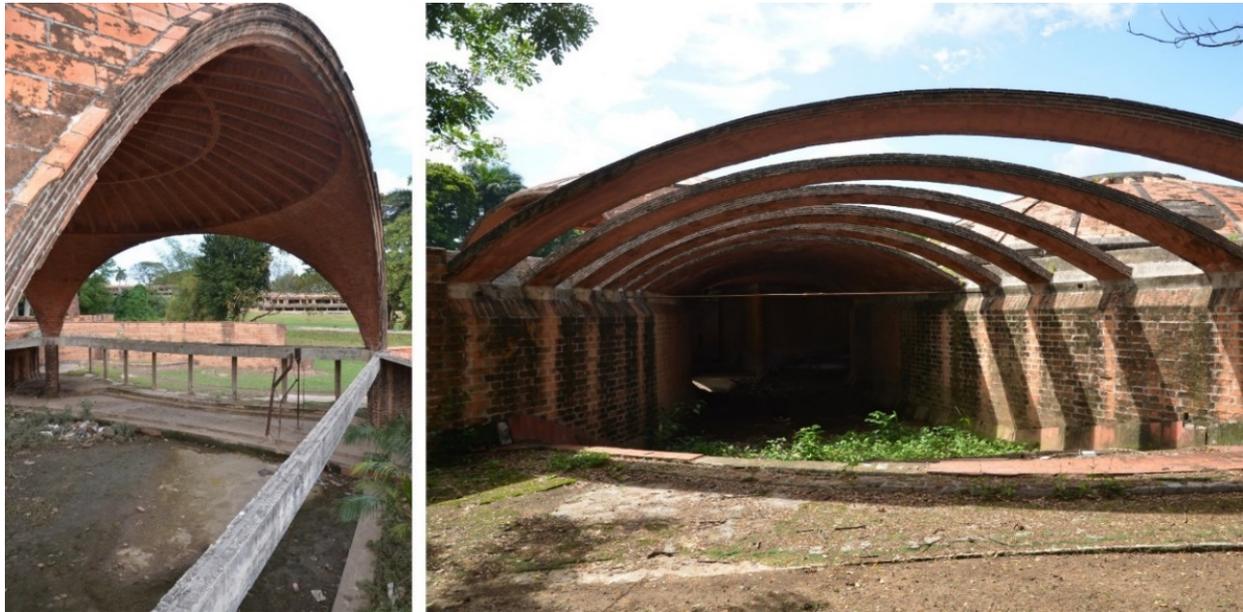
**Figure 5.** The deceptive appearance of the side finishing of the domes and vaults of the School of Ballet, displaying alternating layers of clay tiles and mortar (photo by the authors).

This way, once the concrete had set, the wooden formwork could be dismantled, leaving the tile coating in sight while hiding the core structure underneath. To complete the job, the extrados was also tiled, so that it would in fact appear as a thin-tile vaulted structure [22]. The side finishing of the arches is particularly misleading as it shows the typical pattern of this construction technique: alternating layers of tiles and mortar (Figure 5).

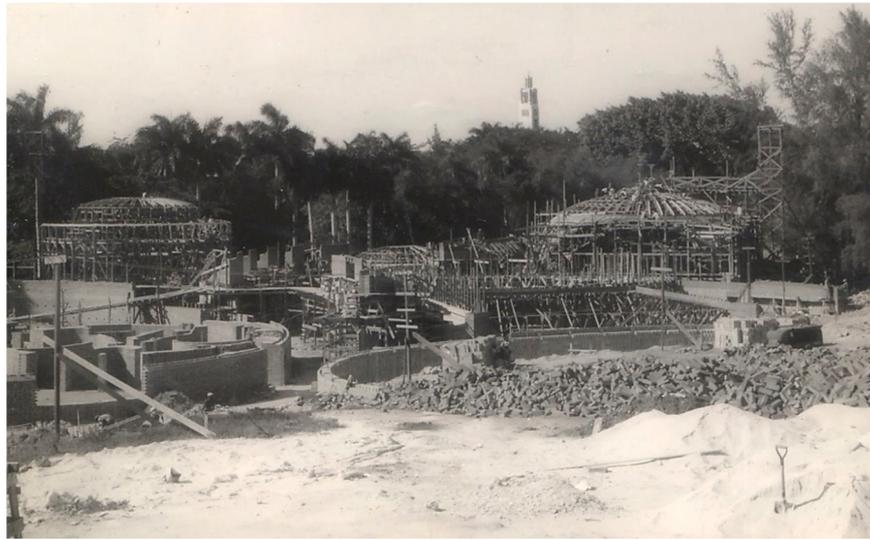
**Figure 6.** The wooden scaffoldings installed for the construction of the School of Ballet's dance pavilions (ISA archive).

wooden scaffoldings, which, given the dimensions of the pavilions, ended up being rather complex structures (Figure 6).

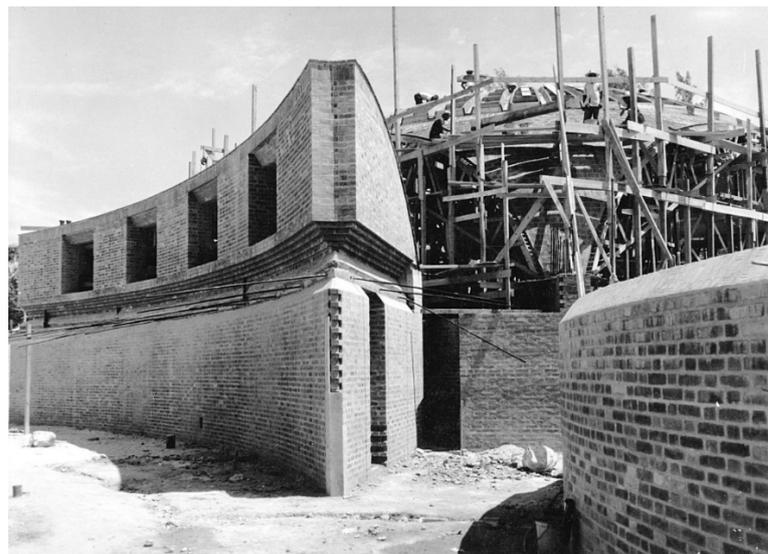
**Figure 7.** One of the pendentives of the dance pavilions' domes during construction. As can be noticed, the tiled intrados of the pendentive was configured as a work form for the subsequent concrete casting (ISA archive).

Once the scaffoldings were in place, masons proceeded to lay one or more layers of clay tiles to build the work forms. In particular, for the pendentives of the dance pavilions and the annular sector at the base of the choreography theater's dome, the intrados was shaped following the geometry of the supporting centering (Figure 7). On the other hand, the work form of the rings and ribs composing the grid of the upper spherical cap were basically made of wood and were then coated with tiles on the inside (Figure 8). Reinforcing bars were subsequently positioned (Figure 9) and finally the concrete was poured to create the main bearing framework (Figure 10). The next step was to fill the gaps of the concrete grid, which was achieved through the construction of narrow tile vaults.

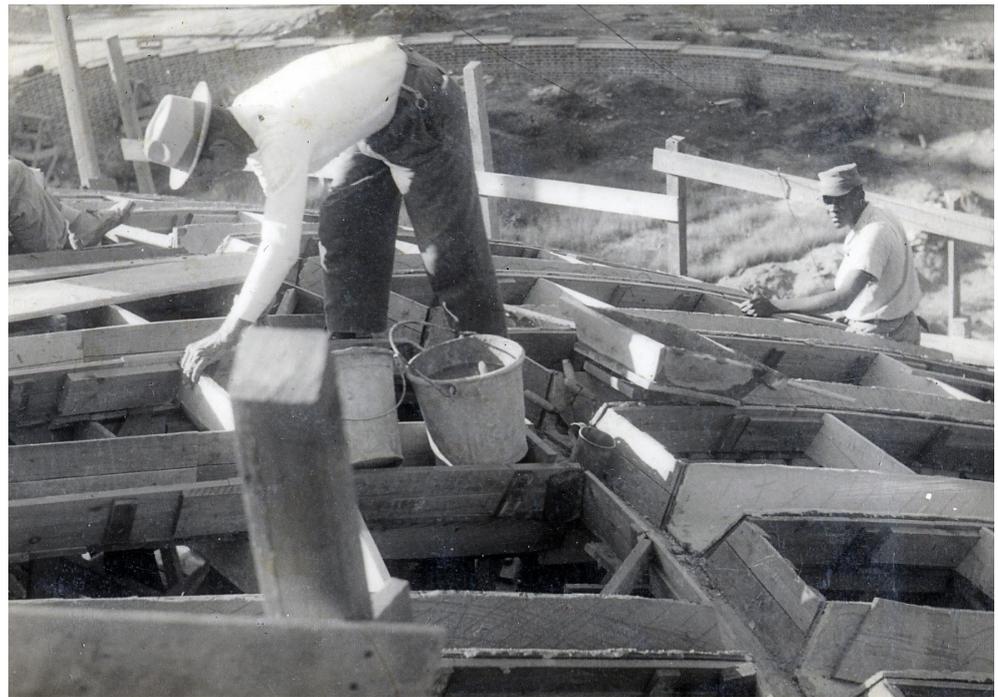
**Figure 8.** The wooden formworks of the ribs and rings of the choreography theater while being coated with clay tiles on the inside (ISA archive).

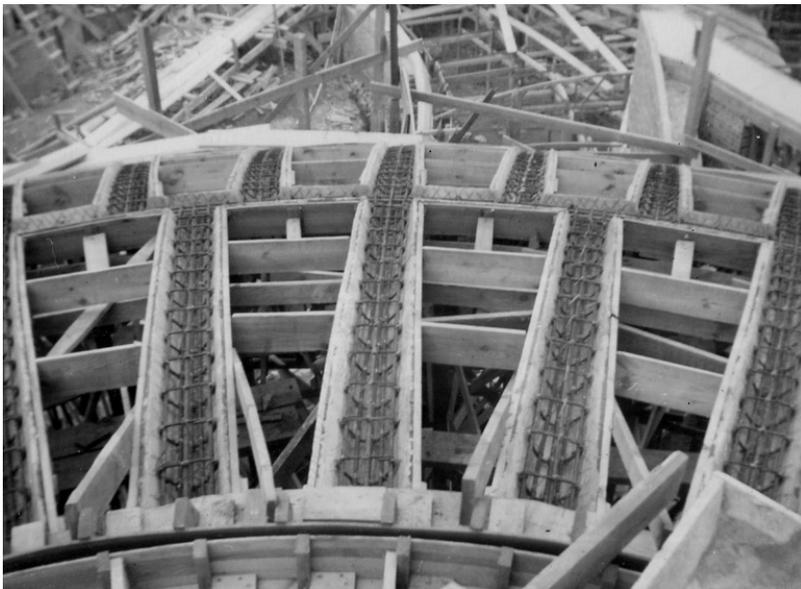
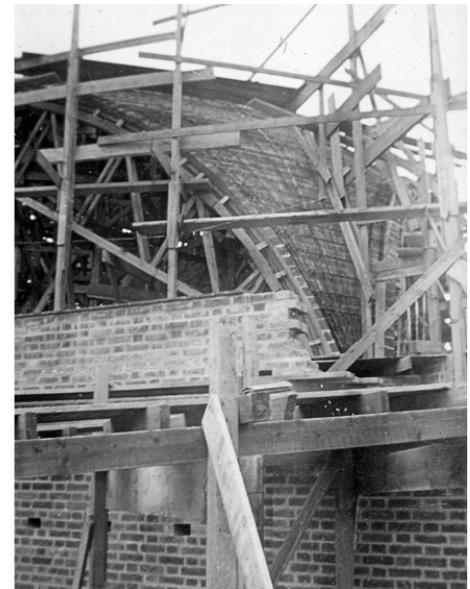
**Figure 9.** (a) The reinforcing bars positioned in the domes' ribs and rings before the pouring of the concrete. (b) The rebar grid located at the intrados of the pendentives of the dance pavilions before the concrete casting. An analogous reinforcement was placed around the annular sector at the base of the choreography theater (ISA archive).

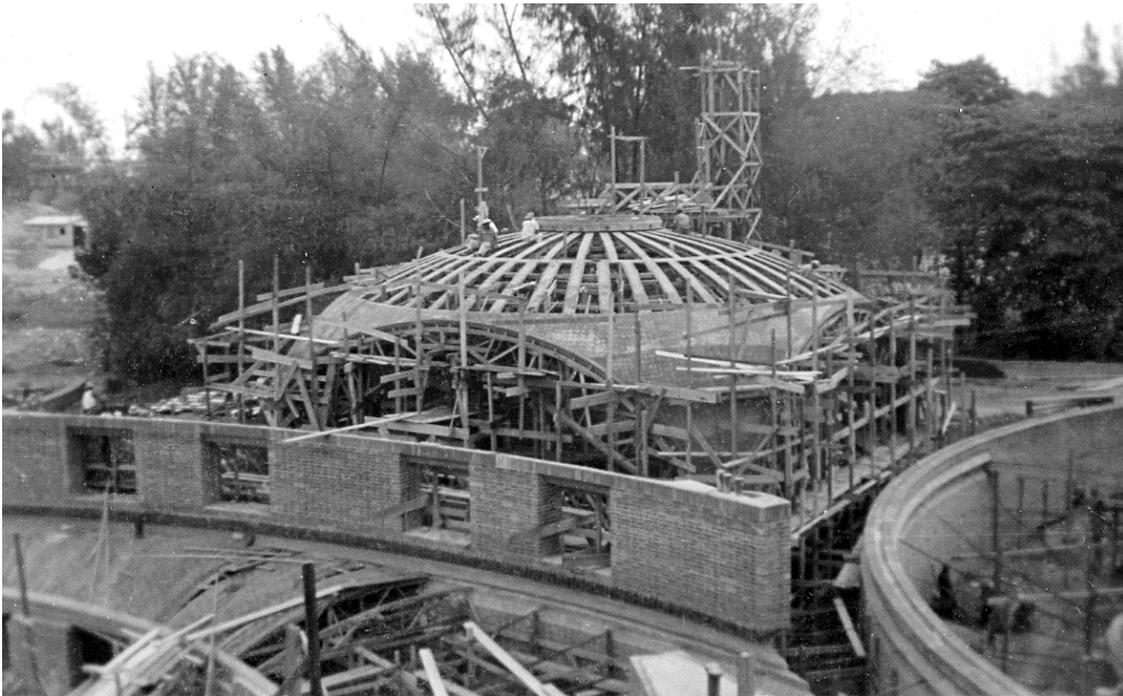
**Figure 10.** One of the dance pavilions after the concrete casting. The picture clearly shows the concrete framework hidden beneath the current clay tile covering (ISA archive).

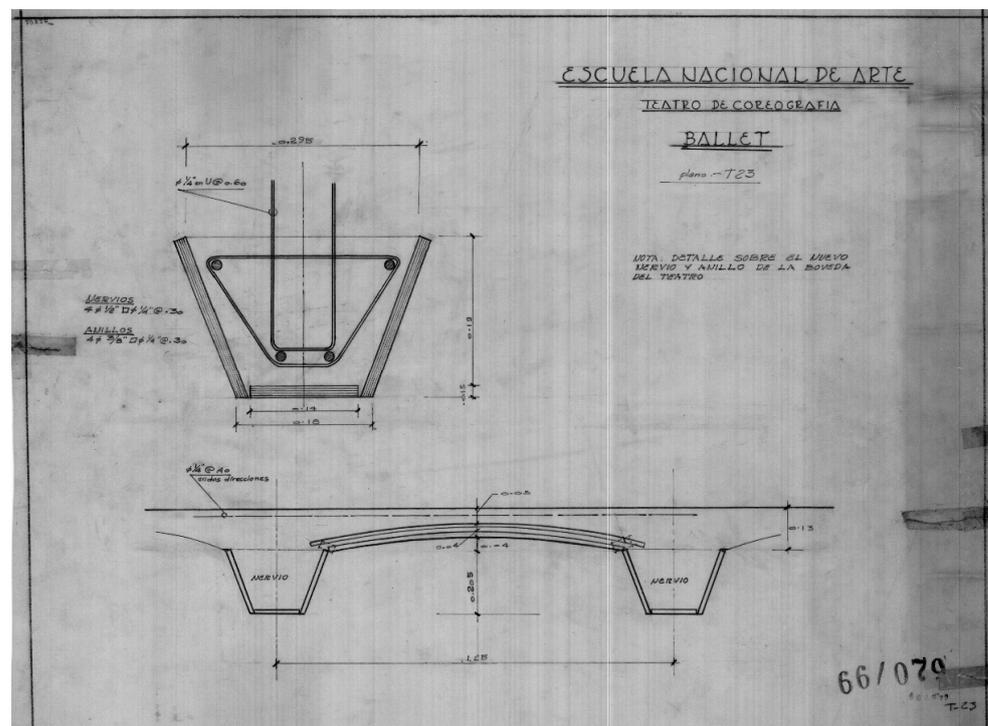
**Figure 11.** A drawing from the original 1960s project showing the intention of covering the narrow tile vaults between the ribs with a further layer of reinforced concrete (ISA archive).

Although the “filling vaults”, due to their limited span, could reasonably be taken for actual Catalan vaults, a newfound drawing by Garatti (Figure 11) and a picture from the construction site (Figure 12) prove otherwise, showing how even these elements were intended as work forms.

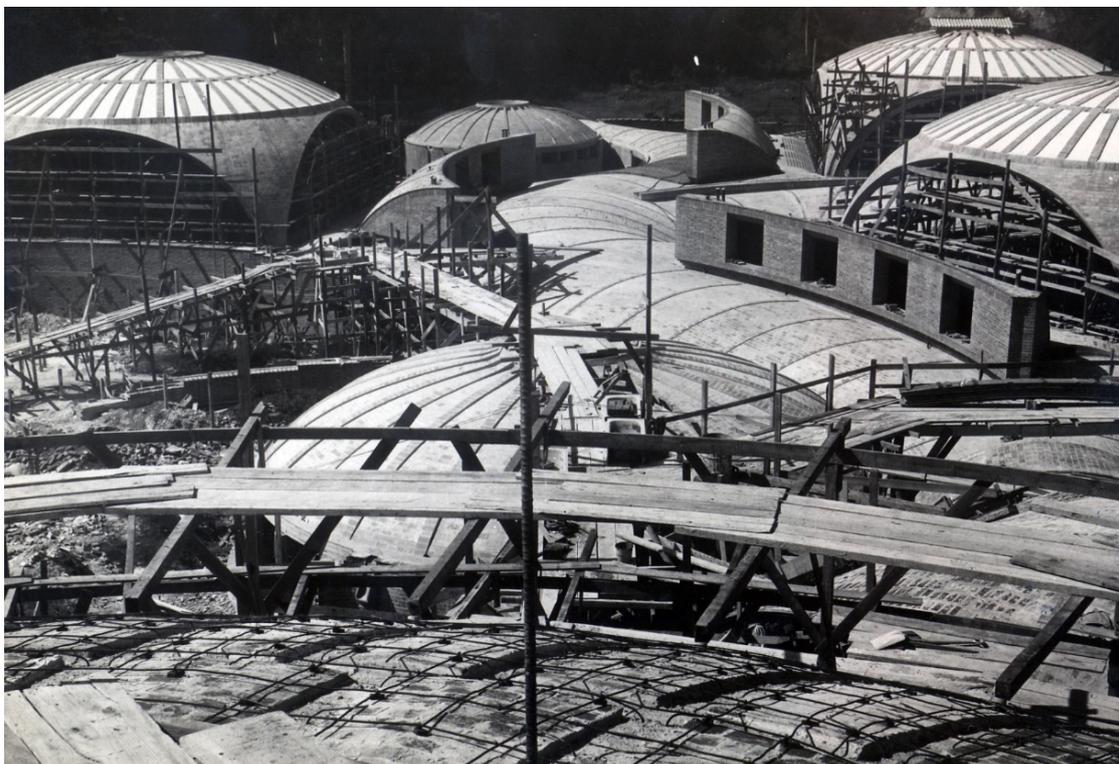
**Figure 12.** The reinforcing steel net positioned above the ribbed cap of the choreography theater before the second concrete casting (ISA archive).

Figure 12 displays a reinforcing steel net positioned above the ribbed cap of the choreography theater, indicating the intention of casting a further concrete layer, just as illustrated by the architect's original design. While no further pictures documenting the next stages of construction of the choreography theater were found, some photographs of the dance pavilions suggest that the same technique was adopted there. Figure 13 shows

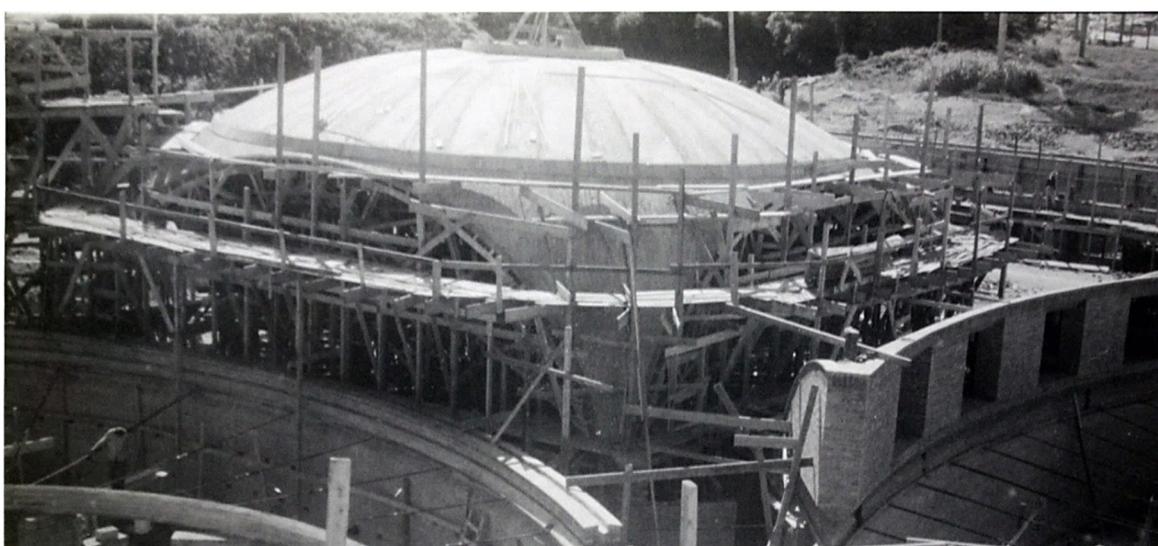
**Figure 13.** One of the dance pavilions after the second concrete casting (ISA archive).

one of the latter after the second concrete casting, which covers the entire surface of the dome, creating a smooth and continuous shell. Although there are no records to confirm that the reinforcing net was also used in the dance pavilions, the upward steel connections linked to the ribs and rings' rebar seem to validate this theory (Figure 14). Finally, the extradoses of the domes were covered with clay tiles, hiding the reinforced concrete from the sight and definitely simulating a masonry structure (Figure 15).

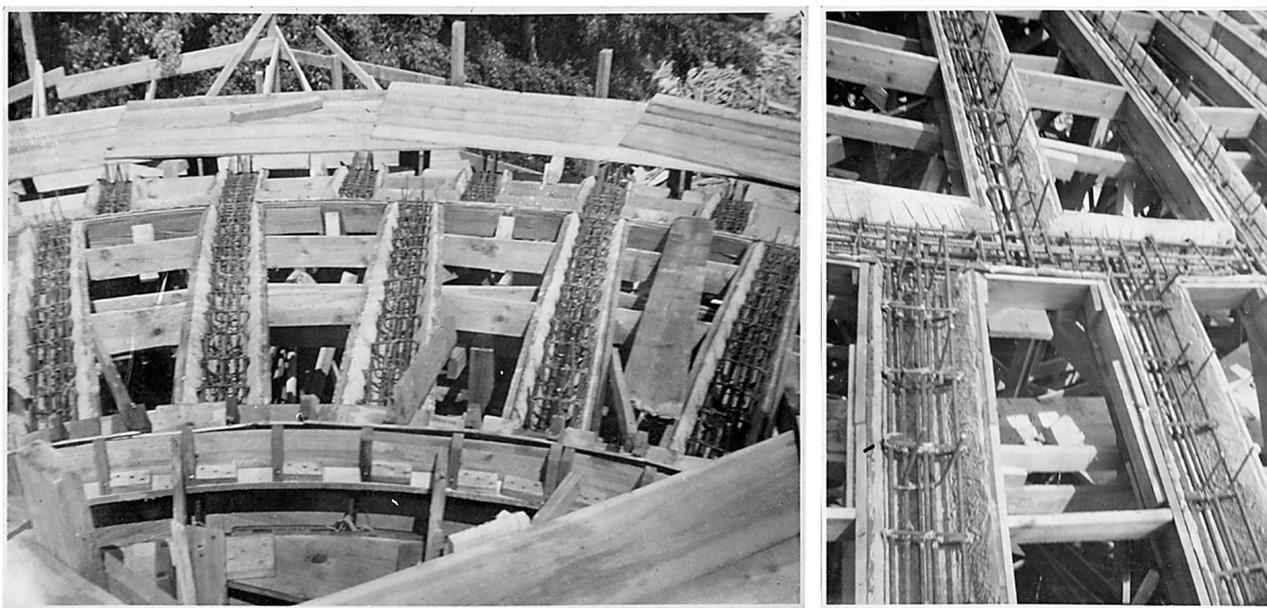
**Figure 14.** Two photos of the construction site, showing the upward steel connections protruding from the dance pavilions' ribs (ISA archive).

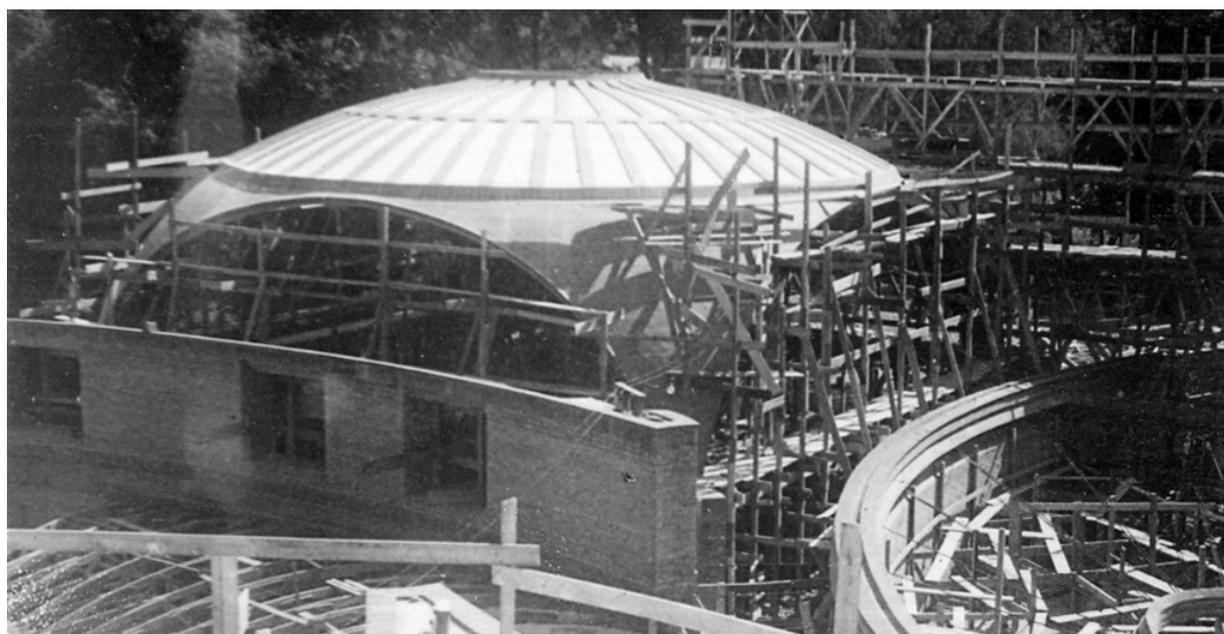
**Figure 15.** One of the dance pavilions right after completion: the concrete has been completely hidden from sight thanks to a covering layer of clay tiles (ISA archive).

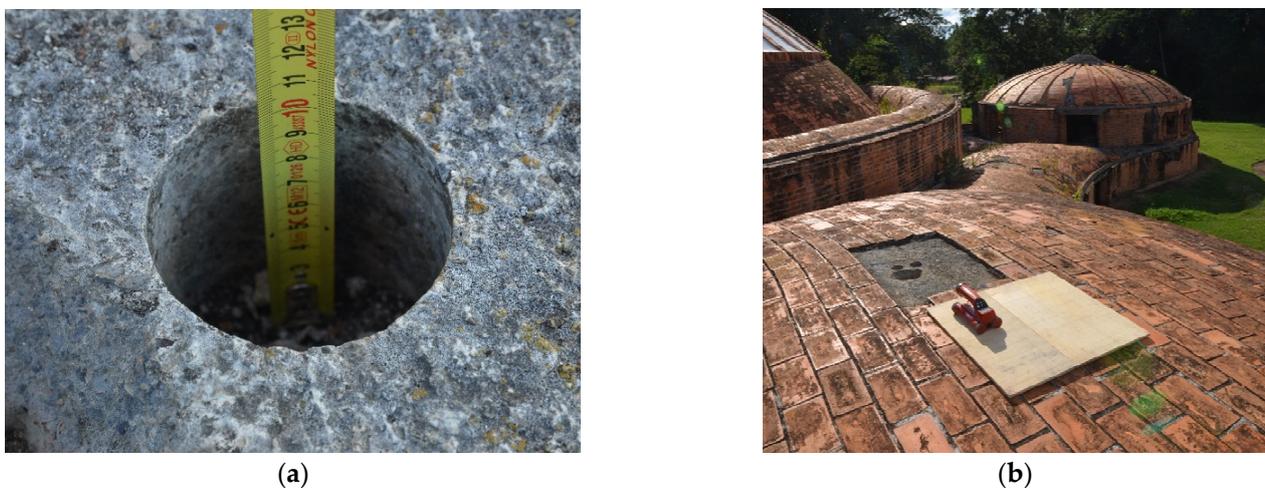
**Figure 16.** (a) The 10 cm hole left by previous core testing, proving the presence of a concrete slab (photos by the authors). (b) Pachometer testing performed to detect possible rebar in the same vault.

Further verification of rebar absence was offered by the outcomes of the pachometer testing performed at the extrados of the vault (Figure 16b), which did not highlight any iron presence within the detection range. These results do not come as a surprise since, as observed in the construction process of the previously described domes, rebar should be located in proximity of the intrados. Finally, a drawing by Vittorio Garatti reveals that the original intent of the architect was in fact to strengthen the pasillo's vaults with reinforced concrete (Figure 17). Even though the blueprint only focuses on the vaults covering the main entrance of the building, it is reasonable to think that the same technique was to be applied to all the larger vaults covering the pasillo.

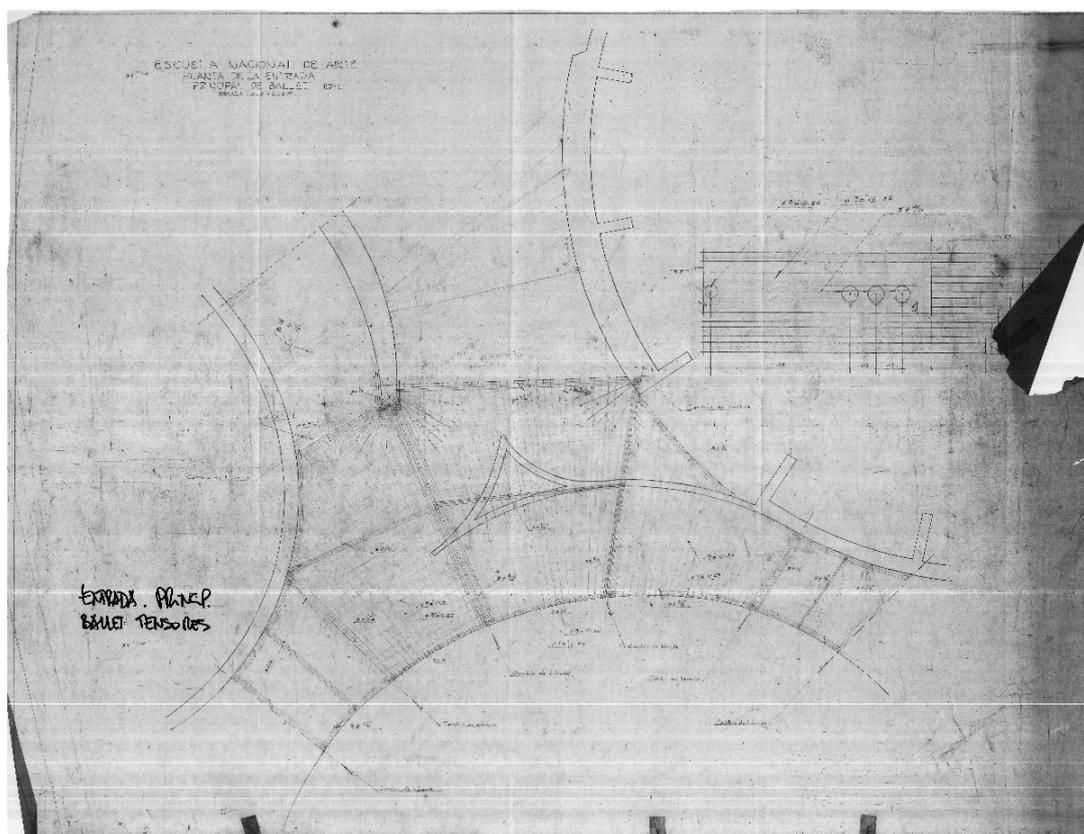
**Figure 17.** Drawing from the 1960s blueprints, highlighting the intention of using reinforced concrete for the vaults of the pasillo located nearby the main entrance of the building (ISA archive).

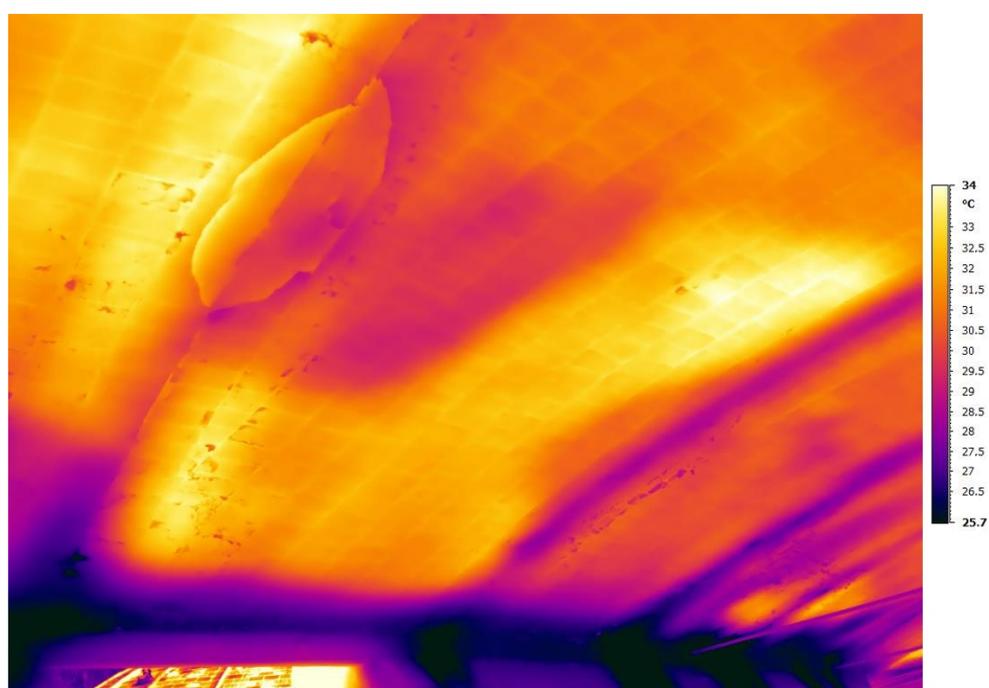
**Figure 18.** Thermograph of the pasillo (thermal range 25.7–34.0 °C). The survey was performed on 13 February 2020. Environmental parameters at 1:00 PM: 28.2 °C—Relative Humidity (RH) 75.0% (image by Luca Valisi).

The thermographic survey performed on vaults with smaller spans also highlighted the presence of rebar (Figure 18). Although in this case the actual structural system is not reinforced concrete, it is still not possible to talk about pure Catalan vaulting but rather of a mixed technique, as suggested by Michele Paradiso [23]. The outcomes of the thermographic survey were also confirmed by visual inspection: Figure 19 shows a reinforcing bar located above the lower layer of tiles of the pasillo's intrados, which was made visible by current decay.

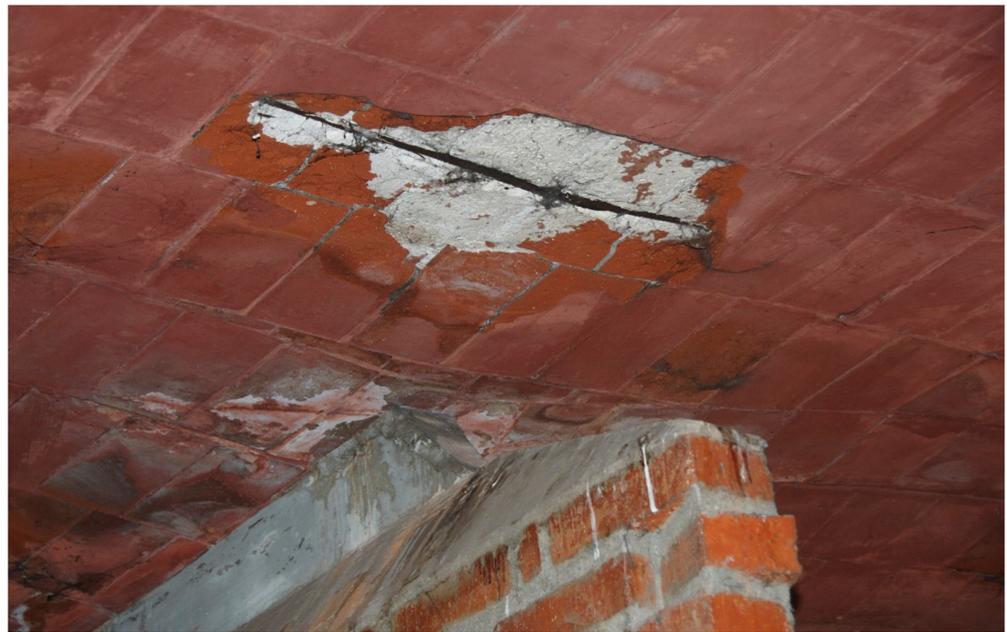
**Figure 19.** Exposed steel rebar at the intrados of the pasillo (photograph by the authors).

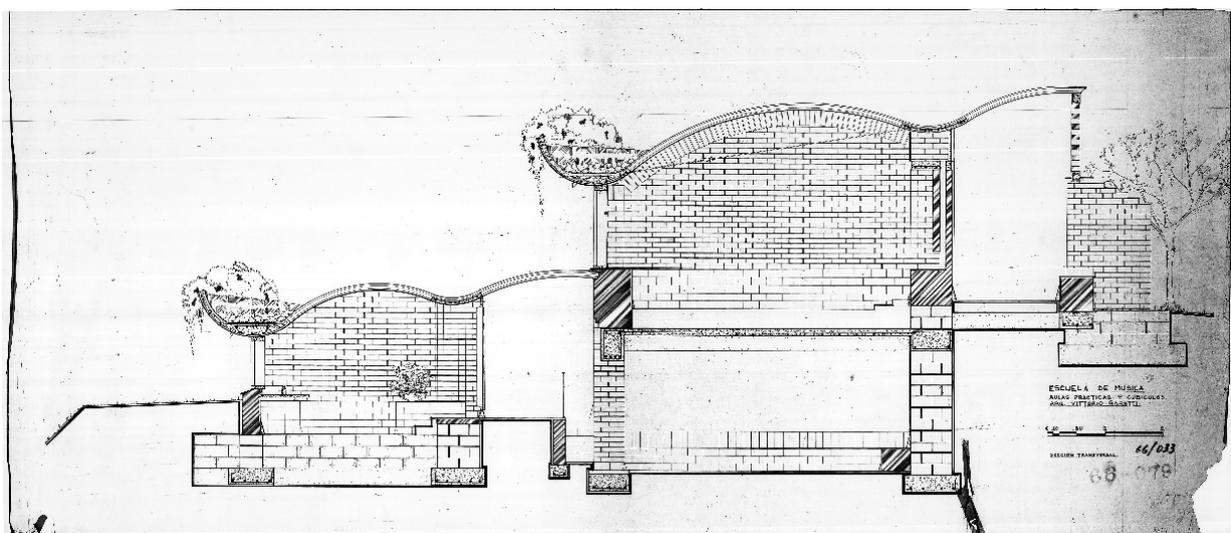
**Figure 20.** Cross-section of the *gusano* building taken from the 1960s original drawings (ISA archive).

Despite the large amount of documentation concerning the original design of the School of Music, detailed information regarding the building technique to be employed in its construction is scarce. The most significant drawing in this regard is the cross-section reported in Figure 20, where the global organization of the structure can be observed. The same pattern repeats on two different levels with slight differences in terms of span, but seemingly identical stratigraphy. The illustration clearly distinguishes elements that are made of bricks from elements that are made of reinforced concrete, even providing a rather precise representation of rebar distribution. According to this drawing, the vaults are clear of any concrete or steel reinforcements, truly resembling the Catalan technique. The arches appear to be composed of three different layers, of which the middle one is by far the thickest, while the extrados one appears to be roughly half of the intrados one.

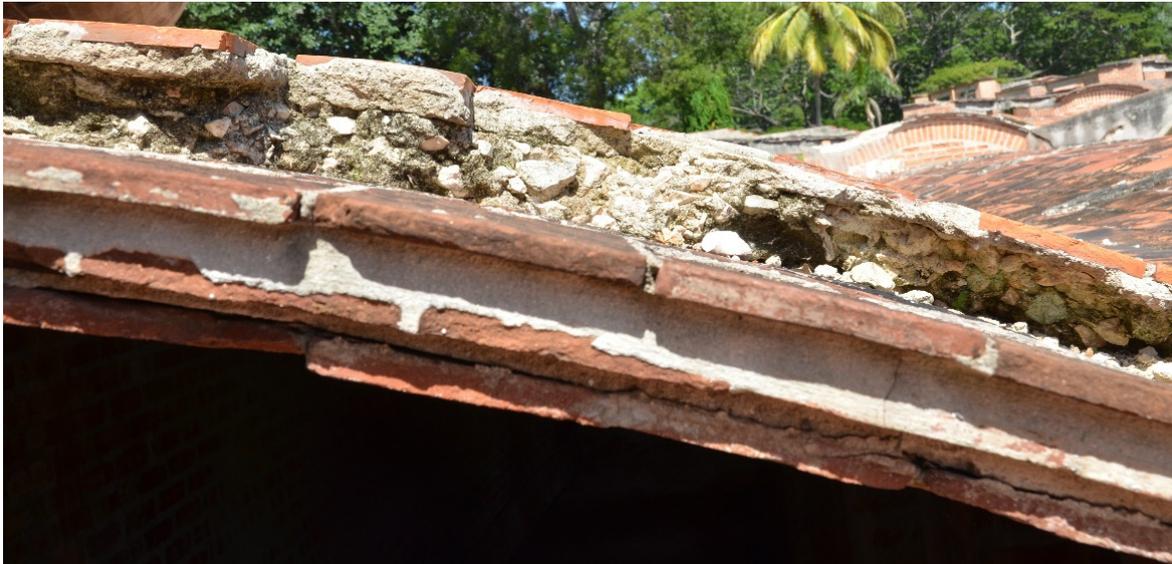
**Figure 21.** Current stratigraphy of the vault covering the lower corridor of the gusano building (photo by the authors).

The described ratio is faithfully reflected by the real building, as the vaults comprise, from top to bottom, one layer of clay tiles, one layer of cement, and three further layers of clay tiles held together by layers of mortar (Figure 21). The consistency between the original design and the current situation seems to suggest that, at least in the School of Music, the principle of favoring Catalan vaulting over reinforced concrete was actually put into action [1,2]. Nonetheless, further analyses were carried out to validate this hypothesis.

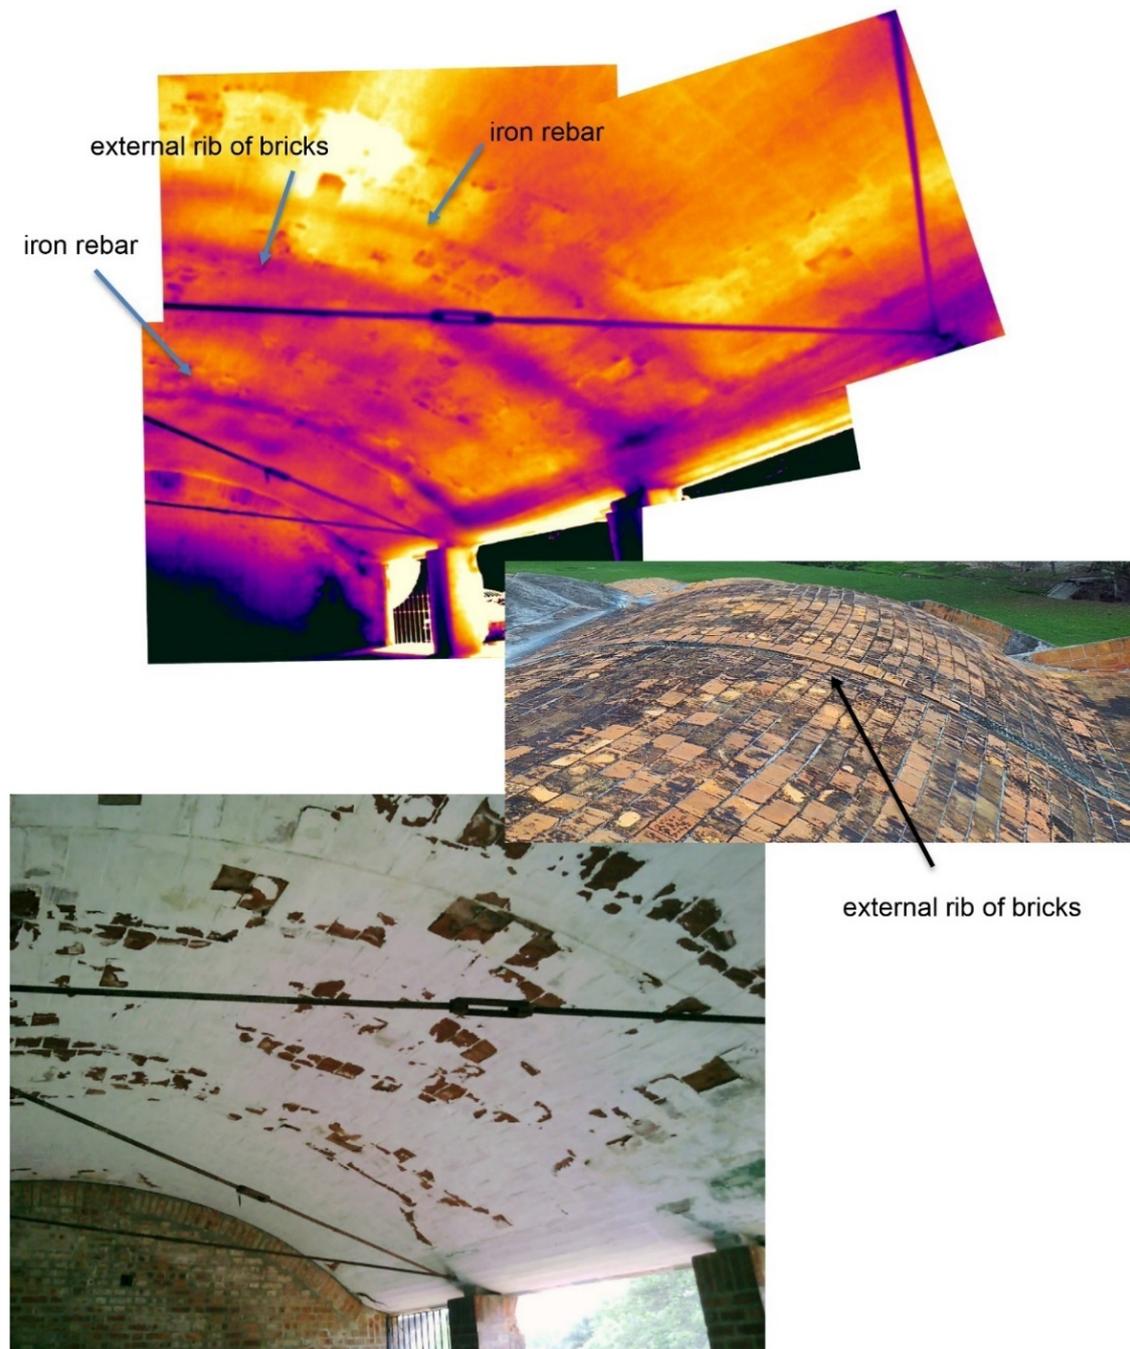
**Figure 22.** Thermographic survey of one of the vaults covering the classrooms located on the upper floor of the gusano building (thermal range 27.1–28.6 °C). The survey was performed on 20 February 2020. Environmental parameters at 1:00 PM: 28.8 °C—RH 68.2% (images by Luca Valisi).

Infrared thermography was fundamental here to visualize what could not be seen by the naked eye. The outcomes of the survey seem in fact to indicate the presence of reinforcing bars hidden in the vaults covering the classrooms of the higher level (Figure 22). It should be noted that such classrooms, designed to host group rehearsals, are much bigger than the individual rooms located on the ground floor, as well as than the corridors. The larger span of the vaults (approximately 5 m) clearly worried the structural engineers who promptly decided to install solid metallic tie rods to avoid their collapse (Figure 20). It was probably for the same reason that the builders saw fit to strengthen the tile vaults with the rebars identified by means of thermal imaging. Although no surveys were conducted on the vaults of the cubicles on the ground floor, their good state of repair (no crack patterns were found, despite the absence of tie rods [71]) suggests that iron rebar might also have been used on the lower level. Unluckily, there are no photographic records of this stage of construction, and we were thus unable to further analyze this aspect.

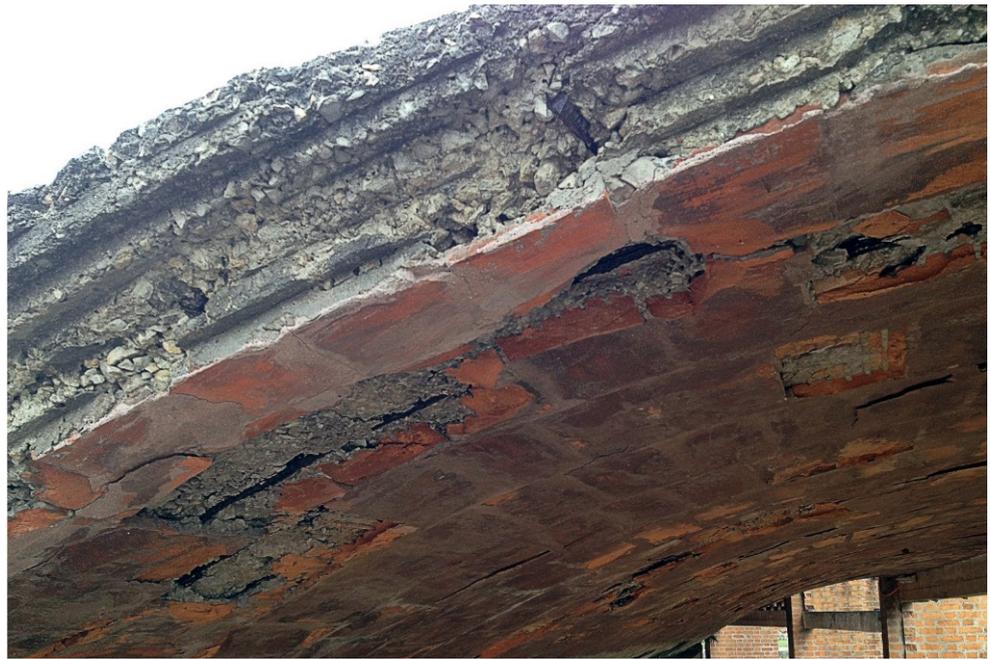
**Figure 23.** One of the vaults replaced with plain concrete vaults. The poor quality of the materials employed resulted in delamination and consequent exposure of steel rebar (photo by Luca Valisi).

While we had to acknowledge that, regardless of the original designs, some of the vaults were not built according to the Catalan technique, uncertainties still remained with regard to the structural system of the corridors' covering, with particular reference to the one on the upper floor. The direct inspection of the building offered some helpful insights on the topic: firstly, it was understood that some sectors of the vault, which had probably collapsed, were completely replaced with similarly shaped reinforced concrete ones. However, the poor quality of the materials employed caused their quick deterioration, and today, due to the diffused delamination of the intrados tiles (which could very well be a consequence of concrete spalling), rebar is largely visible (Figure 23).

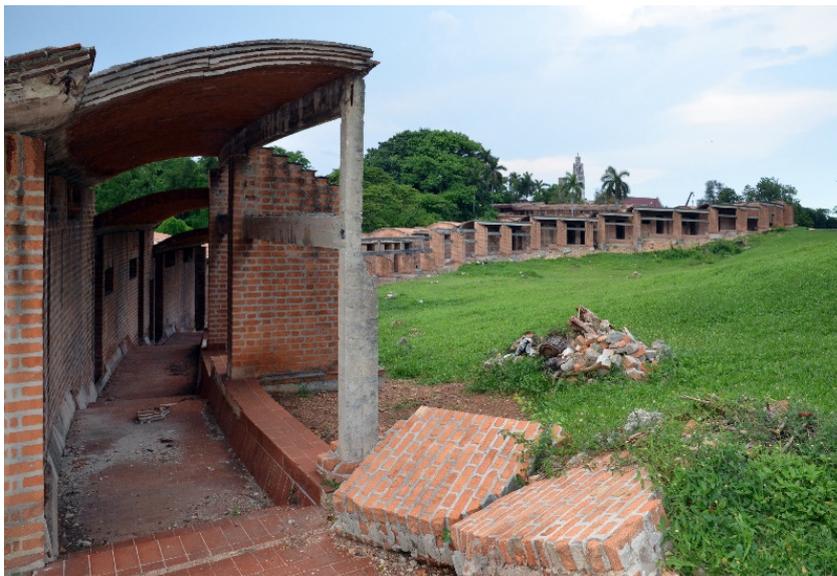
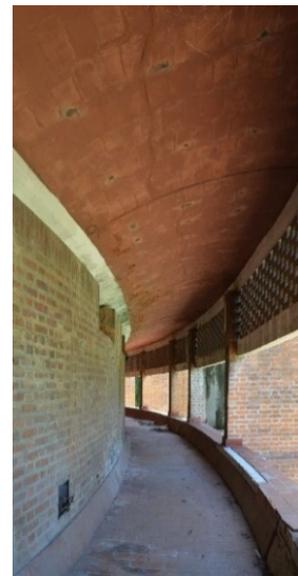
**Figure 24.** The cracks running along the crown of the vaults covering the upper corridor of the gusano building (photo by the authors).

On the other hand, the vaults that were not substituted are not affected by delamination phenomena but consistently show cracking along the crown (Figure 24). The latter represents the typical crack pattern of segmental masonry vaults [72], leading one to believe that the external hallway could in fact be covered—at least in the authentic portions—by true Catalan vaults. This hypothesis is however denied by the outcomes

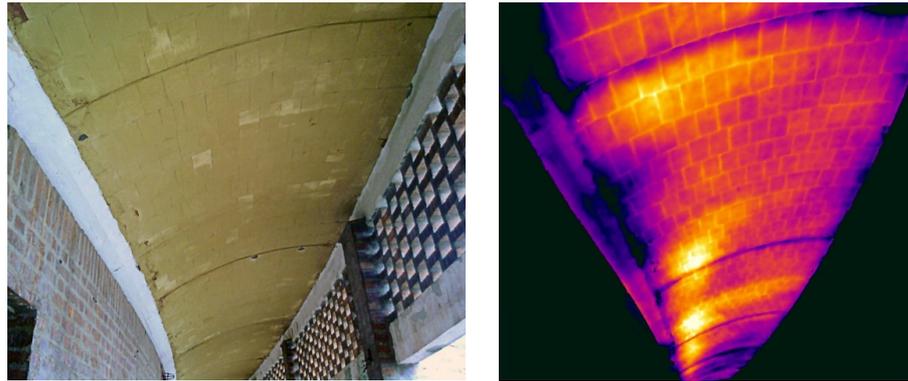
**Figure 25.** Thermograph of the upper corridor (thermal range 27.2–29.1 °C). Survey performed on 20 February 2020. Environmental parameters at 1:00 pm: 28.8 °C—RH 68.2% (images by Luca Valisi).

of the thermographic survey, which seem to display the presence of steel rebar along the vaults (Figure 25). The structural system should thus be similar to that of the smaller vaults of the pasillo of the School of Ballet, which, although not made of reinforced concrete, are strengthened by metallic bars, mostly located in proximity of the joints between adjacent sectors.
