# The Treachery of Images: Redefining the Structural System of Havana's National Art Schools

**Abstract:** This paper illustrates the contribution that on-site survey and graphical documentation offer to the structural comprehension of 20th century architectural and civil engineering heritage and, therefore, to its sustainable conservation. The research herein presented has identified the true structural system of Havana's National Art Schools, an internationally well-known architectural masterpiece that was recently investigated within the drafting of a comprehensive conservation management plan. This iconic complex was built right after the Castro's revolution and was meant to embody Cuba's newfound freedom. To this end, the complex was supposed to be built using Catalan vaulting, a technique loaded with significance due to its provenance, affordability, and flexibility. While most of the literature, the architectural features, and the very designers assert that no concrete nor steel were employed during construction, recent studies suggested that a reinforced concrete core might be hidden behind the masonry-like appearance of the five buildings. The structural analysis performe

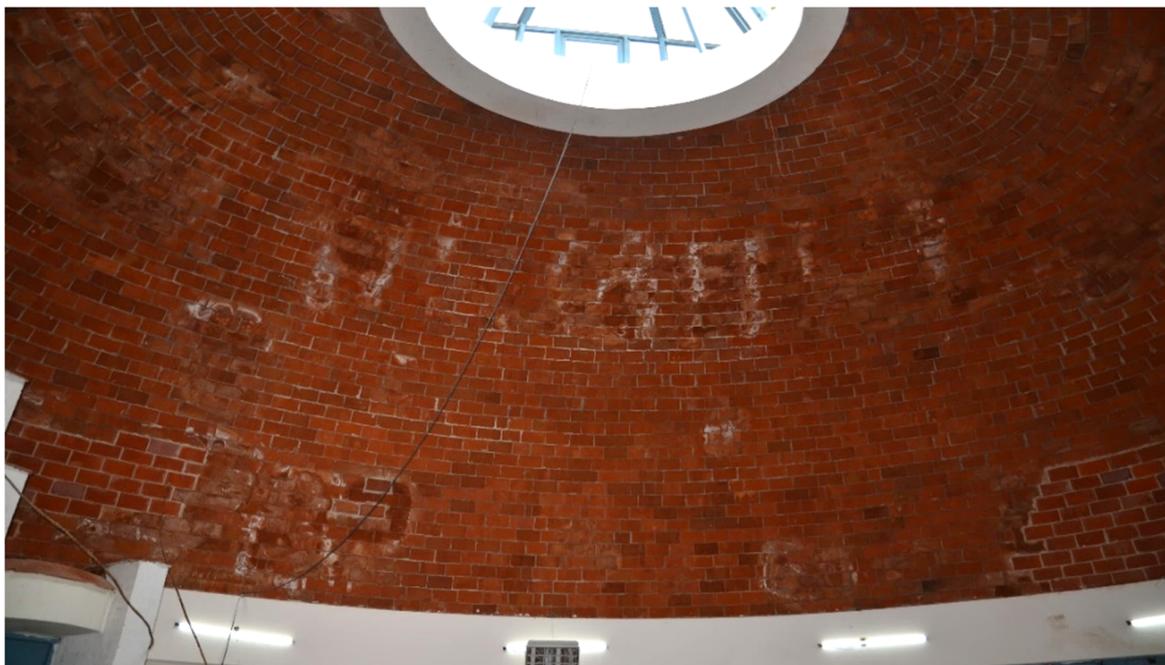
**Figure 26.** Efflorescence patterns at the intrados of the domed classrooms (photo by the authors).

The first suspicions about the true structural nature of the domes covering the school's classrooms aroused during an on-site inspection. While examining the intrados of one of the smaller cupolas, a rather regular efflorescence pattern was noticed on the tiled surface, resembling a sort of grid (Figure 26). With the aim of further analyzing the phenomenon, the few historical records available were scrutinized seeking for clues. The original blueprint collected, strictly regarding the architectural features of the building, did not provide any technical detail, whereas one of the pictures taken during the construction site (Figure 27) seemed to suggest the presence of a hidden concrete framework supporting the domes. Although quite straightforward, the image was not exhaustive, as it only portrayed the summit portion of the dome. Indeed, the empty work forms that can be seen nearby the top could have been owed to the need to strongly fasten the skylight to the vault below and not expand to the whole structure.

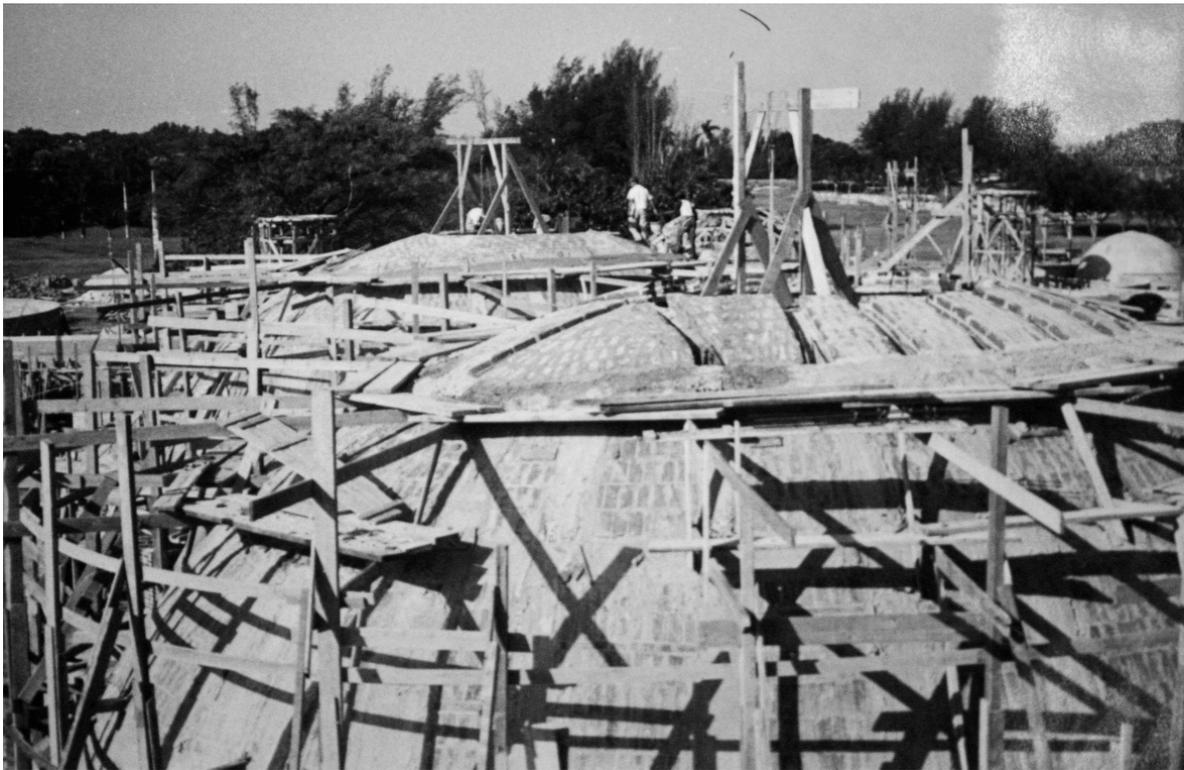
**Figure 27.** The domes of the School of Plastic Arts during construction (ISA archive).

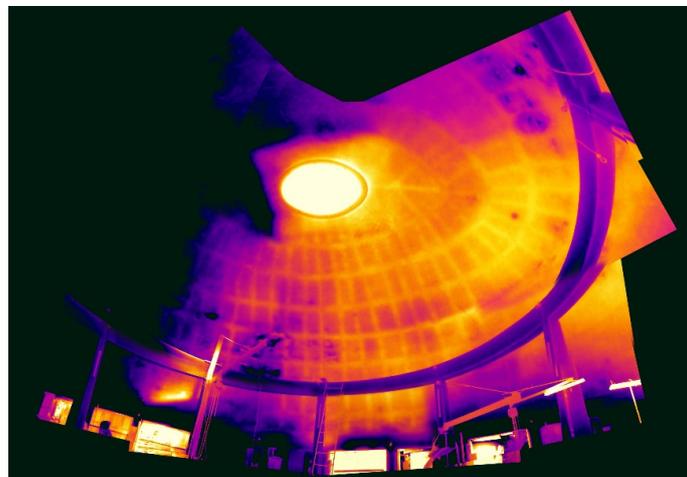
**Figure 28.** School of Plastic Arts: Thermograph of the dome of the foundry (thermal range 28.5–30.4 °C). 19 February 2020 at 1:00 p.m., 29.1 °C—RH 67.0% (Image by Luca Valisi).

As anticipated, the decisive tool to finally identify the construction system of the domes of the School of Plastic Arts was infrared thermography. The concrete grid included in the domes' shells appears neatly in the thermal images (Figure 28), dispelling any residual doubt. The survey was carried out both on the larger and on the smaller domes, detecting the same structural arrangement. However, conversely to what observed in the domes of the School of Ballet, Figure 27 hints at the possibility that the masonry filling the voids of the bearing framework is actually concrete free. As a matter of fact, the photograph seems to indicate that rather than thin tiles, the inner layers were built using full bricks. At the end of the construction process, both the intrados and the extrados of the dome must have been coated with one or more layers of clay tiles, to both hide the concrete ribs and rings to the sight and to increase the overall homogeneity of the structure.

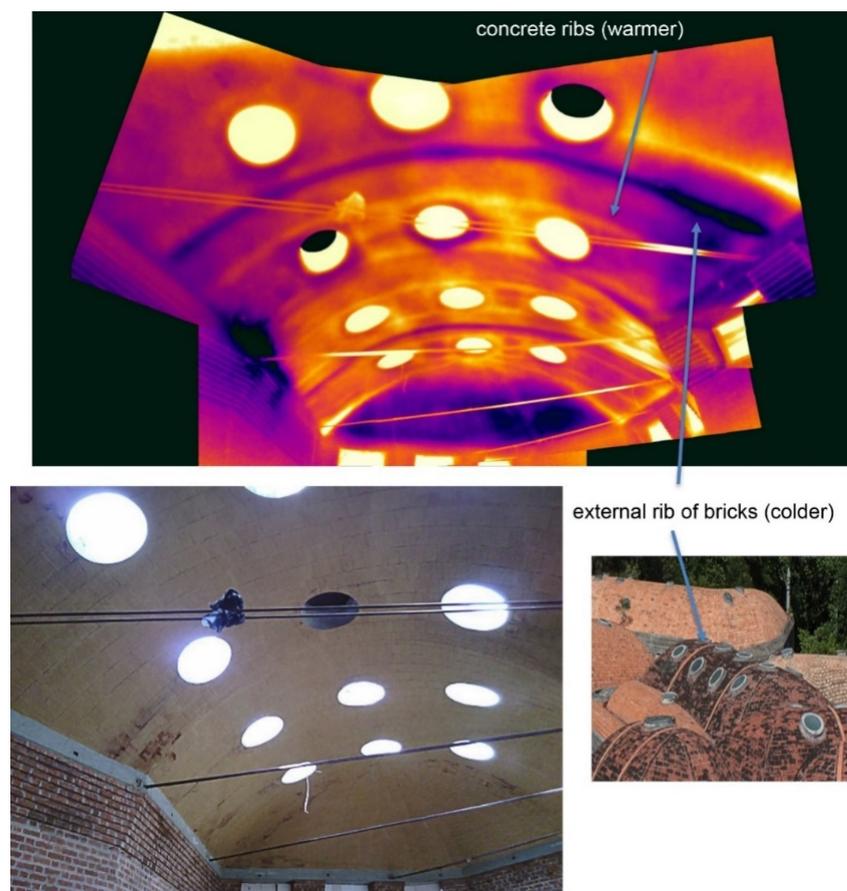
**Figure 29.** School of Dramatic Arts: Thermograph of a vault (thermal range 28.0–30.0 °C). 19 February 2020 at 1:00 p.m., 29.1 °C—RH 67.0% (Images by Luca Valisi).

Finally, Roberto Gottardi's School of Dramatic Arts was also briefly examined. Given the little availability of archival materials, the analysis mainly consisted in a thermographic survey. As expected, the resulting images highlight the presence of concrete elements supporting the masonry-looking vaults (Figure 29). In particular, the ribs appear to run crossway, delimiting and strengthening the strips of the vault where the skylights are located.
