# Living Heritage in the Urban Landscape. Case Study of the Budapest World Heritage Site Andrassy Avenue

**Abstract:** Historic allées and urban avenues reflect a far-sighted and forward-thinking design attitude. These compositions are the living witnesses of olden times, suggesting permanence. However, the 20th century's urban development severely damaged the environment, therefore hundred-year-old mature trees are relatively rare among city avenues' stands. Due to the deteriorated habitat conditions, replantation may be necessary from time to time. However, there are a large number of replanted allées and urban avenues considered historical monuments, according to the relevant international literature in urban and living heritage's preservation. The renewal often results in planting a different, urban tolerant taxon, as seen in several examples reviewed. Nevertheless, the allée remains an essential urban structural element, though often with a changed character. The Budapest Andrassy Avenue, a city and nature connection defined in the late 19th century's urban landscape planning, aimed to offer a splendid link between city core and nature in Városliget Public Park. The 19–20th c

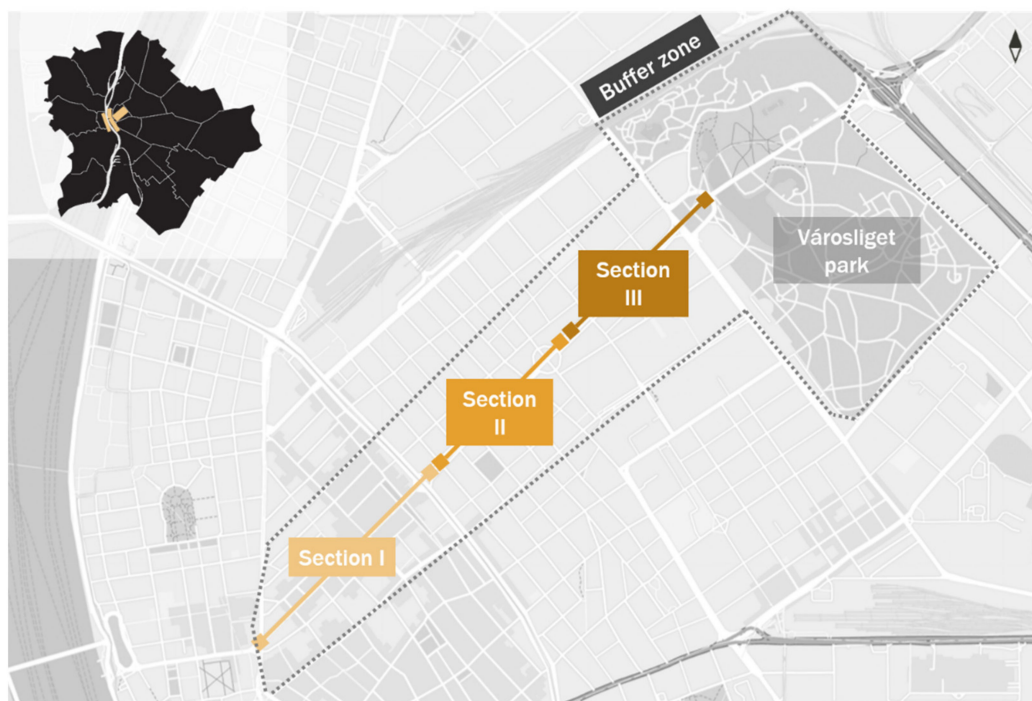
Figure 1. Map of the inner Pest region with the three sections. (edited by Rosa & Lahmar).

Moving back to the Hungarian scenario, the plan of the great Andrásy Avenue had been elaborated by 1876. The promenade is divided into three segments, with a broader space in each part, offering a pleasant and elegant open space suited equally for carriage, horse rides and walks [17] (Figure 1). The greenway consisted of double-tree lines in its first segment running from the city centre. Further, in the second and third sections running through the outskirts, the plantation formed  $2 \times 2$  lines in the even broader cross-sections. This exquisite design symbolised the experience of arriving from Town to Nature; the latter represented by the first urban public park, the City Park of Budapest, designed by H. Nebbien in classical landscape garden style. The approximately 2km-long avenue offered the green corridor of almost 600 plane trees (*Platanus × hybrida*), the same species used in the Városliget's allées and clumps [18,19].

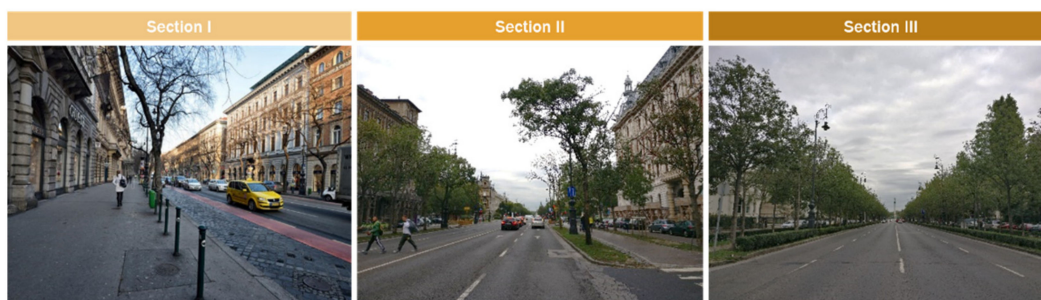
**Figure 4.** The three sections and their typical urban landscape character. (Section 1. *Celtis occidentalis*; Section 2. *Fraxinus excelsior*; Section 3. *Fraxinus excelsior* 'Westhof's Glorie'. (edited by Szilágyi, K.; source: <https://www.nomadepicureans.com/europe/hungary/free-budapest-walking-tour-self-guided/> (accessed on 27 February 2021)).

The first section, or inner part, comprehends Bajcsy-Zsilinszky—Oktogon; the second, middle part, is from Oktogon to Kodály körönd; the third, outer part, extends from Kodály körönd to Heroes Squares. Within the main sections, we can differentiate subsections bordered by crossing streets and the two main squares—Oktogon and Kodály körönd—and the Heroes' Square at the City Park termination (Figure 4).

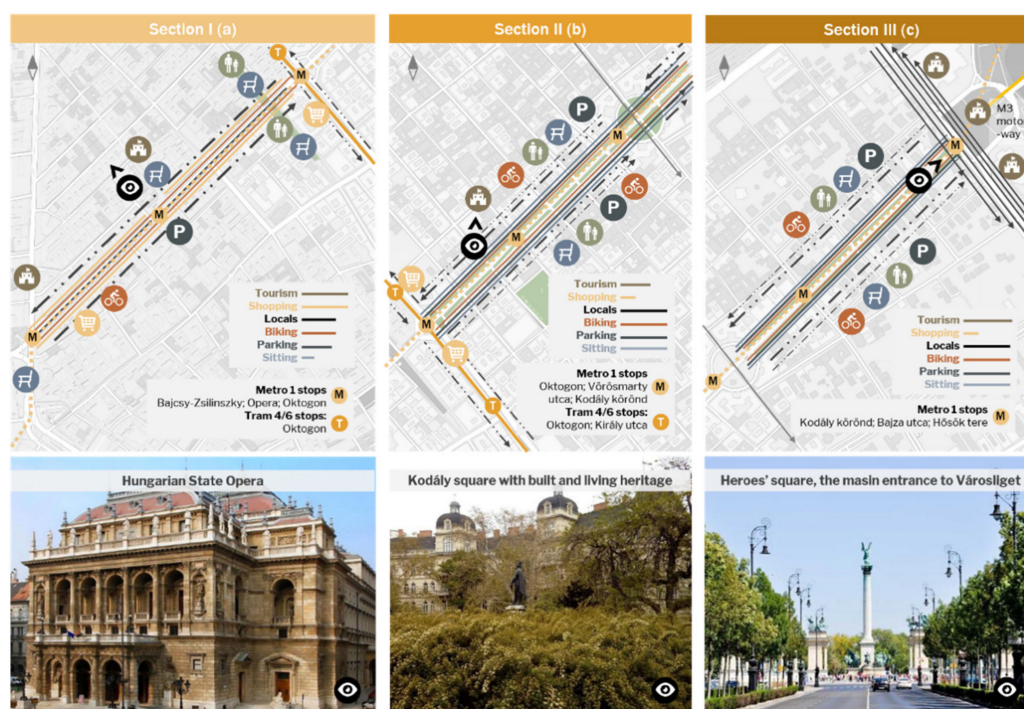
**Figure 5.** Urban context, functions, monuments and character; (a) Section 1; (b) Section 2; (c) Section 3. (edited by Rosa & Lahmar; sources: <https://pocketoz.com.au/suitcase/dest-budapest.html> (accessed on 27 February 2021); <https://www.budapesttips.co.uk/budapest-attractions/opera-budapest/> (accessed on 27 February 2021)).

The research findings for the urban land use and functions show that Section 1 has an imposing metropolitan atmosphere, together with strong commercial and cultural values, high tourism activity and internationally famous brands' shopping stores (Figure 5a). With a significant profile change, Section 2 presents an increase in urban green character. Consisting of more residential and educational buildings and with a double tree-lined promenade on each side, this part still has a high tourism activity (Figure 5b). From Kodály körönd square to Városliget (City Park), in Section 3, the avenue reflects a more "natural" atmosphere. There, detached housing and villas' gardens resemble a significant increase of green coverage. Continuing with the doubled tree-lined promenade, many buildings here function nowadays as embassies, institutions, hotels, museums, and restaurants, maintaining the tourism activity (Figure 5c).

Regarding the allées traffic & functional connections, Andrassy can be considered an urban motorway with heavy traffic throughout. Starting at Bajcsy-Zsilinszky, the first section with a 34m width consists of the main road (2 + 2 traffic lanes) and a 1 + 1 bike lane, up to the Oktogon (Figure 5a). The 45.5 m wide second section progresses to Kodály körönd with the main road plus 1 + 1 service roads and 1 + 1 bike lane (Figure 5b). The width and traffic lane structure is similar in the third section, but the residential villas' front gardens add extra green to the urban landscape. (Figure 5c). Furthermore, there is no bus line, except for tourism buses going to and from Heroes square. Multiple stops of the metro line 1 are also present, connecting the city centre to the Városliget Park and beyond.

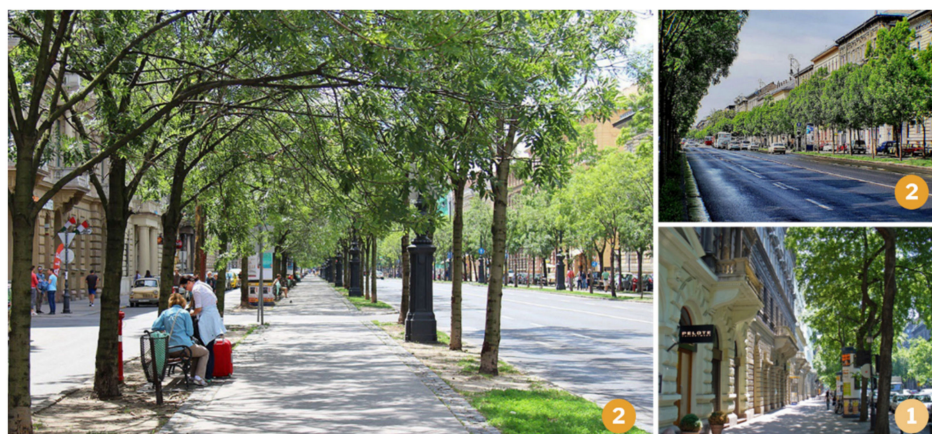
All along Andrassy Avenue, the urban habitat and the trees' vulnerable condition are negatively impacted by the urban context and functions (Figure 6). The dense traffic, four-five-storey high buildings (typically in Section 1) causing sizeable shaded area together with compacted and polluted soil and artificially restricted place for the root system resulted in severe damages, like heavily tilted trunks and deformed crowns. The century-old hackberry trees need regular crown shaping maintenance to improve stability.

**Figure 6.** Stressful urban habitat along Andrassy Avenue, Section 2. and 1. (edited by Rosa & Lahmar; source: <http://holpihenj.com/andrassy-ut/> (accessed on 27 February 2021)).

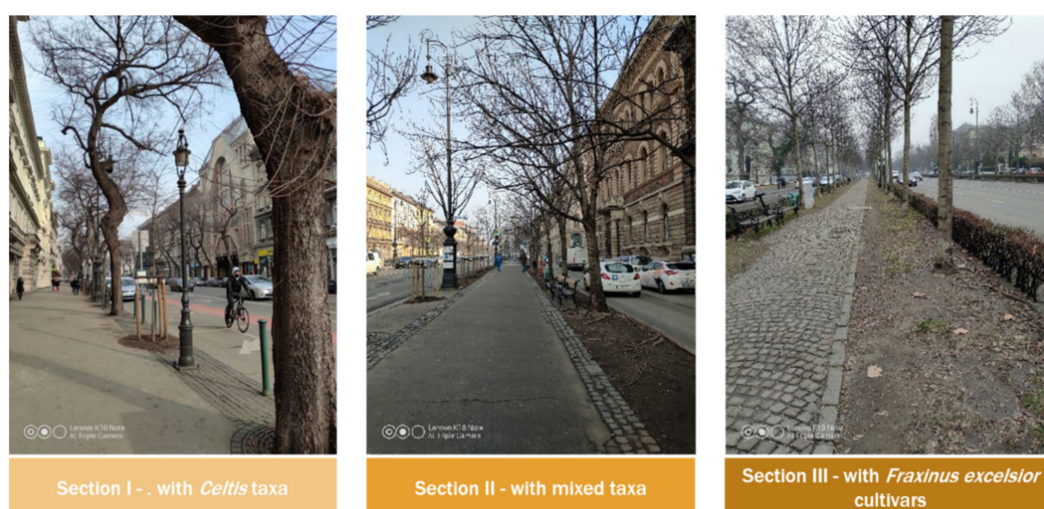
There are different tree-planting situations in the three sections, which strongly determine the life cycle and lifespan and their decorative character and health conditions (Figure 7). The examined trees were 816 in three sections and two squares among different states (Table 1). In terms of individual numbers, the data are as follows: Ten trees stand in the four green islands of Kodály körönd square; 13 trees are in Oktogon square along the pavement. The first section contains 182 trees in two rows (A-95, B-87), the second section has 274 individual trees in four lines (A-74, B-68, C-59, D-73), and the third section has 337 trees in four lines (A-92, B-81, C-77, D-87). In Sections 2 and 3, the inner rows (B and C) are significantly weaker because of the traffic disturbance and have much fewer trees than the outside lines.

**Figure 7.** Urban allée's habitat in the three sections from the strictly urban to a moderate urban green space, 2021 January. (photo: Szabó, K., 30 January 2021).

The root growth is severely limited in the first section because of small tree pits ( $1 \times 1$  m). In the case of older individuals, the roots push into the tree grates and covers. Due to the lack of space and the buildings' shading, the trunks are oblique, and the crowns asymmetrical.

In the second section, the trees grow in narrow green stripes without protection against trampling, compaction, salting, etc. The roots of medium, adult, and old trees are visible on the surface due to maintenance problems. Despite the intensive pedestrian use, the maintenance insisted on creating and keeping up green surfaces; as all plantation and greening efforts failed, artificial grass cover supplied the green surface colour without supporting, regulating green ecosystem supply. The roots started to grow upwards in the absence of sufficient oxygen. The artificial irrigation system, keeping the perennials' plantation, also motivated the root system towards surface growth. The wide pathway between the two green stripes is not water permeable. The narrow plantation line has no protection against winter salting, causing severe damage along the traffic road lanes. Salting material, dangerous for young trees' root system, has a high chlorine emission into the absorption zone. Thus, the overall environmental condition is deficient in Section 2, resulting in many trees dying out or felling.

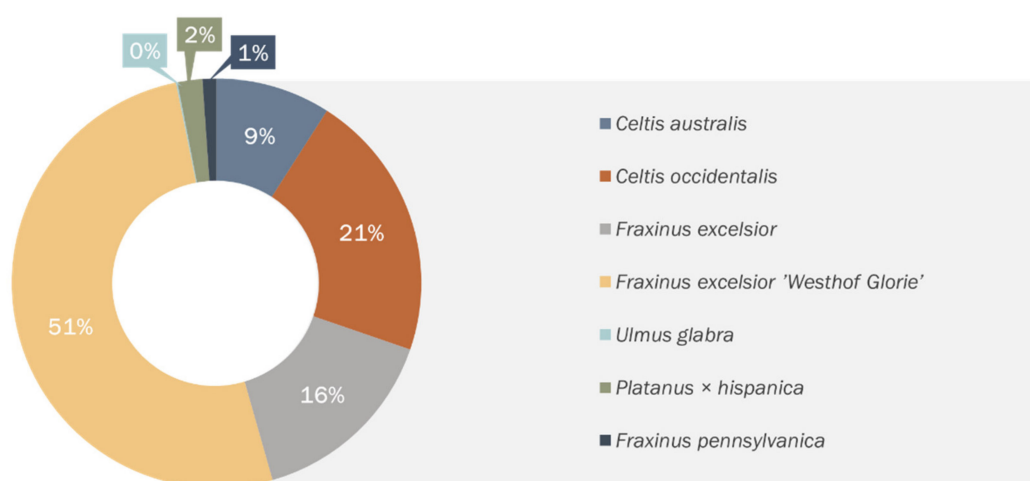
Seven different taxa live nowadays in the allée owing to several reconstructions and renewals (Figure 8). There are still some old individuals, such as the sycamore trees (*Platanus* × *hispanica*) from the first plantation on Kodály körönd square, and in the second section from the replantation program after WW1. Old *Celtis* trees are still in Section 1, and one single old elm tree (*Ulmus glabra*) planted in 1949 stands in the middle area. Hackberries (*Celtis* spp.) grow in the squares too. The first and second sections show a great variety in the time dimension.

**Figure 8.** Taxa variety in Andrassy Avenue. (edited by Szabó, Rosa & Lahmar).

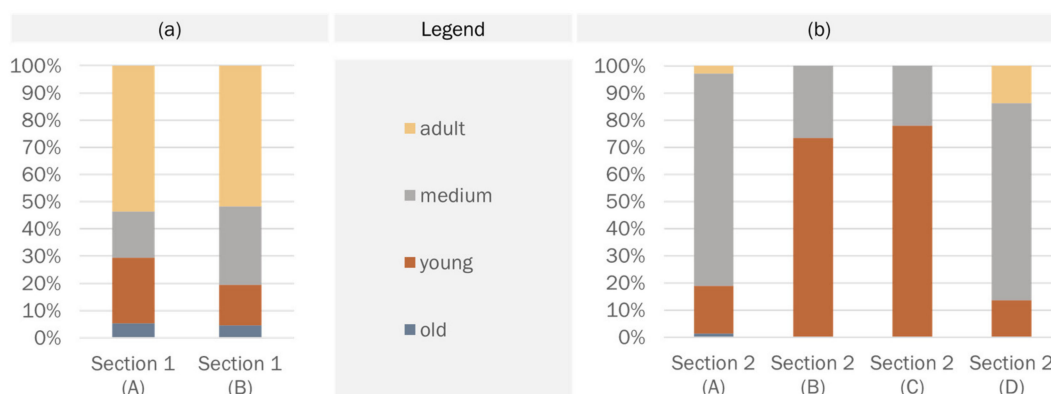
The oldest trees live in the Kodály körönd square, while the youngest individuals stand in the second section. The age difference between the oldest and the most immature trees is around 150 years. In many cases, the difference is about 70–80 years. Many trees had to be replanted in the past decade owing to severe environmental load and plant protection problems. The proportion of young or freshly planted trees is high in Section 2, line B and C (Figure 10a,b).

**Figure 10.** Tree's age variety; (a) Section 1; (b) Section 2. (edited by Szabó, Rosa & Lahmar).

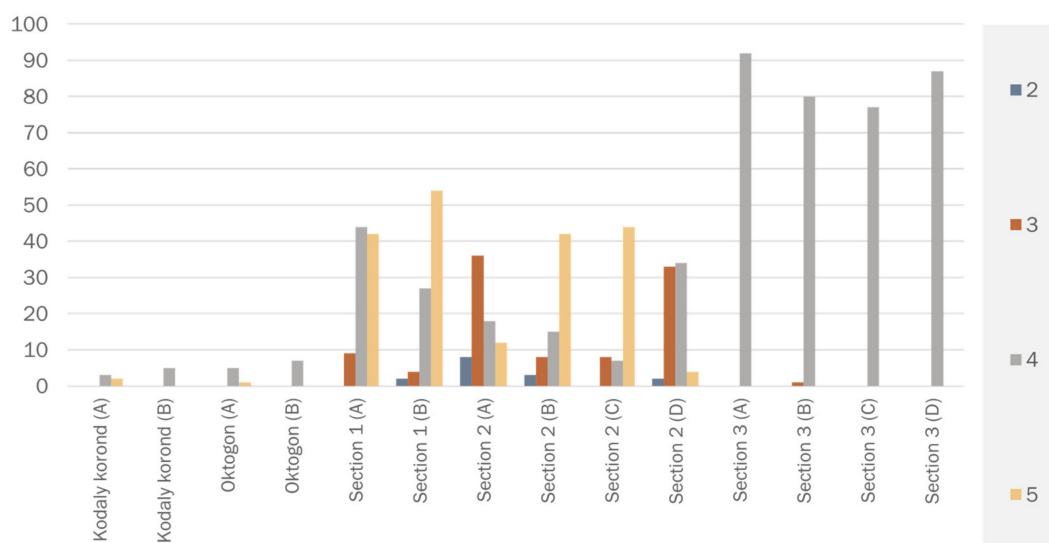
Based on Rado's value (see Appendix A), the relationships of roots, root collars and planting circumstances are different among places and sections. Individuals who did not show any abnormal symptoms (ground cracks, root congestion, girdling roots, damaged roots, bark, phloem, xylem injury, fungal infection, etc.) received excellent values. The highest value (5) is characteristic in the second section due to the many new replanted

trees; good and medium values are typical in the first section thanks to healthy rooted individuals (Figure 11).

**Figure 11.** State of the root system in the studied area. (edited by Szabó, Rosa & Lahmar).

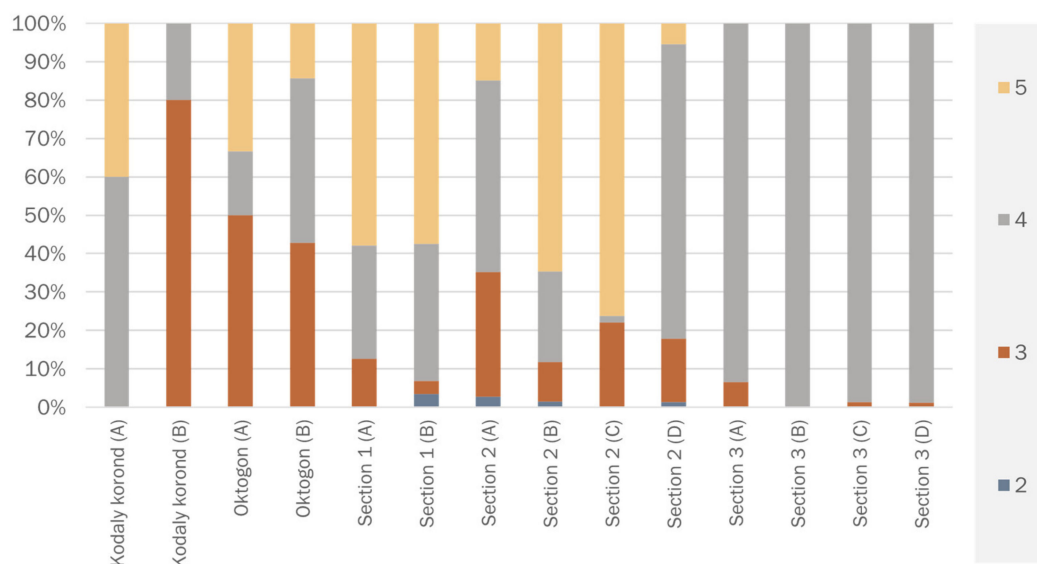
The trunk condition shows relatively high values. Severe wounds, damages, and serious injuries are infrequent (Figure 12). Values B in Appendix A.

**Figure 12.** Correlations of the trunk values in the studied sections. (edited by Szabó & Rosa & Lahmar).

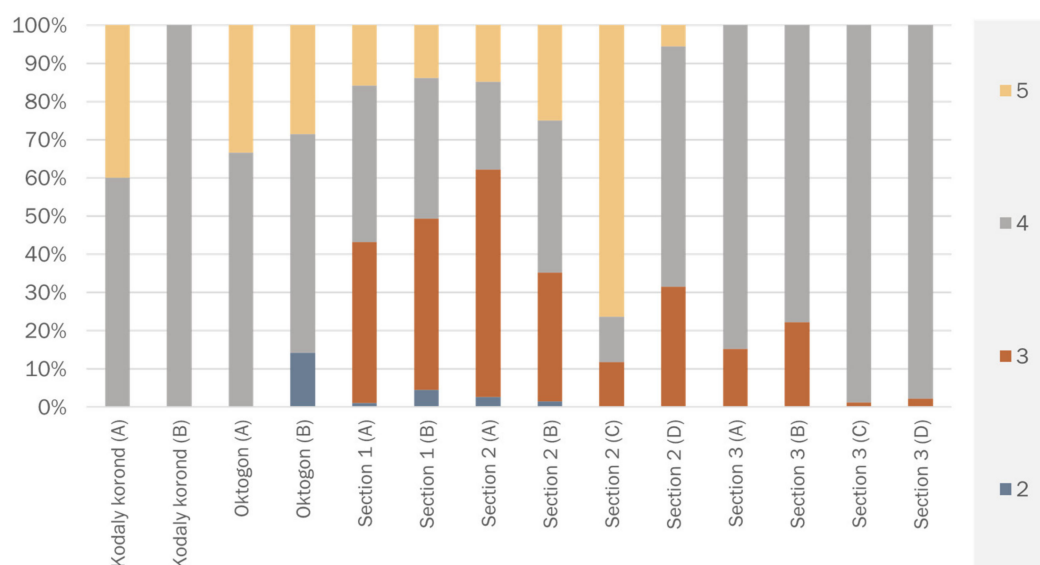
The crown shape and size depends on location and retention condition. If root development is limited, water absorption and the nutrient transition is also limited, and the crown shows a less decorative value than the ideal. A value of 5 is scarce, almost only in the case of a new plantation as in the inner row C in Section 2 (see in Figure 13). Value 2 occurs in some individuals with foliage loss of more than 50% and severe crown damages. Value 4 reflects a good tree stand with a foliage loss of 11%–25%. We found many weak

crowns in (values 3 and 2) Section 2 during the survey, where replantation is necessary within five years.

**Figure 13.** Correlations of crown values in the studied sections (value C in Appendix A). (edited by Szabó, Rosa & Lahmar).

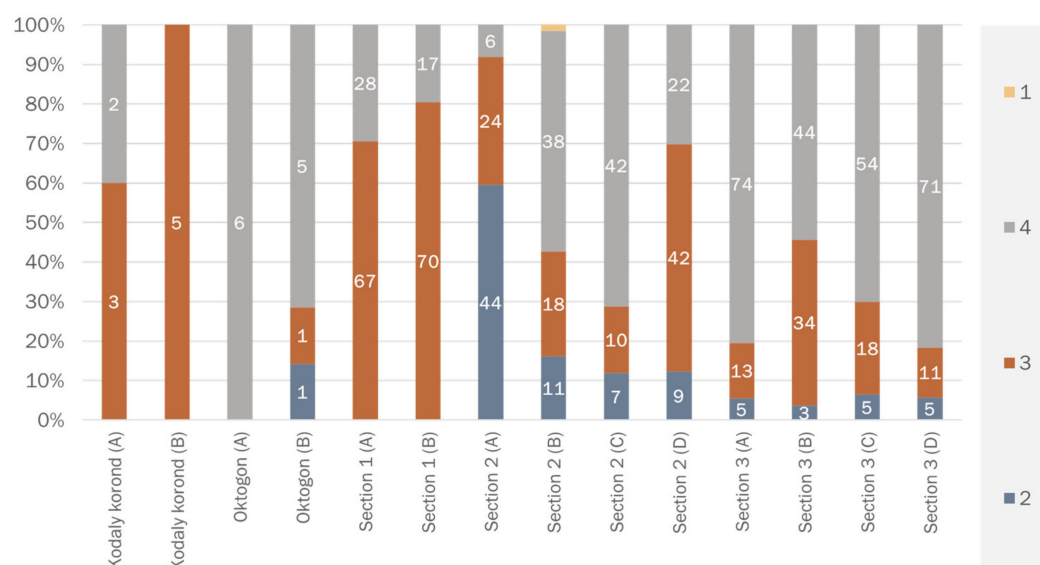
The vitality is a complex value, and it is difficult to determine, as assumptions are needed regarding future habitat conditions. Trees planted in congested urban environments, especially when planted in a tree pit, cannot survive without proper maintenance. Thus, only in exceptionally optimal cases did the individuals receive a rating of 5 (excellent) for their vitality; otherwise, trees with good values received only 4 (it can reach maximum age by intervening). At the time of our study, only one individual needed urgent removal (values 1) (Figure 14).

**Figure 14.** Correlations of vitality values in the studied sections (value D in Appendix A). (edited by Szabó, Rosa & Lahmar).

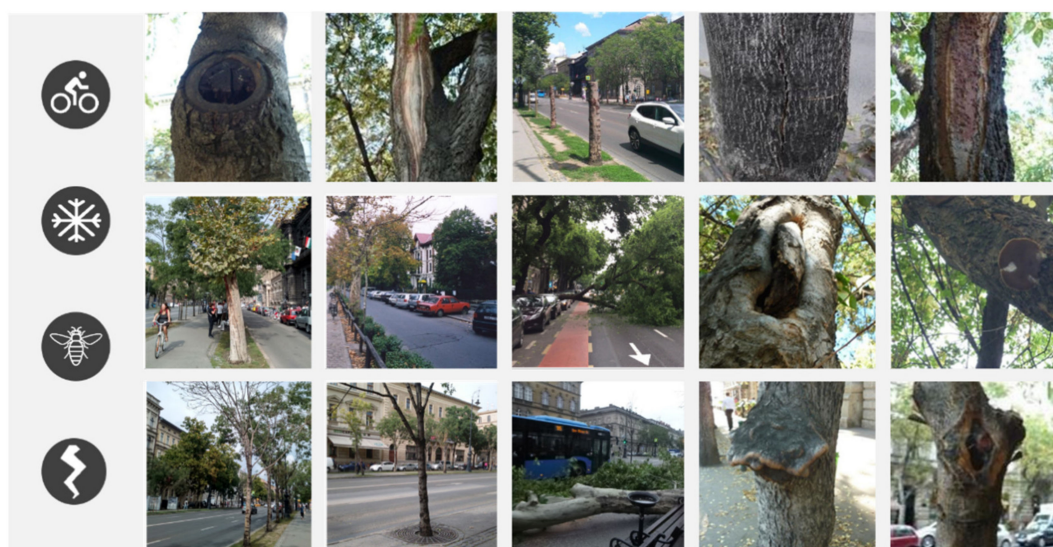
The professional maintenance experienced a 15-year decrease in life expectancy due to the polluted and disturbed urban environment. This is the second section's very situation so far (Figure 15).

**Figure 15.** Trees' damages, diseases and accidental falls. (edited by Szilágyi, Rosa & Lahmar; photo: Szilágyi, Szabó, Rosa, Lahmar, Szaller, 2010, and online source: <https://www.fokert.hu/andrassyut/> (accessed on 15 October 2020).

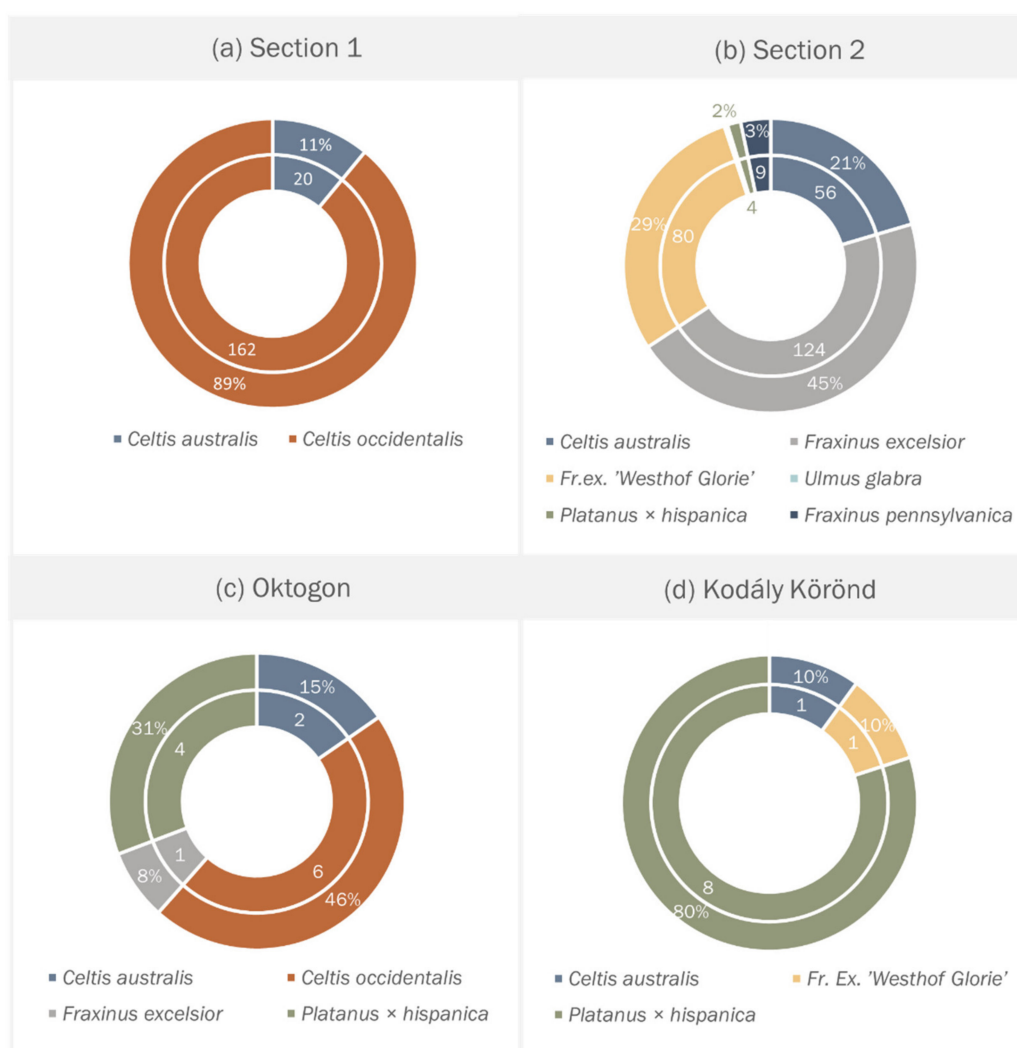
The planted tree species are very different along Andrassy Avenue except for Section 3 (Figure 16). Still, there is no relationship among the number of individuals, tree species and various areas. The tree diversity is due to previous plantations' abandoned specimens, the extent and replacement of dead trees owing to environmental burden and conditions, and different professional considerations. Section 1 has a characteristic, mature *Celtis occidentalis* allée with more and more dying trees. Still, thanks to intensive maintenance, tree pits do not remain empty for a long time. In Section 1 and even in Section 2 with a new taxon, *Celtis australis*, the replantation went on here, hoping to maintain a healthy allée for a longer time. Section 2 seems the most confused and mixed in the number of taxa (six different taxa in two rows), the age and the quality context. Section 3 is homogenous according to the taxon and the age resulting from the last renewal program, but the condition is not so much promising. *Fraxinus excelsior* 'Westhof's Glorie' was considered urban tolerant in the early 2000s. Since then, the plantation's state has questioned this professional statement.

**Figure 16.** Tree's taxa variety (percentage and number of individuals); (a) Section 1; (b) Section 2; (c) Oktogon; (d) Kodály Körönd. (edited by Szabó, Rosa & Lahmar).

Section 1 has a characteristic, mature *Celtis occidentalis* allée with more and more dying trees; thanks to the intensive maintenance, tree pits do not remain empty for a long time. In Section 1 and even in Section 2 with a new taxon, *Celtis australis*, the replantation went on here, hoping to maintain a healthy allée for a longer time. Section 2 seems the most confused and mixed in the number of taxa (six different taxa in two rows), the age and the quality context.

the quality context. Section 3 is homogenous according to the taxon and the age resulting from the last renewal program, but the condition is not so much promising. *Fraxinus excelsior* ‘Westhof’s Glorie’ was considered urban tolerant in the early 2000s. Since then, the plantation’s state questioned this professional statement.
