# Mitigating Harmful Effects of Climate Warming on Ceiling Paintings by Ceiling Insulation: An Evaluation Using Timed IR Imaging and Numeric Modelling

**Abstract:** Due to climate change, ceiling paintings in many historic buildings are subjected to increasingly high short-term temperature change, resulting in high thermal tension caused by the construction assembly. This article focuses on the combined use of timed IR imaging and numeric modelling to evaluate insulation measures on the upper side of a ceiling to reduce thermal tensions in the painting layers, overheating in summer as well as cooling down in winter. As a model room, the southern splendour stair hall in the Burgtheater Vienna was chosen. Famous ceiling paintings created from 1886 to 1888 by Gustav Klimt and his brother Ernst Klimt can be found on this ceiling. The results show that timed IR imaging is an adequate tool to study the transient thermal behaviour of ceiling paintings which are not accessible to standard sensor measurements. Moreover, it could be shown that the presented measurement technique is well suited to validate a numeric model. The latter was applied to evaluate the potential insulation on the to

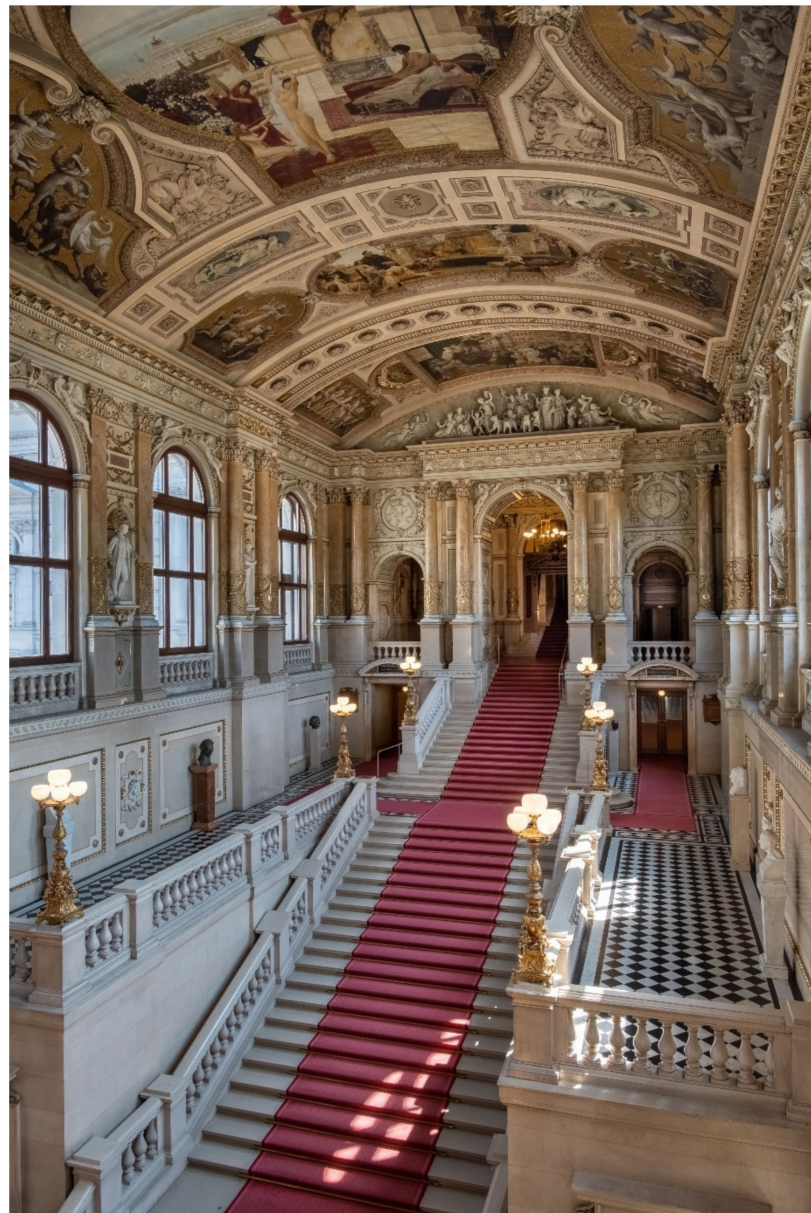
**Figure 1.** Splendour stair hall of the Burgtheater with ceiling paintings created by Gustav Klimt [24].

The building consists of the central theatre and two spacious stair halls with a barrel vault (Figure 1). Its construction is a clasps construction with brickwork fillings. A similar vault construction can be found in the Museum of Natural History in Vienna, which was erected at the same time as the Burgtheater [22]. The metal construction likely consists of wrought iron because the use of Martin steel for such constructions was obligatory not before 1894 in the Danube Monarchy [23].
