Post Evaluation of Slope Cutting on Loess Slopes under Long-Term Rainfall Based on a Model Test

Abstract: The failure of treated slopes around the world, especially in China, is occurring at a noteworthy rate, resulting in an urgent requirement for post evaluation of the treated slopes; however, there is no mature technique established for post evaluation. By using a real loess slope treated by slope cutting in Shaanxi Province as the prototype, indoor geotechnical tests and model tests were performed to reveal the rainwater infiltration characteristics and pressure-varying characteristics inside the slope, the results of which were used to conduct a post evaluation of the slope in situ. The results mainly showed that the effect of rainwater scouring on the slope surface weakened gradually into a steady state at the end of the first year. The rainwater upon the slope surface preferentially infiltrated the platforms with gradually reducing rates; however, the observed wetting front cannot be regarded as the border between the unsaturated and saturated loesses. The soil pressures inside the slope did not increase, but decreased during the early period of rainfall. The displacements

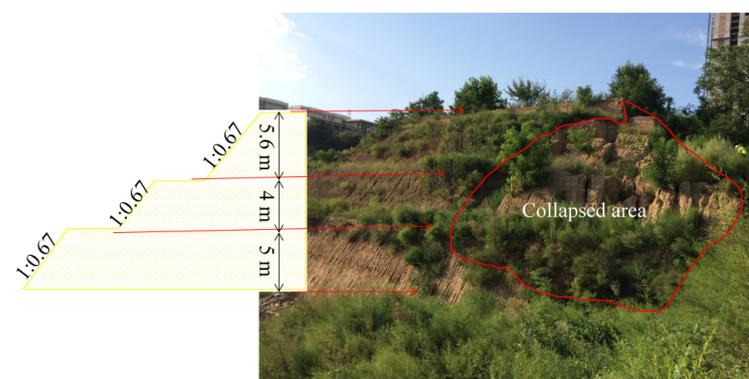
Figure 2. Slope prototype section with collapse.

Located on the Loess Plateau, the loess slope included in this study was treated by slope cutting, and has a group of houses on the crest. From the field investigation, the slope wholly consists of loess formed in the late Pleistocene epoch. As Figure 2 illustrates, the slope prototype was 7.6 m high, and was cut into three grades of the same gradients 56° . The first grade was 5 m high, while the second and the third grades were 4 m and 5.6 m high, respectively. The widths of the second and third grade platforms were both 3.8 m, while the length of the slope was approximately 38.7 m. With the gully close to the right of the slope, the slope was excavated inward by the rainwater vented by the gully, eventually forming the collapse area (see Figure 2).

According to the field investigation performed on 20 August 2017, this project was built in approximately 2012 and ran for approximately 5 years. After a long run, affected by rainfall, the slope had main damage on its right side (see Figure 2). From the above, it can be considered that this slope prototype was composed of homogeneous loess and was in operation for a relatively short period; however, a major collapse was caused by rainwater scouring. Thus, it was reasonably chosen as a typical loess slope treated by slope cutting, which was destroyed by rainwater, as this study concentrated on the effect of rainfall on the treatment effect of loess slopes under slope cutting regardless of other factors, such as geological conditions. To conduct the post evaluation of the current loess slope through a model test, it was determined that the total simulated duration should be 5 years to be consistent with the actual running period. According to the similarity theory, the simulated time can be shrunk by 100 times, allowing the model test to be finished in a reasonable duration.

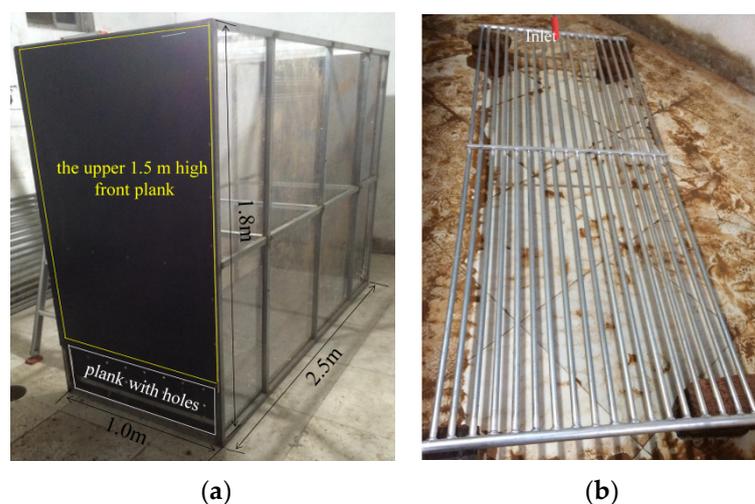
Figure 3. Model test box and rainfall simulator: (a) Model test box, (b) Rainfall simulator.

The model test was performed in the Soil Mechanics Laboratory of Shangluo University, China. From the report of Liu et al. [42], a model box with a width of 1 m, length of 2.5 m and height of 1.8 m was used in the test (see Figure 3a). The box walls of the left and right sides were made from organic glass, allowing the displacements inside the slope model to be captured by the camera. The base, front and back walls of the box were all made from planks, while the upper 1.5-m-high part of the front plank was removable, allowing the model slope surface to be free.

The rainfall simulator was a steel frame with drilled holes of 1 mm in diameter on one side. A valve connected the rainfall simulator to the water source (see Figure 3b) and adjusted the rainfall intensity. Before the start of the experiment, the simulating rainfall intensity was calibrated to a certain value according to the real rainfall, in which a beaker and measuring cylinder was adopted as the calibrator. The rainfall intensity calibration steps were as follows: (1) three beakers were placed under the rainfall simulator at different positions after the valve connecting the water pipe and the rainfall simulator was opened; (2) the three beakers were moved out five minutes later, and the water volumes contained within them were measured by the cylinder; (3) the rainfall intensities of the three positions were calculated as the corresponding water volume divided by the cross-sectional area of the beaker; (4) the average rainfall intensity was calculated from the rainfall intensities of the three positions; and (5) if the average rainfall intensity did not equal the required value, the valve opening was adjusted, and the steps above were repeated until the required rainfall intensity was achieved. Additionally, from the collected water volumes in the three

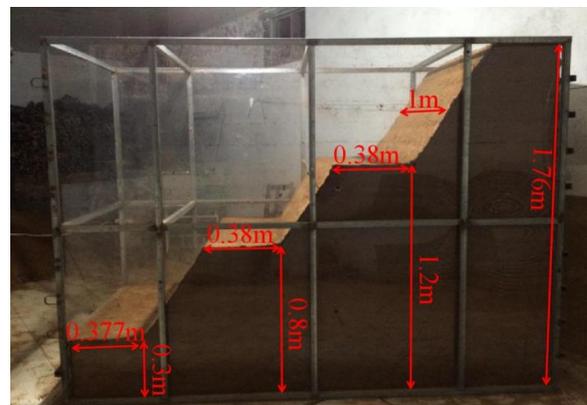
Figure 4. Slope model.

The current slope model was built to fully correspond to the prototype slope in Luochuan County, Yan'an City, Shaanxi Province, as depicted in Figure 1. With a scale of 1:10, the height of the model slope was 1.76 m, while the length of the model was 2.5 m. The three platforms of the slope model were approximately 0.38 m, while the gradients of the three grades of the slope were exactly 56° , identical to the slope prototype. In full correspondence with the slope prototype, the first, second and third grades of the slope heights were 0.5 m, 0.4 m and 0.56 m, respectively (Figure 4).

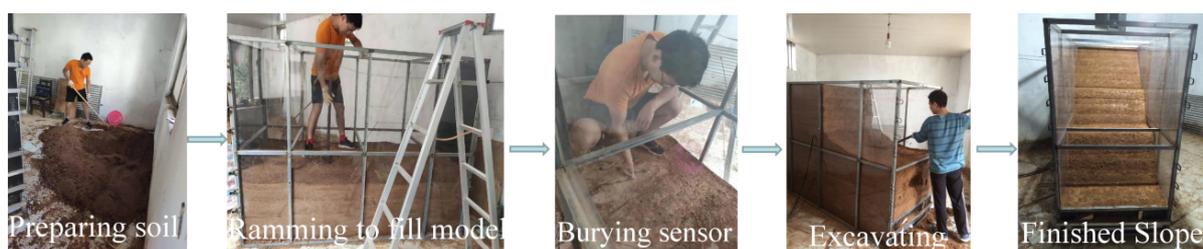
Figure 5. Slope model construction process.

As Figure 5 shows, building the slope model was a complex process and it can be expressed by the following:

The loess obtained from the slope site was prepared such that it had an identical water content to the prototype slope ($\omega = 17.4\%$), and then, a certain mass of the prepared loess was added to the model box as a layer, which was compacted to the thickness of 10 cm.

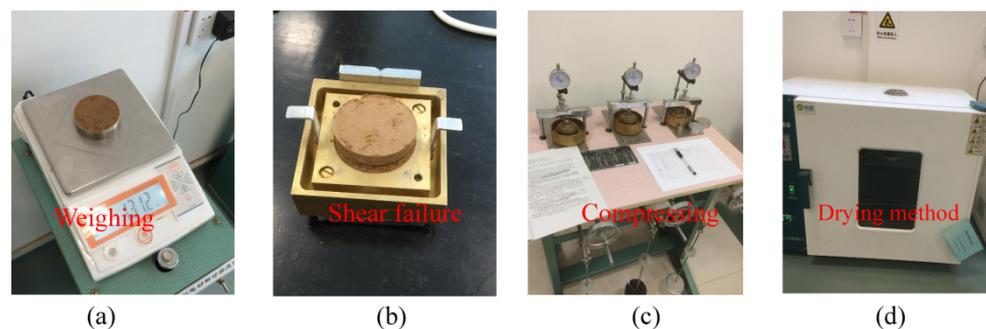
Figure 6. Photos of indoor geotechnical tests: (a) Density test, (b) Direct shear test, (c) Compression test, (d) Water content test.

It is noteworthy that the parameters in Table 1 were obtained from geotechnical tests conducted according to Liu et al. [42]. The water content of the soil was taken from the water content experiment using the oven drying method. The permeability coefficient of the soil was obtained from the standard permeability test of varying head. The soil density was obtained from standard ring knife tests. The compression modulus of the soil was measured by the compression test. The cohesion and internal friction angle of the soil were obtained from the direct shear test of quick shear, as the quick and sudden failures of loess slopes usually happen under rainfall. For the sake of clarity, the geotechnical test process is depicted in Figure 6.

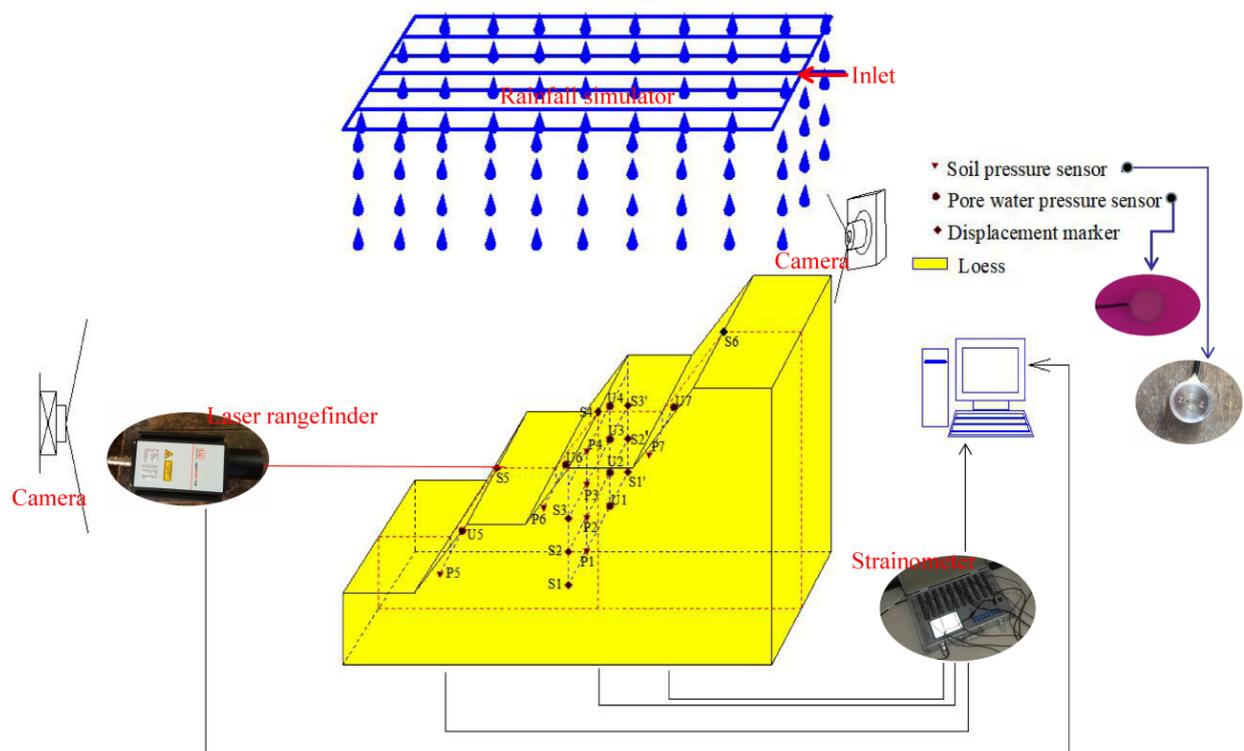
Figure 7. Full dimensions of the model slope and layout of the measurement points.

were seated 10 cm under the slope toes of the first, second and third grades, respectively. To facilitate meaningful results, the soil pressure sensors P1, P2, P3, P4, P5, P6 and P7 were buried at identical positions with those of U1, U2, U3, U4, U5, U6 and U7, respectively. A strainometer was connected to the pressure sensors, and converted the pressures into digital signals for the computer to store. Although the model test analyzed a planar problem, the pressure sensors were seated close the axial plane of the model to deliver more reliable data [42].

Three displacement marks were set at the three slope shoulders, which are shown in Figure 7 as S5, S4, and S6 at the first, second and third grades of slope shoulder, respectively. Three points were marked by colored sand particles close to the right wall of the model box to measure the inner displacements of the model slope, which were S1, S2, and S3. Similarly, three displacement marks, S1', S2' and S3', were set by colored sand particles close to the left wall of the model box, corresponding to the positions of S1, S2 and S3. To obtain meaningful data, the depths of S1 (S1'), S2 (S2') and S3 (S3') were the same as those of P1, P2 and P3, respectively, as shown in Figure 7. The displacements of the marked positions were defined as the distance differences before and during rainfall, which were measured by a laser rangefinder fixed in front of the model slope. A computer connected to the laser rangefinder was used to display the distance data. It is noteworthy that the accurate displacement of S1 was the average displacements of S1 and S1', and the same applies for S2 and S3.

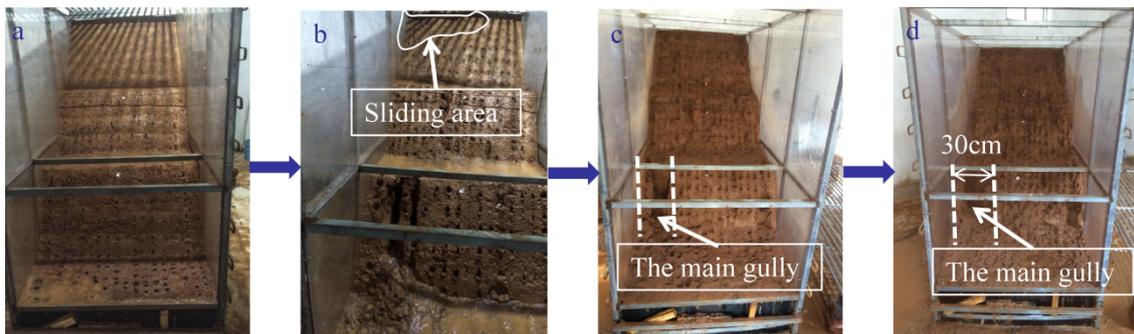
Figure 8. Scour failure process during three rounds of rainfall: (a) First round of the first rainfall event lasted for 5 min, (b) First round of the first rainfall event lasted for 70 min, (c) First round of the second rainfall event lasted for 120 min, (d) Third round of the third rainfall event lasted for 120 min.

Figure 8 presents the scouring process of the slope model during rainfall. Evidently, the scouring effect in the first round was very significant. Within 25 min from the beginning of the first rainfall, the scour was reasonably categorized as splash erosion, as the raindrops impacted the slope surface and made shallow pits. Later on, from 25 min to 60 min, the scour form transformed into surface erosion. While the first rainfall progressed for 25 min, the formed shallow pits gradually connected, inducing shallow gullies. At 45 min from the start of the rainfall, a shallow sliding of a small size occurred on the left portion of the top grade of the model slope. Meanwhile, gullies on the model slope were completely formed. Lastly, in the period from 60 to 120 min, the scour pattern was found to constitute gully erosion and sliding. At 60 min from the start of the first rainfall, the left portion of the first slope grade developed a deep gully with a depth of 7~8 cm and a width of

As Figure 8 shows, different to the first rainfall event, the scour process of the second rainfall event consisted of only two phases, namely the undisturbed phase and the gully erosion with sliding phase. The period from the start of the rainfall to 20 min of rainfall comprised the undisturbed phase, which resulted in no perceivable surface erosion to the model slope, as the rainwater downflow was weak. Understandably, the loess within the shallow layer of the model slope consolidated in the interval between the two rainfall events, making further erosion difficult, which induced an undisturbed phase later in the process. As the rainfall continued, the shallow layer of loess softened again, inciting gully erosion with a sliding phase. The gully erosion with a sliding phase occurred in the period after 20 min of rainfall, where gullies developed and slides happened occasionally. Small scales of shallow slides occurred on the second grade of the model slope at 30 min, 40 min, 56 min and 78 min from the start of the second rainfall event, which fully ruined displacement mark S4. In the meantime, larger scales of slides occurred on the third grade of the model slope at 80 min and 100 min from the start of the second rainfall event, inducing the declination of the gradient of the third grade of the model slope. Evidently, different from first rainfall event, the slope slides in the second rainfall event had initiation stages compromising the duration of approximately the first 20 min of rainfall. As the rainfall progressed, the deeper layers of loess was wetted by the infiltrating rainwater, which caused declines in the matrix suctions, the cohesion and the frictional angles of the deeper loess. It is proven that the matrix suctions, the cohesion and the frictional angles have positive contributions to the soil shearing strength, which is the critical factor in slope safety. Thus, the decline in matrix suctions caused larger slope failures during the second rainfall event. Additionally, the dimensions and number of gullies also increased in this phase. When this rainfall event was over, the main gully at the left of the first grade of the model slope was approximately 13 cm wide, which can be seen in Figure 9a.

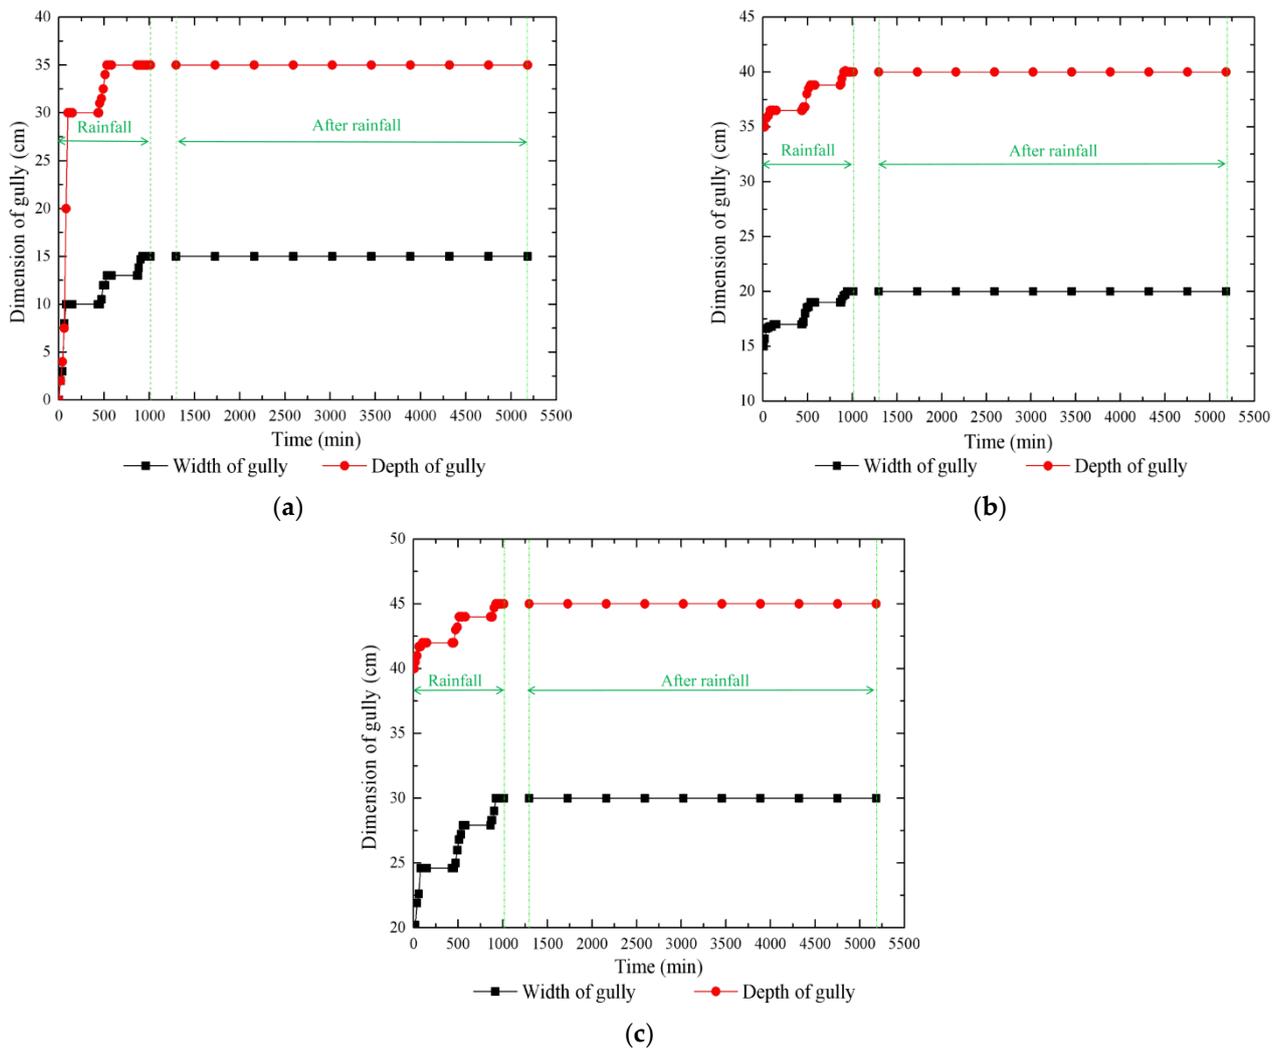
Figure 9. Development of the dimensions of the main gully on the left of the first slope grade: (a) During the first round, (b) During the second round, (c) During the third round.

5 cm, while the second slope grade showed a gully with a depth of 4~5 cm and a width of 3~4 cm. Meanwhile, larger slides happened on the middle portion of the third grade of the model slope, and ruined displacement mark S6. Understandably, the rainwater pooled on the left portion of the platform of second grade, softened the soil beneath it and promoted gully development there, which was inevitable for a loess slope under rainfall. Additionally, it was observed that the larger scale of slides on the third grade of the slope model was induced by rainwater pooled on the slope crest, which softened the loess there while percolating. In the later phase of the first rainfall, the developed gullies were widened and deepened by the downflow of the rainwater. When the first round of the first rainfall event ended, the main gully in the left part of the first slope grade was approximately 30 cm deep and 10 cm wide, as shown in Figure 9a.

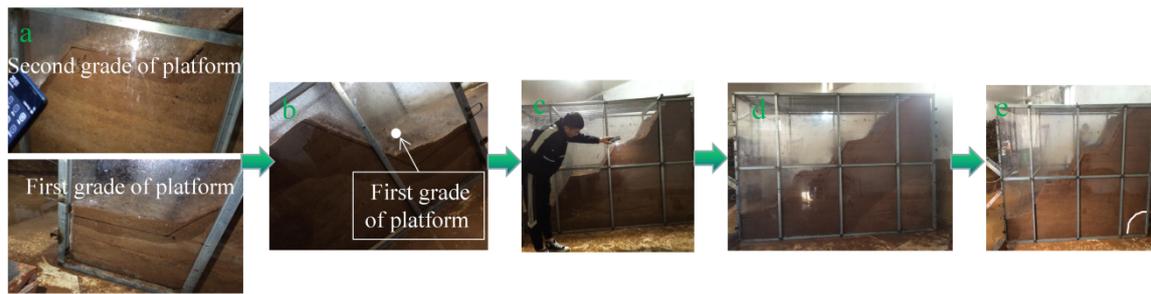
Figure 10. Rainwater infiltration process within the slope model: (a) After 30 min of the first round of the first rainfall event, (b) After 120 min of the first round of the first rainfall event, (c) 5.2 h after the first round of the second rainfall event, (d) After 120 min of the second round of the third rainfall event, (e) After 120 min of the third round of the first rainfall event.

Figure 10 shows the advancing process of the wetting front in the rainfall rounds. Evidently, the rainwater percolated into the platforms preferentially, which may have been caused by rainwater pooled on the platforms. The water pooled on the platforms generated water heads there, which actuated the water into the platforms with large rates. After 10 min of the first rainfall, the percolation depths beneath the three platforms were identical at 8 cm. After 20 min of the first rainfall, the percolation depths under the first, second and third grade of the platform were 9 cm, 11 cm and 10 cm, respectively. After 40 min of the first rainfall, the percolation depths beneath the first, second and third grade of the platform were 11.3 cm, 11.5 cm and 12 cm, respectively. Therefore, it can be derived that the percolation rate of the rainwater declined with the progression of rainfall. The average percolation rate was approximately 0.8 cm/min within the first 10 min of rainfall, decreased to approximately 0.2 cm/min after 20 min of the first rainfall, and then decreased to approximately 0.075 cm/min after 40 min of the first rainfall. The pores of the unsaturated soils are partly filled with air and water. Under rainfall conditions, the rainwater must discharge the pore air to percolate into the slope soils. In the shallow layers of slope soils, the pore air was easier to be discharged, and thus showed a higher permeability; therefore, it showed a larger percolation rate at the beginning of the rainfall event, which decreased gradually with the progress of the rainfall event. Eventually, by the end of the first rainfall event, after 120 min, the average vertical percolation rate declined to approximately 0.090 cm/min. In summary, the advancement rate of the wetting front declined gradually within the first round of the first rainfall event, and eventually stabilized at 0.090 cm/min.

In addition, it was found from Figure 10e that almost the whole model slope was wetted in the test, with all pore water pressures in the model slope except U5 showing negative values from Figure 12, indicating unsaturated conditions. Therefore, we could infer that the wetting front cannot be considered as the boundary between the saturated and unsaturated regions during rain. According to the Green-Ampt infiltration model [54], the infiltrating rainwater persistently migrates forward after rainfall, resulting in an unsaturated region in front of the wetting front. Clearly, this finding of the Green-Ampt model is in agreement with the current study.

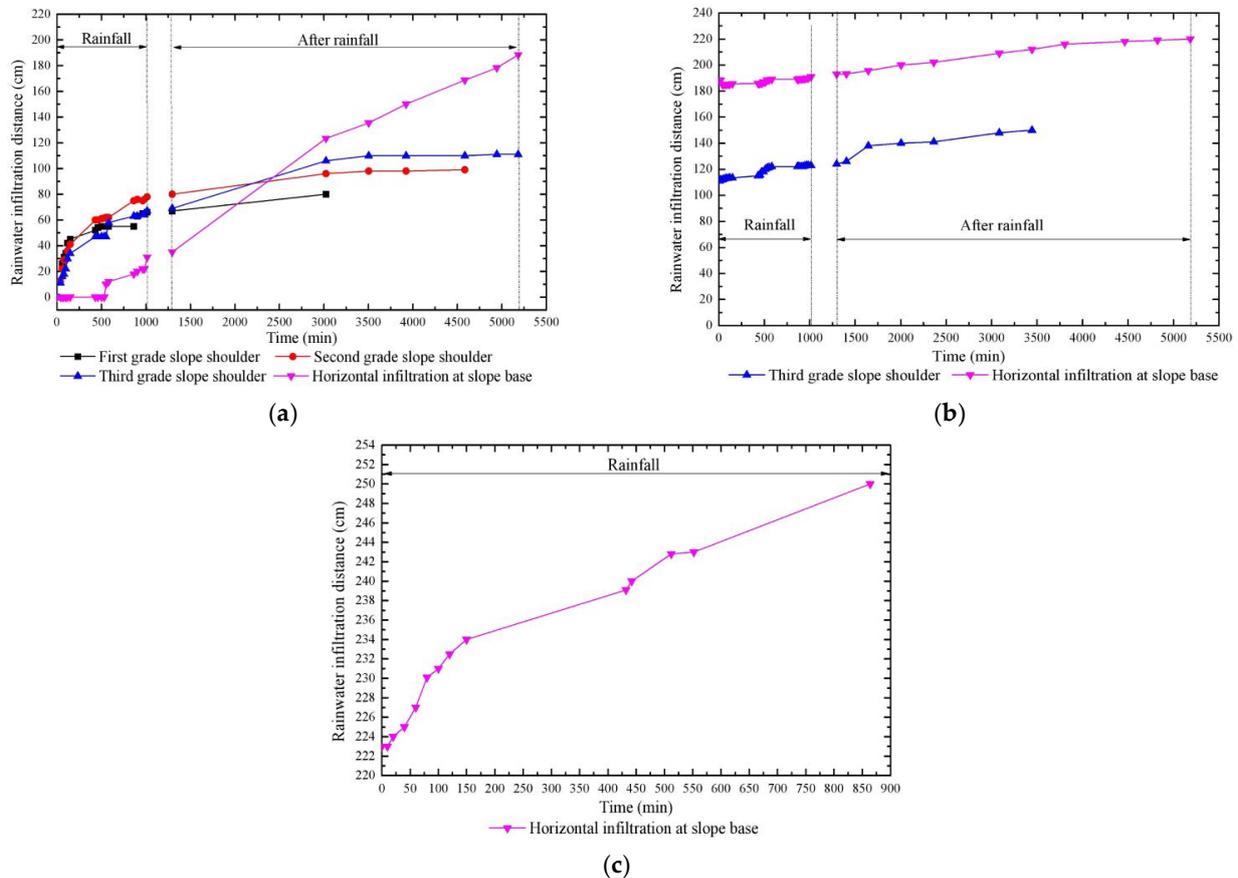
Figure 11. Rainwater infiltration distance with time: (a) Within the first round, (b) Within the second round, (c) Within the third round.

Figure 11 presents the vertical infiltration distances under the three slope shoulders and the horizontal infiltration distance at the slope base over time. It is evident that the vertical infiltration distances under the slope shoulders increased sharply in the first round, particularly during rainfall. However, the increasing rates of the vertical infiltration distances gradually decreased over time. Forty-one hours after the second round of the third rainfall event, rainwater infiltrated the slope base beneath the third grade slope shoulder, while the vertical infiltration rate decreased to approximately 0.0056 cm/min. Thus, the vertical infiltration under the slope shoulders after that time was not presented. Similarly, the horizontal infiltration caused by the migration of the rainwater accumulated near the first grade slope toe with a gradually decreasing rate. The difference being that the horizontal infiltration at the base of the slope had an initiation stage, which occurred during the 500 min after the start of the first round of rainfall. It is most noteworthy that the horizontal infiltration rate was obviously higher than the vertical infiltration rates

under the slope shoulders. From Figure 11a, the average vertical infiltration rate under the slope shoulders was approximately 0.021 cm/min, while the average horizontal infiltration rate at the base of the slope was approximately 0.036 cm/min. This could be due to the structure of the horizontal layer of the slope model formed in the construction process, which provided a larger horizontal permeability compared with the vertical permeability.

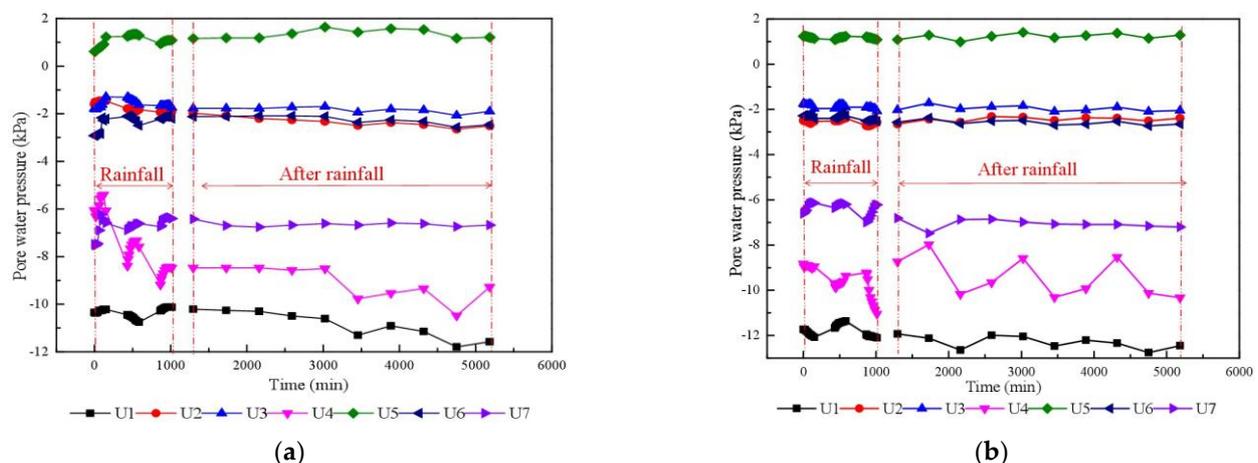
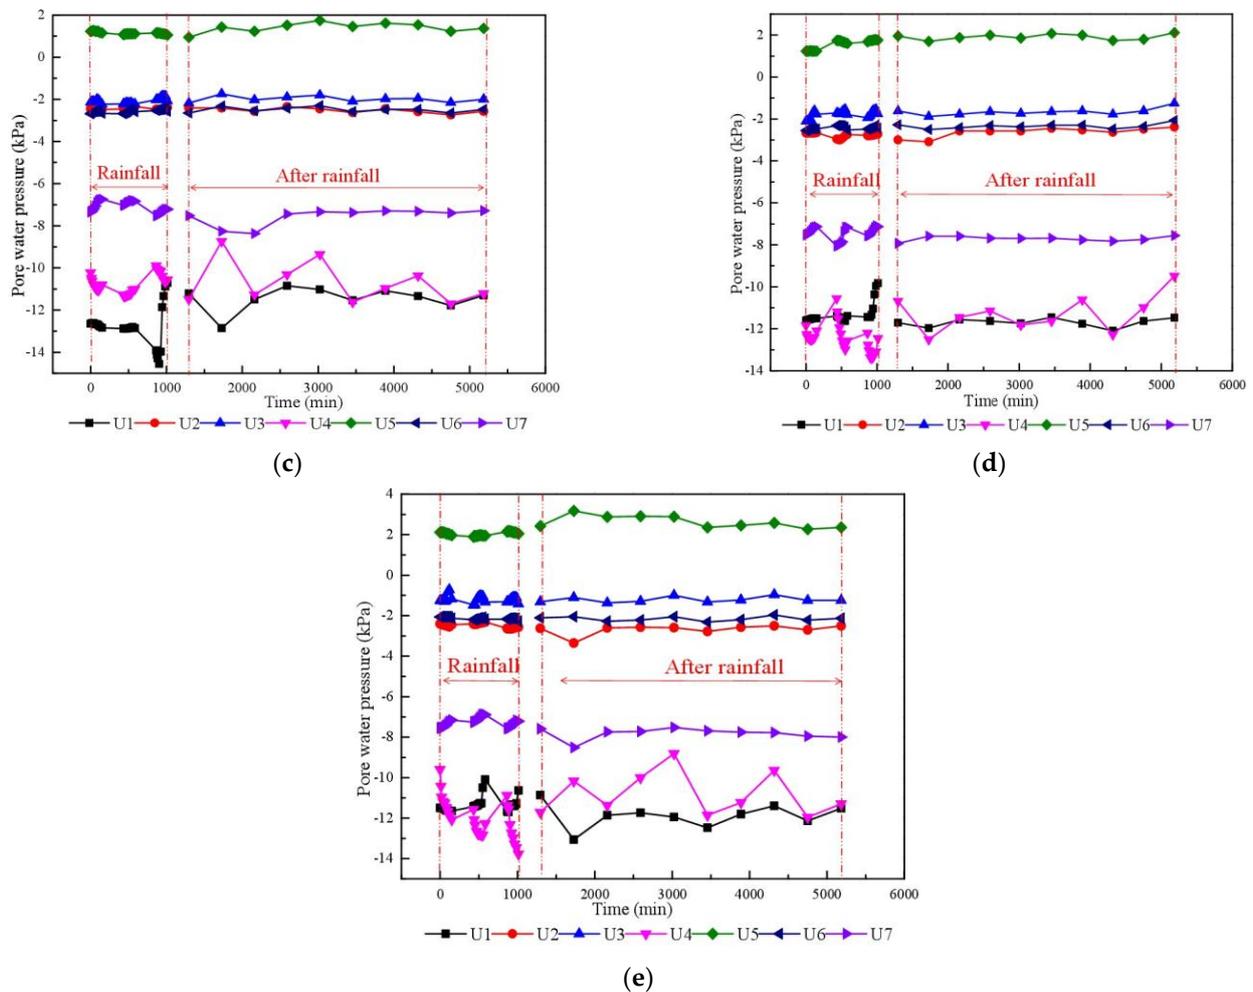
Figure 12. Cont.

Figure 12. Pore water pressure variations within the test: (a) First round, (b) Second round, (c) Third round, (d) Fourth round, (e) Fifth round.

Generally, within the five rounds of rainfall, the pore water pressures of the seven points fluctuated sharply, with a total trend of declining, except for point U5. This result appeared inconsistent with the classical theoretics of soil mechanics [50]. Only point U5 showed positive pore water pressure values during the rainfall rounds, indicating nearby saturated conditions. It increased from almost 0 kPa to approximately 1.5 kPa in the first round of rainfall and then fluctuated up to approximately 2 kPa by the end of the fifth round, indicating that the infiltrated rainwater concentrated around the toe of the first slope grade. This is consistent with the findings of Chueasamat et al. [52]. Regarding the other key points, it is most evident that the pore water pressure of U1 declined persistently from -10.35 kPa to approximately -12 kPa, and the pore water pressure of U4 decreased persistently from -6.05 kPa to approximately -12 kPa, with a higher declining rate during the early rounds. For U1, at the deepest position, it was hard for the rainwater to recharge, while the underlying soils absorbed the water around it, and thus caused the declination of the saturation degree near U1. Adopting Fredlund's unsaturated soil theoretics [50], the negative pore water pressures in the soils bring on suction, with less saturation corresponding to higher suction. As a result, the pore water pressure on U1 declined within the rainfall rounds. Given that U4 was at the shoulder of the second slope grade, it was washed out by the rainwater in the first round of the first rainfall event. That is why the pore water pressure decreased abnormally, producing meaningless data. While U2 and U3 were situated at intermediate depths in the slope model, the water compensation effect from the soil above and the absorption effect from the soil below remained in balance, which led to no perceptible variation in the pore water pressures nearby.

However, carefully checking the pore water pressure data of U4, U5, U6 and U7 within the first round of rainfall, we found that there was an increasing trend in the pore water pressures for these four points during the first rainfall event, which implicates the saturation effects of the rainfall on the shallow layer of loess slopes. As the shallow layer of the loess was saturated, the matrix suction thereby vanished and the cohesion and internal friction angle attenuated, which caused the degradation of the shear strength of the loess overall. With a decline in the shear strength, the shear stress thereby exceeded it, thus causing the shallow slides stated above.

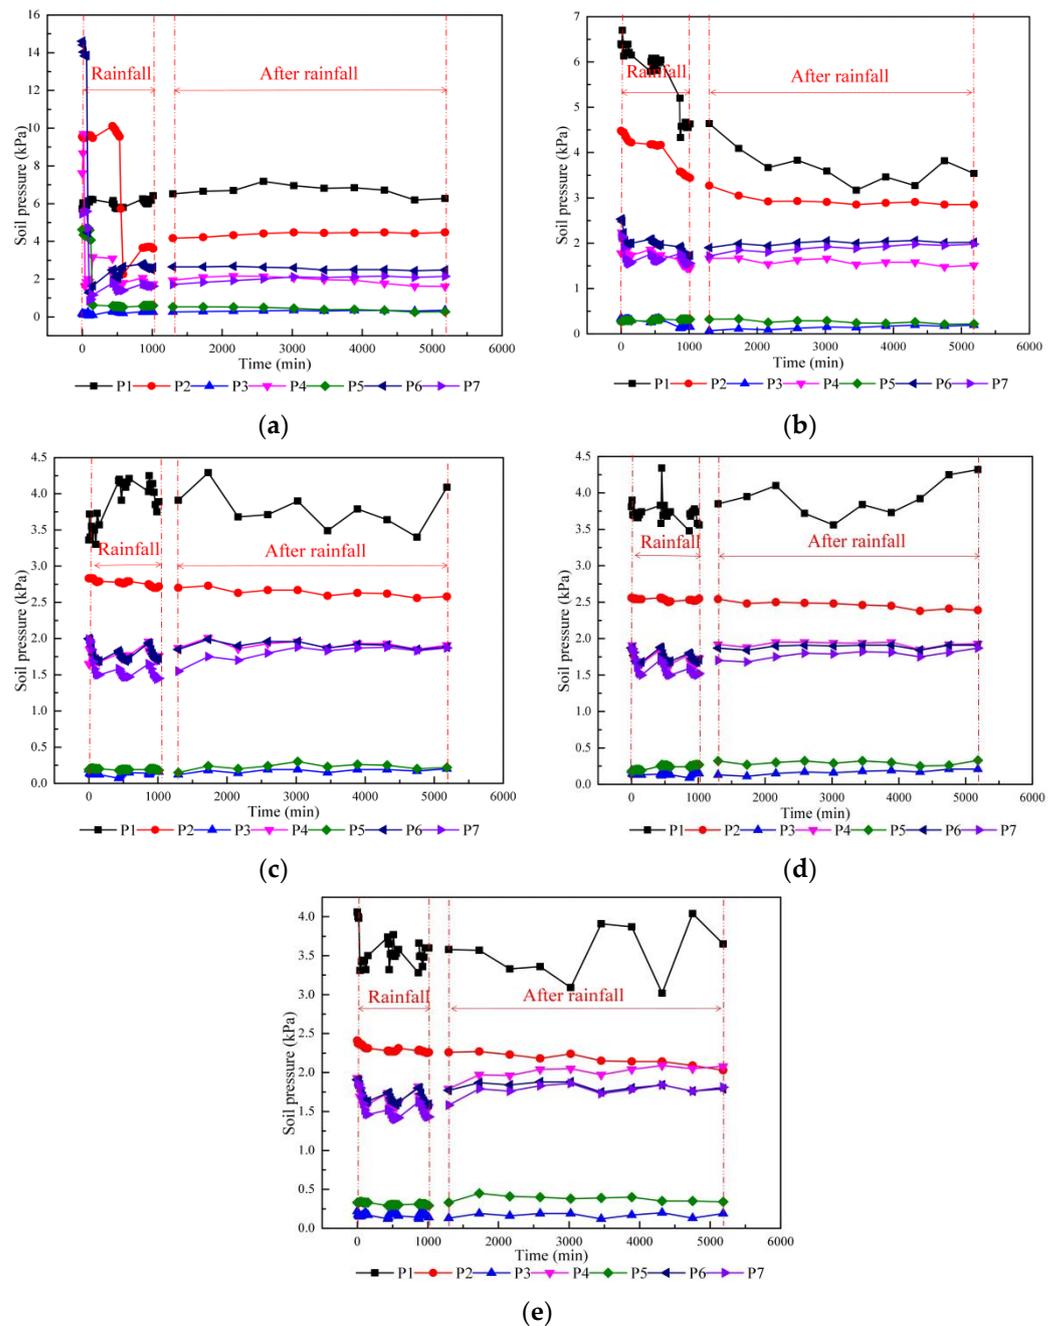
Figure 13. Variations in soil pressure inside the model slope: (a) First round, (b) Second round, (c) Third round, (d) Fourth round, (e) Fifth round.

The soil pressure variations of the seven representative points (P1, P2, P3, P4, P5, P6 and P7) over time are shown in Figure 13. During the first round of rainfall, it was in opposition to the developed soil mechanics as the soil pressures of all the representative points except P1 decreased sharply, which was caused by the in situ stress release as the rainwater infiltrated. This was most evident for P6, incorporating a decline from 14.3 kPa to 1.0 kPa in the first round of the rainfall event. After the first round of rainfall, all seven representative points presented no regular variation in the soil pressure with some small fluctuations, representing a relatively steady state of the slope model. Nevertheless, the soil pressure of P1 started to decline in the second round of rainfall, which was later than that of the other points. These results were caused by P1 being in the deepest location, which needed a longer duration for the rainwater influence to occur. Thus, the second deepest point, P2, represented a persistent decrease in soil pressure in the second round, implying that the release of the in situ stress was still in progress in the deeper positions at this duration. In the subsequent rounds, the soil pressure of P2 persistently declined at a smaller rate, as the soil pressure of P1 fluctuated. When the fifth round of rainfall was over, the soil pressures of P1 and P2 were approximately 3.5 kPa and 2.0 kPa, respectively. On the contrary, the soil pressures of the other points were steady over the entire second round, indicating the steady state of the shallower part of the slope model. In summary, induced by the release of in situ stress, the soil pressures in the slope model declined but did not increase, indicating that the influence of the in situ stress release was greater than that

of the self-weight increase through rainwater percolation, which is seemingly different from the classical soil mechanics [55]. Classical soil mechanics deems that the saturation of soils increases during rainfall, thus inducing a self-weight increase in the soil. As it does not consider the in situ stress increase inside the soils, theoretically, the soil pressures inevitably increase during the rainfall process. However, in the current study, the slope model construction process exactly simulated the loess-forming process, thus leading to high in situ stress in the slope soils, which was higher than the gravity stress. When the rainwater penetrated, the soils of the slope model were softened and dilated, causing the in situ stress to be released abruptly. As the greatest portion of the in situ stress is released, the measured soil stress must decrease rather than increase.

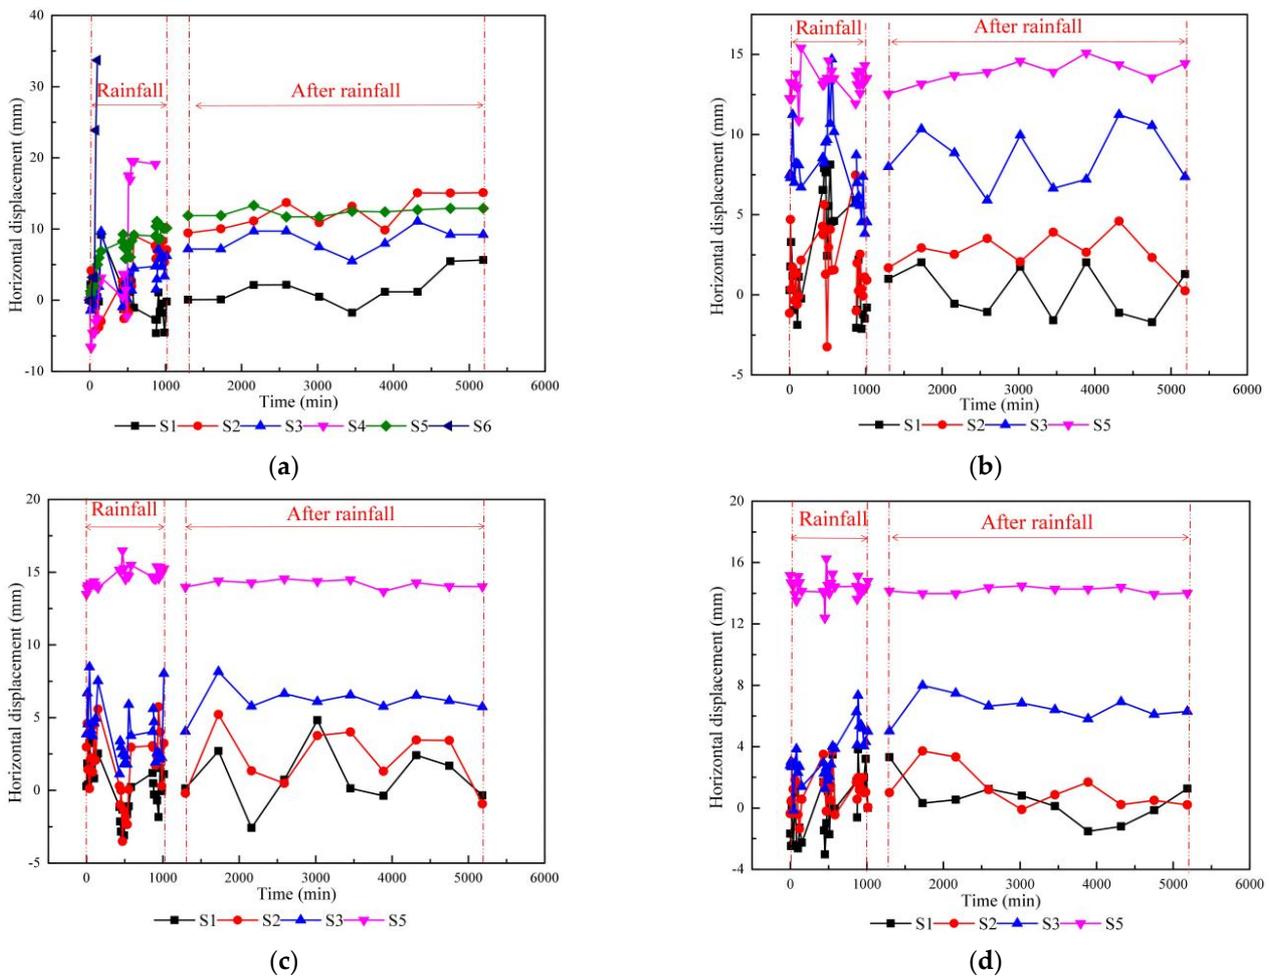
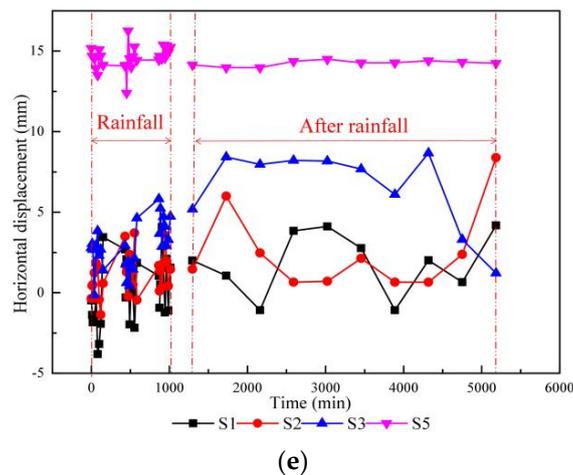
Figure 14. Cont.

Figure 14. Variations in the horizontal displacements of the six key points over time: (a) First round, (b) Second round, (c) Third round, (d) Fourth round, (e) Fifth round.

A laser rangefinder was used to measure the distances between the six key points (S1, S2, S3, S4, S5 and S6) and a fixed point, the changes in which before and during the rainfall events were the horizontal displacements of the corresponding positions. Figure 14 presents the variations of the horizontal displacements of the six points over time. In the first round, all six points except S1 had displacements rising from 0 mm, especially within the rainfall events. As the rainfall process advanced, the slope soils were humidified, and the internal frictional angle and the cohesion were lessened, causing the yielding of parts of the model slope, which in turn induced the displacements of the model slope. When the first round of rainfall was over, the horizontal displacements of S2, S3 and S5 rose up to 15.1 mm, 9.2 mm and 12.9 mm, respectively, while that of S1 fluctuated at approximately 0 mm. Understandably, the fluctuations in the displacements were brought about by the errors of the instruments. Additionally, the displacement of S6 rose to approximately 35 mm within the first round of the first rainfall event, and the displacement of S4 rose to approximately 20 mm within the same round of the second rainfall event. According to the rainwater scour data presented earlier, the displacement markers S4 and S6 were destroyed in the first round of the second and first rainfall events, respectively, hence bringing about oddly high increments of displacements. As a result, the figures of displacements do not include those of S4 and S6 after the second round of rainfall.

Within the second round, the displacement for S5 fluctuated up to approximately 14 mm and was still fluctuating around this value in the subsequent rounds. The displacements for S2 and S3 fluctuated at approximately 2.5 mm and 9.2 mm, respectively, as the displacement for S1 kept fluctuating at approximately 0 mm. Reasonably, it could be concluded that point S1 remained stationary during all five rainfall rounds. Considering the points in a vertical line with S1, the longer the upward distance from S1, the larger the displacement. This result indicated that a potential slip surface was situated between S1 and S2. This finding is consistent with the research presented by Cui et al. [56], expressing the landslide progress in five stages: steady deformation, slow deformation, intense deformation, steady deformation and intense deformation. However, it was also found that the displacements of the four remaining points (S1, S2, S3 and S5) fluctuated with no increase after the second round, implying the status of the slope was ultimately stable.

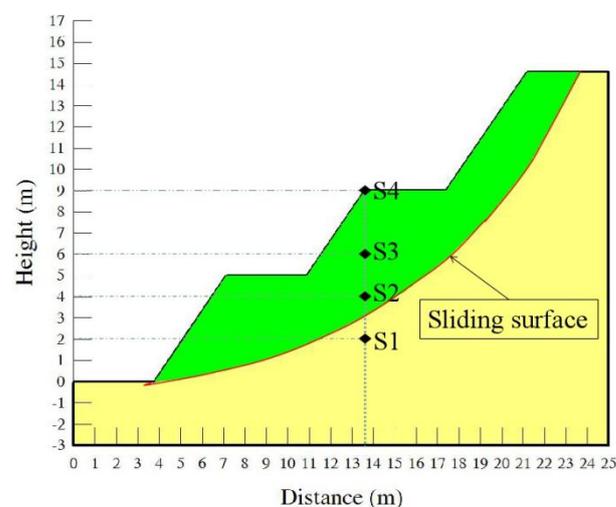
Figure 15. Critical sliding surface from the Morgenstern–Price method (S1, S2, S3 and S4 are displacement markers identical to those in Figure 7).

Figure 15 illustrates the potential sliding surface by the end of the fifth year from the Morgenstern–Price method. Evidently, the generated sliding surface was situated between S1 and S2, which strictly matched the model test results.

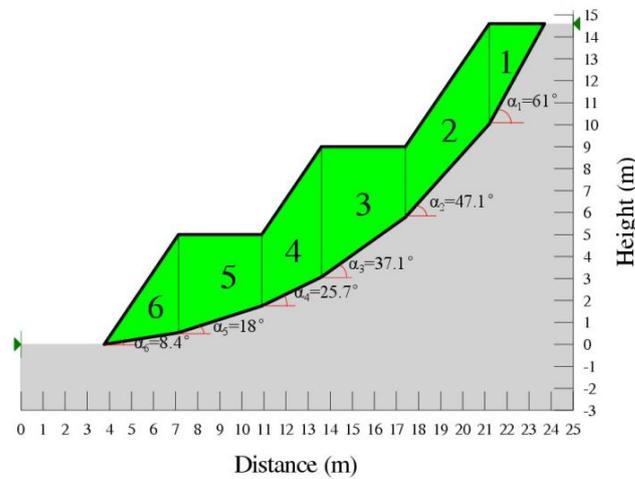
Figure 16. Slice division profile of the sliding mass.

Firstly, the sliding body was divided into six vertical slices, as shown in Figure 16. The measured data of the key points were utilized to derive the soil pressures and suction of

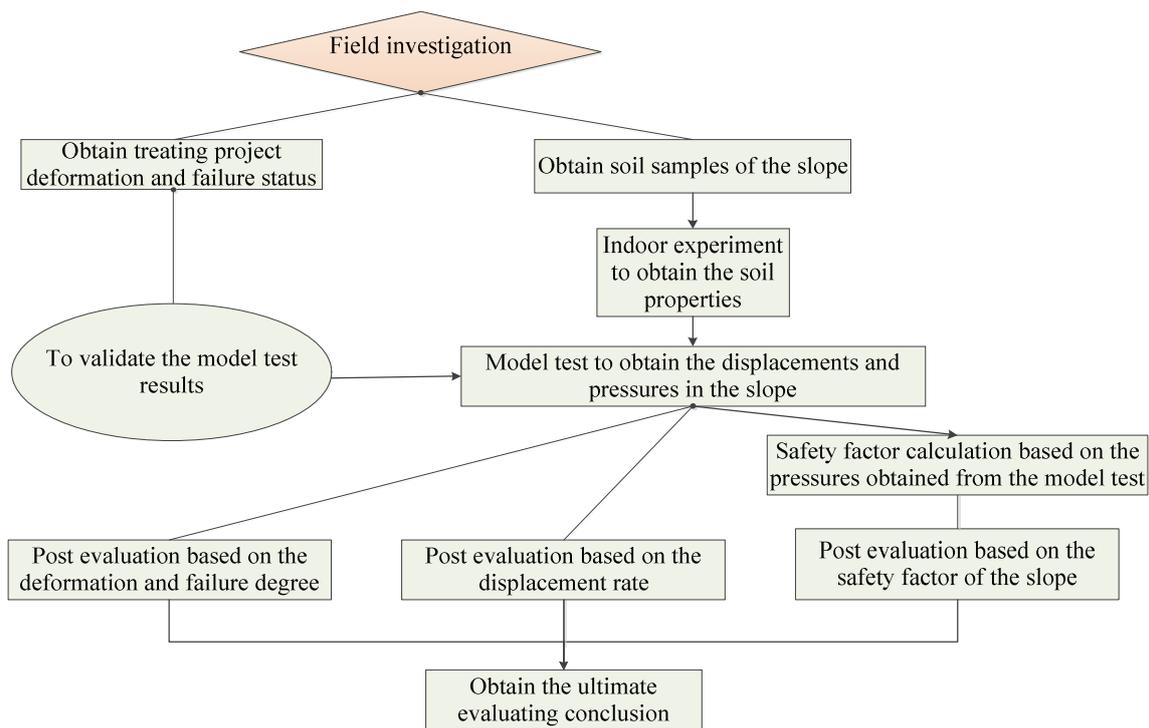
Figure 17. Post evaluation framework for slopes treated by slope cutting.

Last, it is worth noting that the post evaluation framework formed here is useful to other slope treatment projects referring to slope cutting. Therefore, the post evaluation framework is presented in Figure 17.
