Article

Architectural Heritage Indoor Comfort after Retrofit Works: The Case Study of S. Vito Church in L'Aquila, Italy

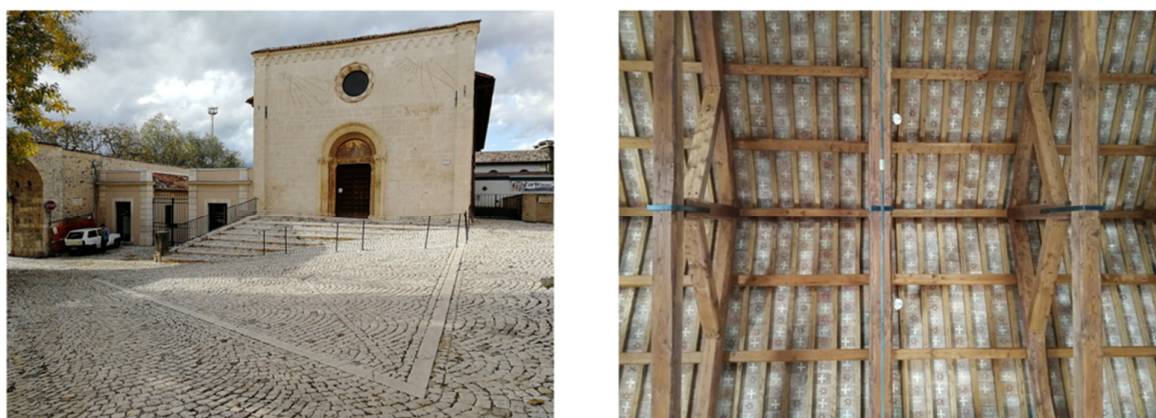
Figure 1. San Vito church in L'Aquila (Italy): on the left the main entrance; on the right a view of the truss.

The San Vito church (Figure 1), characterized by a rectangular plan with a single hall, was built in the second half of the XIII century in the picturesque “Borgo Rivera”—in front of “99 Cannelle” Fountain. The medieval village is part of the “Quarto di S. Giovanni” and the town of L'Aquila sees its foundation here, datable around the second half of the 1200s. The construction of the small church, by Corrado IV of Swabia, a few years after its construction suffered serious damage due to the earthquake that struck the city in 1259. The first reconstruction of the building took place in the 15th century, maintaining the single hall structure, the single portal, the central oculus and the crowning frame on the facade. Then, it was annexed to the Collegiate church of S. Marciano; after the subsequent transfer to the Bonfatelli friars, a convent and a hospital for the sick were founded, both built adjacent to its south-west elevation [32–36].

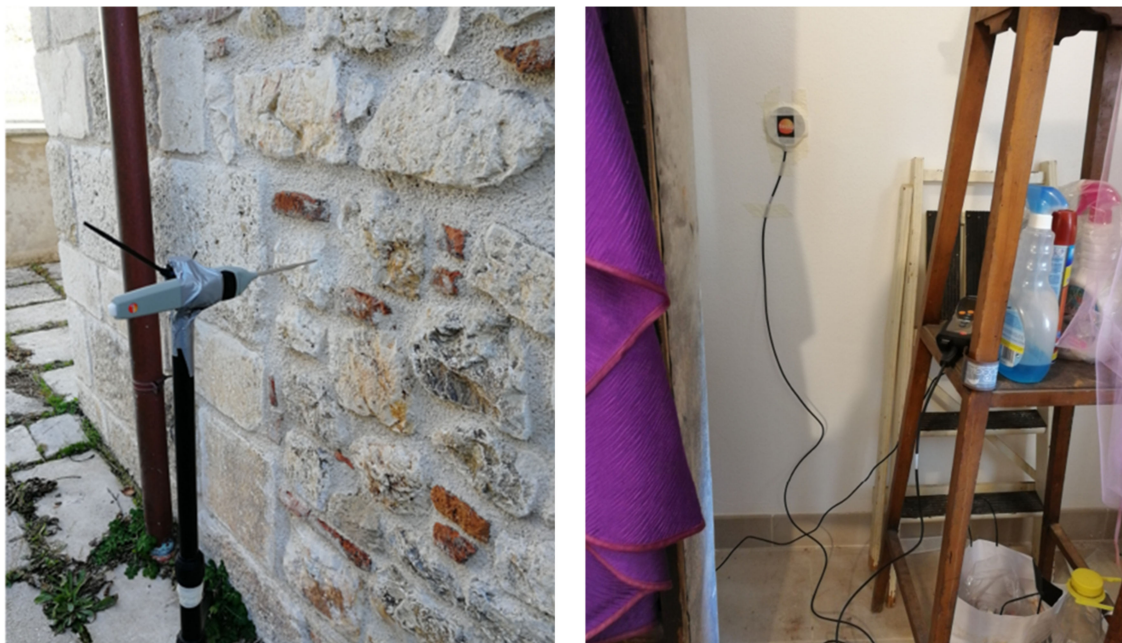
Figure 3. The heat-flow analysis carried out: the monitoring phase on the church masonry.

In the case of the San Vito church, the performance of the vertical closures, mainly characterized by very thick limestone ashlar (70–80 cm), were investigated through a heat flow measurement campaign (the instrument used is the TESTO 434.2 that includes a datalogger, radio probes for measuring surface and external air temperatures, a heat flow meter plate in order to measure the heat flow), consisting of non-destructive measurements regulated by the ISO 9869-1:2014 standard [31], which sets very strict test conditions in order to have reliable results [42] regarding the energy behavior of historical masonry and their transmittance values [43–45].

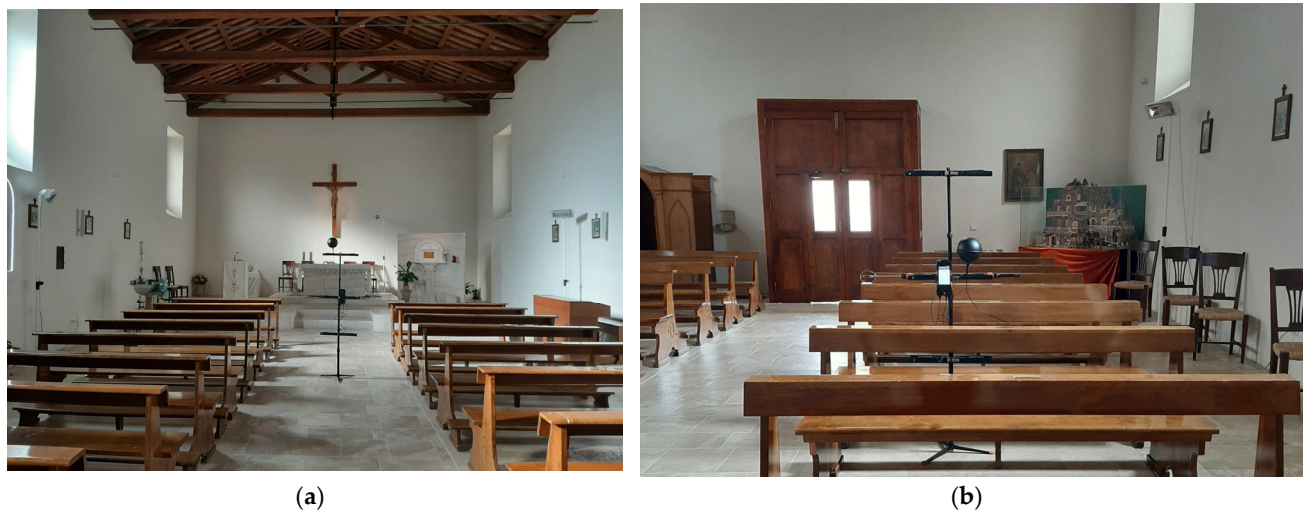
Figure 4. Comfort monitoring of the S. Vito church: (a) Case i; (b) Case ii.

The internal comfort measurements were taken under 2 different conditions and after the conclusion of a religious ceremony with the full church: (i) lamps off and user standing in the center of the room; (ii) lamps off and user seated (Figure 4).

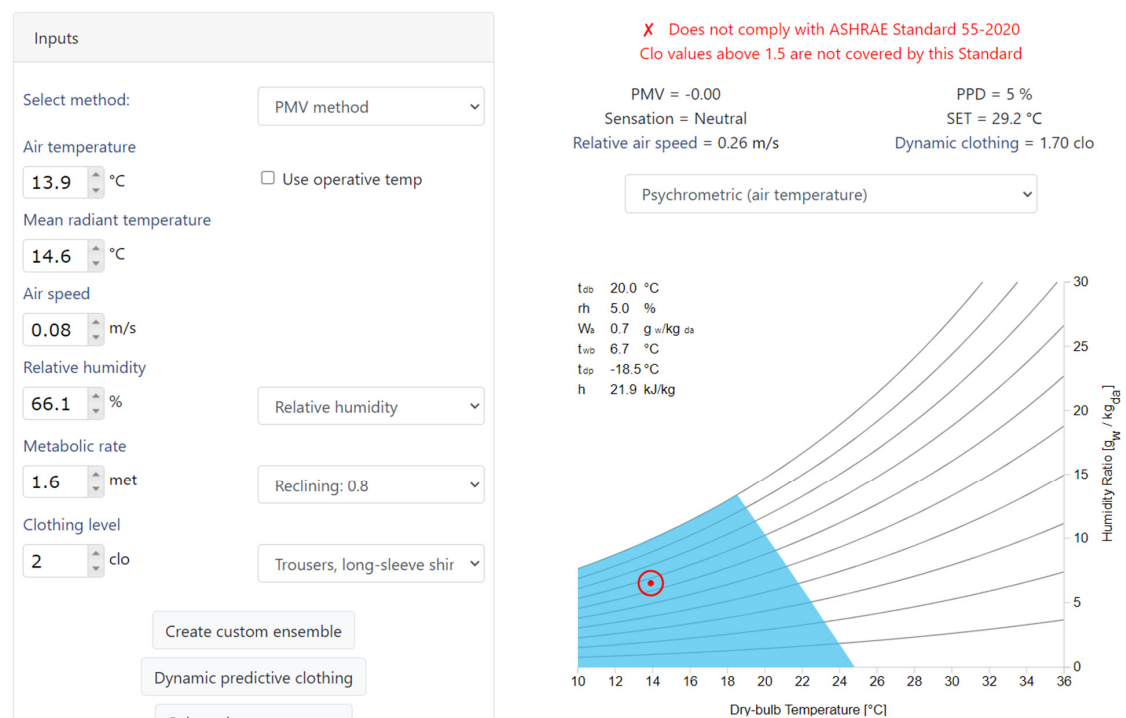
Figure 5. Psychrometric chart for the comfort condition (blue area) defined by Case i input from Table 1 (red point). The abscissa is the dry-bulb temperature and the ordinate is the Humidity Ratio (HR%). The CBE comfort tools automatically calculates the relative air speed and the dynamic clothing insulation [49,52].

Anyway, these slight fluctuations have little impact on the PMV and PPD indices, for which the inputs MET and CLO are instead decisive. From the monitoring results presented in Table 1, it can be seen that in the 2 cases analyzed, the users are in a quite different comfort condition. As expected, the Case i, thanks to the MET value related to the standing activity, allow to keep users in the comfort zone of the psychrometric chart, as shown in Figure 5. Case ii shows a different comfort situation: when the people are seated and relaxed—and this represents the typical condition for most users during religious celebrations—they are in discomfort conditions (Figure 6).

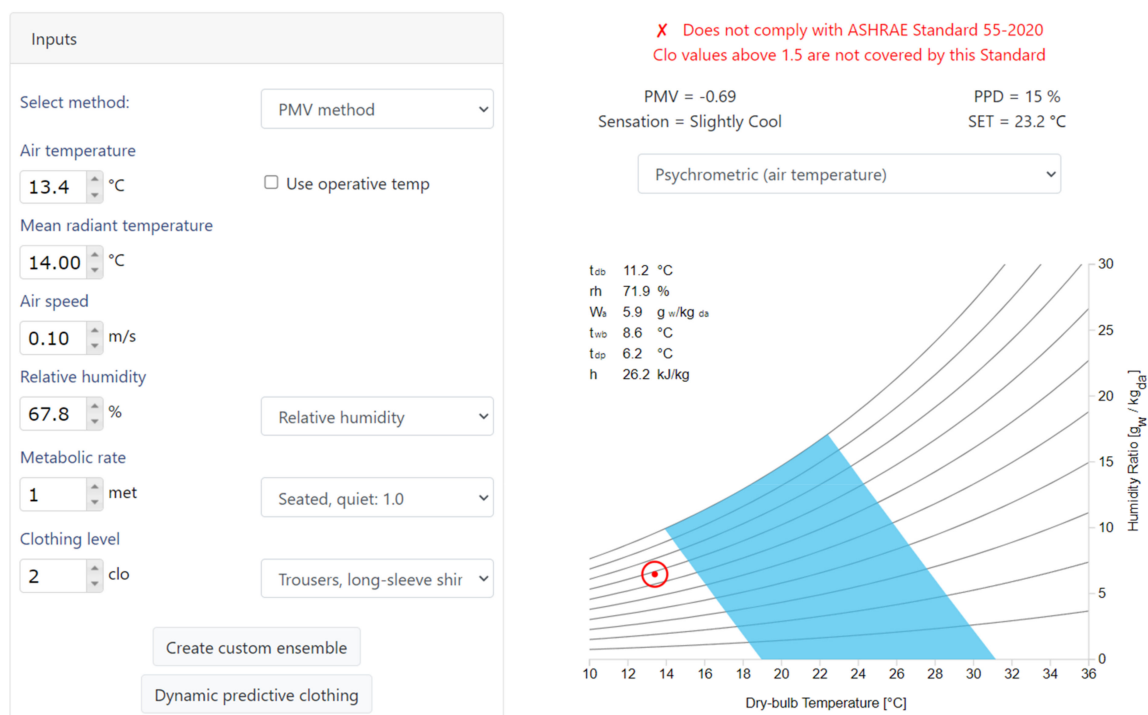
Figure 6. Psychrometric chart for the comfort condition (blue area) defined by Case ii input from Table 1 (red point). The abscissa is the dry-bulb temperature and the ordinate is the Humidity Ratio (HR%). The CBE comfort tools automatically calculates the relative air speed and the dynamic clothing insulation [49,52].

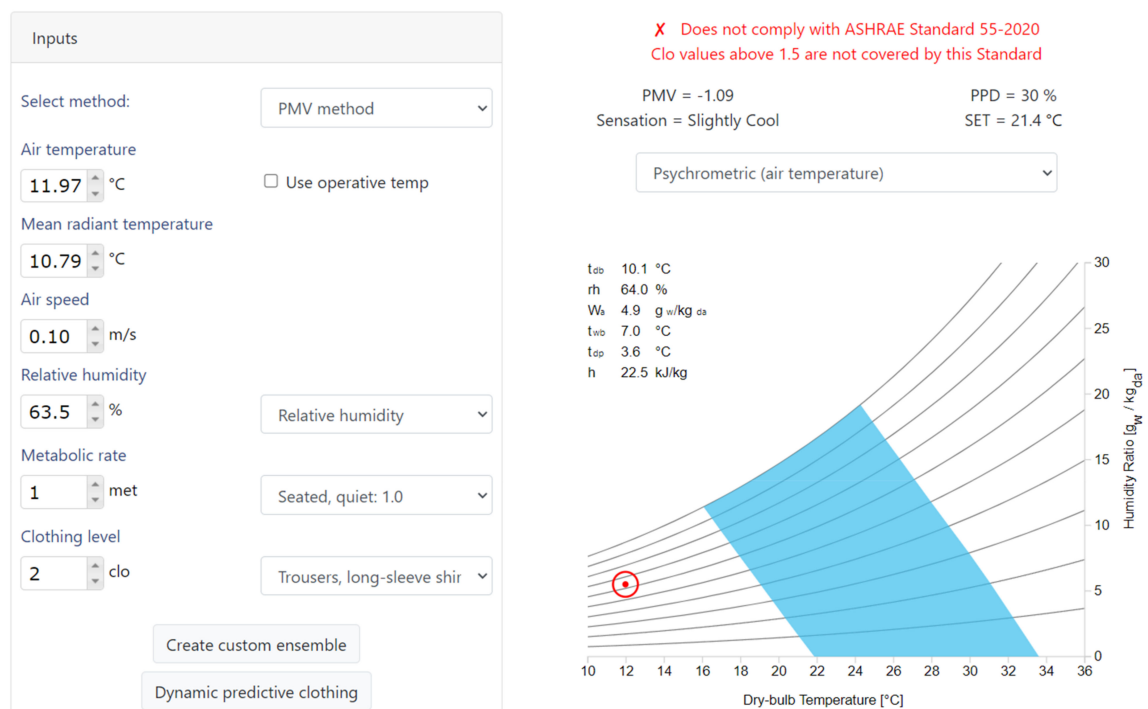
Figure 8. Psychrometric chart for the comfort condition (blue area) defined by Case ii input from Table 2 (red point). The abscissa is the dry-bulb temperature and the ordinate is the Humidity Ratio (HR%). The CBE comfort tools automatically calculates the relative air speed and the dynamic clothing insulation [49,52].

The results of the “model verification simulation” are shown in the following Table 2 and in Figures 7 and 8. As in the monitoring campaign, the internal comfort measurements were simulated under two different conditions: (i) heating off and users standing/walking in the center of the room; (ii) heating off and users seated.

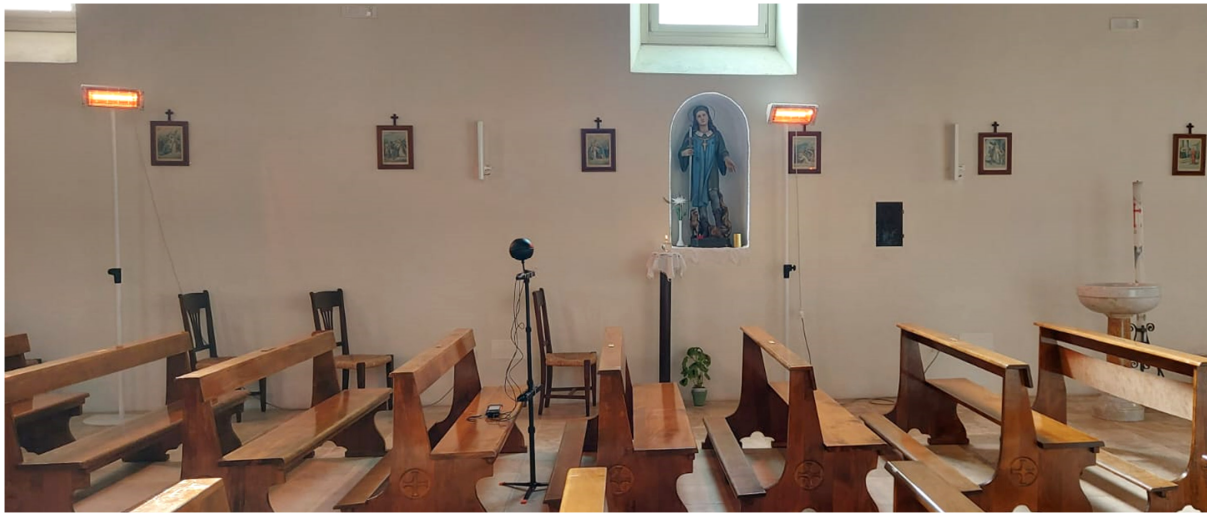
Figure 9. Comfort monitoring of the S. Vito church: Case ii and infrared lamps on.

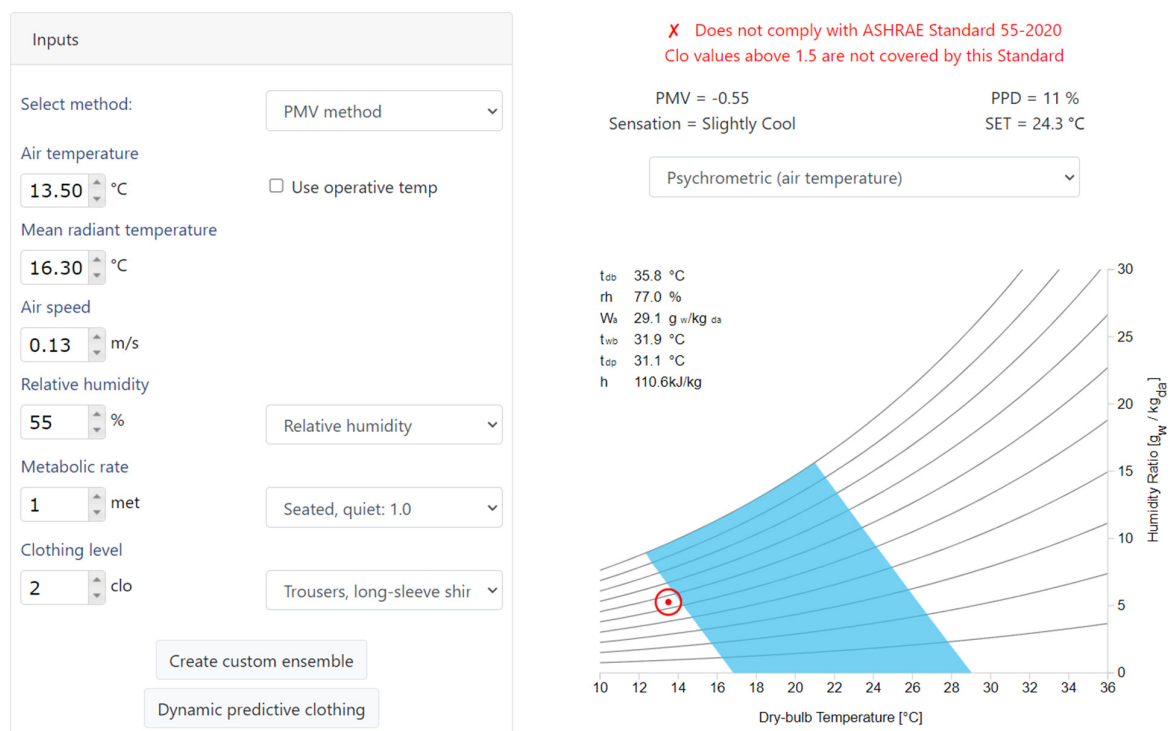
Figure 11. Psychrometric chart for the comfort condition (blue area) defined by Case ii input from Table 3 (infrared laps on: red point on the chart). The abscissa is the dry-bulb temperature and the ordinate is the Humidity Ratio (HR%). The CBE comfort tools automatically calculates the relative air speed and the dynamic clothing insulation [49,52].
