# Architectural Heritage Indoor Comfort after Retrofit Works: The Case Study of S. Vito Church in L'Aquila, Italy

##### *4.1. Non-Destructive Analysis of the Building Envelope of the San Vito Church: The Thermographic and Heat-Flow Measurement Campaign*

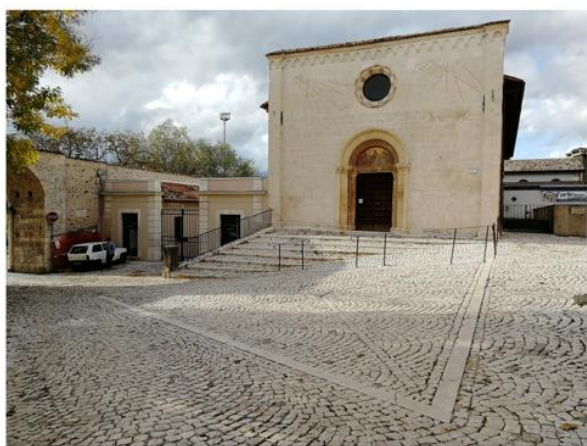
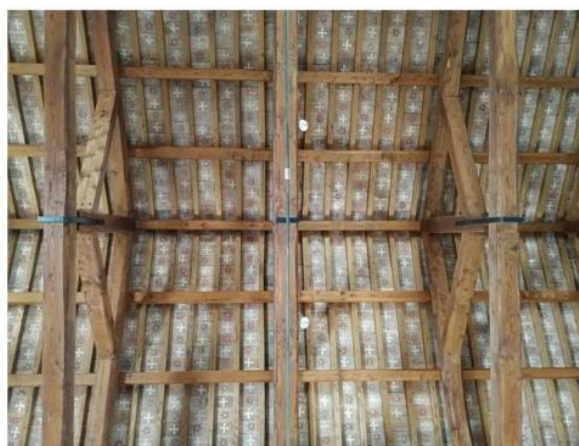
**Figure 1.** San Vito church in L'Aquila (Italy): on the left the main entrance; on the right a view of the truss.

The San Vito church (Figure 1), characterized by a rectangular plan with a single hall, was built in the second half of the XIII century in the picturesque “Borgo Rivera” —in front of “99 Cannelle” Fountain. The medieval village is part of the “Quarto di S. Giovanni” and the town of L'Aquila sees its foundation here, datable around the second half of the 1200s. The construction of the small church, by Corrado IV of Swabia, a few years after its construction suffered serious damage due to the earthquake that struck the city in 1259. The first reconstruction of the building took place in the 15th century, maintaining the single hall structure, the single portal, the central oculus and the crowning frame on the facade. Then, it was annexed to the Collegiate church of S. Marciano; after the subsequent transfer to the Bonfatelli friars, a convent and a hospital for the sick were founded, both built adjacent to its south-west elevation [32–36].

efflorescence, while the damage to the structures is absent. The pavilion roof has wooden trusses with secondary and tertiary warping of purlins and stringers to support decorated terracotta tiles. These tiles, with the exception of the external elevations enriched by the sculptural portal with frescoed lunette and the stone intrados of the windows, stand out as a valuable element in the essential spatiality of the hall, characterized by the absence of a decorative apparatus. The historical information reported in this paragraph derives from an archival research carried out at the State Archive of L'Aquila and from the Archdiocesan Archive of L'Aquila.

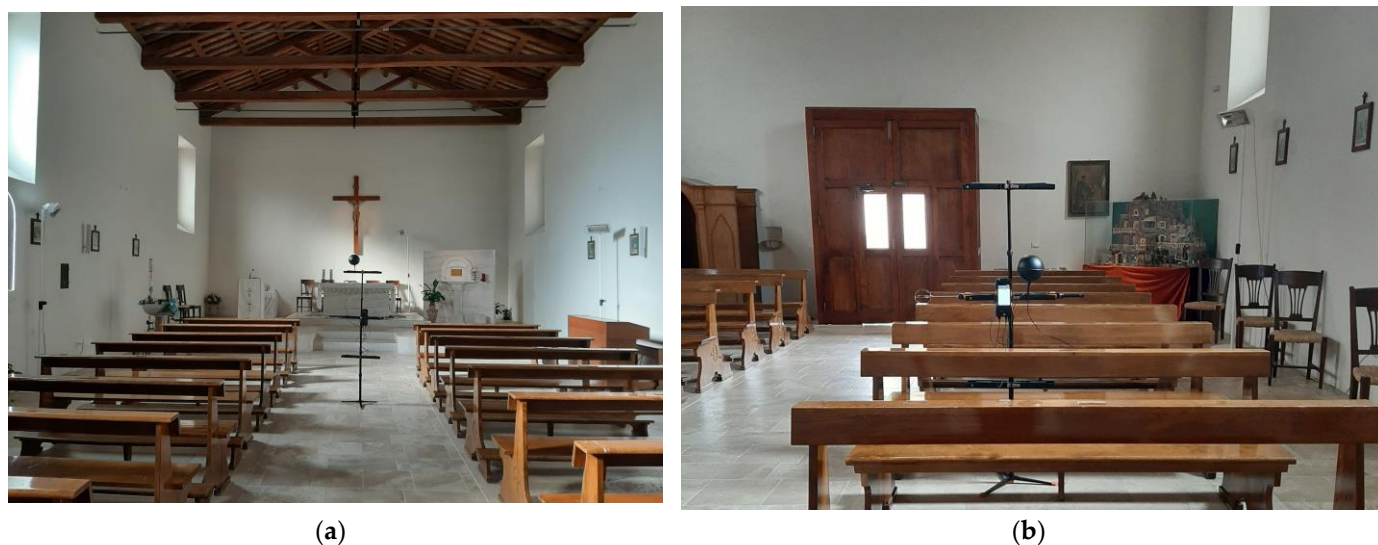
**Figure 4.** Comfort monitoring of the S. Vito church: (a) Case i; (b) Case ii.

The internal comfort measurements were taken under 2 different conditions and after the conclusion of a religious ceremony with the full church: (i) lamps off and user standing in the center of the room; (ii) lamps off and user seated (Figure 4).

It should be noted that in this starting phase the monitoring was carried out when the church was empty and with the infrared lamps off. The first monitoring (Case i) was carried out on 20 November 2022—when the dry bulb outdoor temperature was around 5 degrees at 13.00 p.m.—from 1:15 p.m. to 1.30 p.m.; the second monitoring (case ii) was carried out from 1:30 p.m. to 1:45 p.m. on the same day. This fact explains the slight decrease in temperature between Case i and Case ii as well as the variation of the relative humidity value (RH%): during the monitoring time the people had left the hall of the church and the infrared lamps had been turned off for about 30 min before the data acquisition.

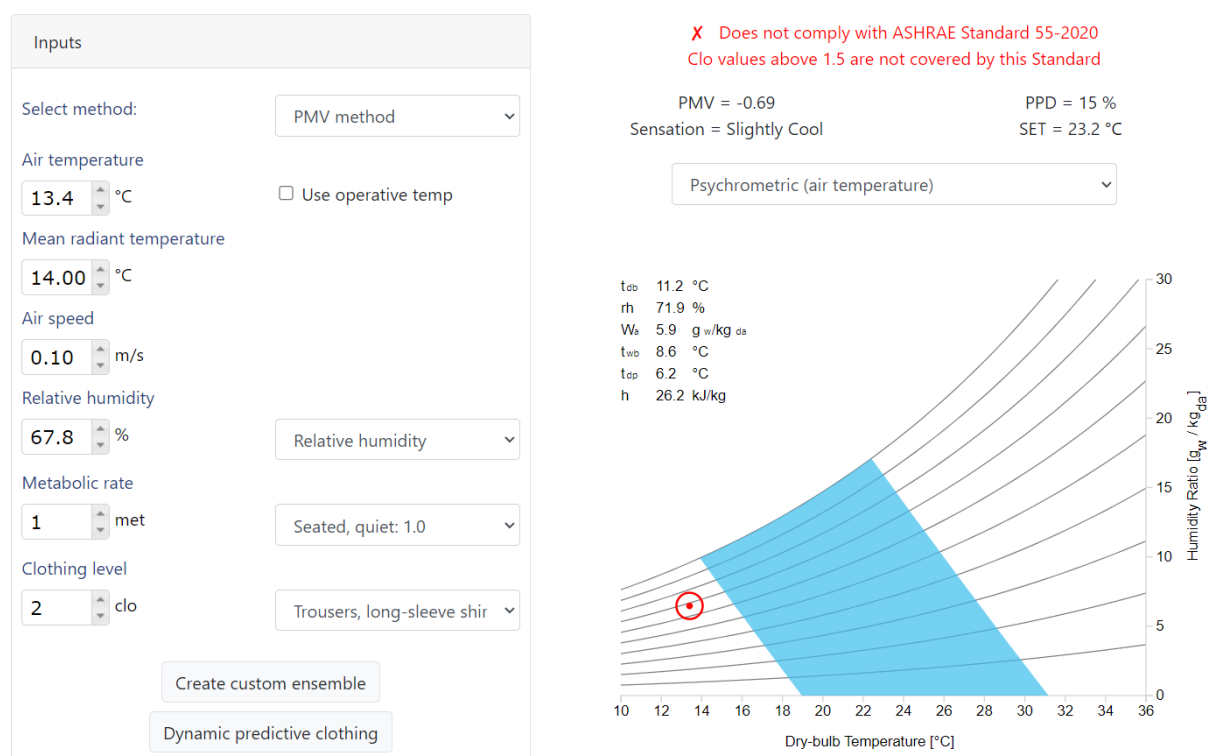
**Figure 6.** Psychrometric chart for the comfort condition (blue area) defined by Case ii input from Table 1 (red point). The abscissa is the dry-bulb temperature and the ordinate is the Humidity Ratio (HR%). The CBE comfort tools automatically calculates the relative air speed and the dynamic clothing insulation [49,52].

Anyway, these slight fluctuations have little impact on the PMV and PPD indices, for which the inputs MET and CLO are instead decisive. From the monitoring results presented in Table 1, it can be seen that in the 2 cases analyzed, the users are in a quite different comfort condition. As expected, the Case i, thanks to the MET value related to the standing activity, allow to keep users in the comfort zone of the psychrometric chart, as shown in Figure 5. Case ii shows a different comfort situation: when the people are seated and relaxed—and this represents the typical condition for most users during religious celebrations—they are in discomfort conditions (Figure 6).

Once the model was built, in order to verify its reliability, a first simulation was carried out with the heating off, with the purpose of comparing the thermo-hygrometric parameters and the internal comfort results from the simulation with the ones measured in situ during the monitoring campaign and reported in Table 1 and in the Figures 5 and 6.

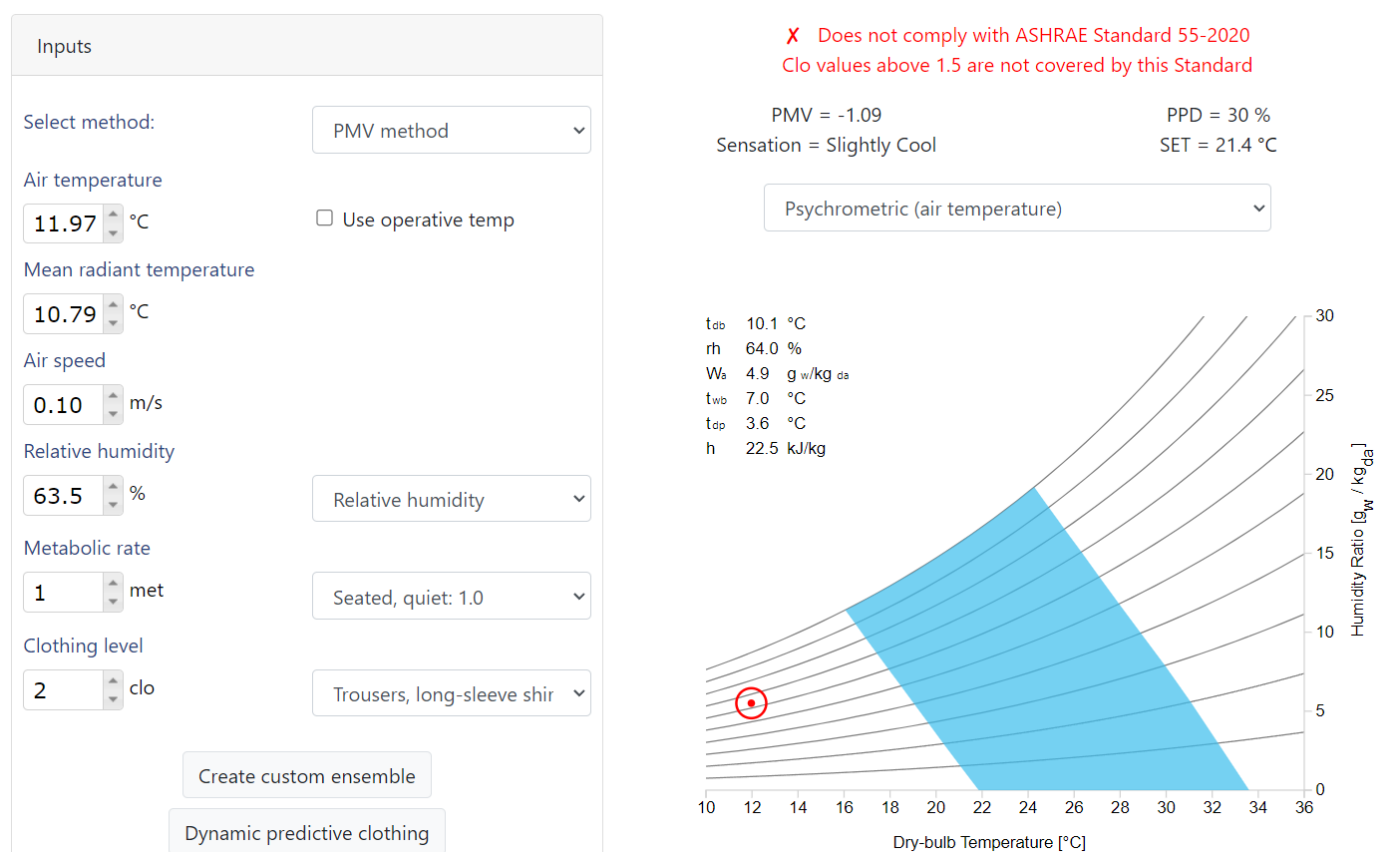
**Figure 8.** Psychrometric chart for the comfort condition (blue area) defined by Case ii input from Table 2 (red point). The abscissa is the dry-bulb temperature and the ordinate is the Humidity Ratio (HR%). The CBE comfort tools automatically calculates the relative air speed and the dynamic clothing insulation [49,52].

The results of the “model verification simulation” are shown in the following Table 2 and in Figures 7 and 8. As in the monitoring campaign, the internal comfort measurements were simulated under two different conditions: (i) heating off and users standing/walking in the center of the room; (ii) heating off and users seated.

Therefore, the results confirm the particular state of discomfort of the users when they are in case ii (sitting in church, relaxed, with no functioning heating system). The discomfort is significantly reduced if the users attend the celebration standing up (case i). At this point, having validated the correct functioning of the simulation model, it was possible to insert the input data related to the retrofit intervention applied to the church into the construction templates of the model, in order to evaluate the benefits in terms of comfort improvement.

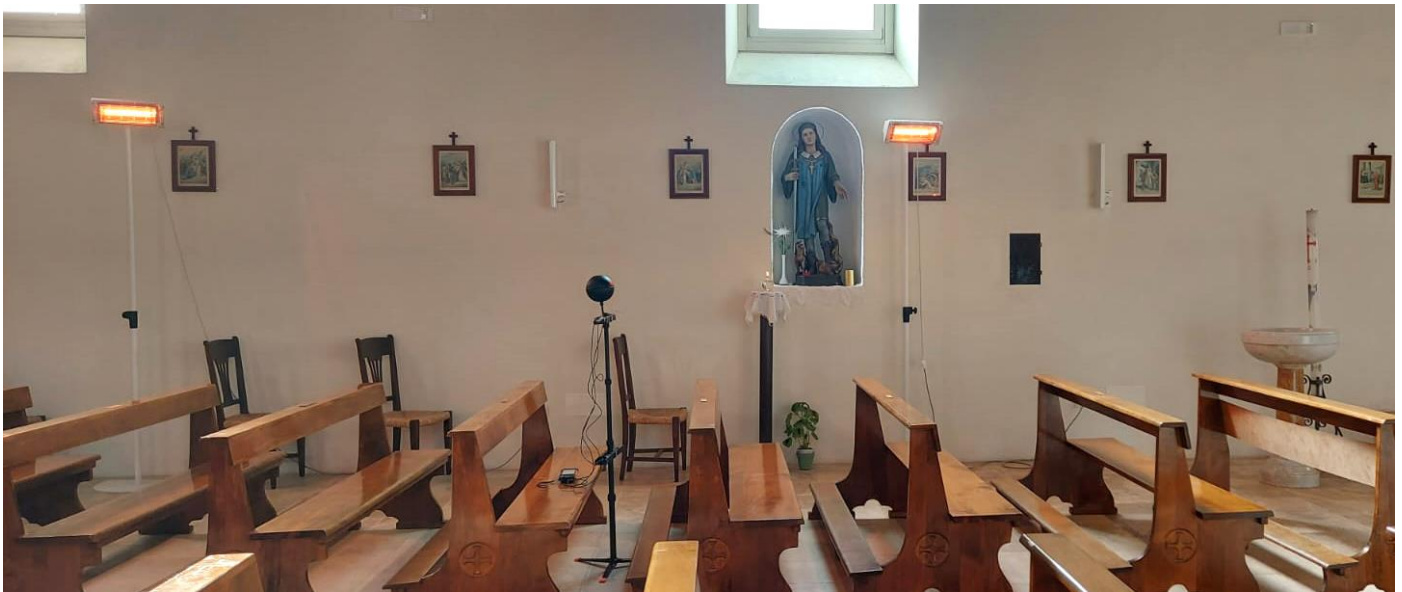
Figure 9. Comfort monitoring of the S. Vito church: Case ii and infrared lamps on.

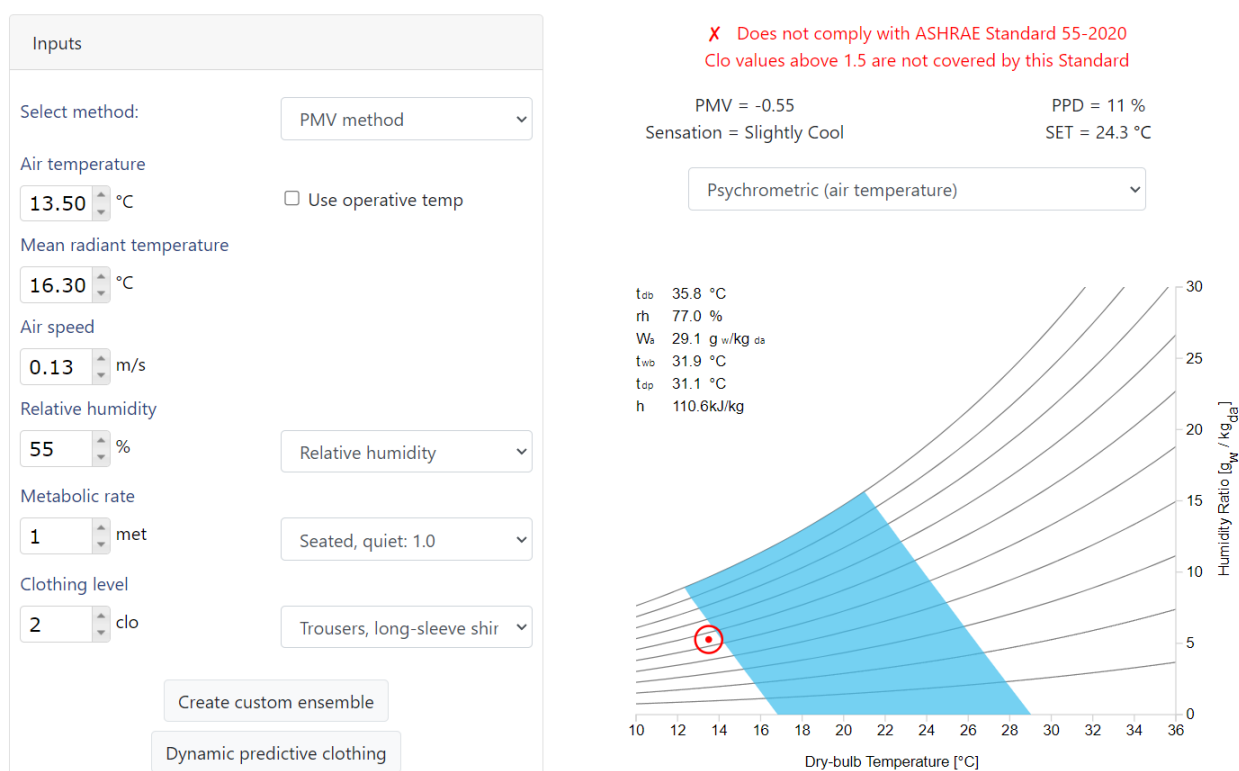
**Figure 11.** Psychrometric chart for the comfort condition (blue area) defined by Case ii input from Table 3 (infrared laps on: red point on the chart). The abscissa is the dry-bulb temperature and the ordinate is the Humidity Ratio (HR%). The CBE comfort tools automatically calculates the relative air speed and the dynamic clothing insulation [49,52].

The table shows how the condition of discomfort related to case ii (users seated, met 1) improves slightly with the use of heating systems. In particular, the verification carried out thanks to the CBE comfort tool, shows these parameters in relation to the psychrometric diagram: it is possible to verify how the use of infrared lamps, while improving the indoor parameters, does not allow to reach the neutral sensation (Figure 11: red point out of the blue comfort area); on the other hand, the simulation data for underfloor heating are the only ones to guarantee a neutral sensation (Figure 12: red point in the blue area).
