Creating a Risk Assessment Plan for Rainfall Impacts on Heritage Buildings Façades via Quantitative Methods

Citation: Hegazi, Y.S.; Fouada, M. Creating a Risk Assessment Plan for Rainfall Impacts on Heritage Buildings Façades via Quantitative Methods. *Sustainability* **2023**, *15*, 1817. <https://doi.org/10.3390/su15031817>

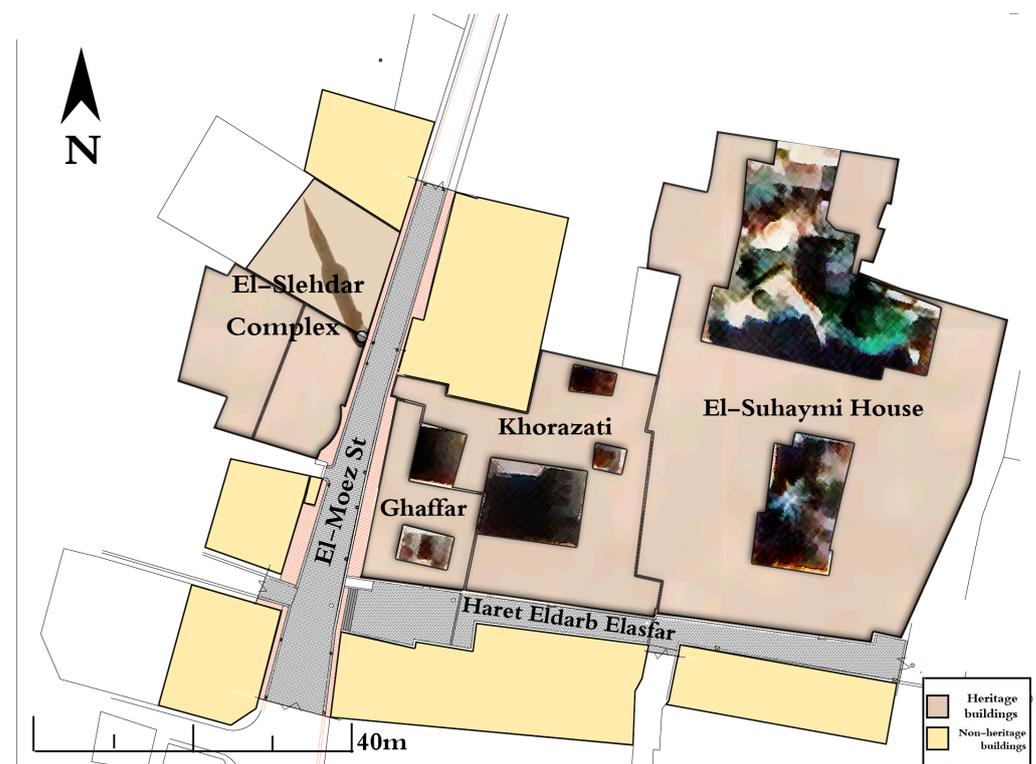
Figure 3. Section (C) of El-Moez street.

The research selected and divided the northern part of El-Moez St. into seven sections according to the intersecting arteries and the number of monuments in each section (Figure 2). Then, it selected section C as a case study, including three monuments and one heritage building: three houses (Mostafaa Ghaffar, Khorazati, and El-Suhaymi) and one multi-use religious complex (the Mosque and Sabil of El-Slehdar). Section C has one of the most valuable alleys in historic Cairo, named "Hart El-darb El-asfar" (Figure 3).

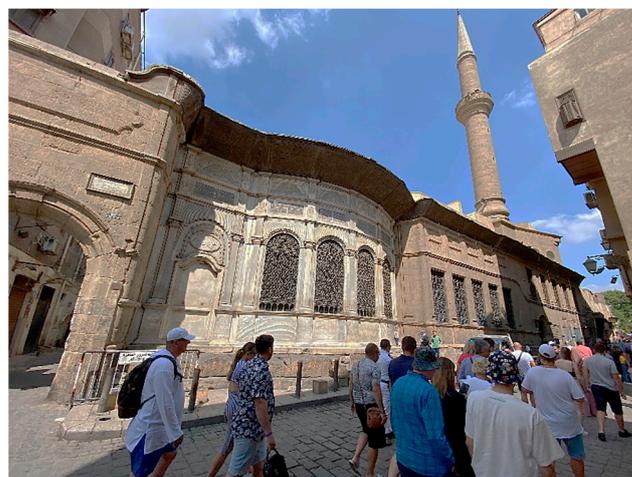
Figure 4. The front view of the main façade of El-Slehdar's complex.

Figure 5. EL-Slehdar complex's main façade.

Figure 6. The Sabil part of the EL-Slehdar façade shows the white marble carved with floral ornaments and inscriptions in the façade, and round-arched windows are covered with cast bronze with hollowed-out ornaments.

The main façade of the El-Slehdar complex overlooks El-Moez St., which is divided vertically into the El-sabil, the kuttab (school), and the mosque, while the main entrance of the mosque is at the rear façade.

The façade of the sabil consists of four round-arched windows, each covered with cast bronze and hollowed-out ornaments. This part of the façade is covered with white marble carved with floral ornaments and inscriptions. The kuttab and mosque's façade consists of ten rectangular windows: Half on the ground floor and the other five on the first floor. They are all covered with metal hollowed-out ornaments. This part of the façade is covered with limestone. A sloping wooden cornice tops the whole façade, including its two parts covered with decorative plaster (Figures 4–6). The Ottoman minaret is covered with limestone [14].

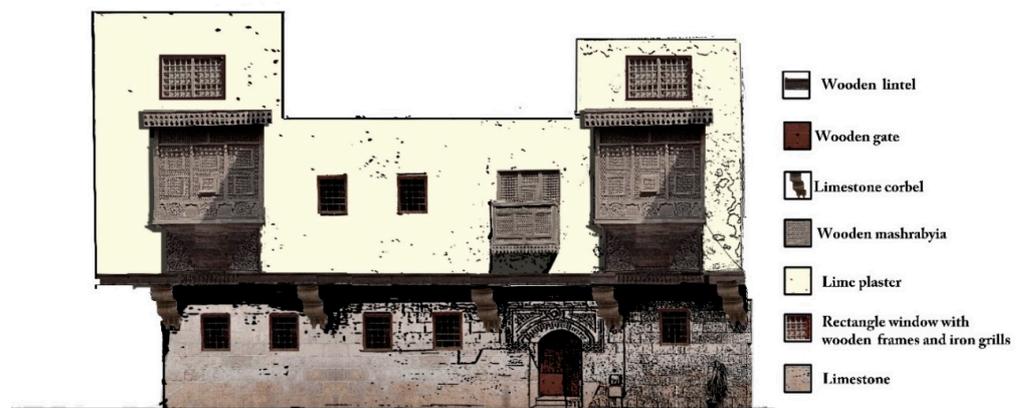
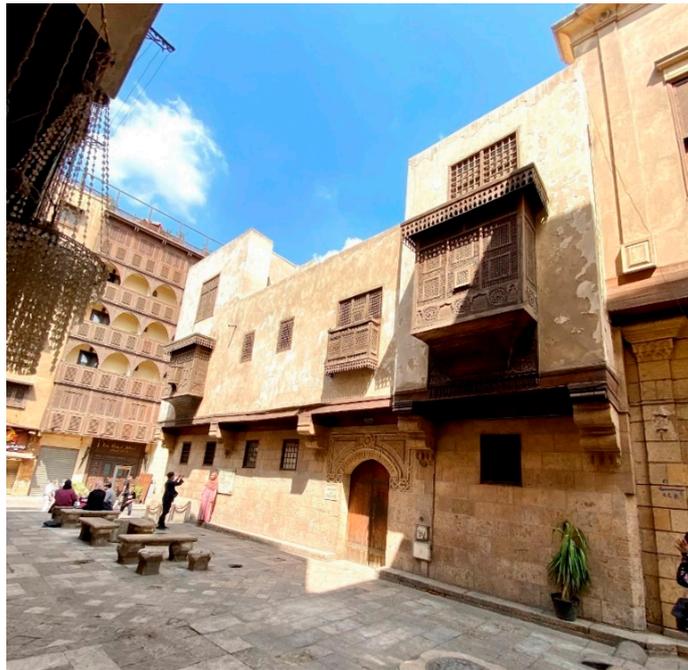
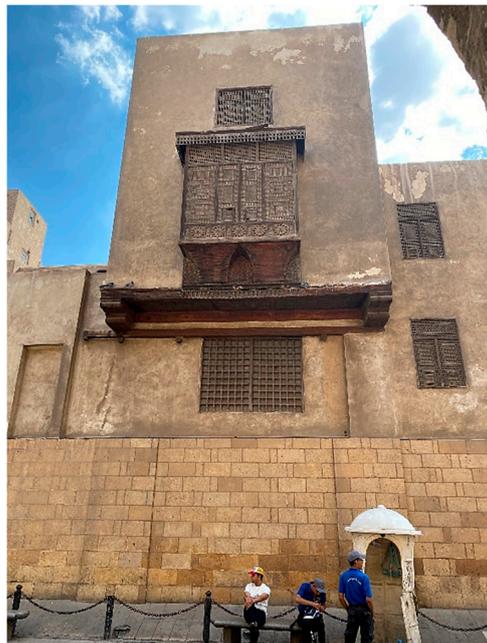
Figure 7. The front view of the main façade of Mostafa Ghaffar’s house overlooking Eldarb Elasfar street.

Figure 8. The main façade of Mostafa Ghaffar’s house overlooking El-Darb Elasfar street.

Figure 9. The side façade of Mostafa Ghaffar’s house overlooking El-Moez street.

The house has two main external façades. The smaller one overlooks El-Moez St., and the bigger (which has the main entrance of the house) overlooks Eldarb Elasfar street. The house consists of three stories. The ground floor has five rectangular wooden windows covered with iron grilles and a stone segmental-arched house gate with wooden doors. The two façades of the house have four wooden bay windows named “mashrabyia”. Only one of them is located in the El-Moez façade. The other three are located in the façade of Eldarb Elasfar st.

The ground floor of the house’s façades is covered by limestone, and the remaining parts of the façades are covered by lime plaster. The façades of the house have limestone corbels and wooden lintel that bear the prominent part of the façades of the house [15] (Figures 7–9).

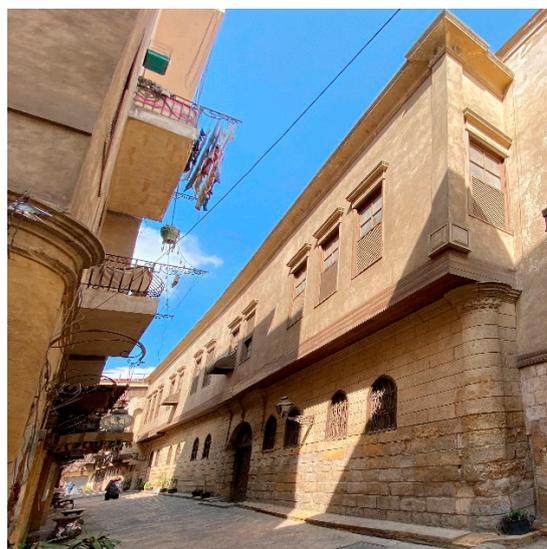
Figure 10. The front view of the façade of Khorazati House overlooking Eldarb Elasar street.

Figure 11. The façade of Khorazati House overlooking Eldarb Elasar street.

The architectural style of the house merged the styles of 19th-century Cairo and Turkish houses. The house consists of two stories. It has one façade that overlooks Eldarb Elasfar st., and the façade of the ground floor has ten wooden pointed arched windows covered with iron grilles and a stone round arched house gate with wooden doors. The

first floor façade has 12 rectangular wooden framed windows with wooden-glassed panes (Figures 10 and 11).

The ground floor of the house's façade is covered with limestone (partially affected by the weather conditions), and the first floor of the façade is covered with lime plaster.

The façade has a wooden lintel, the prominent part of the house's façade, as well as a gypsum cornice that tops the façade [16].

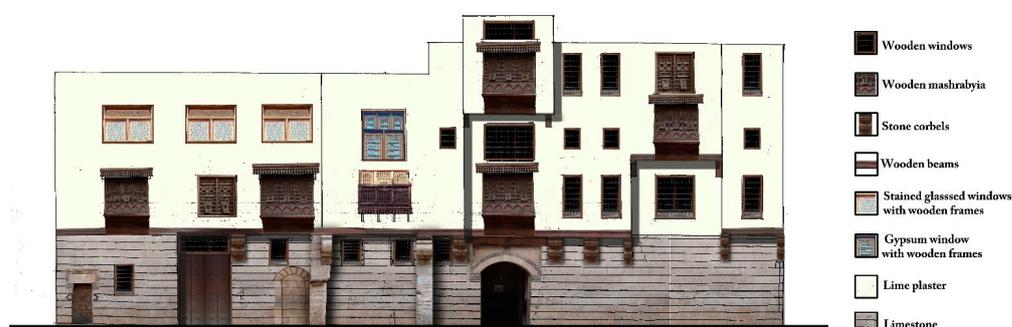
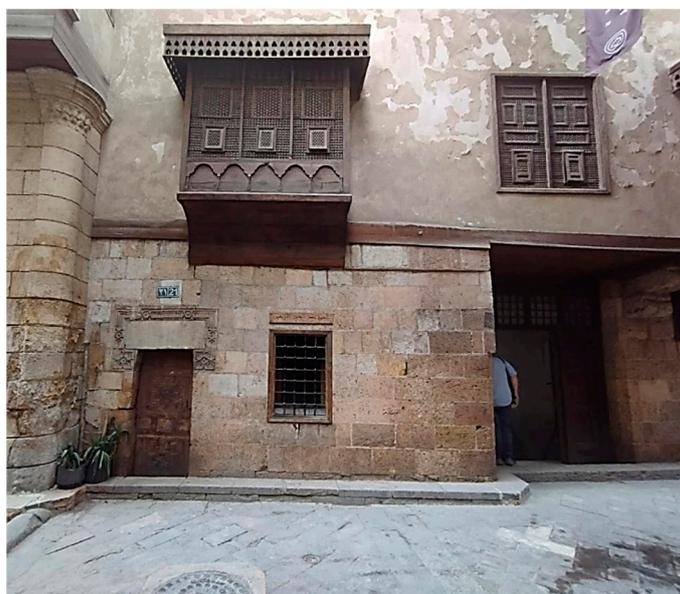
Figure 12. The front view of the external façade of El-Suhaymi House overlooking Eldarb Elasar street.

Figure 13. The external façade of El-Suhaymi House show the multi-entrances.

Figure 14. El-Suhaymi main entrance.

The architectural style of the external façade of El-Suhaymi house is characterized by Islamic architectural elements. It consists of eight mashrabyia windows with three different forms, rectangle windows with wooden frames, and iron grilles of different sizes. The effect

of Ottoman Islamic architecture can be observed in this façade by the two stained glassed windows and single gypsum windows with wooden frames. Like the other two heritage houses of Eldarb Elasar street, the ground floor of the façade of El-Suhaymi House is covered with limestone, and the remaining parts of the façade are covered with lime plaster. The façade has limestone corbels and wooden ones in the upper parts of the façade. There are wooden lintels that bear the prominent parts of the house's façade [18] (Figures 12–14).
