Article

# Energy and Sustainable Strategies in the Renovation of Existing Buildings: An Italian Case Study

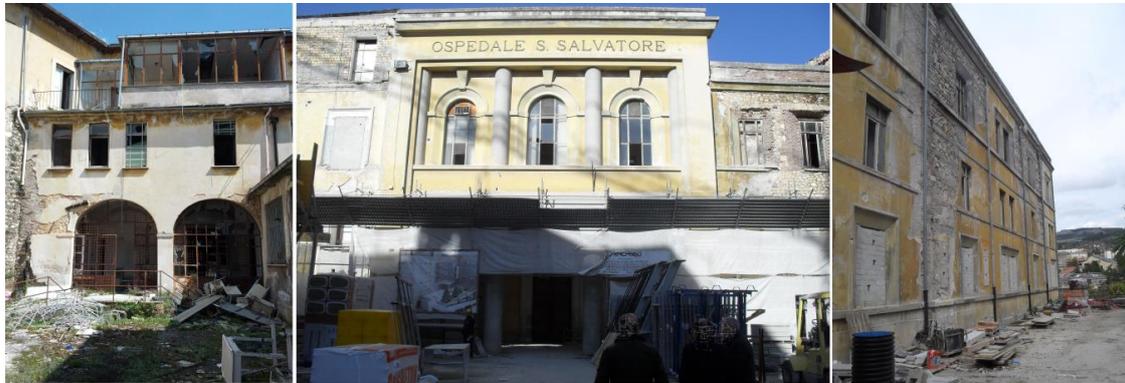
of a new hospital, the building has been left empty and devoid of any function, undergoing a gradual process of degradation, worsened by the serious damage caused by an earthquake that hit the city of L'Aquila in 2009 (Figure 1).

**Figure 1.** Current situation.

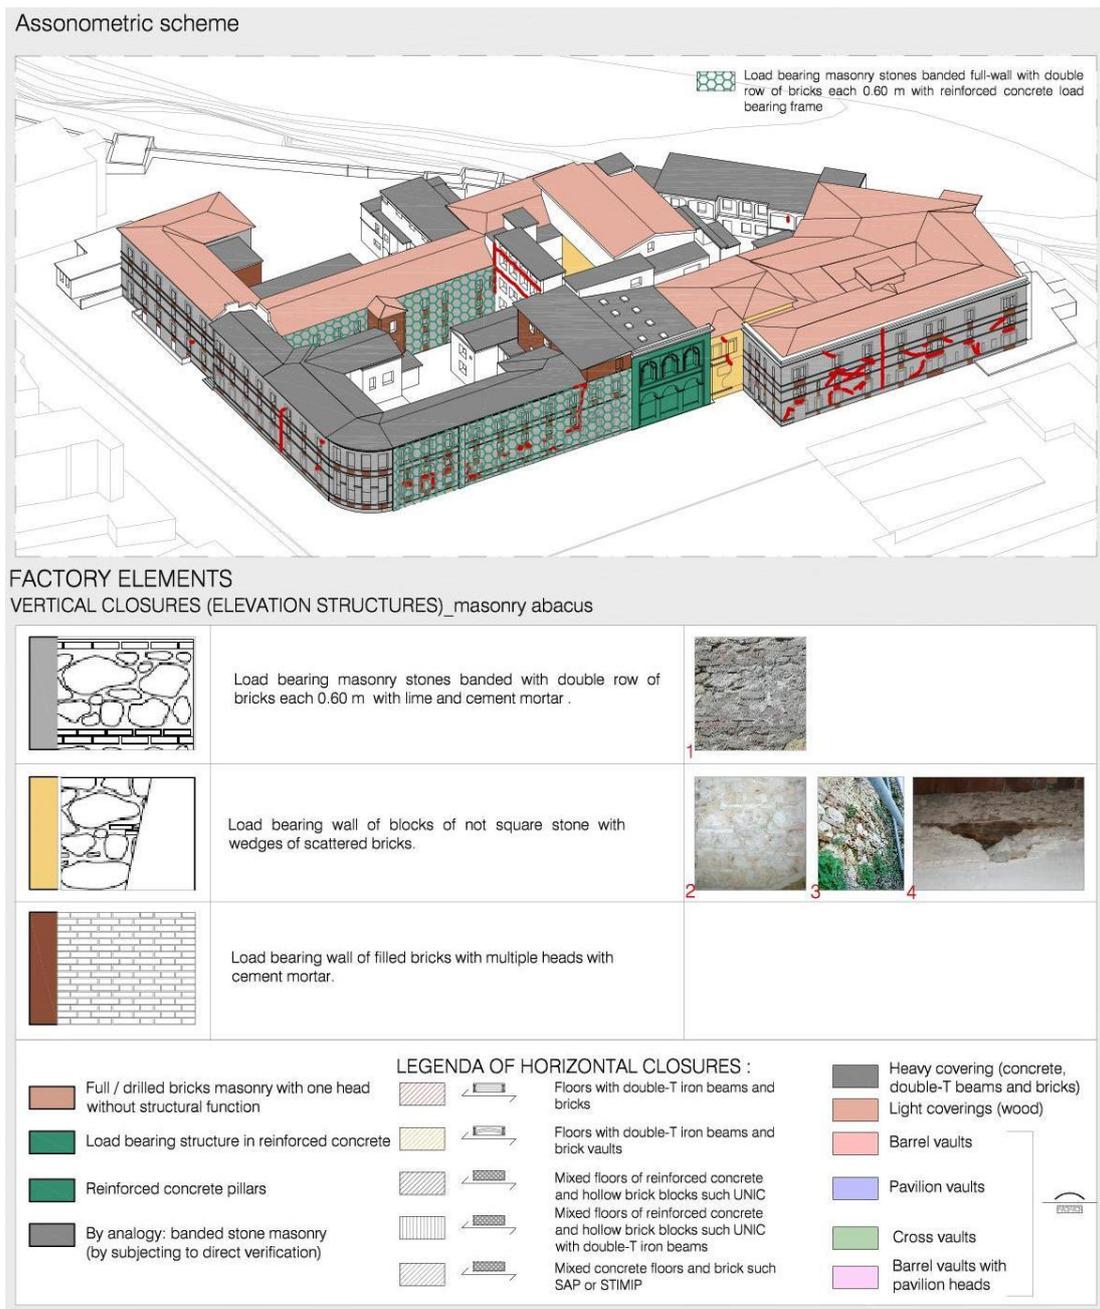
The construction structure of the building complex, clearly visible due to the state of degradation of the plaster, is the result of the transformations undergone over this time. The analysis of vertical closures shows that the medieval core of the building has a structure of stone masonry, while in almost all of the remaining part of the building complex the stones are alternated every 60 cm to a double brick course, reinforced only in some portions of the structure with concrete pillars. As these construction elements do not have a homogeneous layered composition, the related energy and structural behaviors of the building are not linear with the consequent impossibility of assessing its performance (even the floors of the different portions of the building were built using different techniques). In fact, in the original medieval section, there are vaults or mixed slabs with iron and clay bricks (double T iron beams and vaults made of bricks or flooring blocks), whilst in the remaining part of the building there are floors made of hollow bricks and concrete slabs. The roofing structures are made of wood in all sections of the building, despite the fact they were built in different periods (Figure 2).

Figure 2. The constructive structure.

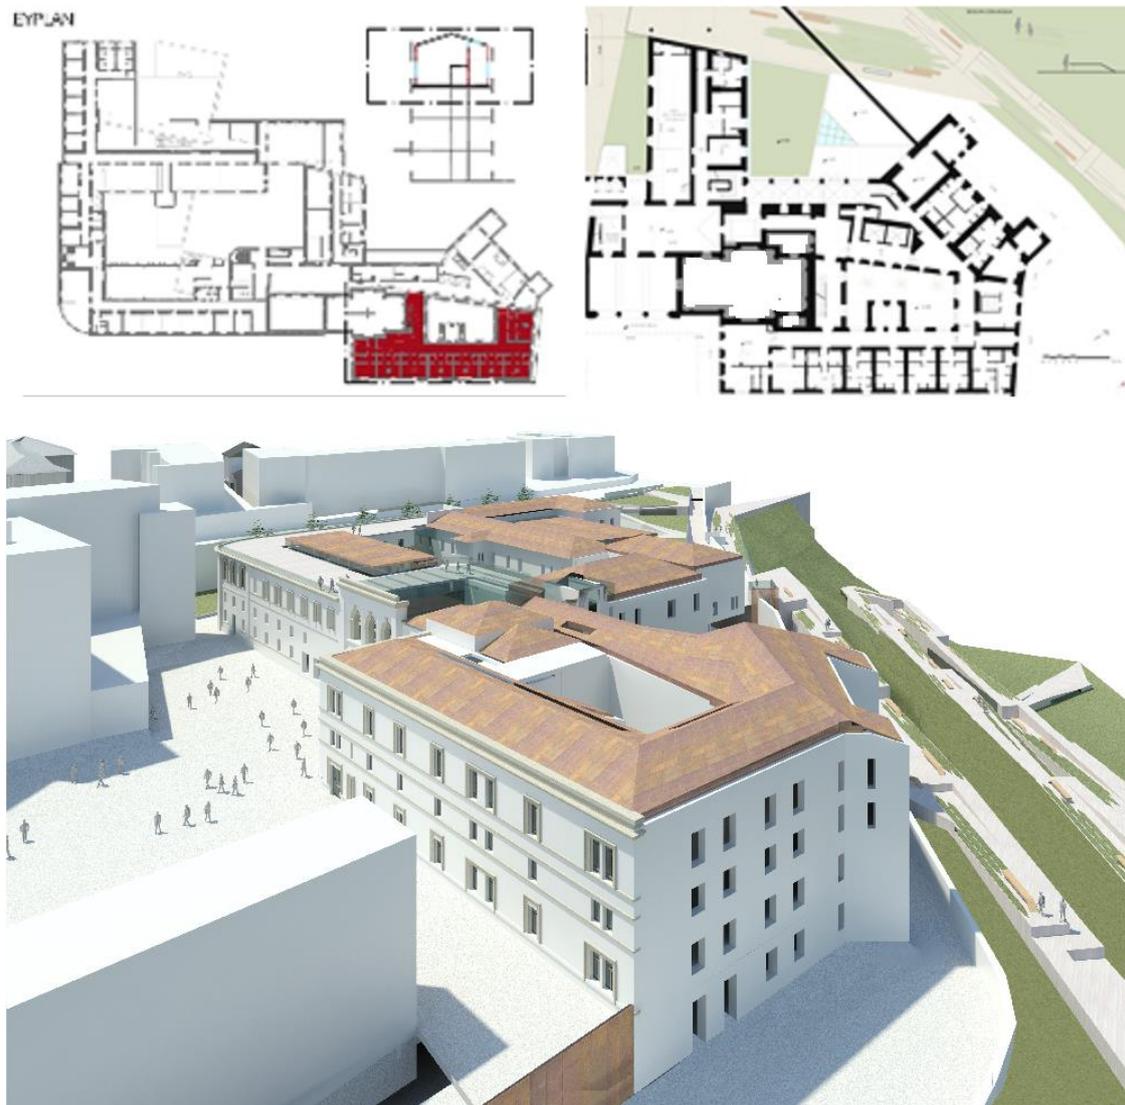
They were only used, however, for the portion of the building complex dating back to the 1950s. In fact, being the most damaged part of the building, it needs to undergo significant recovery work, both from a structural and energetic point of view (Figure 3).

**Figure 3.** Location of part of the building studied in detail.

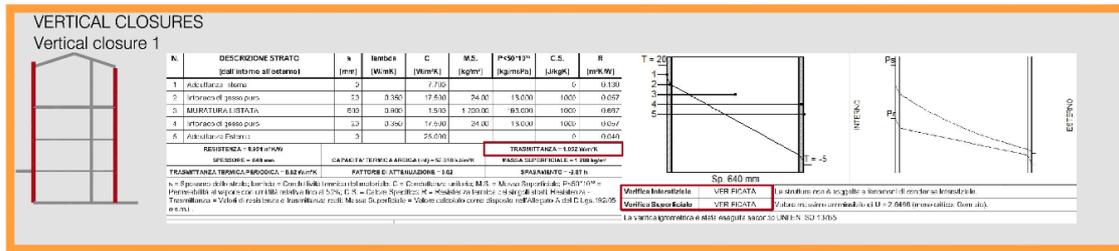
CURRENT STATE

The thermal analysis of the vertical and horizontal closures in a steady state showed inadequate performance, with values of transmittance exceeding the maximum levels permitted by law (D.M. 26 June 2015—Ministerial Decree: “Adjustment of decree of the Minister for Economic Development, 26 June 2009—National guidelines for energy certification of buildings”, in accordance with Article 6, paragraph 12 of Legislative Decree 19 August 2005, n. 192). We see, in fact, walls with U-values of  $1.05 \text{ W/m}^2 \text{ K}$  and floors with U-values of  $1.5 \text{ W/m}^2 \text{ K}$ , compared to the limit values of  $0.30$  and  $0.25 \text{ W/m}^2 \text{ K}$ , respectively, required by law (Figure 4).

Figure 4. Thermal analysis of a wall in a steady state (current state).

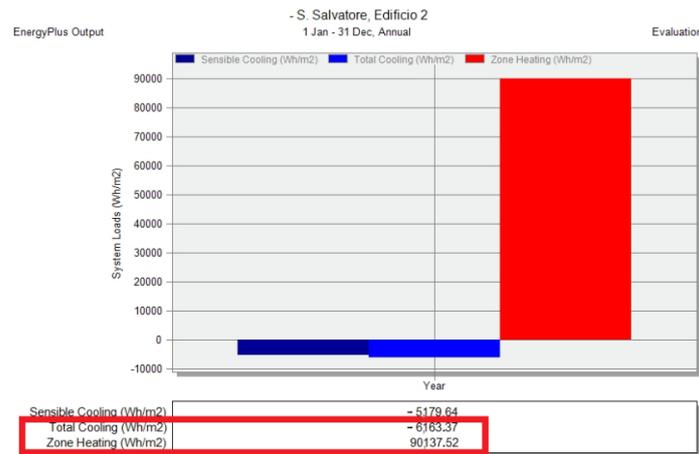
The thermal analysis performed in a dynamic regime showed, consistent with the previous analysis, a high heating demand in winter of approximately 90.137 Wh/m<sup>2</sup> and, conversely, a low cooling demand in summer of approximately 6.163 Wh/m<sup>2</sup> (Figure 5). In the warmest month (August), in fact, the operating temperature was 24.72 °C and relative humidity was 52.47% (Figure 6).

Figure 5. Total consumption of the building in dynamic regime, current situation.

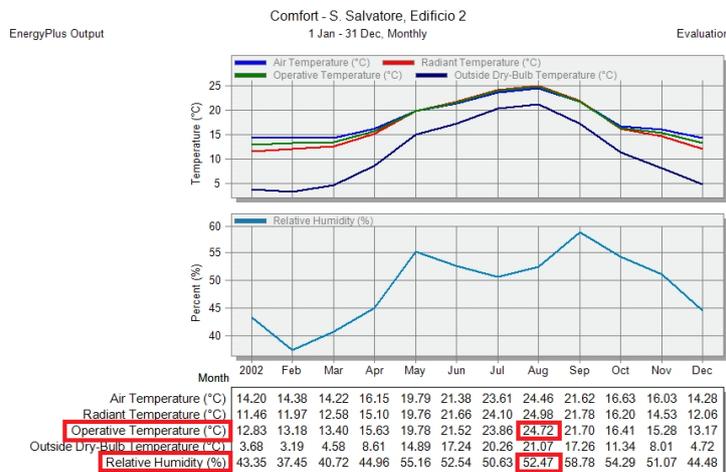
The comfort curve indicates the quantitative levels of the main parameters that influence the thermal comfort in indoor environments, i.e., the operating temperature and relative humidity. As mentioned, the chart shows that the comfort conditions are good in summer, whilst in winter the operating temperature has low values.

Figure 6. Monthly comfort curve (current state).

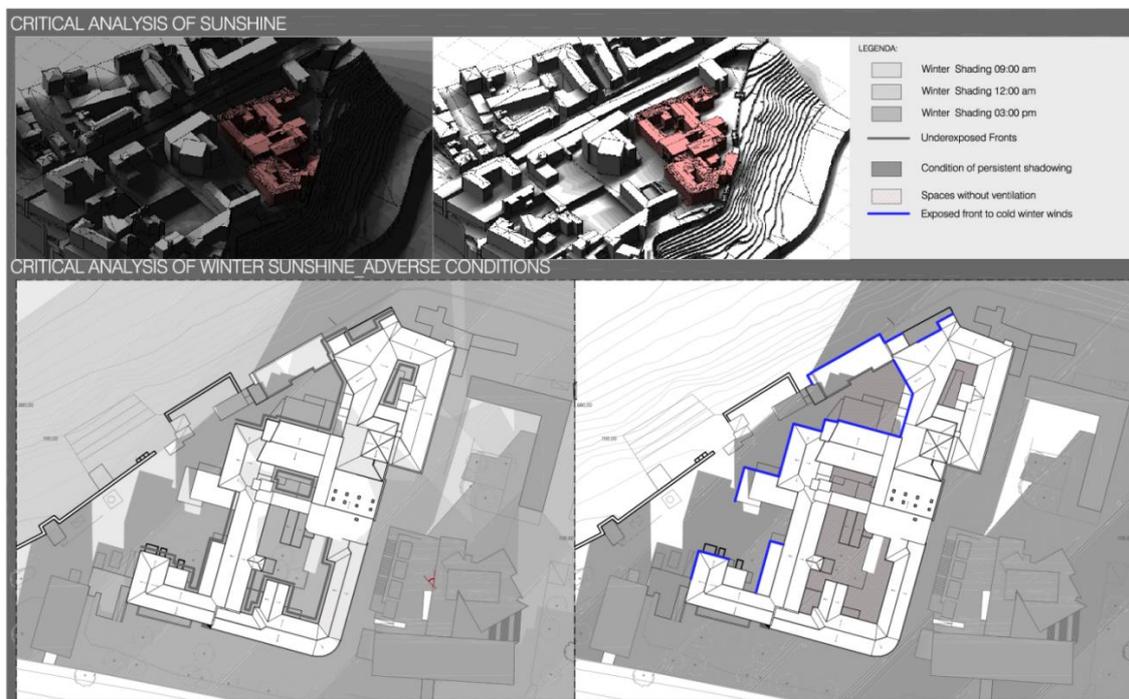
The main issues occur in winter, when the internal courtyards are totally devoid of any natural daylight (Figure 7) [31]. Conversely, the analysis shows that all of the roofs are constantly exposed to the sun. For this reason, we suggest the installation of active solar energy systems.

**Figure 7.** Solar analysis of the building.

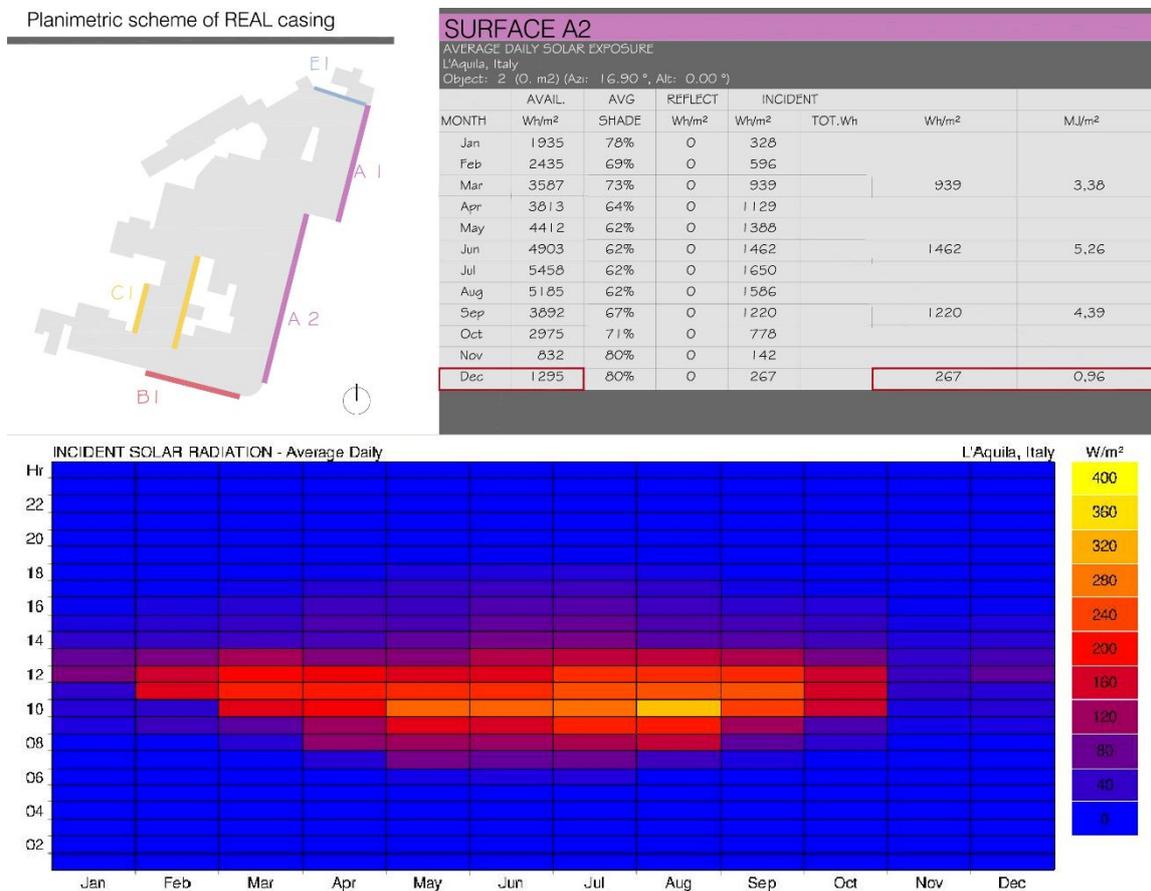
As shown in the picture, the surfaces exposed to the south, (southeast) have the most favorable conditions in winter, with an incident solar radiation of about 20% of the available solar radiation (around 267 Wh/m<sup>2</sup> compared to 1295 Wh/m<sup>2</sup> available) (Figure 8).

Figure 8. Solar radiation analysis.

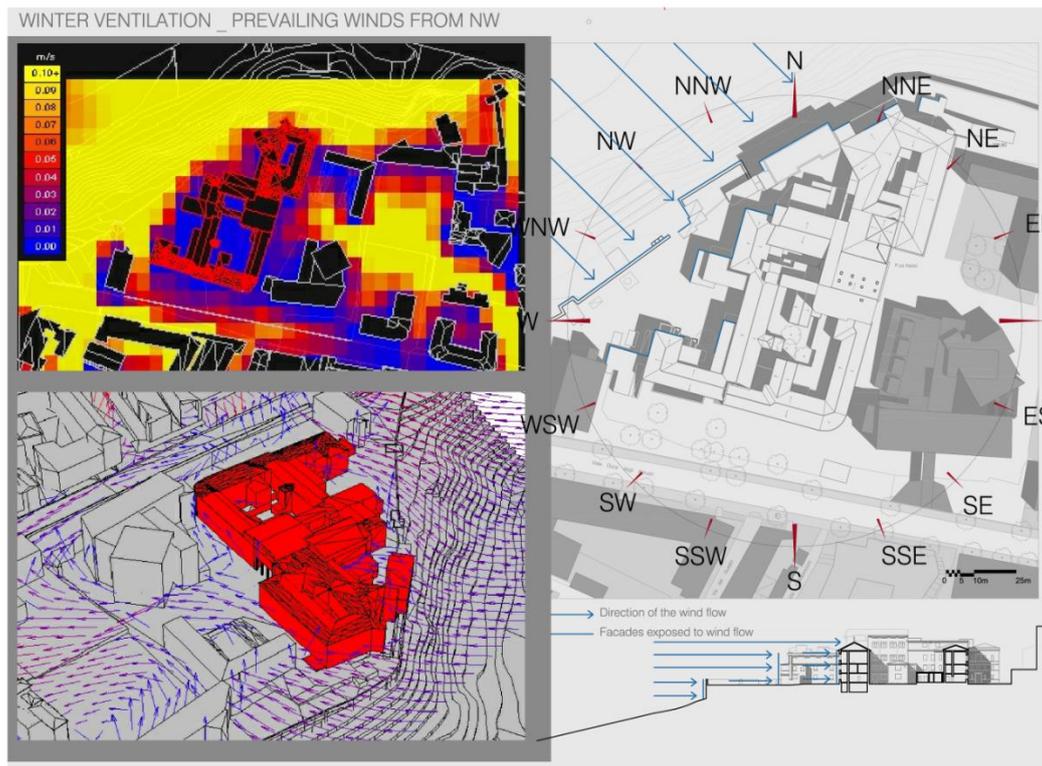
Finally, the analysis of the ventilation showed the prevalence of winter and summer winds blowing from the N-NW, with average speed values of about 1.1 m/s in the various months of the year. The analysis highlighted the fact that there are facades constantly exposed to the winds, both in summer and winter. The summer breezes had a cooling effect on the front of the building. However, it also revealed that there are confined spaces with no ventilation, potentially subject to the formation of damp and unhealthy air (Figure 9).

Figure 9. Ventilation analysis.

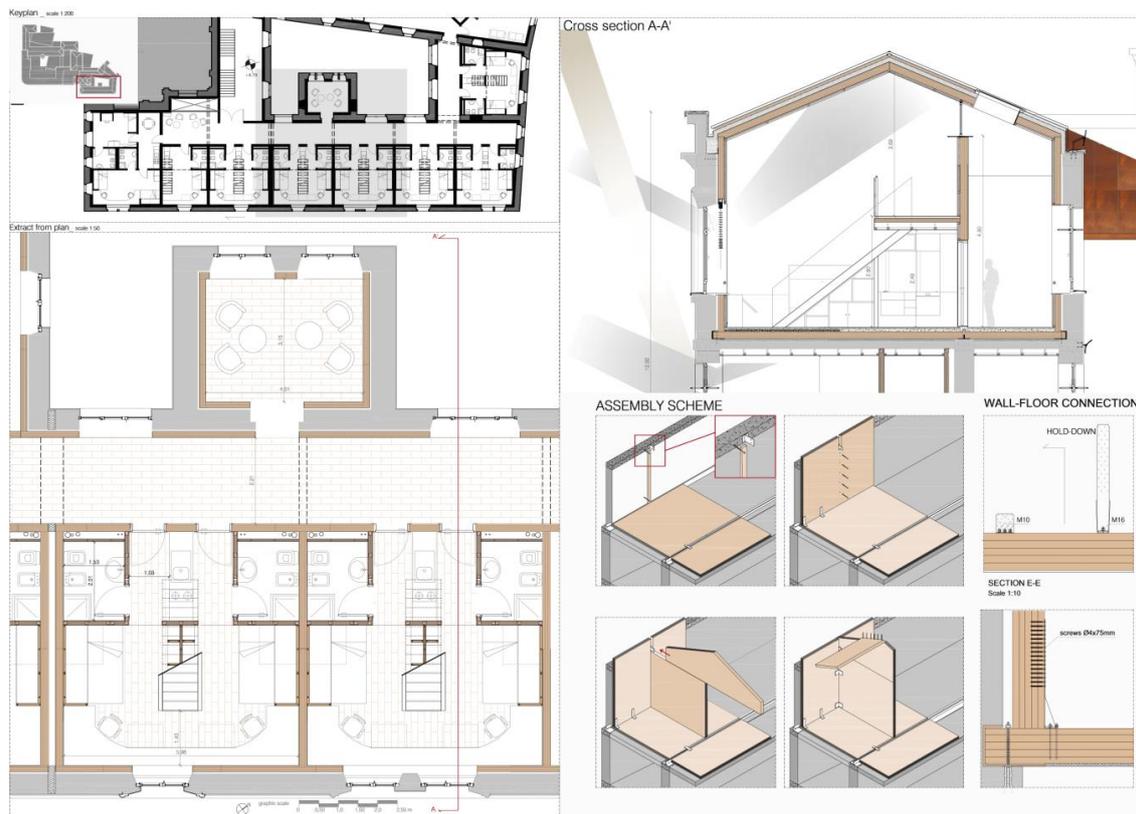
The intervention to upgrade the building's energy efficiency requires, above all, the implementation of a careful compatibility check of the procedure and utilization of newly developed technologies in complex contexts, such as historical ones [36]. High levels of reliability and durability must be achieved by combining technologies consolidated over centuries with the latest high-performance products available on the market. The method consists of superimposing "dry" layers, which improve the performance levels of the building's elements, on the "wet" sedimentation, using minimally invasive and completely reversible techniques. In fact, in addition to the demolition of the roof and of the last floor due to severe structural deficiencies, the project includes the introduction of a new wooden structure inside the existing perimeter walls, which have undergone a structural consolidation, in order to improve both the building's seismic performance and the thermo-hygrometric features of the building envelope. On the second floor, in fact, the introduction of X-LAM self-supporting panels will help solve functional problems, increasing the performance and the overall functioning of the building organism as they work at a structural level, providing stiffness and resistance to the actions carried out on the floor, as well as on an energy performance level, as they can be seen as a surface addition to the treatment of a pre-existing building envelope (Figure 10) [37,38].

**Figure 10.** The new wooden structure adjacent to the pre-existing building.

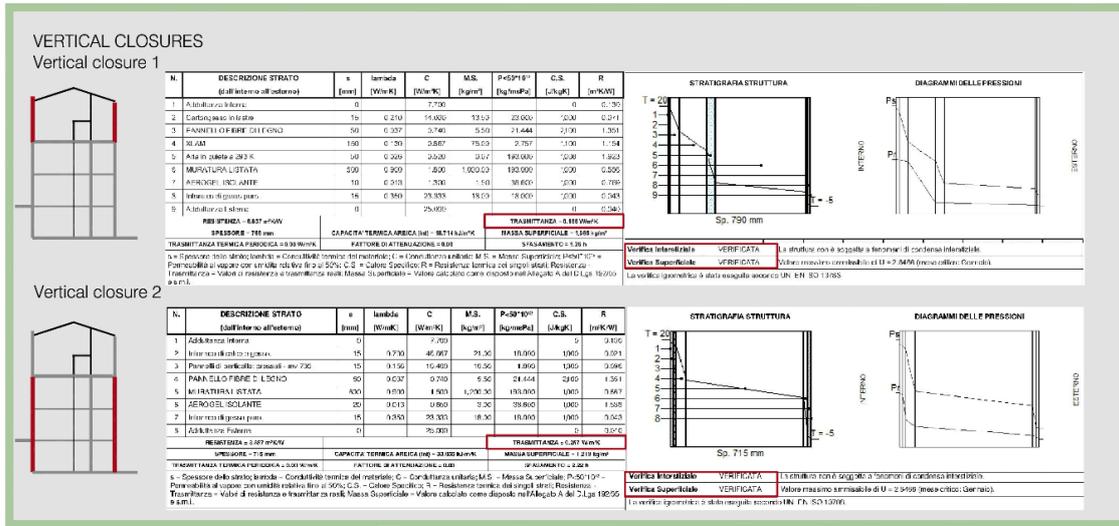
PROJECT STATE

The steady-state assessments of all the envelope elements at the design stage show a significant improvement in both the transmittance values and phase shift values of the thermal wave. For the horizontal closures, there is a U-value of 0.19 W/m<sup>2</sup> K and a phase shift value of 10 h, while the vertical closures have a U-value of 0.25 W/m<sup>2</sup> K and a phase shift equal to 5 h, which are perfectly within the limits imposed by law, as are the superficial and interstitial condensation values (Figure 12).

Figure 12. Thermal analysis of the walls in steady regime, project state.

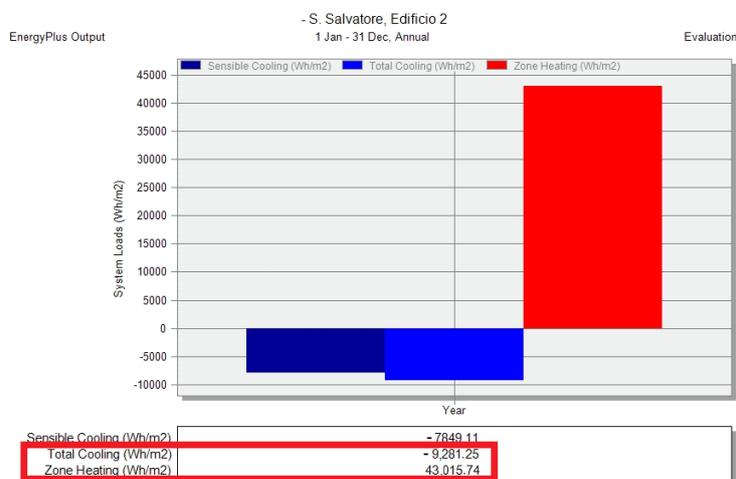
Similarly, the assessments in dynamic state, carried out with Design Builder software, show a significant gain on winter thermal loads, with a reduction of the heating needs of approximately 52.28% (value of about 43,016 Wh/m<sup>2</sup>) and a reduction in the relative indoor humidity value, although there is a slight temperature increase during the month of August, to approximately 25.10 °C, compared to the 24.70 °C of the current state (Figures 13 and 14). This aspect is negligible compared to the considerable reduction in winter heating demand (Figure 15).

Figure 13. Total consumption of the building in dynamic regime, project state.

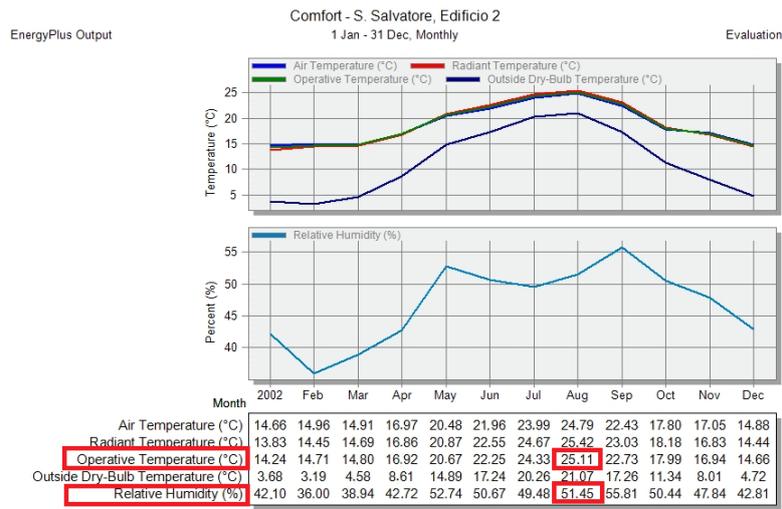
Figure 14. Monthly comfort curve, project state.

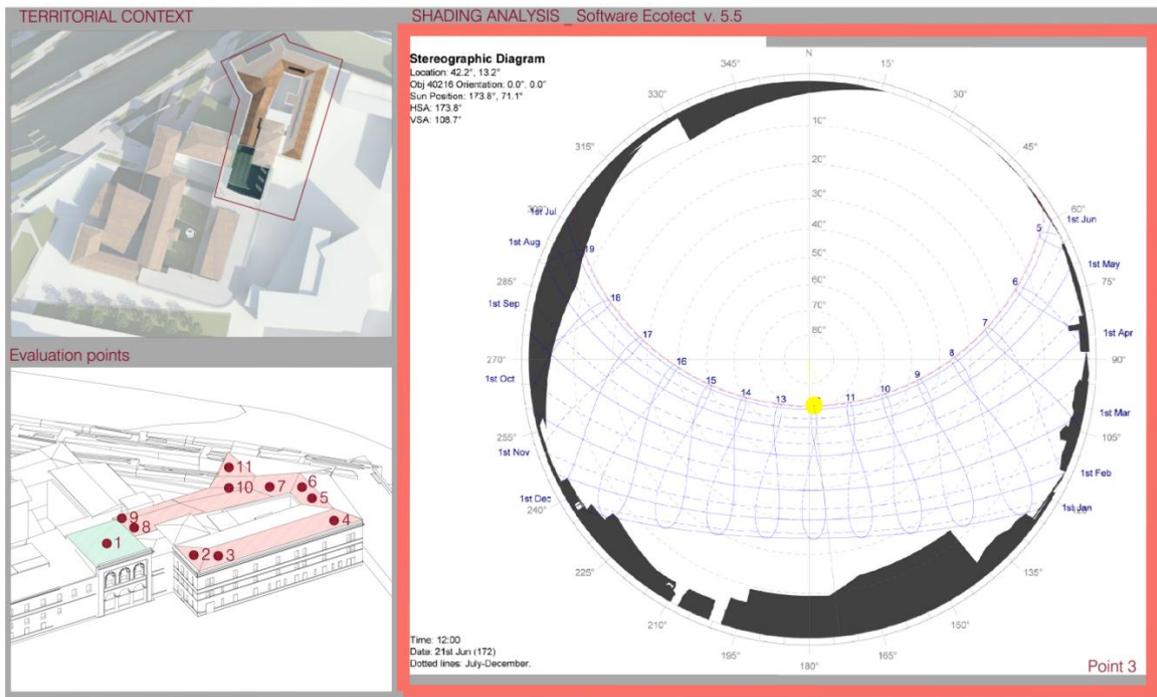
The bioclimatic analyses show, as previously mentioned, that the roof pitches of the building are permanently exposed to the sun (Figure 16). Such data supports the idea of installing systems able to exploit renewable energy [42], also taking into account the considerable annual energy requirements of the portion of the building used as a residence equal to 223,818.90 kWh/yr. Two types of photovoltaic modules are suitable, depending on the orientation and inclination of the roof:

Figure 16. Sun path and shadows on the roof: stereographic diagram.

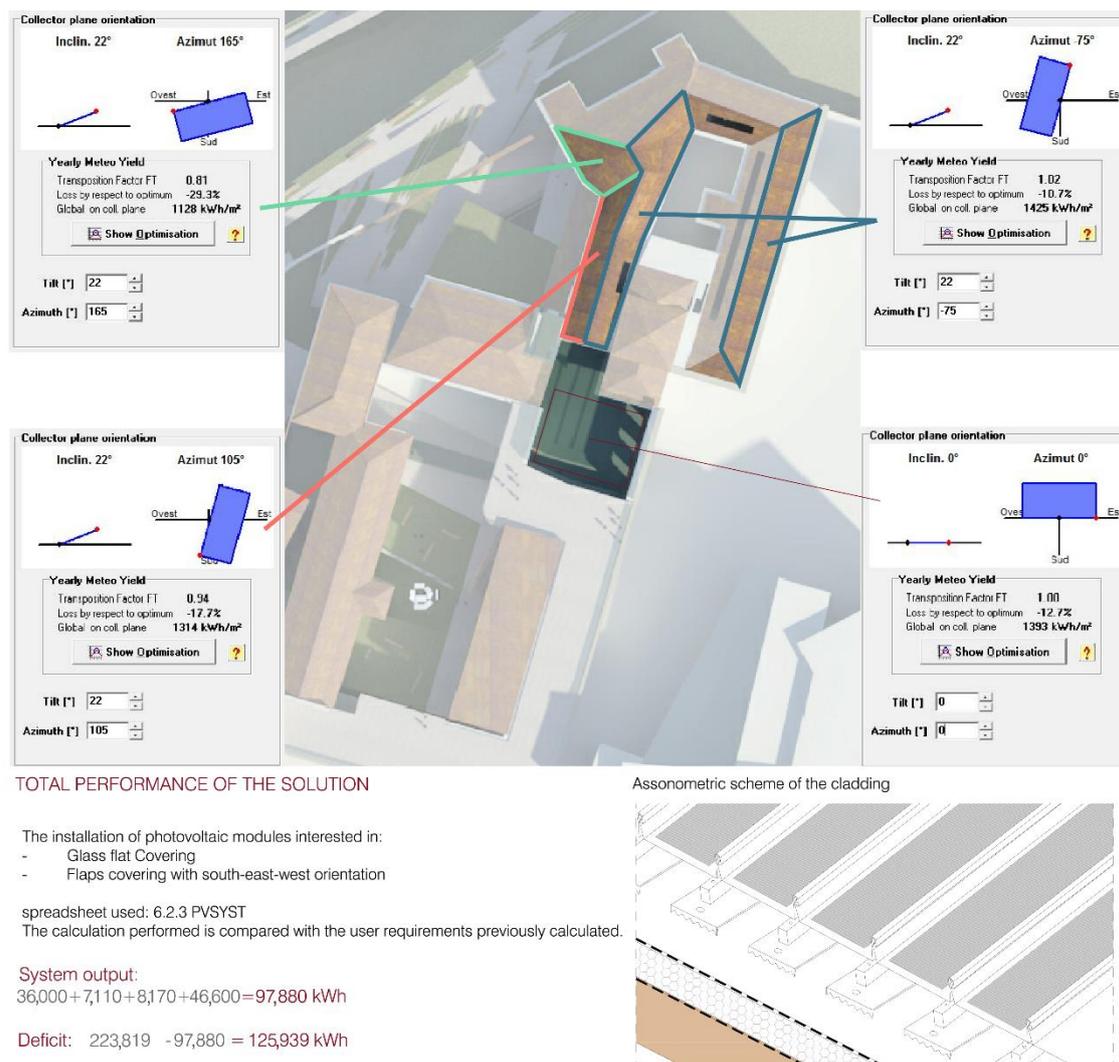
- single-crystal silicon modules integrated into the glass for the flat glass roof, with a peak power of 147 Wp/m<sup>2</sup> and a 17% efficiency;
- flexible thin-film modules installed on the coating of the pitched roofs with east-west orientation, with a nominal power of 68 Wp/m<sup>2</sup> and a 10% efficiency (Figure 17) [8].

Figure 17. Photovoltaic modules installed on the roof.

The roof-integrated photovoltaic systems generate about 98,000.00 kWh/yr of energy, equal to approximately 33% of the electric energy requirements previously calculated.

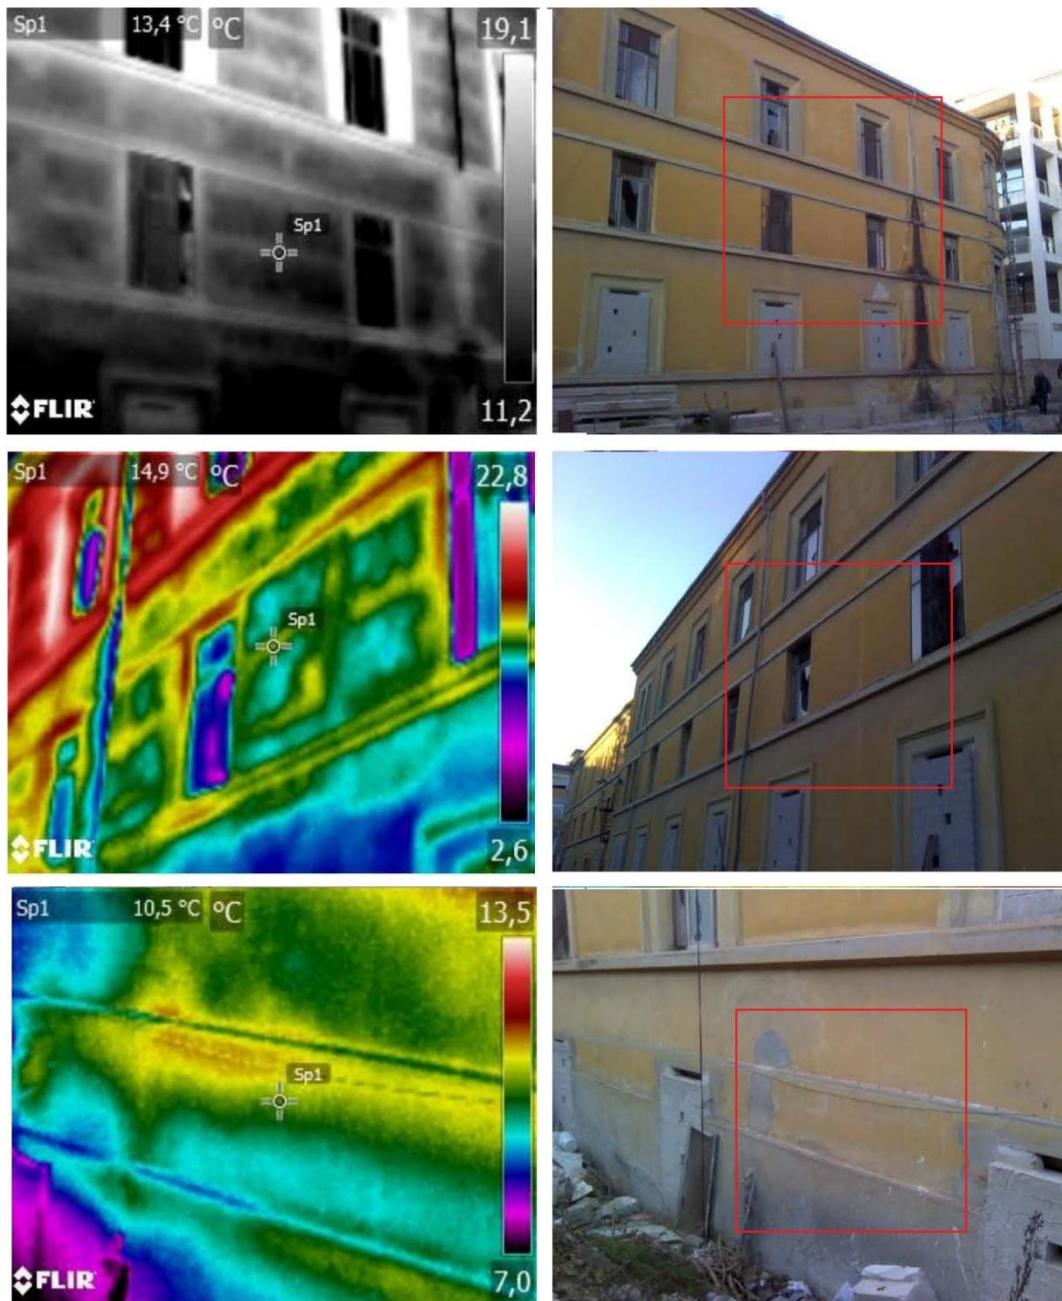
The research illustrated in this paper shows irrefutably the importance of the process of analysis, not only of the formal, material and cultural-historical aspects of a building and its context, but also of the functional and performance behavior of the building elements, in order to achieve a complete and comprehensive characterization of the building elements based on the interconnecting of varying analyses (thermographic, thermo-hygrometric and heat-flux analysis) (Figure 18) [30].

Figure 18. Thermographic diagnosis of the Building.

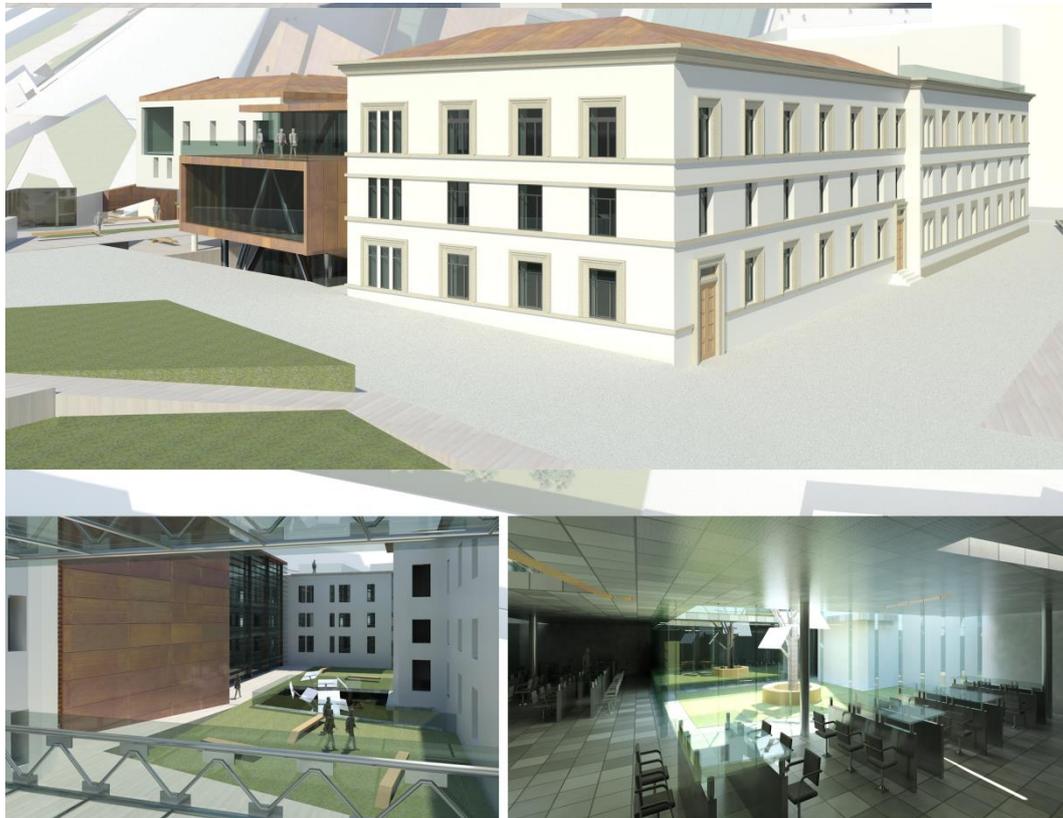
Finally, intervention on historical buildings should be considered and treated as a unique opportunity, not easily transferable to other cases. Work on pre-existing structures and changing the behavior of elements originating in different historical and cultural contexts must be implemented through accurate and localized actions rather than repetitive and universal ones. Therefore, we reaffirm the need for specific, single interventions, and encourage specific rehabilitation projects, as they are the only effective means of responding to the diversity and uniqueness of different contexts (Figure 19).

**Figure 19.** Photorealistic rendering of the new added volumes.
