Assessing Rebar Corrosion through the Combination of Nondestructive GPR and IRT Methodologies

Keywords: reinforced concrete; corrosion; NDT; ground penetrating radar; infrared thermography

The case study presented in this work is located in the military base named “Battery J2 Cabo Udra” (Bueu, Galicia, in the northwest of Spain). The military batteries are constructions that belonged to a former defensive system of the regime of the Spanish dictatorship, which were designed to protect the Galician coast from possible attacks or incursions by sea.

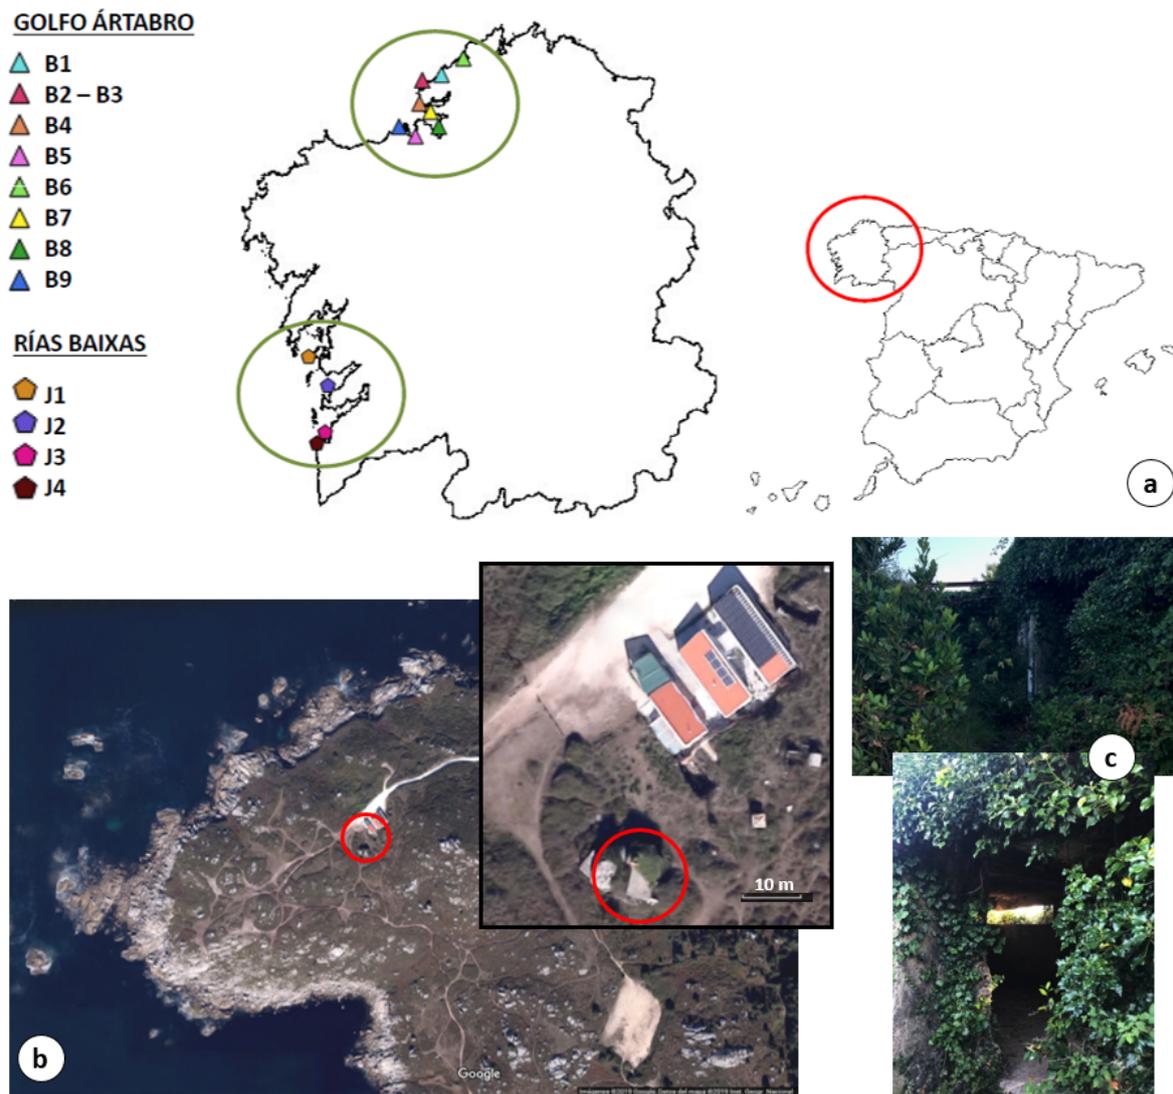
Figure 1. (a) Location of the military batteries in Galicia (northwest of Spain), (b) J-2 battery in Cabo Udra (map images © 2019 Google, National Geographic Institute), and (c) exterior of the battery covered by vegetation.

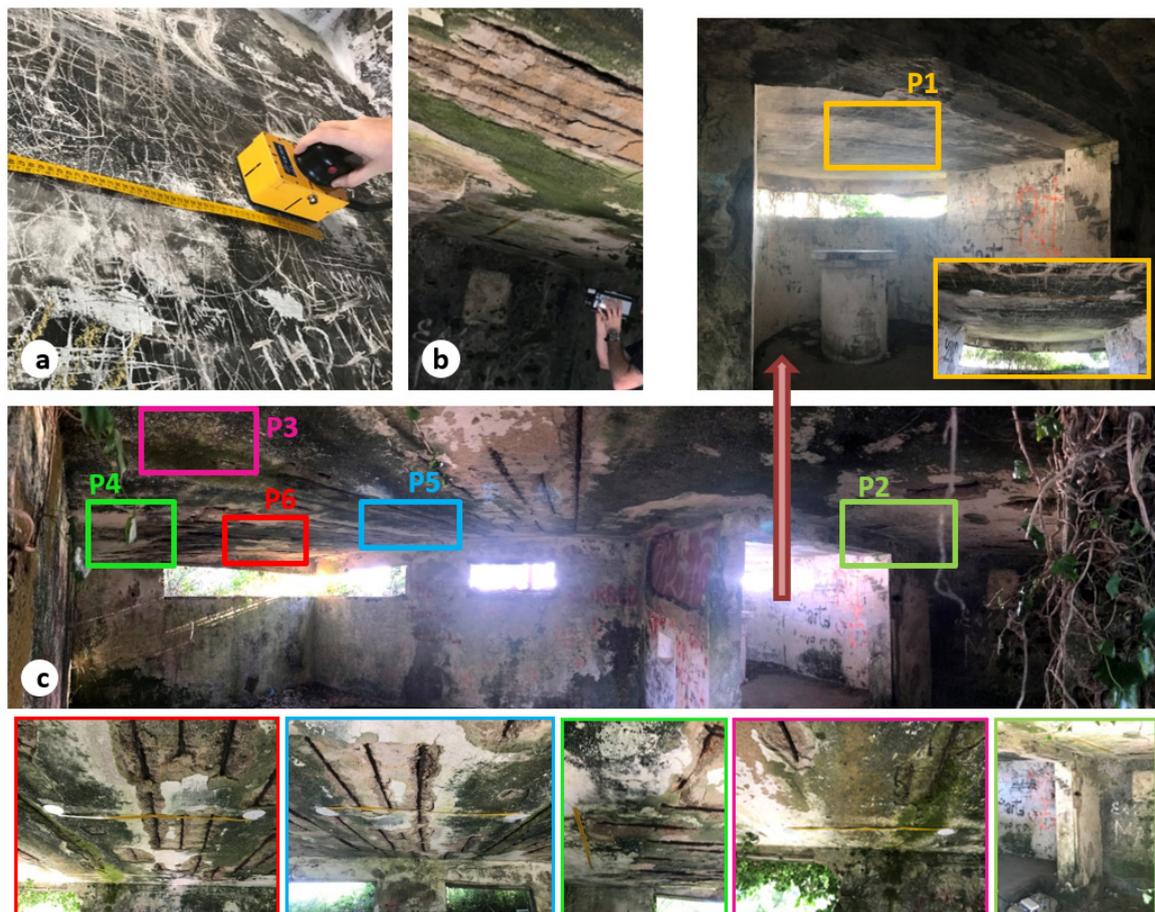
Figure 2. Instruments used for the study: (a) 2.3 GHz ground penetrating radar (GPR) antenna, (b) infrared thermography (IRT) camera and (c) location of the GPR profiles (P1 to P6) through the prospected area (panoramic view of the roof surface).

The GPR study was carried out with a ProEx system from the company MALÅ Geoscience (Malå, Sweden). A high frequency antenna of 2.3 GHz (Figure 2a) was used, with a penetration depth (under ideal conditions) of approximately 40 cm and a spatial resolution of 1–2 cm.

Six profiles were acquired in different areas through the roof of the structure (Figure 2c). The objective was to detect rebar corrosion while evaluating its origins and conditions, as well as to analyze associated pathologies such as cracking, fissures, moisture, etc. The profile lines (data collection) were acquired by moving the antenna perpendicular to the direction of the rebars.

The data acquisition parameters selected were: trace interval distance of 1 cm and total time window of 14 nanoseconds (ns) composed of 292 samples per trace. To measure the profile lengths, and to control the distance between traces, a tape measure was used as a guide (Figure 2a).

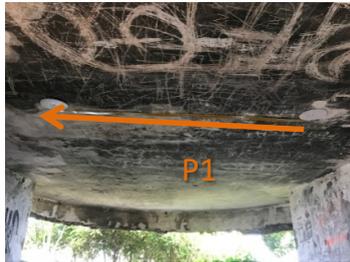
GPR Profile	Length	Description	Image
1	1 m	Zone without pathologies used as a reference

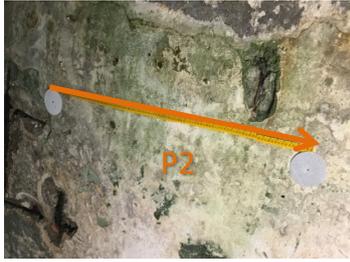
2	1 m	Zone with high presence of moisture, fissuration, delamination, and calcium carbonate salts

Observing the real image of profile 2 in Table 1, this zone presents two main areas with fissuration, moisture, loss of material, and visible bars. In the corresponding radargram (Figure 6), eight hyperbolic reflections were identified: five were interpreted as bars while the other three were interpreted as voids beneath detached concrete, the latter interpreted via reverse polarity. Rebar 4 (at the middle of the radargram) and rebar 8 (at the end of the radargram) were registered at larger travel-time distances most certainly due to higher moisture or corrosion products in such areas that decrease the velocity of propagation of the signal. In the thermographic image, there is variation in the temperature values in the central zone, delimiting the area of detachment and moisture (Table 4) because they offered discordant values with the environment of 0.3 °C.

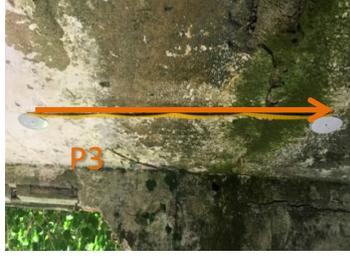
3	1 m	Moisture, fissuration, delamination, rust, and calcium carbonate salts

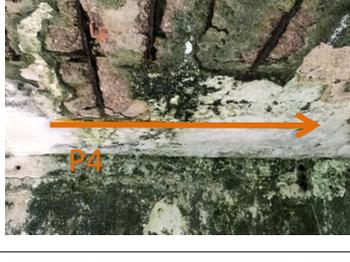
4	1 m	Fractures, cracks, concrete detachment, spalling, corroded steel rebars, and calcium carbonate salts

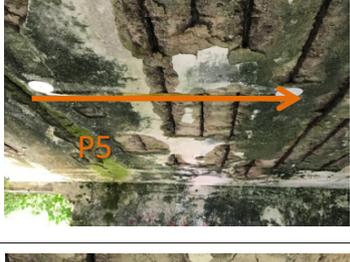
5	1 m	Moisture, concrete detachment, spalling, corroded steel rebars, rust, and calcium carbonate salts

Regarding profile 5, the real image in Table 1 shows a zone divided into two different areas: the left part presents higher moisture and rust, while the right part presents loss of material and visible rebars. The study of the thermal image indicates that the temperature difference between the left and the right part is 1.5 °C, with much lower temperature on the left, because it has greater thickness of material. This implies the presence of detachment and moisture on the left side of the image. In addition, a sudden temperature peak towards the end of the profile can be assigned to the presence of mineral salts, with high reflectivity that provokes an apparent immediate temperature increase. With respect to the GPR data, although the left part of the profile presents material, the rebars appear closer to the surface because of detachment, whereas the reflections produced by the visible rebars show severe signal attenuation, instead of the expected higher amplitude, which could be caused by the higher conductivity of salt solutions.

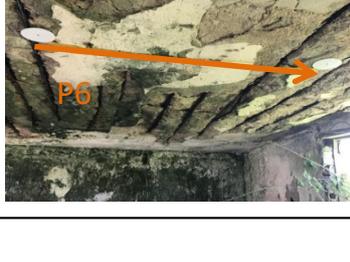
6	0.8 m	Moisture, concrete detachment, spalling, corroded steel rebars, and calcium carbonate salts

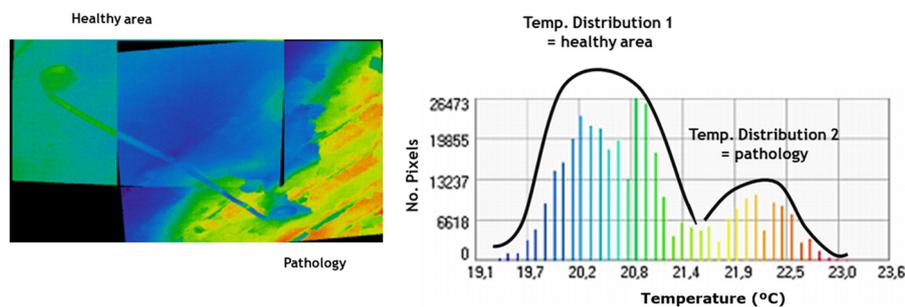
A thermal image with a pathology presents a pseudobimodal temperature distribution (Figure 3), which is a combination between a Gaussian and a bimodal Gaussian distribution. This temperature distribution presents two peaks, one corresponding to the “healthy” area, and one generated by the “pathology” area.

Figure 3. Example of pseudobimodal temperature distribution presented by thermographic images where a pathology is present.

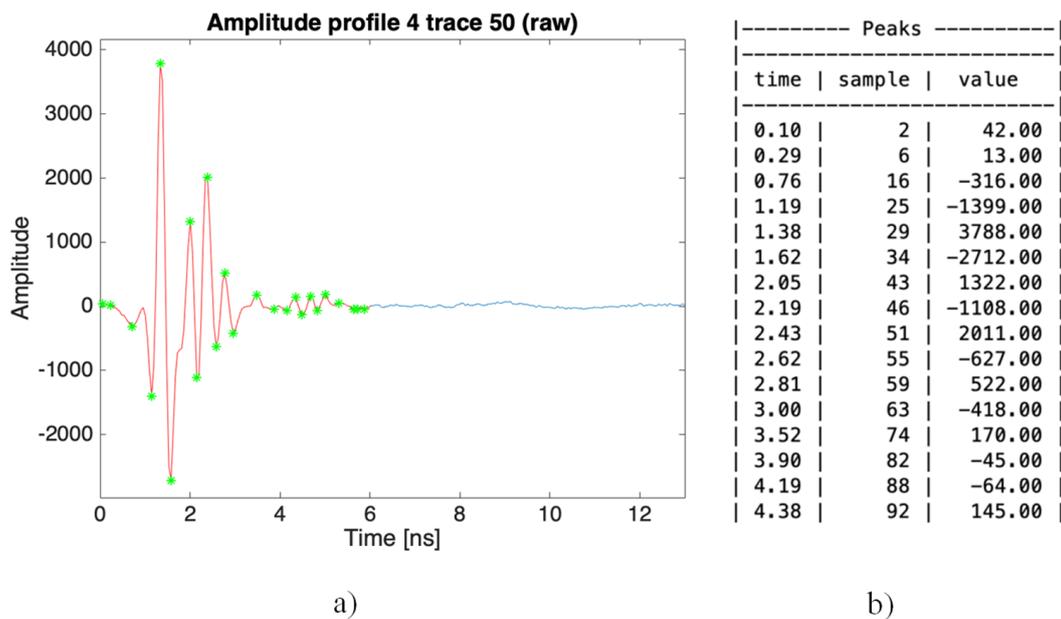
Figure 4. (a) Trace plot where range 0–6 ns has been highlighted in red and peaks marked in green; (b) table showing the information (travel-time distance, sample number, sample value, amplitude) related to some of the peaks in the plot.

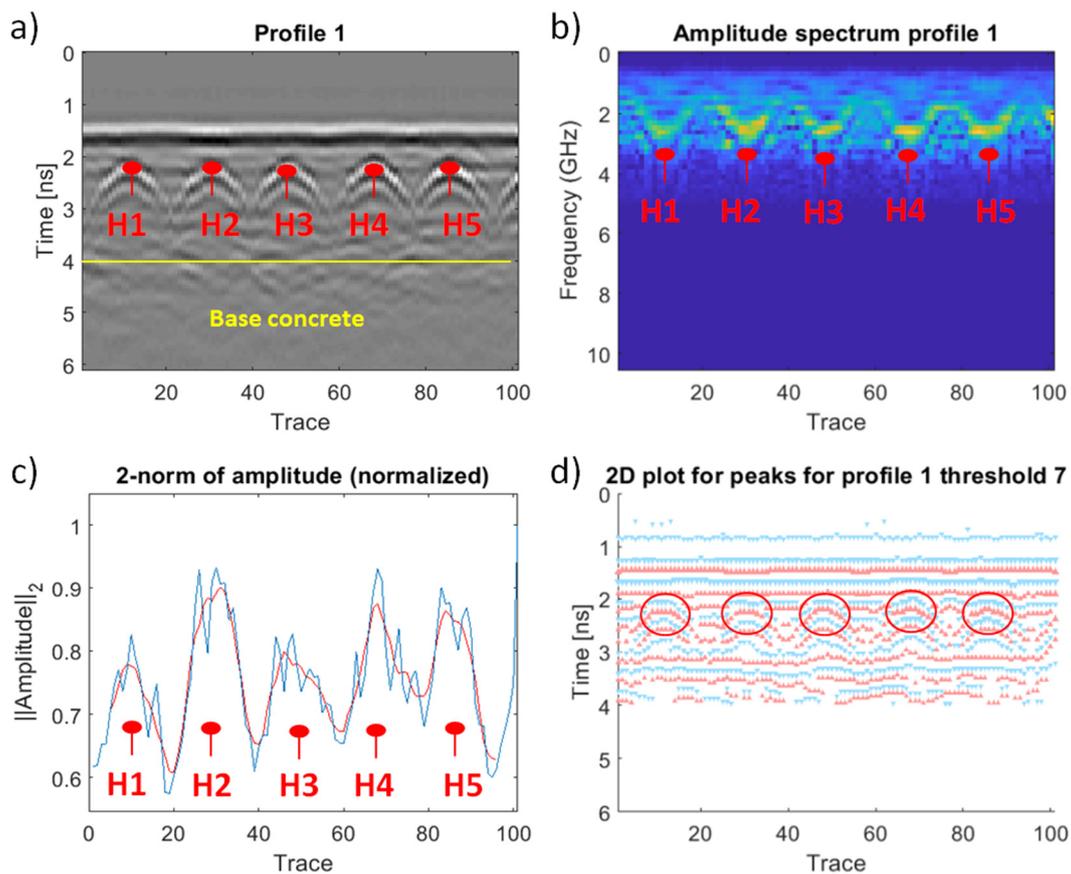
Figure 5 shows the GPR data obtained for profile 1, the nondamage area, highlighting the five hyperbolic reflections (H1 to H5) produced by the rebars located in such area. It is easily observed that rebars are characterized by prominent hyperbolic reflections with a stronger amplitude spectrum (Figure 5c), as well as its positive signal polarity (see Figure 5d and Table 3). Moreover, the reflections from the rebars and the base concrete are seen to be at a time-depth of ~2.25 ns and 4 ns, respectively.

Figure 5. Graphics obtained for GPR profile 1 and interpretation. The five hyperbolic reflections (rebars) produced in this profile line are indicated in graphs (a–c) as H1 to H5. The red circles in (d) represent a positive polarity of the reflections produced by the rebars.

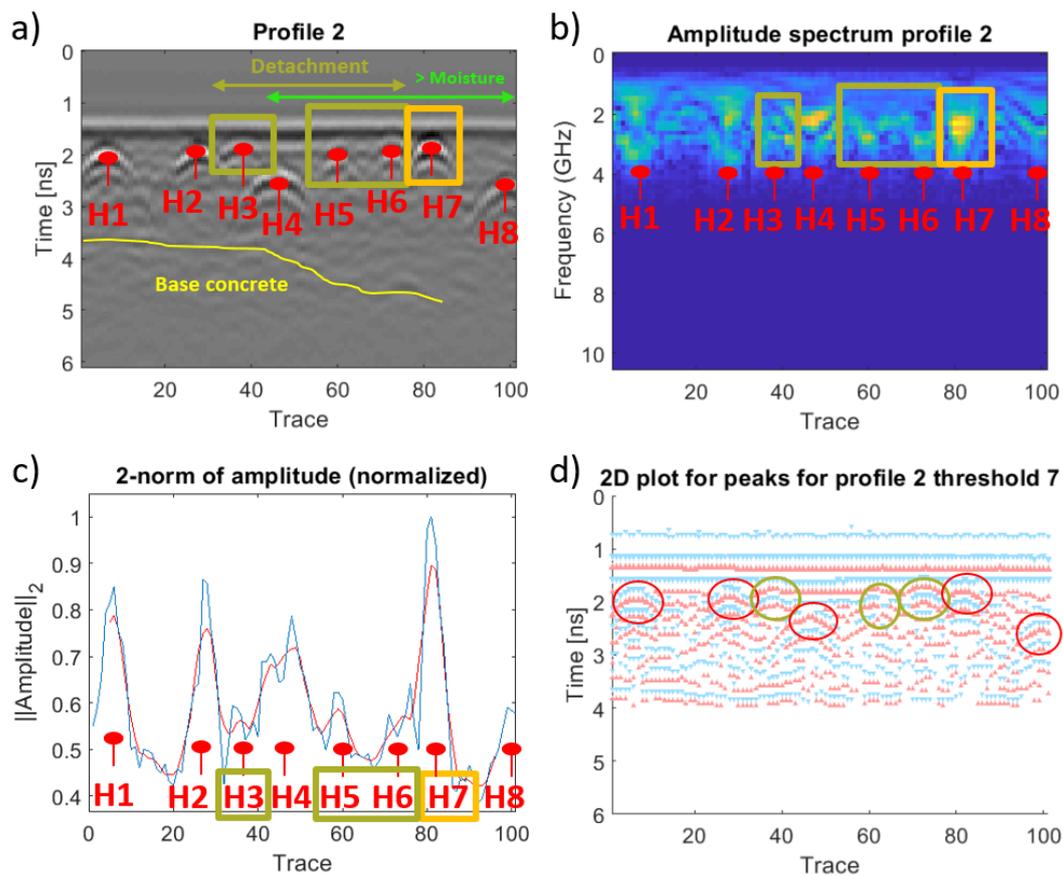
Regarding profile 2, the hyperbolic reflection number 7 presents a stronger amplitude spectrum (Figure 6b) and higher amplitude value (Table 3), which is most certainly produced because it is a nearly open-air rebar (see Table 1), at a travel-time distance of 1.86 ns. On the other hand, the reflections number 3, 5, and 6, at a travel-time distance of ~ 1.9 ns, present reverse polarity (Figure 6d and Table 3) that could be associated to the presence of voids beneath detached concrete (Table 1). Finally, the rebar reflections number 4 and 8 are registered at larger travel-time distances, 2.33 ns and 2.57 ns, respectively, which is produced by an increase on the dielectric constant in the upper media due to a higher level of moisture [29]. It is important to mention here that when a rebar is corroded, corrosion infects the surrounding concrete, causing a severe change in the actual dielectric properties of the upper media of concrete. This leads to a decrease on the propagation velocity in the upper media. Thus, it is possible to observe how the reflection produced by the base concrete presents an increase on the travel-time distances registered, which extends from rebar 4 to rebar 8.

Figure 6. Graphics obtained for GPR profile 2 and interpretation. The olive-green rectangles in (a–c) represent voids or delamination and orange rectangles indicate open-air rebars. The red circles in (d) represent a positive polarity of the reflections produced by the rebars, while the olive-green circles represent a negative signal polarity due to the presence of voids.

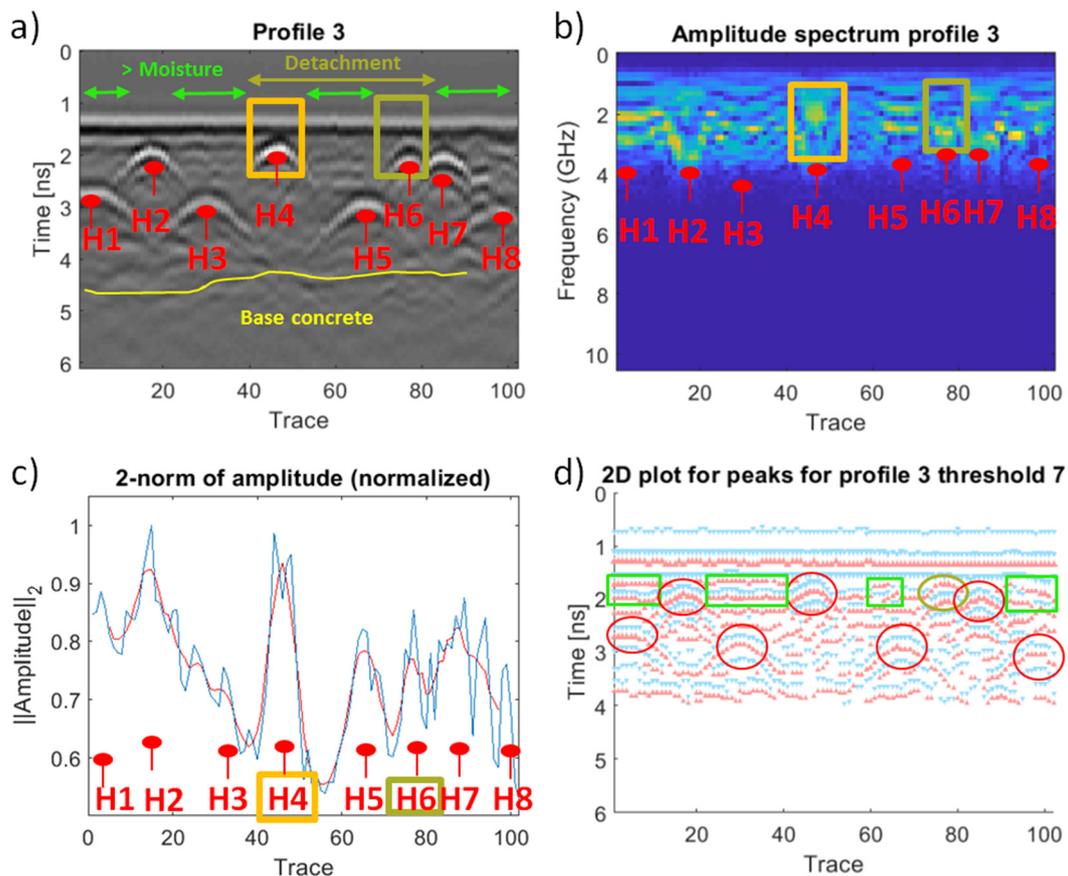
Regarding profile 3, there is a nearly open-air rebar (H4), at a travel-time distance of 1.9 ns, showing a stronger amplitude spectrum (Figure 7b). Observing Table 1, this area presents severe concrete detachment and signs of moisture corresponding to lawn green rectangles in Figure 7d, while showing negative signal polarity (Figure 7d). As a consequence, the reflections produced by rebars 1, 3, 5, and 8 present lower amplitude values, or attenuation, (Table 3) and larger travel-time distances (2.76, 2.90, 3.00, and 3.09 ns, respectively). Furthermore, the hyperbolic reflection H7 recorded at trace 77 (2.05 ns) shows a reverse polarity (Figure 7d and Table 3), most certainly produced by the presence of a void or debonding in the concrete. Finally, it is possible to note an increase in the travel-time distances registered for the base concrete reflection, in comparison with profile 1, due to the higher moisture shown in profile 3.

Figure 7. Graphics obtained for GPR profile 3 and interpretation. The olive-green rectangles in (a–c) represent voids or delamination and orange rectangles indicate open-air rebars. The red circles in (d) represent a positive polarity of the reflections produced by the rebars, while the olive-green circles represent a negative signal polarity due to the presence of voids and lawn green rectangles correspond to moist areas.

The GPR data produced by profile 3 reveals higher moisture along this entire zone, as well as a central area showing concrete detachment (Figure 7). The thermal image shows only the presence of moisture represented with higher temperature (0.5 °C more than the healthy area in profile 1). The lack of identification of detachment in profile 3 with IRT is because the footprint of moisture is more important and covers the identification of any other present pathology.

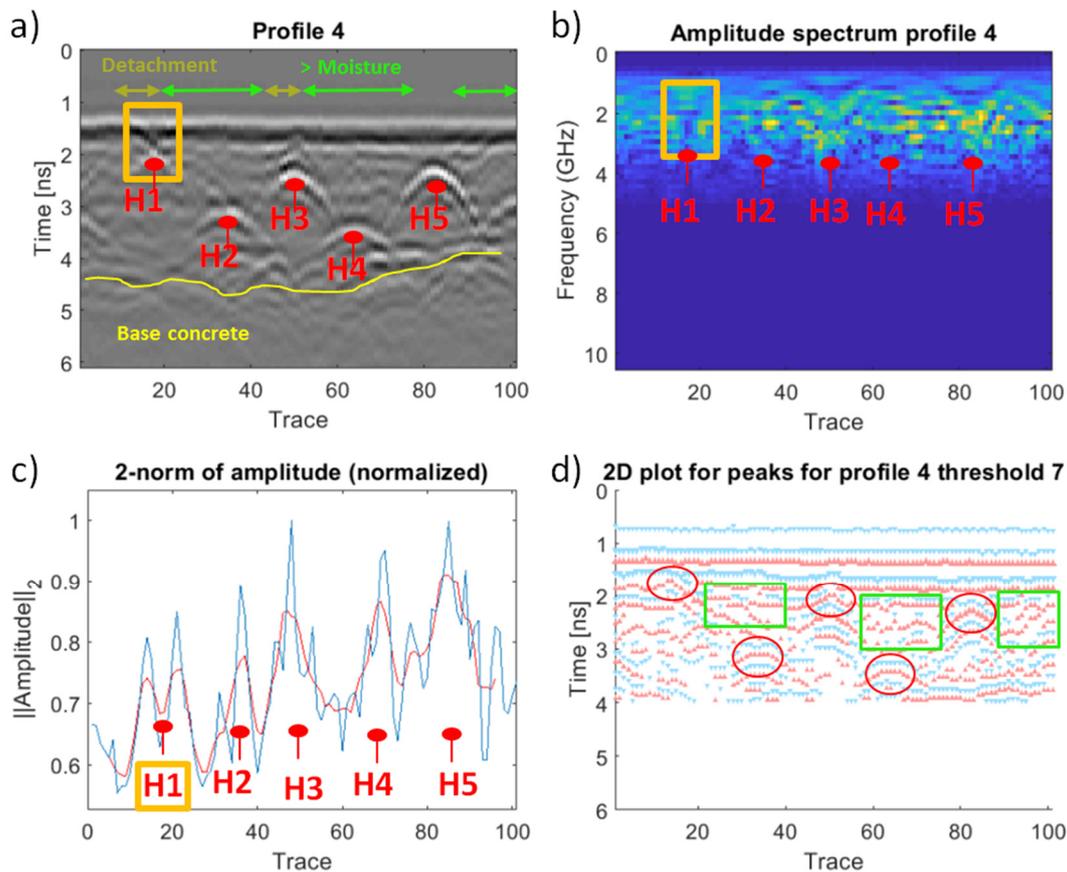
In profile 4, there is a general increase in the travel-time distance produced by the detachment and moisture content externally observed (see Table 1). Figure 8d displays three different zones showing a complex reflections pattern with negative signal polarity (lawn green rectangles), which are most probably caused by a higher water content in these areas. Thus, as shown in Table 3, the reflections produced by rebars 2 (H2) and 4 (H4) present lower amplitude values in comparison with rebar 5 (H5), which is the one presenting a nondamage behavior. Moreover, the reflections H2 and H4 registered larger travel-time distances (3.14 and 3.48 ns, respectively) than H5 (2.33 ns). Observing the reflection generated from the base concrete, the travel-time distances are larger (~ 4.5 ns) from H1 to H4, and lower (~ 4.0 ns) in the H5 area. Finally, concrete debonding, and subsequent spalling or fissuration, was identified over rebars 1 (H1) and 3 (H3).

Figure 8. Graphics obtained for GPR profile 4 and interpretation. The orange rectangles in graphs (a–c) indicate open-air rebars, while the lawn green arrows in (a) correspond to moist areas and the olive-green arrows are associated to detachment. The red circles in (d) represent a positive polarity of the reflections produced by the rebars, while the lawn green rectangles represent a negative signal polarity associated to moist areas and the orange rectangles correspond to open-air rebars.

In profile 4, the thermal image shows the combined effect of detachment (in all the image) with additional moisture (in the second half of the image). The GPR data reveals severe detachment over rebars 1 and 3 (Figure 8), while the other hyperbolic reflections were registered at larger travel-time distances, indicating higher moisture.

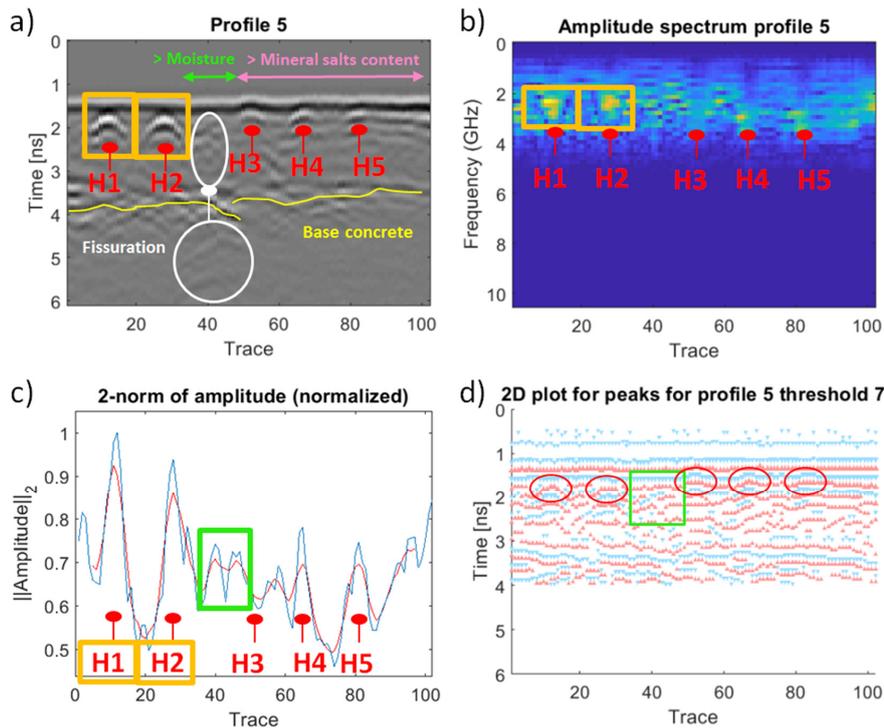
Concerning profile 5, the hyperbolic reflections produced by rebars 1 (H1) and 2 (H2) show more prominent reflections (Figure 9a) and stronger amplitude spectrum (Figure 9b) corresponding to concrete detachment and nearly open-air rebars (1.81 and 1.86 ns, respectively). On the contrary, despite rebars 3 (H3), 4 (H4), and 5 (H5) being superficial open-air rebars, they present more attenuated signal reflections (see amplitude values in Table 3) and lower amplitude spectra, which most probably indicates the presence of corroded rebars with a significant loss of section (mass loss) produced by a higher content of mineral salts in this area. In addition, severe concrete spalling or fissuration is observed before this corroded area (Figure 9a,b).

Figure 9. Graphics obtained for GPR profile 5 and interpretation. The pink arrow in (a) represents a zone with high salt concentration, while the lawn green arrow indicates higher moisture. The orange rectangles in (a–c) indicate open-air rebars. The red circles in (d) represent a positive polarity of the reflections produced by the rebars, while the lawn green rectangle represents negative polarity due to moisture.

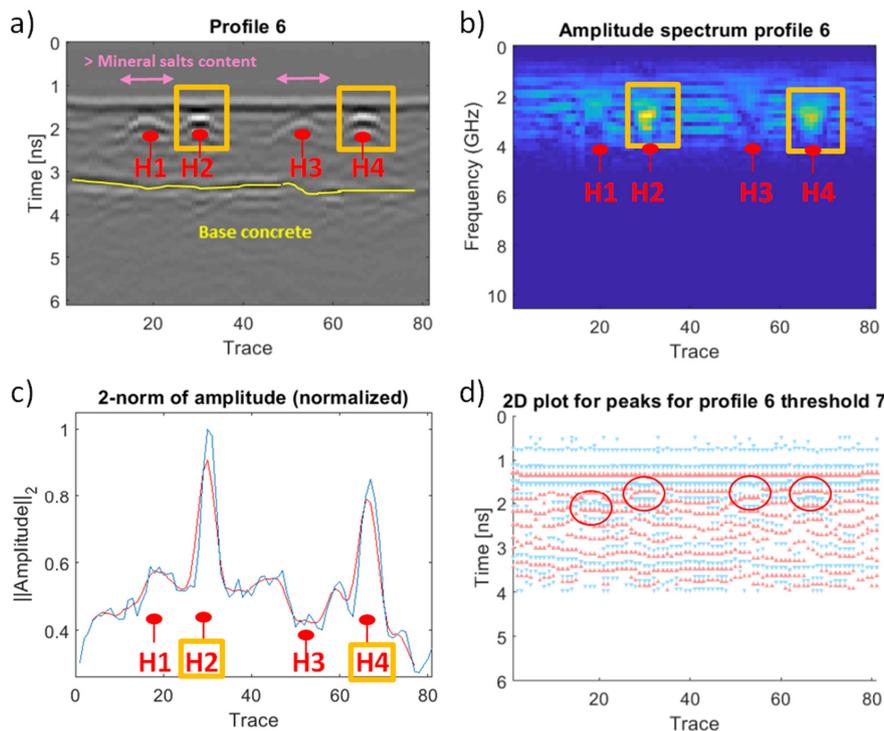
Finally, profile 6 shows prominent reflections (Figure 10c) and a stronger amplitude spectrum (Figure 10b) for the open-air rebars 2 (H2) and 4 (H4); whereas rebars 1 (H1) and 3 (H3) present more attenuated signal reflections (see amplitude values in Table 3) and lower amplitude spectra, which could be connected with a higher mineral salts content in this area (see Table 1) and the loss of section typically associated to corroded rebars.

Figure 10. Graphics obtained for GPR profile 6 and interpretation. The orange rectangles in (a–c) indicate open-air rebars while pink arrows are associated to zones with high salt concentration. The red circles in (d) represent a positive polarity of the reflections produced by the rebars.

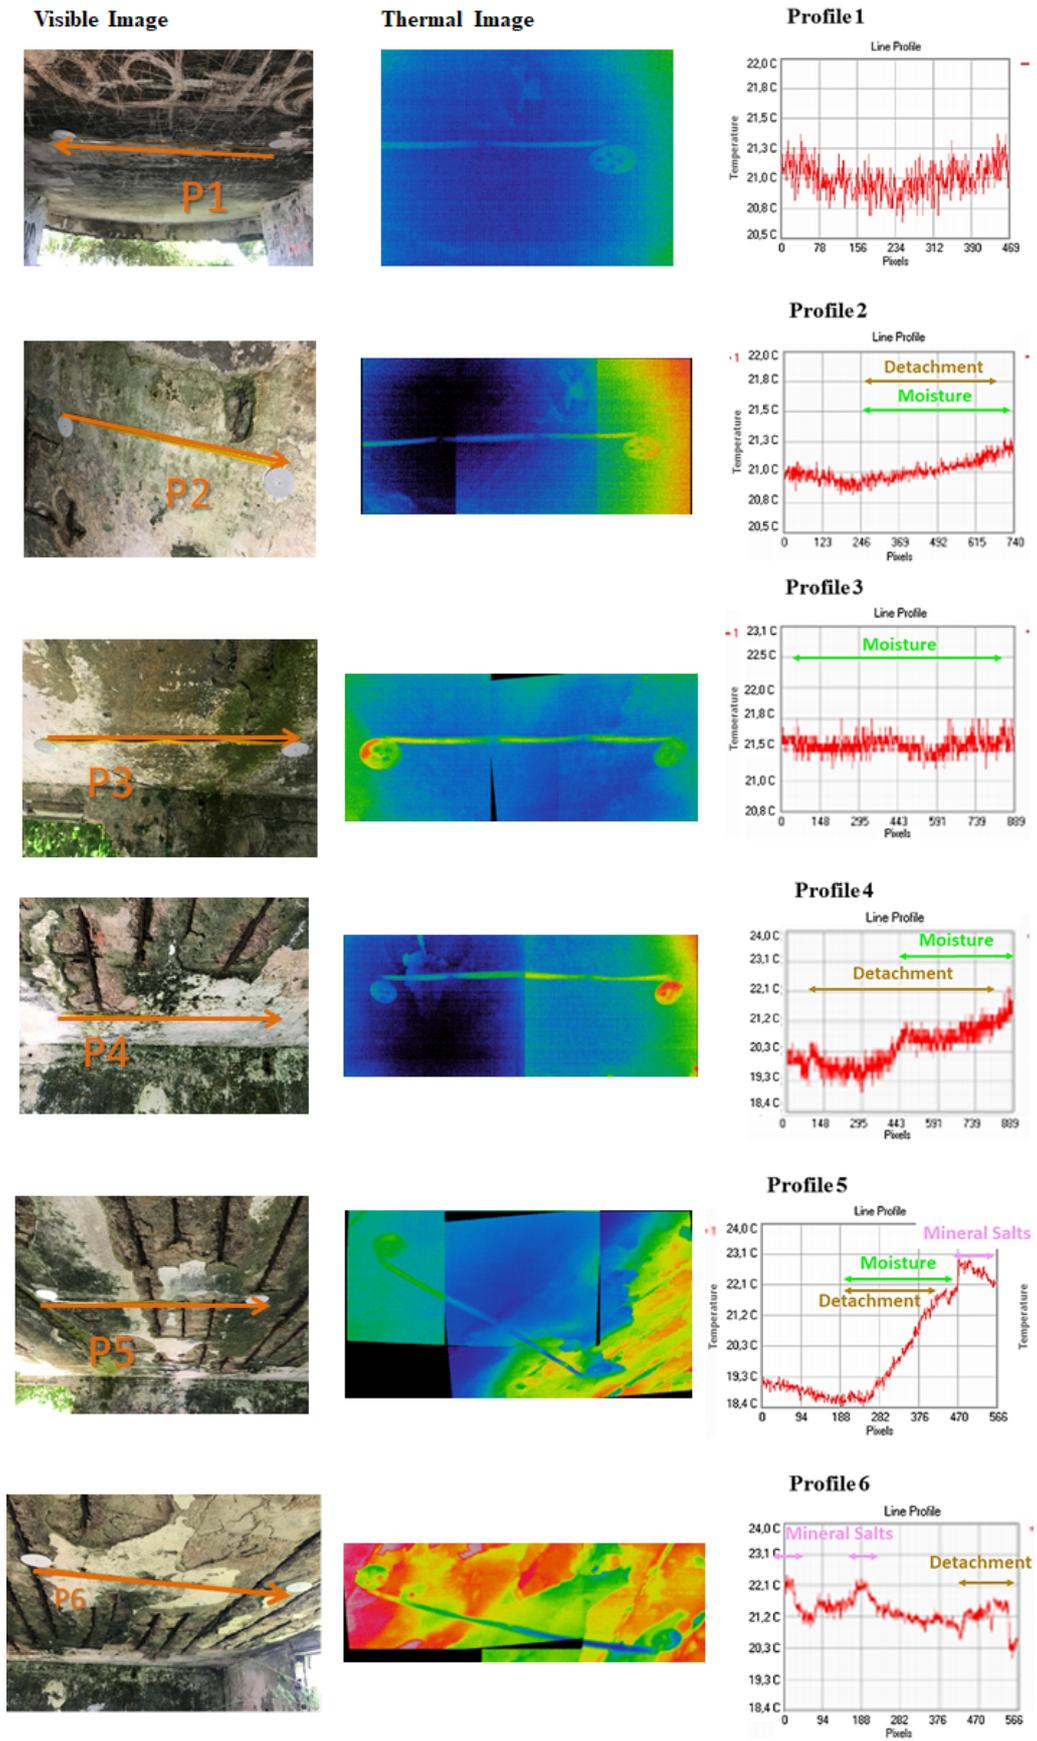
In this case, the thermal print of corroded bars on the surface of the roof is covered by the effect of moisture, rust, and delaminations on the most superficial layer of the roof. Profiles 1 and 3 show constant temperature with different absolute values. This implies that either there is no anomaly, or the whole image covers an area with pathology. Correlation with the GPR interpretation (Figures 5 and 7, respectively), and focusing on the temperature difference, the temperature value of profile 1 (21.0 °C) corresponds to the “healthy” material, while the temperature value of profile 3 (21.5 °C) belongs to continuous moisture. That is, the area covered by profile 3 is completely moist. This temperature difference in moist materials is caused by the higher thermal inertia of water, which slows down the cooling process occurring during the night.

The temperature evolution of profile 2 presents a continuous temperature increase from the first third of the profile. This increase corresponds to detachment in the area, plus the effect of moisture. Detachments appear as an area with higher temperature due to the reduced thickness of the roof in the area where the material is lost and due to the presence of air between the roof and the material pending.

Profile 4 presents two different pathologies, whose effects are more important and visible in different areas. At the beginning, the temperature increase after a sudden temperature reduction corresponds to the presence of detachment, while the last part of the profile presents a deeper temperature increase, caused by the addition of the effect of moisture. This coexistence of pathologies can lead to the correlation of moisture with the detachment in such way that the first is unequivocally the cause of the second.

The temperature evolution in profile 5 also presents the combined effect of detachment and moisture, appearing as a continuous and steep temperature increase. In addition, there is a sudden temperature peak at the end of the profile that corresponds with the presence of mineral salts. These last pathologies are distinguishable due to their high reflectivity (low emissivity), that provokes a temperature peak without a constant evolution, neither before nor after its presence.

The same happens in profile 6, where mineral salts are found at two positions of the profile. In addition, at the end of the profile, the presence of detachment can be detected with a temperature increase, with a more continuous and smooth transition from the healthy parts than in the case of the mineral salts.

Figure 11. Temperature evolution for each profile line with the corresponding visible and thermographic images for context information.
