Automatic Detection of Earthquake-Damaged Buildings by Integrating UAV Oblique Photography and Infrared Thermal Imaging

Abstract: Extracting damage information of buildings after an earthquake is crucial for emergency rescue and loss assessment. Low-altitude remote sensing by unmanned aerial vehicles (UAVs) for emergency rescue has unique advantages. In this study, we establish a remote sensing information-extraction method that combines ultramicro oblique UAV and infrared thermal imaging technology to automatically detect the structural damage of buildings and cracks in external walls. The method consists of four parts: (1) 3D live-action modeling and building structure analysis based on ultramicro oblique images; (2) extraction of damage information of buildings; (3) detection of cracks in walls based on infrared thermal imaging; and (4) integration of detection systems for information of earthquake-damaged buildings. First, a 3D live-action building model is constructed. A multi-view structure image for segmentation can be obtained based on this method. Second, a method of extracting information on damage to building structures using a 3D live-action building model as the geogr

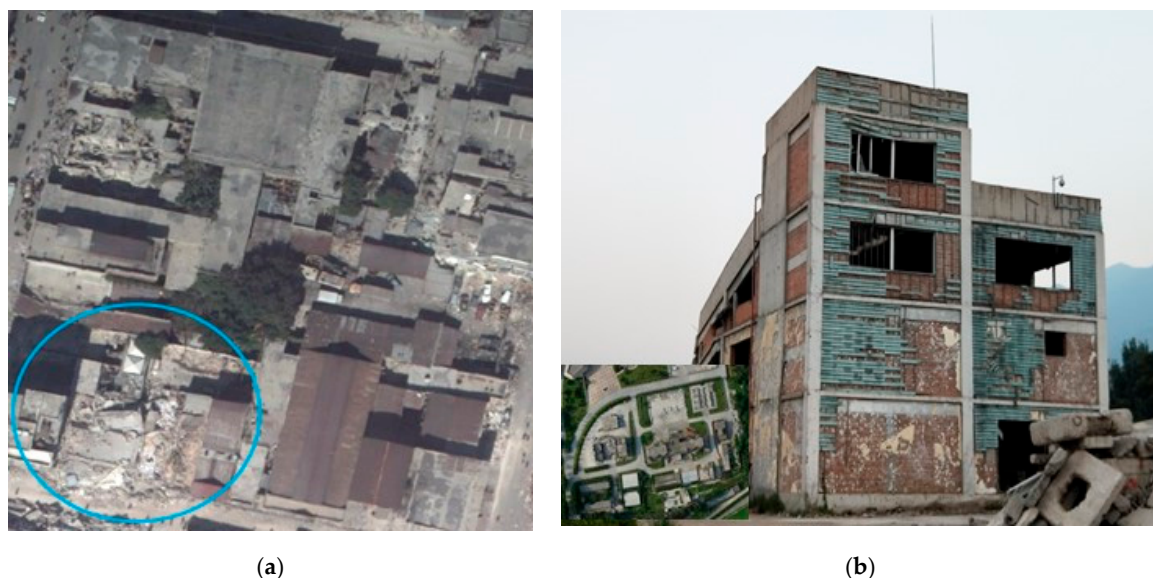
Figure 1. Comparison of (a) remote sensing image and (b) ground photograph.

A conventional remote sensing device can obtain only a single perspective of image features and plane geometry information of objects on the earth's surface through nadiral imaging. However, the obtained information is limited by the imaging conditions; the device is unable to obtain damage information of buildings and crack information of building walls at night [6]. As shown in Figure 1a, severely damaged buildings with large cracks appear intact or only slightly damaged in a nadiral remote sensing image. As shown in the ground photo of Figure 1b, a seriously damaged and oblique building appears intact in the nadiral remote sensing image. Failure to extract the building facade and 3D information prevents timely emergency rescue due to the lack of reference information. Furthermore, the lack of quick emergency response capability at night makes it difficult to accurately assess structural damage to buildings.

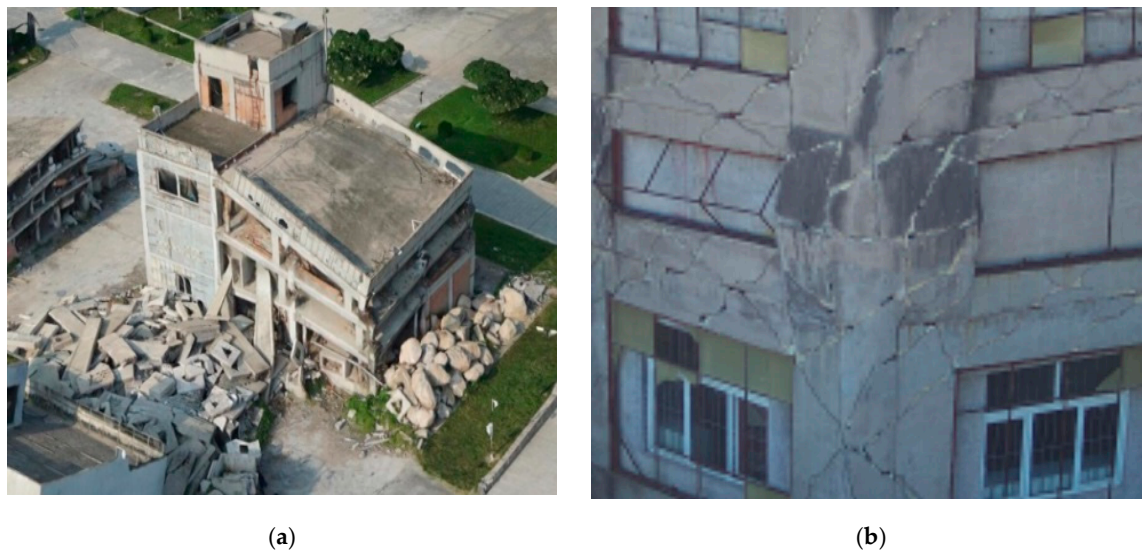
Figure 3. Heavy earthquake-induced structural damage. (a) Partial collapse and (b) cracks in structural elements of a building severely affected by an earthquake.

Owing to differences in the structure, materials, and quality of buildings after an earthquake, destruction forms are also complex and diverse [16]. This paper focuses on earthquake-induced damage to structural and non-structural elements including columns and walls, as well as the structure of the living space after a collapse (Figure 3).

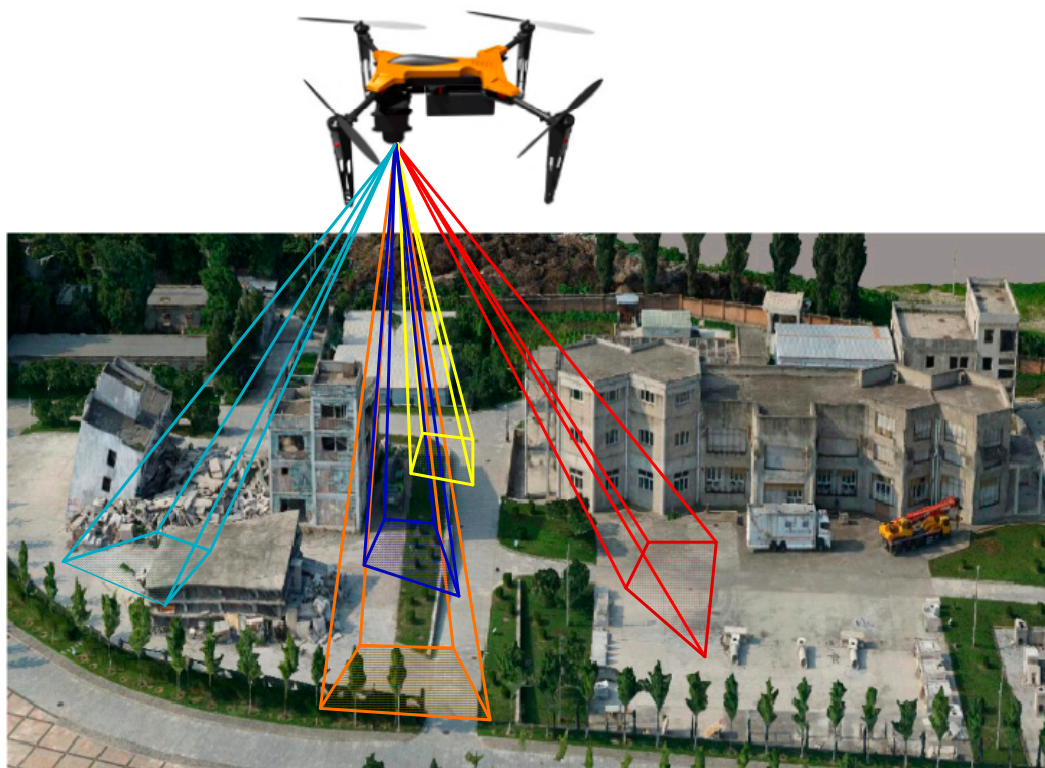
Figure 4. Oblique detection of building damage from an earthquake.

With the wide application of the UAV platform and the development of oblique photography toward high integration and light weight, the ultramicro oblique technology (Figure 4) has emerged as required by the times. The UAV platform [9,10] is equipped with many types of sensors to acquire real surface information through the synchronous exposure and acquisition of images from vertical, tilt, and other angles. Rich, high-resolution textures on the top and sides of ground objects are acquired using oblique images to construct a 3D model in accordance with the principles of human vision.

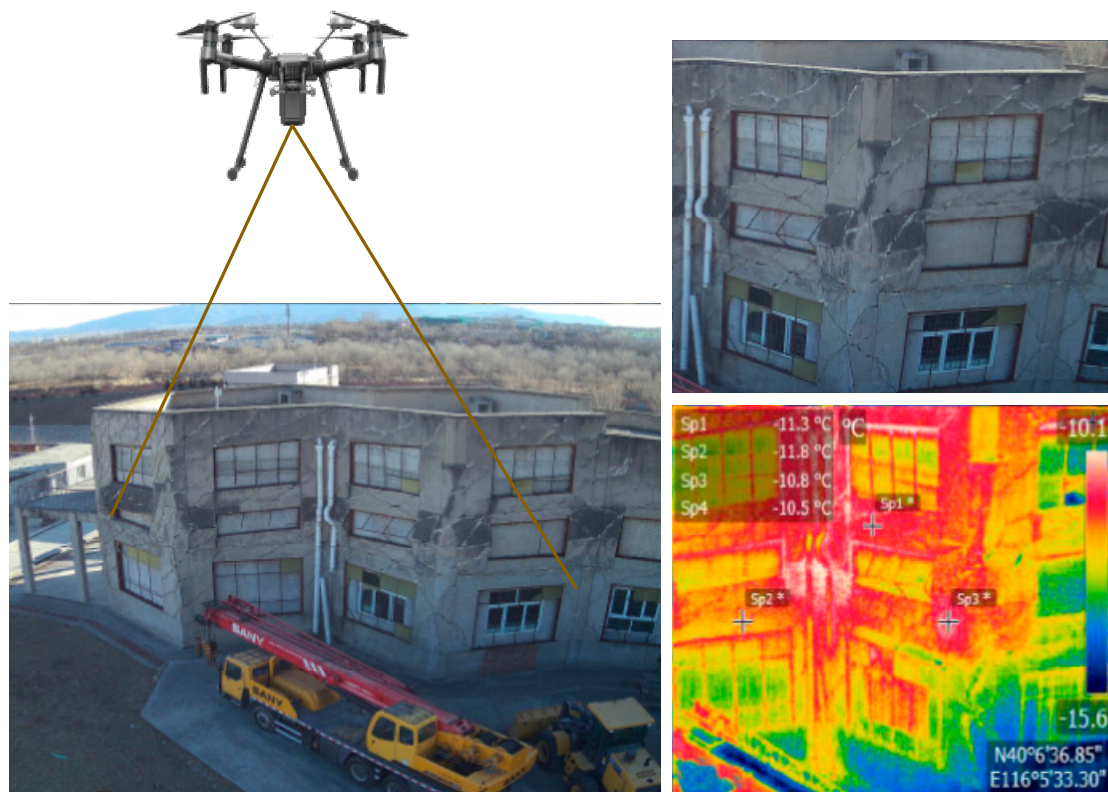
Figure 5. Infrared thermal detection of wall cracks of earthquake-damaged buildings.

reference information and quick emergency response at night. Expanding the sensor-band range greatly promotes information extraction. In recent years, with the application of infrared thermal imaging technology [28,29], we can discover cracks or fractures by detecting the radiation energy and measuring the temperature distribution on the surface of external building walls (Figure 5). Such detection is highly significant to eliminate hidden dangers after a disaster and protect people's property. This technology can also invert the temperature information of the surface of a ground object by sensing its emission energy, which is unaffected by severe weather conditions after an earthquake, thereby playing an important role in emergency rescue at night after earthquakes and other disasters. The acquisition of crack data of damaged buildings and wall fracture data in severe disaster areas to obtain the damage degree of buildings has a unique advantage for emergency monitoring after disasters.

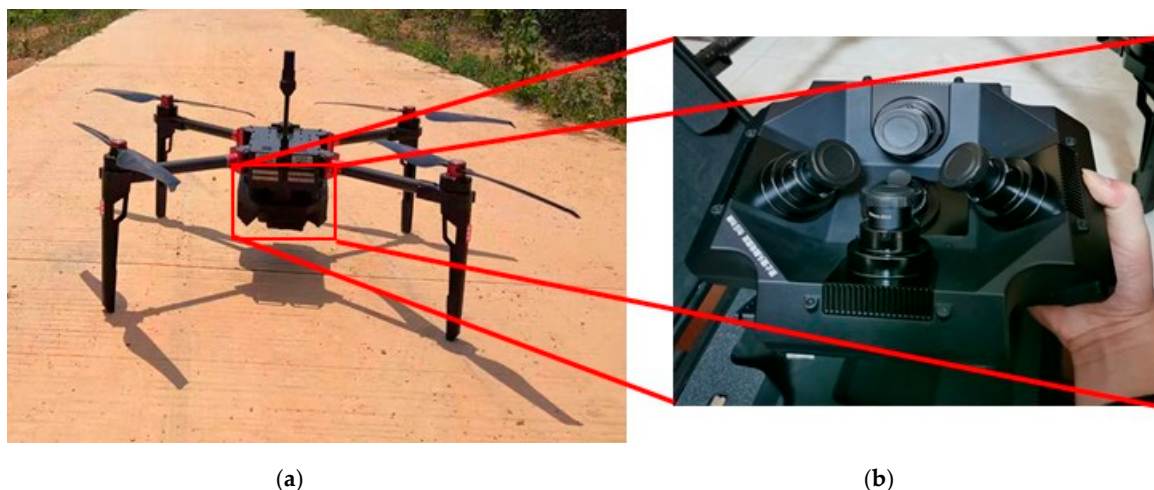
Figure 6. (a) Unmanned aerial vehicle (UAV) and (b) sensor.

Damage information of a building structure and wall cracks was obtained from China's National Earthquake Emergency Rescue Training Base. Experimental data were acquired using an ultramicro oblique platform for a multi-rotor UAV (Figure 6) and a Zenmuse XT2 infrared thermal imager (Table 1). The oblique image was obtained with a QingTing-5S digital aerial oblique camera with a spatial resolution of 0.12 m in four oblique views (looking forward, backward, left, and right) and a vertical view (Table 2). The resolution of the image is 7140×5360 and the equivalent focal length is 28 mm/F2.4. The vertical camera is 80 mm in focal length and has a 40° oblique lens, with a GPS/IMU system providing the exterior orientation elements. Infrared thermal images were formed using a Zenmuse XT2 infrared thermal imager, which can use simultaneous dual-mode imaging with visible and thermal infrared light.

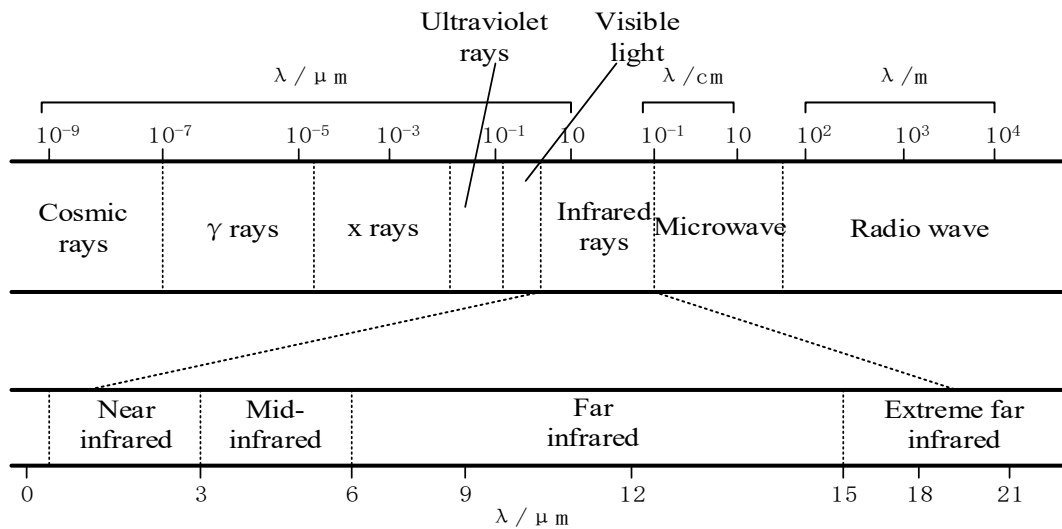
Figure 7. Infrared electromagnetic spectrum range.

The thermal difference in buildings damaged by an earthquake greatly differs from that of unaffected buildings. In this study, infrared thermal imaging technology was adopted to determine the quantitative relationship between thermal infrared images and cracks in damaged buildings after a disaster. Infrared thermal temperature data (Figure 7) show the electromagnetic waves radiated by the building surface detected by the thermal imager. According to the strength and wavelength of the electromagnetic wave, the temperature distribution on the external wall of the building is calculated and then transformed into an image to satisfy the requirements of human vision. The Zenmuse XT2 infrared thermal imager equipped with a high definition 4K color camera and a high-resolution radiation thermal imager enables a self-adaptive switch between the two devices. At the same time, FLIR multi-spectral dynamic imaging technology was adopted to imprint visible high-fidelity details on the thermal images, thus enhancing their quality and perspective.

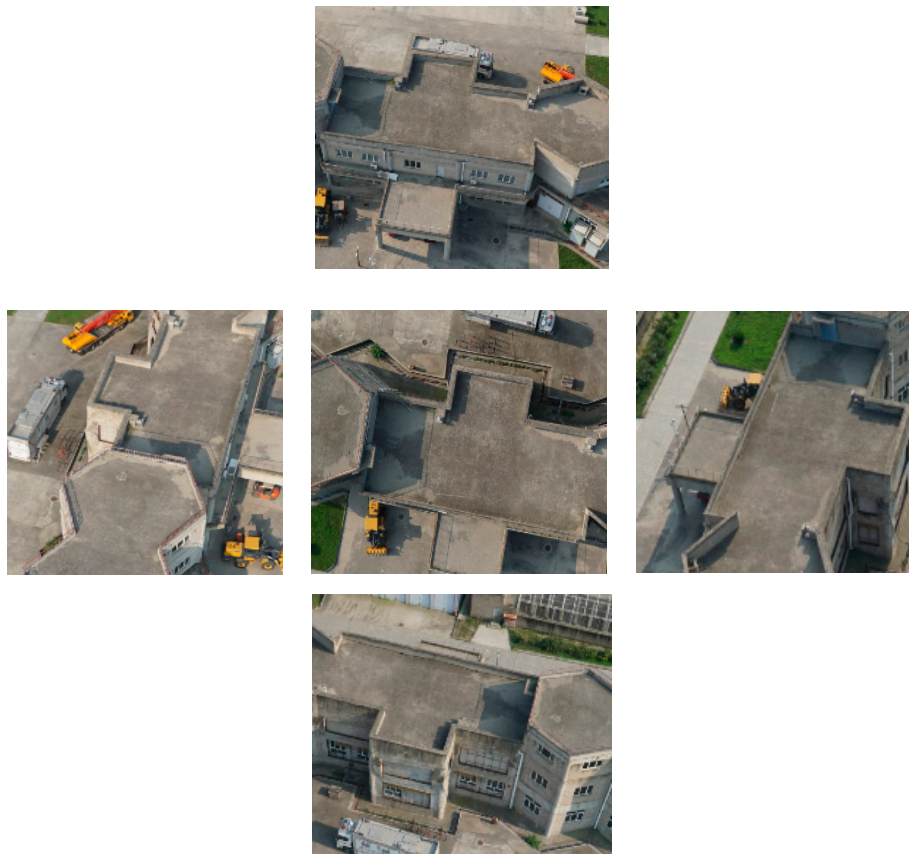
Figure 9. Original five views of ultramicro oblique images.

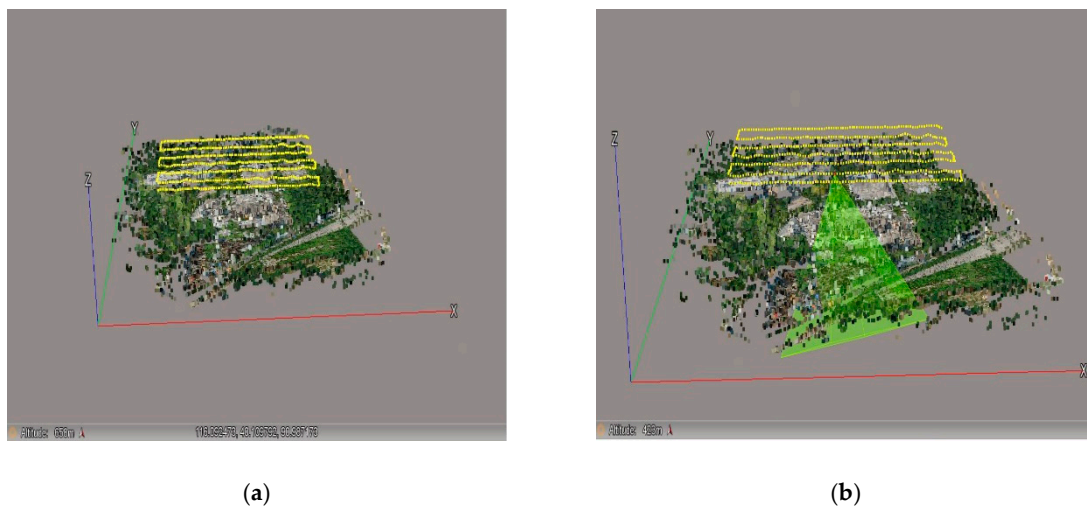
Figure 10. Preprocessing of multi-view images (a) encryption points and (b) aerotriangulation.

The whole and part of the 3D model of the ultramicro oblique image at the earthquake rescue base are shown in Figures 10 and 11. From the global image of the 3D model of the collapsed building, the whole situation can be clearly observed. A large amount of ruins and debris formed because of the building collapse, showing a rough and disordered shape in the 3D texture characteristics and slightly changed color. Contrastingly, the undamaged buildings have a smooth texture, uniform density, and consistent color. UAV oblique photographs were taken of some damaged and collapsed buildings in the severely earthquake-affected area, and a 3D real-scene model was constructed. The UAV oblique photography can analyze the damage of the roof from the vertical perspective and the structural damage of buildings from the side perspective. Moreover, we can evaluate the damage degree of buildings based on the damage situation, thereby providing the necessary disaster information for post-disaster assessment.

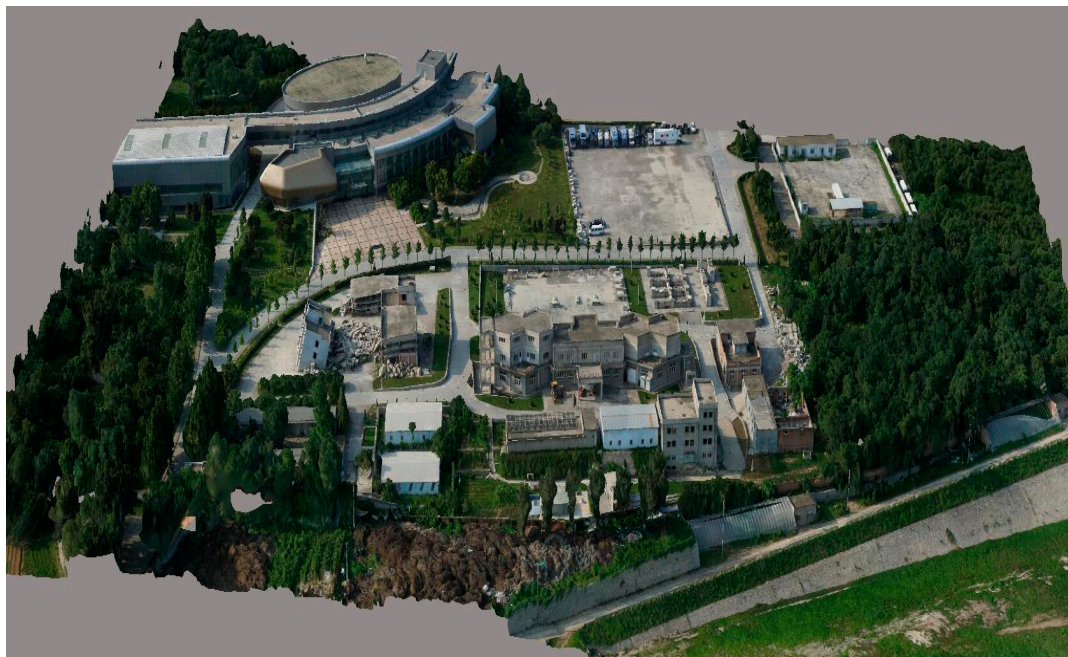
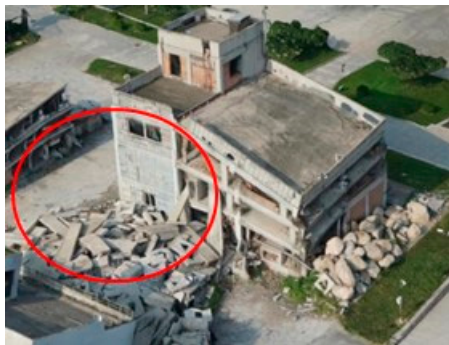
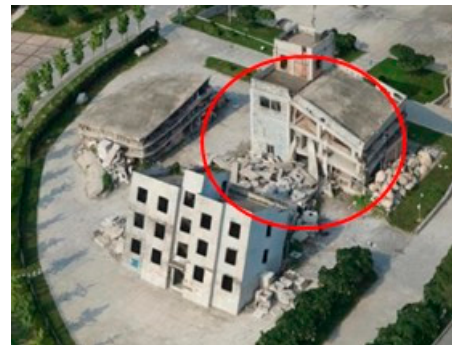
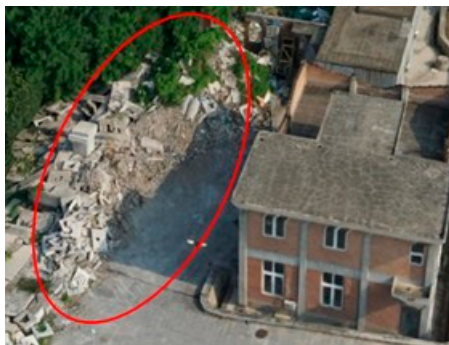
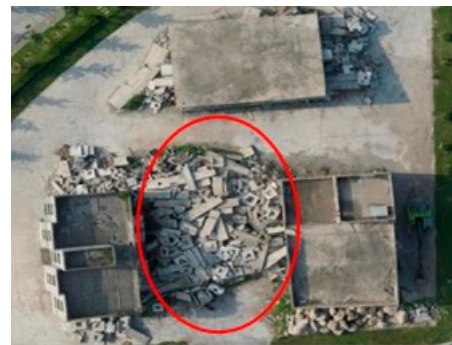
Figure 11. Structural information of a three-dimensional (3D) model (global and local) at the earthquake rescue base (a) 3D panorama and (b) Local details.

The details of the damage and structural information can be seen from the local information of each view of the three-dimensional model, and the location and volume of the building can be clearly seen. The red circle in the figure shows the damaged part of the building. From the partial and detailed images, it can be found that there are different degrees of damage inside the building frame. If we rely on only traditional vertical orthophoto images, the interior area and details of damage to the building cannot be detected. The oblique photography technology has the unique advantage of

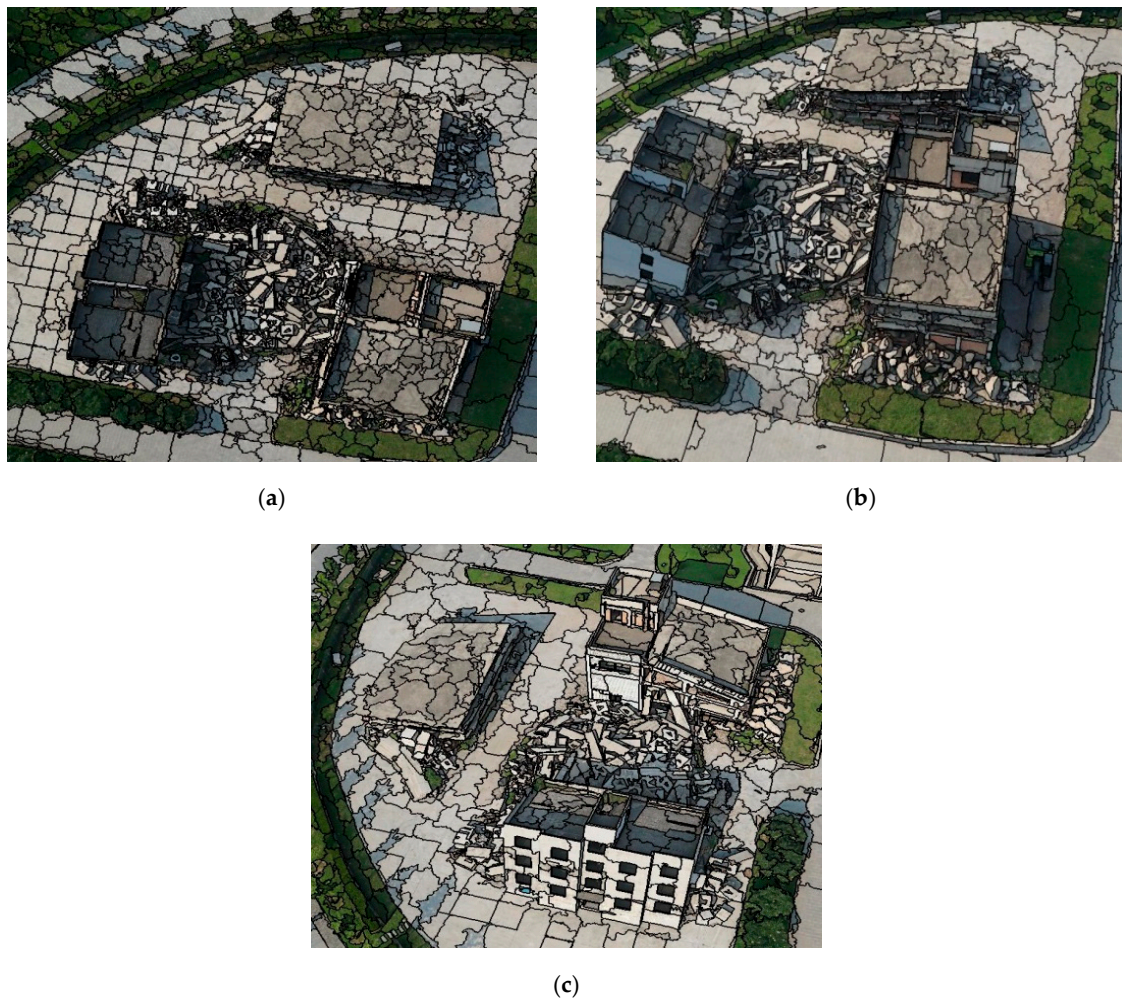
Figure 13. Multi-scale segmentation in different directions of oblique image. (a) Vertical direction; (b) backward direction; (c) forward direction.

In this paper, oblique images with obvious seismic damage characteristics were divided into segmentation scales. The shape and compactness factor were set to 0.3 and 0.5, respectively, and the segmentation scale ranged from 20 to 90 (in intervals of 10). Through the image analysis after segmentation, it can be seen that when the scale is too small, the segmentation is too excessive, especially where the cracks and walls fall off; when the scale is too large and the segmentation effect is poor, the cracks are mixed with the external walls and are not well divided. Through the multi-scale segmentation test, 50 was chosen as the segmentation scale to better separate the damaged parts.

The spectrum, shape, texture, space, and other characteristics of buildings after a disaster drastically differ from those before the disaster. After homogeneous object blocks are formed by object-oriented multi-scale segmentation, the feature space is established by selecting the spectrum, texture, shape, and other characteristics of buildings. Information on the exterior wall and structural damage of concrete buildings is extracted through the membership classification method. Among them, the characteristic of vertical image extraction (Figure 14a) is that Asmetry is more than 2.87, the characteristic of positive-backward image extraction (Figure 14c) is that Entropy is more than 8, the characteristic of positive-forward image extraction (Figure 14b) is that Max.diff is more than 0.26, and the shape index is more than 1.6. The extraction result of the structural information of the building facade is shown in Figure 13.

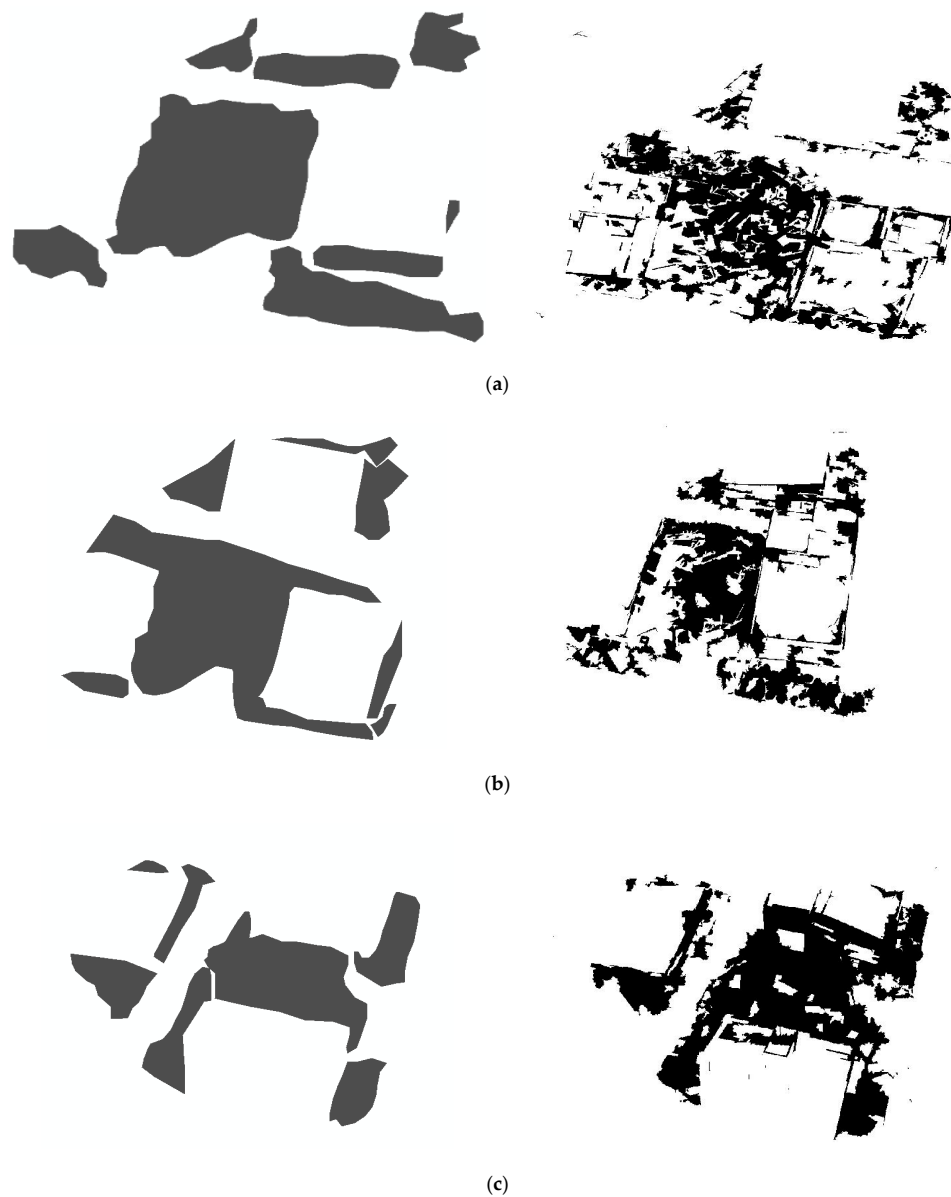
Figure 14. Building structure damage information extracted from different directions of oblique images. (a) The extraction result of vertical image; (b) the extraction result of forward image; (c) the extraction result of backward image.

The accuracy of the oblique image extraction result was assessed to help quantitatively evaluate the effect of building structure damage information extraction. A confusion matrix was obtained by calculating real pixels on the ground surface and the corresponding pixels in the classification results, which does not require vast prior knowledge in the field. In this work, the accuracy assessment was made for oblique image extraction results by using the confusion matrix. The four indices used were overall accuracy, kappa coefficient, producer accuracy, and user accuracy. As shown in the analysis in Table 3, overall accuracy in three perspectives reached 80%, indicating that the information of damaged buildings can be accurately extracted from the side view. It shows that oblique images can effectively detect the damage of the side facade and quickly grasp the details of building structure damage during emergency rescue after the disaster.

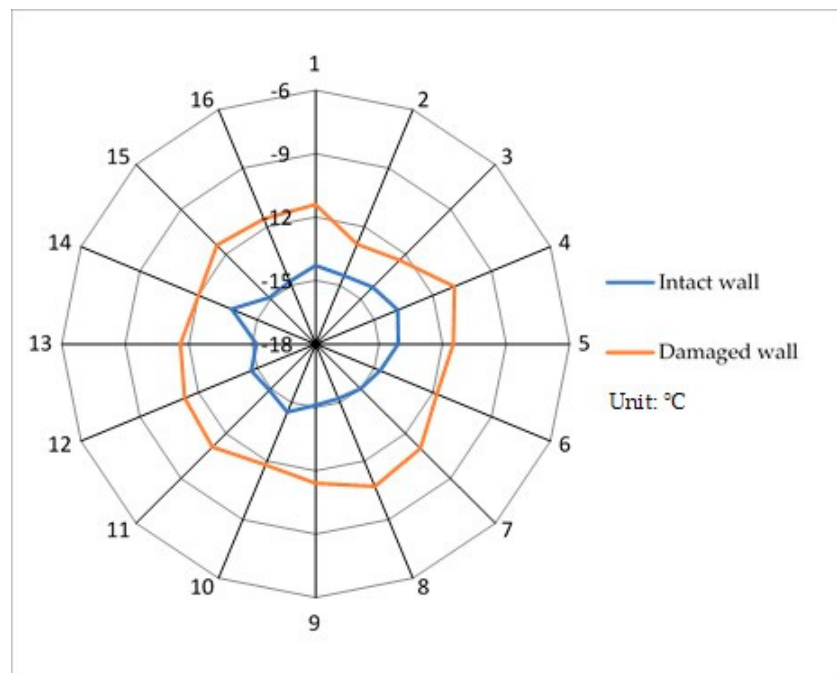
**Figure 15.** Wall temperature distribution radar map.

After analyzing the temperature of sampling points through infrared thermal imaging, we found that the temperature of the points of the damaged wall significantly differed in the whole wall environment, given the uneven spatial distribution. This provides the physical significance and data basis for establishing the relationship between the thermal infrared spectra of building cracks and other damage after disasters and damaging situations.

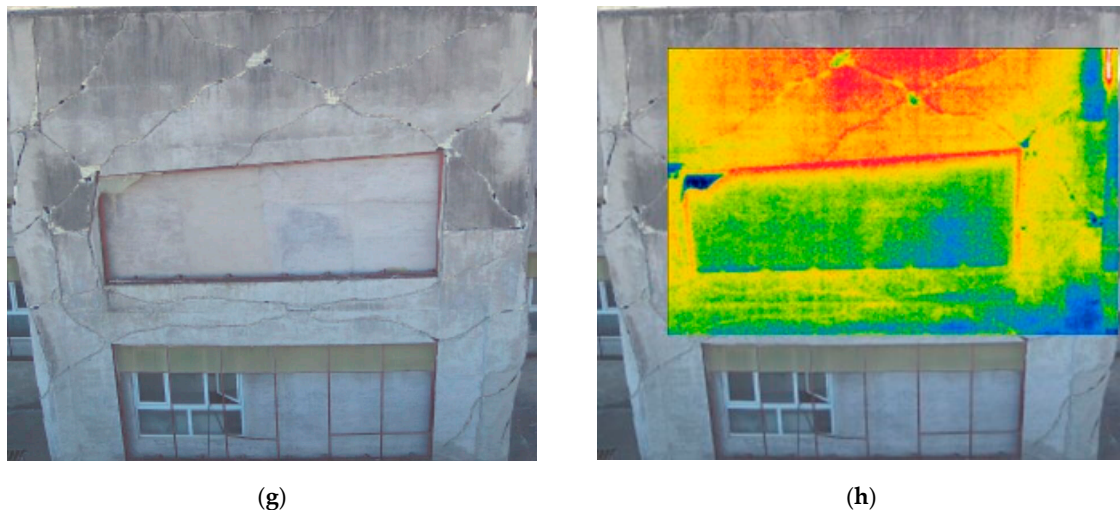
Figure 16. Superimposition of visible and infrared images of wall cracks after an earthquake. (a) Thermal infrared image of exterior wall damage; (b) thermal infrared image of window damage; (c) visible image of undamaged wall; (d) infrared image superimposed with visible image of undamaged wall; (e) visible image of wall cracks; (f) infrared image superimposed with visible image of cracks; (g) visible image of wall cracks; (h) infrared image superimposed with visible image of wall cracks.

To verify the reliability of infrared thermal imaging technology in the detection of wall damage after a disaster, we collected post-earthquake site photos of different types of building structures at the earthquake emergency rescue base (116.09° E, 40.27° N). After image preprocessing, the visible and thermal infrared images were analyzed. The thermal infrared images, which represent the details and characteristics of the building wall from different sides, were then superimposed on the visible images of the wall. As a supplement to visible images, thermal infrared images reveal the temperature characteristics of the building wall surface. Figure 16 shows the typical thermal infrared spectra of different structural wall types after the earthquake and the performance characteristics of the thermal infrared and visible images. From the thermal infrared images in Figure 16a,b, we observe that the temperature in the damaged area of walls and around the window significantly differs from that

of the intact area. The damage is detected using the temperature differences. Figure 16c–h show superimposed visible images of the building wall and thermal infrared visible light in the damaged area. In the intact wall area, the spatial distribution of temperature is relatively even, with a consistent color tone. For example, in the undamaged wall and window shown in Figure 16c, the intact wall temperature image shows a blue distribution. The boundary of the window in the thermal image is well distinguished. In Figure 16f,h, the wall cracks around the window are clearly shown by the thermal image; the wall radiates energy outward. The thermal infrared image shows characteristics of diffusivity, and the features of the wall have a certain degree of fuzziness.

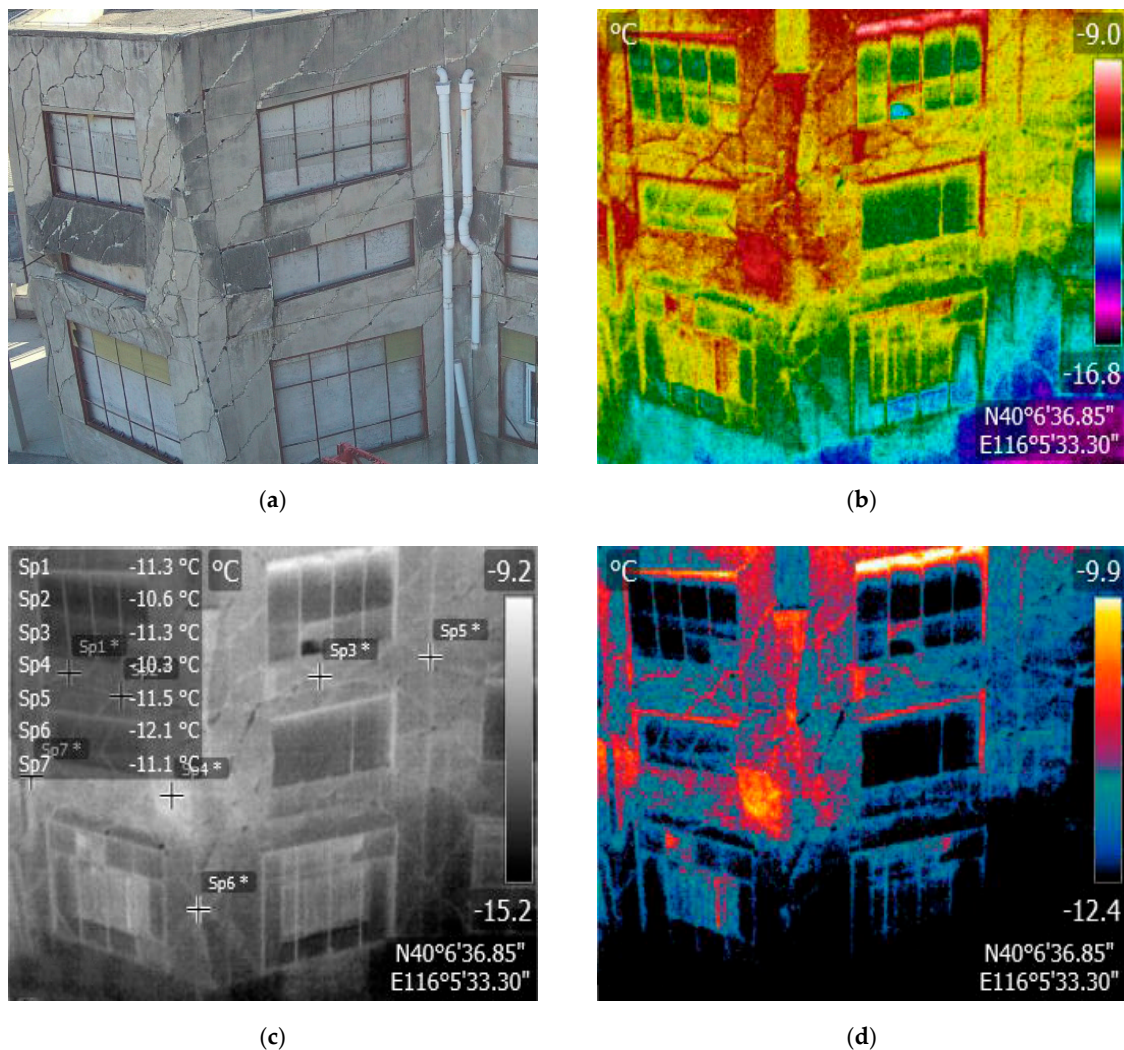
Figure 17. Thermal infrared image detection results of building wall cracks after an earthquake. (a) Visible image; (b) infrared thermal image; (c) gray image and crack mark point temperature; (d) crack extraction result.

Through histogram equalization, spatial sharpening, and other preprocessing of visible and thermal infrared images, and through the combination of morphological processing methods such as open and closed operation of images, the interference of crack images is eliminated. Then, the thermal infrared image is converted into a grayscale image to place temperature marks of the locations of damaged cracks or fractures. Finally, the binary threshold is extracted according to the marked temperature value to obtain information of the damaged position on the wall. The extraction result is shown in Figure 17d. The red areas represent cracks or fractures of the damaged wall. We can clearly observe from the temperature distribution that the temperature of the damaged area greatly differs from that of surrounding areas; it is slightly higher than that of the intact wall. Thin cracks, though they may be severely damaging, appear insignificant in the thermal image. In contrast, wide cracks appear significant in the thermal image, since the exchange between the energy inside and outside the wall is conducted through the cracks. The temperature difference of crack damage on the infrared image shows a certain relation with the depth of damage. As the damaged part is gradually aggravated by the slight damage, the significance of cracks in the image also gradually strengthens.
