# UAV Photogrammetry for Concrete Bridge Inspection Using Object-Based Image Analysis (OBIA)

**Abstract:** Monitoring infrastructures is becoming an important and challenging issue. In Italy, the heritage consists of more than 60,000 bridges, which need to be inspected and detected in order to guarantee their strength and durability function during nominal lifespan. In this paper, a non-destructive survey methodology for study concrete bridges surface deterioration and viaducts is presented. Terrestrial and unmanned aerial vehicle (UAV) photogrammetry has been used for visual inspection of a standard concrete overpass in L'Aquila (Italy). The obtained orthomosaic has been processed by means of Object-Based Image Analysis (OBIA) to identify and classify deteriorated areas and decay forms. The results show a satisfactory identification and survey of deteriorated areas. It has also been possible to quantify metric information, such as width and length of cracks and extension of weathered areas. This allows to perform easy and fast periodic inspections over time in order to evaluate the evolution of deterioration and plan urgency of preservation or maintenance measures.

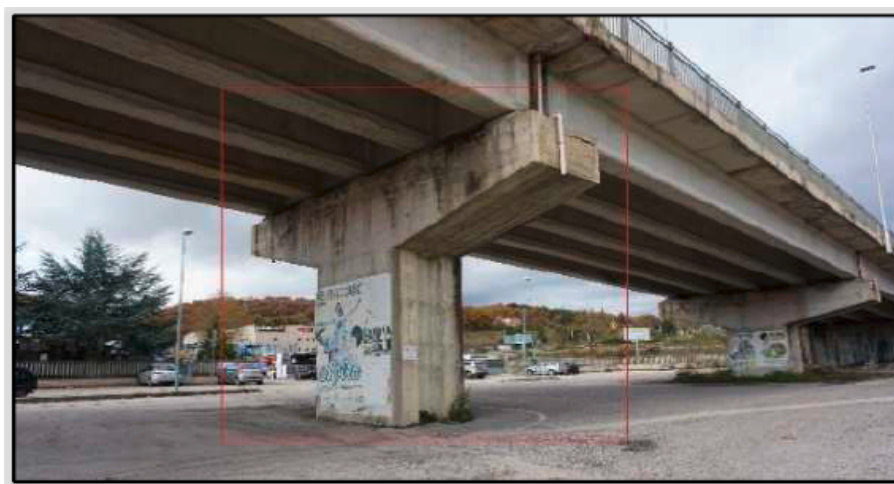
**Figure 2.** Case study pillar.

After a preliminary inspection of the whole overpass structure, the second pillar in the N-S direction was chosen as representative (Figure 2).

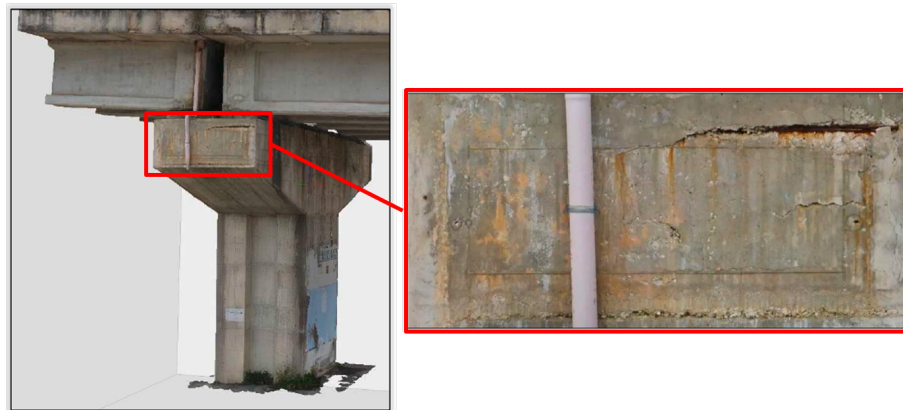
**Figure 6.** Results of photogrammetric process: high resolution 3D model and ROI orthomosaic.

The results of the data processing are the high resolution 3D photogrammetric model and the ROI high resolution orthomosaic (1.95 mm/pixel) (Figure 6).

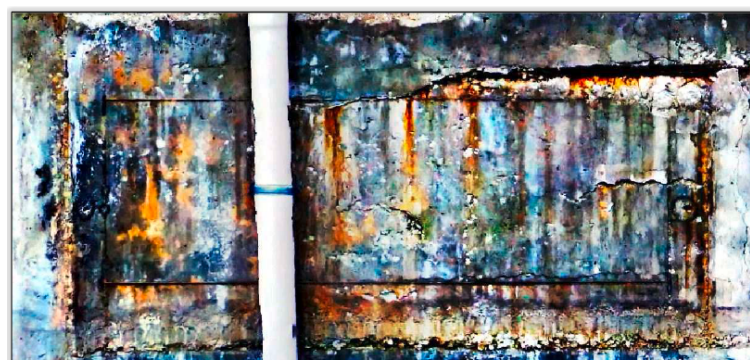
**Figure 7.** ROI image after contrast enhancement.

The result of contrast enhancement on orthomosaic ROI, using linear stretch algorithm, is reported in Figure 7.
