Technical Note

An Integration of UAV-Based Photogrammetry and 3D Modelling for Rockfall Hazard Assessment: The Cárcavos Case in 2018 (Spain)

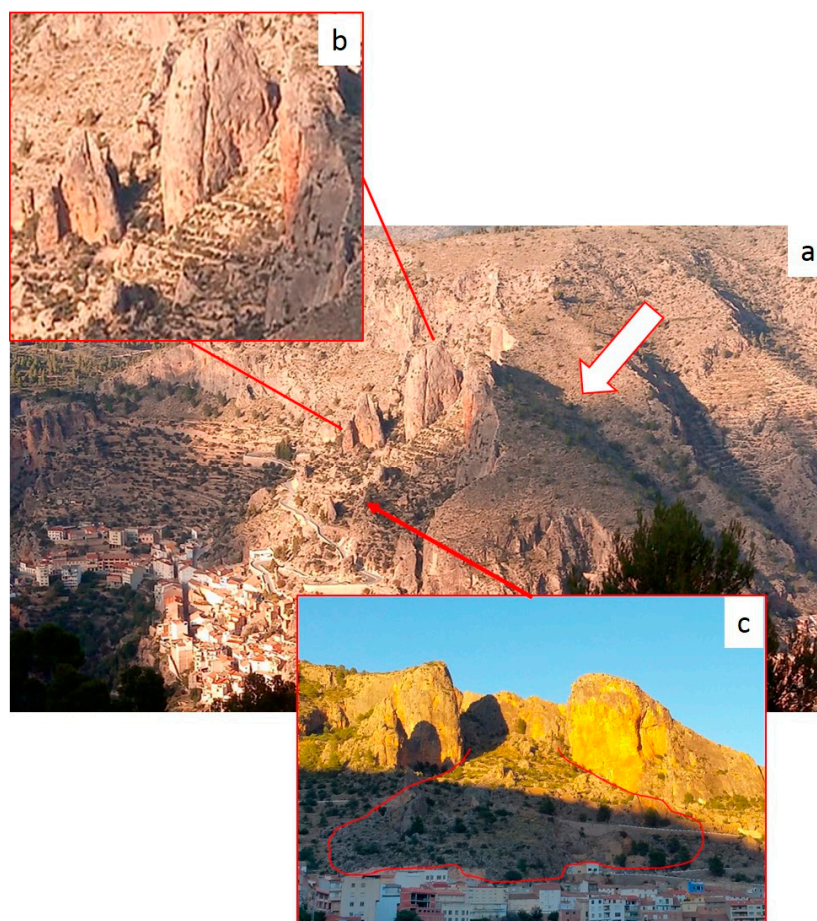
Figure 3. A deep-seated gravitational slope deformation affects the rocky slope facing Ayna, with evidence of double ridge (white arrow) (a), rock toppling (b) and rock slide (c) processes.

In the study area, a rough topography therefore combines to outcrops of tectonized rocks, affected by prolonged physical and chemical weathering. Steep and high scarps (up to 60 m), modelled by rockfall events, are cut into fractured rocks characterized by a number of families of structural discontinuities. Such rocky scarps are very prone to landslide processes, particularly where geological discontinuities intersect slopes with unfavourable orientation. As a whole, such characteristics determine widespread predisposing conditions for development of slope movements in the municipality of Ayna (Figure 3).

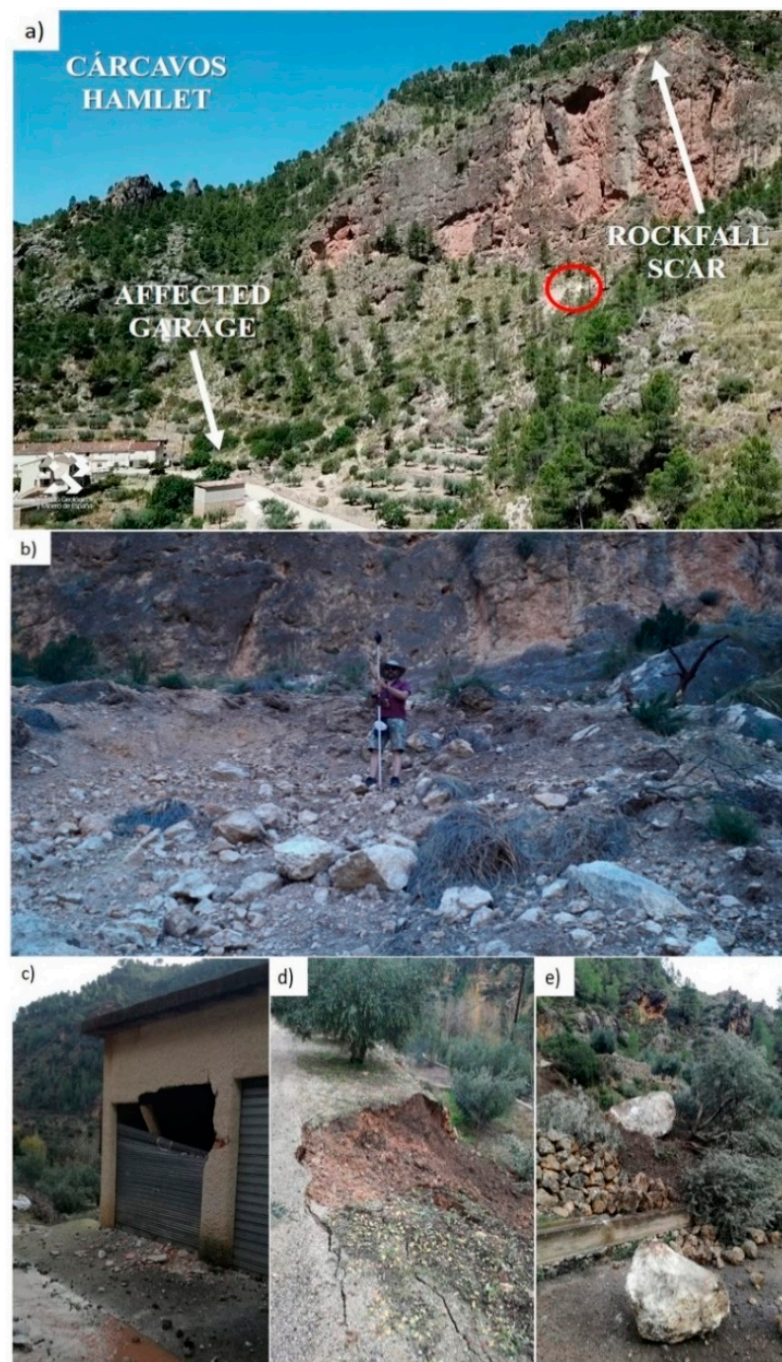
The 2018 event originated at the uppermost portion of a sub-vertical limestone scarp about 80 m high, NE-striking and facing SE (J2: 147/83). In the rock mass, three main families of discontinuity (J1: 086/84; J3: 118/81; J4:100/90) were found. The slope movement

started as a wedge-shaped translational rock slide [60,61] involving a single block 260 m^3 in volume (700 tons). After a limited displacement, the slide evolved into a free fall, and then reached the 30° slope at the base of the scarp, creating an impact crater 11.5 m long, 7.7 m wide and 1 m deep. Due to impact, the block broke into more than 600 boulders of various sizes that kept travelling downslope, rolling and jumping down to the road and through the olive-tree plantation, finally reaching a building and a garage.

Figure 4. The 2018 rockfall: (a) overall view, with source, impact crater (red circle), and stopping sector; (b) close view of the impact crater; (c) damaged garage; (d) damage on the local road; (e) blocks in the olive-tree plantation.

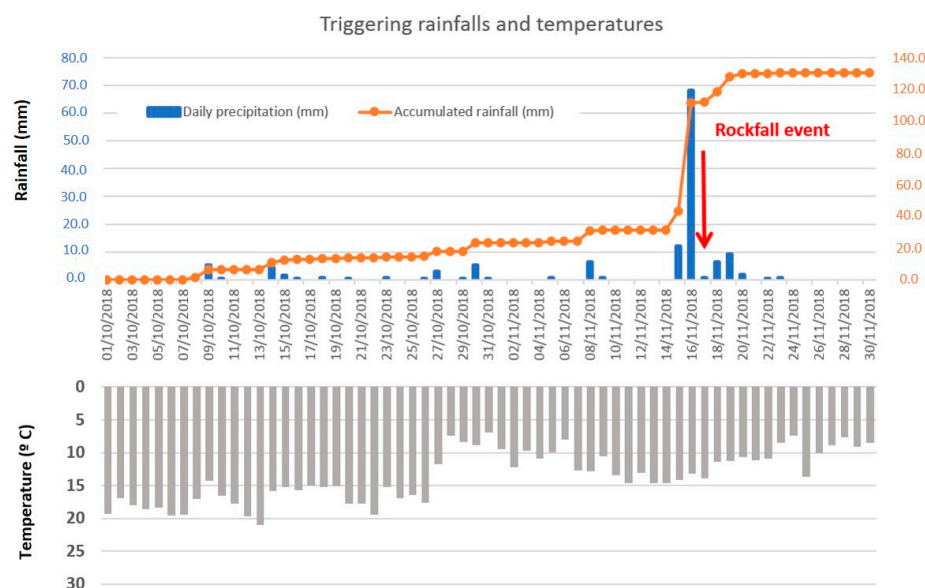
The day prior to the triggering of the rockfall, severe rainfall (61.3 mm) had been recorded at the closest rain gauge (Liétor, 15 km east of Cárcavos, at 642 m a.s.l.) (Figure 5). The event followed an antecedent period of moderate rains, cumulating in 50.3 mm in 46 days. As no evidence of seismic shocks nor other potential triggering factors could be identified, the rainfall event recorded on 16 November is assumed to be the triggering factor of the 2018 Cárcavos rockfall.

Figure 5. Daily and cumulated rainfall and temperatures recorded at the Liétor rain gauge from 1 October to 30 November 2018 (data after [62]).

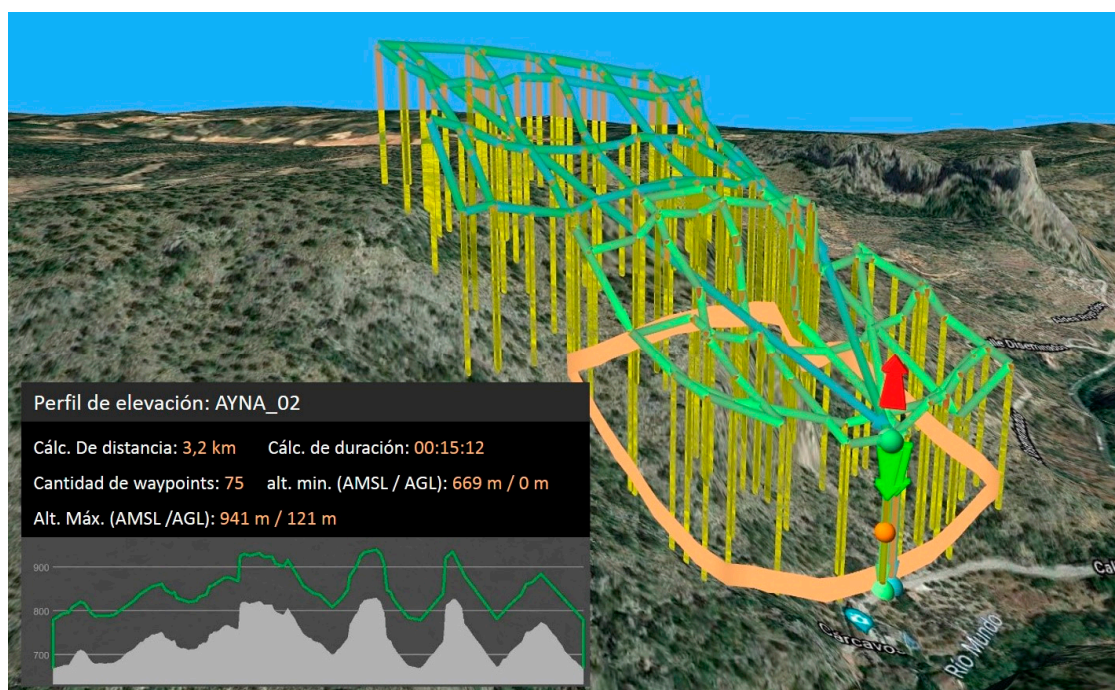
with adaptive flight height with respect to the ground, as GSD can be fixed. In this case, a 5 m resolution DSM [67] was incorporated into the fly trajectories calculation. The obtained photographs maintained the ratio pixel size/ground area covered in order to minimize possible correlation errors in the photogrammetric calculations (Figure 7). The flight paths were calculated to obtain a longitudinal and transverse image overlap of 80% and 70%, respectively.

Figure 7. 3D representation of the trajectories and profile of flights scheduled in UgCS in the study area.

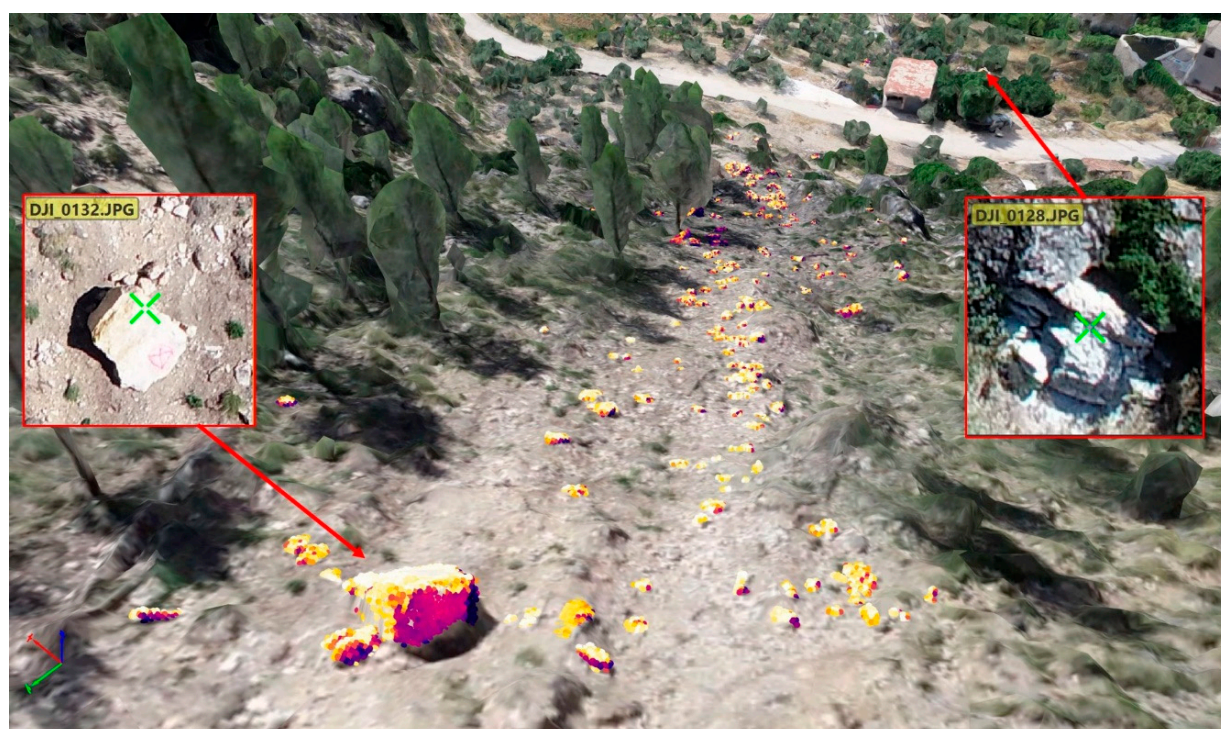
Figure 8. 2018 rockfall deposit viewed from the base of the scarp in the 3D DSM. The identified blocks are marked with bright colours whereas the biggest ones are evidenced with detailed photos.

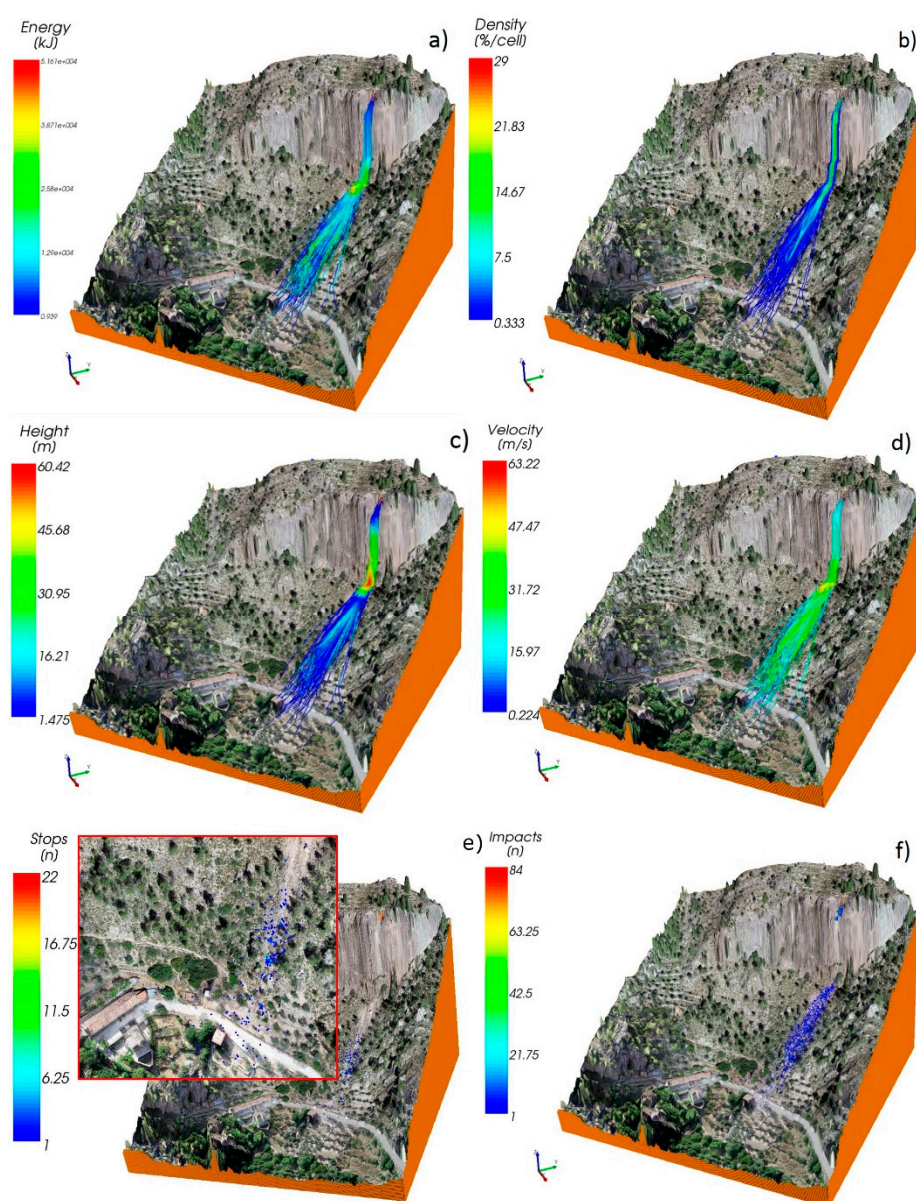
First, through a back-analysis technique, the model was calibrated to simulate the 2018 event by selecting appropriate coefficient values of ground parameters to obtain trajectories similar to the actual ones. This step was extremely important for the evaluation of the risk, as it affects the accuracy of successive simulations from potential sources. In fact, after calibration, 300 spherical rock blocks with diameters of 3 m (ca. 15 m^3) and densities of 2700 kg/m^3 were launched from the potential detachment areas, thus calculating energy, density, height, velocity, and stop and impact points of each simulated trajectory (Figure 10).

Figure 10. 2018 rockfall simulation: (a) Energy map, (b) density map, (c) height map, (d) velocity map, (e) stopping points map, (f) impact points map.

The results obtained by simulating the largest blocks (fifth order) showed energy peaks ranging from 20,000 KJ to 30,000 KJ, and velocity peaks of ca. 47.5 m/s at the base of the scarp, i.e., where an impact crater was actually originated by the event. The preferential direction of the blocks is evidenced in the density map, where the higher trajectory densities are concentrated in a well-defined chute.

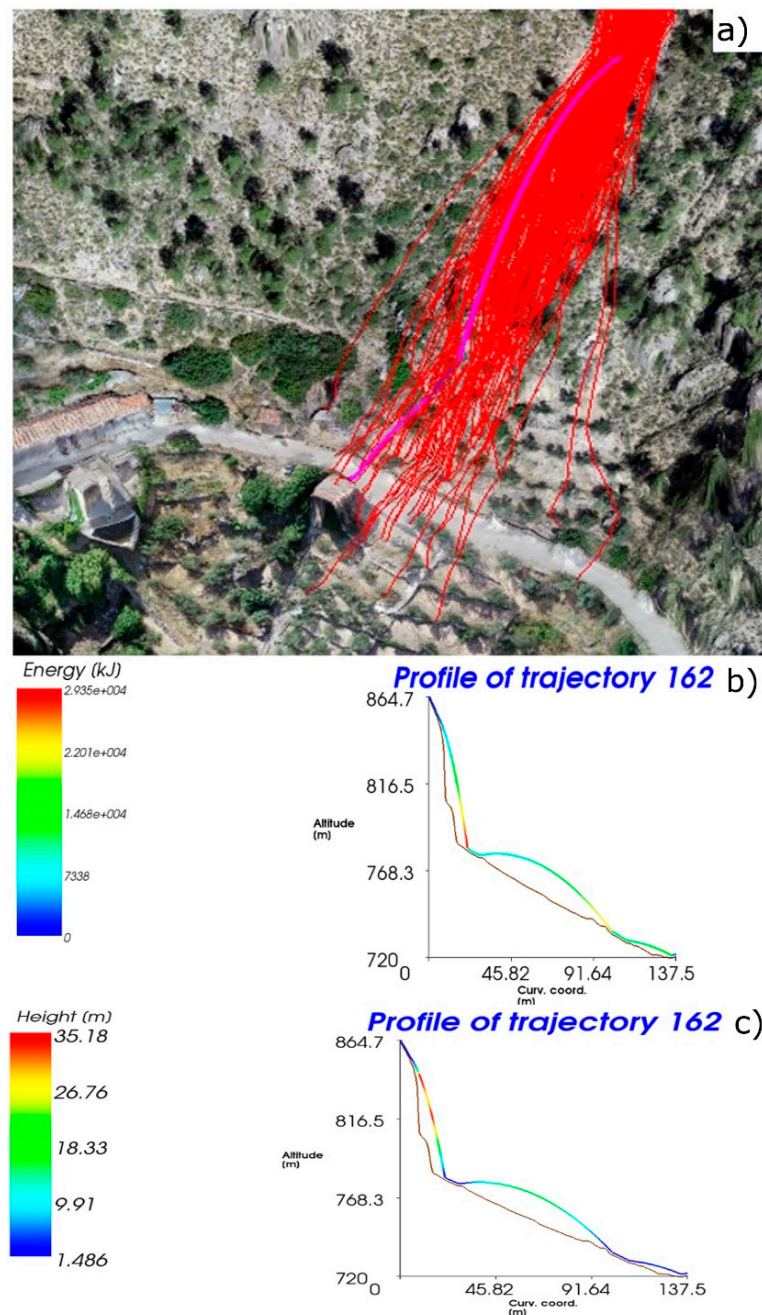
In more detail, among the simulated cases, trajectory n. 162 was found to be the most similar to the one followed by the block that hit the garage (Figure 12). The analysis of this trajectory showed that a block of ca. 15 m^3 hit the garage with an energy between 3000 KJ and 5000 KJ, a velocity of ca. 10 m/s, and a height between 1 m and 2 m.

Figure 12. Trajectory paths (a), with case n. 162 marked in pink. In (b,c), energy and height profiles are shown for trajectory n. 162.

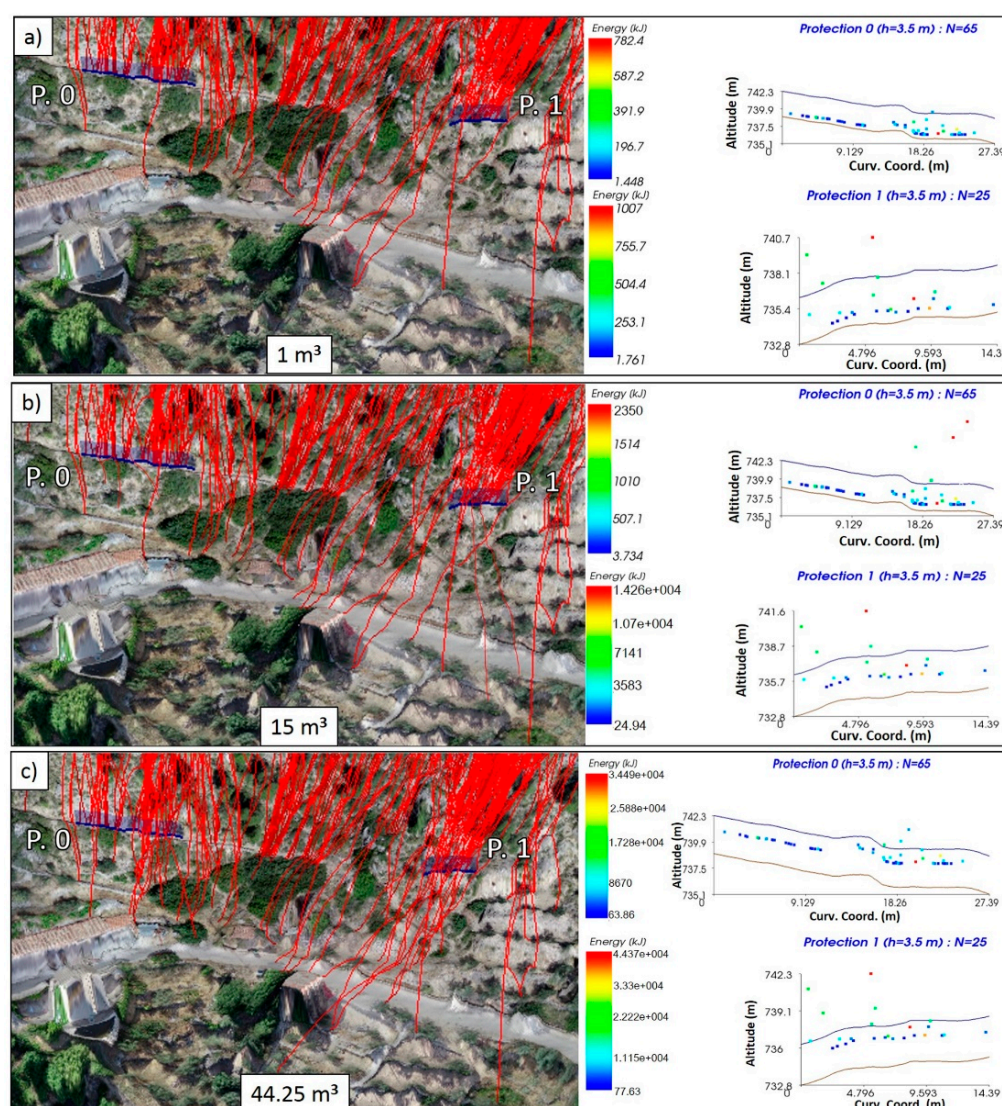
The 90.8% of the 15 m^3 blocks were retained by barrier n.0 with a maximum energy of 11,081 KJ and a maximum velocity of 24 m/s. About 6.2% of the blocks passed through the protection, and only 3.1% of them passed above, with a height of rebound of 4.5 m. On the other hand, barrier n.1 retained 64% of the blocks, with a maximum energy of 13,689 KJ and a maximum velocity of 26.7 m/s. About 20% of the remaining blocks passed through the protection, whereas 16% passed above, with 7.4 m of height of rebound.

Finally, when simulating the biggest volume class, barrier n.0 retained 69.2% of 44.25 m^3 blocks, with a maximum energy reached of 34,487 KJ and a maximum velocity of 24 m/s. As for the remaining cases, 4.6% passed above the barrier, with a maximum height of rebound of 5.3 m, and 26.2% passed through the protection. Barrier n.1 retained 36% of blocks, with a maximum energy of 42,603 KJ; about 24% of the blocks passed above, with a maximum height of 8 m, whereas 40% passed through the protection.

Figure 16. Performance simulations of dynamic barriers, with blocks volumes of 1 m^3 (a), 15 m^3 (b) and 44.25 m^3 (c). Energy and height values reached by the blocks for protection n.0 and protection n.1 are also shown.

In particular, the location of the impact and the stopping points was fundamental to assessing the hazard and the vulnerability of the exposed elements. Trajectory characteristics contributed to the assessment of the rockfall hazard and the susceptibility in the study area, and were therefore relevant to the designing of appropriate mitigation measures. Combining trajectory characteristics and the results of fragmentation analyses allowed for the designing of two dynamic barriers whose performance was evaluated by means of RocPro3D [19]. The results showed that the blocks simulated from the NE-sources reached barrier n.1 with higher values of energy, velocity, and height of rebound. As a consequence, such barriers retained fewer blocks. Most simulations showed excellent barrier performance. In only one case (i.e., considering the largest blocks) was the percentage of retained blocks below 50% (36% retained blocks of 44 m³ at barrier n.1).

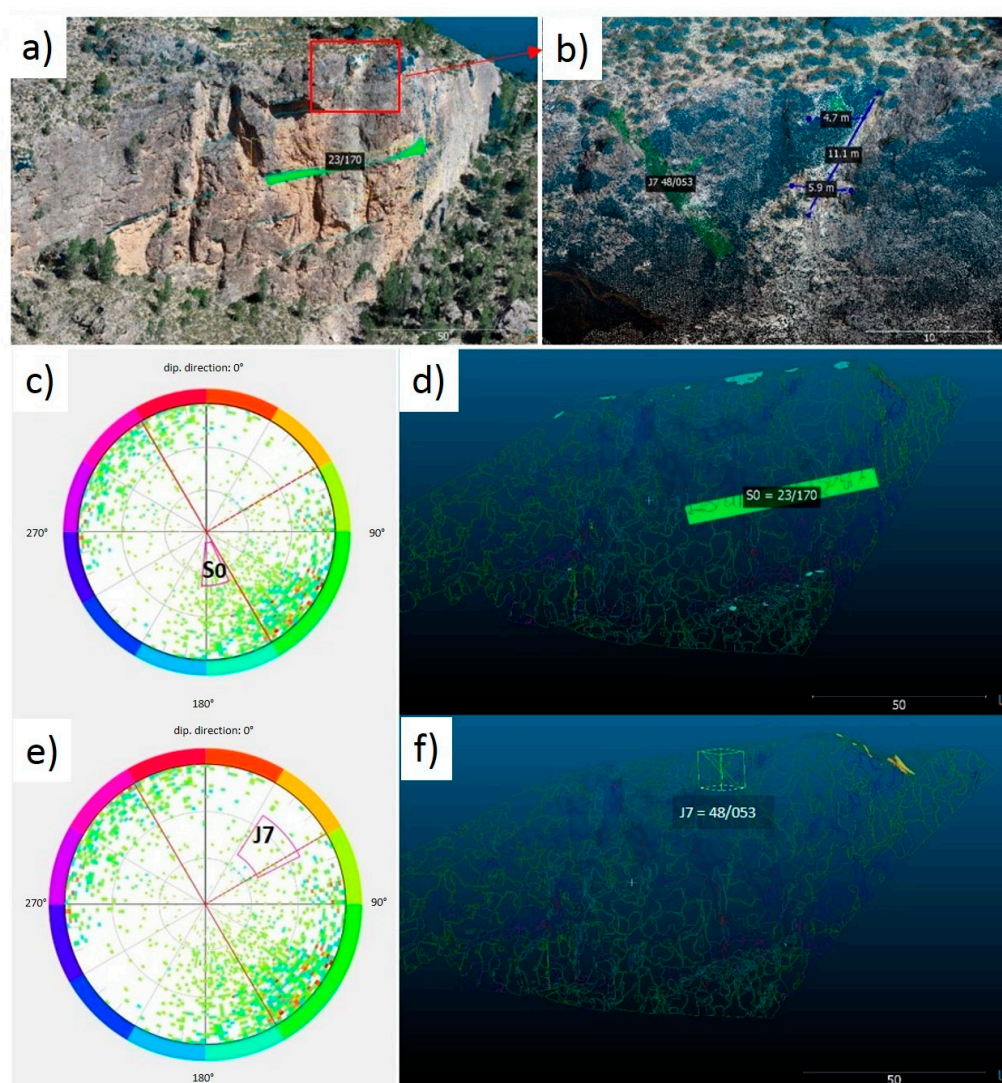
Figure 17. (a) Example of obtaining a bedding plane (S0) orientation using the Cloud Compare's Trace tool. (b) J7 family joint plane orientation obtained using the Cloud Compare trace tool and the 2018 maximum rockfall scar's dimensions calculation using Cloud Compare's point to point tool (c,e) Stereographic representation of the 3DPC Cárcavos planes obtained through Facets Cloud Compare plugin. Those corresponding to the S0 and J7 families, respectively, are indicated in red windows. (d,f) 3D representation of the S0 and J7 families, respectively.
