Application of Geomatic Techniques for the Assessment of Anthropogenic Changes in the Urban Beaches of “La Magdalena” (Santander, Spain)

Abstract: Since the 1970s, dredging sands have been poured onto the embayed beaches of La Magdalena in the western mouth of the estuarine Bay of Santander (N Spain) in order to increase beach width. Up until the year 2000, the sands were systematically fed by a trailing suction dredge, which was later replaced by truck sand transfers from the surplus sands of the western beach to the eastern ones and by mechanical redistribution to create artificial berms. A recent project aimed to solve sand losses after each storm by building two perpendicular breakwaters about 620 m apart. The eastern breakwater was built in the early summer of 2018, and wave storms in November 2018, February 2019, October 2020 and the last days of 2021 progressively dismantled the reconstructed upper beach areas and eroded other segments. The western breakwater, however, designed to retain the E–W sandy beach drift, was never built. Four photogrammetric restitutions from 2005, 2010, 2014 and 2017 and an aerial LiDAR in 2012 were obtained to better understand the previous topo

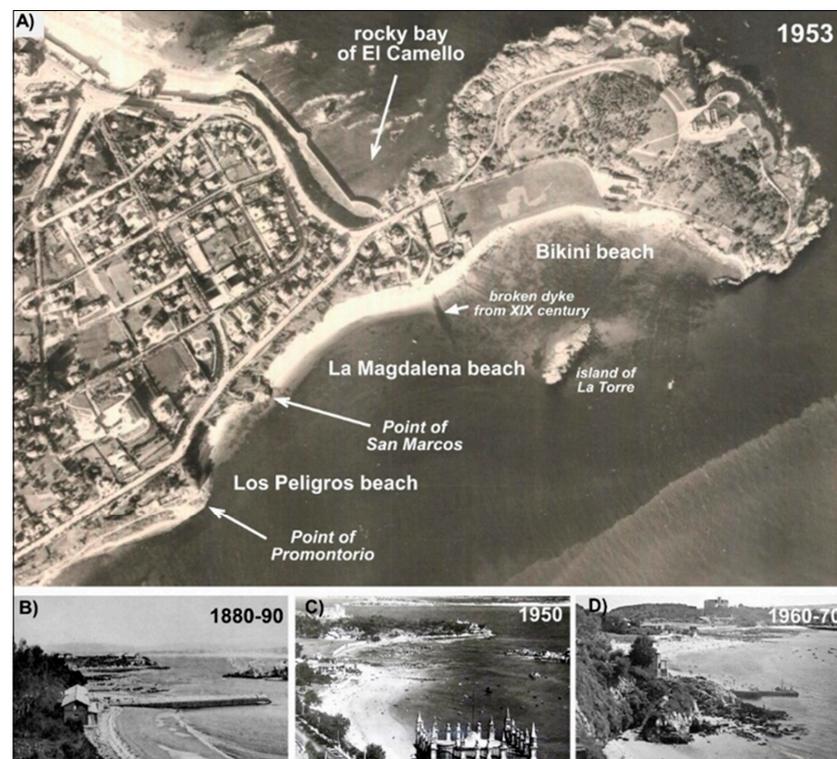
Figure 3. (A) Beach area of La Magdalena. Vertical photograph from 1953 (Diputación de Santander). (B) Eastern area of La Magdalena with the old sea-spa building and the breakwater (XIX century, now disappeared). (C) La Magdalena beach and, in the background, the Bikini beach, with its rocky outcrop at low tide (1950). (D) Eastern area of Los Peligros beach in the foreground and the point of San Marcos and the elongated dyke named El Puentuco (old dock), where the eastern side of La Magdalena beach begins (1960–1970).

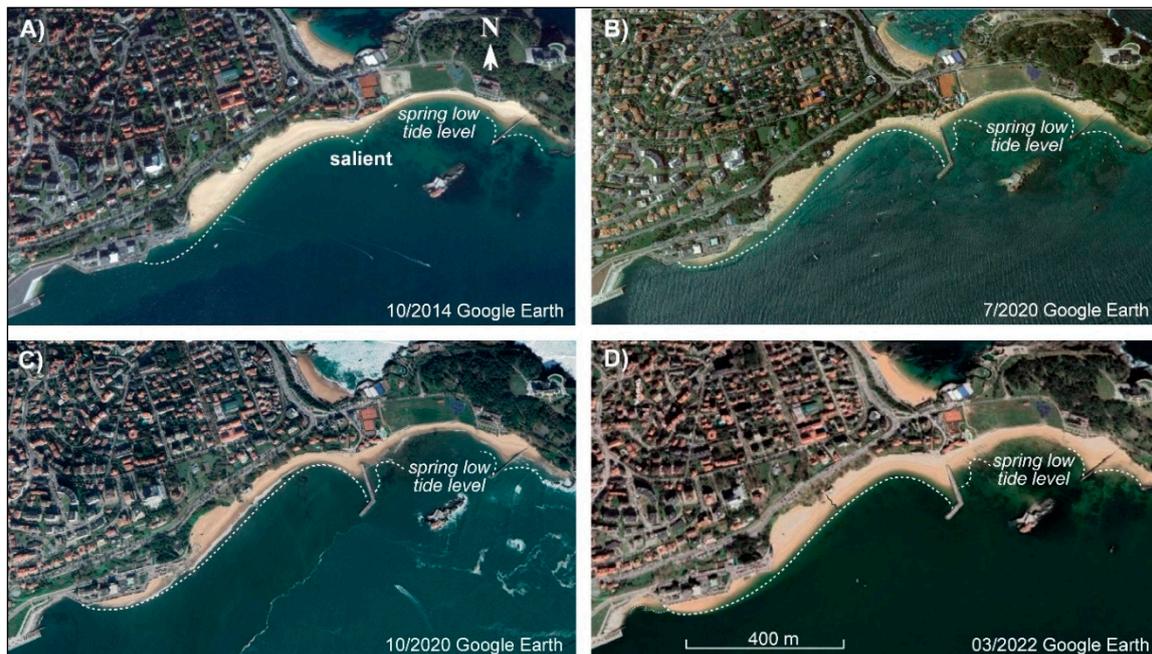
Figure 12. Google Earth satellite images: (A) Changes in the beach plan shape of La Magdalena beaches before the construction of the breakwater in 2014. (B,C) Afterwards in 2020. (D) In 2022, with the profile modified by the redistribution of sediment with machinery. The western Bikini beach grew towards the breakwater, as well as the foreshore of La Magdalena, and the eastern half of La Magdalena widened.

Clearly, the plan shape of La Magdalena beach has changed, becoming more concave seaward in the sheltered area of the breakwater (Figure 12B–D) compared with the previous morphology (Figure 12A). The effects of storms are more destructive, generating erosive steps above 2 m in height (Figure 11H–K), backshore narrowing and the disappearance of the sandy prism in front of the restaurant, as occurring in 2018 (Figure 11G) as well as on walkways and promenades (Figure 11H–K).
