# GNSS Real-Time Warning Technology for Expansive Soil Landslide—A Case in Ningming Demonstration Area

**Keywords:** expansive soil landslide; GNSS real-time monitoring; multi-source data; early-warning model; successful warning

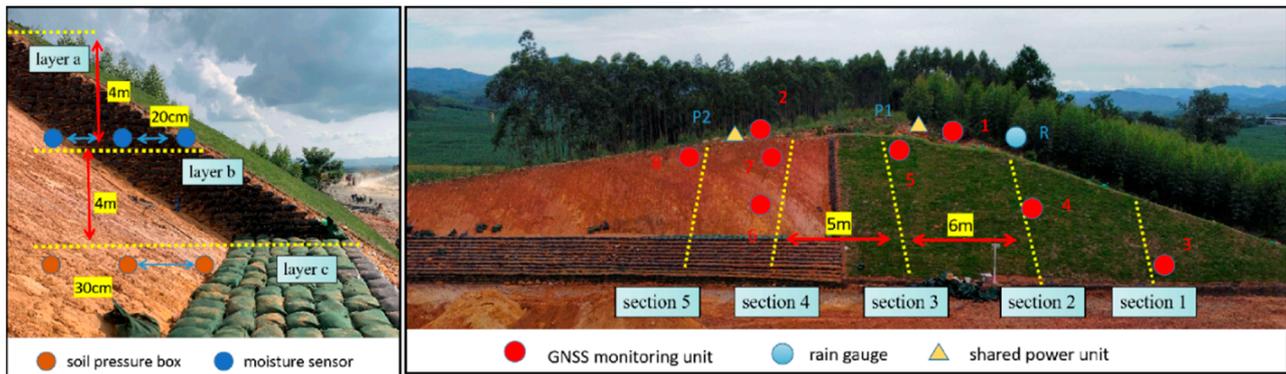
**Figure 2.** Landslide monitoring sensor deployment network.

The layout of GNSS monitoring points follows the principles of economy and rationality. The monitoring points were deployed at the slope shoulder–slope surface–slope toe, which is prone to deformation. Numbers 1~8 represent different GNSS monitoring points. According to the three-dimensional monitoring system composed of monitoring lines and monitoring points [24], the slope was divided into 1~5 sections and a~c layers; the average distance between sections is about 5.5 m; the height difference between them is about 4 m. GNSS monitoring units were deployed in areas with some cracks and relatively active deformation so that they can capture the displacement characteristics of the slope. As shown in Figure 2, eight GNSS monitoring units were deployed in total. On layer b, three sets of soil moisture meters (SF) were deployed from inside to outside with 20 cm. Regarding layer c, three sets of soil pressure cells were also deployed with 30 cm. Two sets of “shared power supply” integration stations and one rain gauge were added.

The first slope failure occurred on 11 October 2021; it was in the middle and upper layers of the slope, i.e., between the fourth and fifth sections (in Figure 2). The landslide area was about 104 square meters. Since 1 October 2021, eight GNSS displacement monitoring sensors were deployed, and the complete 1 Hz real-time GNSS displacement results were estimated using the monitoring and early-warning system.

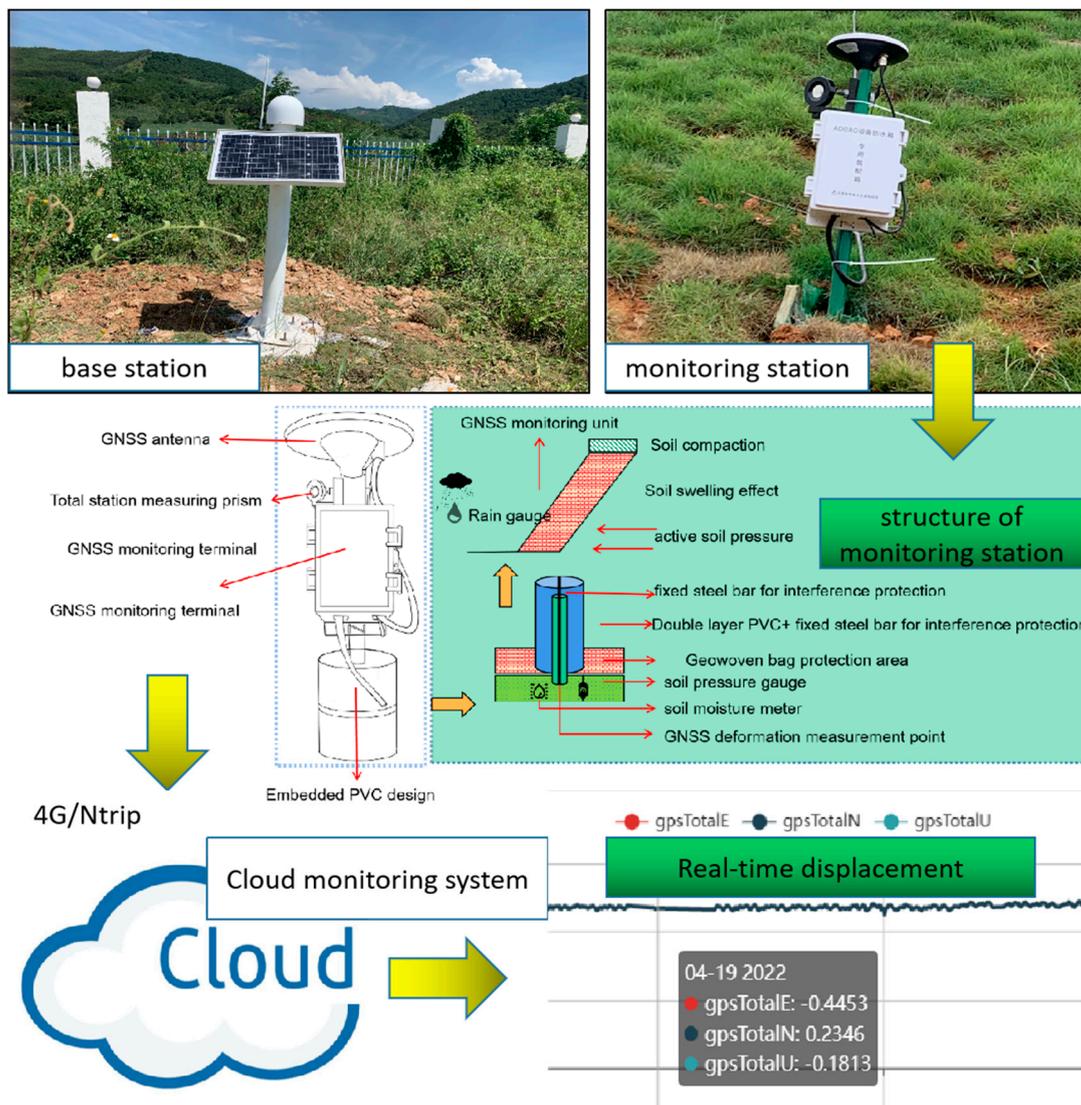
Figure 3. GNSS field monitoring device and principle.

The equipment structure and the displacement acquisition method are presented in Figure 3. The field displacement monitoring was based on self-developed GNSS monitoring equipment with a Ublox ZED-F9 P board. One monitoring reference station was established at the stable area, the monitoring stations are shown by red dots in Figure, and the average baseline length between the monitoring reference station and monitoring stations is 2.8 km. The data sampling rate was 1 s. The monitoring principle is as follows:

The multi-GNSS pseudo range and phase observations are received by monitoring equipment, then the RTK technology is used to obtain three-dimensional coordinates of monitoring stations. The measurement accuracy is better than 3 and 5 mm for horizontal and vertical directions, respectively. The difference between coordinates from RTK and initial reference coordinates are calculated, then transferring them to horizontal and vertical directions displacements. Thereafter, the displacements can be obtained. The detailed method to calculate displacement is as follows: First, the observation equation of GNSS real-time-kinematic (RTK) positioning is as follows:

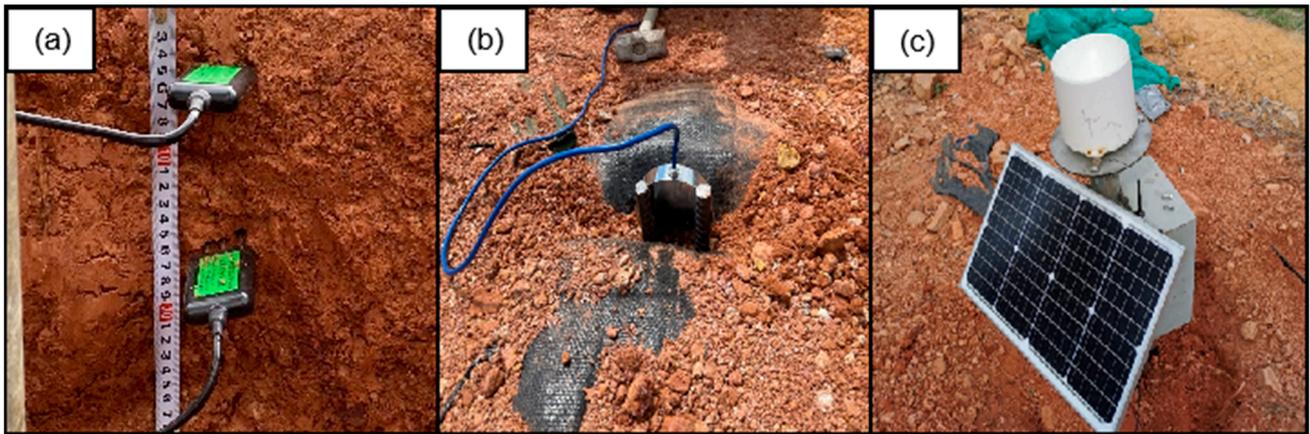
**Figure 4.** Field diagram of multi-source monitoring sensors installed on slope. (a) Soil moisture meter. (b) Soil pressure box. (c) Rain gauge.

Failure mode of ground displacement induced by rainfall could be deeply understood by precipitation monitoring. One funnel-type rainfall sensor was deployed in the demonstration area for data acquisition, and its measurement principle is that the rainwater enters the rain catcher, the tipping bucket will lose its balance and turn over when the accumulated water reaches a certain height; then, the precipitation result can be obtained by transforming the number of flips into a telecommunication signal in the rainfall process. Its nominal accuracy of measurement is  $\pm 0.2$  mm. Moreover, the signal will be transmitted to the monitoring system by the Nb-IoT technology. The details of the multi-source monitoring sensor installation for the slope in the demonstration area can be seen Figure 4.

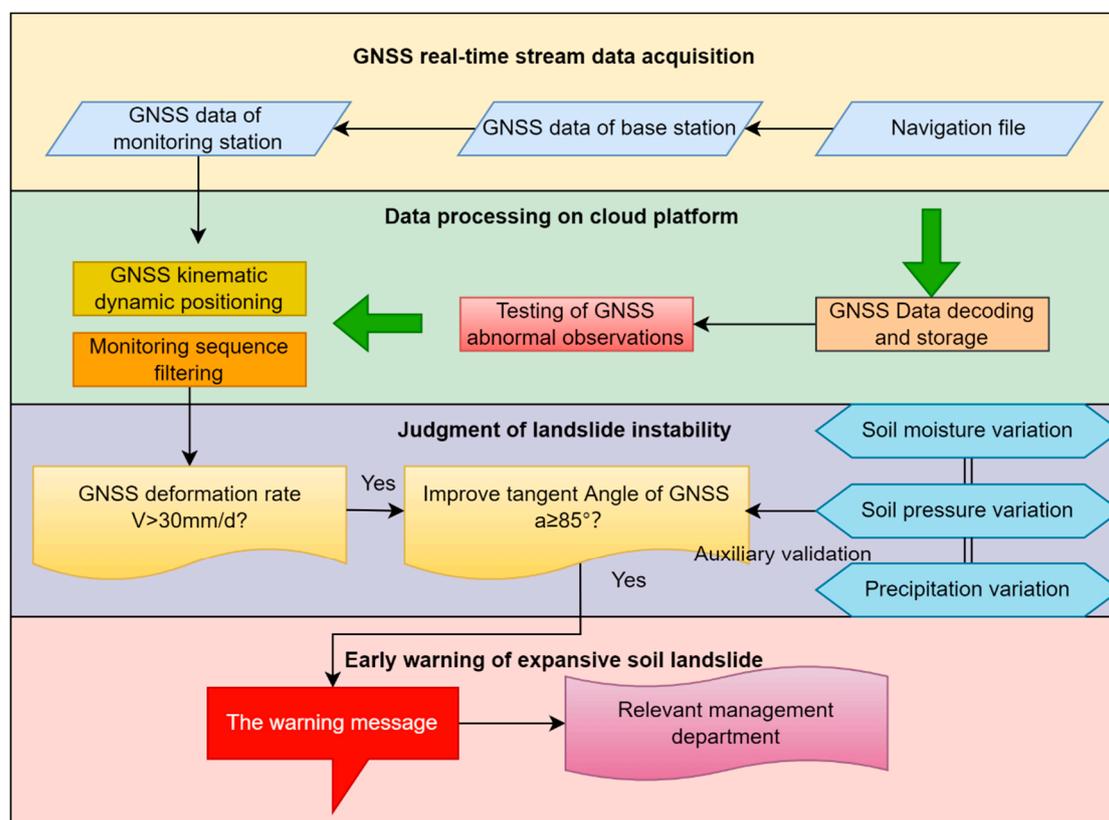
**Figure 5.** GNSS real-time early-warning process of expansive soil landslide.

The specific early-warning model and early-warning level are shown in Table 1.

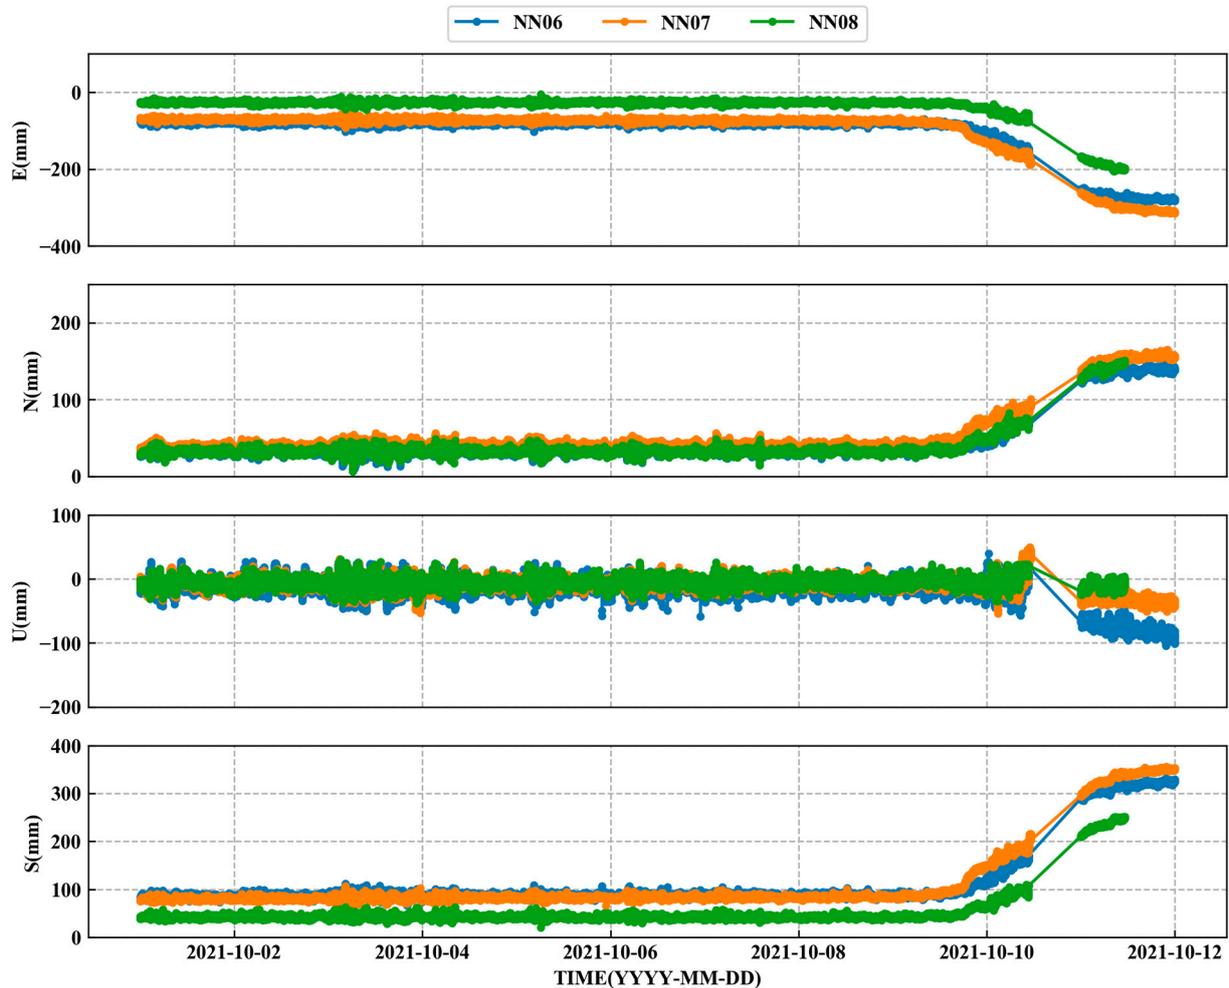
**Figure 6.** Raw displacement in different directions of each point in the first instability.

The landslide displacement versus time data collected from GNSS monitoring equipment are shown in Figures 6 and 7 [31]. Two periods of significant deformation occurred at

NN06, NN07, and NN08 monitoring stations (the first and the second time was in October 2021 and February 2022, respectively), and there was no obvious deformation for other monitoring stations. Among them were some irregular displacements for NN06 from 7 February 2022 to 12 February 2022, which were caused by an interruption of data transmission.

It can be seen from the Figures 6 and 7 that the two displacement curves had similar characteristics.

Taking the first instability as an example, the cumulative displacement of the three monitoring stations in E, N, U, and 3D directions remained stable before 9 October. The average rainfall intensity during this period is 0.602 mm/d, which is a dry period. At 00:00 on 9 October 2021, the cumulative displacements of the three monitoring stations in the 3D direction reached 89.02 mm, 83.53 mm, and 42.45 mm. However, at 13:10 on 9 October 2021, 6:02 on 9 October 2021, and 14:16 on 9 October 2021, the slope began to enter the accelerated deformation stage, with obvious increase trends appearing for the east and north directions. At about 17:00 on 11 October 2021, the displacement of the monitoring station reached its maximum value, and the three-dimensional displacements were 323.41 mm, 348.06 mm, and 246.79 mm, respectively. After checking the rainfall data, it was known that the displacement increment was larger than 200 mm within 3 days, according to the rainy trend during this period. It can be inferred that the expansive soil slope became unstable in this area in which the horizontal displacement was significant, while the vertical displacement was not, and the sudden change of displacement was significantly related to the precipitation. The three-dimensional displacement curve has

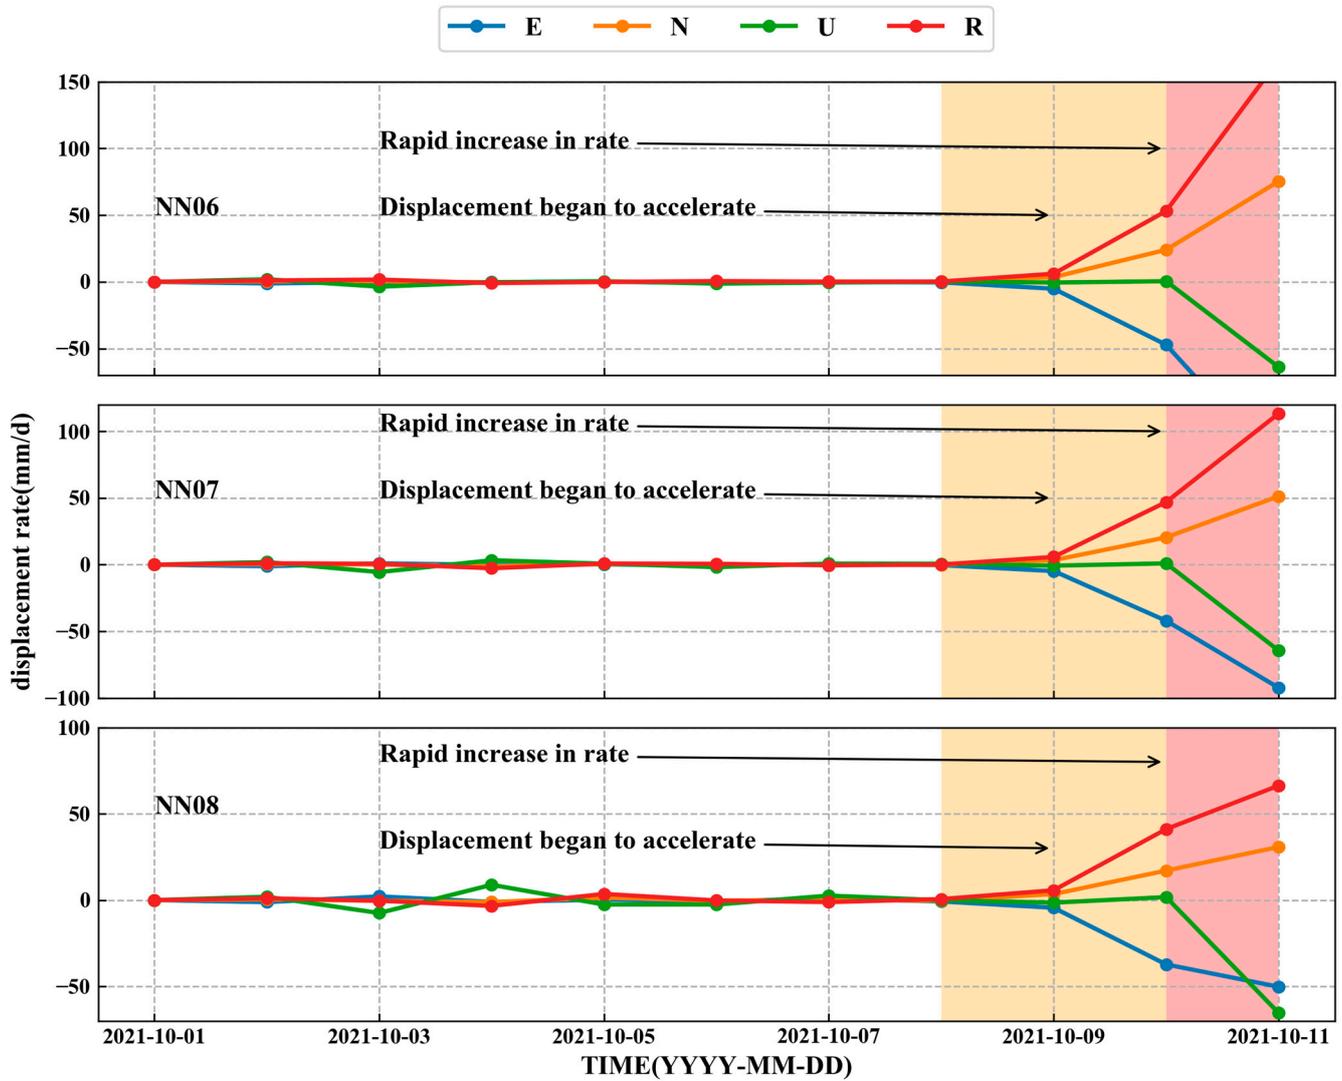
**Figure 8.** Displacement rate curve of monitoring points (2021/10. E, east; N, north; U, elevation; R, 3D direction).

The different stability stages can be obtained according to judgement method of the early-warning model (Table 1). The displacement rate in each direction (daily solution) obtained using the early-warning system based on the accumulative displacement is shown in Figure 8. For NN06, NN07, and NN08 monitoring stations, the displacement rate in the horizontal direction is larger than that in the vertical one. The main reason is the dominant lateral expansion force. The lateral deformations also lead to the increase of the distribution of further cracks after the failure, which is due to the superficial failure feature of common gently expansive soil slopes for the Ningming Basin [32]. The displacement rate of the monitoring stations in the first seven days was stable (0.42 mm/d, 0.02 mm/d,

and 0.07 mm/d for NN06, NN07, and NN08 stations, respectively). On 8 October 2021, the slope acceleration trends were sensitively found by the early-warning system, thus beginning the preparation of the early warning. Nevertheless, it is unreliable to judge the slope stability using only a single rate or tangent angle indicator, which is proven in the next warning case.

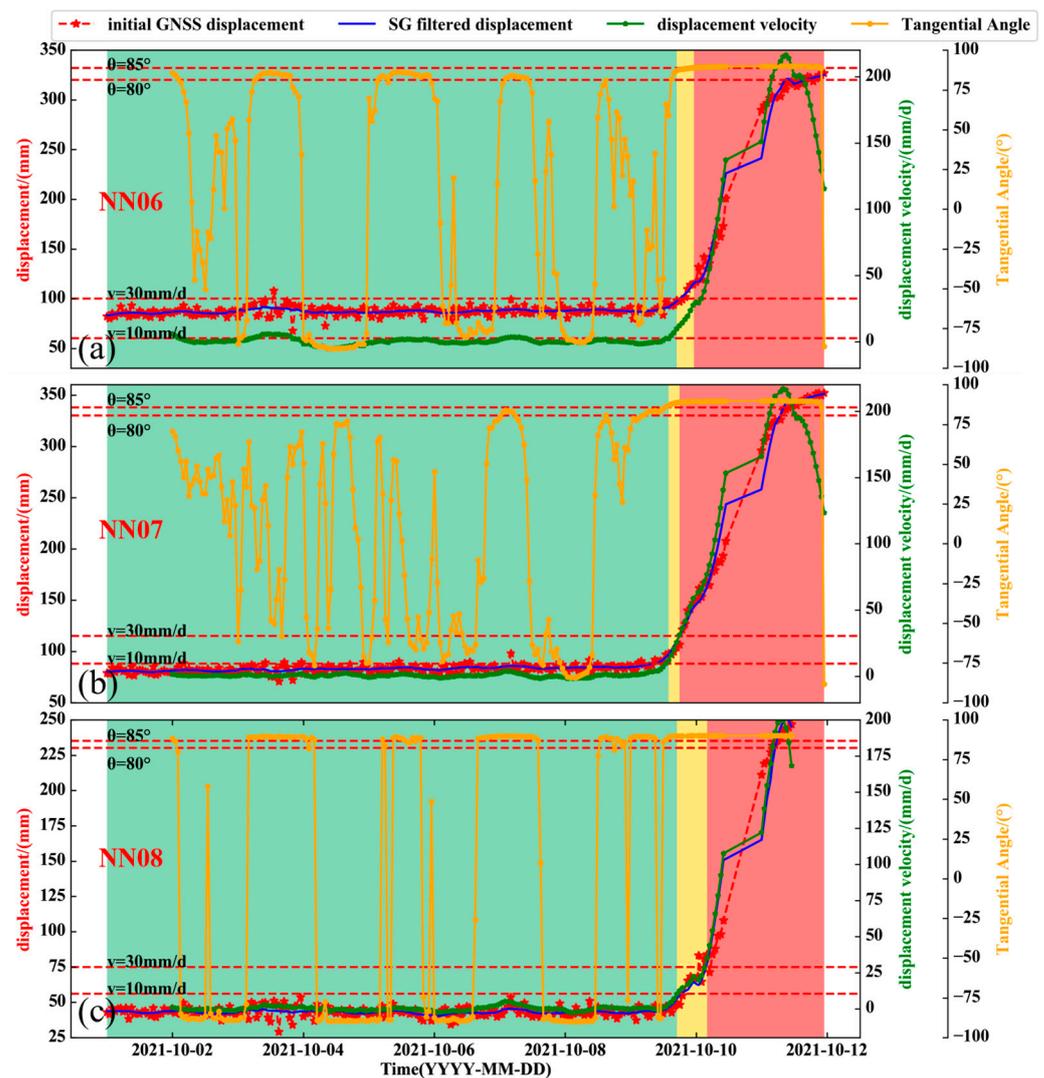
**Figure 9.** First instability real-time warning information: (a) NN06; (b) NN07; (c) NN08.

GNSS displacement information can be calculated and tracked by real-time warning system. The real-time GNSS surface displacement, displacement rate, and improved tangent angle curves of unstable areas are shown in Figure 9a–c.

The obvious deformation instability area is near the fourth and fifth section. Before 8 October 2021, the real-time displacement rate of the NN06 station was less than 10 mm/d, and the tangent angle was continuously oscillating below 80°. The stable deformation stage was judged by the early-warning system, and the probability of failure was very low; thus, only regular monitoring was required.

At 0:02 on 10 October 2021, 18:05 on 9 October 2021, and 3:36 on 10 October 2021 for NN06, NN07, and NN08, both the rate and tangent angle began to exceed the default alarm threshold, and the oscillation characteristics of tangent angle disappeared. A red alarm was sent out by the warning system. The landslide process was preliminarily divided into different stages (green, yellow, and red represent stable deformation stage, accelerated deformation stage, and near instability stage, respectively) according to different levels of alarm conditions, which are marked in Figure 9. The warning was issued by the system, which was about 47 min earlier than the real failure on average. The detailed early-warning time and warning time in advance can be seen in Table 2. After landslide, a field investigation was conducted, as is shown in Figure 10. Compared with before the landslide, four obvious fissure areas (1–4) were found in the yellow frame, and all of them were distributed on the slope shoulder with an average length of 9 cm. The specific failure position of the slope is shown in Figure 11. The red frame is the instability boundary, and the blue dotted line represents sections 4 and 5. By conducting the investigation, it was found that the drainage trough was choked on the rear boundary of the slope body. A great amount of rainwater infiltrated into this area; obvious shallow damage near this area occurred, and it was repaired in time after the shallow slide.

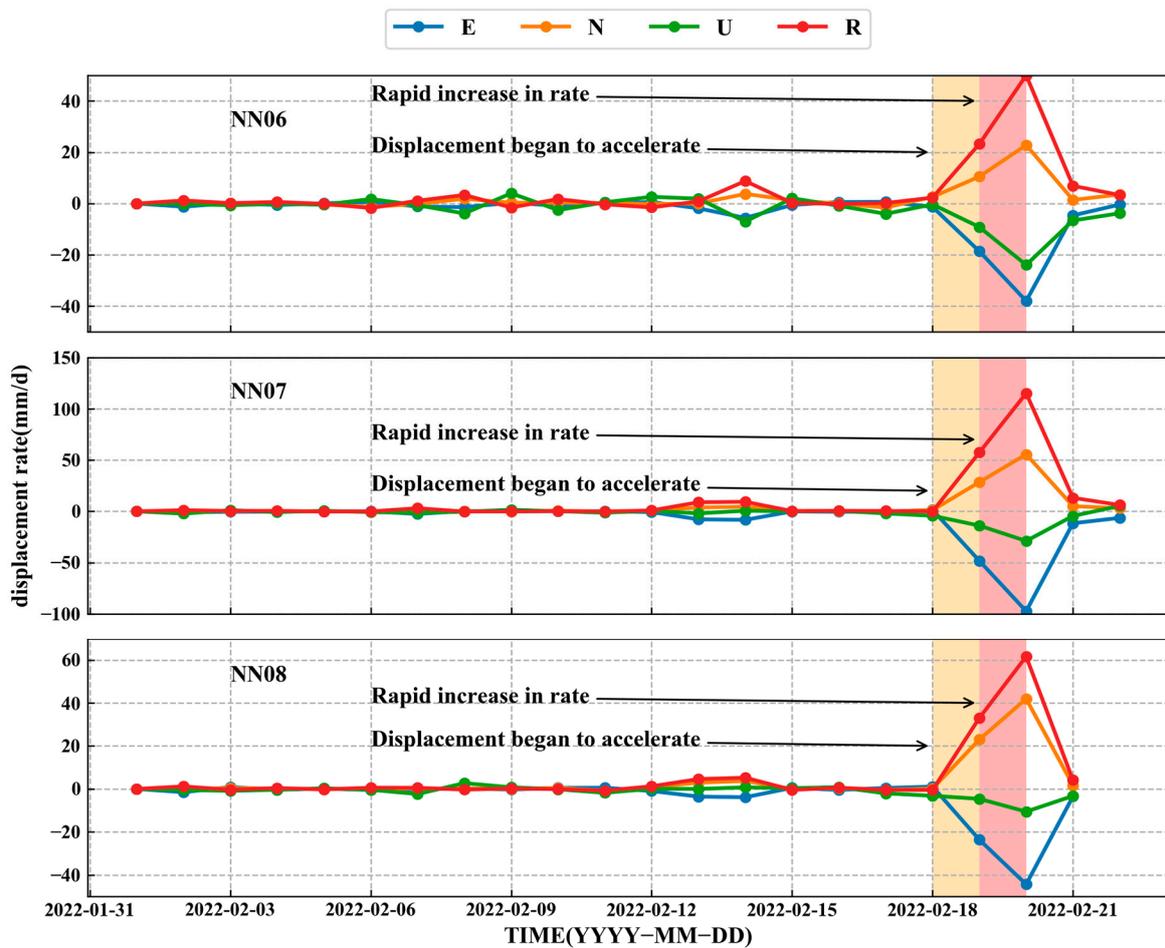
Figure 12. Displacement rate curve of monitoring points (2022/02. E, east; N, north; U, elevation; R, three-dimensional direction).

Another slope instability occurred in February 2022. Similarly to the first landslide, it was caused by short-term heavy rainfall, and the failure form was shallow, local instability; it is shown in Figure 12 that the displacement of the slope was stable during the first 17 days, deformation was captured by the early-warning system on 18 February 2022, and after deformation acceleration, the early-warning system prepared to track and analyze the alarm parameters.

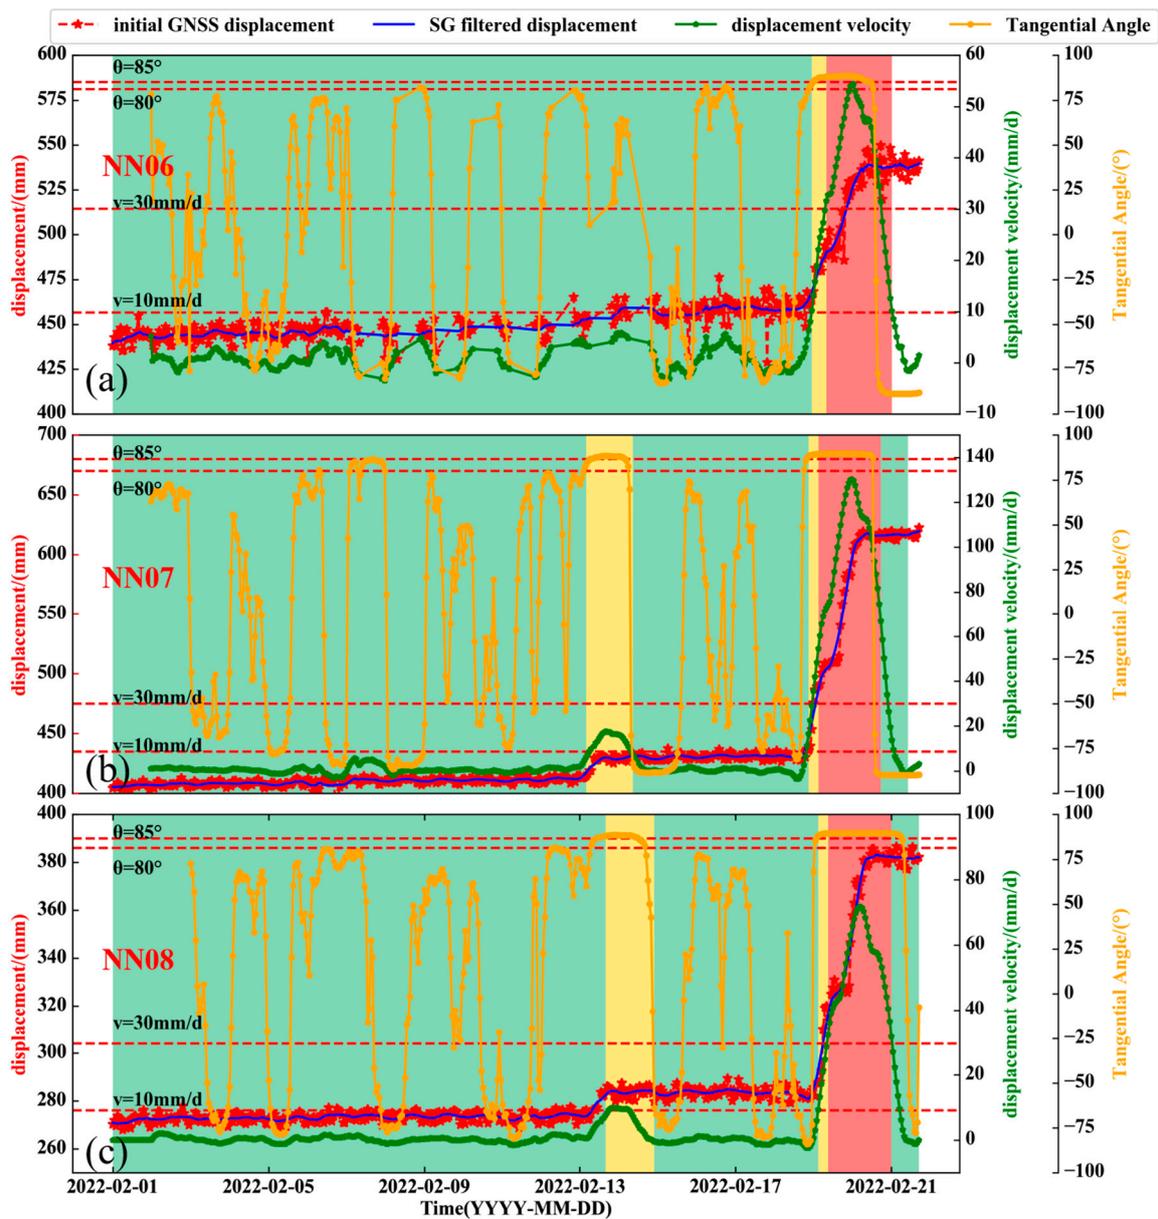
Figure 13. The second instability real-time warning information: (a) NN06; (b) NN07; (c) NN08.

Figure 13a–c show that the real-time curves of GNSS surface displacement, displacement rate, and improved tangent angle were processed by the early-warning system during the second instability period. As of 17 February 2022, there was no distinct deformation at the three stations, while for the NN06 station, the rate and tangent angle were 30.35 mm/d and 88.05° at 13:50 on 19 February 2022, respectively. In terms of the NN07 station, the rate and tangent angle were 29.13 mm/d and 88.98° at 4:24 on 19 February 2022, respectively. For the NN08 station, the rate and tangent angle were 30.86 mm/d and 89.51° at 8:42 on 19 February 2022, respectively. The warning principle was required, and the researchers sent an alarm message after a brief analysis. The detailed warning level division, alert time, and advance alarm time are shown in Table 3.

The NN06 station experienced three deformation stages (stable–acceleration–failure), while NN07 and NN08 experienced five stages, namely “stable–acceleration–stable–acceleration–failure”, which is a representative failure mode of rain-induced expansive soil landslides [33]. For the first accelerated deformation stage, the tangent angle exceeded 85° from 9:00 on 13 February to 9:00 on 14 February, but the average displacement rates were 17.2 mm/d and 10.2 mm/d, respectively. The numerical value increased significantly, whereas it did

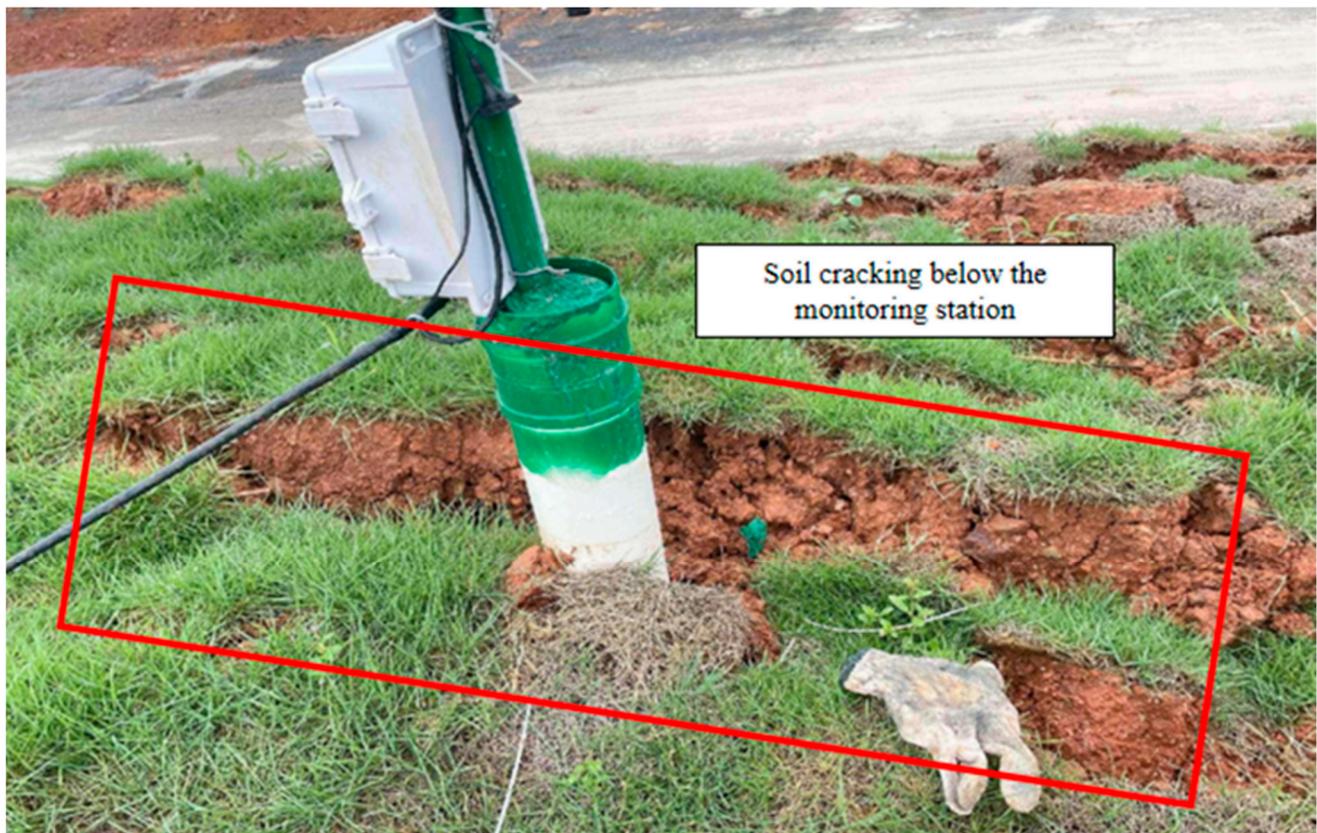
**Figure 14.** The rupture near GNSS monitoring station after the second failure.

As shown in Figure 14, The red frame shows the visible cracks near the station after failure, compared with the first slope failure, the cracks on the surface were denser and more developed, and some parts were severely damaged this time.

For example, the soil mass near the slope surface of NN08 was obviously collapsed (red frame in the figure), the slope displacement gradually recovered on the 21st, and the value of the early-warning parameters dropped significantly and accordingly.

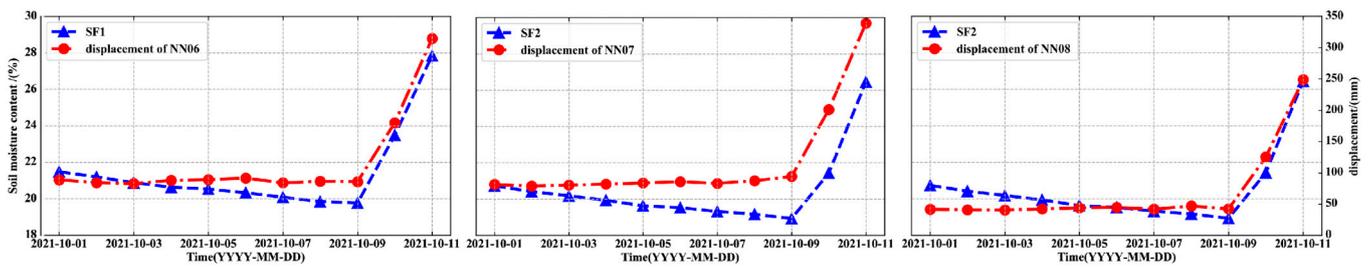
Figure 15. Monitoring curves of soil moisture content at different location.

The soil moisture content versus time for the first landslide at NN06, NN07, and NN08 is shown in Figure 15. The soil moisture content sensors SF1 and SF2 are near NN06, NN07, and NN08 stations, respectively. The soil moisture content slowly declined at the two sensors, SF1 and SF2, in the early stage of monitoring, which can be attributed to the fact that the main dry and wet effect of the slope was dominated by evaporation. After entering the rainfall period on 9 October 2021, the soil moisture content at SF1 and SF2 was increased about 8% and 7% within 3 days, respectively; it was increased simultaneously with the rainfall. The lag period between soil moisture content and the rainfall was very short, and the nearby GNSS monitoring displacements simultaneously experienced obvious uplifts.

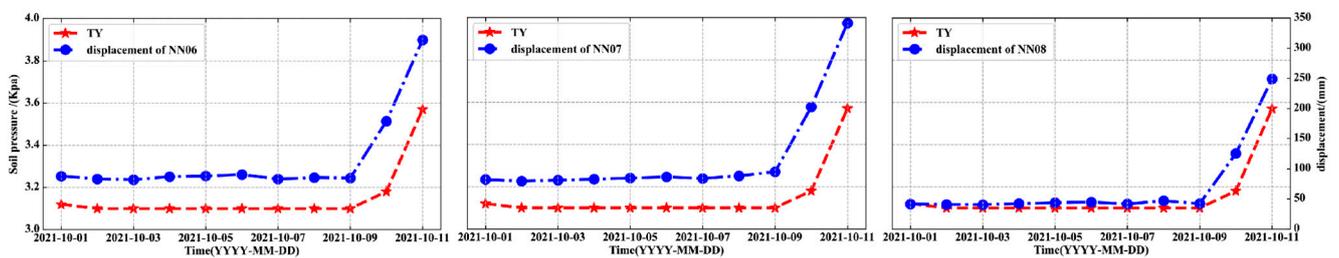
Figure 16. Numerical curves of earth pressure at different positions.

The soil pressure value can reflect the expansive force variation in expansive soil [34]; the monitoring results are shown in Figure 16.

When the slope experiences meteorological events such as heavy rainfall [35], the soil inner pressure also accordingly changes. In the no-rain period, the displacement of the slope was slight, the slope was in the process of drought and shrinkage, and the additional thrust could not be received for the sensors embedded in five sections of the slope. Therefore, the soil pressure was nearly constant. Under rainfall conditions, water was absorbed by the soil behind the sensors, producing obvious force perpendicular to the soil pressure box; thus, the horizontal soil pressure increased accordingly. During the accelerated deformation of the slope, the soil pressure value also had a corresponding sudden change.

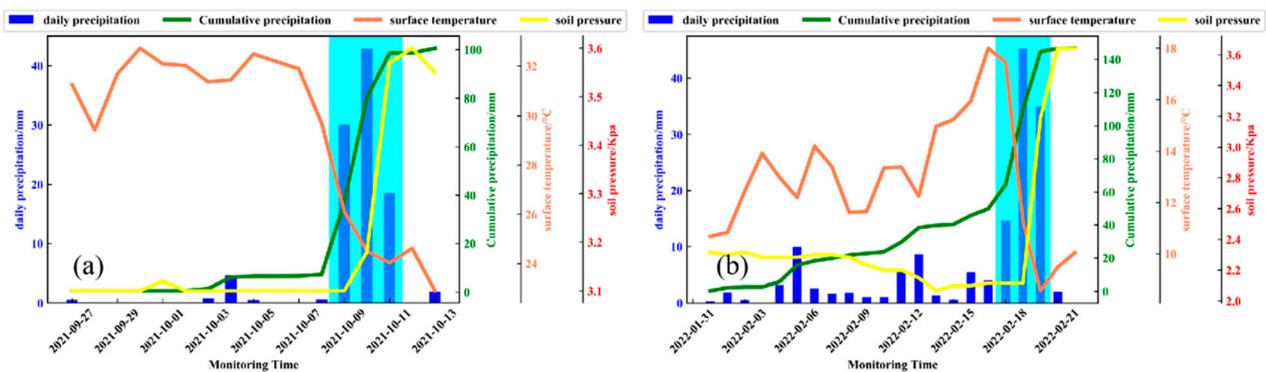
Figure 17. Monitoring results of precipitation. (a)The first failure. (b)The second failure.

The precipitation monitoring results during the two instability periods in this area are shown in Figure 17. The first and second landslides occurred in a dry period before 8 October 2021 and 17 February 2022; the cumulative rainfall and soil pressure remained stable, and there were periodic fluctuations of the ground temperature. From October 8 to 11 October 2021, the cumulative precipitation continued to rise in the rainy period, with an average rain intensity of 30.2 mm/d. The rainfall was also intensive from 17 February to 20 February 2022, and these two periods were continuous heavy rainfall periods. During these two periods, the soil pressure and surface temperature increased and decreased, respectively. The precipitation was the direct cause of the significant change in GNSS displacement of the expansive soil slope.

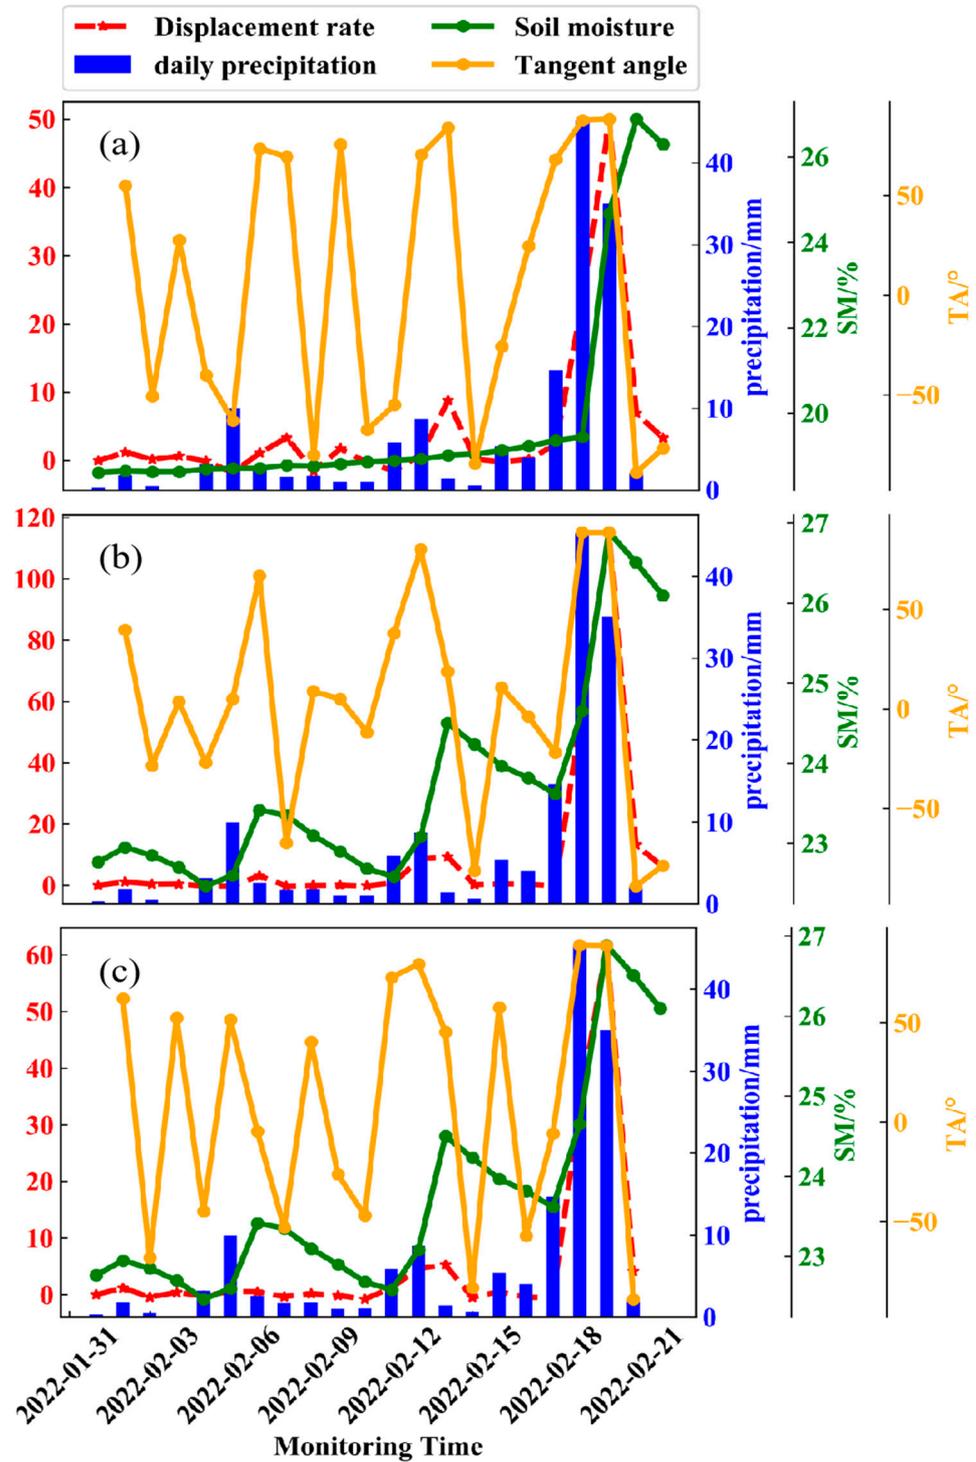
Figure 18. GNSS warning parameters and multi-source monitoring data changes during the second instability periods: (a) NN06; (b) NN07; (c) NN08.

Taking the second failure as an example, the multi-source monitoring parameters are shown in Figure 18. Before 17 February 2022, the average daily rainfall was 2.93 mm, which was in a dry period, and the displacement rate remained stable. A heavy rainfall event was occurred on 17 February to 20 February 2022, with an average daily rainfall of 31.62 mm. During the rainy period, the GNSS displacement rate increased significantly at three stations. During this stage, the GNSS displacement was accelerated, and the tangent angle showed a monotonous increase. On 22 February 2022, the slope returned to stability, and soil moisture content and soil pressure showed a sudden change at same time. The monitored values of the soil moisture content near NN06 and NN07 increased by 6.88% and 3.68%, respectively. It is worth noting that small rainfall events around 13 February 2022 also caused a small increase in the ground deformation rates at NN07 and NN08, but it did not exceed the warning threshold. The nearby soil moisture content phased increased, and the GNSS tangential angle also shortly exceeded  $85^\circ$ , showing a characteristic of highly consistent change. Soil pressure, moisture content, rainfall, displacement rate, and GNSS tangential angle showed an obvious time response, and the correlation coefficient was 0.9 (strong correlation). There was a lag effect between GNSS displacement rate and rainfall, and the lag time was about 1 d.

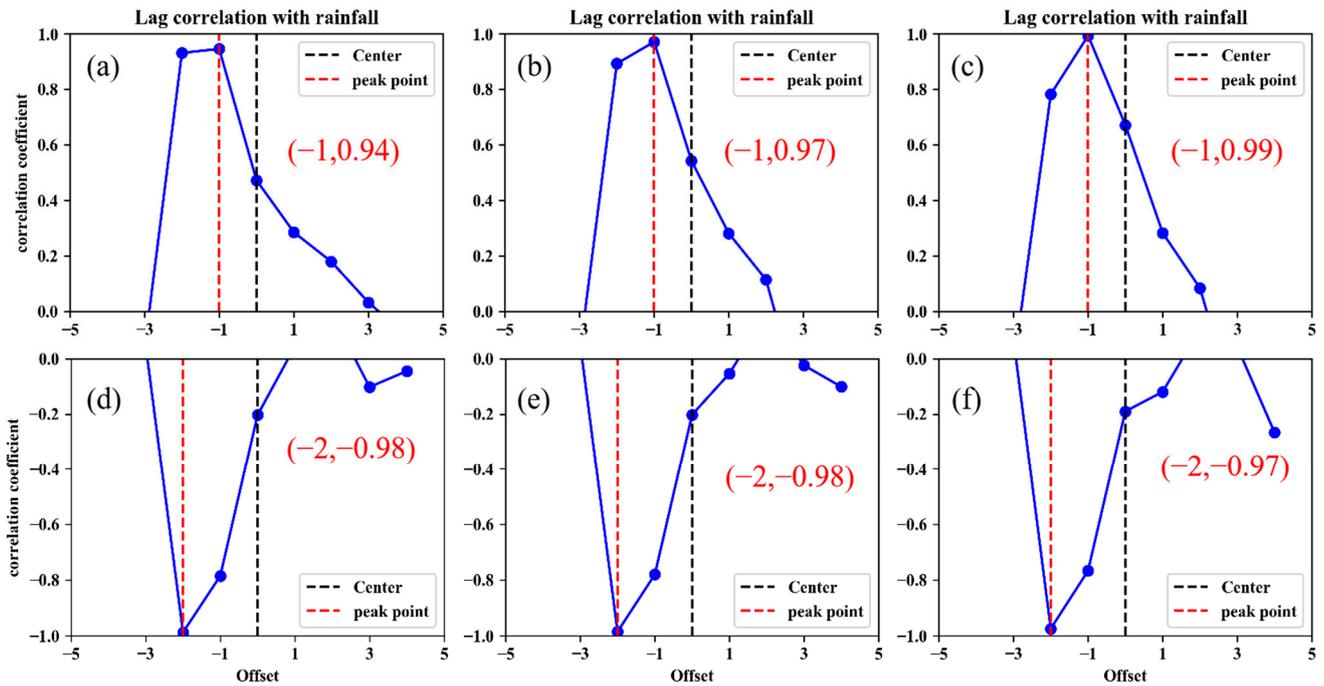
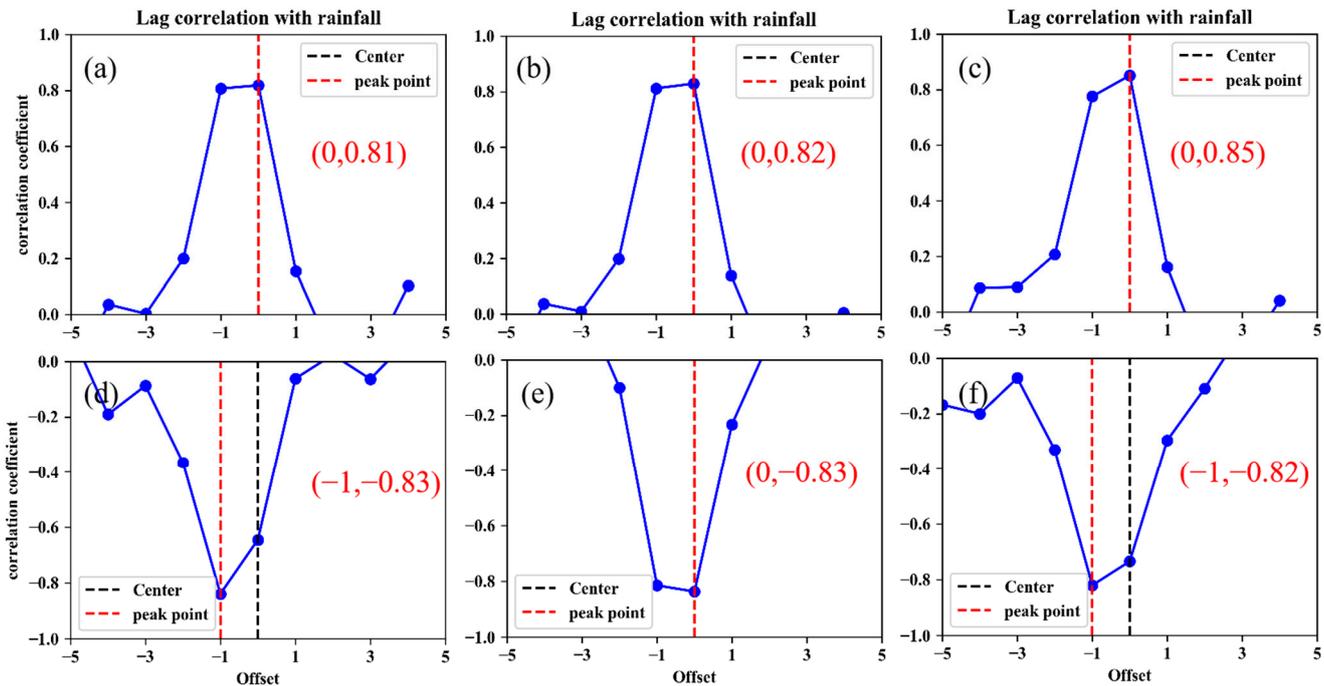
Figures 19 and 20 show the lag correlation curves of displacement rate and rainfall during the first and second instability, respectively: (a), (b), and (c) are the horizontal direction; (d), (e), and (f) are the vertical direction; each column represents NN06, NN07, and NN08; the horizontal axis represents the offset time (d); the negative number represents the lag time; and the positive number represents the advance time. It can be seen from the figure that in the first failure, when the lag time of the horizontal and vertical displacement rate and rainfall is 1 d and 2 d respectively, the correlation reaches the extreme value. In the second failure, when the lag time of the horizontal and vertical displacement rate and rainfall is 0 d and 1 d, respectively, the correlation reaches the extreme value. The extreme values of lag correlation and lag time of each point are shown in Table 3. Therefore, the

response time of soil and rainfall is within 3 d, and the horizontal displacement rate is 1 d earlier than the vertical direction for Ningming’s expansive soil demonstration area. This is due to the fact that the lateral expansive force is dominant in expansive soil deformation, and horizontal-direction deformation is more sensitive than that in the vertical direction.

**Figure 19.** Lag correlation between displacement rate and rainfall in the first failure. (a)–(c) are lag correlation between horizontal displacement velocity and rainfall, (d)–(f) are lag correlation between vertical displacement velocity and rainfall.

**Figure 20.** Lag correlation between displacement rate and rainfall in the second failure. (a)–(c) are lag correlation between horizontal displacement velocity and rainfall, (d)–(f) are lag correlation between vertical displacement velocity and rainfall.

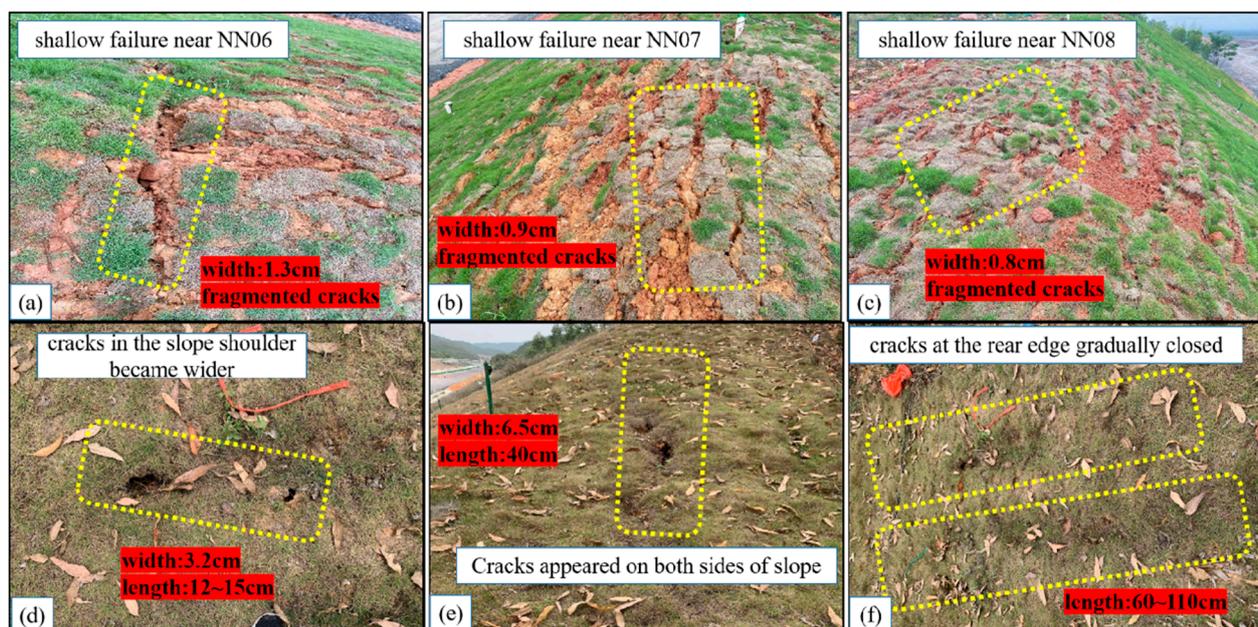
**Figure 21.** Cracks change after the two failure of slope: (a–c) Cracks change after the first failure; (d–f) cracks change after the second failure.

After the slope failure, a site survey of this geological hazard was conducted on 19 February 2022, and the slip direction of the monitoring stations was identical to the GNSS monitoring results. The cumulative displacements of NN06, NN07, and NN08 were 537.61, 430.92, and 284.90 mm, respectively. Most deformed parts were located on the slope shoulders, as the terrain of this area is relatively gentle. The soil showed fragmentation and slight settlement but without overall slide. The detailed fractures near the monitoring stations after the first instability are shown in Figure 21. The yellow areas in Figure 21a–c are fractures distributed by shallow instability, and the fissures of fracture closure were not obvious. The average widths near NN06, NN07, and NN08 were 1.3, 0.9, and 0.8 cm, respectively.

After the second instability, the depth of the fissures on both sides of the slope and its shoulder were increased (see Figure 21d,e), and the average width and length were 3.2 and 6.5 cm and 13 and 40 cm. Many cracks at the trailing edge of the slope are gradually closed, which are shown in Figure 21f, indicating that the significant deformation of GNSS

not only has a time–response relationship with multi-source data but also has a consistent spatial-matching feature with the development of cracks in the slope. Most expansive soil slopes in the Ningming Basin were gently expansive soil slopes. The characteristics of fissures and shallow layers were the main factors for the instability risk of gentle slopes. Several pieces of GNSS monitoring equipment were scientifically deployed in the area where the main cracks developed, as they could monitor the shallow deformation of the slope in real time, providing a data basis for early warning. In addition, with the increasing demand for modern disaster monitoring, low-cost GNSS acquisition of real-time high-accuracy shallow deformation and main slip direction will be conducive to large-scale monitoring and warning of expansive soil disasters. The early-warning model based only on one single GNSS displacement and its derived parameters could preliminarily judge the deformation stage of the landslide mass and successfully forewarned slope failure twice. Both instantaneity and efficiency are considered in this model, which can provide a certain reference for other fields of expansive soil hazards.
