Article

Mapping and Pre- and Post-Failure Analyses of the April 2019 Kantutani Landslide in La Paz, Bolivia, Using Synthetic Aperture Radar Data

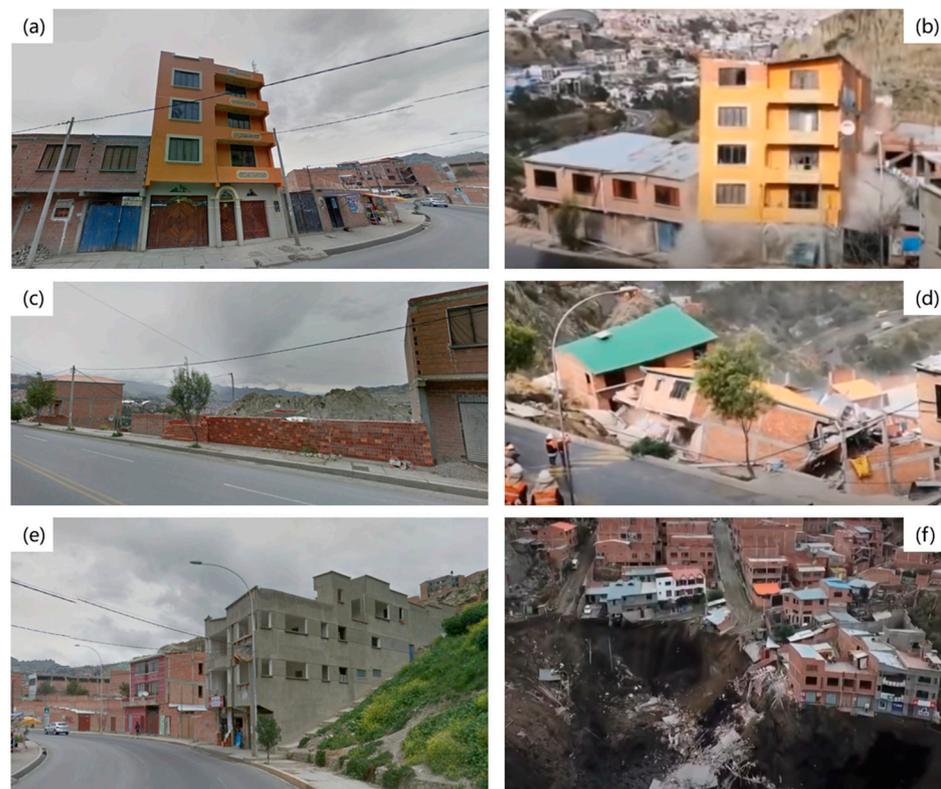
Figure 11. Screenshots taken from Google Maps Street View on the Puente Libertad Road and social media that represent the overload of the landfill caused by the construction work from March 2015 to April 2019. (a) refers to a 3-level building in 2015, and (b) refers to the collapsing building during the landslide. The building had 4 levels in 2019 compared to 3 levels in 2015. (c) refers to a brick wall and according to (d), the former brick wall had been replaced with a building and it collapsed with the two-level building on the left of the picture during the landslide. (e) refers to an unfinished building in 2015 and in (f) the construction had been finished in 2019.

Using Google Maps Street View images collected in March 2015 (Figure 11a,c,e) and pictures of the landslide from social media (Figure 11b,d,f), construction work on houses near the backscarp of the landslide continued over the years. Such activities increased the

mass of the slope and played a long-term role in triggering the landslide. Figure 12a–g are screenshots taken from Google Maps Street View and Figure 12h–k are images taken of houses nearby the Kantutani area after the landslide by onsite geologists from GAMLP. Figures 12a–g and 12h–k show cracks in the walls and roads and of the landslide-affected area, and Figure 12g shows the lack of a well-planned underground drainage system for the site. (l) indicates the locations where Figure 12a–g were taken. Because of privacy reasons, the locations of Figure 12h–k are not presented in this work.

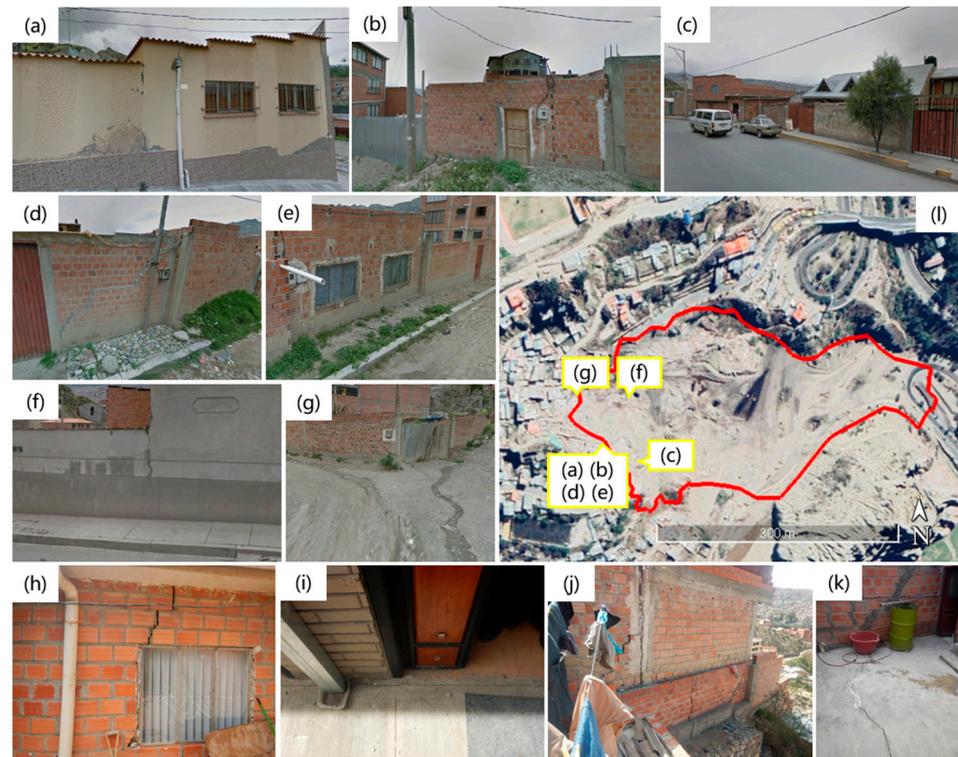
Figure 12. Screenshots taken from Google Maps Street View: (l) the locations of (a–g). The locations where (h–k) were taken are not presented because of privacy issues.
