Breach Progression Observation in Rockfill Dam Models Using Photogrammetry

Geir Helge Kiplesund *, Fjola Gudrun Sigtryggisdottir and Leif Lia

Department of Civil and Environmental Engineering, Norwegian University of Science and Technology, 7491 Trondheim, Norway

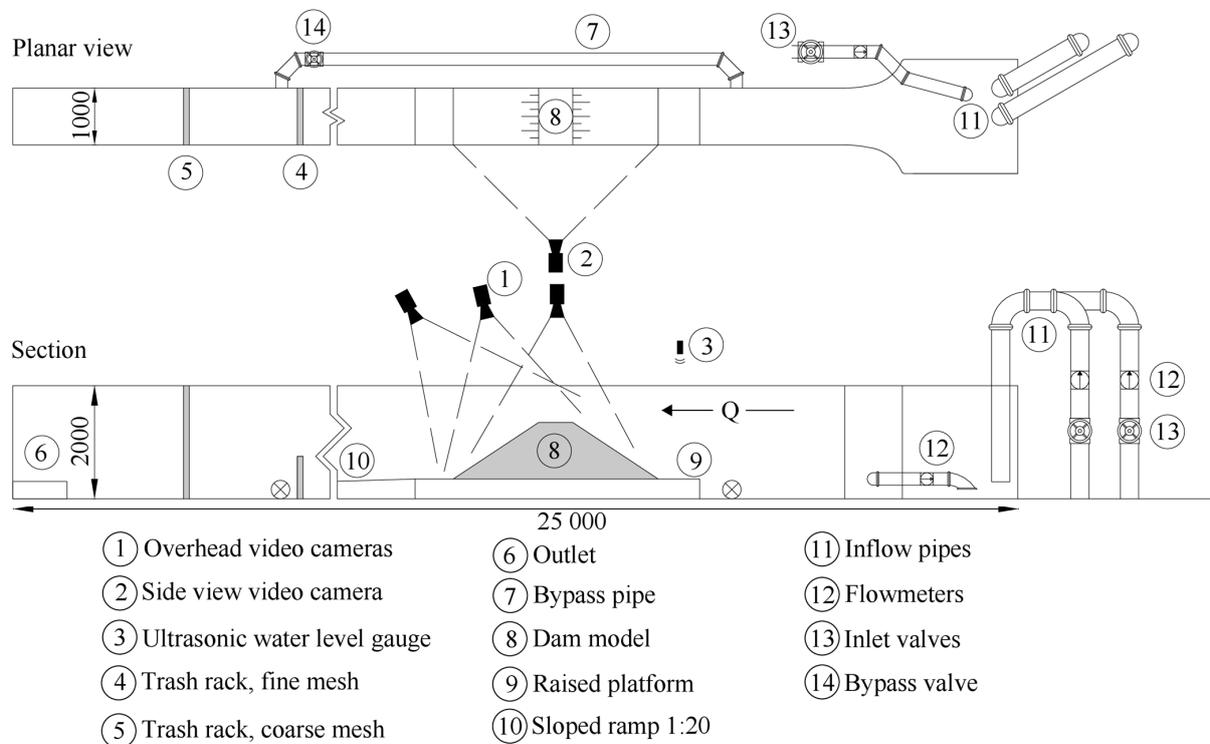
Figure 1. Hydraulic flume at NTNU (units in mm) flow from right to left.

The physical model tests described here are the continuation of a long series of laboratory investigations into the stability of riprap and/or rockfill dams subjected to overtopping, continuously ongoing since 2013. For this reason, the model scale was decided to be unchanged from previous models tested in the same facility (Figure 1) to facilitate the comparison of results from the different tests. The choice of scale and other design principles for the series of tests is discussed in [23]. The size of the model is primarily determined by the dimensions of the testing facility. The model is a conceptual model of a rockfill dam. The model design considers the typical geometry of rockfill dams currently being built. The model is constructed at a scale of 1:10 assuming Froude similarity. The model was designed to be tested both with and without an impermeable core. The model tests of the present study are listed in Table 1. In addition, there were three trial tests

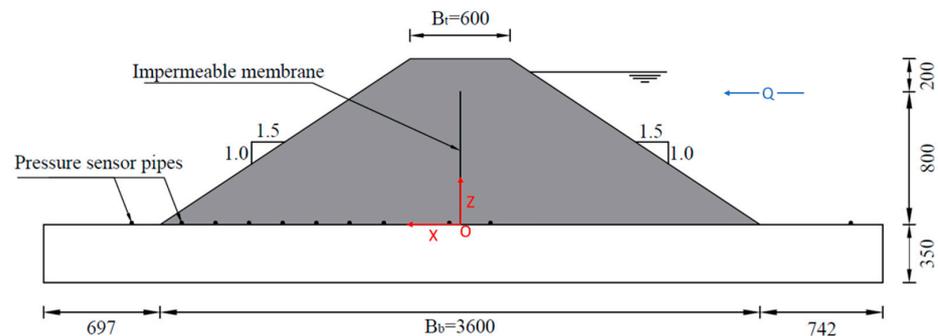
Figure 2. Model setup including core and axis system (units in mm) Y-axis out of paper plane.

The dam model (Figure 2) has a height $H_d = 1$ m, bottom width $B_b = 3.6$ m, top width $B_t = 0.6$ m and transverse length $L_d = 1$ m, which is equal to the flume width (Figure 1). The upstream and downstream slopes were chosen at $Z_{dss} = Z_{uss} = 1.5$ (1.5H:1V), which is a common slope when building with rockfill with an angle of repose around 45° .

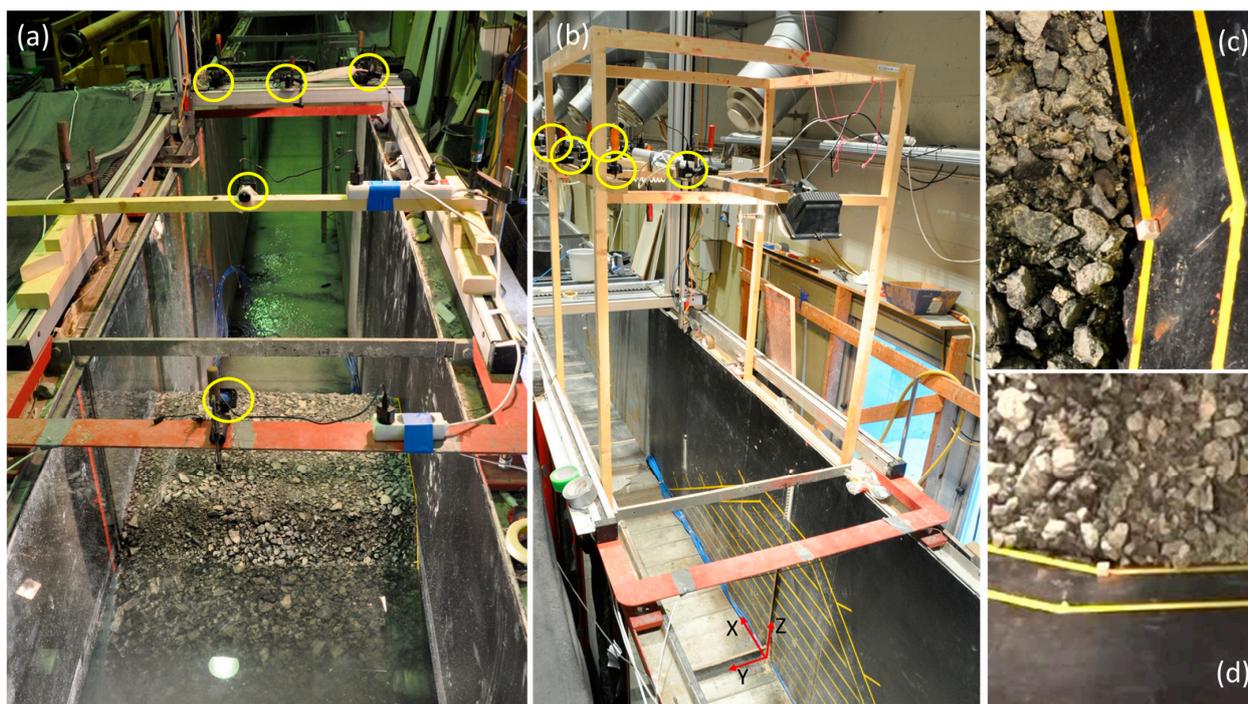
Figure 3. Camera rig setups (a) Model U1-U3 (b) Model U4-H3, camera locations indicated by yellow circles, coordinate system definition shown on (b) with red arrows and axis labels (c) shows DSLR image of a GCP cube (d) shows video frame of the same GCP cube.

The coordinate system defined for these tests was a right-handed cartesian X-Y-Z coordinate system with its origin at the base of the dam, at the right-hand end of the centre line seen in the direction of flow. Figure 2 shows the X and Z axes, and Figure 3b shows all the axes.

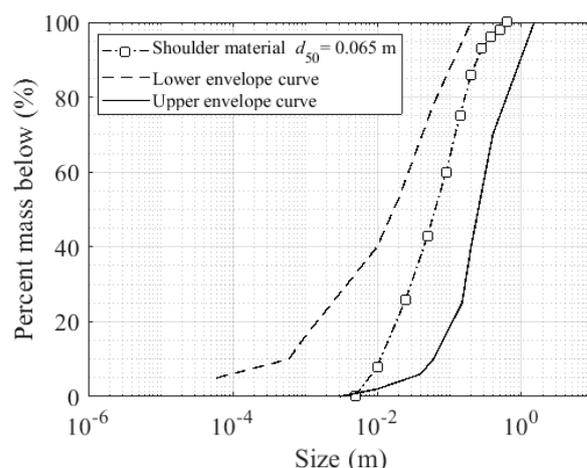
Figure 4. Grain size distribution enveloping curves from dam database and for chosen shell material (scaled up 10:1 to prototype scale) previously presented in [26].

As can be seen from Figure 4, the gradation is biased towards the coarser range of the curves found in the database, and all particles smaller than 0.5 mm were washed out of the final mix. This was performed due to restrictions on materials used in the flume to protect the pump system in the laboratory. The gradation curve is also evaluated against filter criteria recommendations as described by NVE and USDA [25,32], and further details on these calculations can be found in [26]. The material was produced by mixing appropriate amounts of various commercially available crushed rock gradations to obtain the desired gradation curve. The total mass of the rockfill shell for these models was 4500 kg.

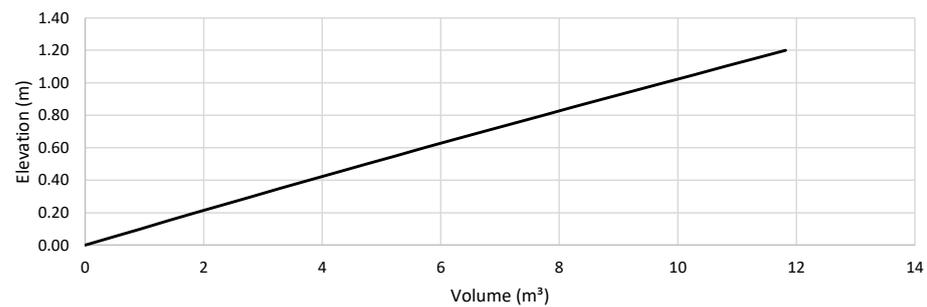
Figure 5. Reservoir curve for model tests.

Breach outflow also includes a very small amount of leakage flow, which is, however, insignificant compared to the breach outflow. The volume change (ΔV) was derived from a reservoir curve (Figure 5) developed for these models based on a detailed 3D model of the upstream part of the flume. To facilitate a precise estimate of leakage flows, the reservoir curve also accounts for the pore volume in the upstream half of the dam model based on the measured porosity of the supporting fill material. This calculation was based on an idealised geometry of the dam and does not account for any minor construction deviations from the desired geometry in the individual model dams.

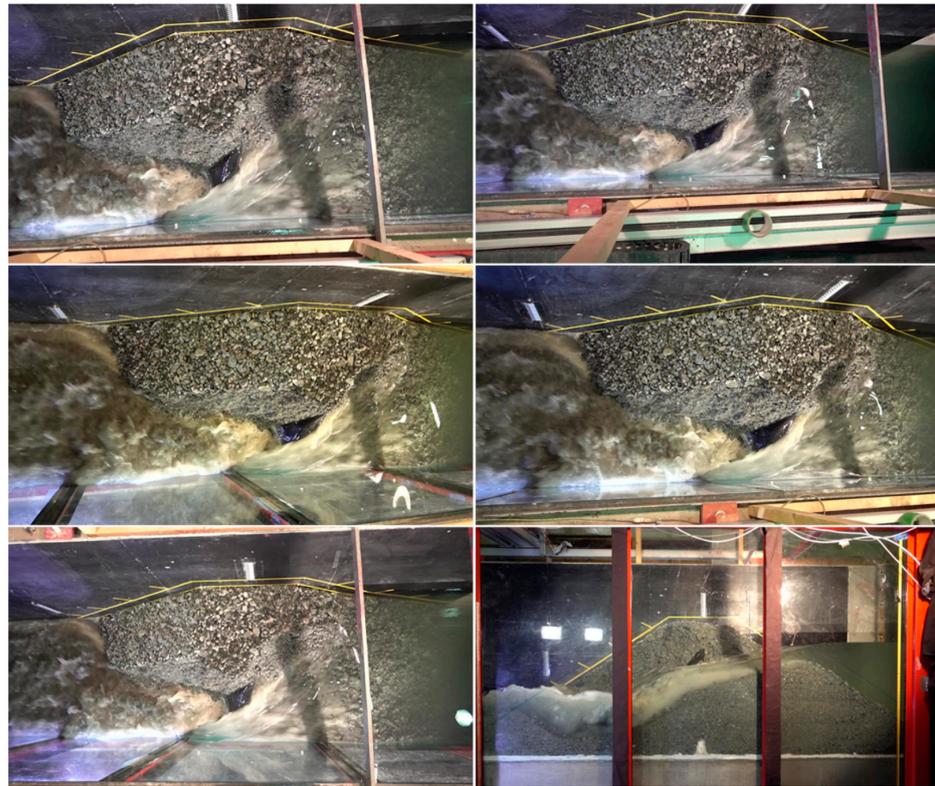
Figure 6. Example set of synchronised images from test U4—3170 s from start of test.

Figure 6 shows an example of six images of test U4 extracted at 3170 s after start of test, 470 s from start of synchronised video sequence. A detailed inspection of the images will reveal some small differences in the water surface due to small timing offsets since the synchronisation is not hardware based but rather by post processing; the solid surface, however, is unchanged.

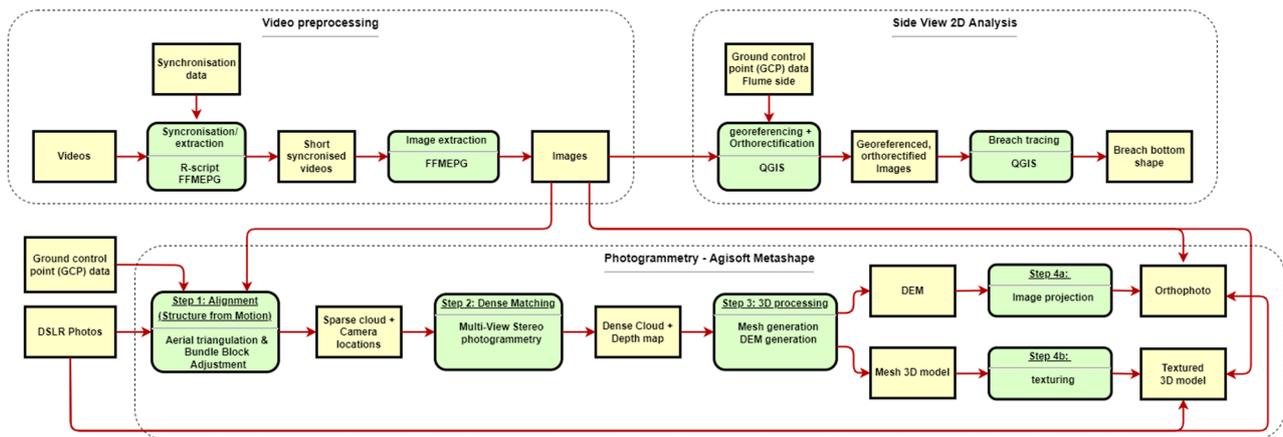
Figure 7. Photogrammetry and image analysis workflow.

(1) Step 1 in the Agisoft analysis, the alignment step, requires the images from the video pre-processing, as well as ground control points (GCP) data and DSLR photos. In this step, areas of the images can be masked out to prevent it from being processed; this was considered here for masking water surfaces but was in the end skipped since it would require significant work adjusting the masks as the breach opens up. Moreover, the main focus of the present study is to identify changes in the dam surface, and hence, accurate surface measurement of the water is not of direct interest. The alignment step consists of what is termed bundle block adjustment. Here, the software searches for recognisable features in the images and tries to match these between images; the resulting feature matches are referred to as tie points in the software. In this step, the position of each camera is determined, and camera calibration parameters are refined. The camera calibration parameters can also be found initially by photographing a calibration pattern displayed on a screen. This is not a prerequisite for running the analysis, but a pre-calibration was performed in this case. The output from this stage is a sparse point cloud and camera positions. The sparse point clouds typically had 30,000 to 100,000 points for the start and end models, and the dynamic models had around 3000 to 8000 points. (2) The second step of the process produces a dense point cloud and a depth map based on the output of the first step. The dense point clouds for the start and end models were in the range of 7 to 50 million points, and the dynamic models typically had around 800,000 points. (3) A three-dimensional surface can be generated in the form of a 3D mesh or a digital elevation model (DEM) based on the output of the previous step. This is the primary output used for this research. (4) A further step of processing is also possible with the generation of either (4a) an orthomosaic by projecting the photos or video images to represent the model seen from directly above or (4b) a textured 3D model with the images draped onto the 3D mesh.

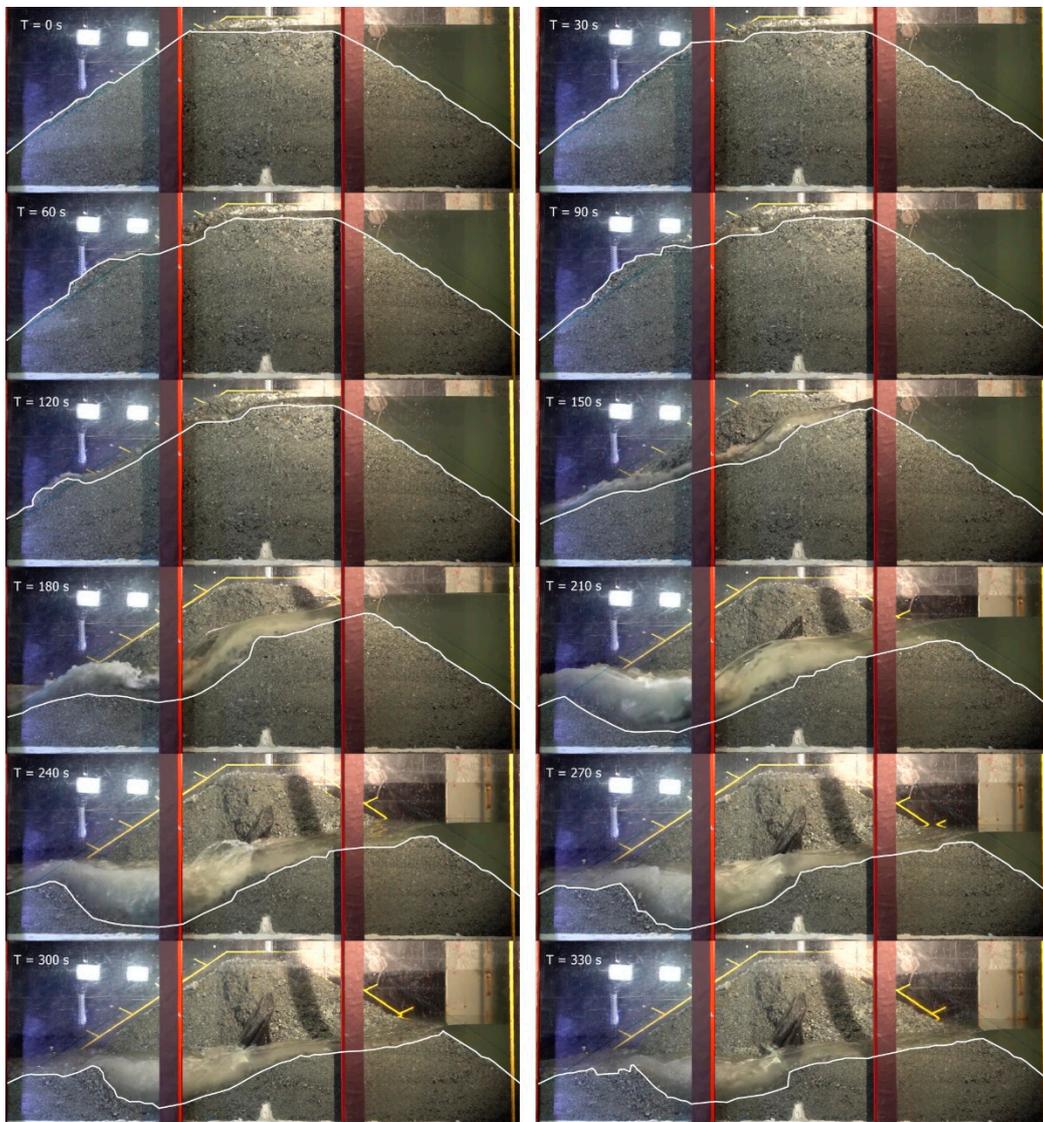
Figure 8. Side-view tracking of breach progression of model U4 (central core); direction of flow is **right to left**; white line indicates traced solid surface.

Figure 8 shows the breach progression as seen through the side window for model U4, while Figure 9 shows the same for model H1. As previously described, $T = 0$ s is defined as the last 5 s frame before erosion can be visibly observed from the side. The side-view track clearly shows the erosion process described above for these two tests of models with and without a core.

The vertical erosion development was tracked for several sections of the side-view in Figure 8 and throughout the breaching process of test U4. Figure 10 shows a plot of breach bottom elevation (the y elevation) versus time at four different locations along the flume, $X = -0.5$ (upstream), $X = 0$ (centre line), $X = 0.5$ (downstream) and $X = 1.0$ (downstream).

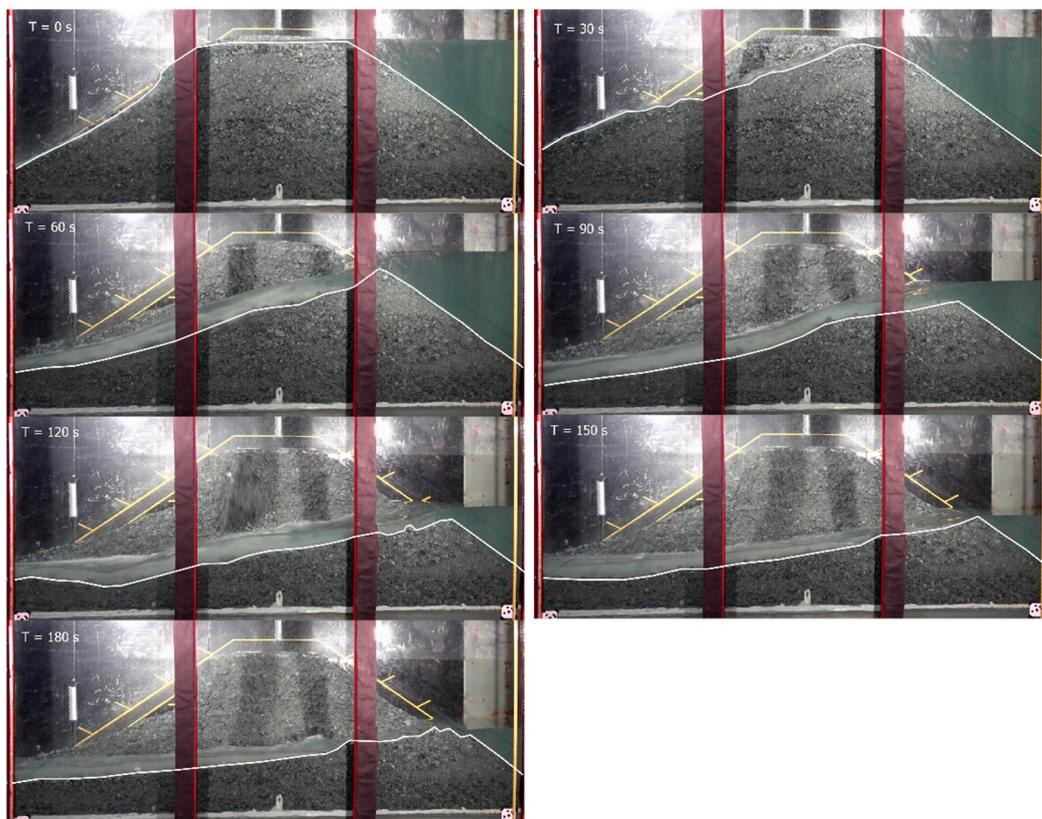
Figure 9. Side-view tracking of breach progression of model H1 (no core); direction of flow is **right to left**; white line indicates traced solid surface.

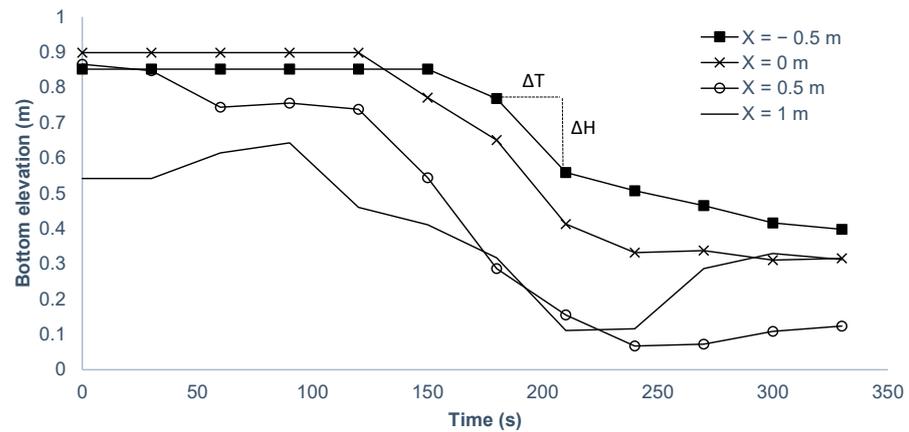
Figure 10. Vertical breach development model U4 (central core). The bottom elevation on the vertical axis is the Z coordinate from the DEM.

Looking at breach development in the centreline, $X = 0\text{ m}$, in Figure 10, we can see that the breach bottom stays at 0.9 m for two minutes, while the breach is developing (by surface erosion and slides) as described from visual observations in the downstream end of the pilot channel and on the downstream slope. This can be observed in $X = 0.5\text{ m}$ on the slope just downstream of the pilot channel. Further downstream, at $X = 1.0\text{ m}$, there is an increase in elevation due to slides from the top of the slope building up material here.

where ΔH is the vertical difference in dam slope surface (eroded surface) within time step ΔT (see Figure 10).

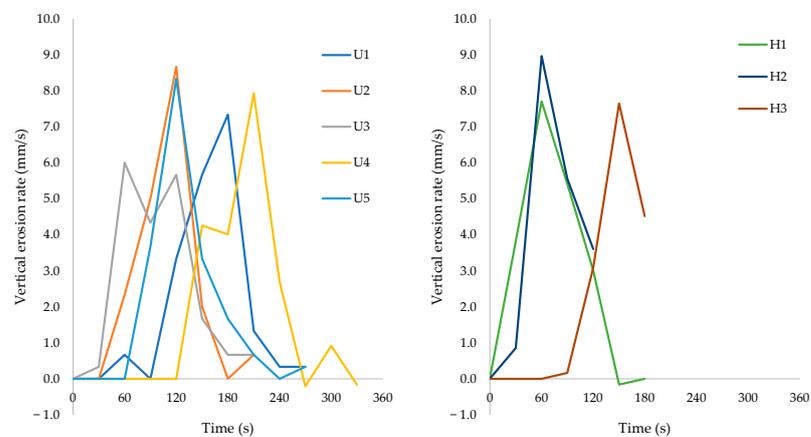
Figure 11. Vertical breach erosion rate E_v at $X = 0\text{ m}$ from traced side-view profiles (mm/s).

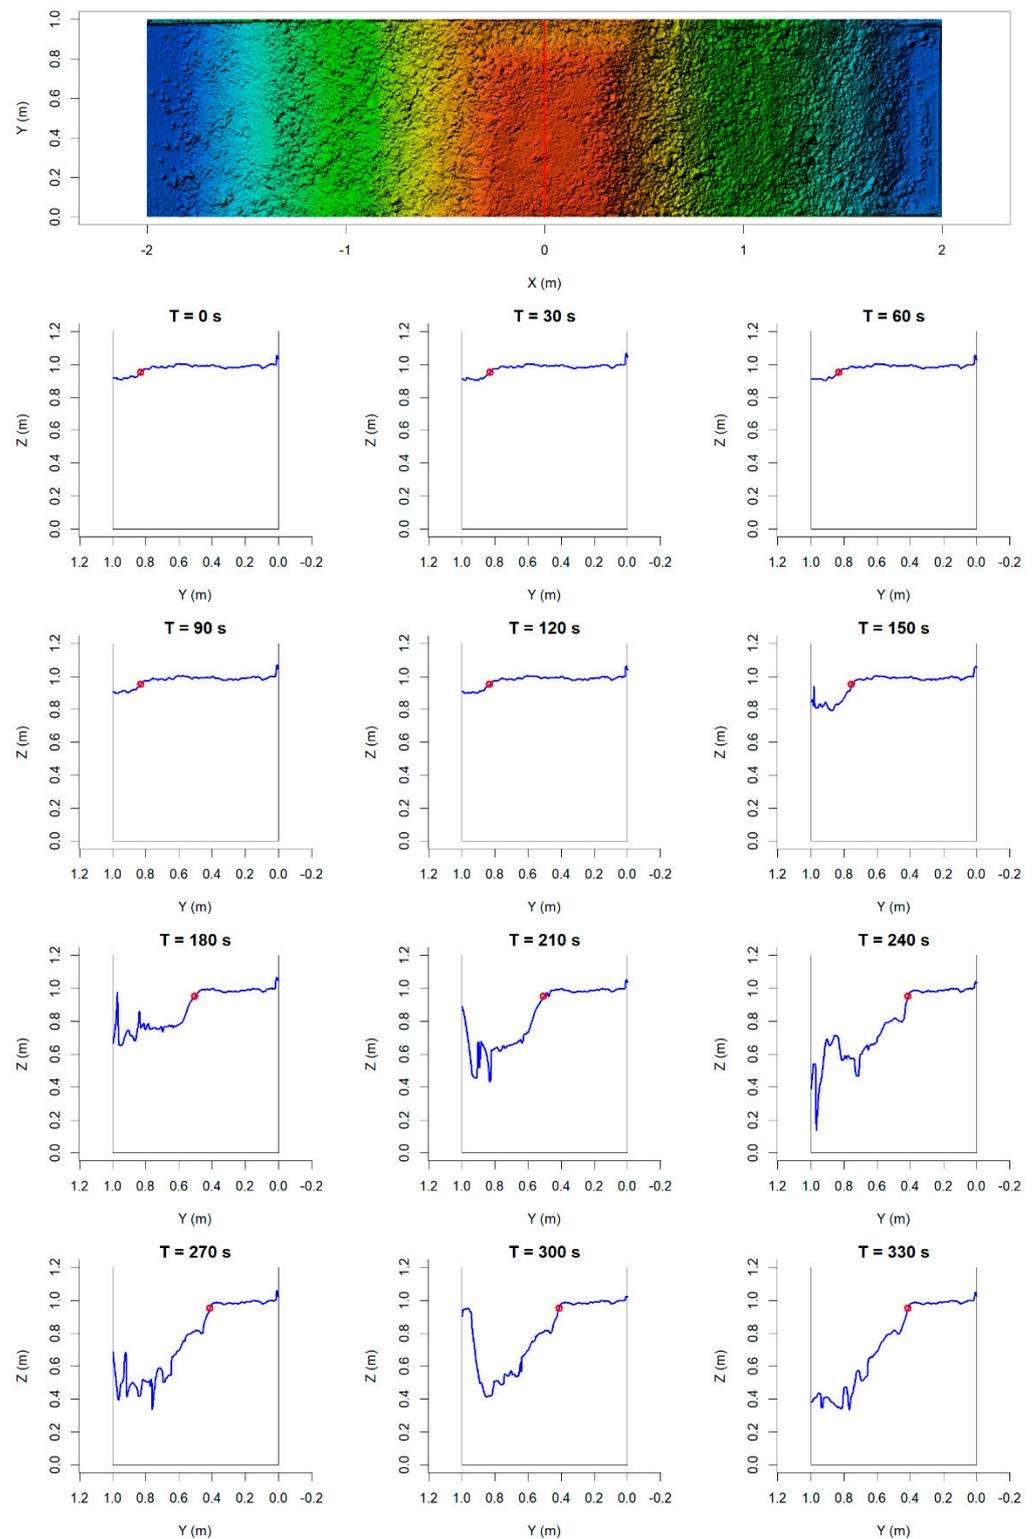
Figure 12. Cross-section profiles for $X = 0$ m (centre line) extracted from U4 (central core) dynamic 3D model; $T = 0$ s is immediately before initially observed erosion at the downstream edge of the crest; red circle indicates breach edge as used in further analyses.

A clear pattern can be noted from joint observation of the breach edge in Figure 12 and the breach width in Figure 14. The breach edge moves laterally out from the pilot channel (Figure 12) and the breach width increases (Figure 14). The lateral movement of the breach edge (and widening of the breach) occurs in discrete increments, as seen by the plot of W in Figure 14. Each incremental widening is followed by a fairly steady state during which gradual erosion of the channel bottom occurs. This erosion results in the undercutting of the side slope, which then slides down and increases the breach width further. This erosion process is repeated in discrete events.

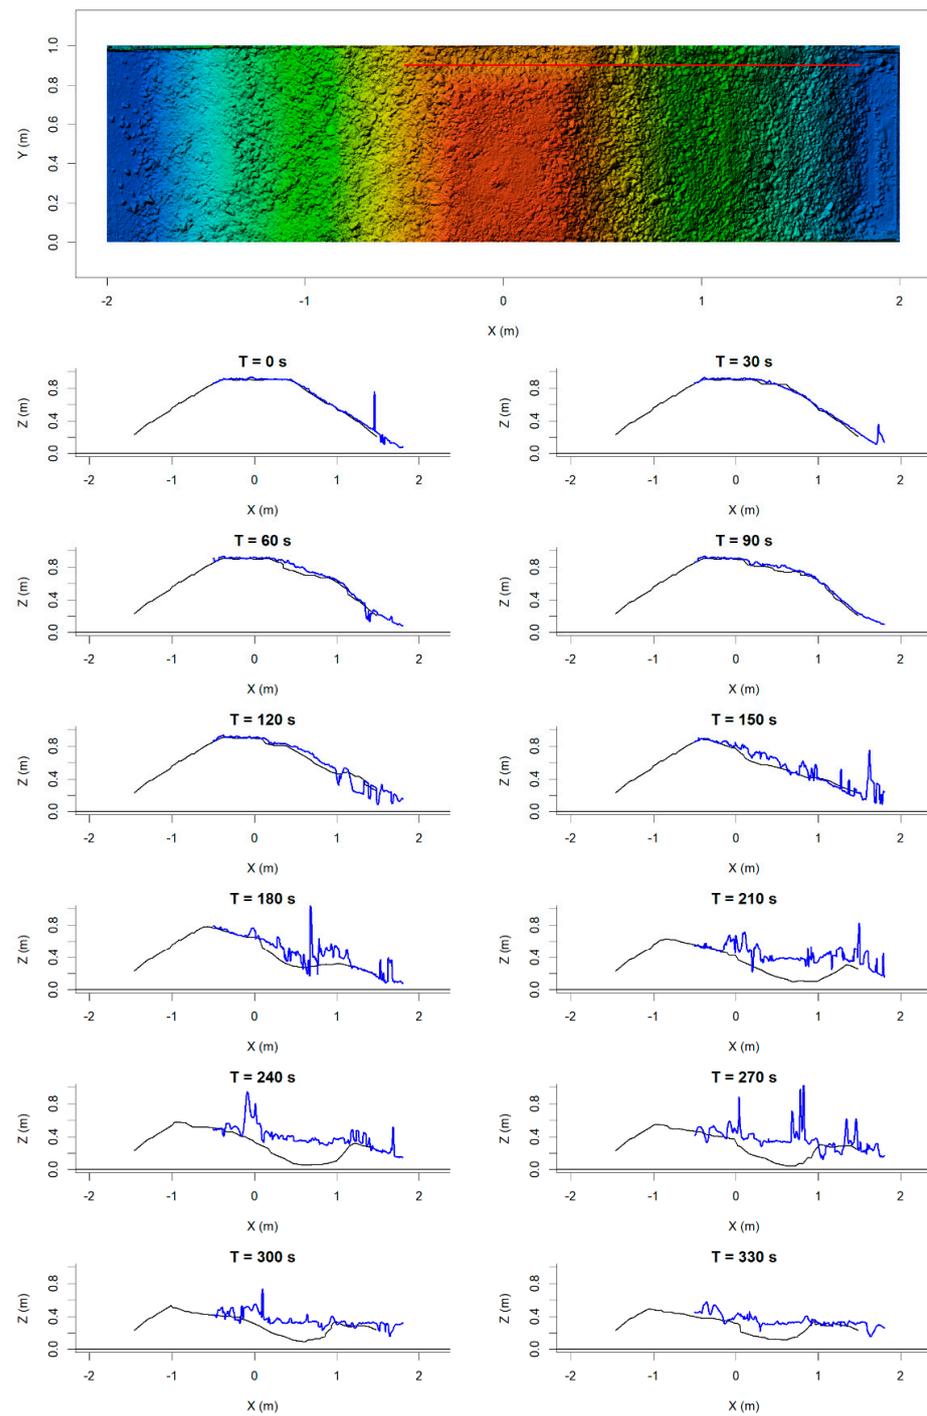
Figure 13. Longitudinal profiles of test U4 from low-resolution dynamic DEM at $Y = 0.9$ m (blue) and side-view tracking (black) throughout the breaching process; direction of flow is **left to right**; $T = 0$ s is last frame before initial observed erosion at downstream end of pilot channel.

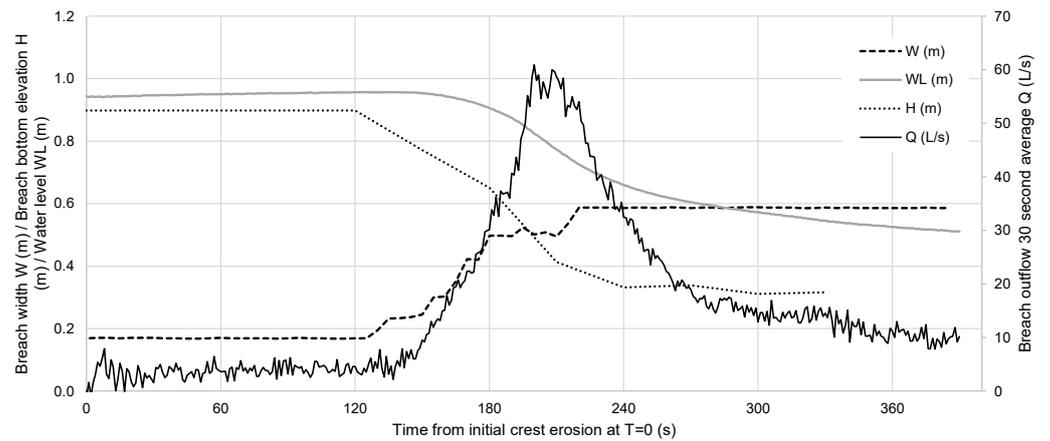
Figure 14. Breach width (W) and breach bottom elevation (H) for model U4 (central core) plotted against breach outflow (Q) and upstream water level (WL).

Figures 14 and 15 below show the lateral and vertical breach development, respectively, for tests U4 and H1 plotted against upstream water level and calculated breach discharge. W is the breach width calculated as the distance between the flume glass wall and the top of the breach edge, H is the Z coordinate of the breach bottom as seen from the side, WL is the measured upstream water level and Q is the calculated breach outflow discharge. Note that breach outflow also includes some leakage flow as well as some flow through the crest above the impermeable core when the water level is above the core level.

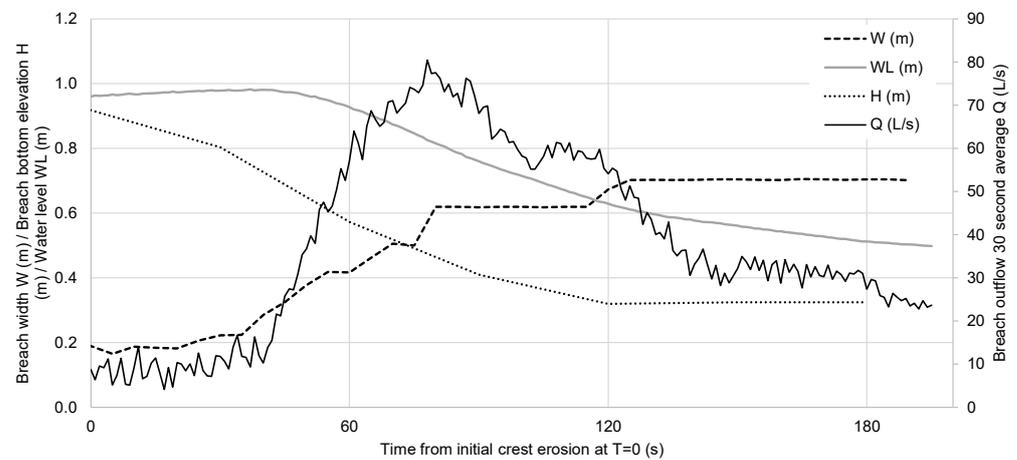
Figure 15. Breach width (W) and breach bottom elevation (H) for model H1 (no core) plotted against breach outflow (Q) and upstream water level (WL).

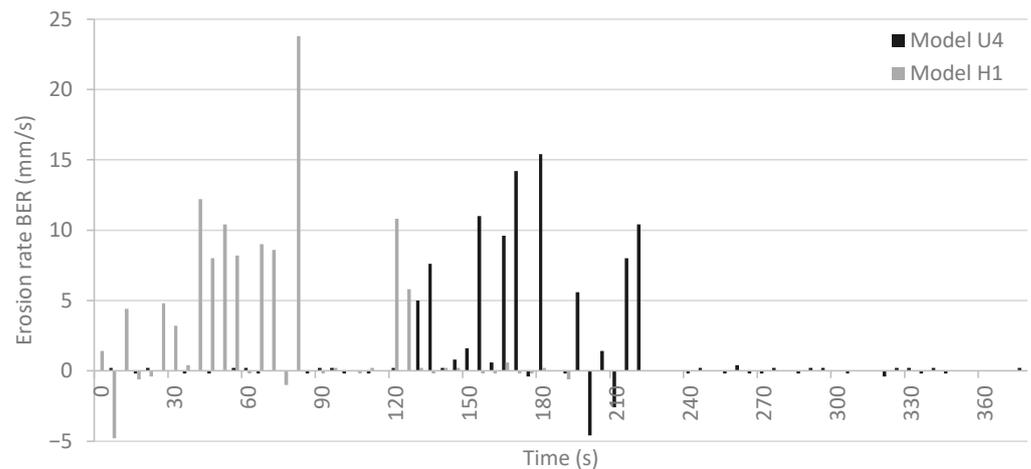
Figure 16. Lateral erosion rates (BER) over 5 s time steps (mm/s) at $X = 0$ m for tests U4 (central core) and H1 (no core).

For all the tests, we have calculated the rate with which the breach opening expands, the lateral erosion rate, for both 5 s and 30 s intervals, as well as the average over the period from the time the breach expands outside the pilot channel until the breach expansion stops. Figure 16 shows the calculated 5 s erosion rates for tests U4 and H1. In some cases, small slides occurred some minutes after the main breaching process was over, and these were not considered part of the main breaching and were not included in the calculation. The breach expansion rate is here defined as $BER = \frac{\Delta W}{\Delta T}$ [mm/s], where ΔW is change in breach width, and ΔT is the length of the time step that the breach width change is calculated for (here, 5 s). In a few time steps, there is a negative erosion rate, which is a result of a poorly resolved 3D model for that time step where the breach opening apparently jumps back; this could be filtered out by using longer time steps for the calculation.

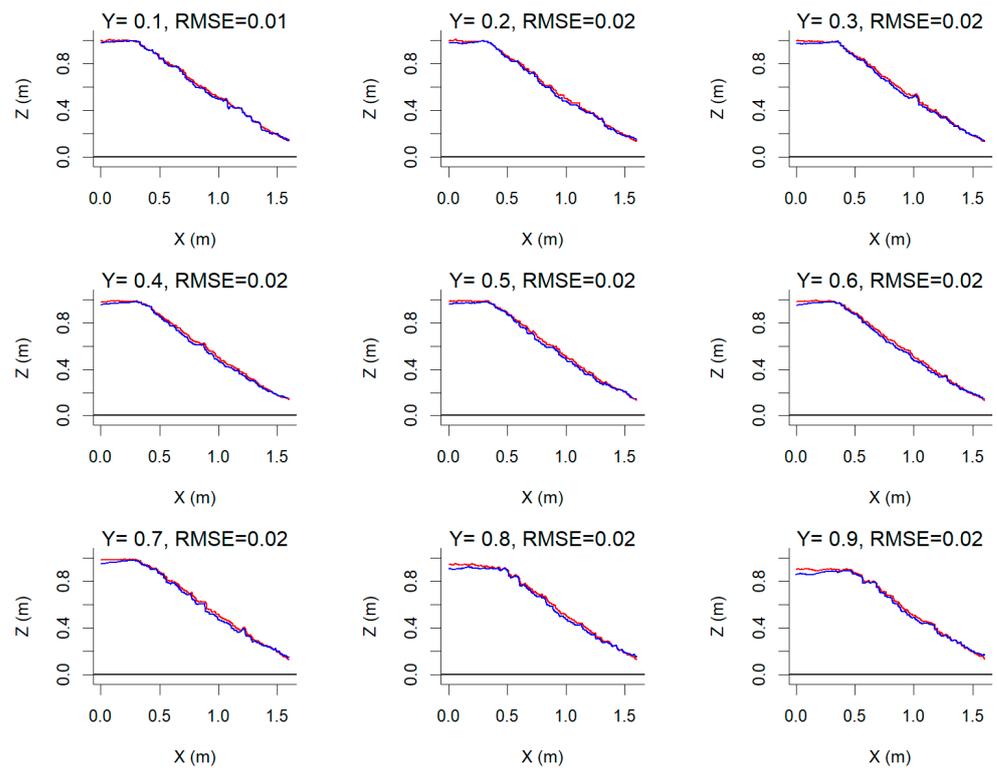
Figure 17. Longitudinal profiles of test U1; high-resolution DEM (red) and low-resolution DEM (blue); nine different profiles, with 0.1 being close to the back wall and 0.9 being near the glass wall (with pilot channel visible); calculated RMSE is shown for each profile.

where n is the number of points, here 1 point per mm, Z_A is dynamic DEM elevation and Z_B is the start DEM elevation. These profiles and the resulting calculated RMSE are shown in Figures 17 and 18 for tests U1 and U4, respectively.

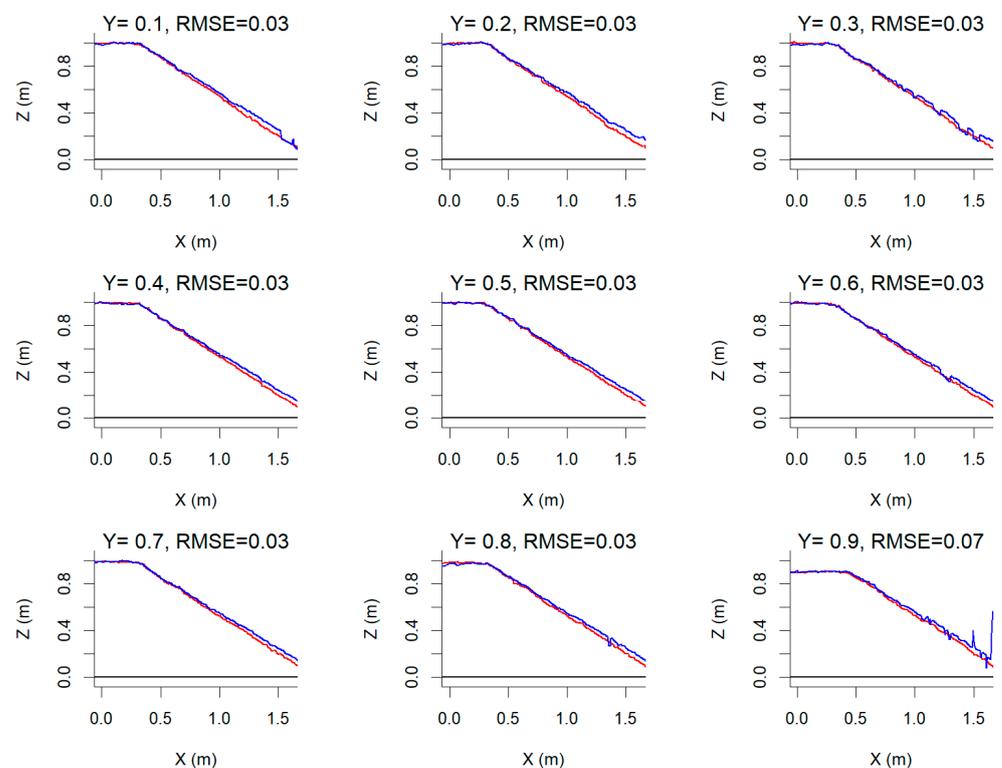
Figure 18. Longitudinal profiles of test U4; high-resolution DEM (red) and low-resolution DEM (blue); nine different profiles, with 0.1 being close to the back wall and 0.9 being near the glass wall (with pilot channel visible); calculated RMSE is shown for each profile.

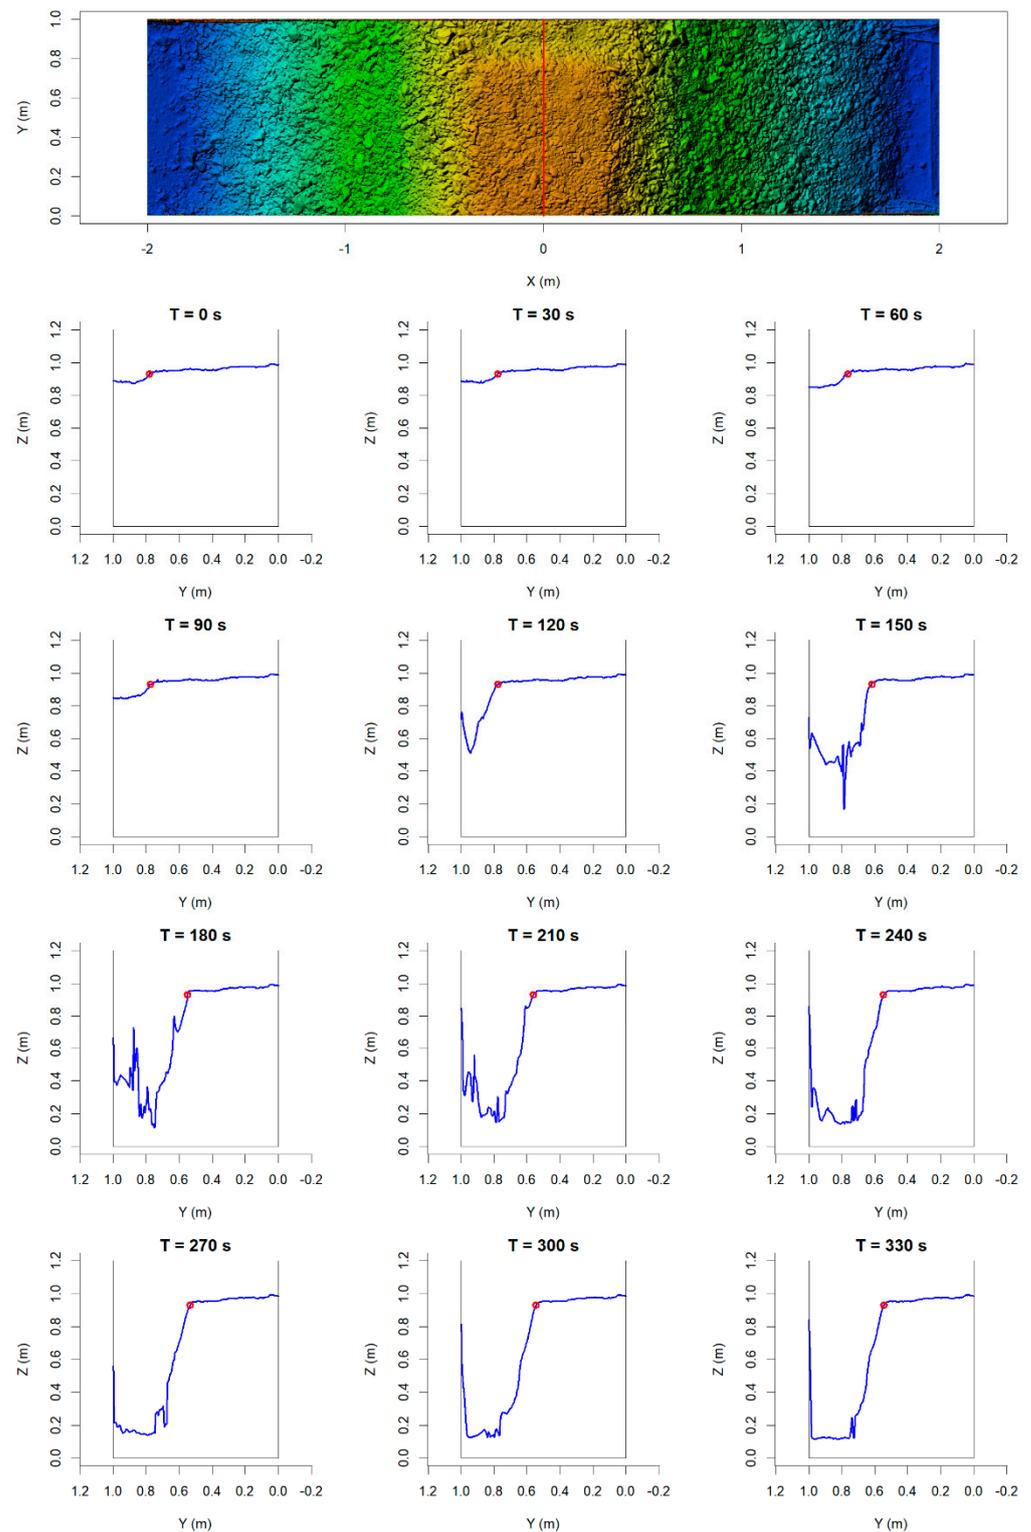
Figure A1. Cross-section profiles for $X = 0$ m (centre line) extracted from U1 dynamic 3D model; $T = 0$ s is immediately before initial observed erosion at downstream edge of crest; red circle indicates breach edge as used in further analyses.

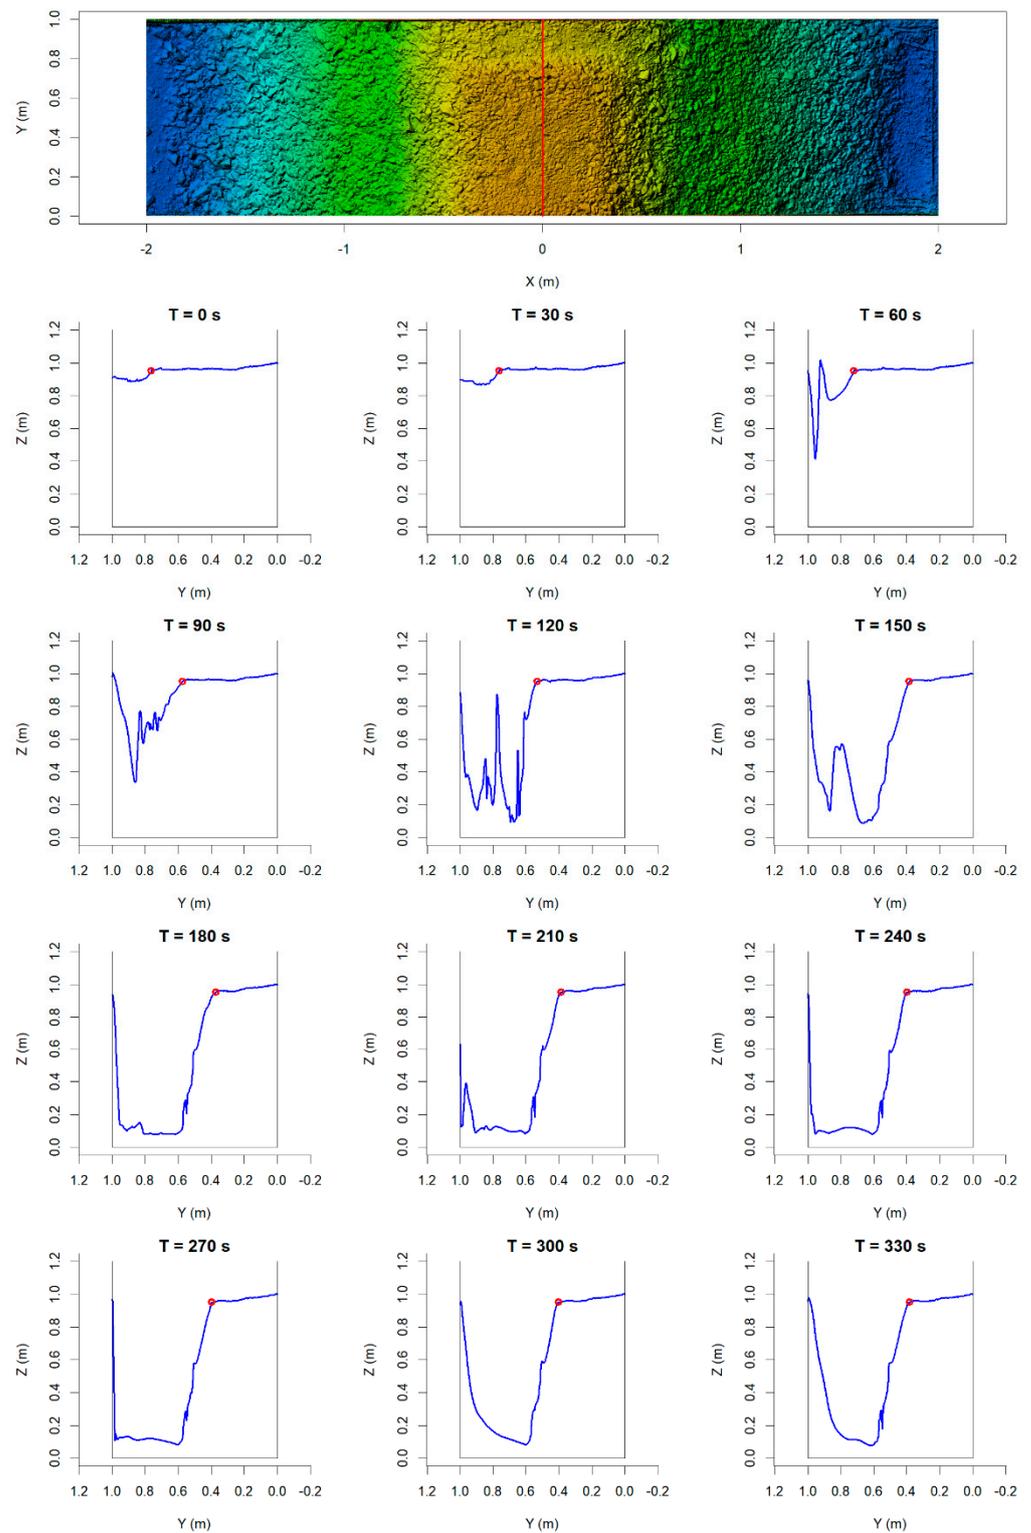
Figure A2. Cross-section profiles for $X = 0$ m (centre line) extracted from U2 dynamic 3D model; $T = 0$ s is immediately before initial observed erosion at downstream edge of crest; red circle indicates breach edge as used in further analyses.

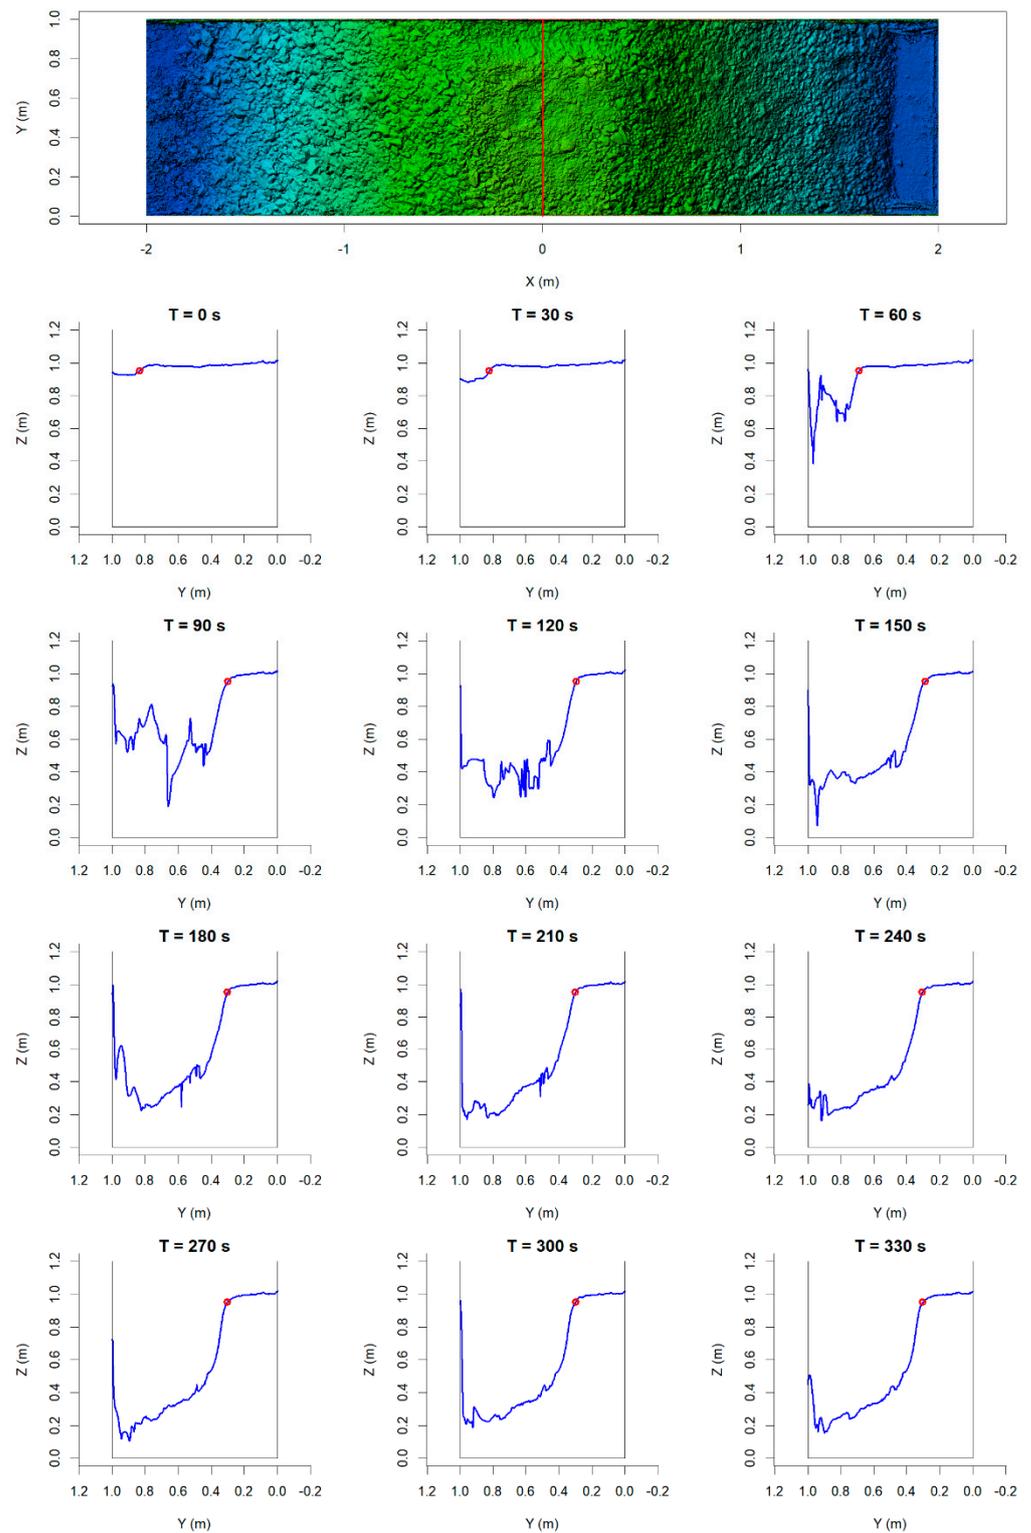
Figure A3. Cross-section profiles for $X = 0$ m (centre line) extracted from U3 dynamic 3D model; $T = 0$ s is immediately before initial observed erosion at downstream edge of crest; red circle indicates breach edge as used in further analyses.

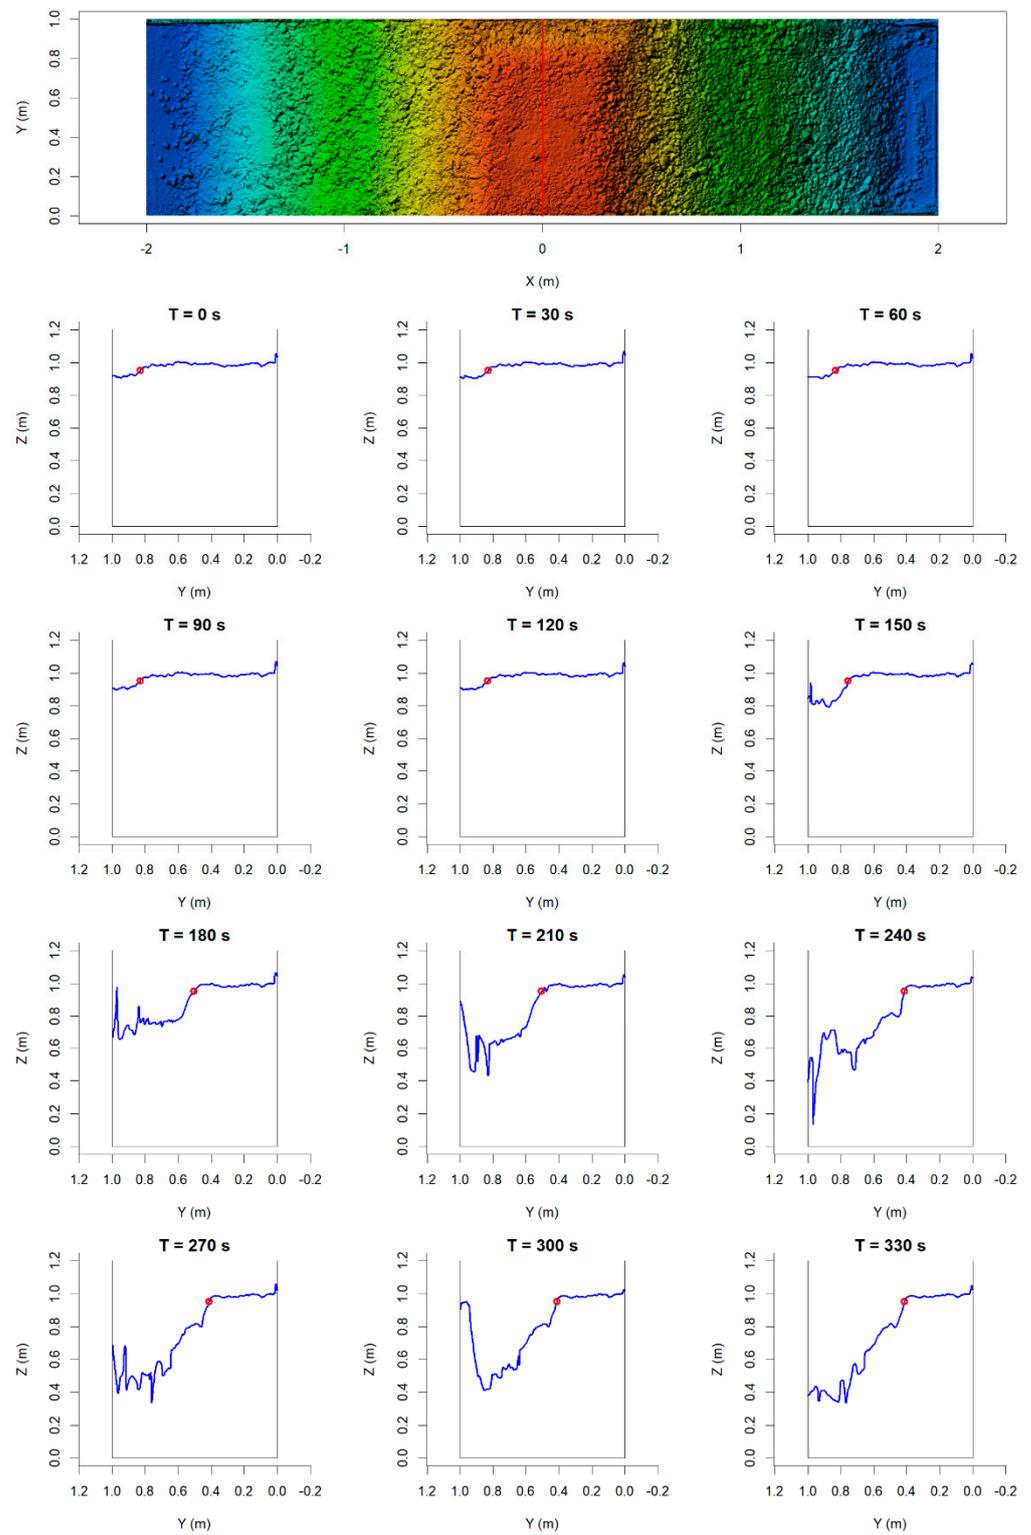
Figure A4. Cross-section profiles for $X = 0$ m (centre line) extracted from U4 dynamic 3D model; $T = 0$ s is immediately before initial observed erosion at downstream edge of crest; red circle indicates breach edge as used in further analyses.
