Breach Progression Observation in Rockfill Dam Models Using Photogrammetry

Geir Helge Kiplesund *, Fjola Gudrun Sigtryggisdottir and Leif Lia

Department of Civil and Environmental Engineering, Norwegian University of Science and Technology, 7491 Trondheim, Norway

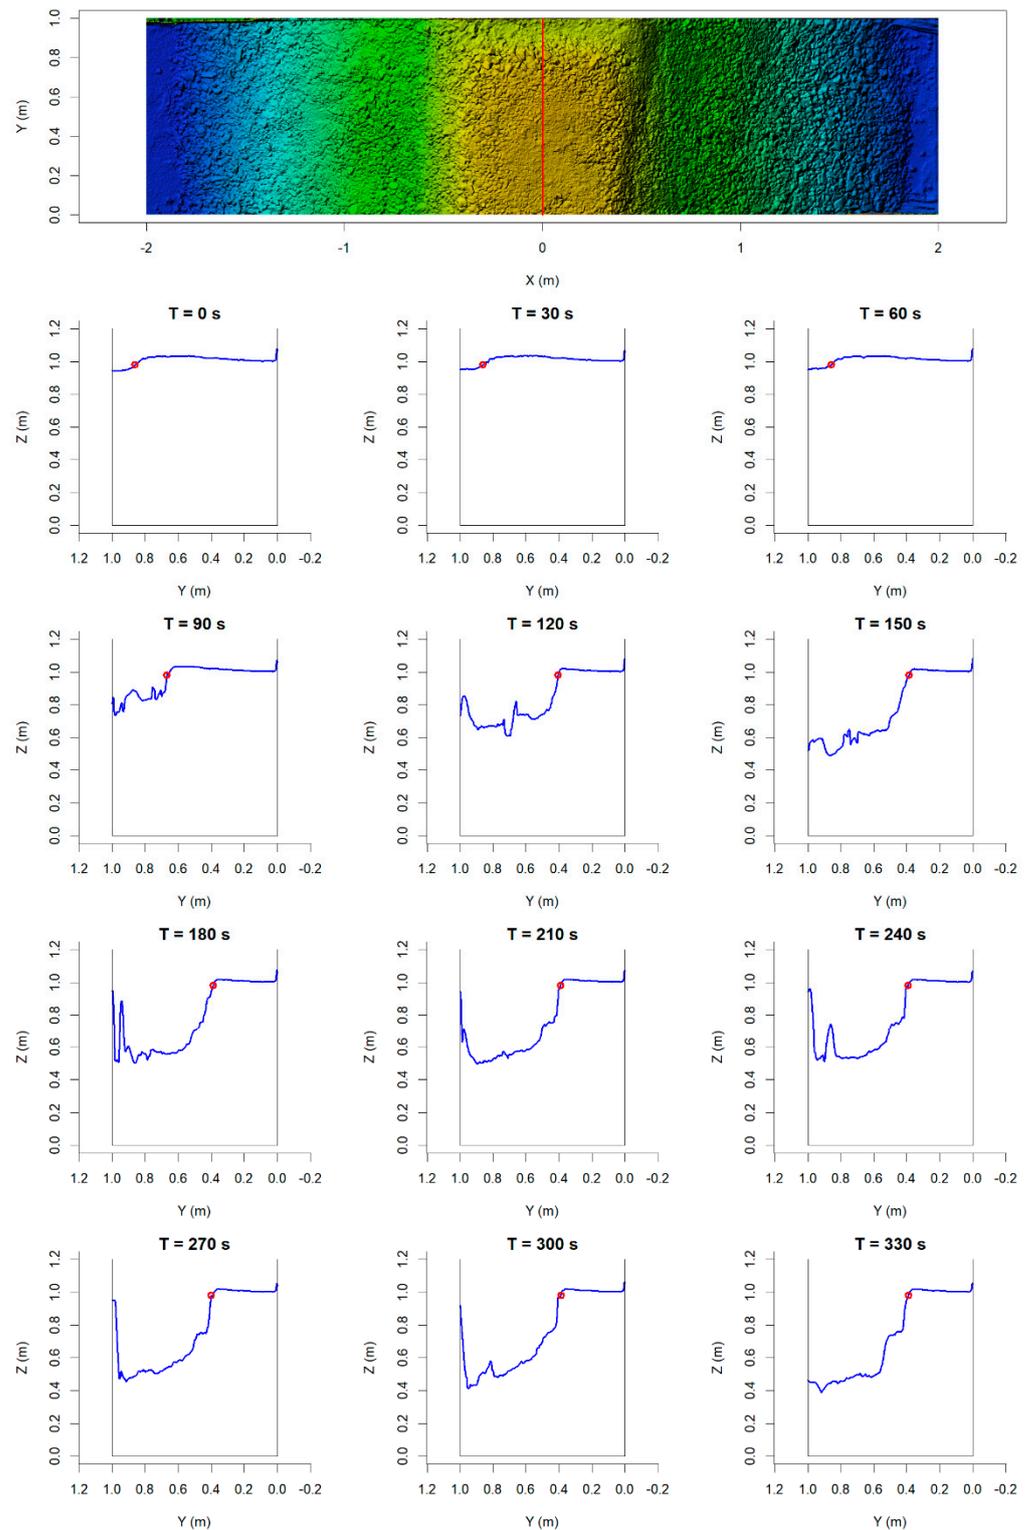
Figure A5. Cross-section profiles for $X = 0$ m (centre line) extracted from U5 dynamic 3D model; $T = 0$ s is immediately before initial observed erosion at downstream edge of crest; red circle indicates breach edge as used in further analyses.

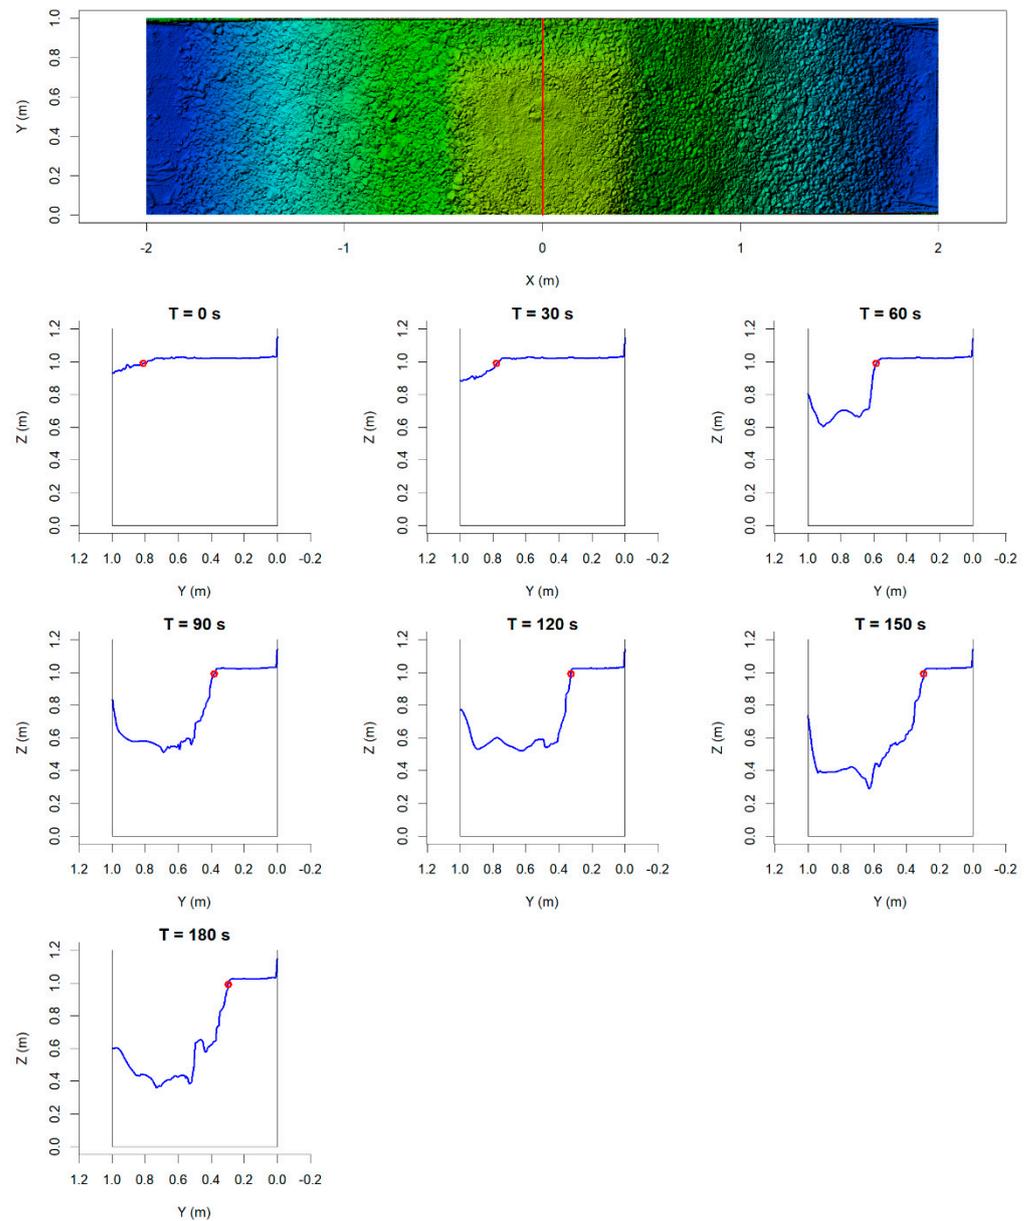
Figure A6. Cross-section profiles for $X = 0$ m (centre line) extracted from H1 dynamic 3D model; $T = 0$ s is immediately before initial observed erosion at downstream edge of crest; red circle indicates breach edge as used in further analyses.

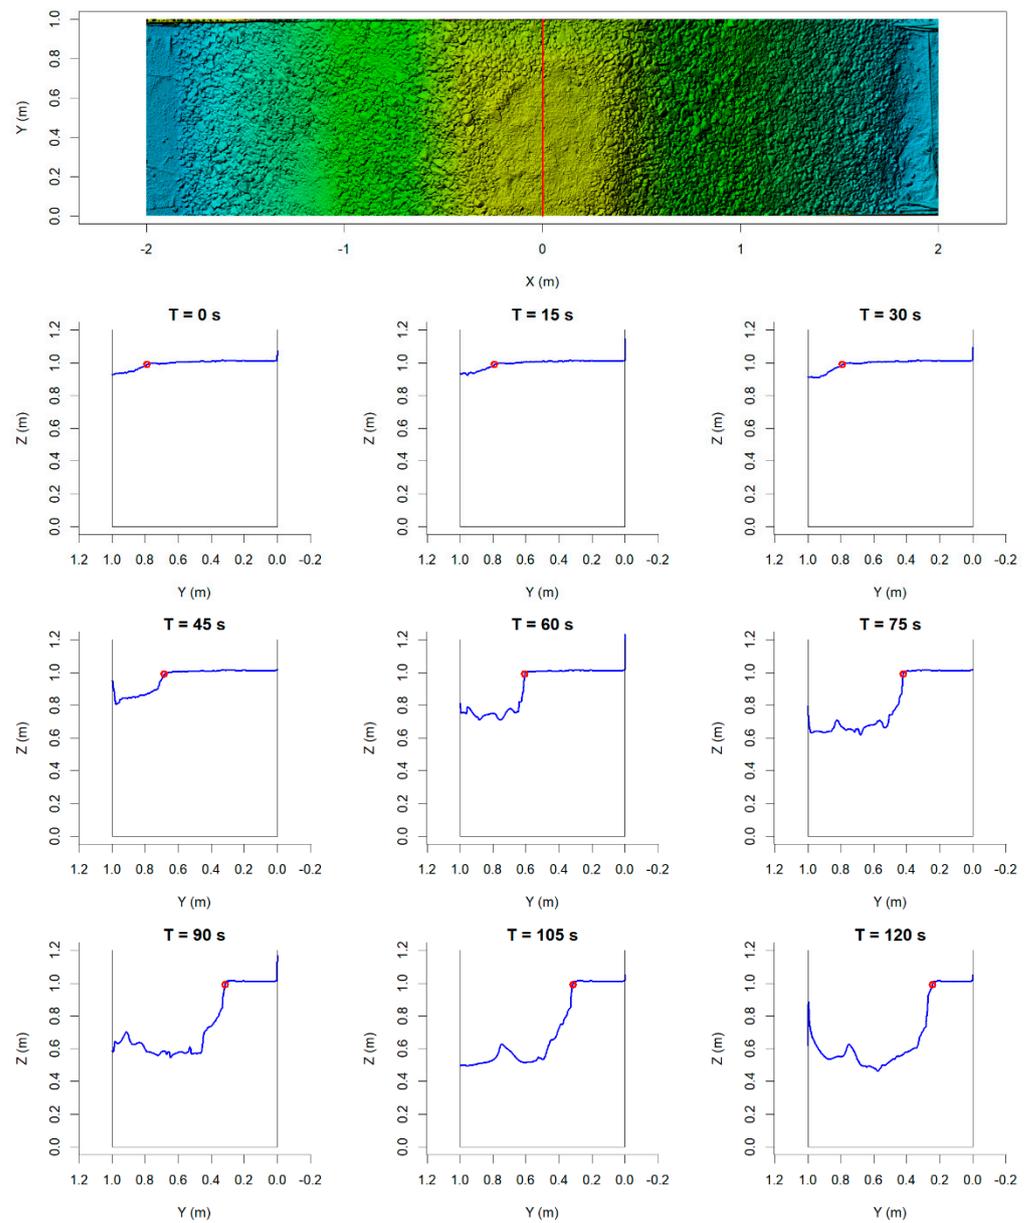
Figure A7. Cross-section profiles for $X = 0$ m (centre line) extracted from H2 dynamic 3D model; $T = 0$ s is immediately before initial observed erosion at downstream edge of crest; red circle indicates breach edge as used in further analyses.

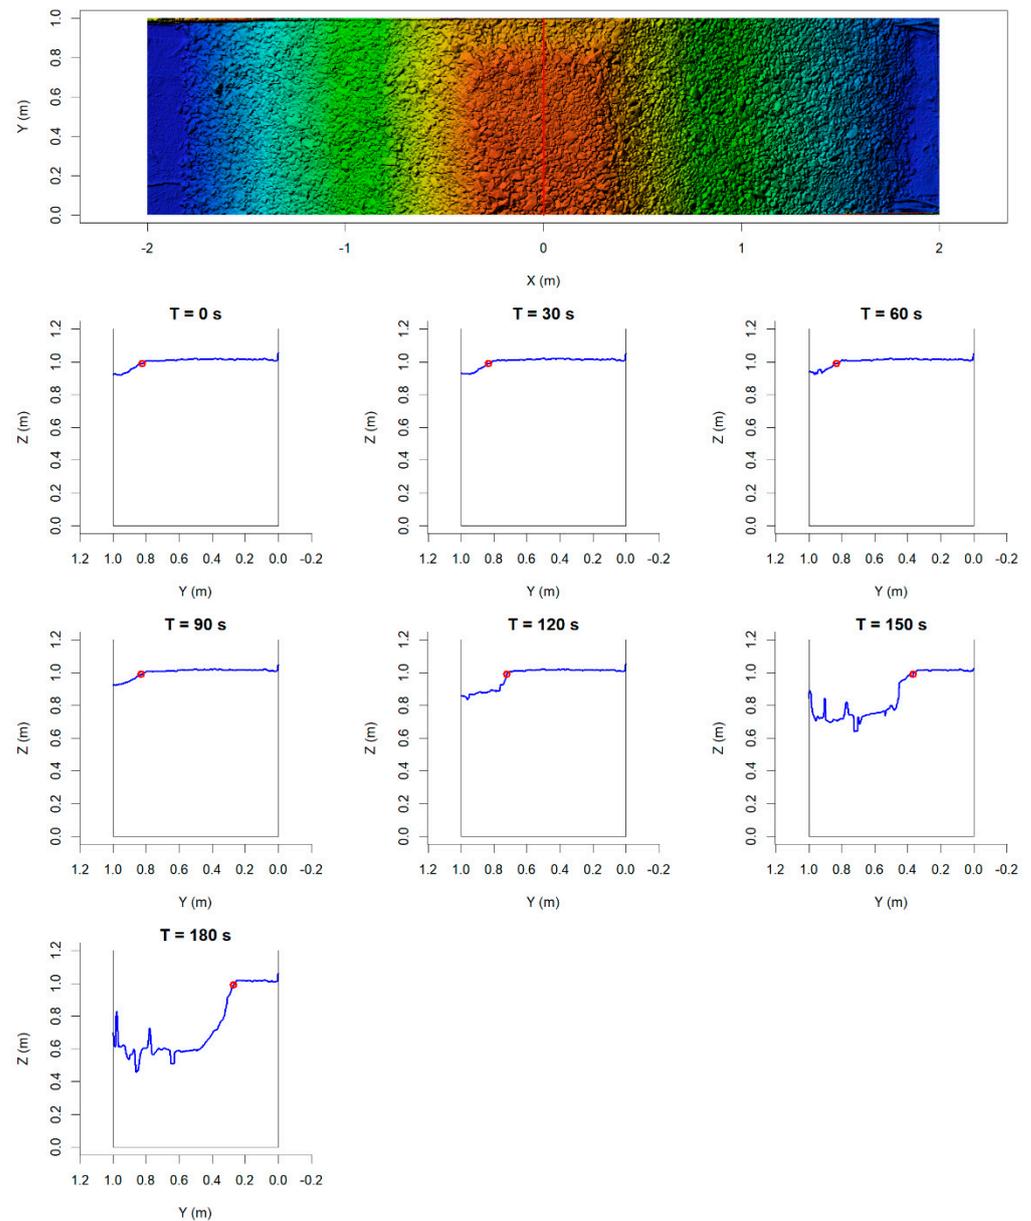
Figure A8. Cross-section profiles for $X = 0$ m (centre line) extracted from H3 dynamic 3D model; $T = 0$ s is immediately before initial observed erosion at downstream edge of crest; red circle indicates breach edge as used in further analyses.
