Breach Progression Observation in Rockfill Dam Models Using Photogrammetry

Geir Helge Kiplesund *, Fjola Gudrun Sigtryggsdottir and Leif Lia

Department of Civil and Environmental Engineering, Norwegian University of Science and Technology, 7491 Trondheim, Norway

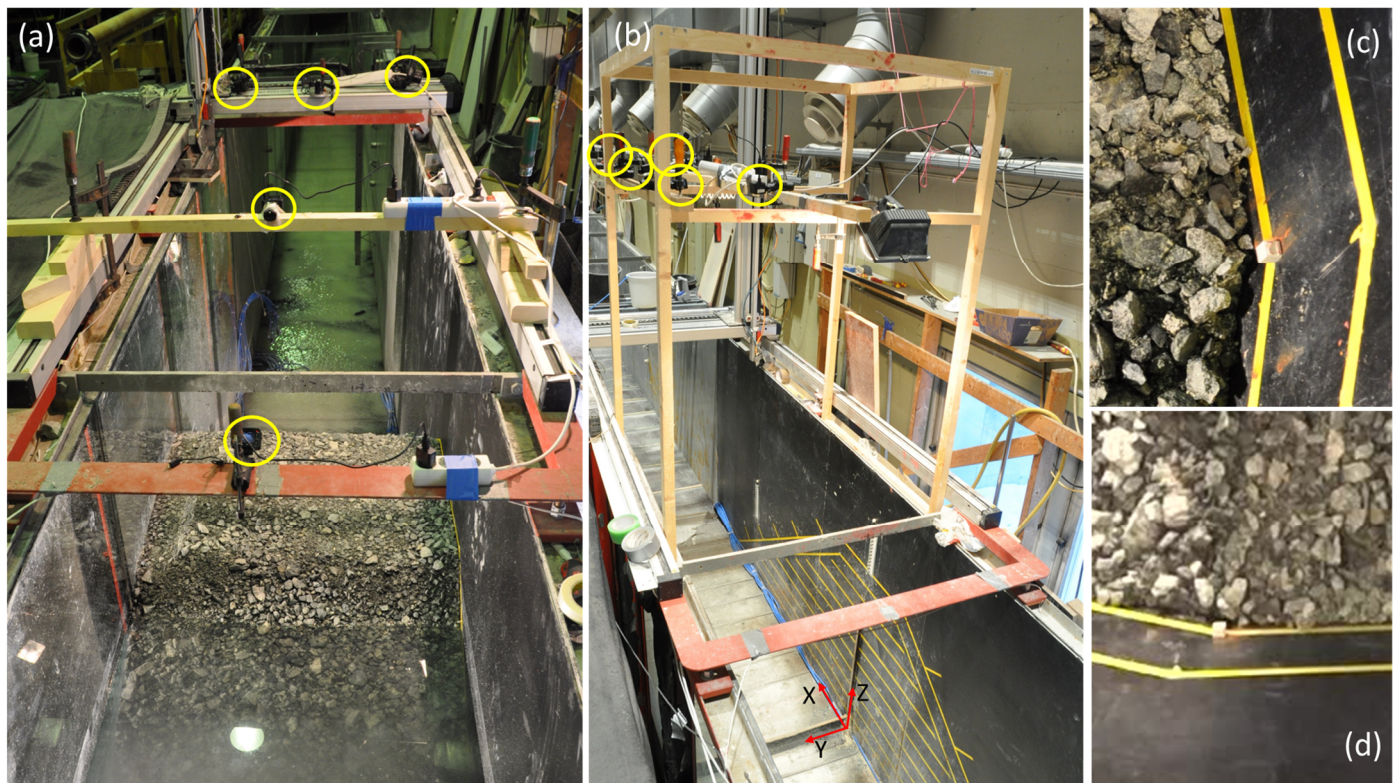
Figure 3. Camera rig setups (a) Model U1-U3 (b) Model U4-H3, camera locations indicated by yellow circles, coordinate system definition shown on (b) with red arrows and axis labels (c) shows DSLR image of a GCP cube (d) shows video frame of the same GCP cube.

The coordinate system defined for these tests was a right-handed cartesian X-Y-Z coordinate system with its origin at the base of the dam, at the right-hand end of the centre line seen in the direction of flow. Figure 2 shows the X and Z axes, and Figure 3b shows all the axes.

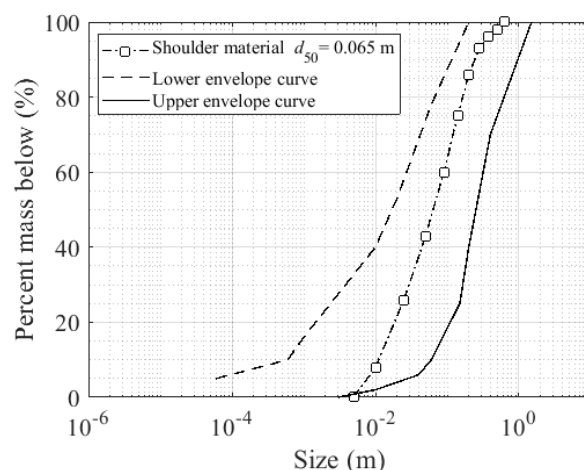
Figure 4. Grain size distribution enveloping curves from dam database and for chosen shell material (scaled up 10:1 to prototype scale) previously presented in [26].

As can be seen from Figure 4, the gradation is biased towards the coarser range of the curves found in the database, and all particles smaller than 0.5 mm were washed out of the final mix. This was performed due to restrictions on materials used in the flume to protect the pump system in the laboratory. The gradation curve is also evaluated against filter criteria recommendations as described by NVE and USDA [25,32], and further details on these calculations can be found in [26]. The material was produced by mixing appropriate amounts of various commercially available crushed rock gradations to obtain the desired gradation curve. The total mass of the rockfill shell for these models was 4500 kg.

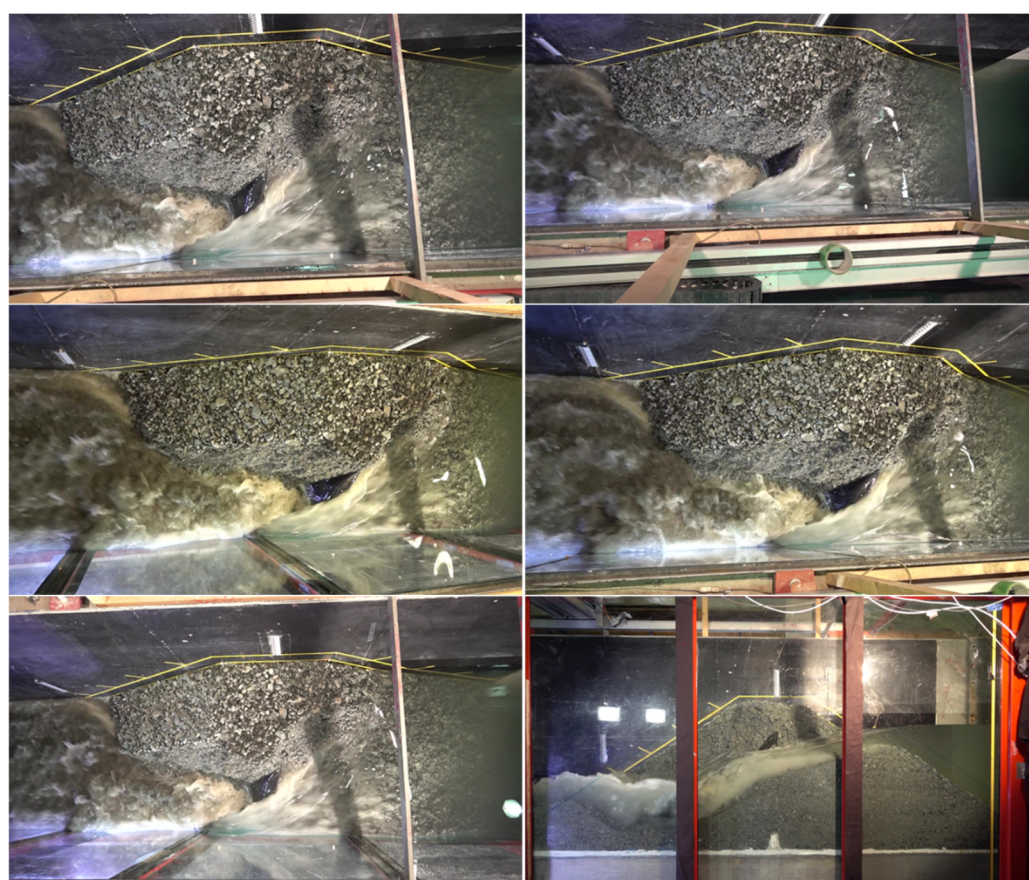
Figure 6. Example set of synchronised images from test U4—3170 s from start of test.

Since the video files are synchronized, each set of six images shows the model from six different viewpoints at that time. Correct synchronisation of images is important. A mismatch in timing may result in the photogrammetric process not producing any data for the breaching area, as the images would not display the same geometry in the areas of active erosion, and no tie points would be found in that area.

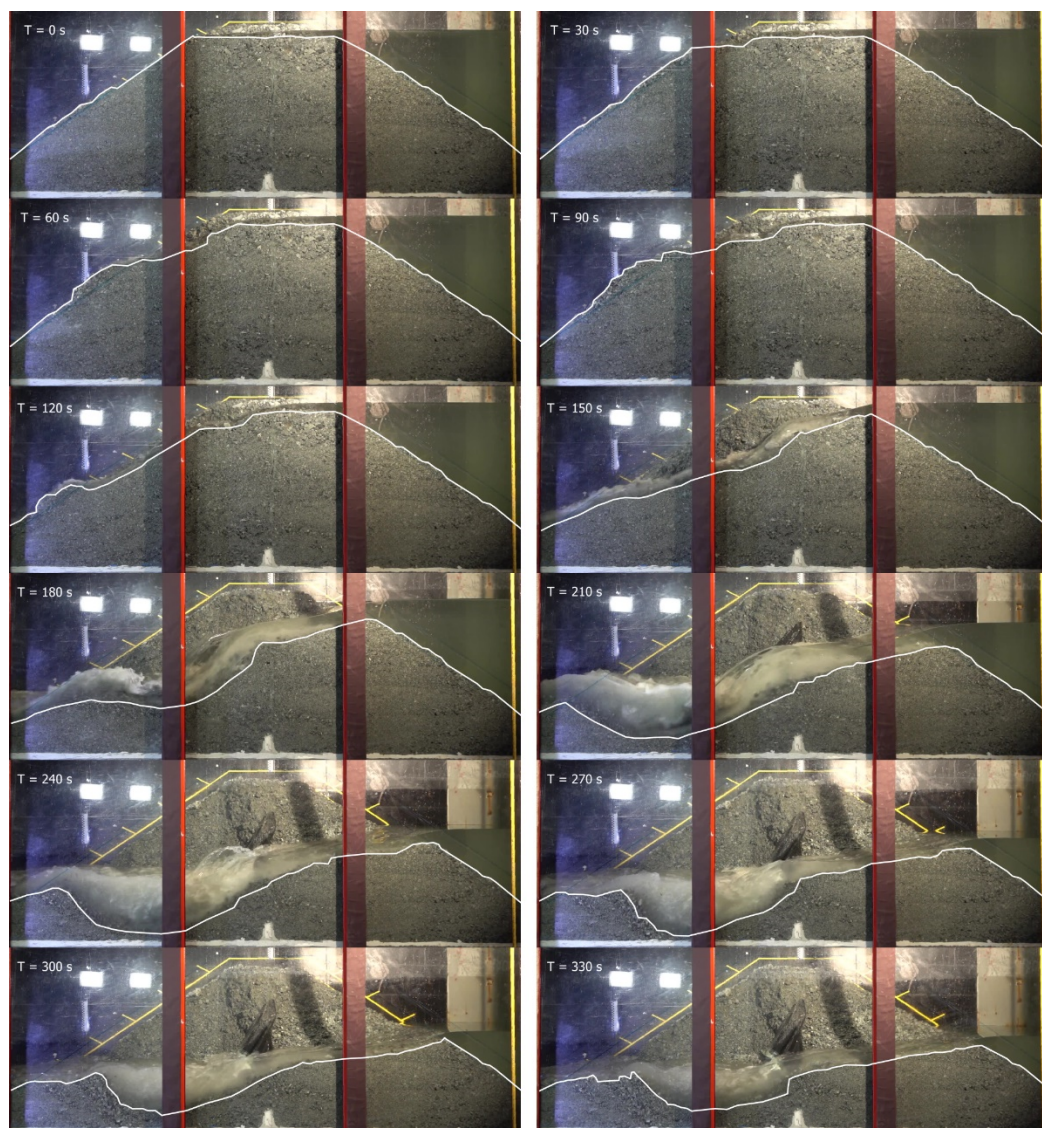
Figure 8. Side-view tracking of breach progression of model U4 (central core); direction of flow is **right to left**; white line indicates traced solid surface.

Figure 8 shows the breach progression as seen through the side window for model U4, while Figure 9 shows the same for model H1. As previously described, $T = 0$ s is defined as the last 5 s frame before erosion can be visibly observed from the side. The side-view track clearly shows the erosion process described above for these two tests of models with and without a core.

The vertical erosion development was tracked for several sections of the side-view in Figure 8 and throughout the breaching process of test U4. Figure 10 shows a plot of breach bottom elevation (the y elevation) versus time at four different locations along the flume, $X = -0.5$ (upstream), $X = 0$ (centre line), $X = 0.5$ (downstream) and $X = 1.0$ (downstream).

is sufficiently eroded to allow for larger blocks of the core material to dislodge. The tests with a core described in this paper (Figure 8) behave quite similarly to the tests without a core (Figure 9) until the breach bottom at the core location reaches the top of the core. When this occurs, a scour hole starts to develop; furthermore, the core within the breach opening is gradually lowered as the core membrane loosens from the glass wall at one end. The top elevation of the core is not even after the loosening at the glass wall begins since the other end within the breach opening is embedded in the part of the dam that is unaffected by the breach. The closest comparison between a test with a core and without a core in this series can be found in Figure A5 (Model U5) and A6 (Model H1), both were tested at the same inflow discharge of 15 L/s.

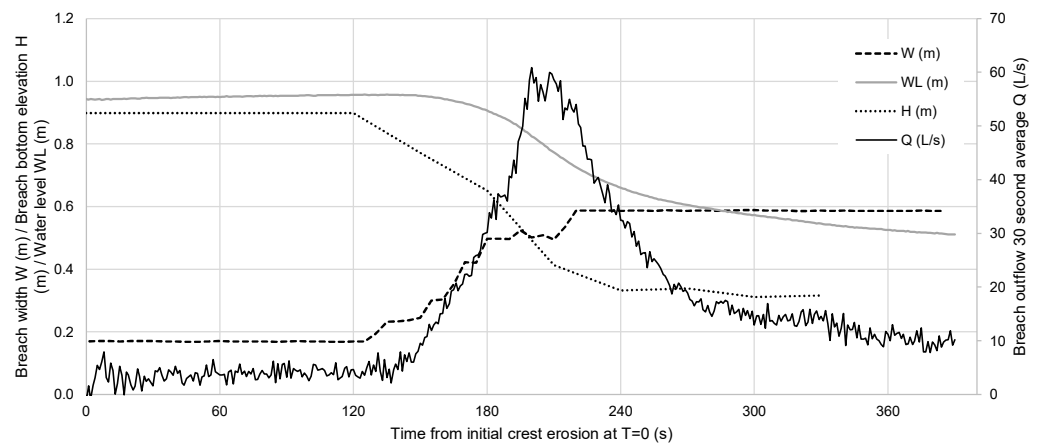
Figure 14. Breach width (W) and breach bottom elevation (H) for model U4 (central core) plotted against breach outflow (Q) and upstream water level (WL).

Figures 14 and 15 below show the lateral and vertical breach development, respectively, for tests U4 and H1 plotted against upstream water level and calculated breach discharge. W is the breach width calculated as the distance between the flume glass wall and the top of the breach edge, H is the Z coordinate of the breach bottom as seen from the side, WL is the measured upstream water level and Q is the calculated breach outflow discharge. Note that breach outflow also includes some leakage flow as well as some flow through the crest above the impermeable core when the water level is above the core level.

A clear pattern can be noted from joint observation of the breach edge in Figure 12 and the breach width in Figure 14. The breach edge moves laterally out from the pilot channel (Figure 12) and the breach width increases (Figure 14). The lateral movement of

the breach edge (and widening of the breach) occurs in discrete increments, as seen by the plot of W in Figure 14. Each incremental widening is followed by a fairly steady state during which gradual erosion of the channel bottom occurs. This erosion results in the undercutting of the side slope, which then slides down and increases the breach width further. This erosion process is repeated in discrete events.

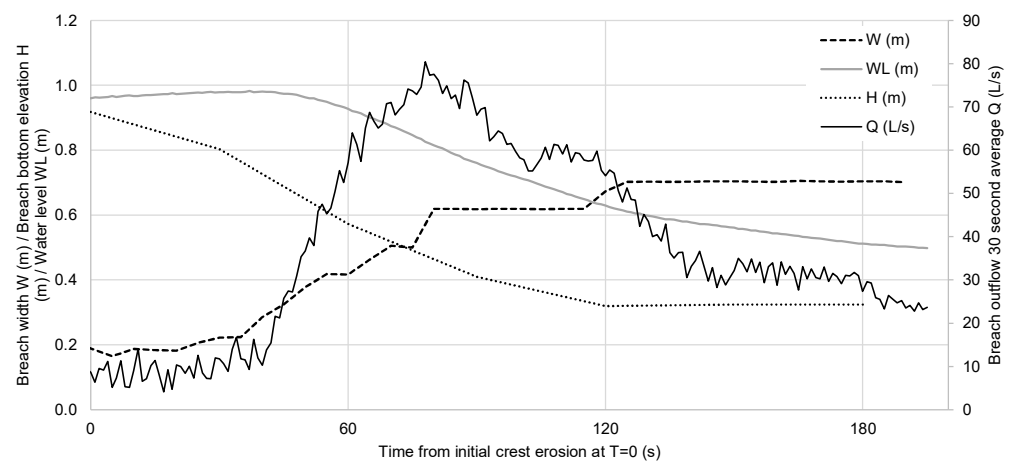
Figure 15. Breach width (W) and breach bottom elevation (H) for model H1 (no core) plotted against breach outflow (Q) and upstream water level (WL).

The breach outflow in Figures 15 and 16 was calculated based on measured flume inflow and measured upstream water level. For plotting and further usage breach outflow has been calculated on a one-second time resolution, as this will show significant fluctuations due to fluctuations in the upstream water level moving averages have also been calculated. The plots show a 30 s moving average calculated breach outflow.

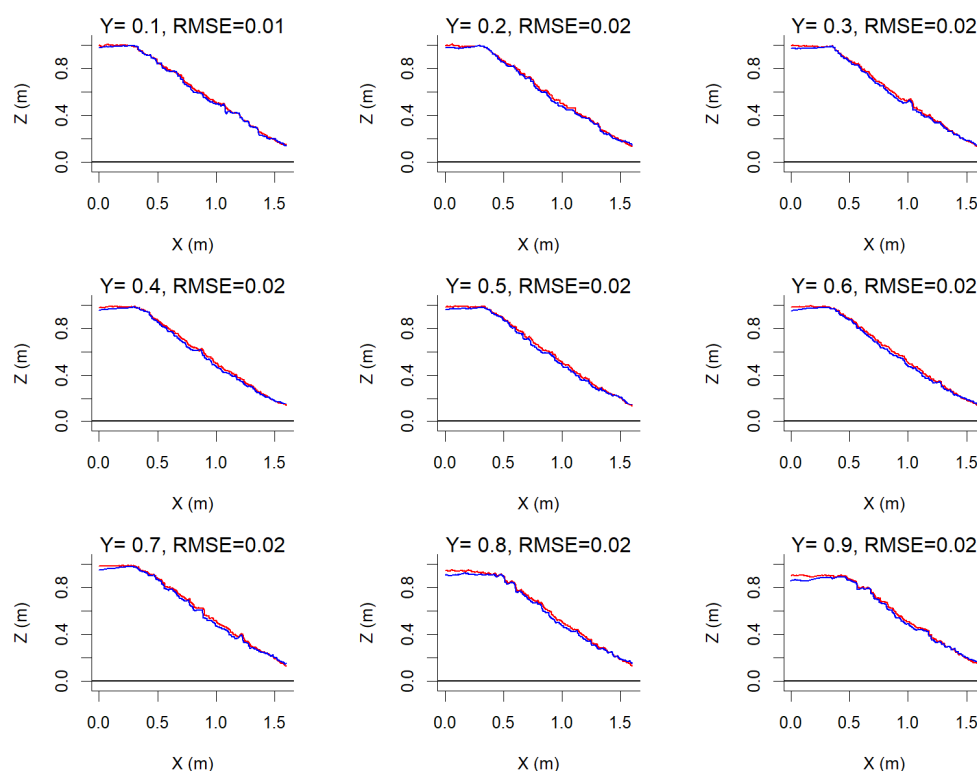
Figure 17. Longitudinal profiles of test U1; high-resolution DEM (red) and low-resolution DEM (blue); nine different profiles, with 0.1 being close to the back wall and 0.9 being near the glass wall (with pilot channel visible); calculated RMSE is shown for each profile.

where n is the number of points, here 1 point per mm, Z_A is dynamic DEM elevation and Z_B is the start DEM elevation. These profiles and the resulting calculated RMSE are shown in Figures 17 and 18 for tests U1 and U4, respectively.

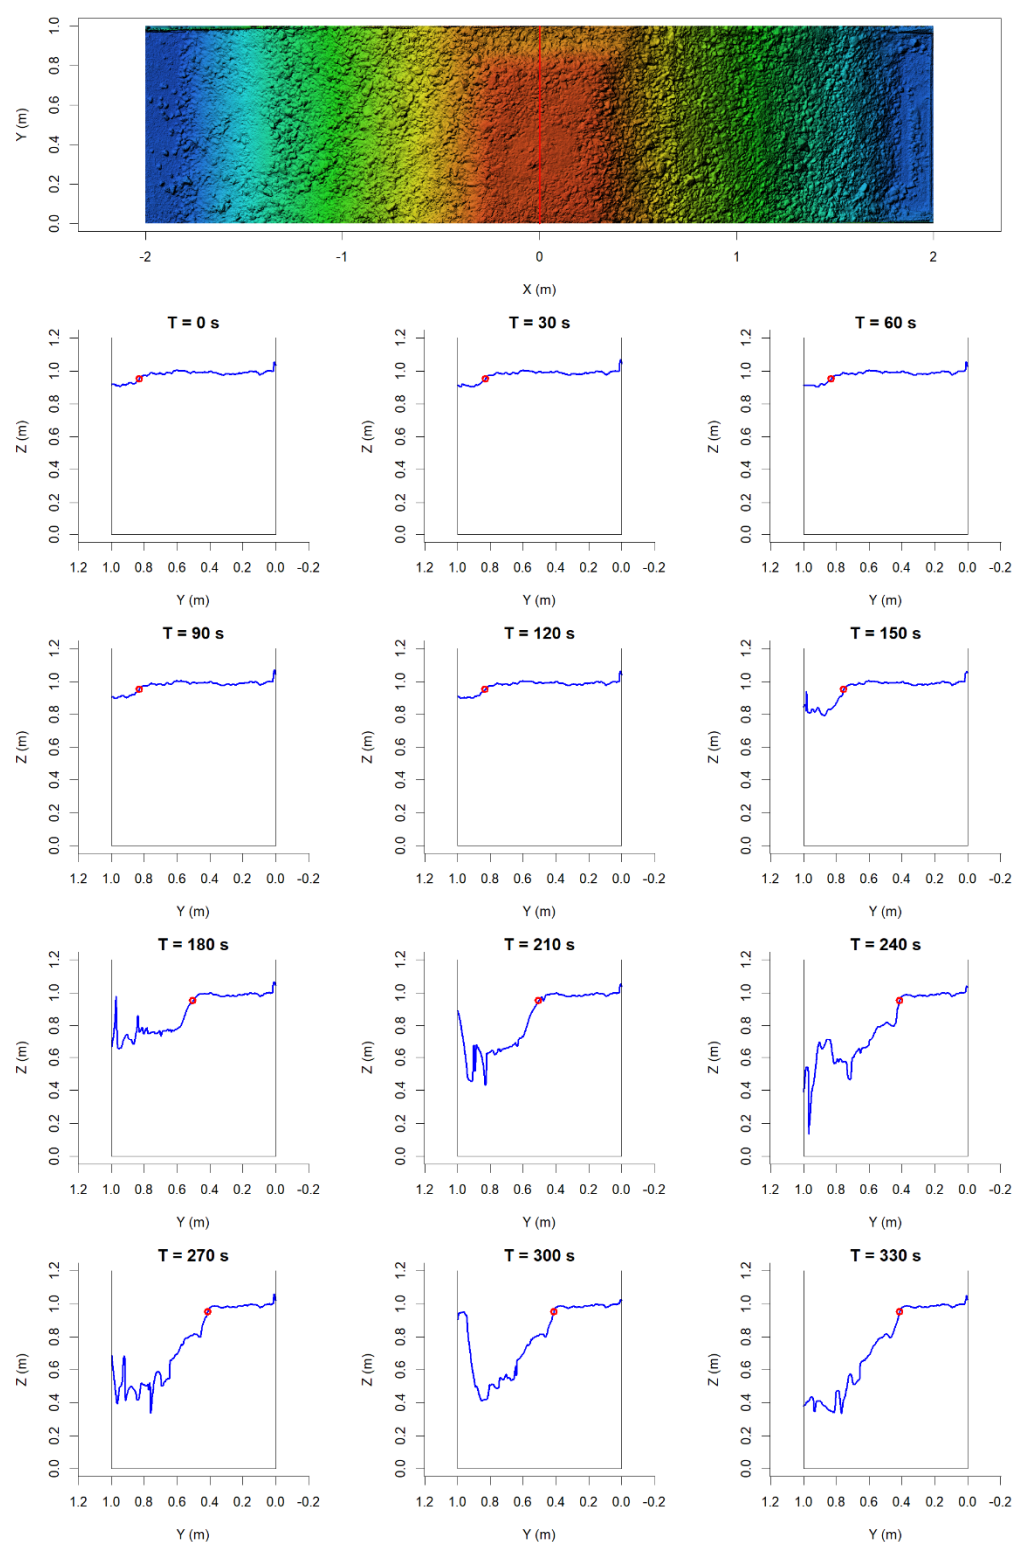
Figure A4. Cross-section profiles for $X = 0$ m (centre line) extracted from U4 dynamic 3D model; $T = 0$ s is immediately before initial observed erosion at downstream edge of crest; red circle indicates breach edge as used in further analyses.

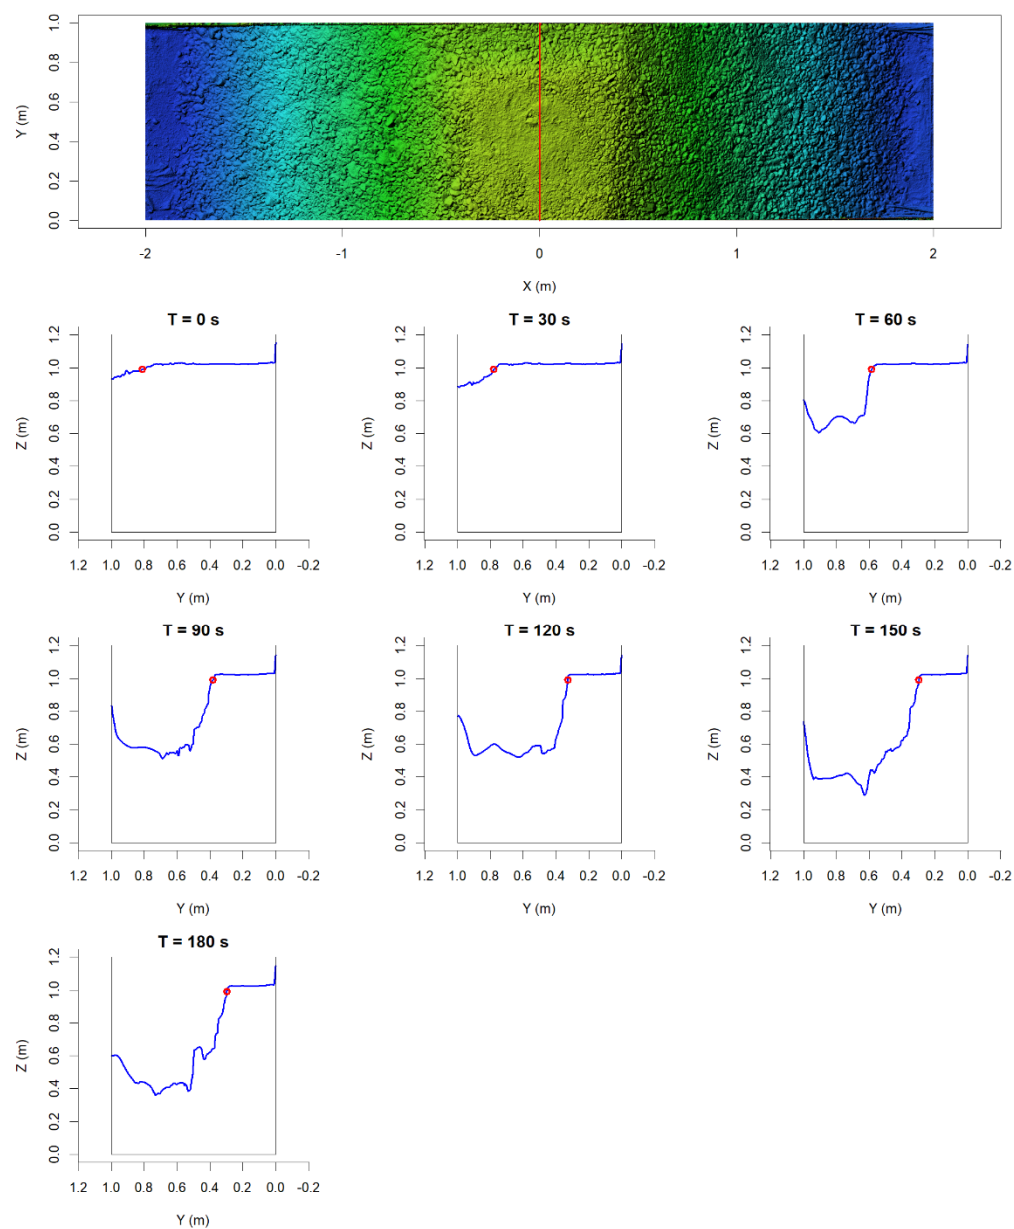
Figure A6. Cross-section profiles for $X = 0$ m (centre line) extracted from H1 dynamic 3D model; $T = 0$ s is immediately before initial observed erosion at downstream edge of crest; red circle indicates breach edge as used in further analyses.

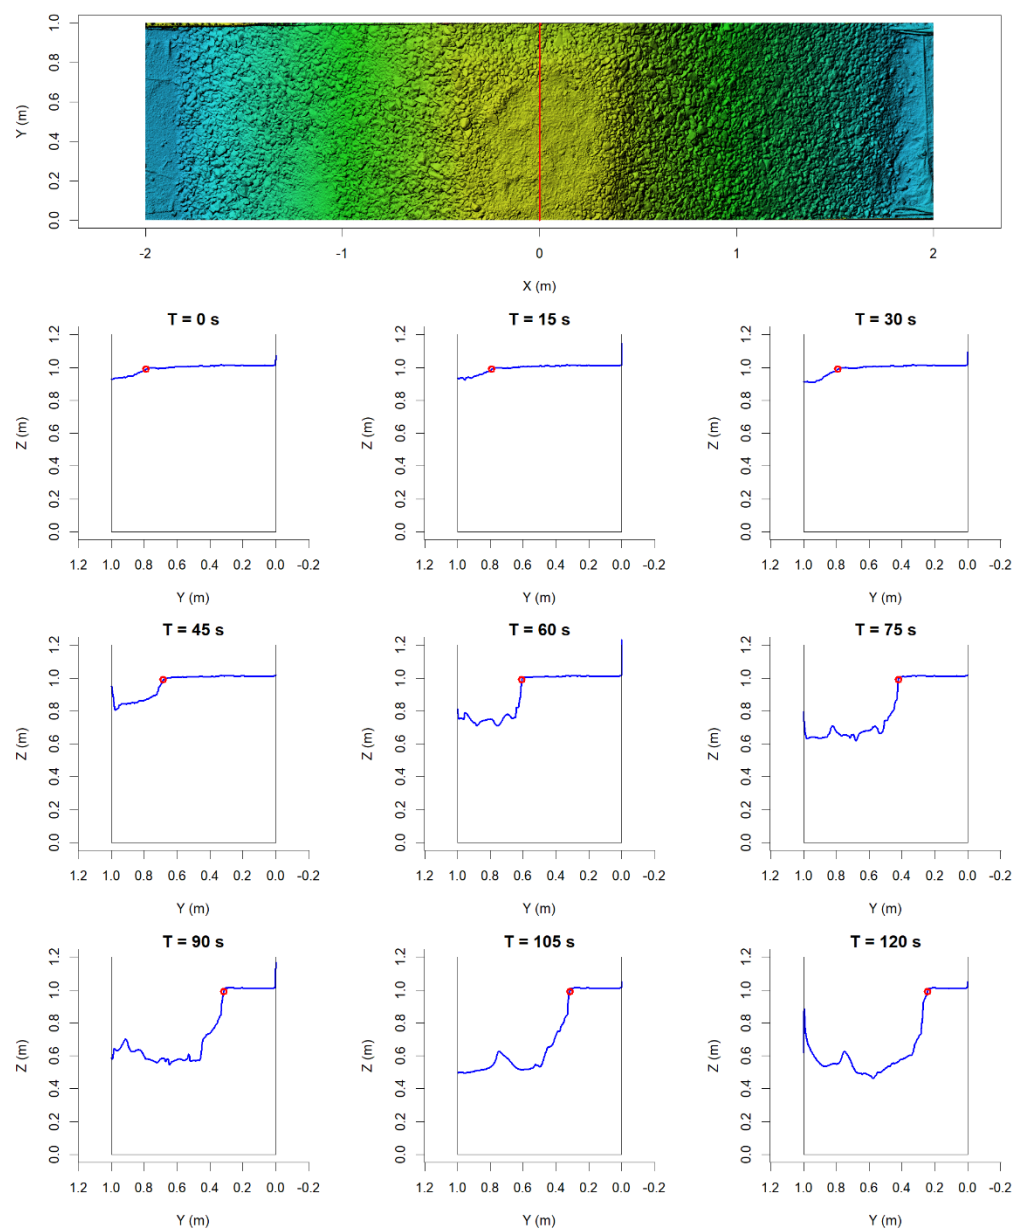
Figure A7. Cross-section profiles for $X = 0$ m (centre line) extracted from H2 dynamic 3D model; $T = 0$ s is immediately before initial observed erosion at downstream edge of crest; red circle indicates breach edge as used in further analyses.

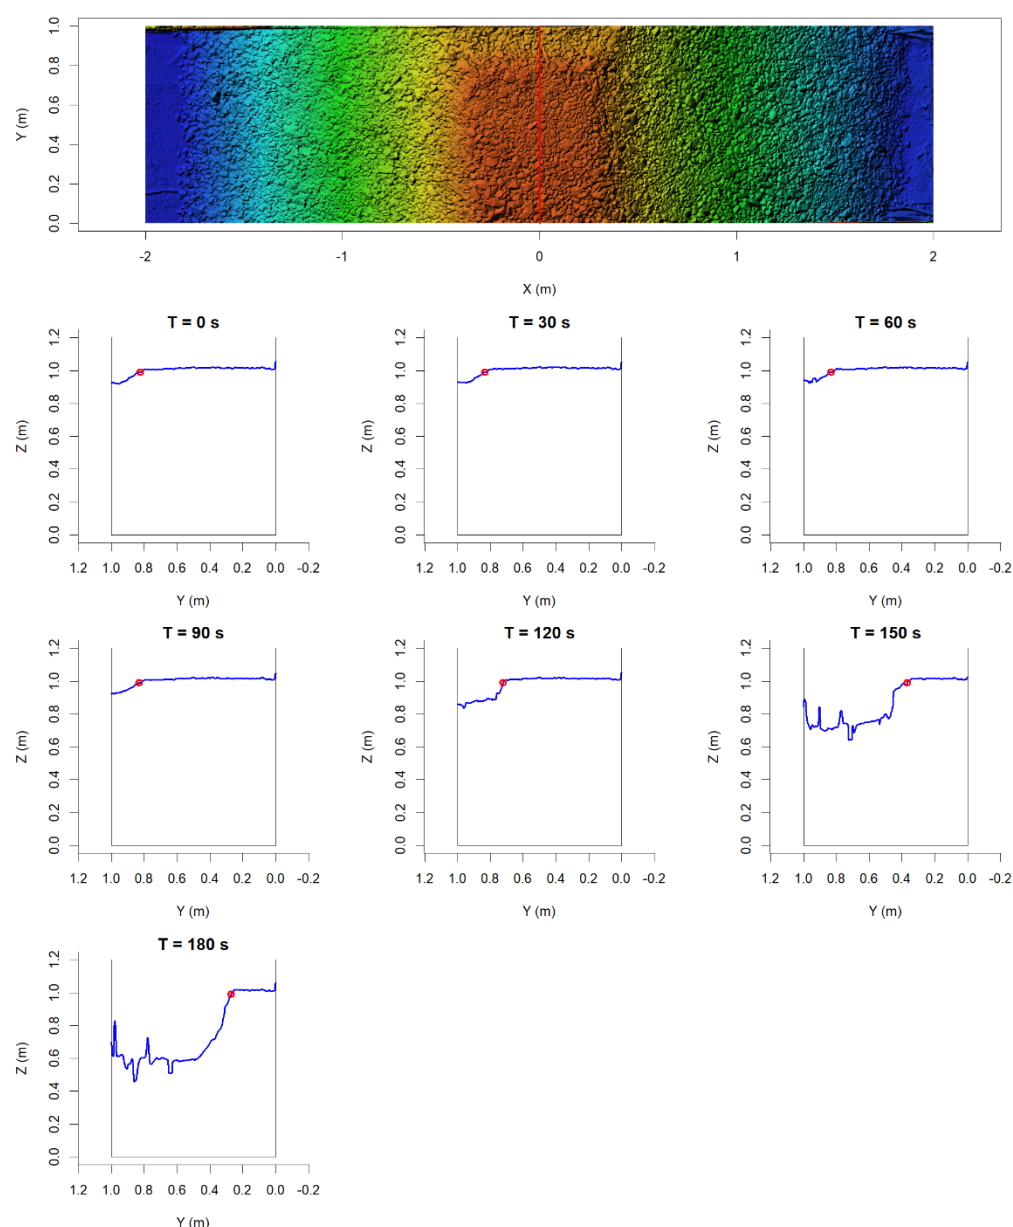
Figure A8. Cross-section profiles for $X = 0$ m (centre line) extracted from H3 dynamic 3D model; $T = 0$ s is immediately before initial observed erosion at downstream edge of crest; red circle indicates breach edge as used in further analyses.
