Article

Macroscopic and Petrographic Analyses of the Mortars from the Roman *villa* of Noheda (Villar de Domingo García, Cuenca)

Abstract: The Roman *villa* of Noheda, located in the municipality of Villar de Domingo García (Cuenca), is one of the most important archaeological sites in Spain and one of the most important museum complexes in Europe. In recent years, several archaeological investigations have been developed (archaeometry of building materials, natural resources, ways and roads). Furthermore, various restoration and consolidation works have been carried out on structures, walls and floors. The archaeological management team requested a characterisation of the mortars found in the coatings of the walls and floors of the complex to identify differences in its production. After checking the rooms, the state of conservation of the elements and the significance of the materials used, several mortar samples were analysed by means of macroscopic techniques before applying a petrographic analysis. The results showed an interesting variety in the distribution of aggregates, a complex microstratigraphy and a range of grain sizes in the mortars from different rooms. Magnesium,

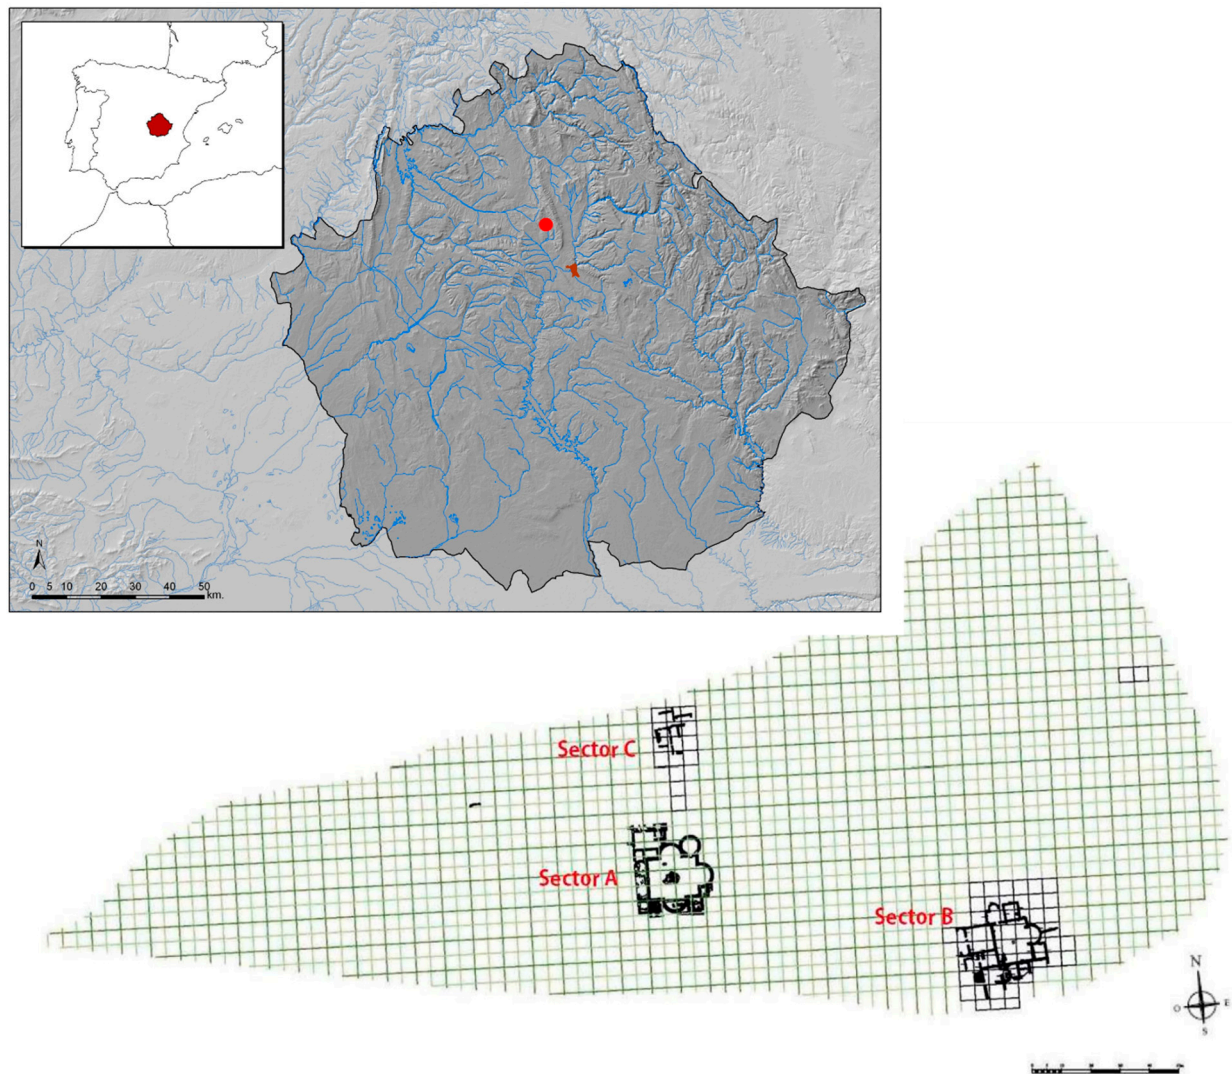
Figure 1. Location of the settlement (red dot) within Cuenca Province, and planimetry of the Roman *villa* of Noheda, indicating the archaeological sectors.

There are written references to the Roman *villa* of Noheda dating back to ancient times [1–5]. The site is located in the centre of the Iberian Peninsula, about 18 kilometres north of the city of Cuenca. It lies a mere 500 metres northeast of the village it is named after and is part of the municipality of Villar de Domingo García (Figure 1).

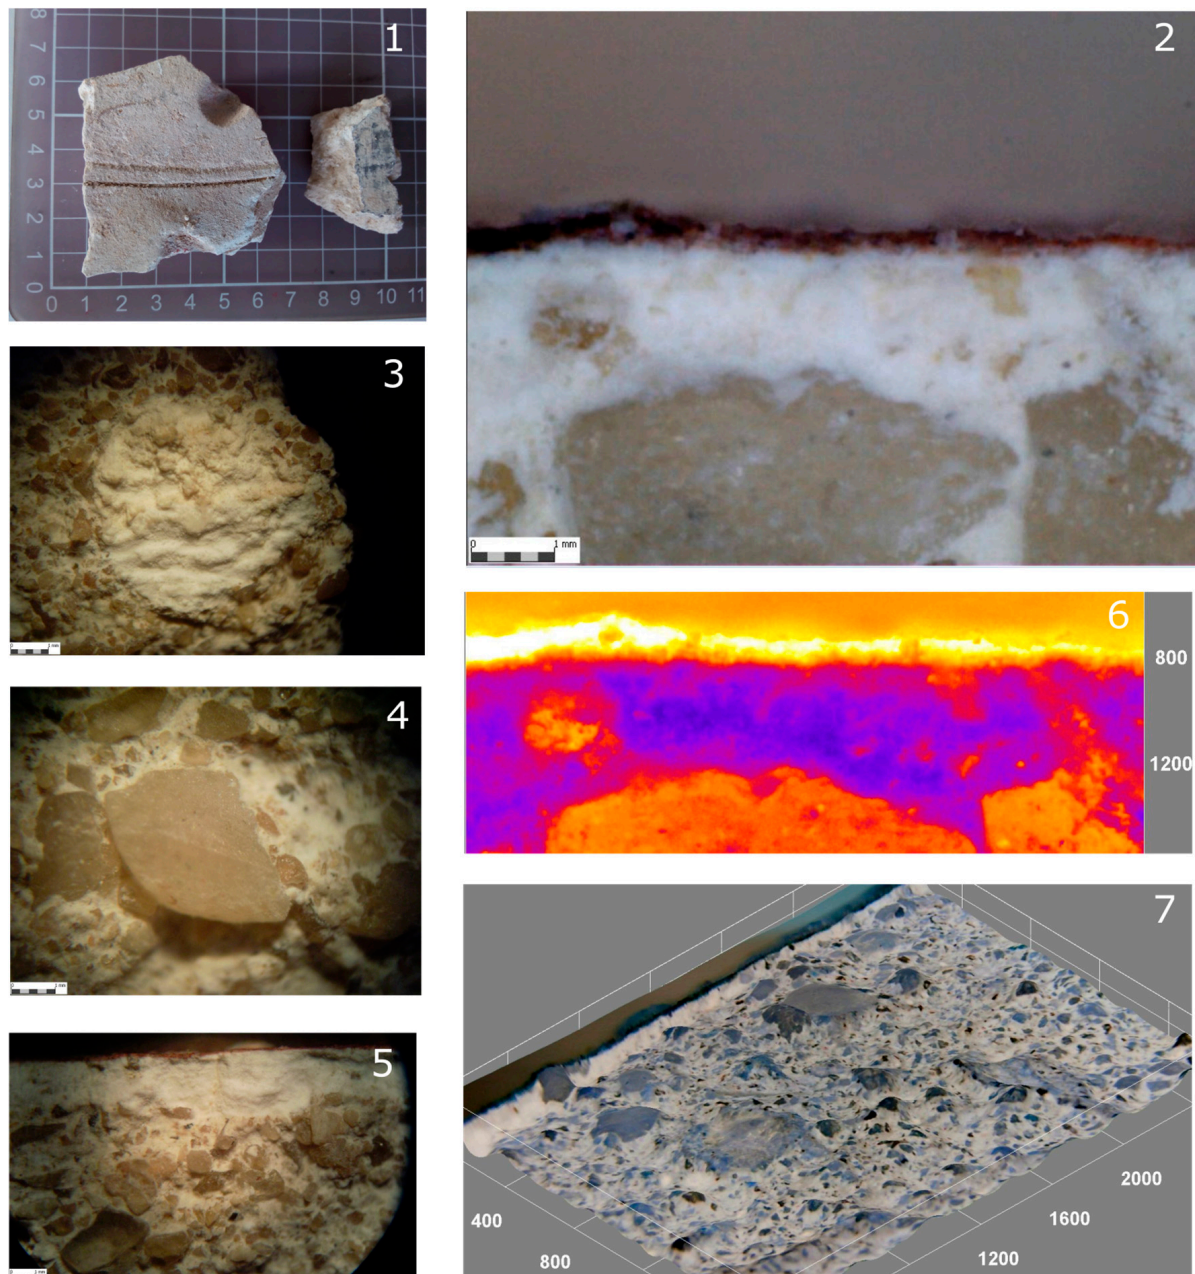
Figure 4. Macroscopic analysis of sample NO1 (1 mm scale): (1) Photo of sample before treatment, (2) cross-section without treatment ($\times 50$ mag.), (3) lumps of lime, (4) quartz grains, (5) cross section with reflected light, (6) thermal LUT analysis of cross section using ImageJ software showing the outside layer (yellowish), and (7) photogrammetry surface of sample using ImageJ software showing the irregular distribution and sizes of aggregates.

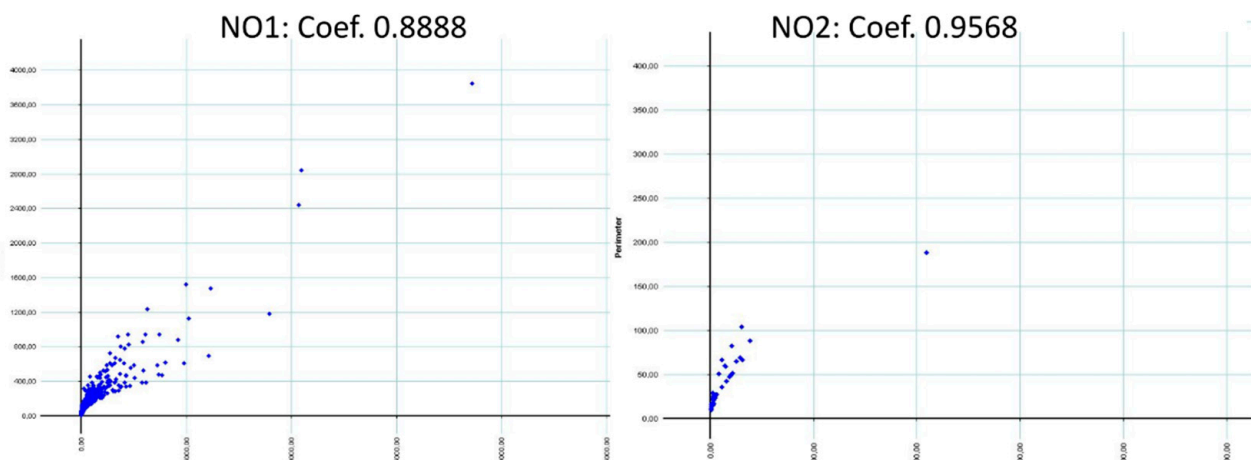
Figure 5. Graphs of the coefficient of sphericity in NO1 and 2, the most relevant results based on the area-to-perimeter ratio (JMicrovision Software). Two groups are found according to the sizes and 2D surfaces.

Regarding the granulometric measurements, the hyperspectral analysis revealed a wide variety of sizes in the aggregates in terms of the area-to-perimeter ratio, as can be seen in Figure 4, photo 7. Table 4 shows an homogeneous coefficient ratio of aggregates. NO1 and NO3 samples present a similar area-perimeter ratio, in relation with the rest, with similar dates (both main examples are referred to in Figure 5). The results obtained are the following:

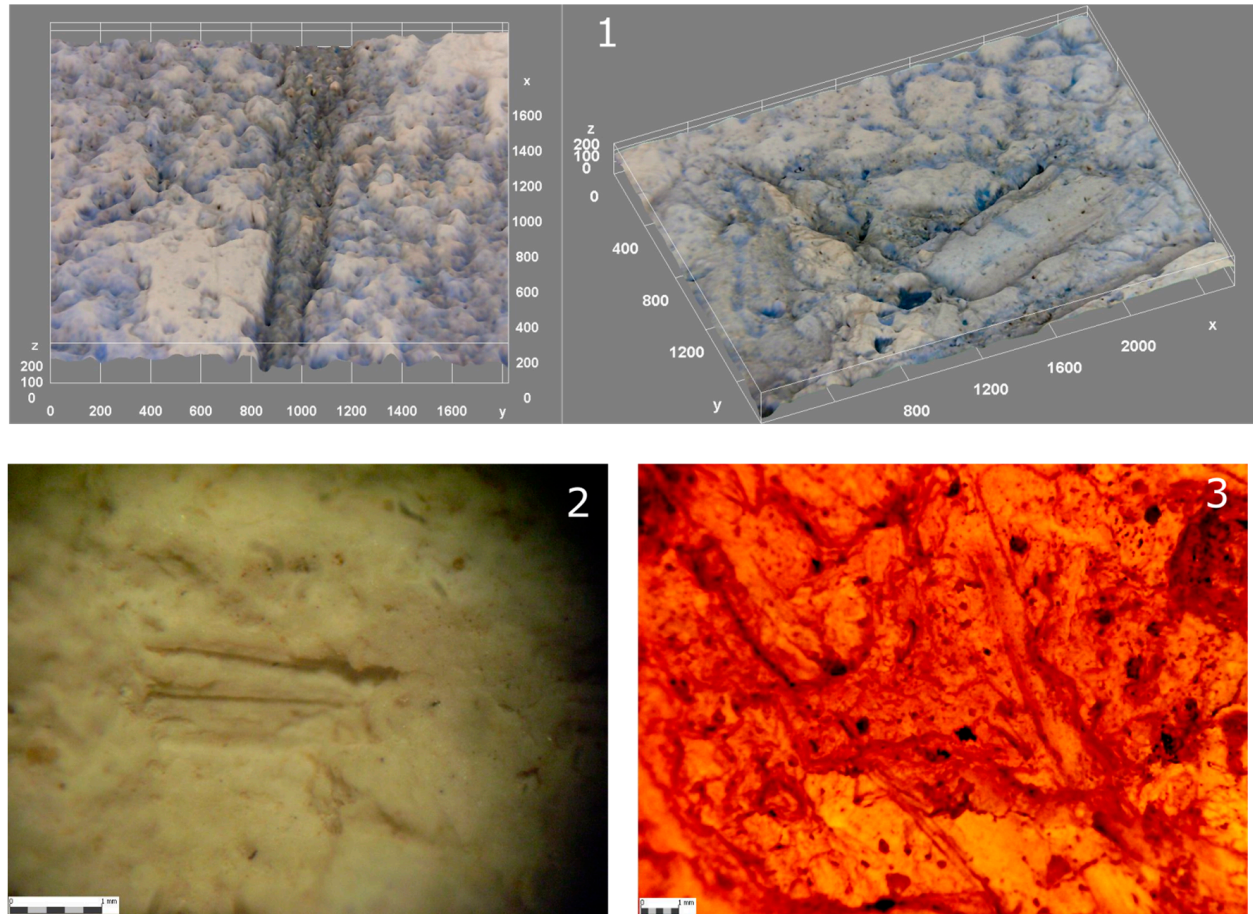
Figure 6. Organic remains in samples NO2 and NO5 (1 mm scale): (1) 3D scan of surface showing fibres (left) and microvertebrates prints (right) in sample NO2, (2) possible dental print in NO5, and (3) infrared picture with several organic prints in sample NO5.

Noteworthy among the components identified are the organic additives found in sample NO5, belonging to the bedding mortar of a mosaic. The localised imprints mostly

belong to plant phytoliths (shown in Figure 6 using microphotogrammetric analyses conducted with ImageJ software), although it has been possible to identify some remains of microvertebrate fauna. These imprints are assumed to have occurred during the setting and hardening process.

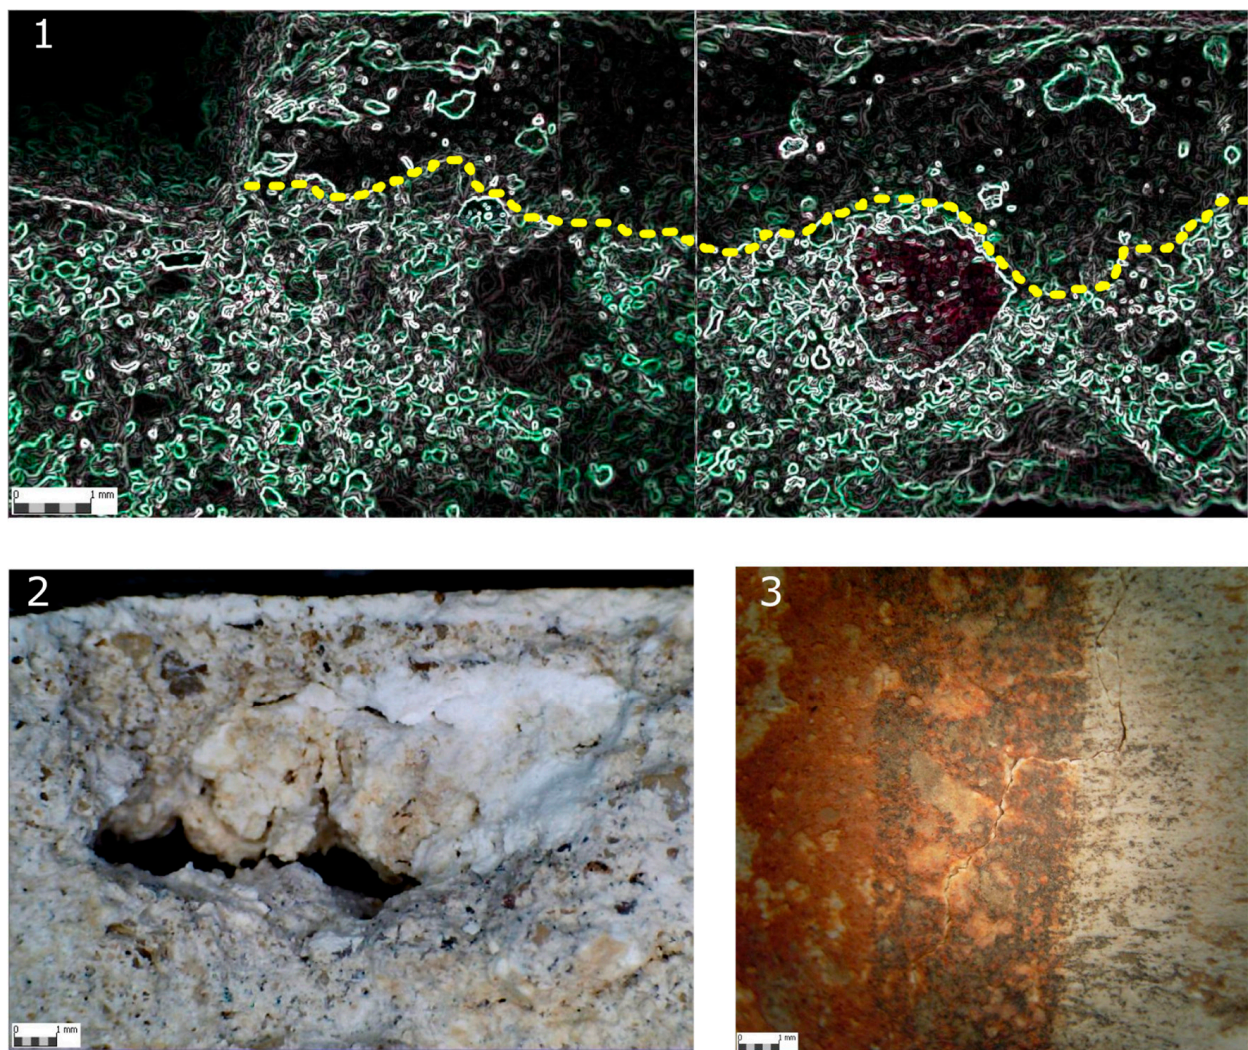
Figure 7. (1) Sobel treatment in sample NO4 showing the difference (separated by yellow dashed line) between the outside layer (less presence of aggregates) and inside (arriccio and intonaco). (2) Sample NO2 with recalcification in the pores (left). (3) Spatula marks on the surface of sample NO7.

In terms of microstratigraphy, we find an arriccio showing the morphological characteristics described above, and various intonacos of different thicknesses depending on the presence or absence of a pictorial layer, showing very fine aggregates and high-quality finishes (Figure 7). These finishes can function as base for pictorial decoration (as in samples NO1, NO2-II, and NO 7). Using in-situ microphotographs and colourimetry (pictures taken using portable lenses and processed using Micam, ImageJ, and Gimp software), black, red, and white tones (base backgrounds) with irregular lines and spatula marks on the surface have been identified. These spatula marks are accompanied, in some cases, by outer layers of organic material, as has been verified in the optical microscopy of the NO1 and NO2 samples. This material could be an organic binder applied after the pictorial finish (maybe a casein fraction). The chemical analysis is currently in progress.

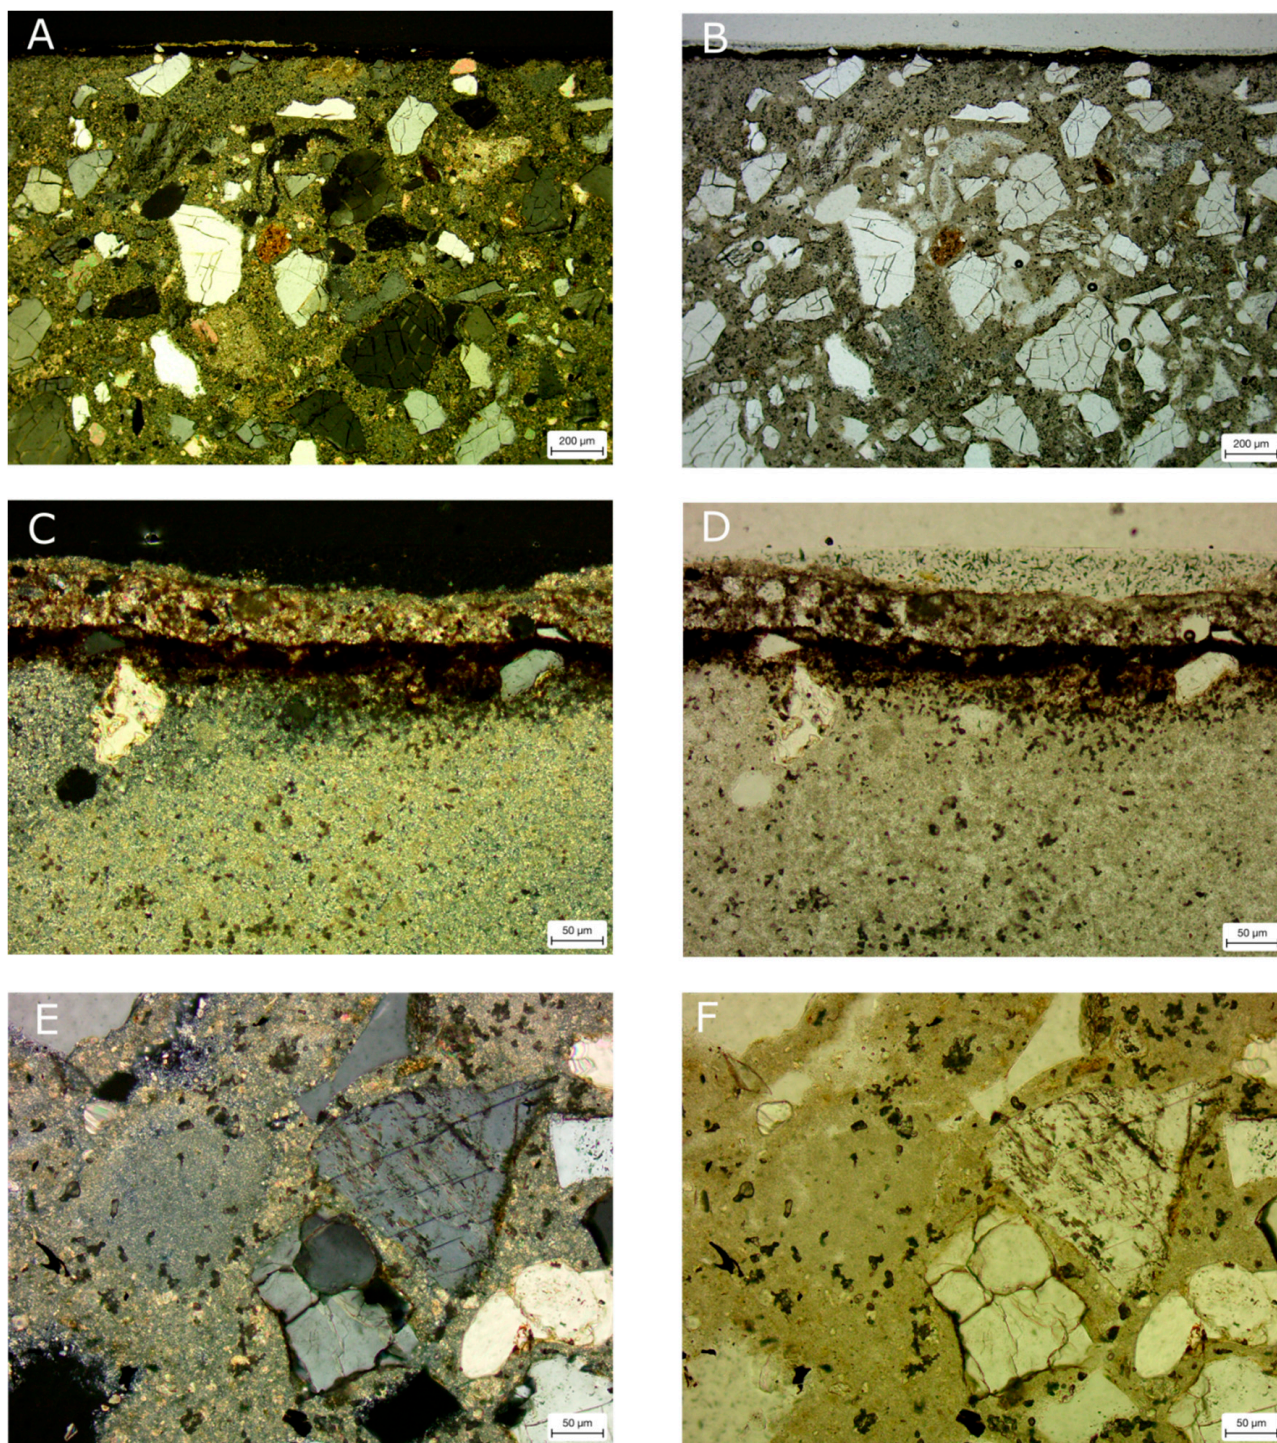
Figure 8. (A–F) Showing reddish aggregates (A); quartz grains, triangular feldspars, and plagioclase (E,F); and the layers checked in sample NO1 (C,D).

In turn, the aggregates are very angular, facilitating interlocking (Figure 8A,B). The aggregates are mainly quartz grains (Figures 8E,F and 9C,D), containing, in turn, microcline and plagioclase feldspars (triangular grain in Figure 8E,F), mica, and a low percentage of calcareous rock fragments (central aggregate in Figure 9A,B). In general, opaque minerals are not observed, although occasional reddish aggregates can be seen, which could be iron oxides or altered mica (reddish grains in Figure 8A).

Regarding the stratigraphy of the external face of the mortar, three well-differentiated layers are observed (Figure 8C,D). The first is homogeneous, reddish, and quite opaque, with an average thickness of approximately 40 microns. The second layer is composed of a limestone binder and small quartz aggregates (approximately 20 microns) that are widely dispersed. The thickness of this layer is highly variable, ranging between 0 and 50 microns. The last and outermost layer appears to be organic in nature and has thicknesses ranging from a few microns to 50 microns, with an average thickness of 30 microns.

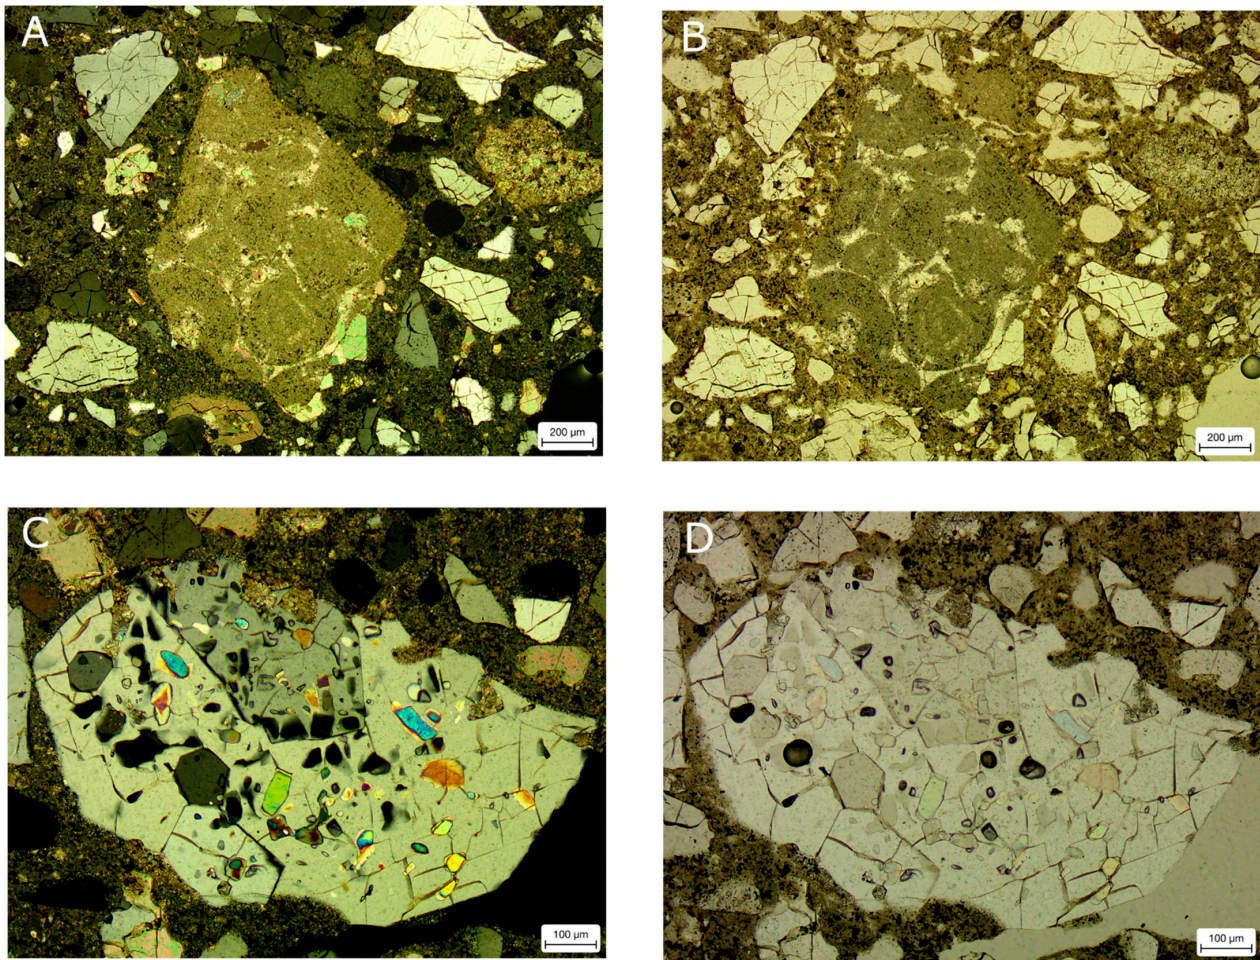
Figure 9. (A,D) Showing calcareous rock fragments in (A,B) (central view), and fractured quartz grains as the main aggregate in (C,D).

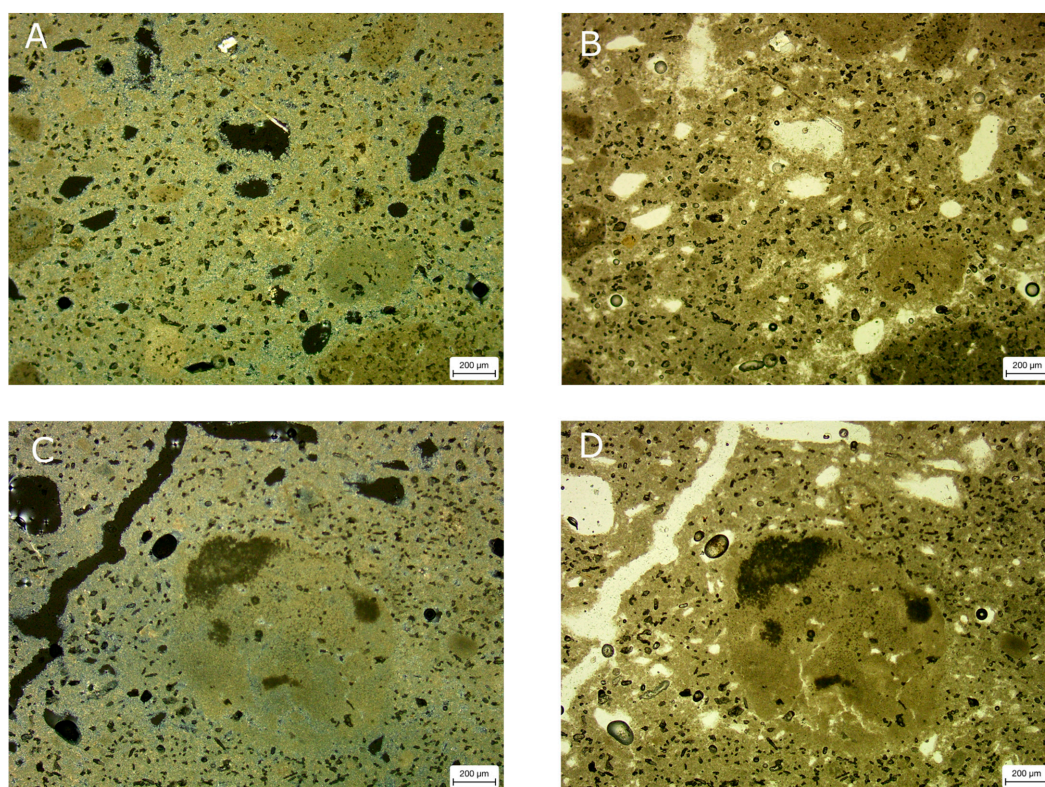
Figure 10. Photos (A–D) from sample NO2 with a low presence of aggregates. In photos (C,D), the lumps are clearly visible in the centre.

The NO2 mortar presents a homogeneous mass-type texture composed mainly of lime binder, with a negligible presence of aggregates (Figure 10A–D). Aggregates are dispersed and can be seen more as binder impurities than aggregates. The grains are mica particles hundreds of microns in size (Figure 11C,D) and some scattered quartz.

The binder is carbonated, primarily calcite-rich and microsparite calcite, mainly associated with recrystallisations in the pore walls. Its appearance is homogeneous, with several lumps (rounded lump in Figure 10C,D). The clay content is low.

Regarding the stratigraphy of the mortar, it is observed that it is composed of three layers at the scale of a hand sample. Photos A and B from Figure 10 show the representative texture of the first layer. The limit where this layer meets the second one is marked by the appearance of large, elongated pores parallel to the stratification. The second layer has a similar texture to the first but with a greater presence of fractures, which increase porosity (Figure 10C,D). The last and outermost layer is composed of two clearly differentiated sublayers: the first sublayer is homogeneous, reddish and quite opaque, approximately 200 microns thick on average, with small quartz aggregates (approximately 30–40 microns) and interspersed with lumps of lime; the second sublayer appears to be organic in nature and is approximately 350 microns thick on average (photos A and B from Figure 11). The chemical analysis of these layers is currently in progress.

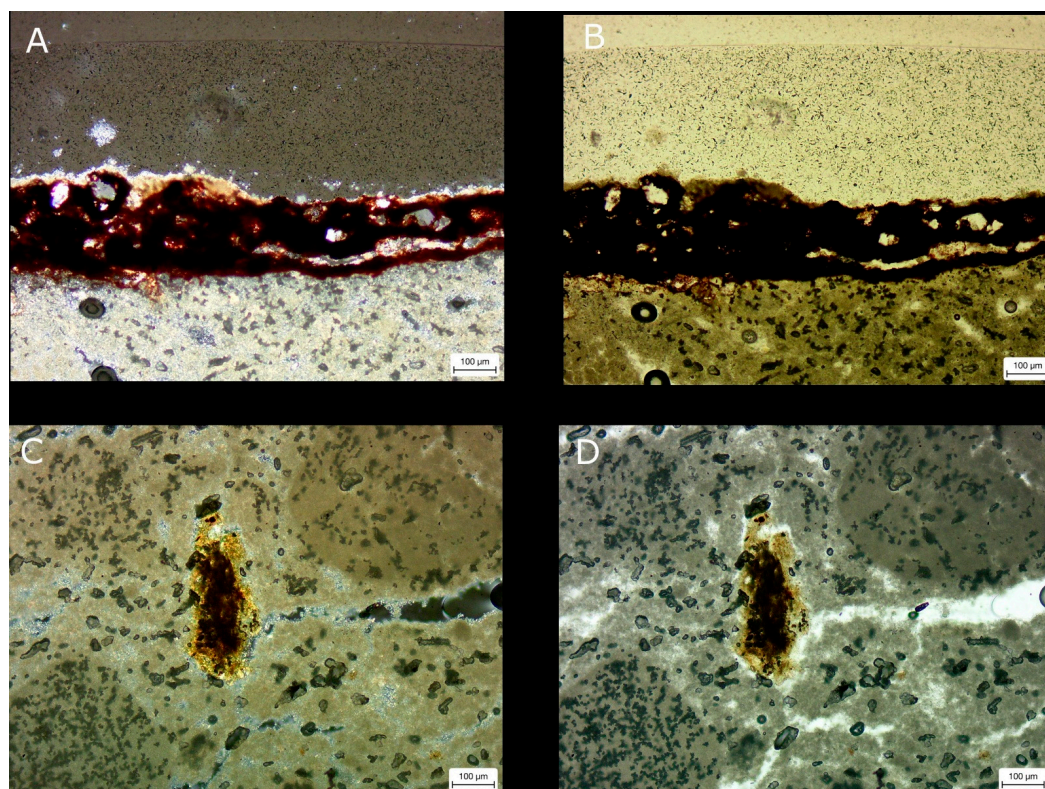
Figure 11. Photos (A,B) showing the layer with organic coating outside; photos (C,D) show micas of approximately 200 microns in size.
