Article

Residual Axial Capacity Comparison of CFFT and RC Bridge Columns after Fire

Alicia Echevarria ^{1,*}, Arash E. Zaghi ², Richard Christenson ² and Rachel Plank ²

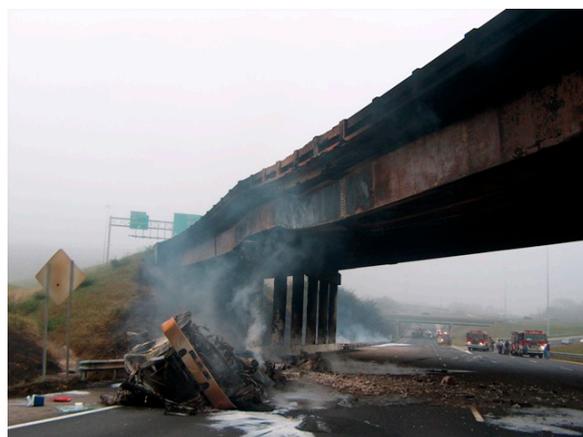
Figure 1. Visible bridge damage due to vehicular fire.

After extreme fire events, damage to bridge elements is often visually evident as shown in Figure 1. In other instances, a fire event may cause structural degradation with minimal outward signs of damage. This is especially true for concrete components, which can be problematic for officials faced with the emergency decision to keep a bridge in-service or order a costly bridge closure after a fire event. Columns are critical for keeping a bridge open to regular traffic or emergency responders. Even if a bridge's superstructure is significantly damaged, temporary structures, like the one shown in Figure 2, may be rapidly installed to restore service if the columns are able to retain their capacity.

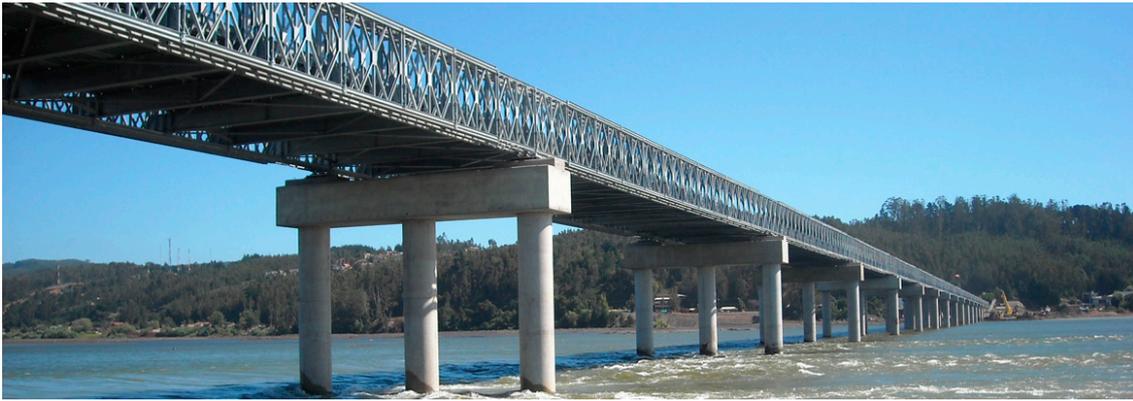
Figure 2. Emergency bridge over Bio Bio River in Concepción, Chile.

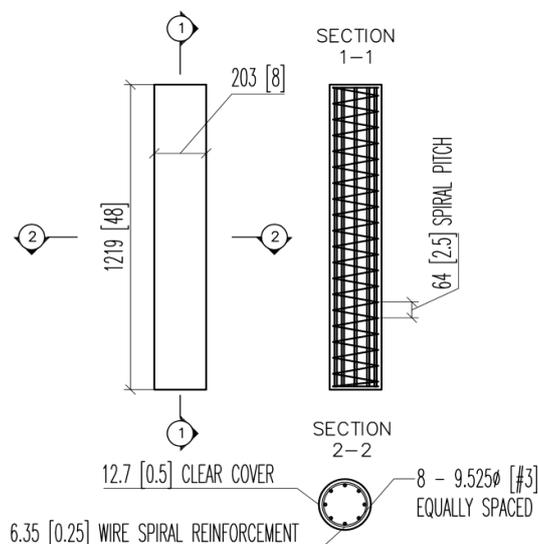
Figure 3. Reinforced concrete (RC) Column Design Drawing.

The one-fifth scale columns had a design height of 1.22 m (48 in.) and diameter of 203 mm (8 in.). The columns were longitudinally reinforced with eight Grade (Gr.) 60 #3 (9.53 mm (0.375 in.) diameter) bars cut to 1.19 m (47 in.) to provide 12.7 mm (0.5 in.) of clear cover on either end. The longitudinal reinforcement ratio, ρ_s , was equal to 1.75%. Spiral reinforcement pre-fabricated from 6.35 mm (0.25 in.) diameter smooth wire was used as transverse reinforcement for the RC specimens. The outer spiral diameter was specified as 178 mm (7 in.) to provide 12.7 mm (0.5 in.) of clear cover to the column surface. Drawings of the RC column design are shown in Figure 3.

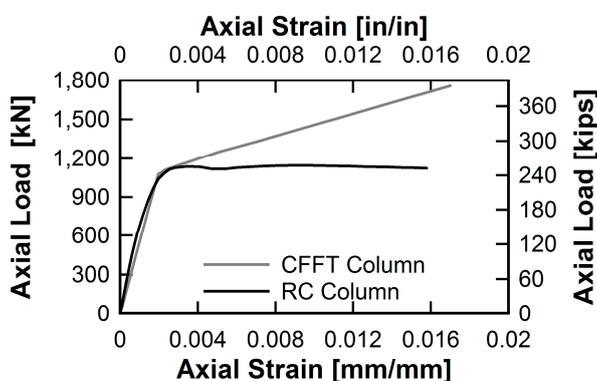
Figure 4. XTract axial load-strain curve for RC and concrete-filled fiber reinforced polymer (FRP) tube (CFFT) columns.

To ensure that the one-fifth scale RC design would have axial capacity less than 1779 kN (400 kip), the column cross section was modeled in XTract [31] prior to construction. The resulting axial load-strain curve for the RC specimens is shown in Figure 4. The ultimate capacity of the column was expected to be 1192 kN (268 kip) falling within the constraints of the UConn load frame.

The axial load-strain curve for the CFFT column resulting from the XTract analysis is shown in Figure 4. The tri-linear FRP material model presented by Zoghi *et al.* [26] was used to model the FRP tube, and the FRP confined concrete model described by Saiidi [34] was used to model the confined concrete core. The resulting ultimate axial capacity obtained from XTract was 1758 kN (395 kip). Because the FRP tube material was modeled as having a nearly linear stress-strain relationship, the CFFT column has a large post-yield stiffness. However, some softening was expected to occur during the axial test experiments; thus, the axial capacity of the CFFT column would be within the limits of the UConn test frame.

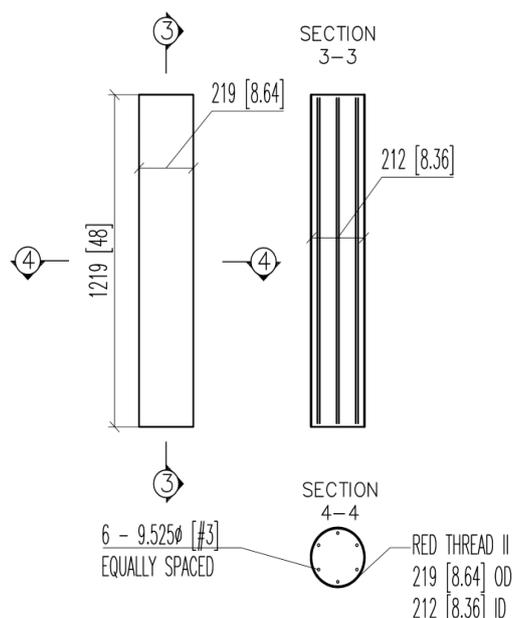
Figure 5. CFFT column design drawing.

The CFFT design consisted of a Red Thread® II pipe manufactured by National Oilwell Varco (NOV) Fiberglass Systems (FGS) [33]. The pipe had outside and inside diameters of 219 mm (8.64 in.) and 212 mm (8.36 in.), respectively, resulting in a thickness of 3.56 mm (0.14 in.). The composite pipe is made of glass fibers aligned at 55° with respect to the longitudinal axis. This particular fiber alignment provides both longitudinal and hoop strength to the column. Thus, no steel transverse reinforcement was included in the CFFT design, and the longitudinal reinforcement was reduced to six Gr. 60 #3 bars (9.525 mm (0.375 in.) diameter), resulting in a reinforcement ratio of 1.12%. Drawings of the CFFT column design are shown in Figure 5.

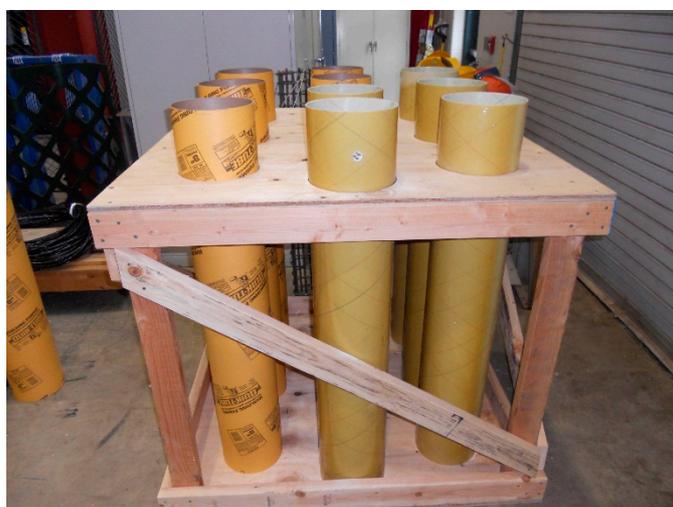
Figure 6. Wooden framework for column construction.

A wood frame was constructed to hold the sonotube forms and FRP tubes for simultaneous construction of the RC and CFFT columns. The framework used to hold the columns plumb is shown in Figure 6. The additional columns shown in this figure were used for blast experiments performed by UConn. The blast experiments are not discussed herein, but detailed information regarding the blast experiments can be found in Echevarria *et al.* [21–23]. The steel reinforcement for the columns was placed inside their respective tubes, and spacers were used to maintain clear cover between the steel and column surfaces. All of the columns were cast from a single batch of concrete with a specified compressive strength, f'_c , of 27.6 MPa (4 ksi) and maximum aggregate size of 9.53 mm (0.375 in.). The concrete was delivered by truck, poured into the tubes from the top down, and consolidated using vibratory methods.

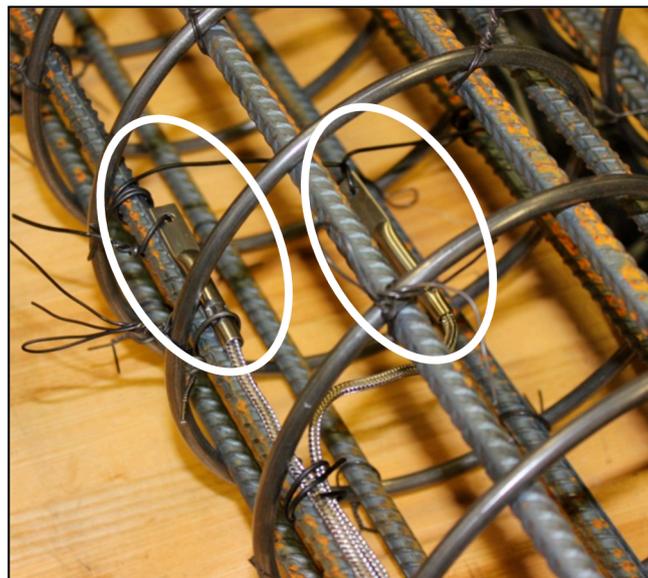
Figure 7. Thermocouples installed within each column specimen.

Each of the four columns was instrumented with two type K Omega[®] high temperature ceramic insulation thermocouples with Inconel[®] overbraid [35]. The thermocouples were rated for temperatures as high as 1090 °C. Both thermocouples were placed at midspan along the length of each column. One thermocouple was fastened to one of the longitudinal bars to record temperatures at the level of the steel reinforcement, and the other was suspended at the center of each column to record core concrete temperatures as shown in Figure 7. Five additional type K thermocouples owned by the fire testing facility were used to record the furnace temperature as well as the ambient temperature of the laboratory.

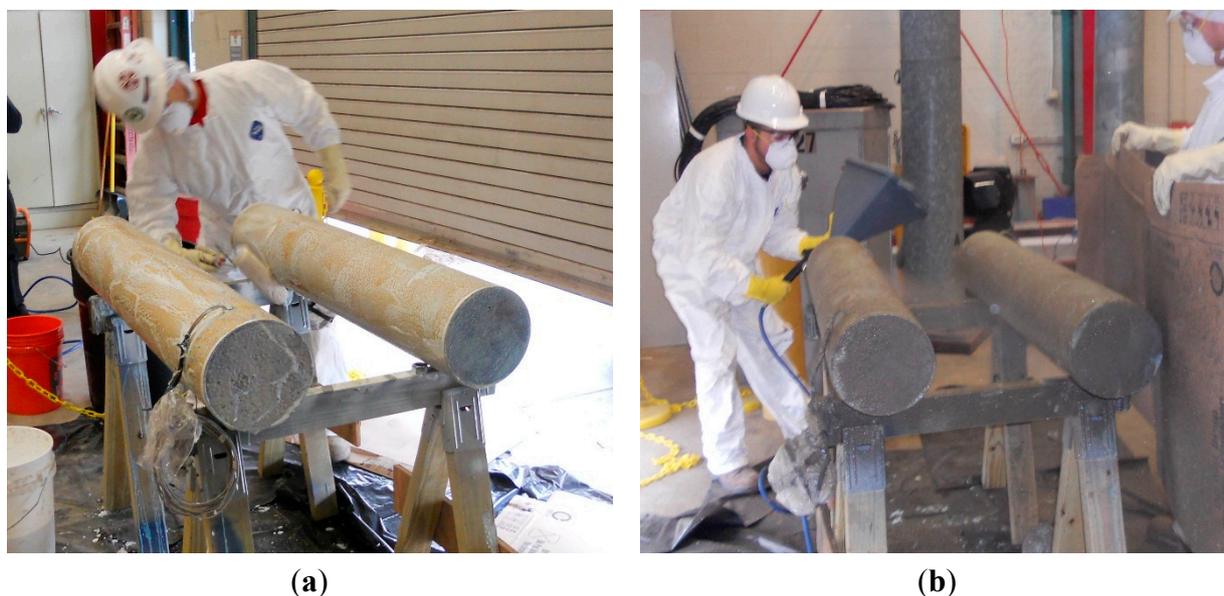
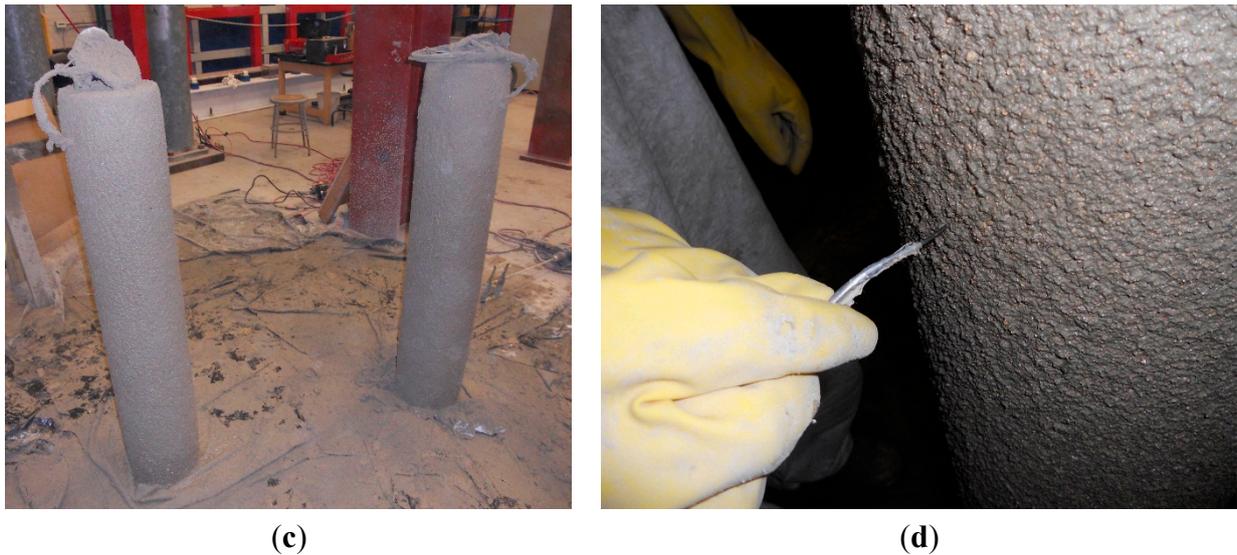
Figure 8. Complete process of Tyfo® CFP fire protection system application: (a) VG primer application; (b) VG dash coat application; (c) WR-AFP application; (d) thickness check of system.

The fireproofing application process was completed by Fibrwrap[®] technicians. First, the Tyfo[®] VG Primer was generously applied to the surface area of the columns. Following the primer, the second component of the CFP System, the Tyfo[®] VG Dash Coat, was spray-applied in a non-continuous spatter pattern and was allowed to dry for approximately 30 min. As the final component of the system, the Tyfo[®] WR-AFP was applied in multiple layers to achieve a minimum thickness of 15.9 mm (0.625 in). To ensure the thickness of the fire protection reached 15.9 mm (0.625 in), the prescribed thickness was marked on a piece of wire which was inserted into the wet material as shown in Figure 8d. Photos of the complete application process are displayed in Figure 8.

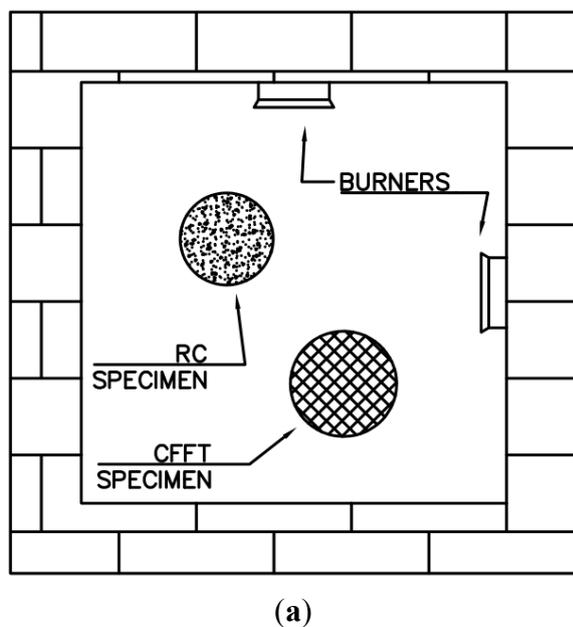
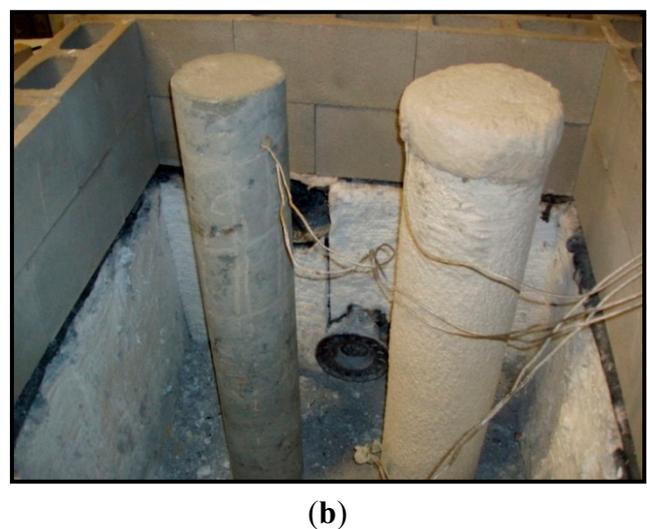
Figure 9. (a) Plan-view schematic of test setup and (b) test set-up photo.

The fire exposure tests were conducted at Guardian Fire Testing Facility in Buffalo, NY, USA. The laboratory’s furnace had a square footprint with inside dimensions of approximately 1.25 m (4 feet (ft)) and an adjustable height. The furnace was equipped with two natural gas burners located at the center of two adjacent walls as shown in Figure 9. After the columns were placed in the furnace, cinder blocks and insulation were used to adjust the height prior to placing the concrete slab cap.

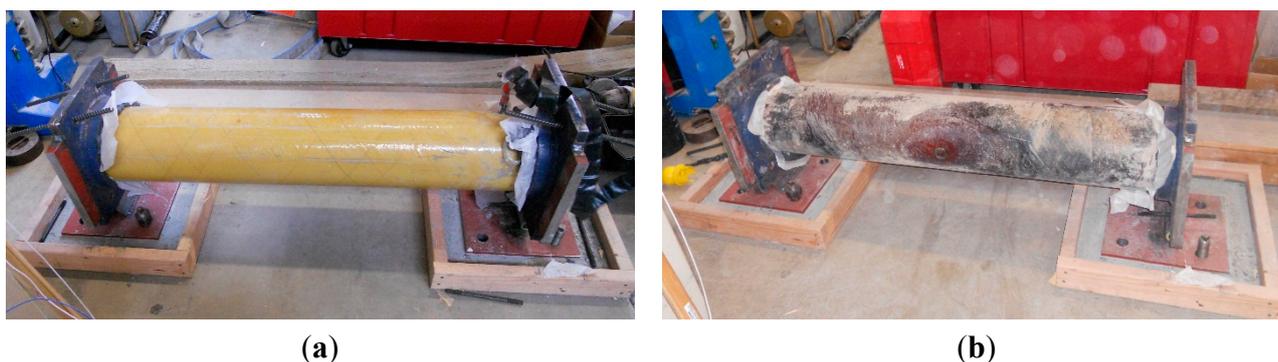
Figure 10. (a) Undamaged CFFT column and (b) discolored fire damaged CFFT column.

Upon removal from the furnace, none of the columns showed any significant outward signs of material degradation. The most noticeable signs of damage included discoloration of the FRP tube of the CFFT column after the 2-Hr test as shown in Figure 10b, and a change in the sound properties of the RC columns after both the 1- and 2-Hr durations. After the RC columns were removed from the furnace, a sound similar to that of a ceramic material was emitted when the surfaces of the columns were tapped rather than the typical sound expected when tapping a concrete column.

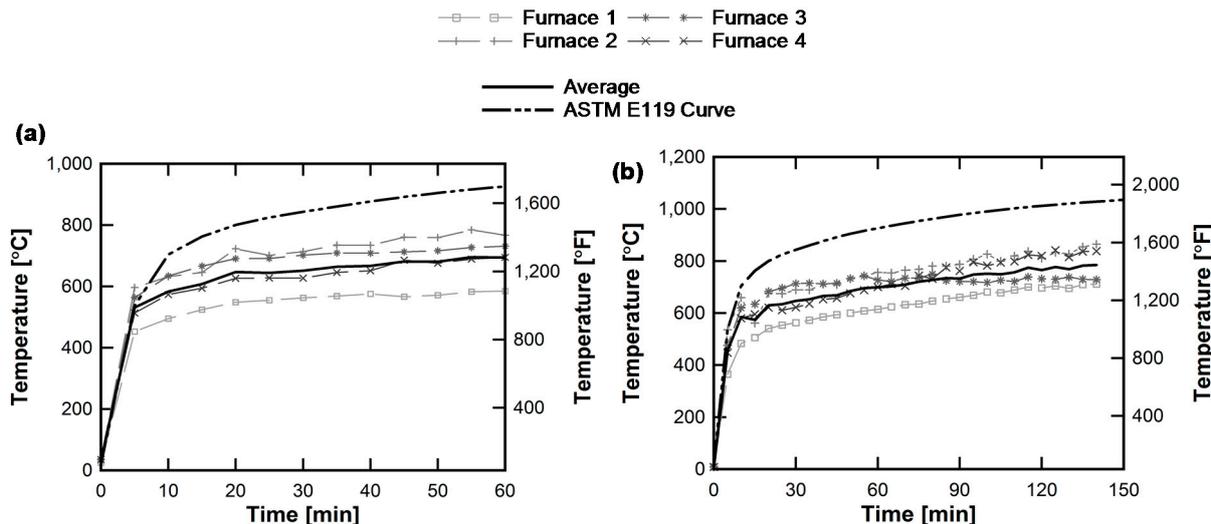
Figure 11. Furnace temperatures for (a) 1-Hr and (b) 2-Hr tests shown with the American Society for Testing and Materials (ASTM) E119 curve.

Furnace temperatures were recorded every five minutes throughout the duration of both tests, and the recorded temperature time histories are shown in Figure 11. Although the furnace burners were able to closely match the steep initial temperature increase rate of the ASTM E119 curve, the average furnace temperatures were about 200 °C below the ASTM curve for the majority of each test. The peak average furnace temperatures recorded were 696 °C and 786 °C for the 1-Hr and 2-Hr tests, respectively.

Because the furnace temperatures did not meet the ASTM standard, the 2-Hr test was extended by an additional 20 min. By prolonging the 2-Hr test, the total amount of temperature exposure, defined herein as the area beneath the temperature curve, was nearly 96,000 °C-min. This value falls within 10% of the total amount of temperature exposure for two hours following the ASTM E119 curve, or 105,000 °C-min. To maintain the differentiable levels of damage between the two tests, the furnace burners were extinguished at exactly 60 min for the 1-Hr test.

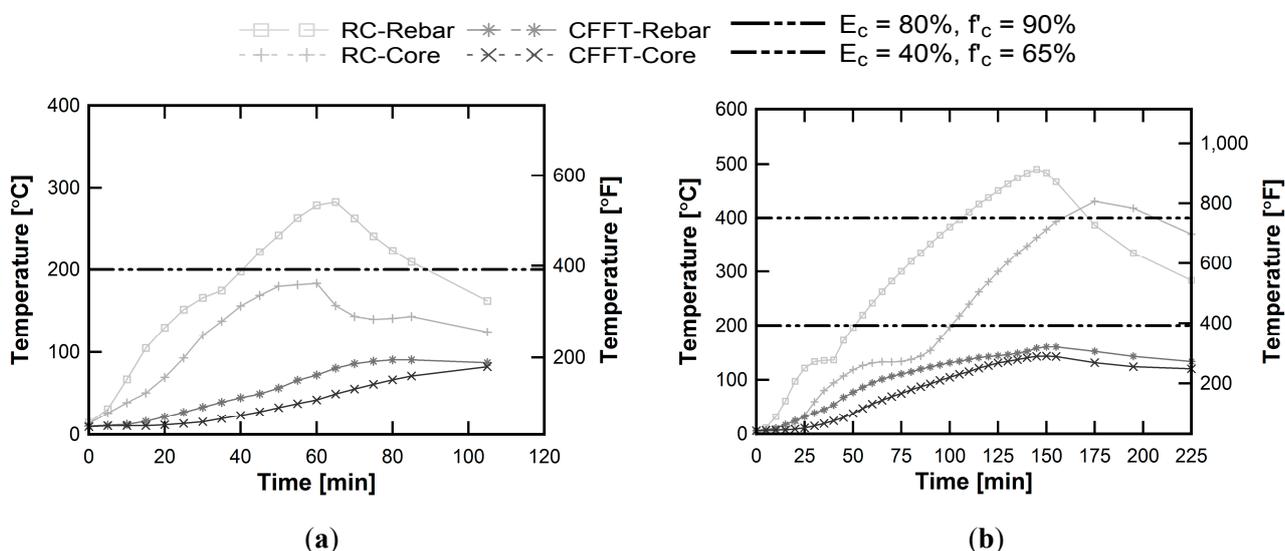
Figure 12. Interior concrete temperatures during the (a) 1-Hr and (b) 2-Hr tests.

Although the columns showed minimal evidence of structural damage, the temperatures of the interior concrete recorded during testing, shown in Figure 12a,b, indicated that there would be a reduction in both strength and stiffness of the RC columns. Chang *et al.* [37] established a database of concrete mechanical properties after being heated to temperatures as high as 800 °C. The study showed that concrete compressive strength is reduced by 10% at a temperature of 200 °C and by 35% at 400 °C. Similarly, the elastic modulus of concrete is reduced by 20% at 200 °C and by 60% at 400 °C. During the 1-Hr test, the concrete temperature at the level of the rebar reinforcement of the RC column reached 283 °C, exceeding the 200 °C threshold. During the 2-Hr test, the concrete of the RC column reached 431 °C at the core and 491 °C at the level of the rebar. Both temperatures exceed the 400 °C threshold, indicating significant losses in strength and stiffness of the entire cross section.

In comparison, the maximum concrete temperature recorded at the level of the rebar of the CFFT column during the 1-Hr test was 91 °C. For the longer duration tests, the peak concrete temperature of the CFFT column was 160 °C at the level of the rebar. Because the fire protection system was able to keep concrete temperatures of the CFFT columns below 200 °C during both test durations, no significant losses in strength or stiffness were expected in the following residual axial capacity tests.

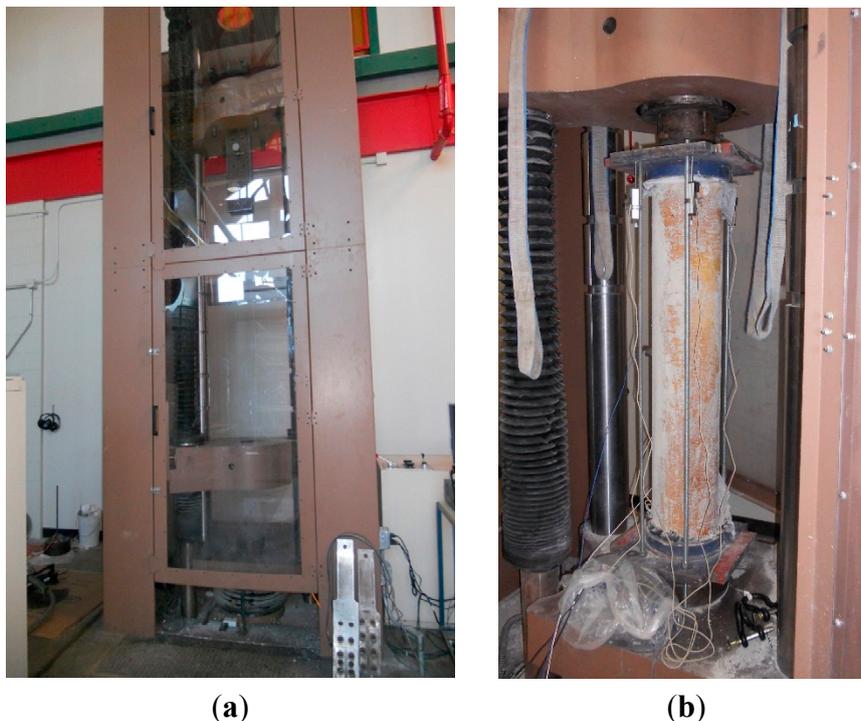
Figure 13. (a) Empty 400 kip load frame; and (b) CFFT 1-Hr axial load test setup.

Upon completion of the fire tests, the four damaged columns were returned to the UConn Structures Laboratory for axial capacity testing. Because bridge columns are primarily axial load carrying members, the residual axial load carrying characteristics were chosen as measures of post-fire robustness for the RC and CFFT columns. The four fire damaged columns (RC 1-Hr, RC 2-Hr, CFFT 1-Hr, and CFFT 2-Hr) as well as two undamaged benchmark columns, one of each type, were loaded axially to failure using a 1779 kN (400 kip) Satec load frame controlled by an MTS FlexTest 40 controller. The empty load frame is shown in Figure 13a.

softening effects of each column. Between each step, the columns were unloaded to a baseline load of 22.25 kN (5 kip) to capture unloading and reloading characteristics. The axial loads were captured directly from the controller, and the axial deformations of the columns were measured using four 50 mm (2 in.) Humboldt potentiometers. Figure 13b shows the complete load frame and potentiometer test setup of the CFFT 1-Hr column.

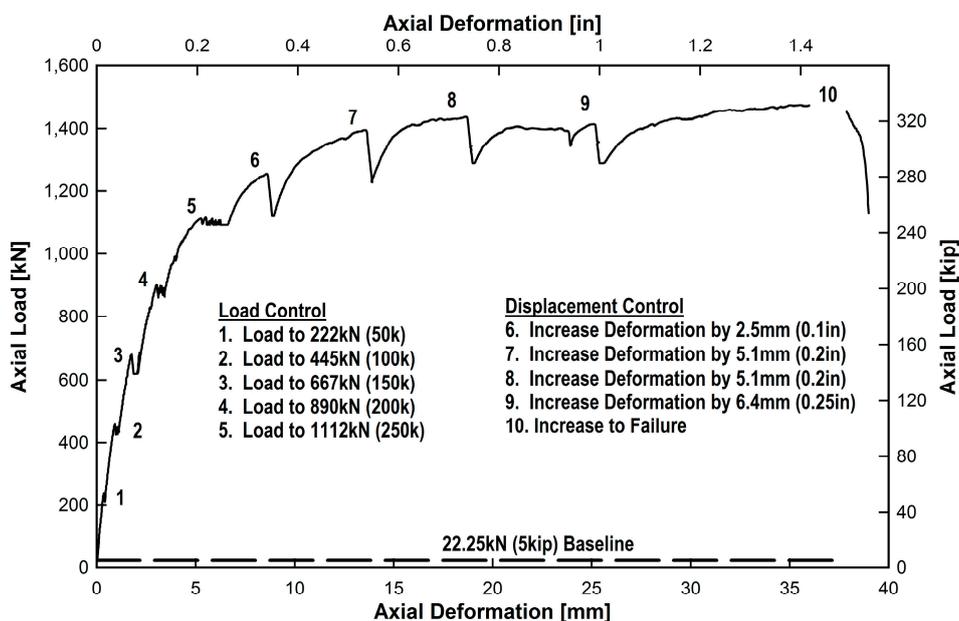
Figure 14. Loading protocol for axial capacity tests.

The 10-step loading protocol shown in Figure 14 was used to determine the axial load carry characteristics of the fire damaged and benchmark columns. The load was increased by 222 kN (50 kip) for the first five steps. Starting with step 6, displacement control was used to capture the

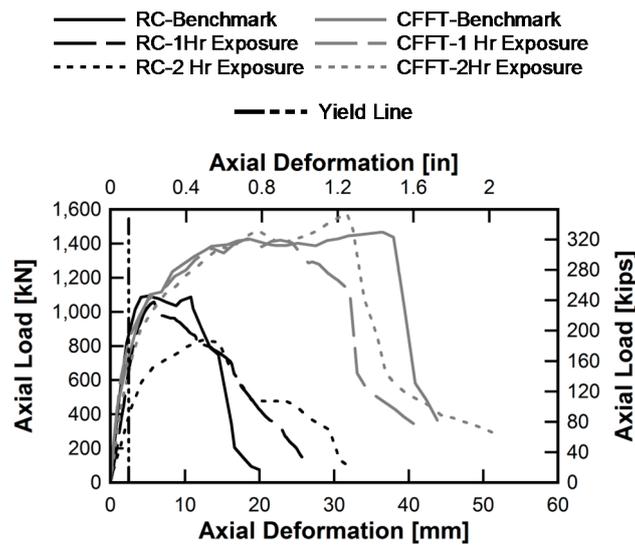
Figure 15. Load-deformation relationships of RC and CFFT fire damaged columns.

The load-deformation curves obtained from the six axial capacity tests are displayed in Figure 15, and a summary of the results can be found in Table 3. Strength measurements were taken at two locations along the curves. First, the maximum capacity was recorded. Next, the axial capacity at an axial deformation, δ_P , equal to 10 mm was recorded. This measurement was selected because the RC-Benchmark column first exhibits a loss in strength at $\delta_P = 10$ mm. The maximum axial capacities of the RC columns were reduced by 3.3% and 23.8% after one and two hours of exposure, respectively. At $\delta_P = 10$ mm, the residual axial capacities of the RC columns were compromised by 14.1% and 26.7% for the same respective test durations.

In contrast, the CFFT columns showed no significant loss in maximum capacity. The CFFT-1-Hr column had a negligible maximum capacity loss of 2.6%. The CFFT-2-Hr column actually exhibited a 7.3% increase in maximum capacity. The fire protection system applied to the surface of the CFFT columns allowed the concrete temperatures to elevate but not exceed 200 °C. In addition, the FRP tube slowed evaporation of the column's moisture content creating an environment similar to steam curing and causing a slight increase in maximum capacity. Negligible axial capacity losses of 2.7% and 5.2% were also recorded for the CFFT columns at $\delta_P = 10$ mm after one and two hours of exposure, respectively.

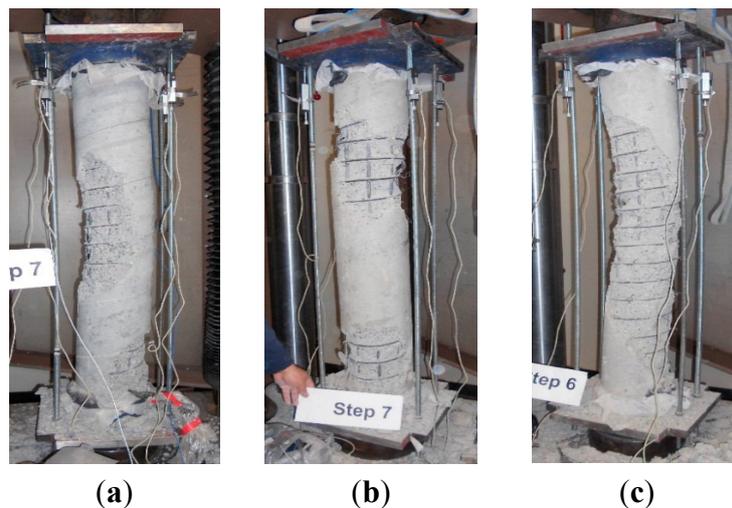
Figure 16. Failure modes of RC-benchmark (a); 1-Hr (b); and 2-Hr (c) exposure columns.

Figure 16 displays the failure modes of the RC-benchmark, 1-Hr, and 2-Hr columns under the incremental axial load. The failure mode of the RC-benchmark column was identified as concrete crushing at midspan which is the typical failure mode for a RC column under pure axial compression. The degradation of the compressive strength of the concrete material is seen in the failure mode of the fire-exposed RC columns. The degraded cover material spalled prematurely, ultimately resulting in the reduced axial capacity of the fire-damaged columns. The columns deformed axially until step 6 of the loading protocol when the loss of the cover concrete became non-uniform.

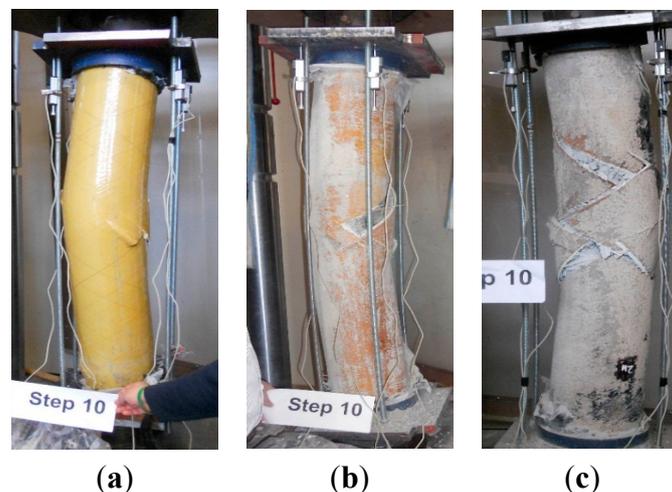
Figure 17. Failure modes of CFFT-benchmark (a); 1-Hr (b); and 2-Hr (c) columns.

Similar photos of the axial failure modes of the CFFT columns are shown in Figure 17. Because, the fire protection system was able to keep the FRP and concrete temperatures low, the fire-exposed CFFTs exhibit the same failure mode that is seen in the CFFT-benchmark column. Although the photos look as though the columns had significant bending stresses, the cap rotations measured by the potentiometers showed negligible rotation of the steel caps until step 10 when the FRP tubes ruptured at midspan.
