Measurement and Mitigation of Radon Concentration in a Traditional Dwelling in Galicia, Spain

Abstract: Radon is a naturally occurring radioactive gas which tends to build up within structures. It is therefore necessary to include techniques to mitigate radon concentration when undertaking refurbishment. The goal of this study is to assess the effectiveness of a mitigation technique based on pressurizing the interior of a building, by testing a prototype of the mitigating device, developed by Siglo 21 Consultores and the LaRUC of the University of Cantabria, under real conditions, to determine its effectiveness during refurbishment. The methodology involved installing the proposed solution in a traditional country dwelling in an area characterized by high radon concentration, on the coast of Galicia, Spain. In order to measure the effectiveness of the solution, continuous measurement sensors, set in an ionization chamber, and properly calibrated by the LaRUC laboratory, were installed. The results obtained show that pressurizing the living quarters brings about an effective reduction in the radon concentration, with a relatively simple building solution. This solution, which is co

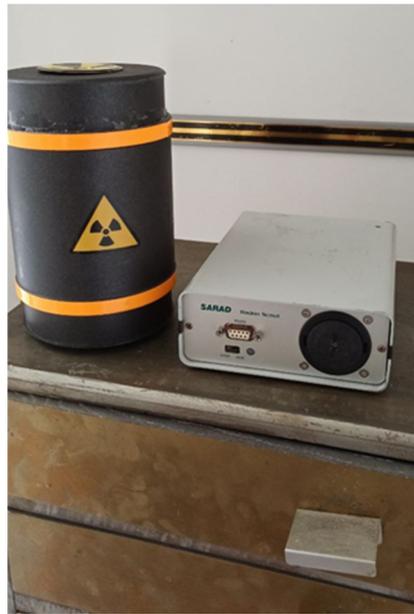
In order to gain a detailed understanding of the fluctuations in radon concentrations, and the effectiveness of the mitigation measures taken, a continuously measuring radon sensor was installed in the dwelling. This was a RICO Wireless model of the Interface[®] brand (A Coruña, Spain), using ionization chamber technology, with a calibration certificate from LaRUC (see Figure 2). This device allows the data gathered to be viewed in real time over the Internet.

Figure 2. Measuring devices. Source: photo by author.

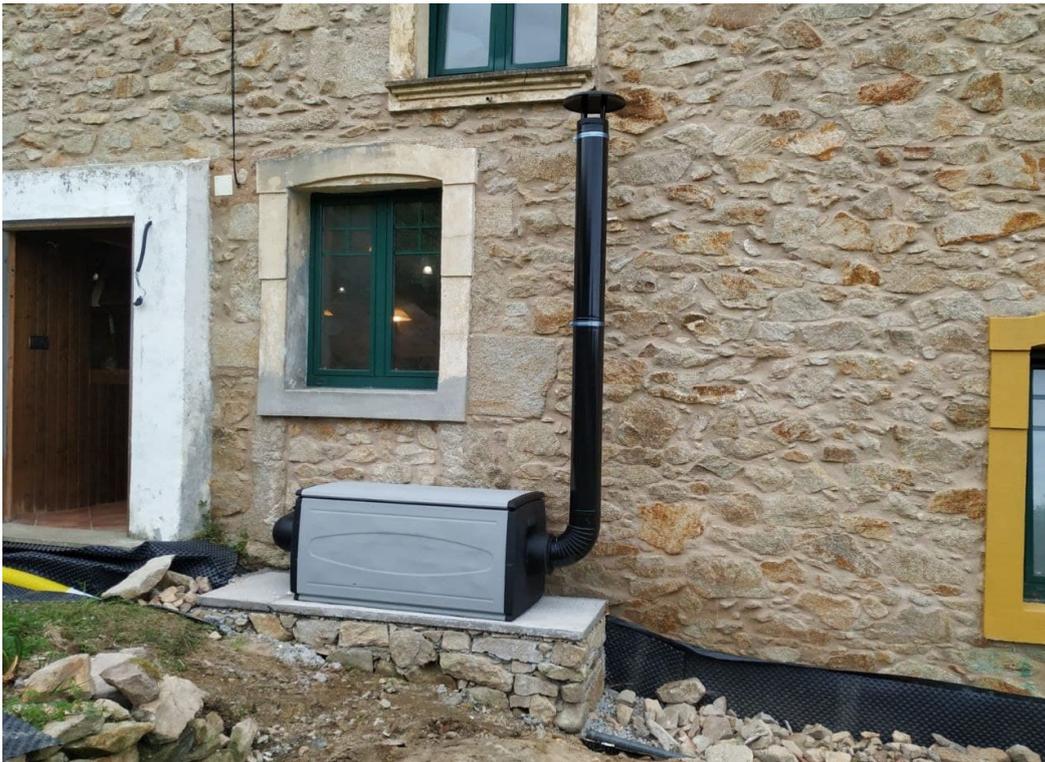
The device was placed on the ground floor, as it is in contact with the source. To minimize the impact of the activity, the device was placed next to the north face of the building (see Figures 3 and 4), with access to the kitchen through the wall below the windowsill. At this point the wall was thinner due to the narrowing of the opening, which made installation easier.

Figure 3. Mitigating device. Source: photo by author.

The prototype tested is an active mitigator of the brand Interface[®] (A Coruña, Spain), developed by Siglo 21 Consultores together with the LaRUC, and part of a preseries of two units, about which no further information can be given at the time of writing this paper as it is subject to a patent recognition process. It can be stated, however, that the working of the mitigator is based on pumping into the interior of the building, clean, dry air from the outside, with sufficient flow to maintain a positive pressure differential between inside and outside, in order to make it more difficult for radon from the ground beneath the building to penetrate inside.

The device reduces the concentration of radon gas through the use of a fan driven by electrical energy that injects a certain air flow from outside.

It also incorporates an activated carbon filter that prevents the passage of coarse particles (diameter less than or equal to $10 \text{ microns-}\mu\text{m}$) in order to guarantee that this air is clean of contaminants.

This air flow, which passes through the filter, is led by the fan towards an exchanger that heats or cools it depending on the chosen option. Two different exchangers are designed based on the pre-existing air conditioning technology in the building. In this case, the building is air-conditioned by means of a system based on biomass combustion, and the mitigator incorporates an electrical resistance and a solid–air exchanger. The combination of filter plus exchanger guarantees the quality of the interior air and solves the thermal aspect of the comfort. A suppressor is incorporated into this flow sequence that guarantees acoustic comfort by lowering the noise level of the unit.

The device, in accordance with the manufacturer's instructions, was placed on the outside of the building in an IP-65 rated box, which is linked to the dwelling through a ventilation duct in the outside wall.

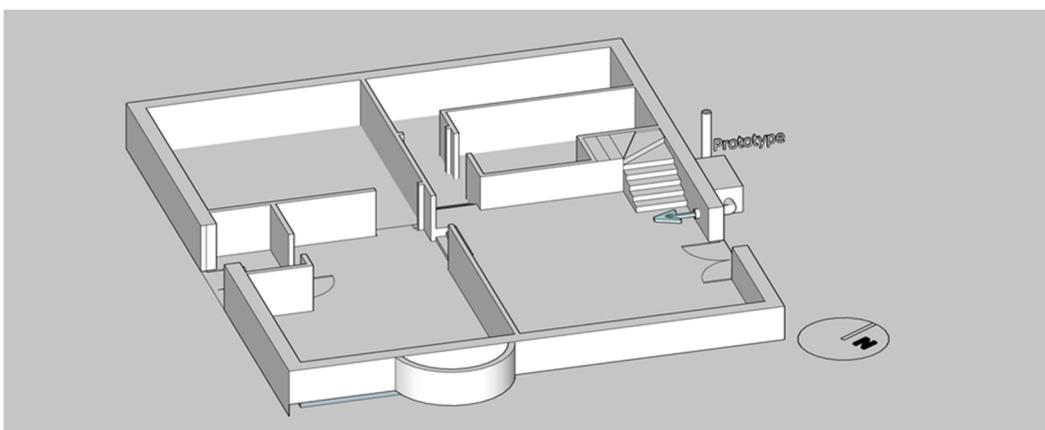
Figure 4. Plan of the installation. Source: created by author.

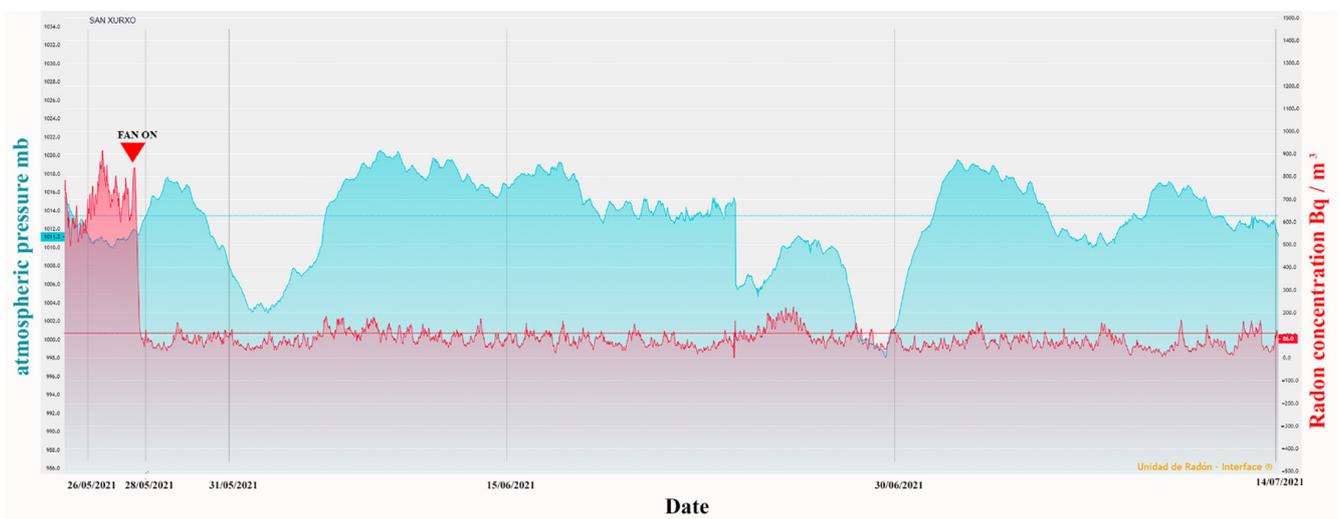
Once the installation work was finished, and before putting the device in operation, a prior measurement of the concentration was taken continuously over 48 h, with the purpose of determining the natural value of the concentration, which was found to be (686 ± 47) ($k = 2$) Bq/m^3 on average. The device was switched on at 12:00 on the 28 May, when the concentration inside the dwelling was $831 \text{ Bq}/\text{m}^3$ (see Figure 5). After 60 min, the concentration had dropped 28.40% to $595 \text{ Bq}/\text{m}^3$. Over the next few hours, the concentration continued to drop at the same rate, down to $90 \text{ Bq}/\text{m}^3$ at 16:00 h, and the concentration remained stable below $100 \text{ Bq}/\text{m}^3$.

Figure 5. Graph of radon concentration from 26 May 2021 to 14 July 2021.

Monitoring of the radon levels inside the dwelling continued over the next two months, using two continuous measurement devices placed within it: the first, a RICO model Interface[®] sensor calibrated by LaRUC [16], which gave an average exposure of (70 ± 7) ($k = 2$) Bq/m^3 , and as a contrast a second device, a SCOUT model SARAD calibrated by LaRUC [16], was used, which returned an average exposure of (76 ± 17) ($k = 1$) Bq/m^3 over the same period.
