# Effects of Erosion Control Works: Case Study—Grdelica Gorge, the South Morava River (Serbia)

**Abstract:** The aim of this research was to analyse the changes in the soil erosion intensity caused by erosion control works (ECW) in Grdelica Gorge (The South Morava River) in the period between 1953 and 2016. For the purpose of quantifying the erosion intensity changes, the erosion potential model (EPM) was used to calculate the annual gross erosion ( $W$ ), sediment transport ( $G$ ), and erosion coefficient ( $Z$ ) in the study area. As a result of the performed technical and biotechnical erosion control works, there was a general decreasing trend in the intensity of soil erosion processes in the last 63 years. The specific annual gross erosion in Grdelica Gorge was  $1920.34 \text{ m}^3/\text{km}^2/\text{year}^{-1}$  in 1953, while in 2016 it was  $492.42 \text{ m}^3/\text{km}^2/\text{year}^{-1}$ . The specific sediment transport was  $1421.05 \text{ m}^3/\text{km}^2/\text{year}^{-1}$  in 1953 and  $364.39 \text{ m}^3/\text{km}^2/\text{year}^{-1}$  in 2016. Due to the changes in the intensity of erosion processes, the specific annual gross erosion in the study area decreased by

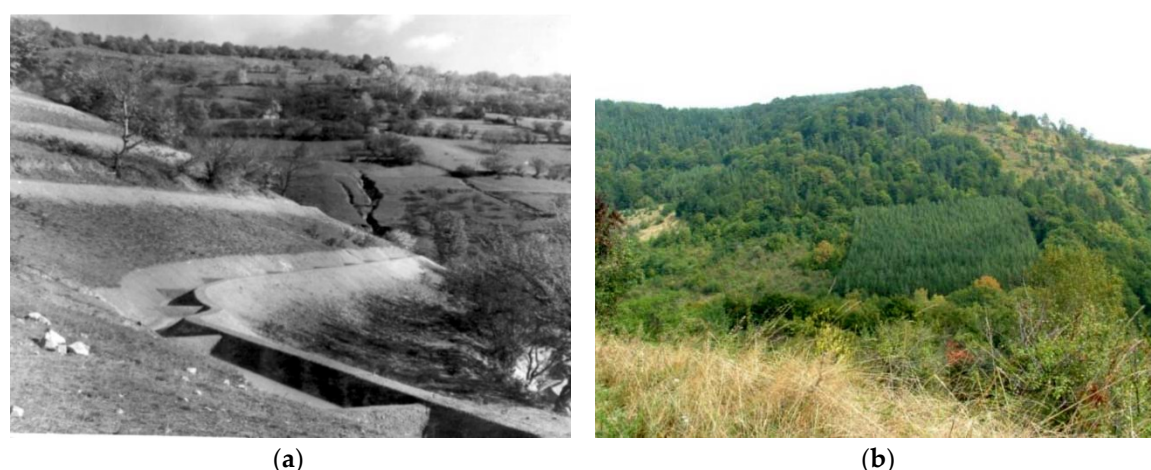
**Figure 3.** Contour ditches and afforestation of bare land: (a) 1953 [58]; (b) 2016 (photo: S. Braunović).

Biotechnical works included afforestation and grassing of barren land and establishment of orchards on terraced slopes (mild slopes). The species used for afforestation included Austrian pine, Scots pine, walnut, locust, chestnut, Turkish hazel, American ash etc. Grassing and pasture reclamation was carried out using a mixture of grass whose cover ensured the protection of slopes. In the early phases of bench terraces, planting was carried out in one or two rows, which resulted in very dense planting (even 4 seedlings per meter). This method of planting was dismissed because of the low survival rate and poor growth of seedlings and replaced with the one-row planting at a distance of 75 and 100 cm. Planting was carried out in pits. Live wattling was also successfully used (Krpejski potok).

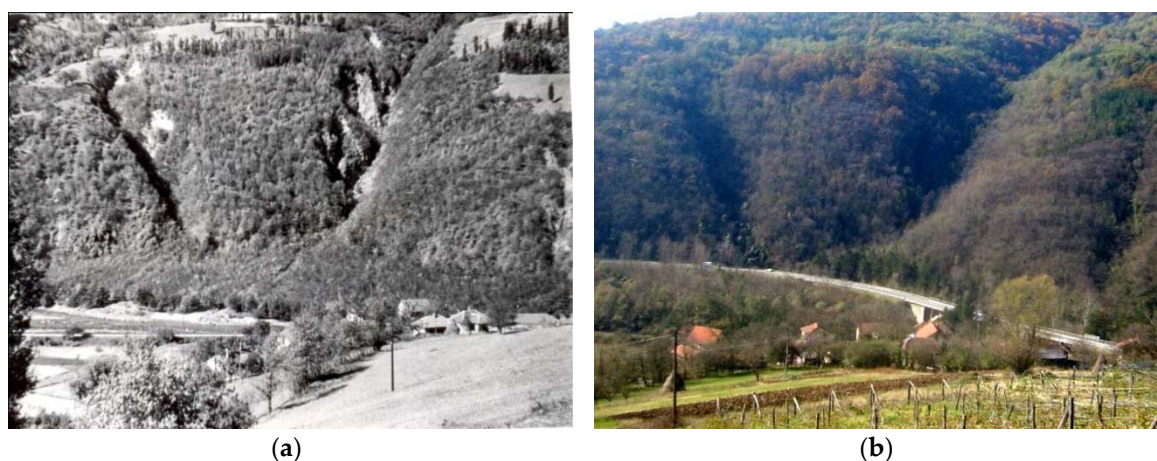
**Figure 4.** Land use change of Zla Dolina: (a) 1953 [58]; (b) 2016 (photo: S. Braunović).

A particular problem was their equal distribution in the valley of the South Morava and in the hilly mountainous region and the same method of cultivation being applied both on the steep and on the mild slopes. The smallest percentage of arable land was covered with orchards (6.28 km<sup>2</sup>), i.e., 3.5% of arable or 1.5% of the total area. The barren land formed by deforestation in the zones of watersheds and by planting along slope lines or under the influence of natural characteristics accounted for as much as 22.4% of the area of Grdelica Gorge (Table 5, Figure 4a).

According to the map data from 2016, 55% of Grdelica Gorge area is forestland, 0.57% of which are degraded forests. Meadows and pastures account for 25% of the area, composed of small surface areas near settlements or abandoned weed-covered ploughlands. Ploughlands are less represented (9.35%) and they are located not only along the South Morava but also at higher altitudes, as part of houseyards. These areas are fragmented and scattered. Planting is mostly done along the contour and the ploughland on steep slopes are abandoned. Thus, from the aspect of erosion, there is currently no danger. Orchards account for 1.96% of the area. The remaining parts of the area (10.2%) are unproductive areas: settlements (9.95%) and barren land which now occupy only 0.25% of the Grdelica Gorge area (Table 5, Figure 4b).
