Article

Field Testing of Porous Pavement Performance on Runoff and Temperature Control in Taipei City

Abstract: The Taipei University of Technology, under contract from the Taipei City Government, completed a study on porous asphalt (PA) and permeable interlocking concrete brick (PICB) pavement performance with respect to stormwater runoff reduction and surface temperature mitigation. Additionally, the variation of infiltration rates against time of these pavements was monitored. The results show the following: (a) Runoff peak reduction ranged from 16% for large, intense storms to 55% for small, long-duration storms. Rainfall volume reduction ranged from 16% to 77% with an average of 37.6%; (b) Infiltration rate: for PICB, it decreased by 25% to 50% over a 15-month monitoring period, but the rate at one location increased significantly after cleaning; for PA, the rate remained high at one location, but decreased by 70%–80% after 10 months at two other locations, due mainly to clogging problems; (c) Surface temperature: during storm events, porous concrete bricks had on average lower temperatures compared to regular concrete with a maximum difference of 6.6 °C; for porous asphalt

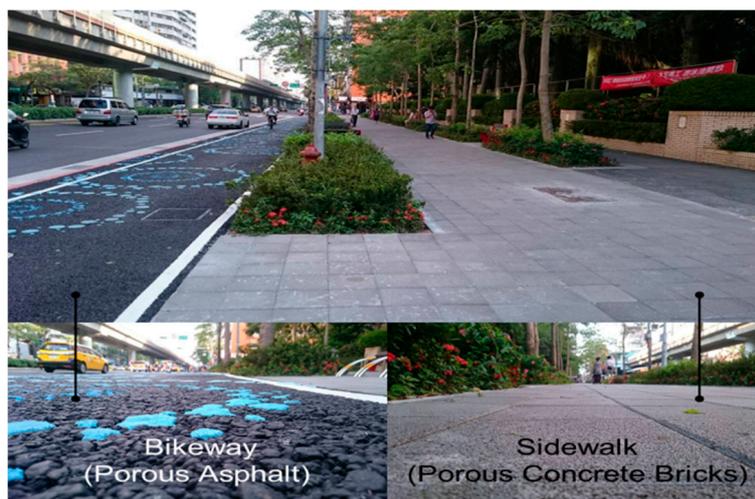
Figure 2. A picture of the permeable pavements test site.

A stretch of pedestrian walkway and a bicycle lane, each 200 m long, were constructed in front of the DAVHS by using porous concrete bricks and porous asphalt pavement, respectively. Figure 1 depicts the site location in Taipei City. The bicycle lane is parallel to a high-traffic road constructed with regular asphalt and concrete, which was used as a control. Underneath the walkway, two runoff storage tanks, each with dimensions of 70 m long, 2 m wide, and 0.5 m deep (70 m³ in volume) were constructed to store infiltration runoff water. Figure 2 is a picture of the test site.

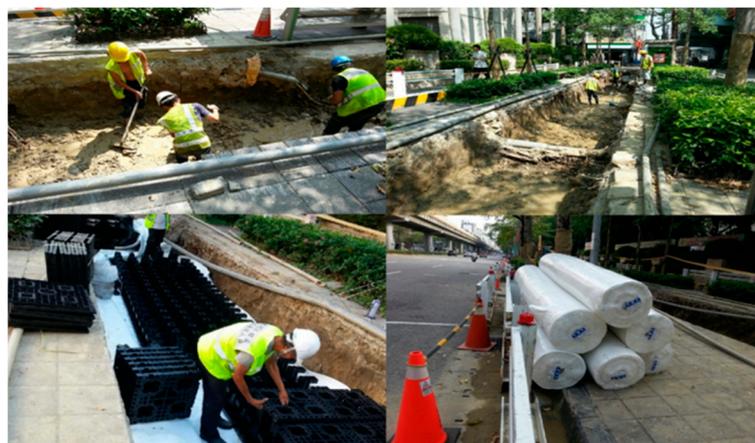
Figure 3. Installation of the underground stormwater storage tanks.

Figure 3 shows the installation of the underground stormwater storage tanks. A cross-section of the storage tank design with materials used is shown in Figure 4.

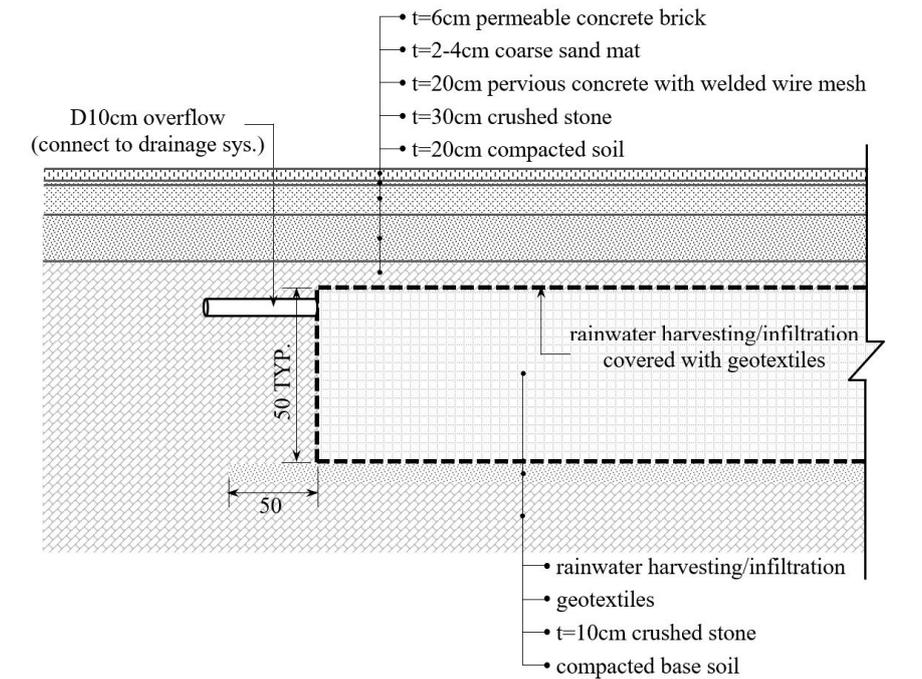
Figure 4. Cross-section of the underground rainwater storage system.

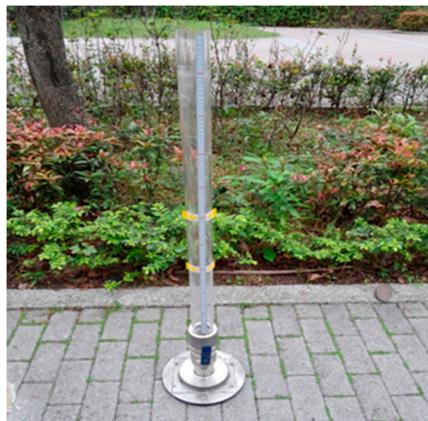
Infiltration rates at seven locations were measured on a monthly basis using permeameters, one of which is shown in Figure 5. The measurement process involved first filling the pipe with water, recording the height of the water level drop in the pipe per unit time, and calculating the infiltration rate at various times. The variation in infiltration rate was plotted over time, and the permeability coefficient (k) of permeable pavement was defined when the infiltration rate reached stability.

Figure 5. A permeameter.

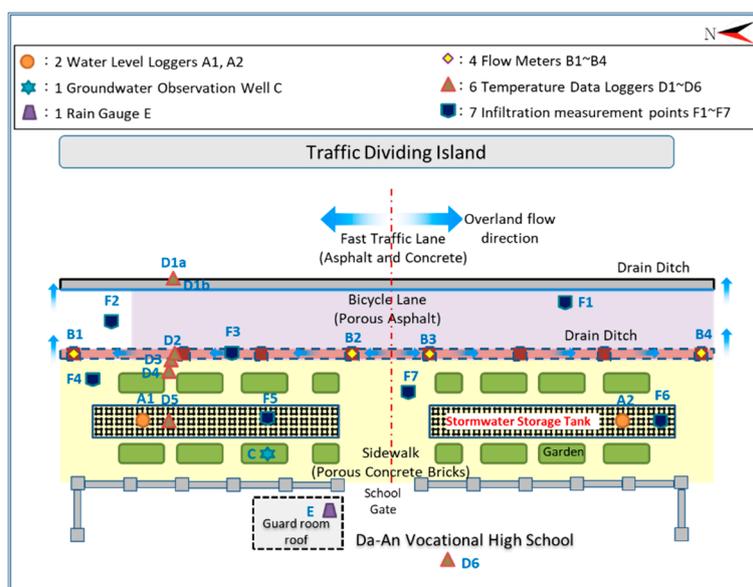
Figure 6. Field test site monitoring locations.

It should be noted that, as shown in Figure 6, the surface drainage dividing line (red dotted line) was at the center of the north–south regular traffic lanes and the bicycle lanes. The sampling points were placed so that data were collected on both sides, as described below:

- One rain gage on top of the guard room roof—E
- Two water level recorders, one each at the underground stormwater tanks—A1, A2
- Four flow meters—north side B1 and B2, south side B3 and B4
- One groundwater level recorder—C
- Six surface temperature recorders—D1 at fast traffic lane with regular pavement; D1a for regular asphalt and D1b for regular concrete section; D2 and D3 for porous asphalt bicycle lanes; D4 and D5 for permeable interlocking concrete brick walkways; and D6 for regular concrete (stucco washing finish) inside the school.
- Seven locations for infiltration rate measurements—F1 (south), F2 (north), and F3 (north on top of the drainage ditch) for porous asphalt bike lanes; F4 (north), F5 (north on top of underground stormwater tank); F6 (south on top of underground stormwater tank), and F7 (south) for PICB walkways.

A detailed description of the monitoring locations for the parameters listed above is shown in Figure 6.

Monthly infiltration rates for PA and PICB pavements were measured at seven locations (F1–F7) as shown earlier in Figure 6. The complete results are listed in Table 3.

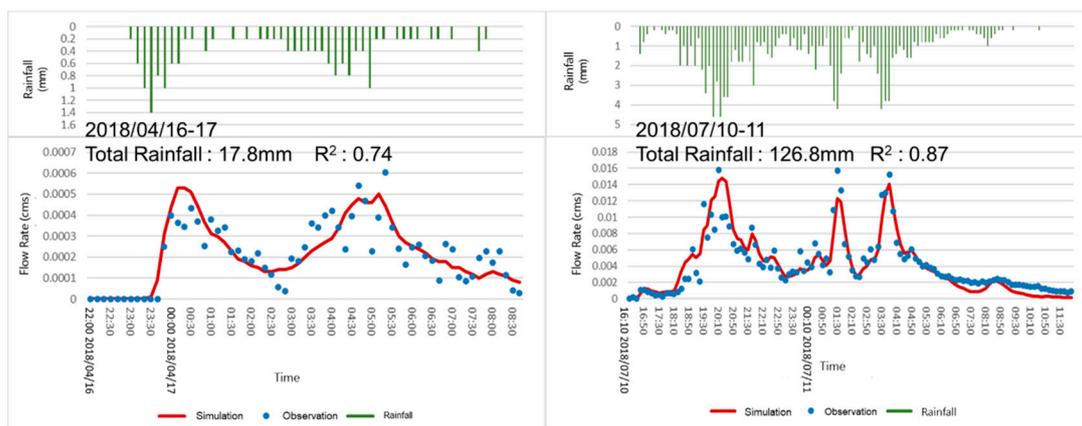
Figure 7. Calibration and validation of SWMM model.

To estimate the runoff reduction performance of the porous pavement, a widely used storm water management model (SWMM) was used. The model was calibrated and verified using local data obtained through this study (Figure 7). Details of the SWMM and how it was applied are described in Lin et al. [10].

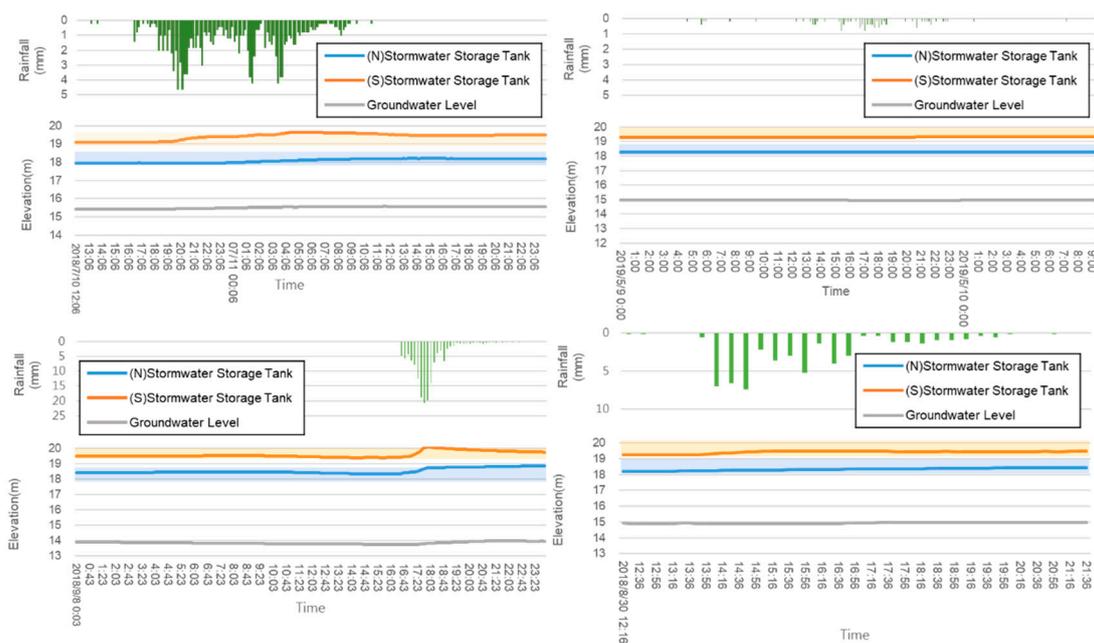
Figure 8. Groundwater and rain water storage tank level observations.

Groundwater levels, measured at hourly intervals, during the monitoring period did not show much variation at all, and were always below the bottoms of the underground storage tanks. This affirms that the storage tanks should have the entire volumes available for storing stormwater runoff. On the other hand, the two storage tanks showed increases in water levels and were even at the full-tank level when the rainfall amount reached the “large” storm category, as depicted in Figure 8.

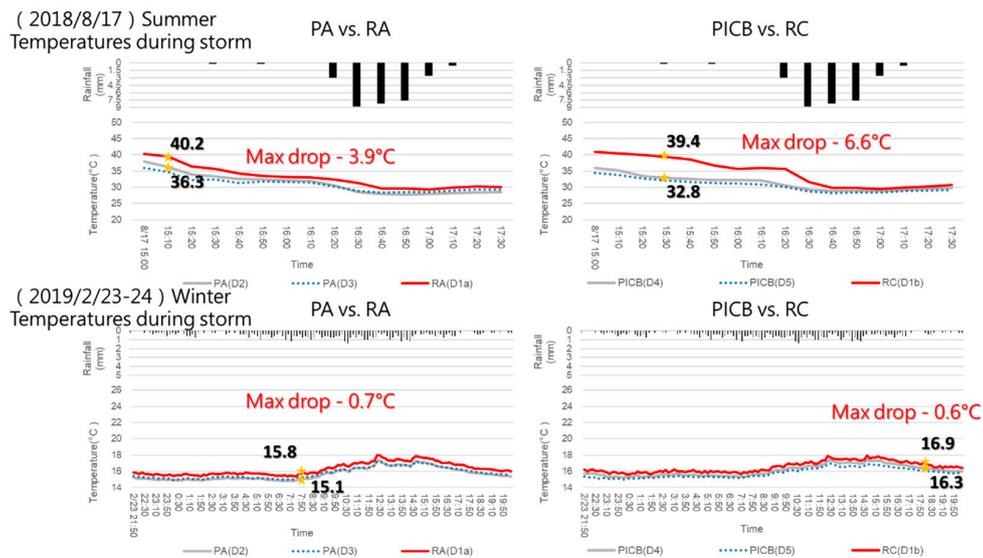
Figure 9. Surface temperature during storm events.

For porous asphalt, data taken at the bicycle lane showed that the surface temperatures for PA were consistently lower than those for regular asphalt pavement. A similar trend was observed for the permeable interlocking concrete bricks. Compared with regular materials, PA had a maximum surface temperature drop of 3.9 °C in summer and 0.7 °C in winter. For PICB the corresponding numbers were 6.6 °C and 0.6 degrees, respectively. The results are shown in Figure 9.

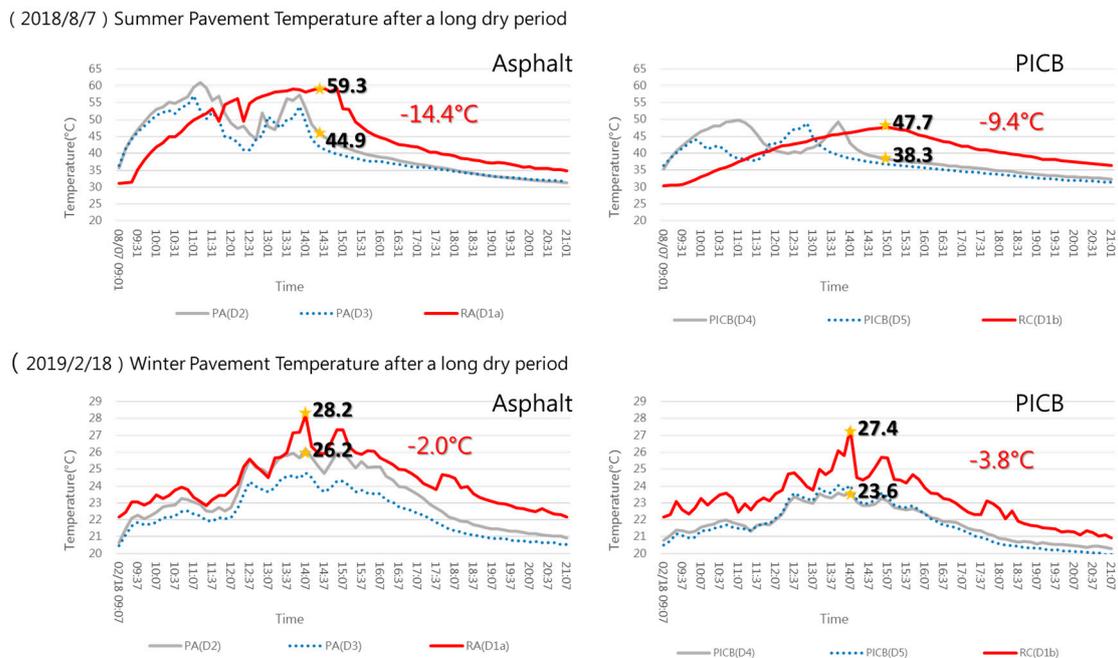
Figure 10. Typical surface temperature results during dry periods.

The data were taken after a prolonged dry period. A typical observation is shown in Figure 10. The 7 August 2018 data were taken after 13 dry days, and the 18 February 2019 data were taken after 1 month of no rain. All observations were made between 9 am and 9 pm at 10 min intervals on the sampling day.

The results indicate that during the winter time, both PA and PICB tended to have lower surface temperatures compared to those for regular materials. In the summer time, however, both porous pavements tended to show faster temperature rise as the air warmed up, but they also showed faster temperature drop as air began to cool down. The temperature drop observed on 7 August 2018 was 14.4 °C for PA and 9.4 °C for PICB, as shown in Figure 10.

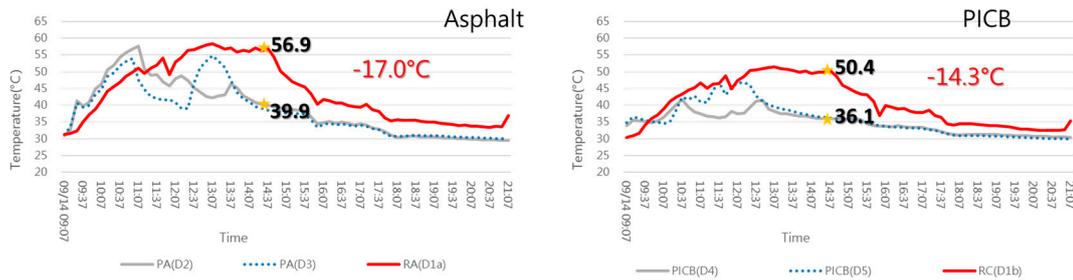
(2018/9/14) Summer Pavement Temperature after a long dry period

Figure 11. Surface temperature during dry periods—maximum values observed.

The maximum temperature differences between regular and porous pavements observed during prolonged dry and high air temperature periods were observed on 14 September 2018. As shown in Figure 11, the temperature differences were observed as 17.0 °C lower for PA and 14.3 °C lower for PICB.

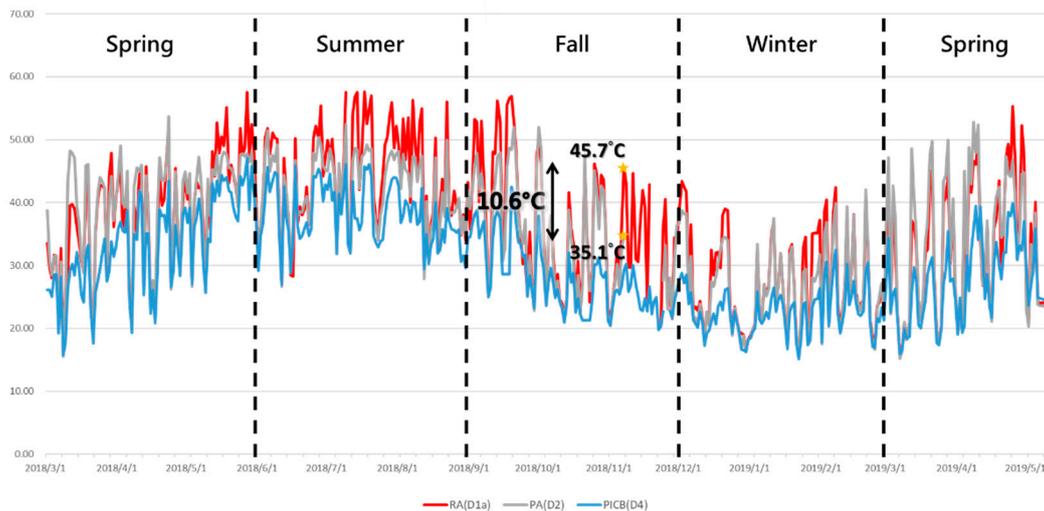
Figure 12. Time series of noon-temperature data.

A composite diagram depicting the continuous time variation of surface temperature for regular asphalt (RA), porous asphalt (PC), and permeable interlocking concrete brick (PICB) pavements is shown in Figure 12. The time series data show clearly that PA and PICB had lower temperatures compared to RA, especially during the high-temperature seasons of summer and fall. The temperature drop was not obvious for PA after January 2019 because the bicycle lane was modified to make the surface smoother in response to bicyclists complains.

During dry summer days when the air temperatures are in the high thirties °C, the regular asphalt road surface temperatures can reach 65 °C and above. Porous asphalt pavements have been reported to have higher daytime surface temperature but lower night time readings [5]. Data obtained in the present study showed a similar trend. For urban areas in regions with summer–fall rainy seasons, the overall benefits of lower temperatures for porous pavements should be considered. With less heat storage capacity, porous pavement should help mitigate the urban heat island impacts.

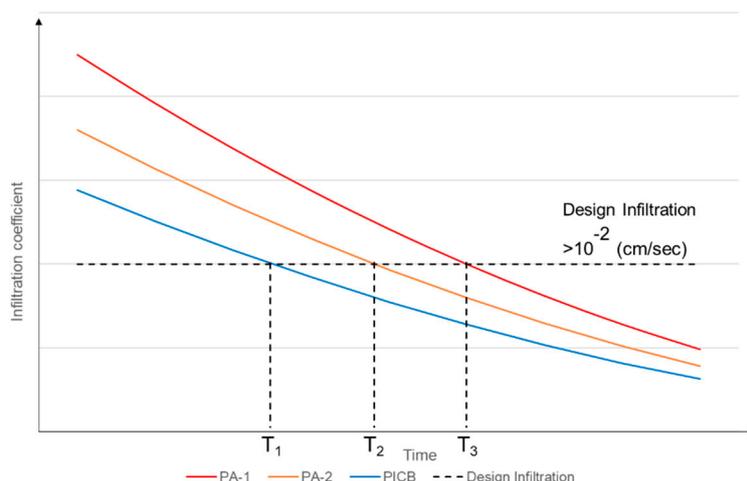
Figure 13. Proposed maintenance schedule curves for porous pavements.

In Figure 13, hypothetical infiltration curves for any two assumed porous asphalt materials and one assumed concrete brick material are shown based on available data. The minimum required infiltration is expressed as a horizontal line with, in this case, a value of 1.0×10^{-2} cm/s. The intersections of the curves with the required infiltration line give the times maintenance work is needed, i.e., T_1 , T_2 , and T_3 . Such information would be very useful for developing operation/maintenance manuals for porous pavement installations.

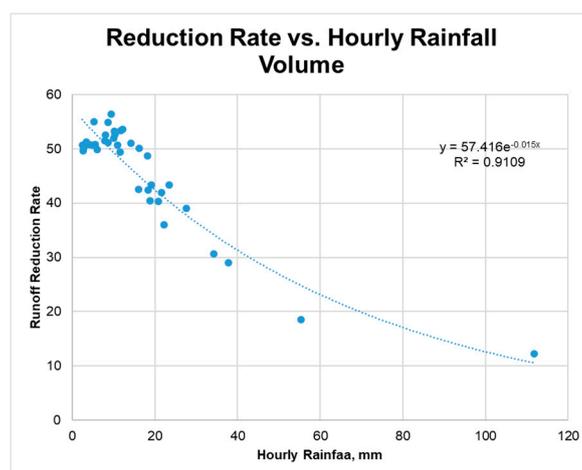
Figure 14. Runoff reduction rate vs. total hourly rainfall.

Data generated by the present study and those found in the literature all indicate that the runoff reduction rate is closely related to rainfall characteristics such as intensity, duration, and total volume of rain. Regression analyses were made relating the reduction rate to various rainfall parameters such as total rainfall volume per specific period of time, intensity, and time-variation of rainfall. It was found that the reduction rate vs. total amount of rainfall per hour had the highest correlation, as depicted in Figure 14.
