Article

An Ecological Function Approach to Managing Harmful Cyanobacteria in Three Oregon Lakes: Beyond Water Quality Advisories and Total Maximum Daily Loads (TMDLs)

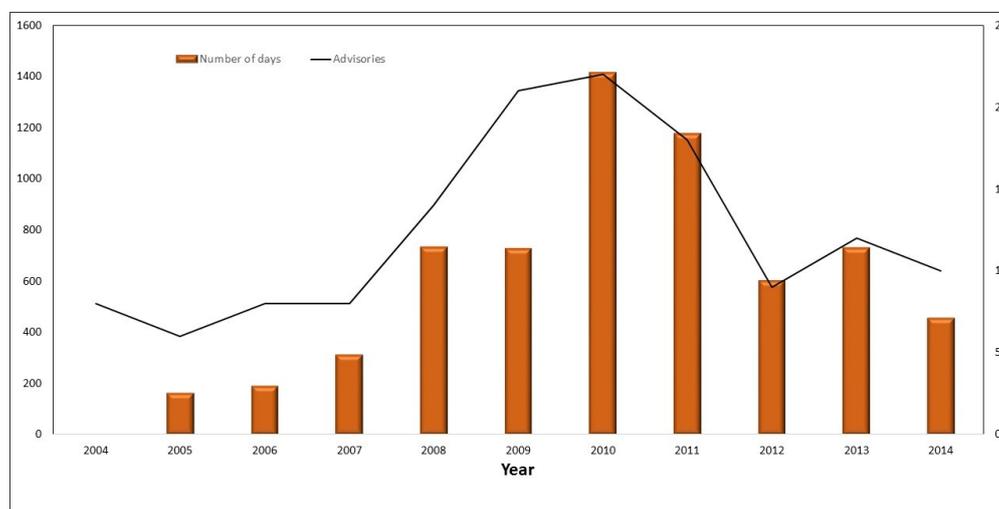
Figure 1. Oregon Department of Environmental Quality (ODEQ)'s number of harmful cyanobacterial blooms (CyanoHAB) waterbody advisories (line), and number of cumulative days per year (bars) under an advisory. (Available online: <http://www.oregon.gov/oha/ph/HealthyEnvironments/Recreation/HarmfulAlgaeBlooms/Pages/index.aspx>; accessed: 28 May 2019). *Note:* There were no CyanoHAB advisory days in Oregon for 2004.

As seen in Figure 1, ODEQ has had difficulty in reducing the number of advisories, and the number of waterbody days under an advisory, to below 2005 levels (when warnings were initiated). As a result, ODEQ used its regulatory authority to develop an early warning system to post health advisories, informing the public of the danger of increased exposure to CyanoHABs, and to “break” the exposure pathway (prevent contact with CyanoHABs in water and/or wildlife exposed to CyanoHABs). ODEQ and the USEPA marked the early warning system as a sign of success in solving immediate health problems. However, these existing protocols miss an opportunity to implement a long-term, sustainable solution to reduce the number of advisories. A sustainable solution is outlined for the Oregon Tenmile Lakes TMDL [37], which states that “improving watershed stream and wetland riparian functions was important in curtailing sediment and nutrient loads”. This study recommends using the ODEQ TMDL approach, in conjunction with, time-series photography, CyanoHAB advisories, and the PFC methodology, as a preferred (best) practice, instead of using TMDLs without complementary approaches. This study illustrates the use of the proper functioning condition (PFC) methodology in assessing the state of the ecosystem of three Oregon lakes, and in developing a resource management plan that can enhance those ecosystems.

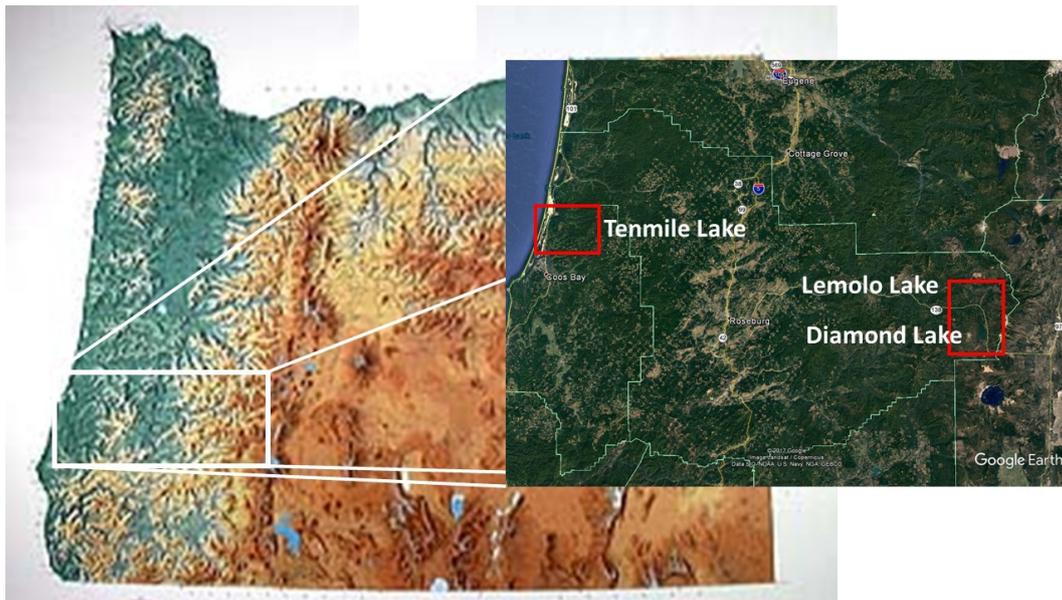
Figure 2. Map of the Lemolo Lake, Diamond Lake, and the Tenmile Lakes study areas. The larger image is a Landsat image from 15 July 2014. The inset image is from Google Earth.

The North Umpqua River is a tributary to the Umpqua River, which headwaters are in the low-relief province of the Cascade Mountains of southwestern Oregon (Figure 2). This portion of the Cascades is underlain by highly permeable Pliocene and Quaternary lava flows, which have low rates of surface-water runoff and sediment transport [43]. Forest management prior to 1970 predominantly consisted of extensive “clear cutting” [44]. After 1970, the forest management approach changed to smaller patchwork “clear cuts” (Figure 3). The United States Forest Service (USFS) ecosystem function assessment indicates that stream channel stability in the managed areas of the North Umpqua River watershed did not significantly differ from those in unmanaged drainages [45]. The USFS determined these streams were relatively stable, and in proper functioning condition [45]. Around 2005, the forest management strategy was changed to “forest thinning”, as seen around Lemolo Lake (Figure 3A,B).

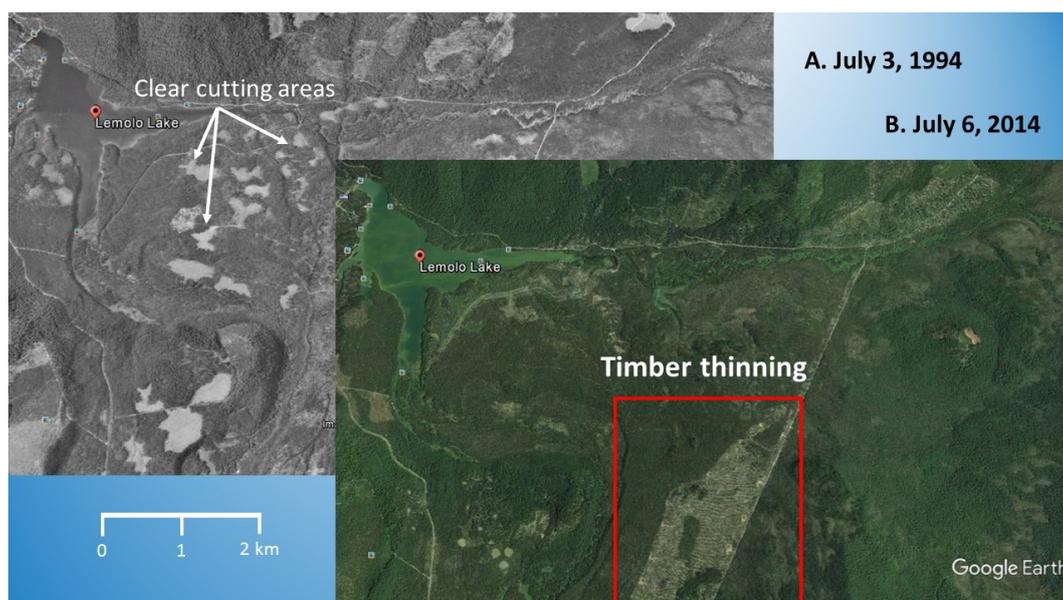
Figure 3. United States Department of Agriculture (USDA) black and white, and color aerial images, of the Lemolo Lake area, Oregon. Images were taken: (A) 3 July 1994 (black and white), and (B) 6 July 2014 (color). Bright patches in image A indicate areas of clear cutting. The red boundary in image B is an area currently being thinned. Source: Images obtained from Google Earth.

Phosphorus is associated with the decomposition of the volcanic rock of the Cascade Mountains, which have been “clear cut” (Figure 3A) [42]. Remote sensing analysis indicated there was a change in forest management from “clear cutting” (Figure 3A), prior to 2005, to “forest thinning” (Figure 3B).

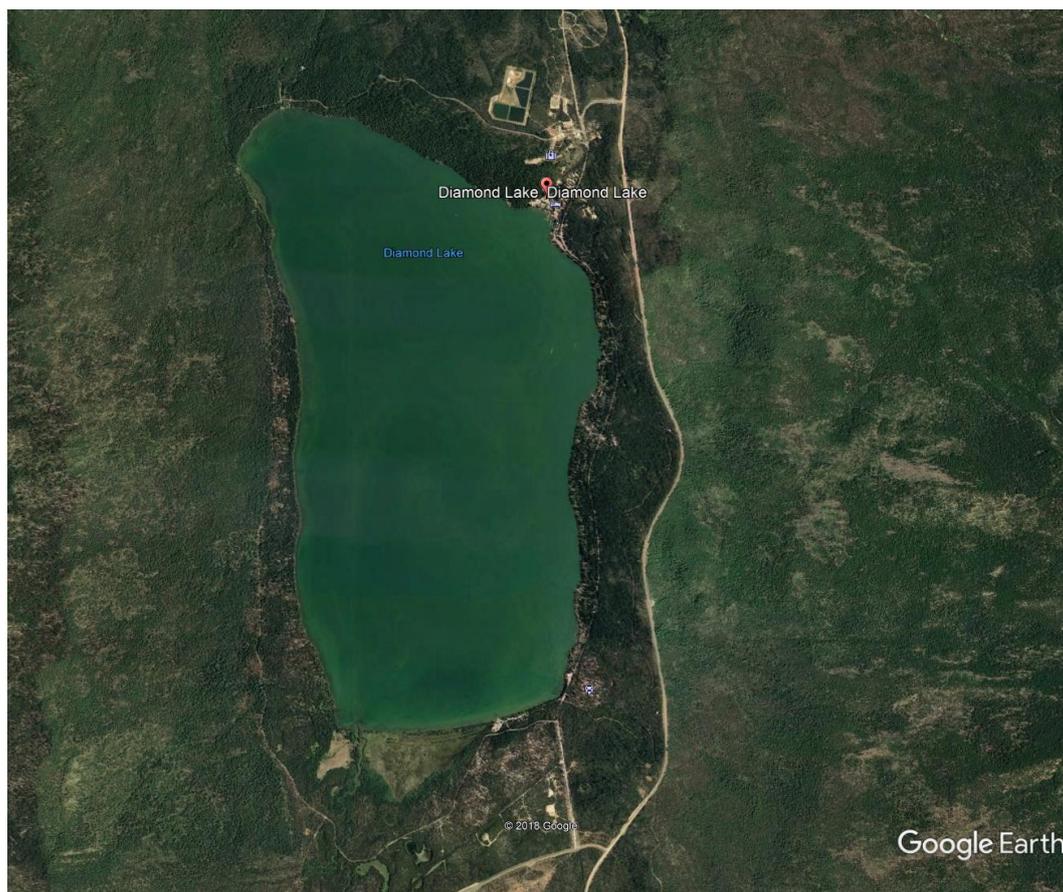
Figure 4. Satellite image of Diamond Lake, Oregon. Image taken 6 July 2014. Source: Image obtained from Google Earth.

Diamond Lake (Figure 4), a nitrogen-limited eutrophic lake, peaking at 0.5 mg/L total nitrogen (N), and nearly 0.2 mg/L ammonium-N in 2007 [41], is an important source of water and nutrients to the North Umpqua River [46]. Diamond Lake is listed as a “water-quality limited” waterbody (pH, CyanoHABs). Diamond Lake is naturally high in phosphorus, as high as 0.060 mg/L [41]. CyanoHABs have occurred in Diamond Lake since 2001 [46], resulting in closures of recreational water facilities. Increased CyanoHABs have been attributed to increased populations of the invasive, zooplankton-eating, Tui Chub fish [47]. Tui Chub feed on zooplankton that would otherwise control phytoplankton and CyanoHABs. The Final Environmental Impact Statement (FEIS) for the Diamond Lake Restoration Project advocated reducing Tui Chub fish biomass in Diamond Lake (natural lake) as the preferred restoration alternative (Available online: http://www.dfw.state.or.us/fish/local_fisheries/diamond_lake/restoration-update.asp; accessed: 28 May 2019). However, dam releases from Diamond Lake, beginning in 2006 resulted in nutrients impacting the summer trophic status of the downstream portion of the North Umpqua River, and Lemolo Lake (impoundment) (Figure 5).

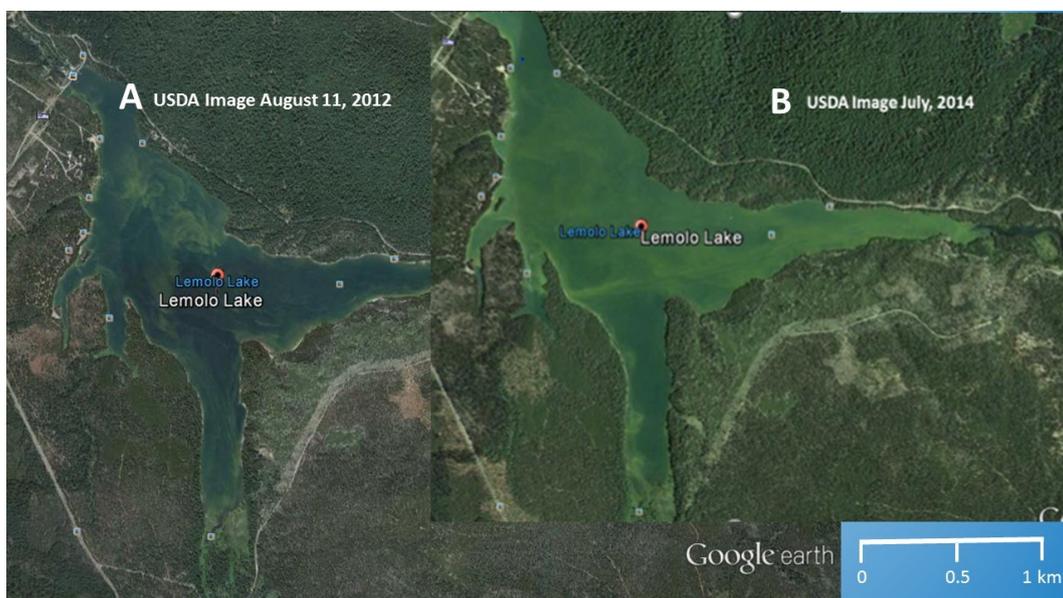
Figure 5. USDA color aerial images of Lemolo Lake, Oregon. Images were taken: (A) 11 August 2012 and, (B) July 2014. Bright green areas within Lemolo Lake (image B) indicates an extensive cyanobacterial bloom occurring at the time the image was taken. Source: Images obtained from Google Earth.

Lemolo Lake, which is the upper-most impoundment on the North Umpqua River, is downstream from Diamond Lake (Figure 5). Hydrodynamic modeling [46,48] of the reservoir indicated an unusual

In Diamond Lake, during the second year of the Tui Chub eradication program (2007), dramatic improvements were noted in water clarity and aquatic community populations [52]. In 2009, the cyanobacterial level had further reduced to a point that Diamond Lake could meet its water quality standards [52]. As seen in Figure 5, Lemolo Lake would take a few more years to meet that goal.

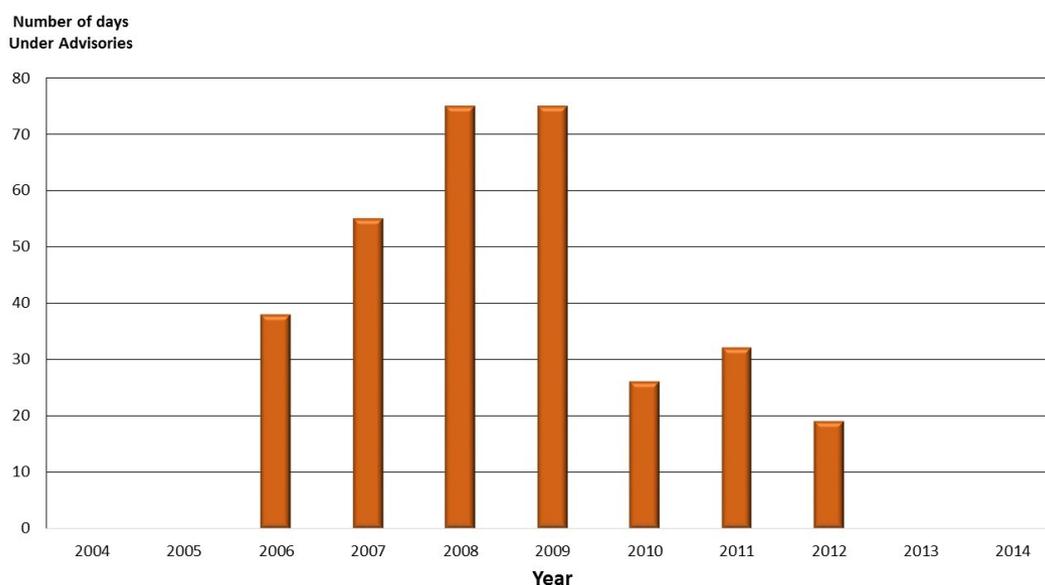
Figure 6. Oregon Department of Environmental Quality’s (ODEQ) harmful cyanobacterial bloom (CyanoHAB) advisories for Lemolo Lake, and the number of days under an advisory. Current (post-2014) data has not been posted on the website: (Available online: <http://www.oregon.gov/oha/ph/HealthyEnvironments/Recreation/HarmfulAlgaeBlooms/Pages/index.aspx>; accessed on 28 May 2019). **Note:** There were no CyanoHAB advisory days for Lemolo Lake in 2004, 2005, 2013, and 2014.

After implementation of the Tui Chub eradication program, the number of days Lemolo Lake was under an advisory were increased in 2007, peaking in 2008 and 2009. In 2010, the number of days under a health advisory was reduced by almost two-thirds (Figure 6). When Diamond Lake was drained, to lower the volume of the lake, and apply less Rotenone pesticide, to eradicate the Tui Chub [45], it had a downstream impact on Lemolo Lake [46,47]. Increased nutrient load into Lemolo Lake overwhelmed the aquatic ecosystem, causing eutrophication, and creating a large area of CyanoHAB (Figure 5), originating from the phosphorus-rich Upper Umpqua River.

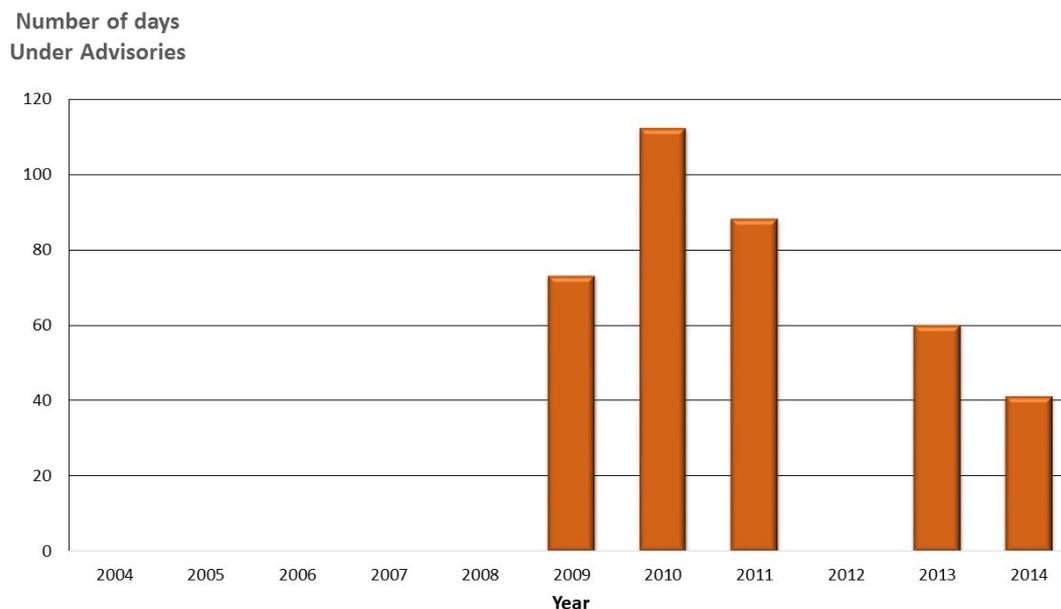
Figure 7. Oregon Department of Environmental Quality’s (ODEQ) harmful cyanobacterial bloom (CyanoHAB) advisories for Tenmile Lakes and the number of days under an advisory. Note: There were no CyanoHAB advisory days for Tenmile Lakes in 2004, 2005, 2006, 2007, 2008, and 2012.

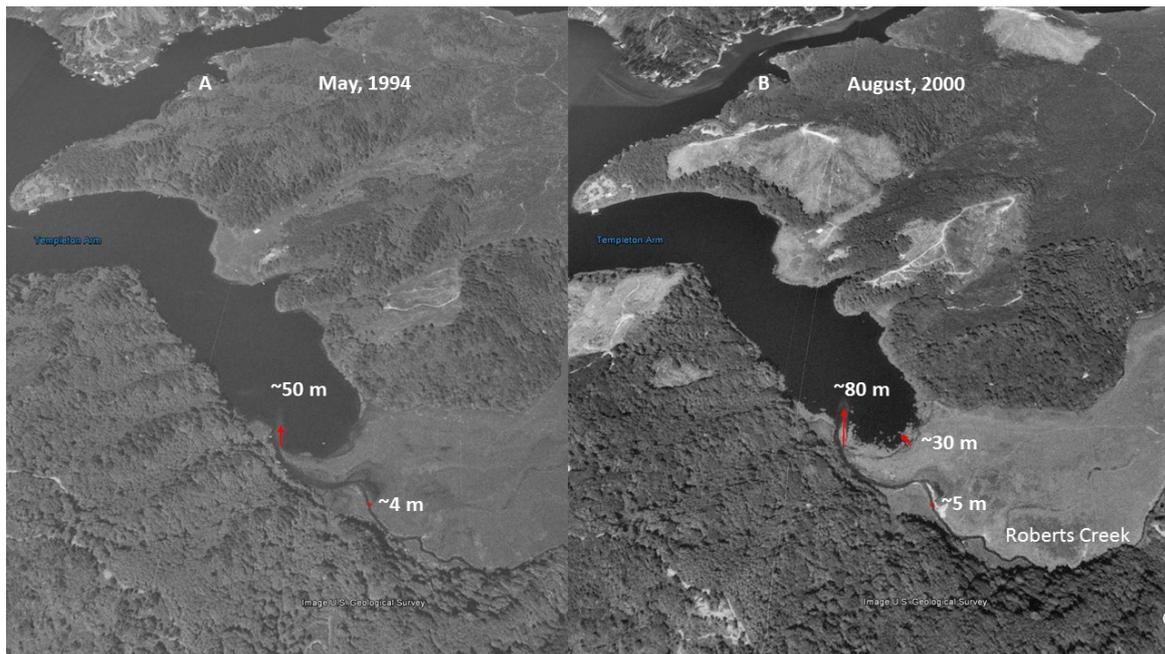
Figure 8. US Geological Survey aerial images of Tenmile Lake, Templeton Arm, and Roberts Creek. (A): The May 1994, black and white aerial image shows the Roberts Creek channel is incised, and the delta is expanding. (B): The August 2000, black and white aerial image shows the Roberts Creek channel has expanded (Note: the white area indicates stream bank slumping), and the delta has extended into the lake approximately 30 m farther than the May 1994 image. It also shows increased clear cuts on the slopes in three areas north of (above) the lake. Source: Images obtained from Google Earth. Note: Red arrows show the extent of delta growth.

Flood irrigation of the meadow required building a diversion dam, and a channel, to flood the upslope side of the field (Figures 8 and 9—north side), consequently incising Roberts Creek, for the

irrigation tail-water to run into (Figures 8 and 9—south side). Lowering the base of the channel caused incision, with a nick point or nick zone, to migrate up the river and tributaries, thus disconnecting the stream from its flood plain. Channelization, and the incising of Roberts Creek, funnels the flow within the channel, resulting in an increased peak flow, causing further incision and bank erosion. Incision, with decreased floodplain access, greatly diminishes sediment and nutrient capture during floods, and greatly diminishes nutrient uptake by riparian vegetation, and the denitrification process [10].

The increased sediment load and dominance of invasive fish species (e.g., Tui Chub, bass) in the Tenmile Lakes have vastly altered the historic condition of the coastal lake ecosystem [42]. These factors indicate changes in the functional condition (i.e., physical processes) of the lakes and watershed, resulting in decreased water quality, loss of salmonid habitat, altered aquatic food chain dynamics, and associated increased CyanoHABs (Figures 8 and 9).

As displayed in a May 1994 black and white (BW) aerial image (Figure 8A), the physical condition of Roberts Creek had an incised stream channel, with an increasing delta, into the Templeton Arm of Tenmile Lake. Delta building indicates two potential sources of sediment: stream channel incision and subsequent channel evolution [14], and other potential land management impacts (e.g., grazing, timber harvesting, and road construction in the harvested areas). In an August 2000 image (Figure 8B), the delta extended approximately 30 m further than in May 1994. The stream channel had widened, and matted CyanoHABs were present, and extending out from the shore. The increase in the delta from 1994 to 2000 matched the sediment increase in the Tenmile Lake core during the same period [37].

As shown in the August 2007 USGS color aerial images of Roberts Creek (Figure 9C), the delta extended approximately 70 m further into the lake than in 1994. In Figure 8B, logging occurred along the north side, and west end, of the Templeton Arm of Tenmile Lake. In 2007 (Figure 9C), logging extended along the length of the Templeton Arm, and into the lower Roberts Creek catchment. The spatial area of the CyanoHAB was larger, and extended further along the shoreline than in August 2000 (Table 2). The July 2012 color aerial image (Figure 9D) shows that the Roberts Creek channel was unchanged, and the delta had decreased in length, by approximately 10 m, from the August 2007 image (Table 2). However, CyanoHABs were much more intensive, and occupy large portions of the shoreline. By 2012, the logged areas were revegetating, and showing some recovery of upland vegetation.

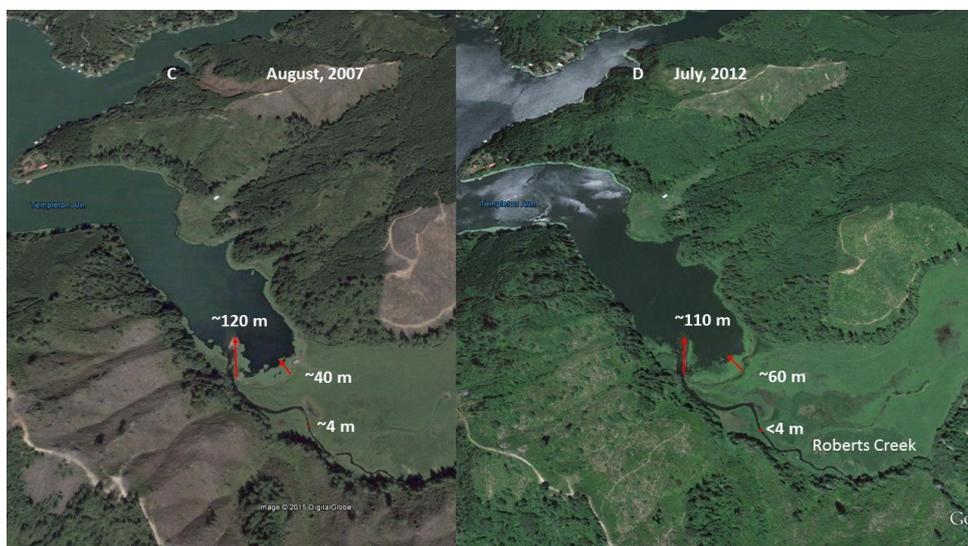
Figure 9. US Geological Survey color aerial images of Tenmile Lake, Templeton Arm, and Roberts Creek. (C): The August 2007, aerial image shows the Roberts Creek channel is incised, and the delta is expanding. (D): The July 2012, aerial image shows the Roberts Creek channel is unchanged, and the delta has been reduced by approximately 10 m from the August 2007 image. The August 2007 image also shows increased clear cuts on the slopes in three areas south of (below) the lake. Source: Images obtained from Google Earth. Note: Red arrows show the extent of delta growth.

Ecosystem function is notably distinct from other water quality management tools [51]. As seen in Figure 9D, it is difficult to determine which best management practices (BMPs) were applied to the logged area (e.g., replanting, road removal). Because of this, other land managers (private, public) require extra steps to determine if the BMPs used could be replicated on their site. To improve BMP sharing, the USEPA maintains a database that tracks restoration projects using the Clean Water Act Section 319 (CWA 319) NPS project tracking system called the Grants Reporting and Tracking System (GRTS—Available online: <https://iaspub.epa.gov/apex/grts/f?p=grts:95>; accessed: 28 May 2019). GRTS is the central oversight, management, and data-sharing tool for the Clean Water Act's Section 319 Program. All data in GRTS is entered by state, territory, or tribal agencies receiving Section 319 grants. Unfortunately, for the Tenmile Lakes, the GRTS CWA 319 tracking system did not have information on the BMPs used.

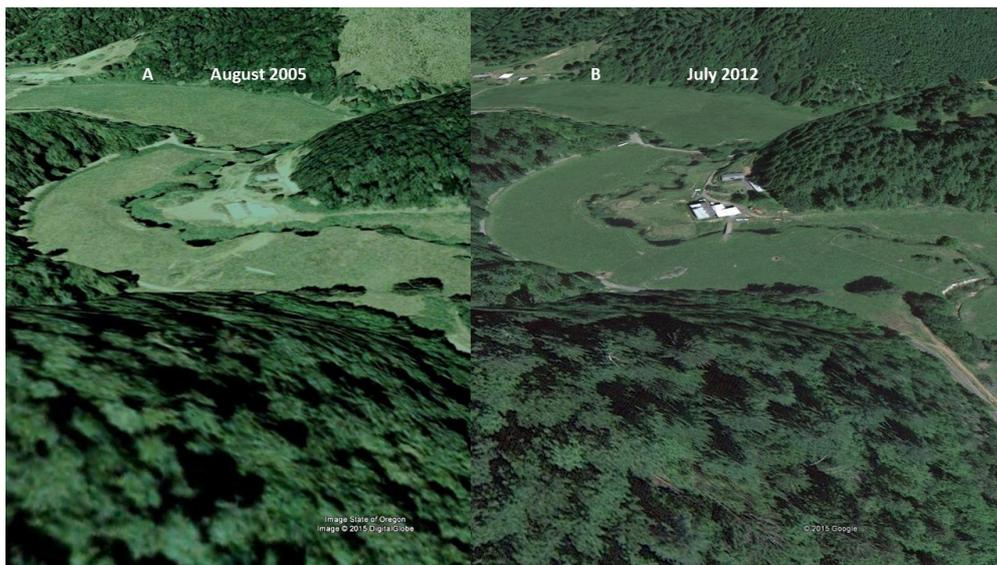
Figure 10. (A): August 2005 color image of the middle Roberts Creek watershed. Image shows that channel incision has migrated up into the sub-watersheds. The stream riparian area shown on the ranchland was prior to implementation of the management plan. The sub-watershed is dominated by woody plants. (B): USDA July 2012 color image after implementation of a natural resources management plan (fencing) for the riparian area. Some woody material has been removed. Source: State of Oregon, DigitalGlobe (2015).

The aerial image, time-series analysis of the upper Roberts Creek shows a reach undergoing a management change (Figure 10). As seen in Figure 10, the potential of this narrow meandering stream is to have hydric soils, stabilizing herbaceous riparian vegetation (sedges, rushes), and to be connected to a broad floodplain. The presence of woody plants indicates that the soils are more oxygenated for this setting, which points to a degraded riparian ecosystem. In 2005, the stream channel was incised, wide, and with woody vegetation (Figure 10A). The floodplain, now a terrace, experienced incursion of upland woody plants and/or willows (Figure 10A). This indicates that the floodplain has been drying out, allowing for the migration of upland plants into the former floodplain. As seen in Figure 10B, the rancher implemented a management plan (building fences) to protect the stream. It appears the rancher removed the woody plants to promote the appropriate herbaceous plant community for hay and forage production.
