Article

Laboratory Assessment of Water Permeability Loss of Geotextiles Due to Their Installation in Pervious Pavements

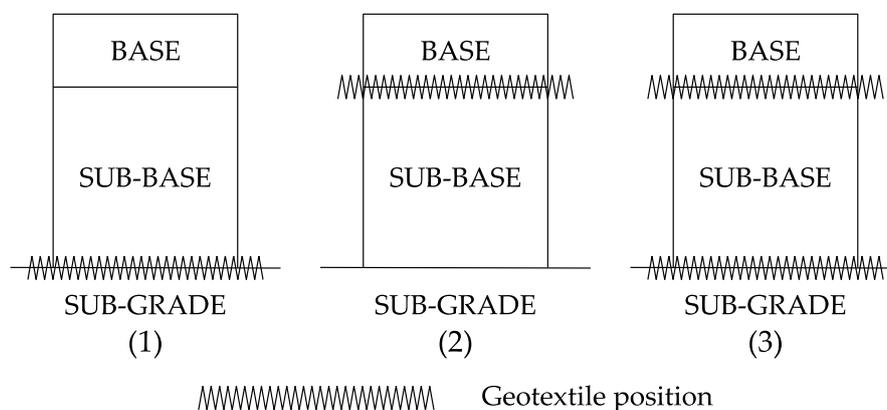
Figure 1. Pervious pavement configurations.

Geotextiles can be located between sub-base and the sub-grade (configuration 1), between the base and the sub-base (configuration 2) or in both positions (configuration 3) (Figure 1). Laboratory tests could be performed only to configurations 1 and 3 to accomplish valid results for all three cases. This simplification is possible because the damage on the geotextile located in the upper position (between the base and the sub-base) is not affected by the inclusion of a geotextile in the lower position (between the sub-base and the sub-grade), as the fines that can potentially clog its pores come only from the base layer. However, in a configuration with both geotextiles, the upper one acts as a filter for the lower one, changing its working conditions, and thus making it necessary to test it in two different scenarios. Therefore, the present study aimed to design a laboratory procedure to determine the new condition factor for the water permeability of a geotextile in the described scenarios.

The two geotextiles were subjected to two complete tests for each ZAD-20 type and geotextile configuration defined in Figure 1. As previously mentioned, the three configurations could be tested by testing configuration 1, with the geotextile only between the sub-base and the subgrade (lower position), and configuration 3, with the geotextile both between the base and sub-base layers (upper position) and the sub-base and subgrade (lower position). This gave a total of 16 complete tests. To achieve this, 24 mechanical damage simulations and 16 washing simulations had to be done. A total of 120 water permeability tests were performed to probes that had previously undergone both the mechanical and hydraulic damage stages. As a result, 12 new condition factors were obtained, depending on the granular material used, the geotextile tested, and the pavement configuration.

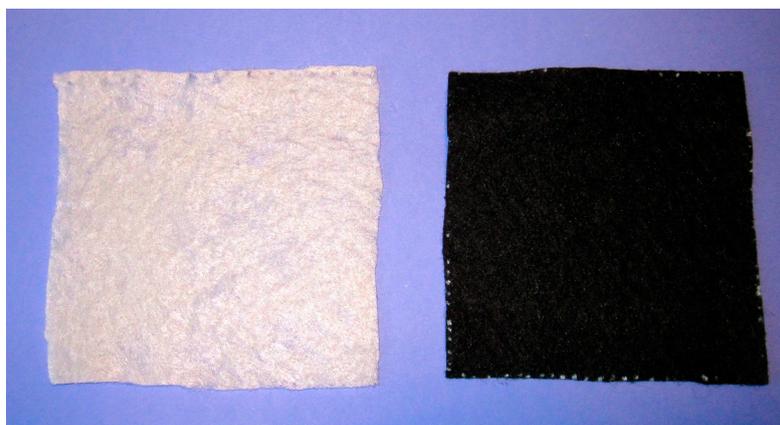
Two different polypropylene nonwoven geotextiles were used in this study (Figure 2). The initial properties of both geotextiles are outlined in Table 2.

Figure 2. Geotextiles utilized in the laboratory campaign. Geotextile A (left) and Geotextile B (right).

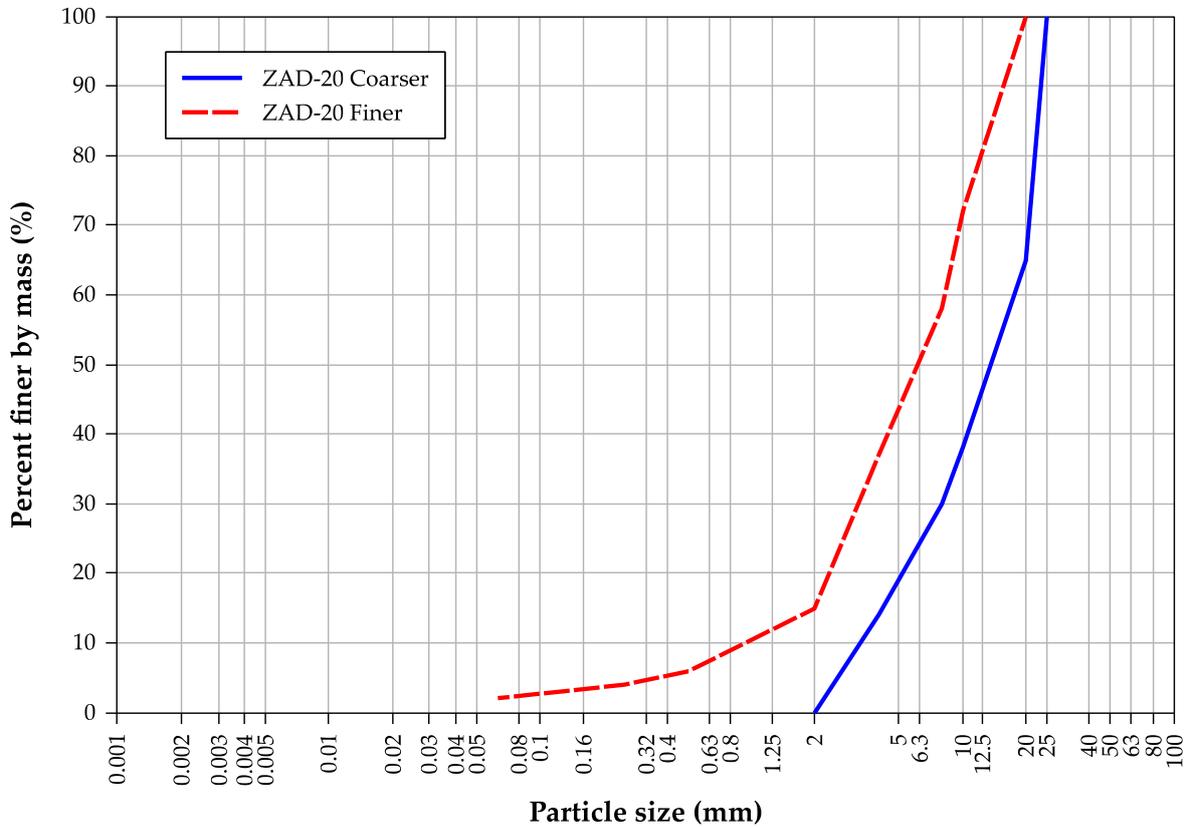
finer boundaries prescribed in the PG-3 are shown in Figure 3. For this study, synthetic samples made to match the particle size distribution of both boundaries were used for the sub-base. These particle size distributions were chosen to reproduce the extreme behaviors of the multiple options that could be used in real pavement constructions.

Figure 3. Finer and coarser boundaries of the particle grain distribution for a ZAD-20 [15].

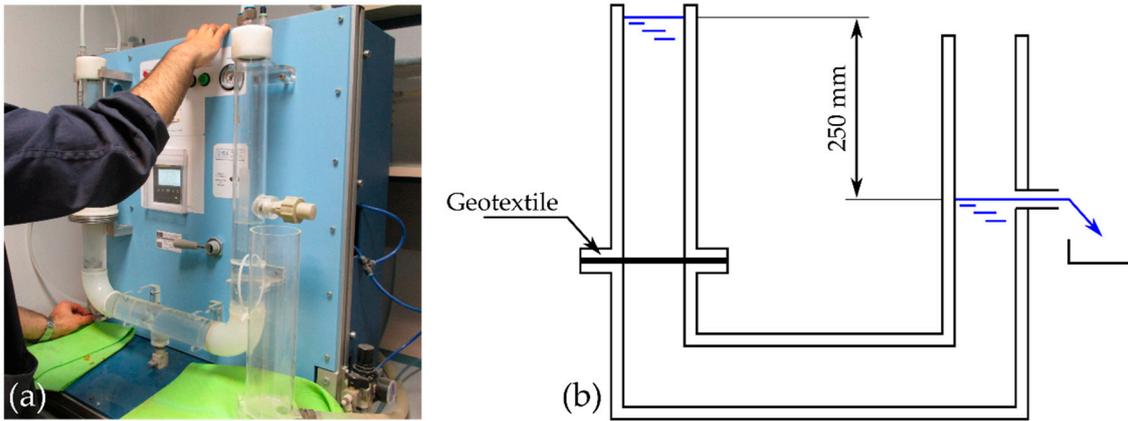
The water permeability normal to the plane for an untested probe of geotextile is determined using the ISO 11058 standard test [16]. This is a standardized procedure, and there is no need for modification of the procedure. For this study, samples of 50 mm in diameter were subjected to falling head, vertical flow tests with an initial water height over the specimen of 250 mm. The equipment used to perform the tests and a schematic drawing modified from the standard are shown in Figure 4.

Figure 4. Equipment used to perform water permeability normal to the plate test. (a) Photography of the equipment; and (b) schematic drawing of the test arrangement (modified from [16]).

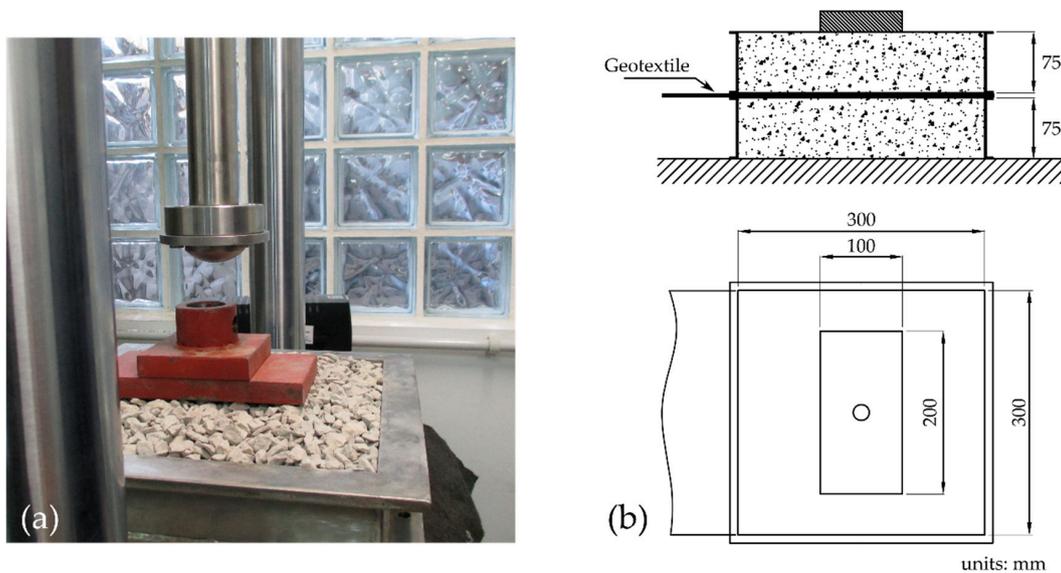
To adapt the test to real installation conditions, both the nature and the particle size of the gravel used are modified to match the characteristics of the real aggregates used in road construction. This modification also implies a change in loading conditions. The final configuration of the mechanical damage stage is shown in Figure 5.

Figure 5. Modified ISO 10722 test carried out in the laboratory. (a) Photography; and (b) schematic drawing (modified from [17]).

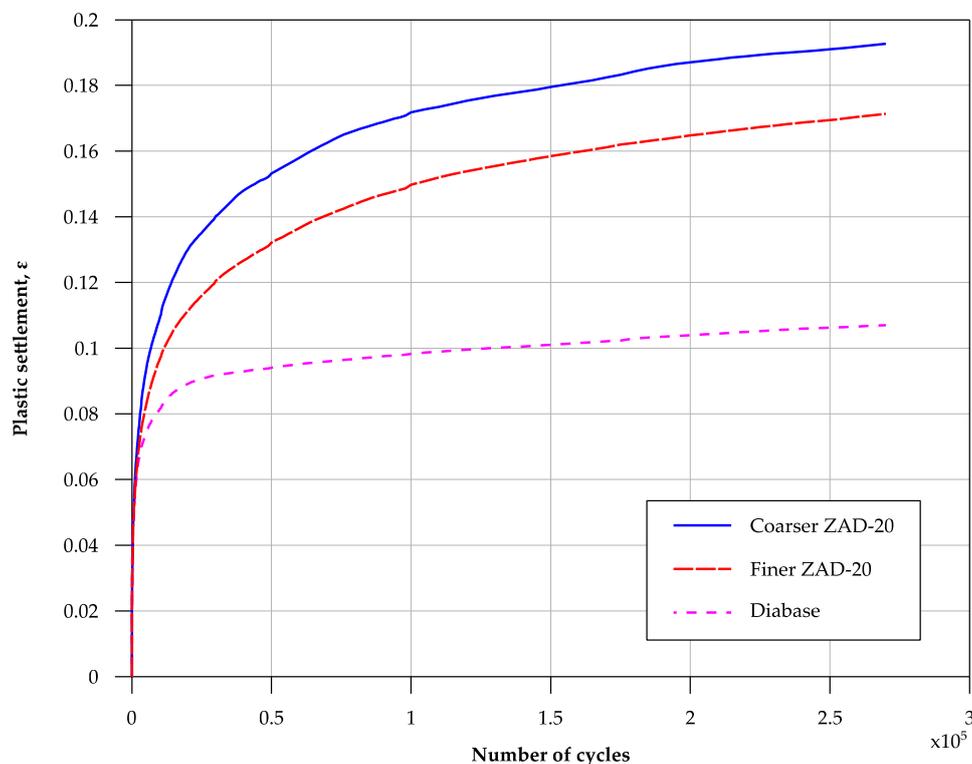
The mechanical damage that a geotextile undergoes during this stage of the test is the consequence of the relative movement of the particles during the cyclic load application process. In this process new fine particles are generated, and this generation of particles also depends on the nature of the granular material and the energy used in the compaction process. As a result, some of the parameters prescribed in ISO 10722 for the reference material need to be adjusted for the use of different materials. The aggregate prescribed in ISO 10722 is corundum with a precise particle size distribution. Since this material is troublesome to obtain, it is usually replaced by a diabase aggregate, with a similar Los Angeles coefficient of abrasion of 16%, with the particle size distribution prescribed in the standard for the corundum. To adjust the test parameters, the three granular materials used in this study, diabase and the two ZAD-20, were tested under cyclic loading conditions. As the compaction equipment was supposed to be the same, it was decided to adjust the procedure by changing the number of applied load cycles and maintaining the load intensity and frequency. As a result, the characterization tests were carried out using the same molds, stresses, and frequency indicated by the ISO 10722 standard, with a higher number of load cycles. As the aim of these tests were to obtain the characteristics of the aggregates, a geotextile was not installed into the test rig. In order to adjust the test parameters, the evolution of the plastic settlement with the application of the cyclic loads for the different materials was compared. Figure 6 shows the plastic settlement over the number of cycle curves obtained in the tests.

Figure 6. Evolution of the plastic settlement with the number of cycles.

As observed in Figure 6, both the magnitude of the settlement and its evolution were clearly different for the three materials. Given this, the variation on the number of cycles applied is one of the adjustments made to the ISO 10722 procedure to better represent the actual on-site compaction conditions. As the standardized procedure consisted of the application of 200 cycles, the number of cycles needed to obtain the same degree of compaction was obtained for the other two materials. To achieve this ratio, the settlement obtained after 270,000 cycles was considered to be the maximum (ϵ_f). Although it could be observed in the graph (Figure 6) that the stabilization of the settlement was not reached, the slope of the curves in this zone indicated that they were close to stabilizing. Furthermore, the elastic modulus stabilized after the application of around 150,000 cycles in all three materials (Figure 7), further showing that the materials had reached their maximum compaction for the applied load. One possible explanation of the lack of stabilization of the settlement, even with a large number of cycles, is the migration of material from the area under the loading plate towards the edge of the mold, which increases the settlement produced without increasing the dry density of the material. This could explain why the settlement does not stabilize for light loads like the ones applied during the tests.

For the tested diabase, the settlement produced after 200 cycles was around 35% of what was considered the maximum settlement; this settlement was labeled ϵ_{35} . The number of cycles applied in

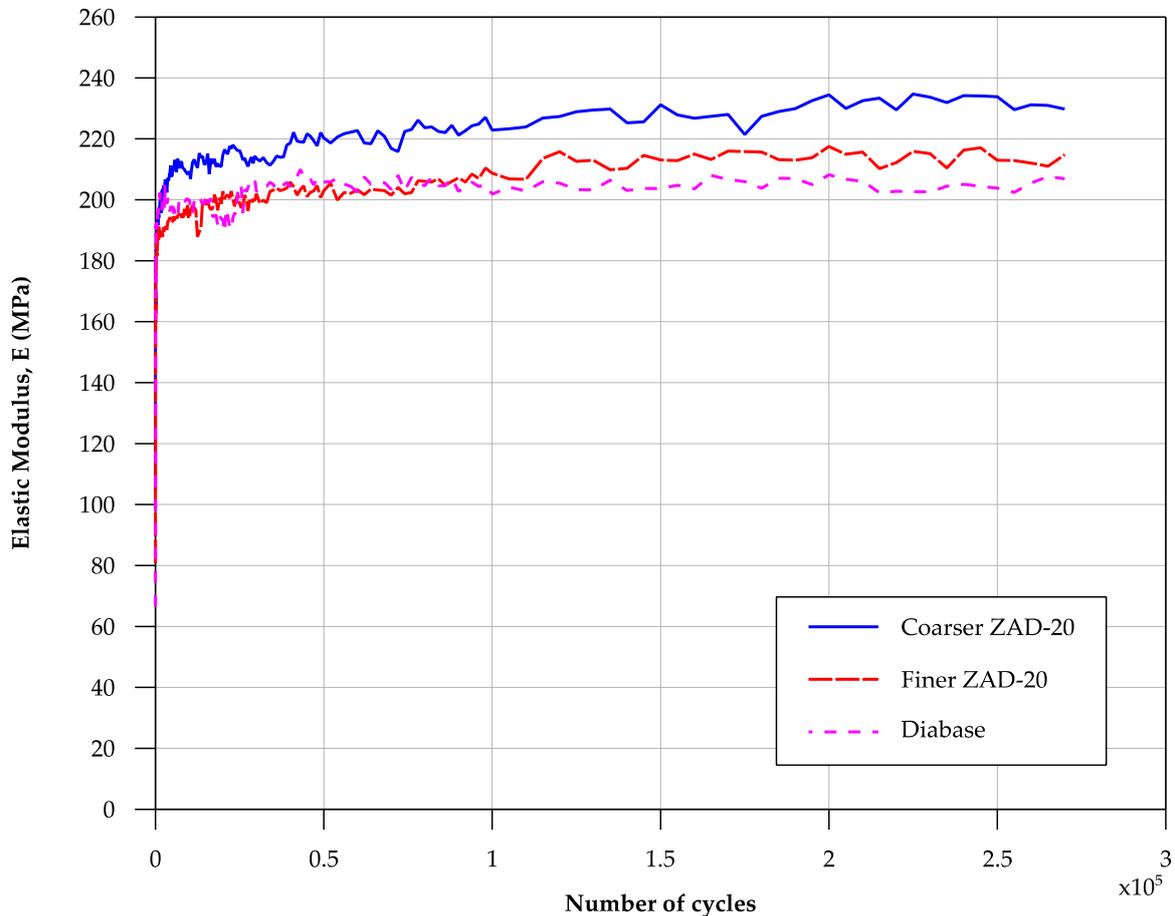
Additionally, the evolution of the elastic modulus (E) when applied with the load cycles was obtained (Figure 7). In order to attain this parameter, the settlement produced in each cycle was considered to be totally elastic. This consideration was not valid for the first load applications, as the permanent settlement produced in each cycle of this test phase was not insignificant. However, it could be disregarded after the application of a relatively small number of load cycles—around 500.

Figure 7. Evolution of the elastic modulus with the number of cycles.

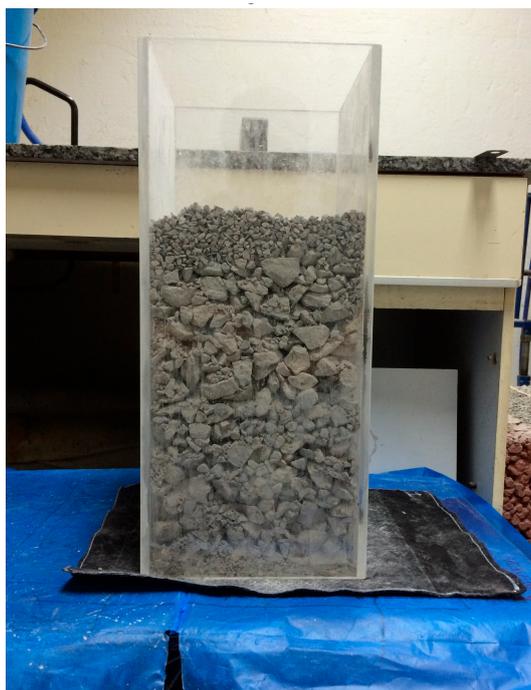
The third test stage consists of passing water through a sample with the same layer arrangement as the studied pavement, using the resulting geotextiles from the previous test stage. The sample is constructed within a bottomless acrylic container, which is placed over a geo-cell, allowing the free flow of water to a drain. In the Spanish code for pavement cross-sections, there are several configurations, depending on the materials used, the sub-grade quality, and the type of traffic. For this study, a 40 cm sub-base layer made of ZAD-20 with an overlaying 7 cm base layer was used. An example of the final arrangement is shown in Figure 8.

Figure 8. Acrylic container that contains the layers of pervious pavement to be tested.

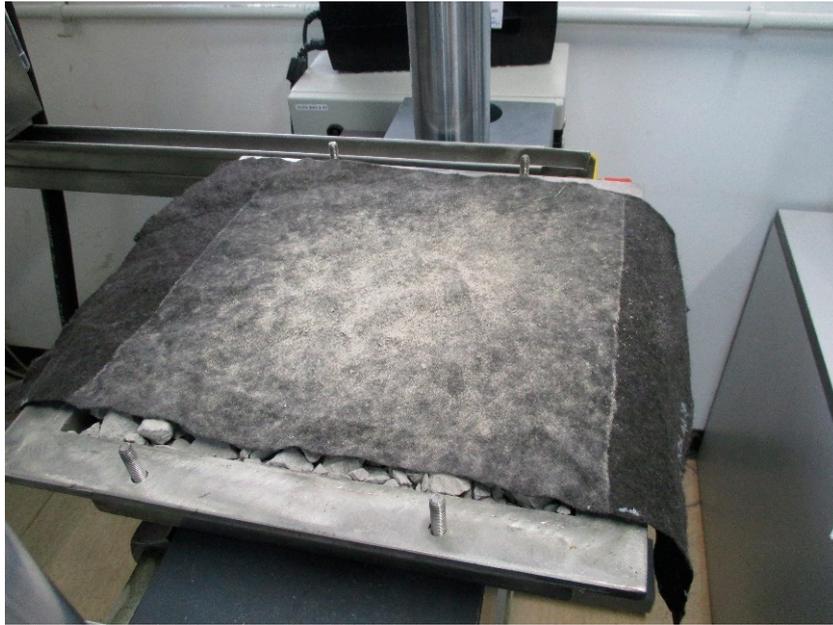
Figure 9 is a picture taken right after a mechanical damage stage. It was observed that the deterioration of the geotextile after the mechanical damage stage was in concordance with those described in previous experiments from other authors. Although this study was focused on the loss of water permeability, it was crucial to observe the degree of mechanical deterioration of the geotextile sheets, as it could affect the permeability through an increase in the size of the openings and creation of holes. In all tested specimens, only minor isolated holes were found, and the main difference with the untested geotextiles was the presence of a layer made up of fine particles from the aggregates.

Figure 9. Appearance of the geotextile after a mechanical damage simulation.

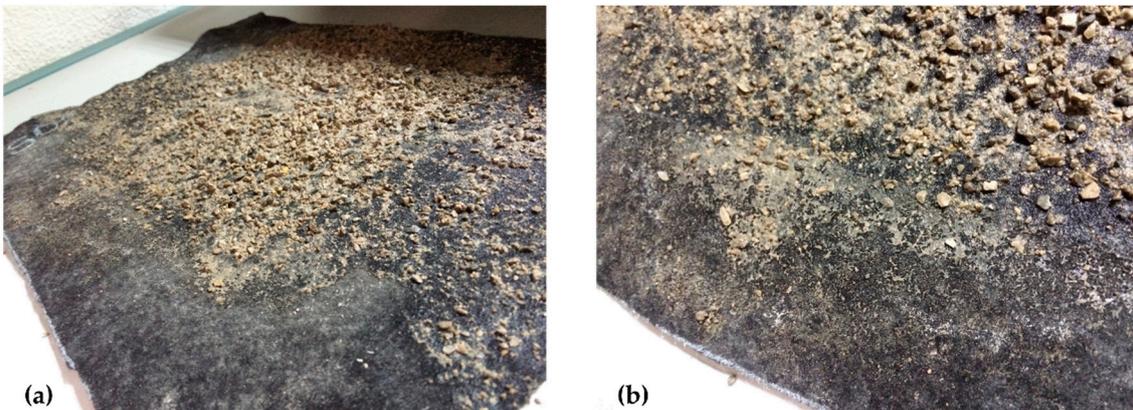
After the hydraulic damage stage, a worsening of the appearance of the geotextile could be observed (Figure 10). This was due to both the migration of the fines stuck to the larger particles of the granular material dragged by water, and their cementation on the surface of the geotextile due to the presence of water. Most of the permeability loss of the geotextile could be attributed to this layer of cemented fines.

Figure 10. (a) Appearance of the geotextile after the hydraulic damage simulation; (b) Detail view, where the cementation produced by the passing of water can be observed.

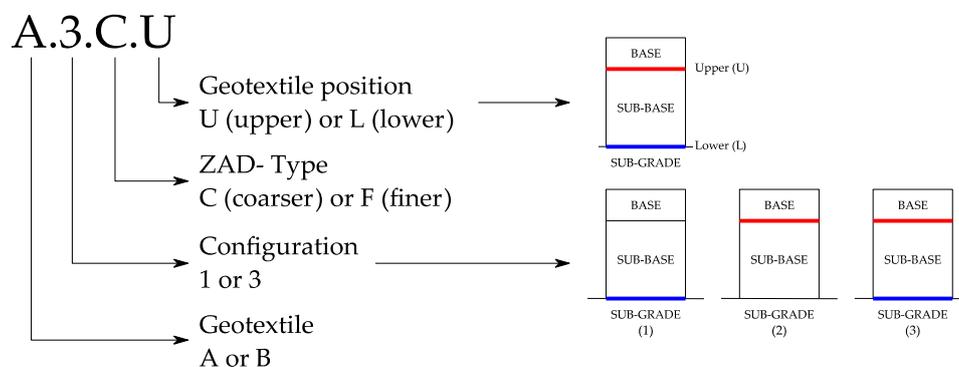
A test code was added to the different tests, to improve their reference within the text. Figure 11 shows the meaning of the code.

Figure 11. Test code explanation.

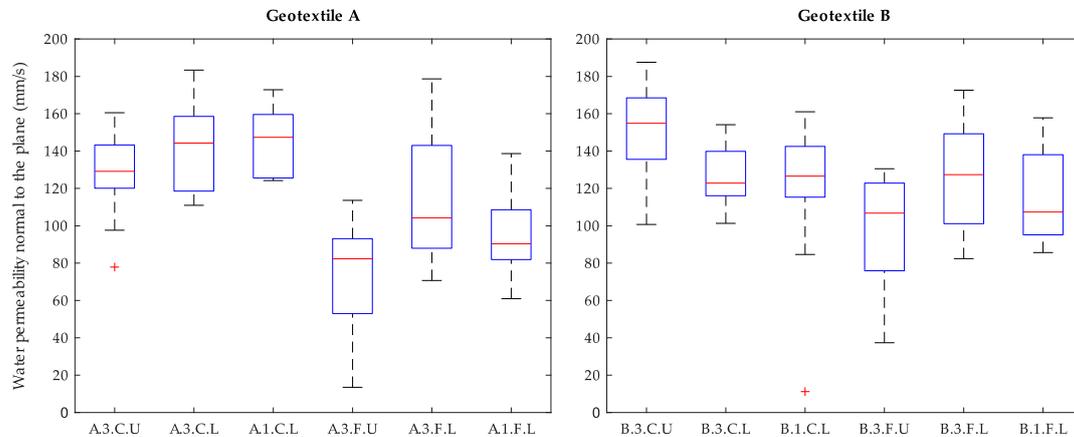
Figure 12 shows a box plot representation of the data obtained from all test scenarios. A total of ten samples were tested to obtain every value of water permeability normal to the plane.

Figure 12. Box plots of the water permeability normal to the plane for every test case.

In both cases, the aggregate type was statistically significant for a 0.05% level of significance. This was in accordance with the thesis of the investigation and pointed out the importance of using real aggregates to perform the tests. For the other two variables, the analysis showed that they were only statistically significant on the tests carried out to geotextile A. This can also be seen in Figure 12, in the similar values for all three tests performed using the same ZAD.
