Article

Effects of Waterlogging with Different Water Resources on Plant Growth and Tolerance Capacity of Four Herbaceous Flowers in a Bioretention Basin

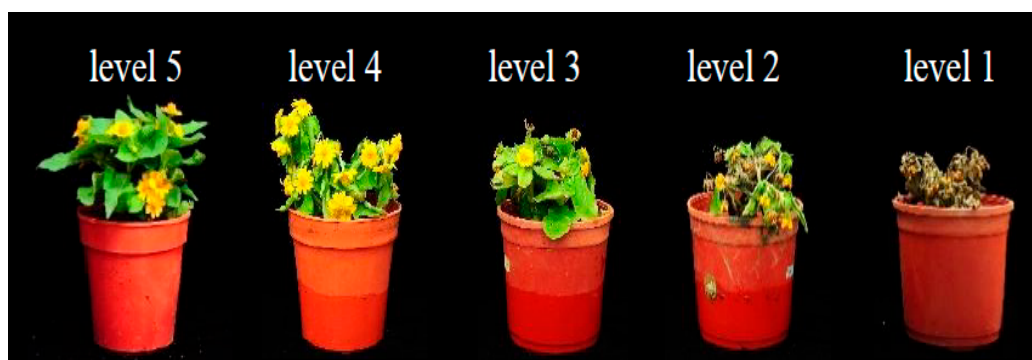
Figure 1. Conditions of the tested plants under 10 days of waterlogging as scored by plant quality. Level 5 (5 points): normal growth without any injured morphological appearance of the tested plants under 10 days of waterlogging. Level 4 (4 points): one or two leaves had become brown and withered. Level 3 (3 points): three or four leaves had become brown, withered, and defoliated. Level 2 (2 points): five or six leaves had become brown, withered, and defoliated. Level 1 (1 point): all leaves had become brown, withered, and defoliated. A score of 5 (level 5) indicates good performance, and a score (level) ≥ 3 indicates ornamental quality.

Throughout the experiment, plant quality was divided into five levels [18]. The morphology of plants was observed and rated on a scale of 1 to 5 points on the basis of the level of waterlog-induced injury: Level 1: more than six leaves had become brown, withered, and abscised; Level 2: five or six leaves had become brown, withered, and abscised; Level 3: three or four leaves had become brown, withered, and abscised; Level 4: one or two leaves had become brown and withered; and Level 5: normal growth (Figure 1). A score of 5 indicates good performance, and a score ≥ 3 indicates ornamental quality. The scores of the plant appearances were visually evaluated by people.

Both angelonia and narrow-leaf zinnia performed well after ten days of waterlogging and maintained good ornamental quality (Figures 1 and 2). In addition, adventitious roots were observed at the base of the stems of waterlogged angelonia and zinnia (Figure 3). On the contrary, leaves of medallion flower appeared to be drooping at day 3 of waterlogging, and those of celosia appeared to be drooping at day 7 of waterlogging, and leaves of both of them became wilted after drainage. Thus, celosia and medallion flower had no ornamental value after waterlogging treatment. To summarize, after being subjected to waterlogging, angelonia performed the best, followed by narrow-leaf zinnia, while celosia and medallion flower were intolerant to waterlogging.

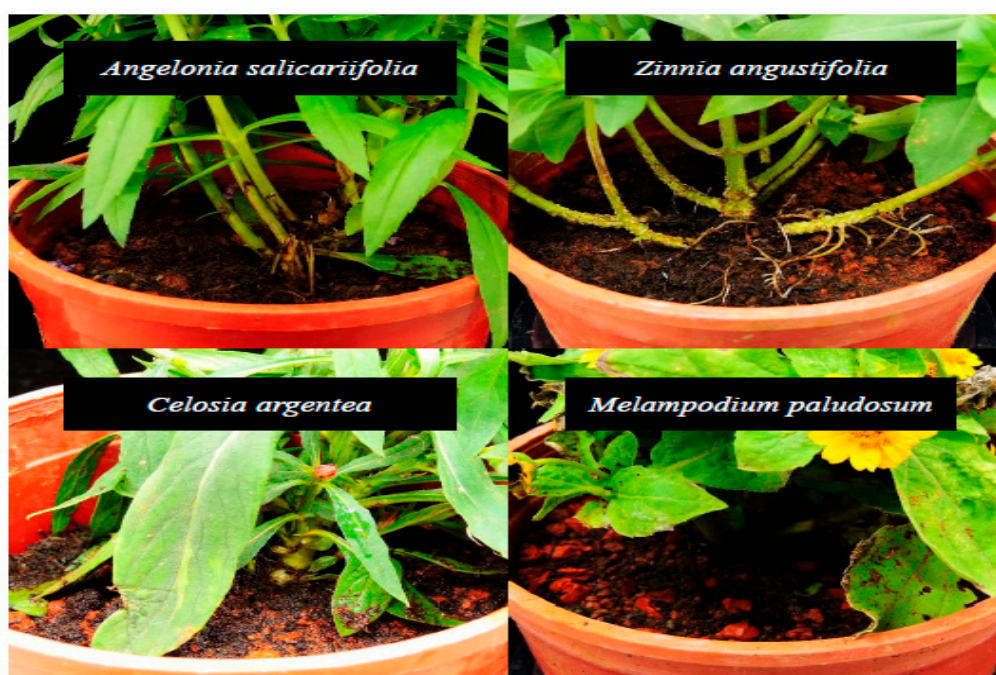
Figure 3. Adventitious roots growth of angelonia, narrow-leaf zinnia, celosia, and medallion flower at 10 days of waterlogging.

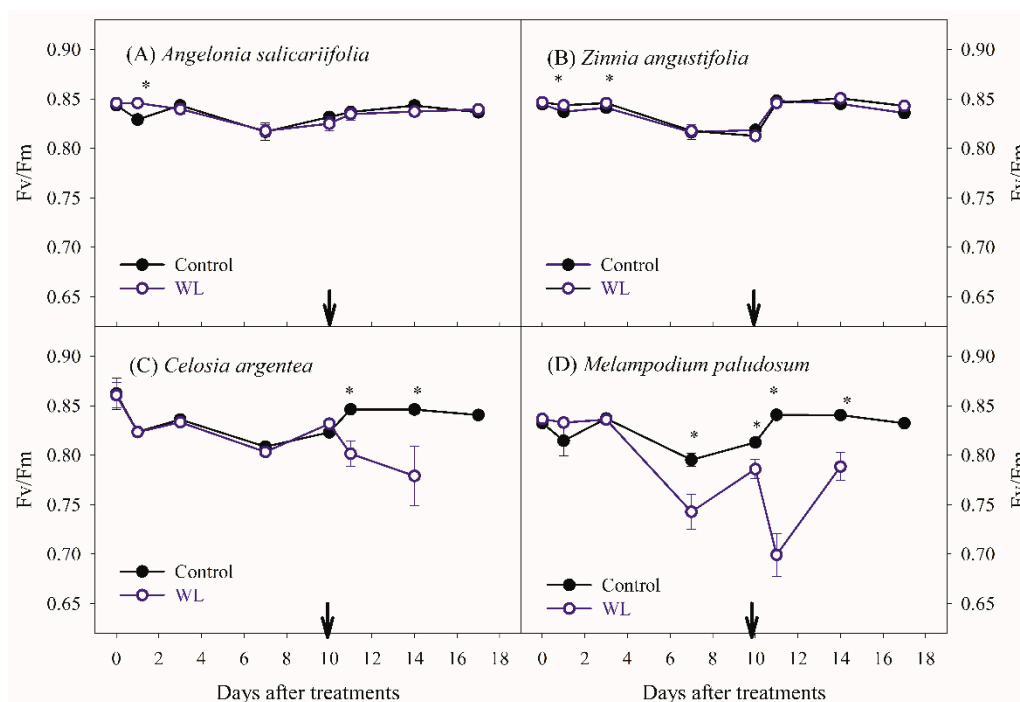
Figure 4. Effects of 10 days of waterlogging followed by a seven-day recovery on maximal quantum yield of photosystem II (Fv/Fm) values of (A) *Angelonia salicariifolia*, (B) *Zinnia angustifolia*, (C) *Celosia argentea*, and (D) *Melampodium paludosum*. Arrows indicate the beginning of the recovery period from waterlogging. * $p < 0.05$ between the control and waterlogged (WL) plants by a t -test. Both *C. argentea* and *M. paludosum* plants had died by day 17. ($n = 5$).

The F_v/F_m values of angelonia and narrow-leaf zinnia plants decreased as the waterlogging period increased, followed by an increase in angelonia during the seven-day recovery, but the F_v/F_m values of zinnia plants displayed a decrease as the recovery period increased (Figure 4A,B). In addition, four days after waterlogging treatments, leaves of waterlogged and drainage angelonia and zinnia plants maintained F_v/F_m levels similar to those of their respective controls. During the 10th day of the waterlogging period, both celosia and medallion flower plants had levels of F_v/F_m of around 0.8 (Figure 4C,D). After drainage, the F_v/F_m value of celosia plant drastically declined to 0.4. However,

four days after waterlogging treatments, the Fv/Fm of medallion flower was significantly lower in control plants. Both celosia and medallion flower could not be measured on the last day of treatment because they had wilted (Figure 2).

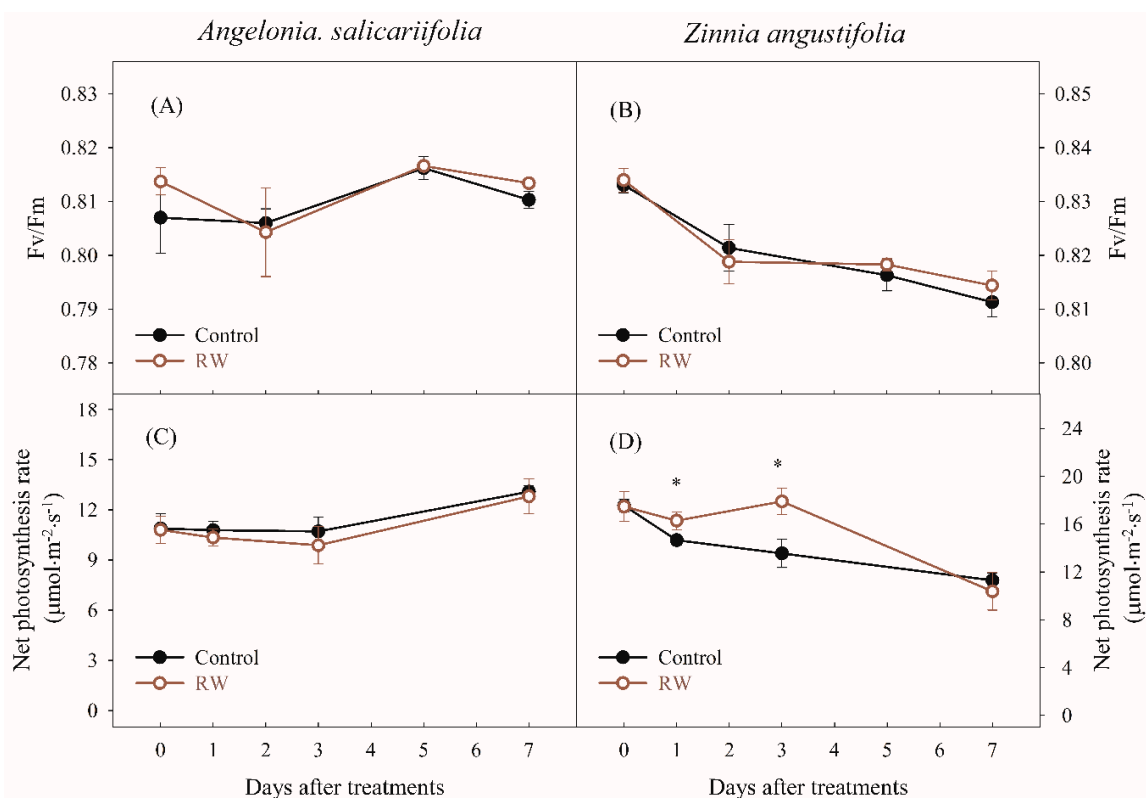
Figure 6. Effects of seven days of waterlogging with tap water (control) and simulated reclaimed water (RW) on maximal quantum yield of photosystem II (Fv/Fm) values (A,B) and the net photosynthesis rate (C,D) of *Angelonia salicariifolia* (A and C) and *Zinnia angustifolia* (B and D). * $p < 0.05$ between the control and RW plants by a t -test. ($n = 5$).

Figure 6A illustrates that the Fv/Fm value of angelonia was not affected by simulated RW, with both treatments maintaining the value at a stable level. As for narrow-leaf zinnia, regardless of whether being waterlogged with tap water or simulated RW, both caused a decline in Fv/Fm, but the values were still in a normal range (Figure 6B). Furthermore, there was no significant difference in the Pn value of angelonia between treatment groups during the experiment (Figure 6C). After one day of waterlogging with RW, the Pn value of narrow-leaf zinnia was obviously higher than the control, while it had decreased by day 7, with no significant difference with the control (Figure 6D).
