# Abrasion Behavior and Anti-Wear Measures of Debris Flow Drainage Channel with Large Gradient

**Abstract:** Debris flow gullies have high potential energy and geomorphic characteristics including a steep longitudinal slope and abundant loose material sources. They often experience debris flow with a strong impact force and a large instantaneous flow. Drainage engineering measures are most commonly used for mitigation in these gullies. However, the abrasion of drainage channels with large gradients (DCLG) is complex and strong because of the high-speed flushing of debris. In this study, the abrasion behavior of debris flow in DCLG is analyzed based on the kinematic characteristics and the theory of composite abrasive wear. Energy dissipation and anti-wear measures are suggested, and their effects are summarized with reference to a case study and in situ observation. The results show that there are four main types of wear morphology in drainage channels. The abrasion system of drainage channels shows the characteristics of system dependency, time dependency and multidisciplinary coupling. Energy dissipation and anti-wear measures include prefabricated reinforced concrete boxes as s

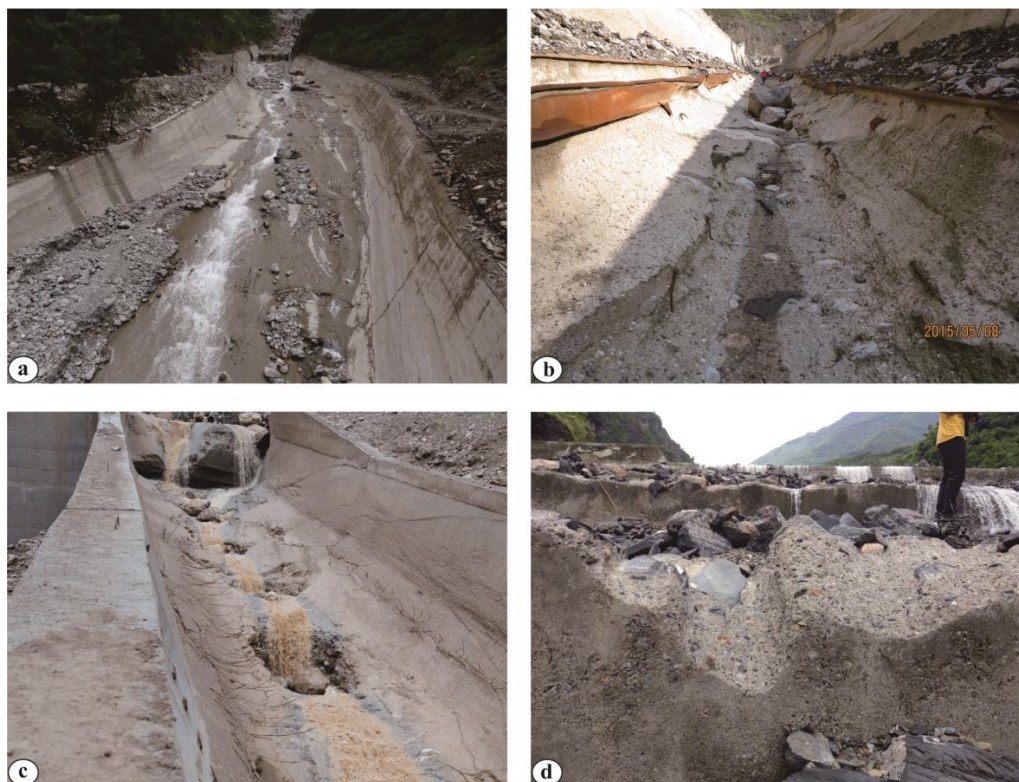
According to field investigation in the study area, the AM of debris flow on structures is mainly divided into four categories (Figure 3): (a) Relatively uniform surface peeling (USP); that is, the scraping on the surface is basically flat and creates a smooth layer by layer thinning, which appears on the bottom surface of the drainage channel and the inner faces of the side walls, when the particles in the fluid are relatively uniform and the flow state is stable; (b) Plowing groove along the streamline direction (PG), which generally appears at the bottom of a fully lined drainage channel, which is steep and long, with the fluid viscous, the bulk density high and the fluid composed of hard and angular block stones; (c) Jumping erosion pits (JEP), which are similar to the “potholes” developed on the bed rock of the high sandy rivulets and rivers in mountain areas [24], which mainly occur on the bottom of a fully lined channel with a large longitudinal slope or under the drop-sills—the flow is turbulent and easily forms eddy currents; (d) Surface wear of the ground sills (SWGS), mainly in the middle of the rib sill, forming a transverse slope from both sides to the middle.

**Figure 3.** Typical abrasion morphology of mitigation works of debris flow. (a) uniform surface peeling (USP) in Yinxingping gully, Wenchuan county; (b) plowing groove (PG) in Haermu gully, Lixian county; (c) jumping erosion pits (JEP) in Xiaogangjian gully, Mianzhu county; (d) surface wear of the ground sills (SWGS) in Qinglinwan gully, Beichuan county.

In field investigations, several forms of AM usually exist at the same time. With a change in working conditions, different forms of wear have different primary and secondary causes.

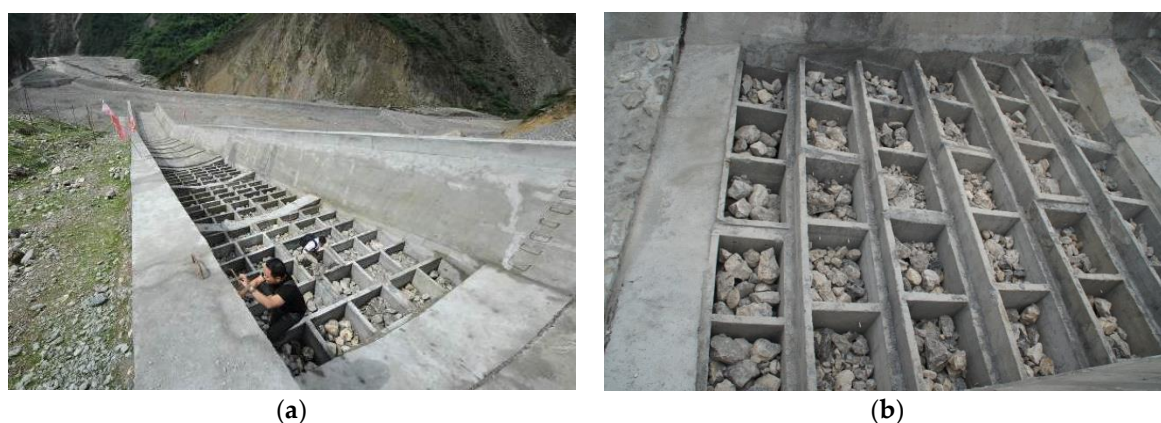
The whole ED section was designed with 18 rows of boxes and four rib sills, so the total length was 22 m. The four walls and bottom plates of the box were equipped with steel mesh. Drainage holes and connection holes were left on the box wall. The box was made in the prefabrication yard and cured as required, before being transported to the site for assembly. Compared with an in-situ placing channel structure, this had the advantages of easier manufacture, fast installation and good adaptability to the terrain conditions (Figure 7).

**Figure 7.** Pictures of energy dissipation (ED) section lined with prefabricated reinforced concrete (PRC) boxes completed. (a): From an upstream perspective of ED section, (b) Structural details of PRC boxes.

The construction methods of the ED section lined with PRC boxes were as follows [35,36]: (1) On the transverse, the cavity size of a single box was set to 1.0 m × 1.2 m, which could be combined into different horizontal rows according to the design width of the channel bottom; (2) In the longitudinal

direction, it was of stepped form according to the design gradient of the channel, and each row of boxes reduced step by step along the flow direction, and the height difference of adjacent steps should be adjusted according to the gradient; (3) A deep buried rib guard was set every 6 m, with a buried depth of 2.5 m, as a longitudinal control node, to provide stable support and protection for the whole section; (4) For the detailed design of the box materials, C30 steel fiber concrete was used for key anti-scour parts; (5) The lower half of each box was filled with boulders, and the upper half was left with empty grooves, as a space for debris flow falling, mixing and material exchange, in order to promote the effective energy dissipation of the debris flow.

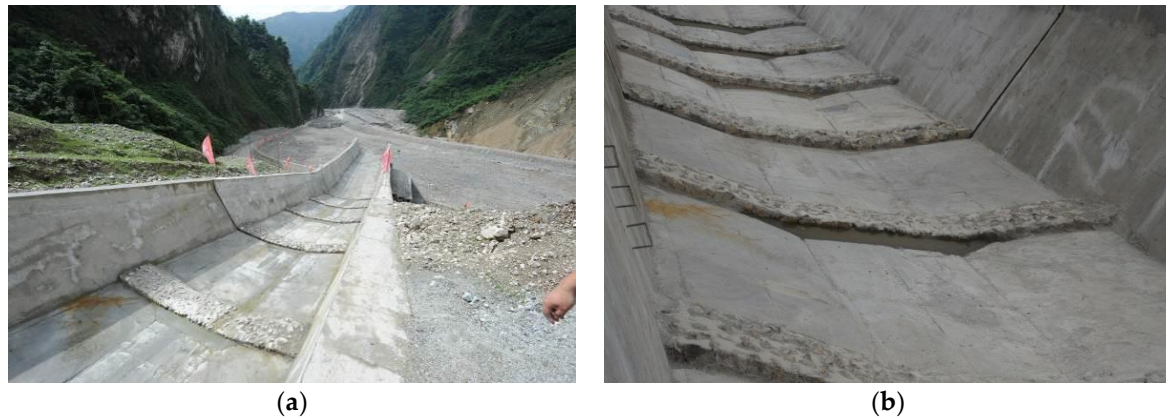
The structure of the roughening belt was a strip bulge that ran horizontally through the bottom, with the top of the strip protruding from the bottom slab. The design width along the flow direction was 1.0 m, and the transverse length was the same as the width of the channel bottom. The spacing between adjacent strips was 5.0 m. Hard and wear-resistant block stones (hard sandstone, granite, etc.)

were selected to be buried in the concrete of the bottom, and blocks of different particle sizes were staggered to give the top of the whole strip both concave and convex shapes, with a raised height of 5 cm~20 cm and a buried depth of 1/2~2/3 of the particle size of the block stone (Figure 8).

**Figure 8.** Pictures of roughening belts for channel bottom turbulence completed. (a): From an upstream perspective of roughening belts, (b) Structural details of roughening belts.

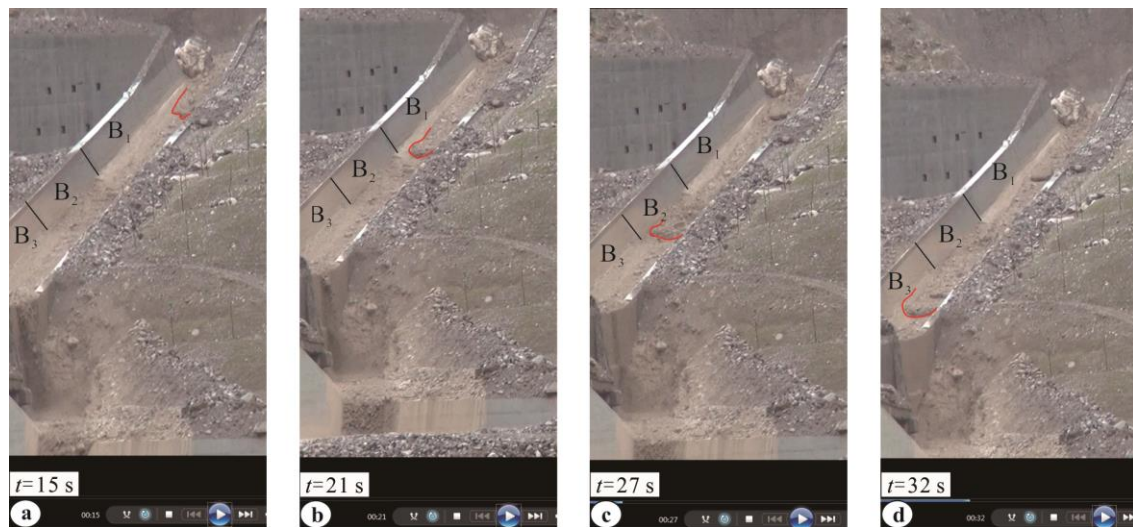
Using the debris flow video recorded in the flood season, the time of flow through each control section was found. According to the distance and the time intervals between the adjacent control sections, the average velocity of the debris flow on the plate of this section was accurately calculated (Figure 9). The selected control sections were divided into four parts: the starting point of the steep channel (0 + 000 m), the starting point of the PRC box section (0 + 046 m), the starting point of the PRC box section (0 + 066 m) and the endpoint of the steep slope section (0 + 100.2 m). In total, the flow time data of 15 debris flows were given.

The change trend of the average velocity of each debris flow in the different channel sections showed that the process of the debris flow in the three sections was as follows: acceleration → deceleration → reacceleration. Except in the case of No.1, the debris flow was gradually slowed down by the roughening belts and lay on the bottom of section B<sub>3</sub> due to the small scale. The other data basically conformed to this change trend. By calculating the velocity attenuation in each section, the average velocity of the debris flow was reduced by 5.7~37.1% in the ED section lined with PRC boxes (Figure 10). The attenuation rate ( $R_a$ ) of velocity in the ED section can be calculated by Equation (4):

**Figure 9.** Observation of flow velocity change of debris flow in drainage channel (17 August 2012). Lengths of each section are  $LB_1 = 46$  m,  $LB_2 = 20$  m,  $LB_3 = 34.2$  m.

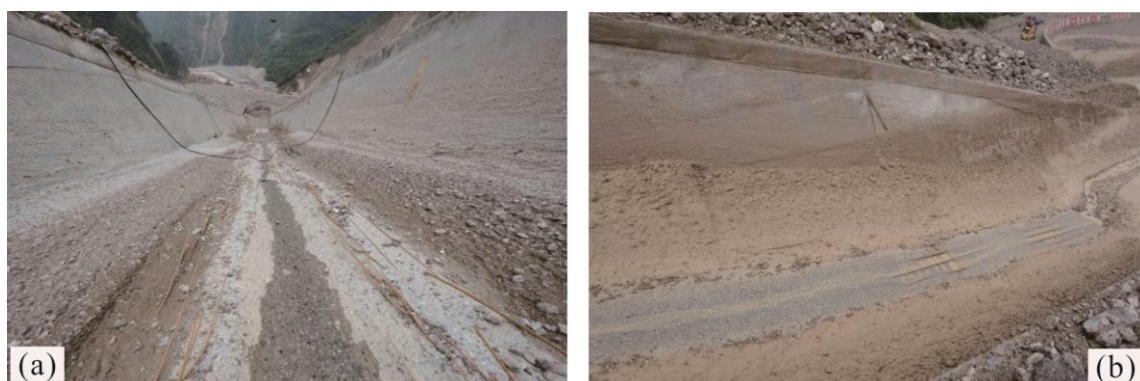
According to the field investigation after the debris flow occurred, the variation in the concrete abrasion at the bottom of the channel was measured, as shown in Figure 12. Photos taken on site are shown in Figure 13, which indicate that the abrasion of section B<sub>1</sub> (Figure 13a) was stronger than that of section B<sub>3</sub> (Figure 13b).

**Figure 13.** Abrasion at the bottom of the upstream and downstream sections of the channel. (a) The steel bar at the bottom of the section B<sub>1</sub> was almost destroyed; (b) the section B<sub>3</sub> was only partially exposed.
