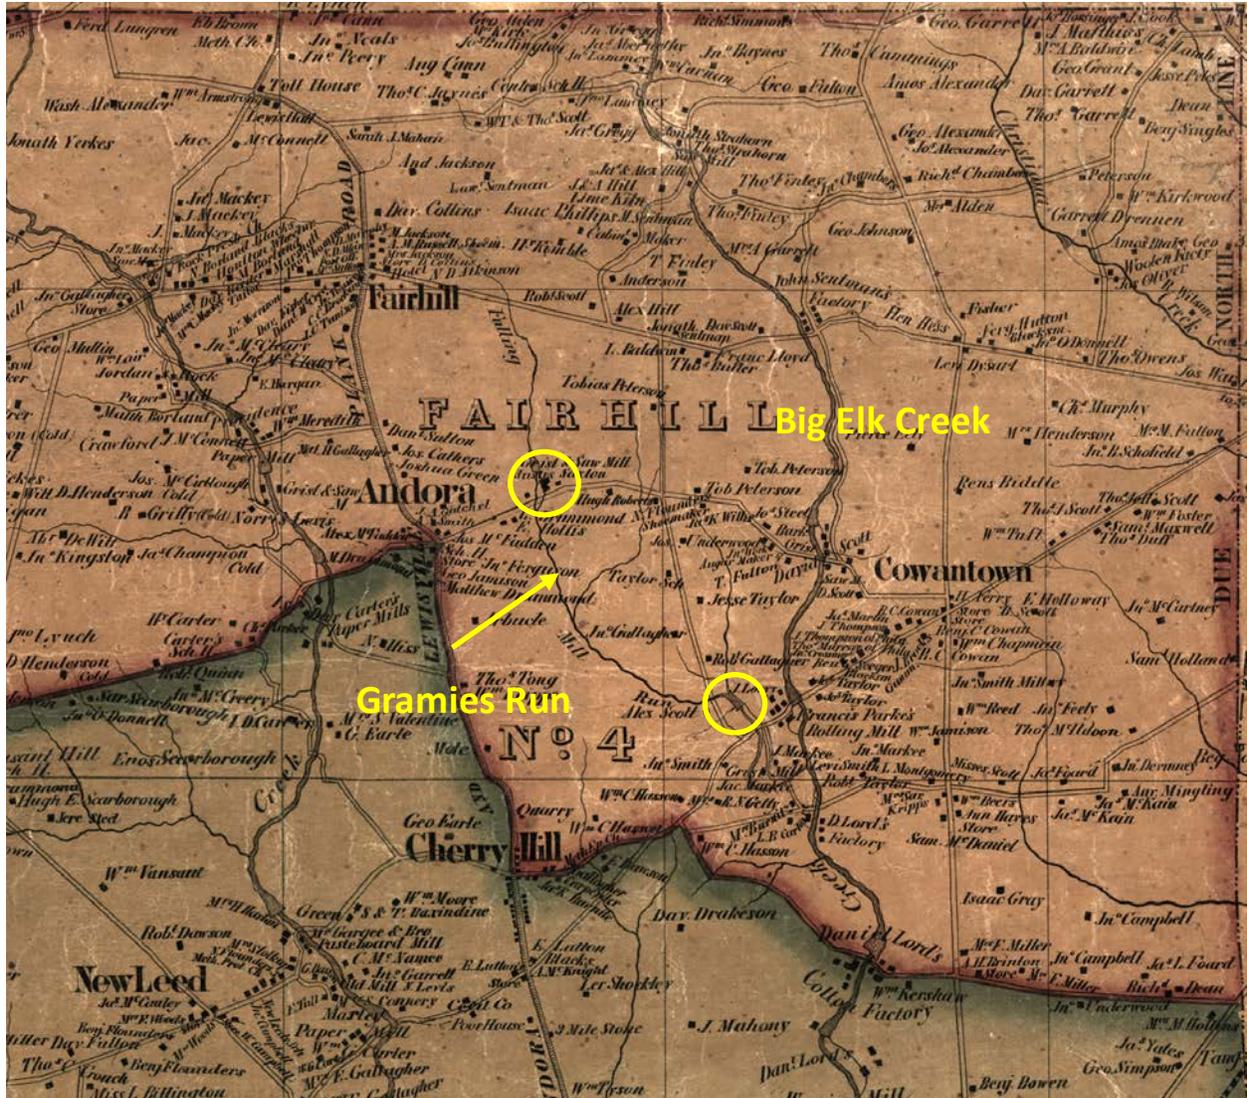
Figure S1: 1858 Martenet map showing historic mill dams (circled in yellow) along Gramies Run (previously known as Fulling Mill Run). The top dam is above the current Big Elk Chapel road while the lower dam is to the right of the current Gallagher road.

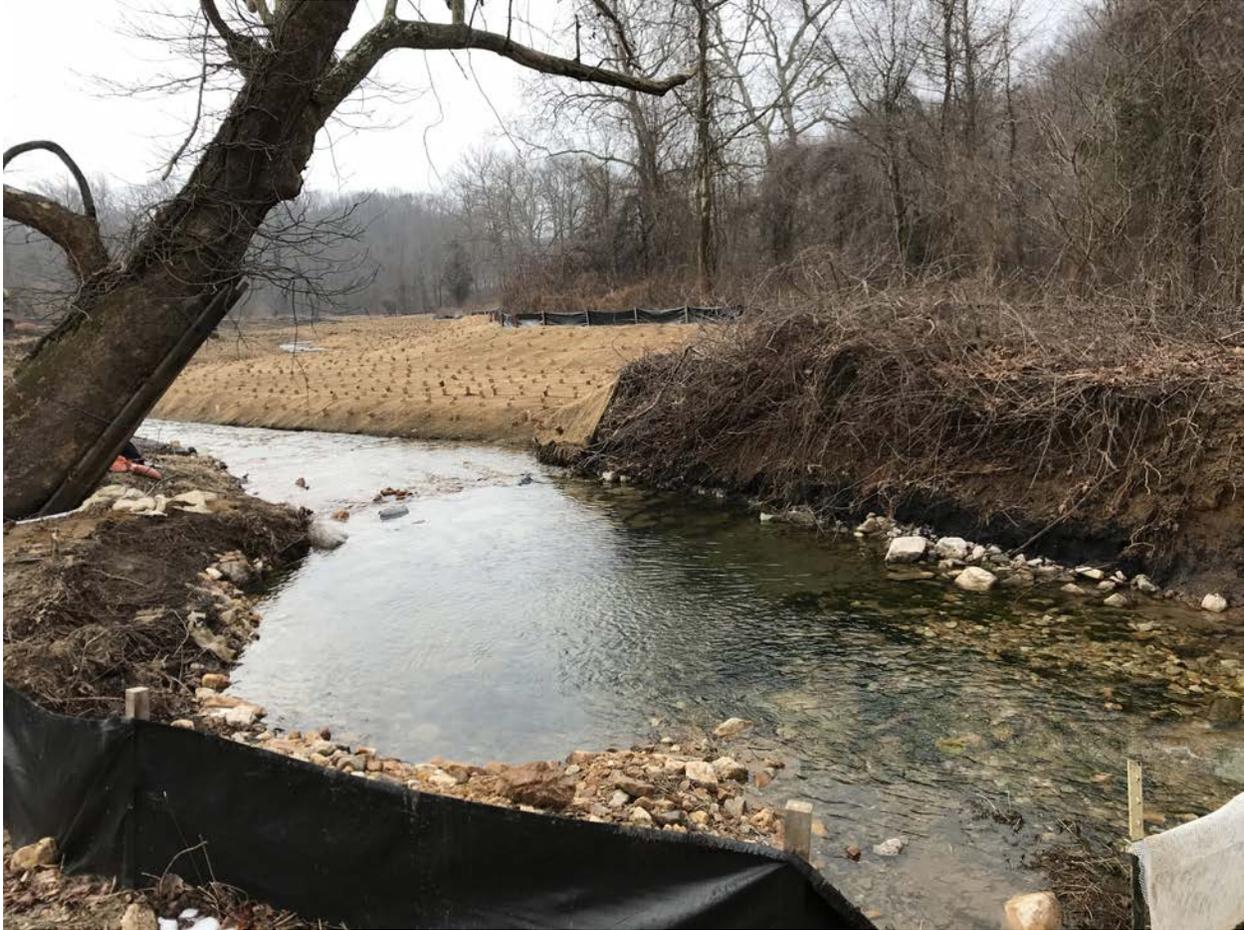
Figure S2: Partial construction/transition along Phase 2 showing restored (left) and unrestored (right) reaches. The junction represents a construction pause for the no-instream work period – March 1 to June 15. Note the height of the incised vertical bank and the buried organic horizon on the right, and the newly created wider floodplain on the left. White, Pleistocene era gravel can be seen below the dark organic horizon on the right.

Figure S3: Streambank at Gramies Run (along Phase II restoration, same reach as in Figure S2) showing freeze-thaw drool and subaerial erosion following freeze-thaw conditions in winter.

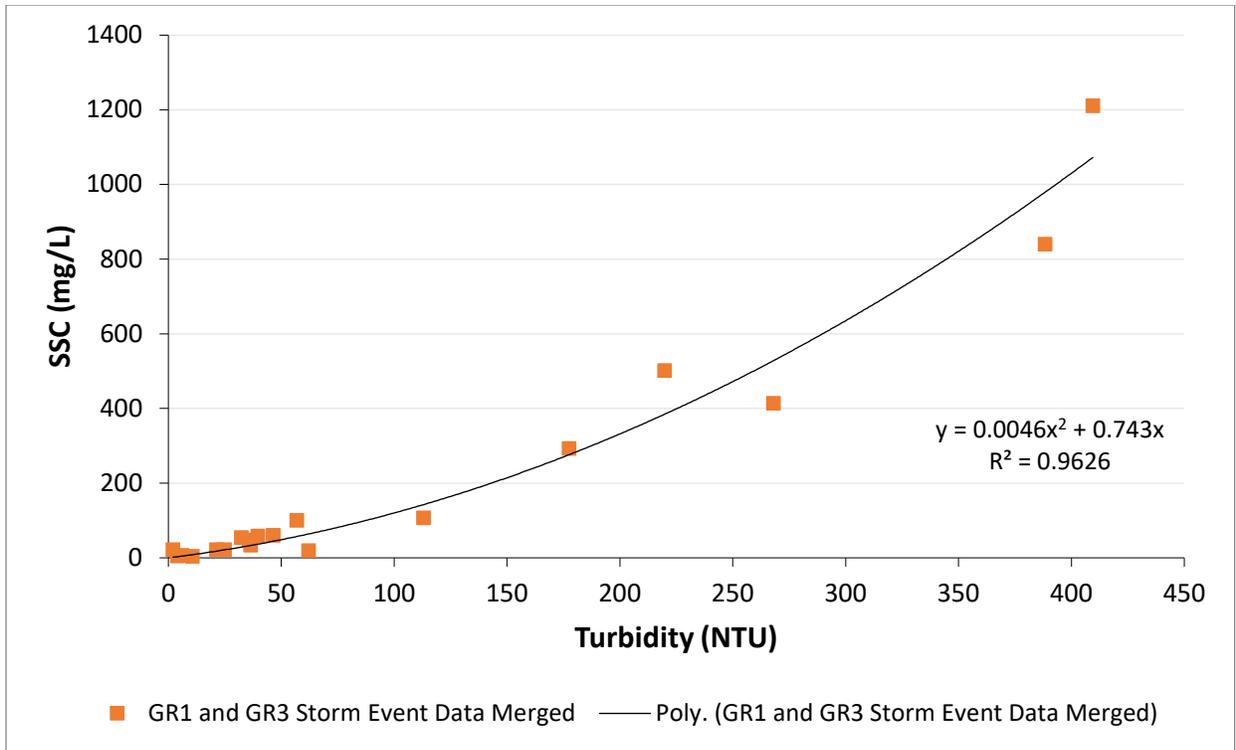
Figure S4: SSC-Turbidity relationship to convert turbidity values to SSC concentrations.
