# Geomats Used to Control Erosion on Reservoir Margins in Brazilian Hydroelectric Power Plants

**Abstract:** Erosion on reservoir margins causes losses in the production of energy in Hydroelectric Power Plants (HPPs), making it necessary to implement control techniques that ensure the reduction in sediment deposits inside reservoirs. Among these techniques, geomats (geosynthetic erosion mats) are widely used to control erosion processes in slopes and watercourses. This material protects the margins both in the short and long term, contributing to strengthening the vegetation's roots developed in the erosion areas. This paper studies the performance of geomats (with and without sack gabion) installed in six margin sections distributed in three experimental units of the Brazilian HPPs called Porto Colômbia and Volta Grande. The geomat performance was evaluated over four years of monitoring through a qualitative evaluation matrix and differential bathymetry. The influence of ultraviolet (UV) radiation on the degradation of geomats installed in each section (natural conditions), as well as on geomat ultraviolet-aging samples in the laboratory (accelerated conditions), was also evaluat

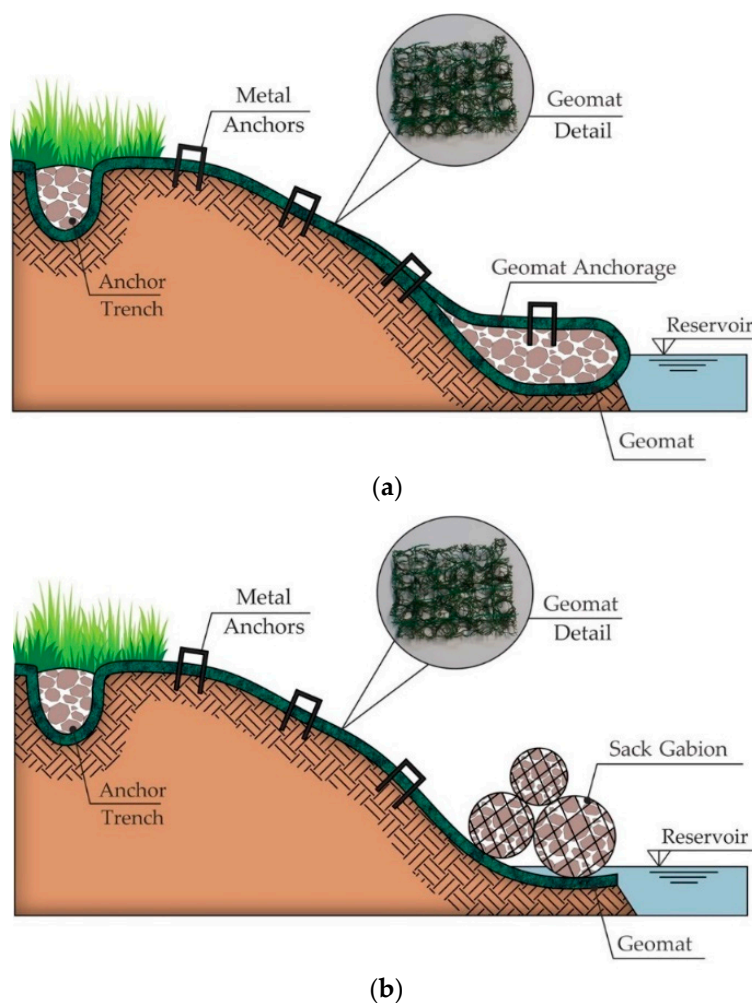
**Figure 4.** Schematic configuration profile of erosion control techniques: (a) geomat and (b) geomat and sack gabion.

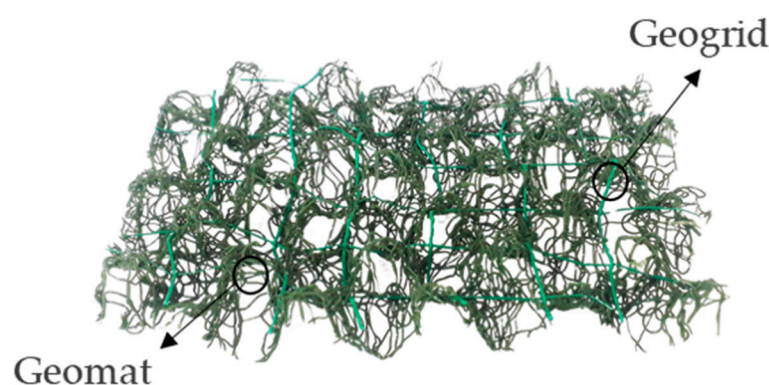
**Figure 5.** Geomat used in the erosion control techniques.

The geomat used to control the erosion on the reservoir's margins is a three-dimensional geomat reinforced with synthetic geogrid. The central part is manufactured using polyethylene, and the geogrid is manufactured with polyester filaments (Figure 5). The geomat has high flexibility and a void index of more than 90%. Interlocking between the roots and the 3D geomat supports the shear forces generated by hydric erosion and stabilizes the subsurface soil [15]. The physical and mechanical properties of the geomat are presented in Table 3.

The geomat consists of two parts (Figure 5): the structural part (geogrid) and the geomat. Therefore, thermal analyses were performed on each part to obtain a better evaluation result. Thus, the geomat was separated into the central part (CP) and structural part (SP).

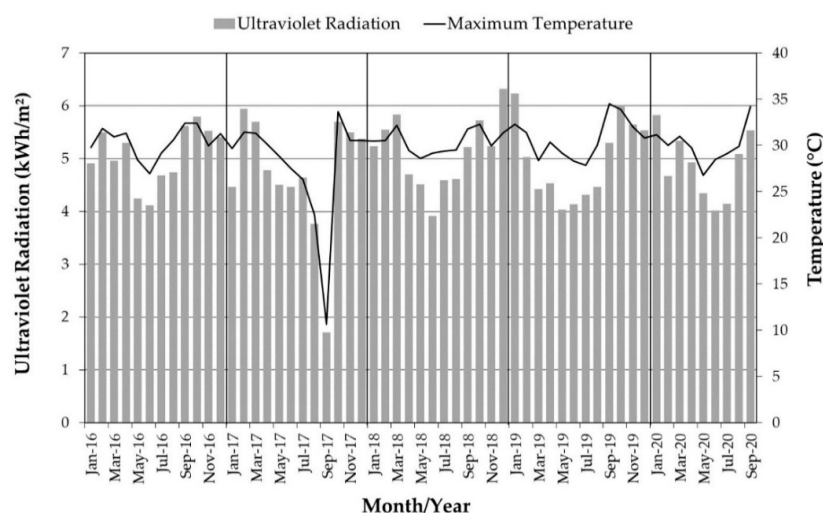
**Figure 6.** Meteorological information (UV radiation and maximum temperature).

Geosynthetics, in general, use polymers as their raw material. Several atmospheric agents can degrade these polymers, among which the UV radiation present in sunlight stands out, as it is the type of radiation that most affects these materials [42]. The main mechanisms of degradation of polyethylene (material from which the central part of the geomat is made) are UV degradation, thermal degradation, oxidative degradation, and the synergistic effects of these mechanisms co-occurring [43]. Figure 6 shows the monthly UV radiation (in kWh / m<sup>2</sup>) and the maximum monthly temperature to which the geomats of the experimental sections were exposed.

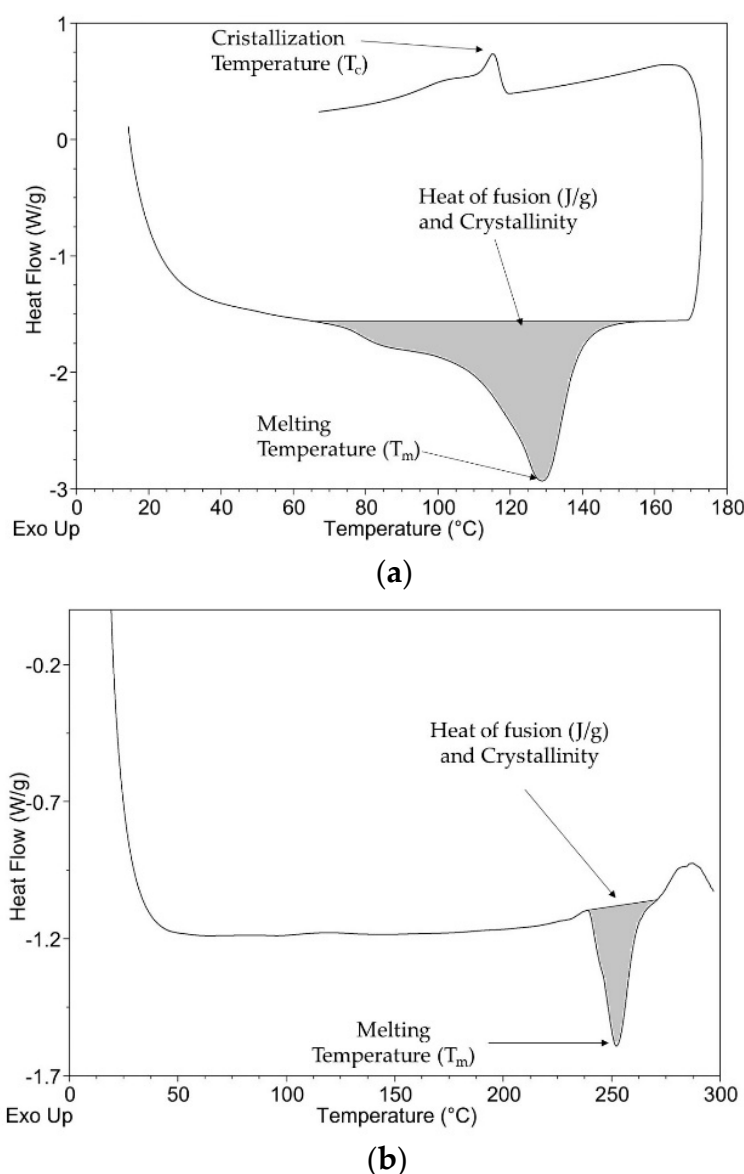
**Figure 7.** Differential scanning calorimetry (DSC): (a) central part (CP) sample; (b) structural part (SP) sample.

DSC parameter curves were used to observe material degradation by determination of melting point temperature (T<sub>m</sub>), crystallization temperature (T<sub>c</sub>), enthalpy of fusion (ΔH), and crystallinity degree, as indicated in Figure 7 below.

The melting enthalpy or enthalpy of fusion ( $\Delta H$ ) is equal to the area under the melting peak. It represents the polymer's crystallinity. The percentage of crystallinity is deduced by comparing a theoretical  $\Delta H$  for the 100% crystalline polymer (285 J/g for polyethylene and high density and 140 J/g for polyester) [53].

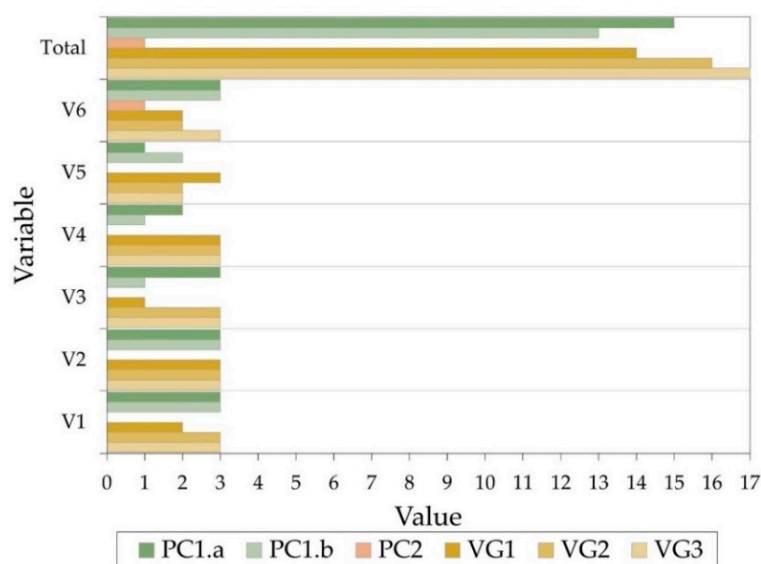
**Figure 8.** Performance of each section.

The performance scores obtained in each experimental section, both total and per analyzed variable (Table 4), are shown in the graph in Figure 8. The experimental unit with the best qualitative performance of erosion control techniques was the VG experimental unit, followed by PC1. Analyzing by sections, the ones that presented the best qualitative performance used the techniques of geomat and sack geogrid (PC1.a, VG2, and VG3), except for the PC2 experimental section unit. These results indicate that bioengineering techniques are improved by implementing semi-rigid erosion control techniques, which have also been shown to be efficient in the work developed by Aparicio Ardila et al. [21] in the margins of the same reservoirs. In the present work, the semi-rigid erosion control

techniques are represented by the geogrid sack. The low performance of the geomat in the PC2 section may be associated with the lack of adequate contact between the material and the soil surface (structural problems reported during the monitoring). The contact problems between geomat and soil reinforce the need to carefully install the product in the field [4], which in the case of the PC2 section influenced its performance since the clamps failed to fix the geomat properly to the reservoir margin.

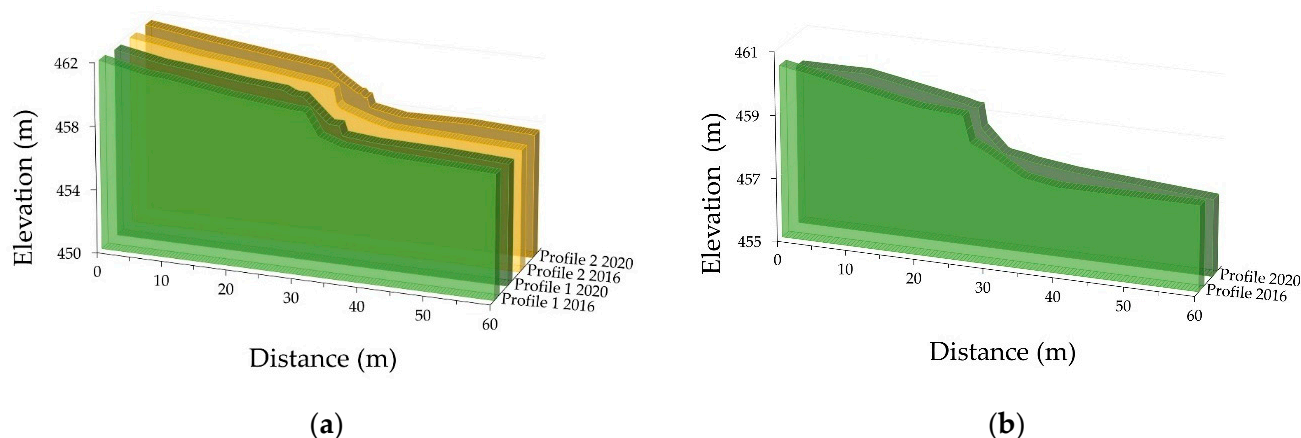
**Figure 9.** Differential bathymetry: (a) PC1.a section; (b) PC2 section.

Examples of the initial and final cross profile 1 and profile 2 (PC1.a and PC2 sections) bathymetry are shown in Figure 9. Section PC2 (Figure 9b) is the only one that presented only one transversal profile. The values of the differential bathymetry by profile and section are shown in Table 5. It should be mentioned that vertical errors can be induced along with the bathymetry measures [54].

In the differential bathymetry analysis (Table 5), the negative values suggest less deposition of sediments, and therefore, higher values indicate more significant sediment deposition in the reservoir. The maximum values of the bathymetric difference (by section) show that the experimental unit that had more sediment deposition in the tested period (2016 to 2020) was the VG, mainly in the only section of the experimental unit without the erosion control technique that includes the sack gabion (VG1). Of the three experimental units analyzed, the section with the least sediment deposition was PC2, despite presenting low qualitative performance (Figure 8).

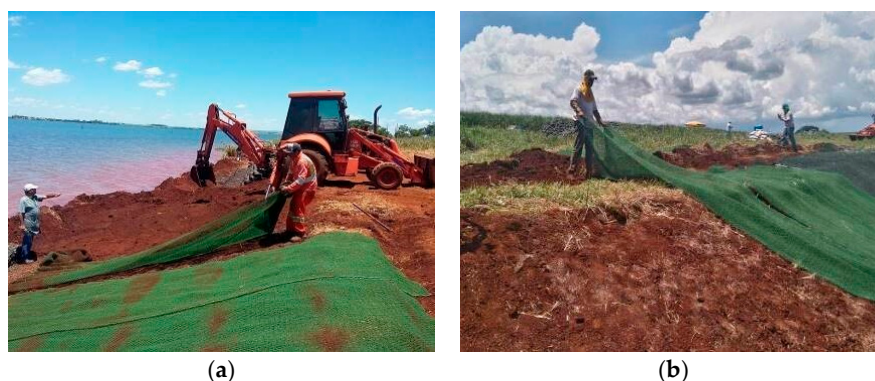
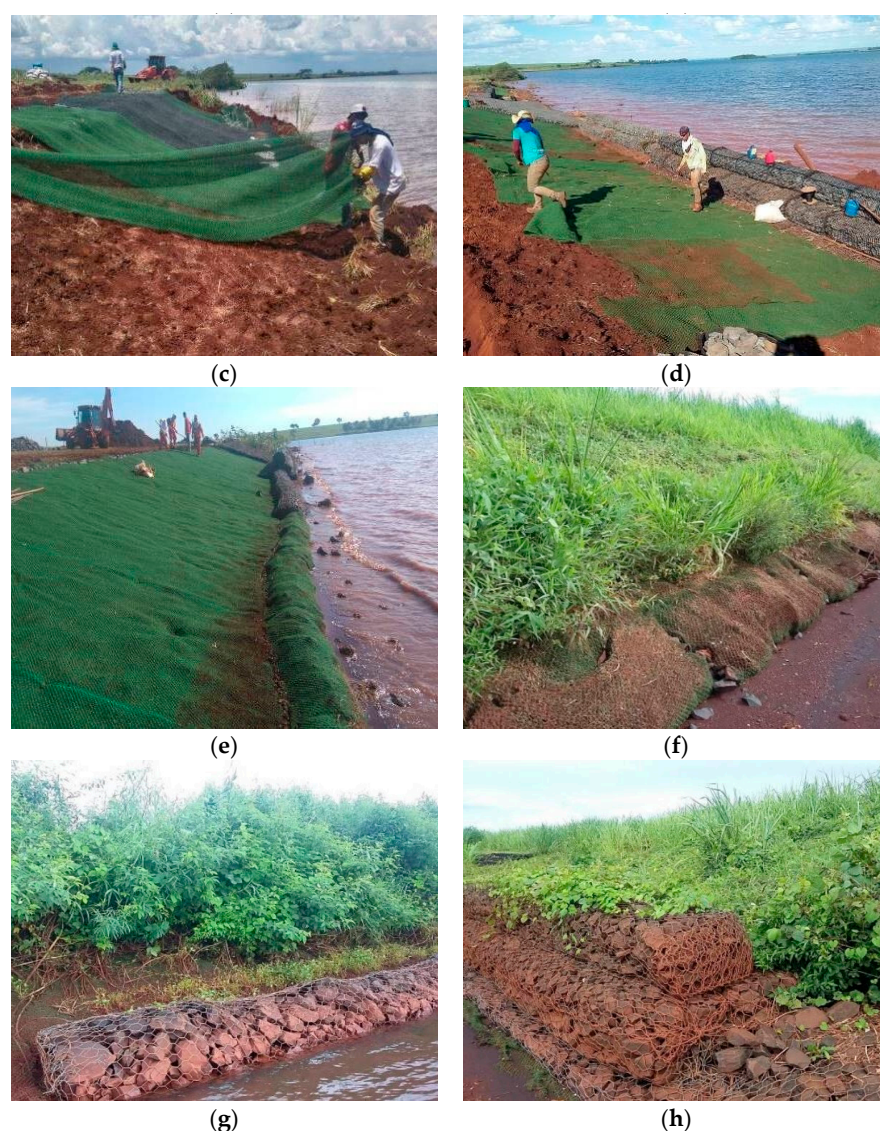
Figure A1. Cont.

**Figure A1.** General installation procedures of the techniques: (a) mechanical reshaping of the margins, (b) construction of the anchor trench, (c) margin anchorage of the geomat, (d) sack gaban installation under the geomat, (e) final installation of the geomat erosion control technique, (f) geomat erosion control technique after two years of installation, (g) geomat and sack gaban after two years of installation, and (h) geomat and sack gaban after four years of installation.

Each UE was divided into a different number of sections, as seen in Figure 3. Each experimental section had a height between 1.5 and 2 m and an approximate area of 150 m<sup>2</sup>. Figure 3 shows the location of the sections in each experimental unit, and Table 2 identifies the type of technique used in each section. Moreover, a schematic profile of each of the techniques analyzed in this study is presented in Figure 4. Images of the general installation procedures of the techniques are available in Figure A1.
