## Supplementary Materials

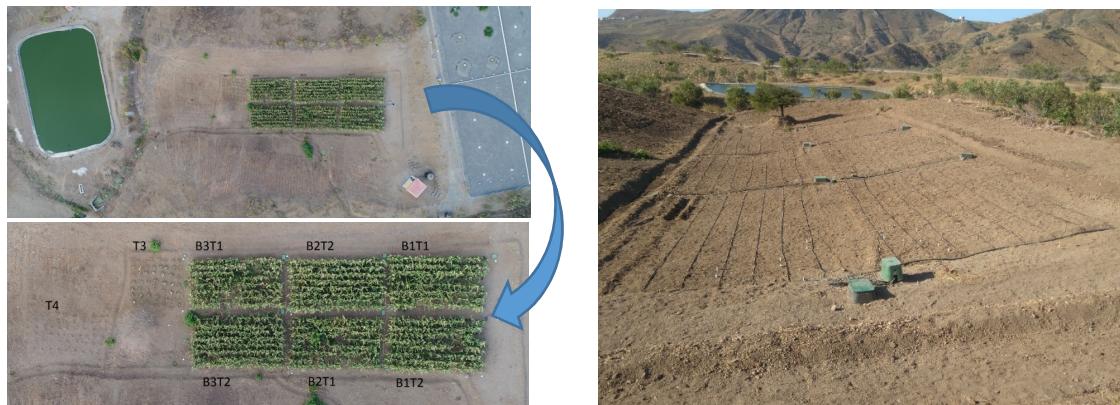
**Figure S1.** Left: Water treatment plant, experimental field and mature lagoon (A, above) and (B, below): lay out of the experimental plot in July 2019, including subsurface drip irrigation (360 m<sup>2</sup>, T1 and T2), support irrigation (60 m<sup>2</sup>, T3) and rainfed (60 m<sup>2</sup>, T4) areas. Drip irrigation area was divided in three blocks in which both of the two irrigated treatments were installed (6 subplots of 8 lines of 10 m long). Observe trees growing close to the T3 and T4 areas. Right: experimental field at the time in which drip lines are being buried. Note soil sensors placed at the topsoil at this time.

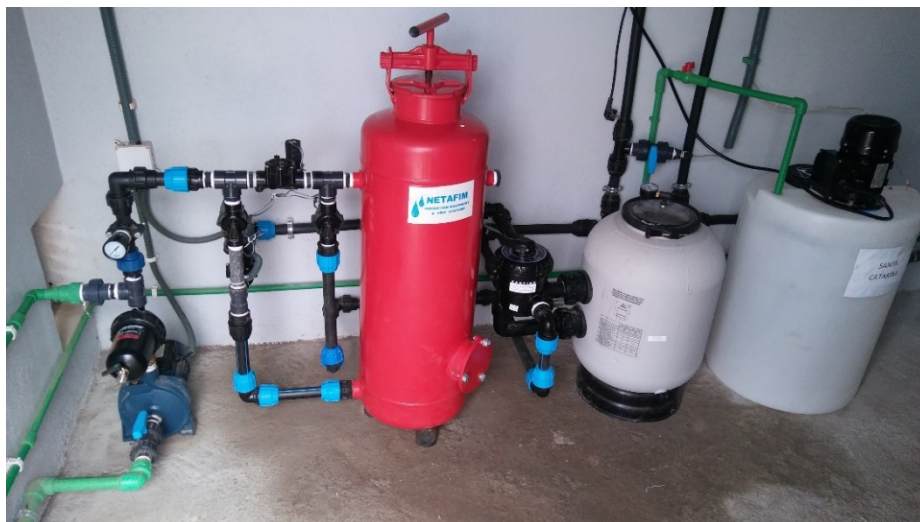
**Figure S2.** Pump, filters and fertigation tank from the irrigation head.

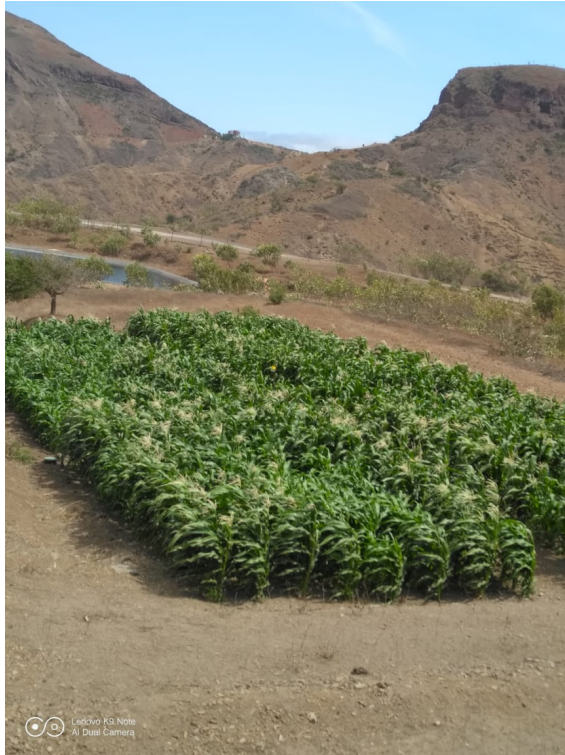
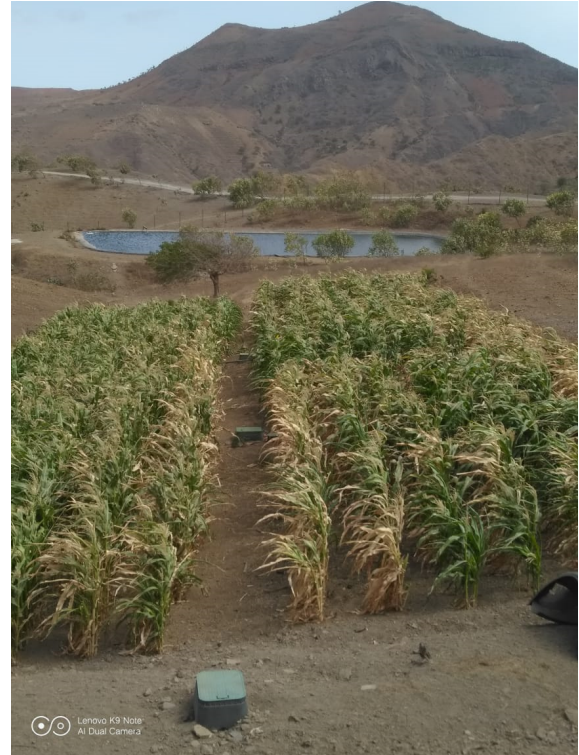
**Figure S3.** Plants just before and after the power outage of 14 days in which plants were not irrigated.

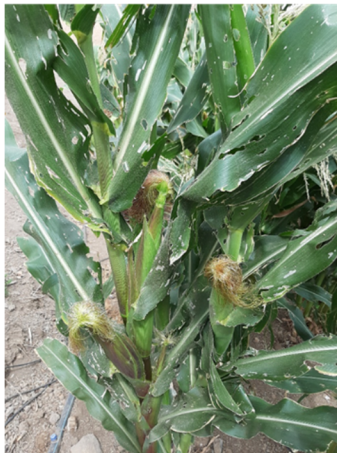
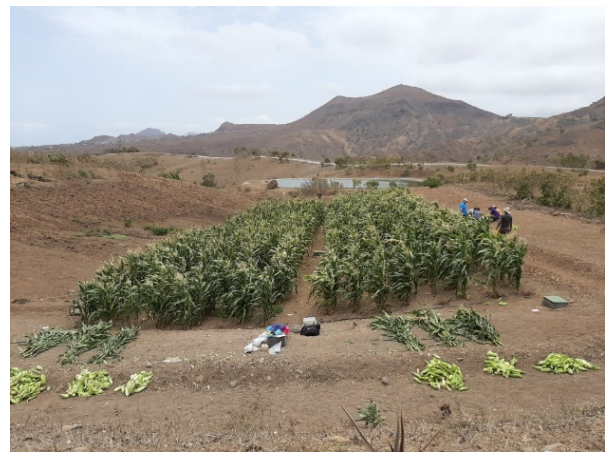
**Figure S4.** *Spodoptera frugiperda* attack causing important losses in plant leaves (left) and in cobs (centre). Right: Cobs classification at field in three qualities: high (centre, below), poor/moderate (centre above) and low pest attack, respectively.
