Article

Experimental Study on Landslides in Terraced Fields in the Chinese Loessial Region under Extreme Rainfall

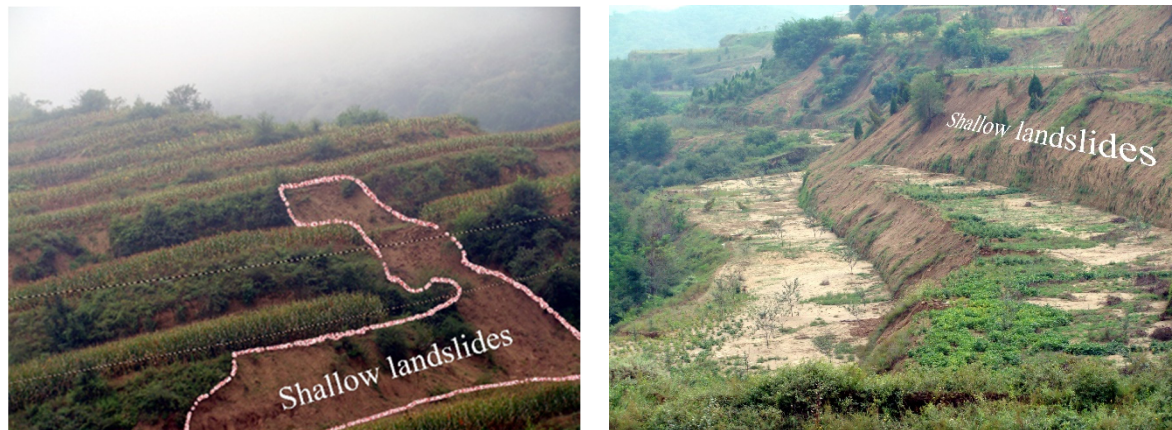
Figure 1. Shallow landslides of terraces in Yan'an China, in July 2013.

With the implementation and promotion of slope-to-terrace projects, large areas of sloping fields have been built into terraced fields [1]. The construction of terraced field projects has changed the minor features of sloping fields, reducing surface runoff and increasing soil infiltration, thus effectively improving soil moisture content, which plays a crucial role in reducing soil erosion and increasing grain yield in the surrounding areas [2,3]. However, after the implementation of slope-to-terrace projects, back-slope terraces in particular experience significantly increased rainfall infiltration, which also leads to the reduction in soil shear strength, thus increasing the risk of landslides [4,5]. For example, an extreme rainstorm event occurred in Yan'an China, which caused a large area of terraces to collapse and landslide in July 2013, as shown in Figure 1.

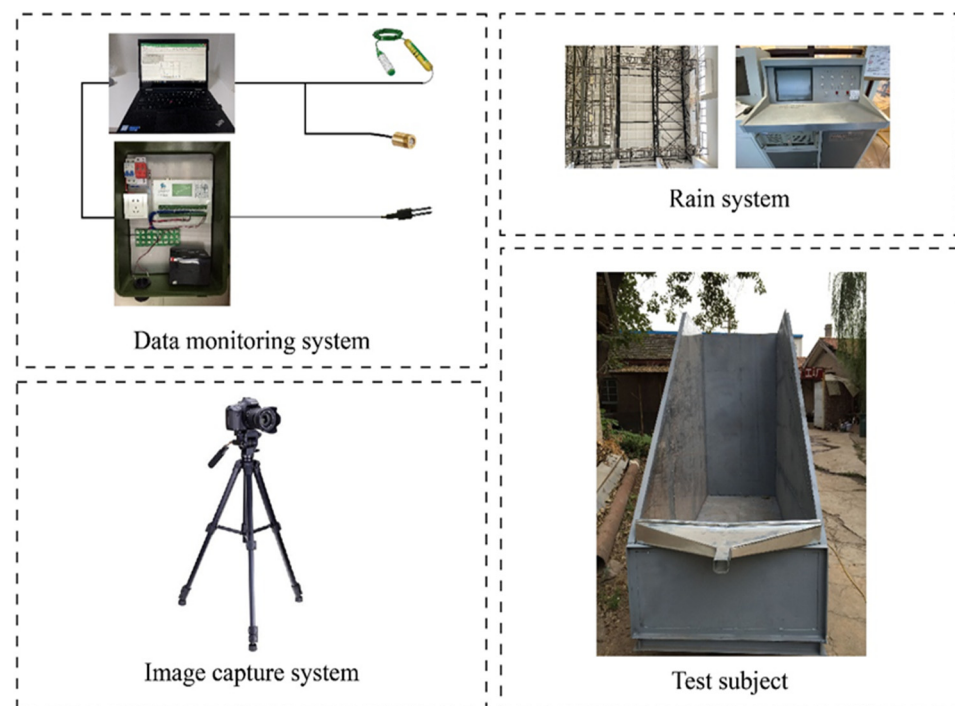
Figure 2. Schematic diagram of model test device.

The test equipment was divided into four major systems: test object, rain, data monitoring, and image capture systems (Figure 2).

The test object system involved a terrace groove with a length of 2.8 m, a width of 1 m and a height of 2.1 m. The height of the slope filled in the test was 1.2 m, with a gradient of 65° . The front and back edges and one side of the model were surrounded by steel plates, and the wall surface of which was smoothed by applying a layer of Vaseline to reduce the influence of the model boundary effect on the test. On the remaining side, transparent plexiglass with a thickness of 1 cm was used as a visual window to help observe the movement of soil at any time in the process of the test. To facilitate the observation of soil movement, a rectangular grid measuring 10×20 cm was drawn onto the transparent poly, and steps were placed close to the steel plate to facilitate the measurement of the channel shape parameters and flow velocity during the test. A catch basin was set up at the front edge to collect runoff sediment.

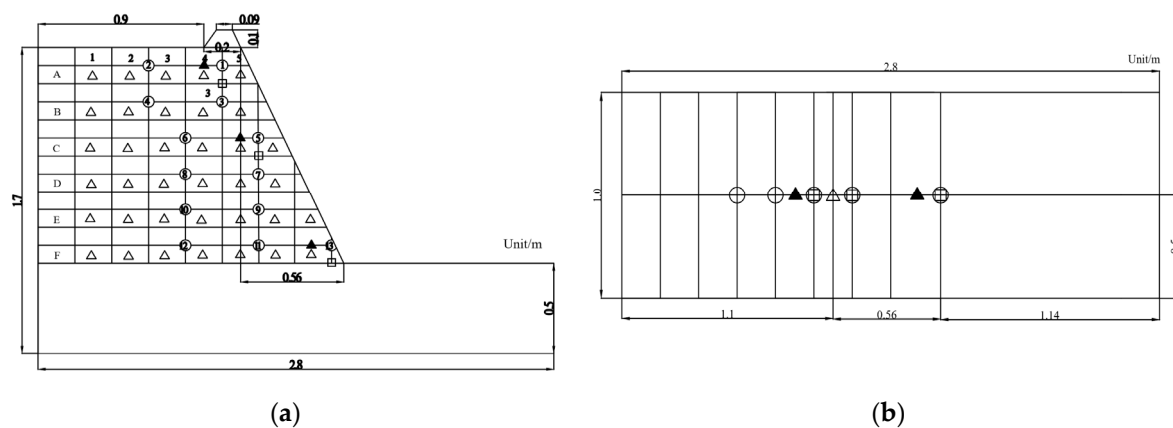
Figure 3. Layout drawing of test sensors. (a) Left view of device, (b) top view of device. Note: Different letters indicate soil layers; Numbers indicate soil columns; ○ indicates soil water content sensor; □ indicates pore water pressure sensor; △ indicates monitor point of displacement; ▲ indicates soil water suction sensor.

To ensure the accuracy of the monitoring data and minimize the impact of sensors on the test results, we arranged the fewest sensors possible. Figure 3a provides a cross-sectional view of terraced soil filling and sensor embedding, showing that two moisture content sensors were arranged on the side close to the slope every 20 cm. Due to the large soil width, one more was arranged on the bottom side, for a total of 13 sensors. To study the mechanical properties of the slope, three pore water pressure sensors and suction sensors were arranged on the top, middle and toe of the slope with a vertical distance of 20 cm from the slope surface. To accurately determine the shape of the slip surface, 5 to 7 displacement sensors were arranged every 20 cm, for a total of 36 displacement sensors. To reduce the influence of the sensor on the test results, the sensor was arranged in the middle of the whole soil, as shown in Figure 3b.

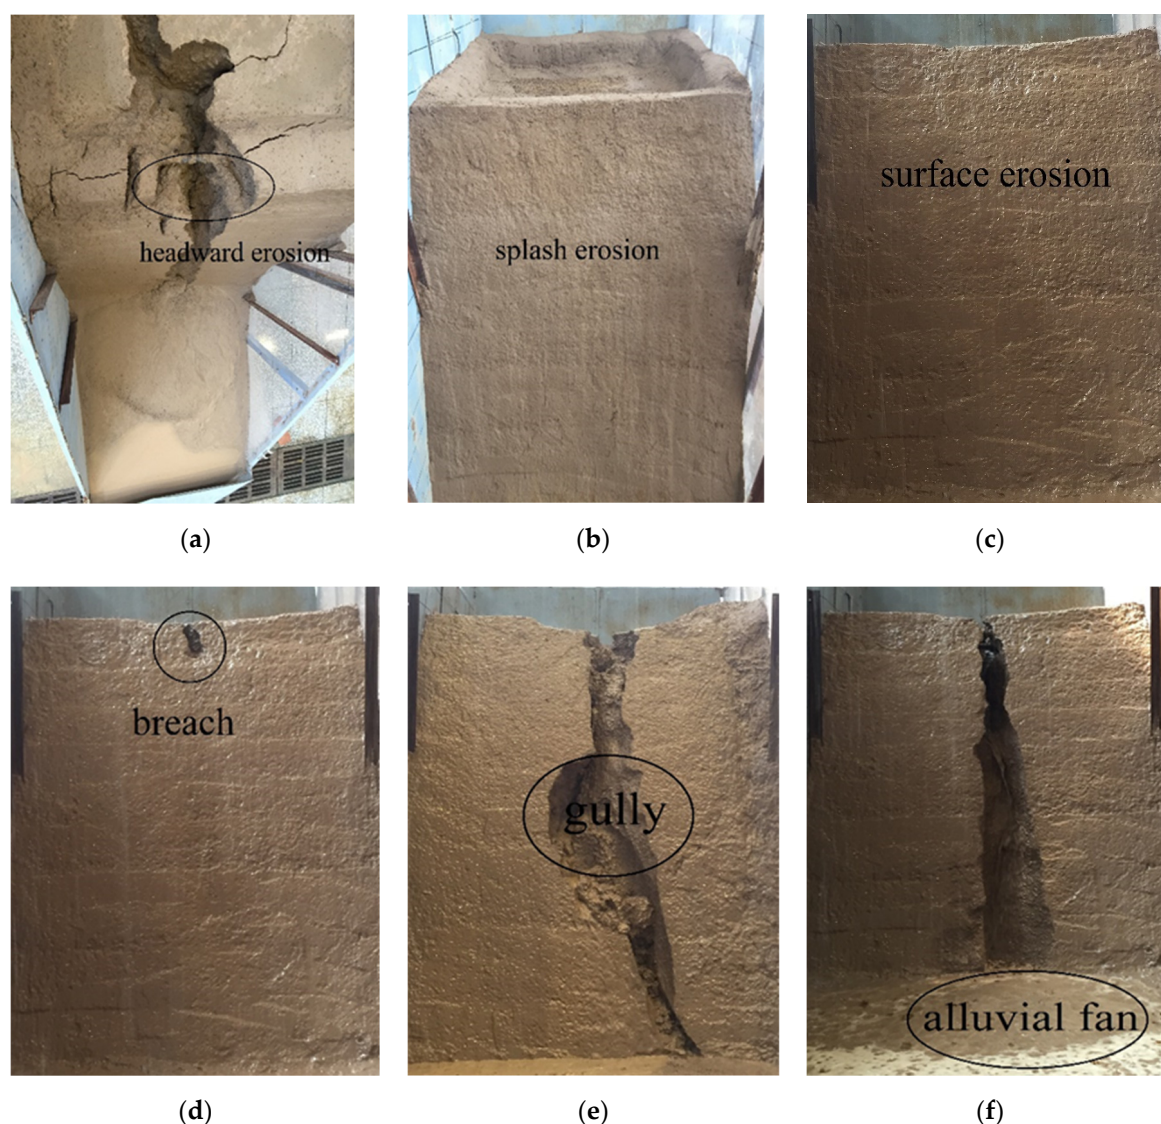
Figure 4. Morphological characteristics of terraces at different rainfall times; (a) Headward erosion, (b) Splash erosion, (c) Surface erosion, (d) Breach, (e) Gully, (f) Alluvial fan.

The results suggest that the shallow landslides of terraces were caused by rill erosion. Most of the rills in the loessial soil were developed by a single drop sill, which was mainly manifested by the headway erosion of the gully head and the collapse of the side wall [42,43] (Figure 4a). By measuring the traceable erosion pattern of terraces, we found that the maximum width of the gully head was 34.25 cm, the maximum depth was 21.32 cm, and the maximum length was 75.86 cm. The total erosion amount was about 270.96 kg. The sediment yield rate of five rainfalls was 181, 475.67, 1707.17, 1624.33, and 527.83 g/min. The sediment yield rate showed a trend of increasing first and then decreasing. Before the runoff, when the exposed slope surface was hit by large raindrops, the surface soil structure was destroyed, and the soil particles splashed up and fell back to the slope surface, forming raindrop splash erosion (Figure 4b). After the runoff, the erosion developed from raindrop splash erosion to layered surface erosion. The time from splash erosion to surface erosion was one hour (Figure 4c). The reason for this finding is that the runoff was low at the initial stage of runoff generation and the runoff eroding force was less than the anti-erosion ability of soil resistance. With the increasing runoff, runoff eroding force also increased. Isolated and sporadic falling ridges were generated in the terrace ridge and the vulnerable parts of the side slope's soil. When the terrace ridge was filled with water, the terrace ridge breached under the action of hydraulic erosion (Figure 4d) and the water cut down along the breach to form obvious gullies, with an average width of 17.8 cm (Figure 4e). Due to the erosion, transportation, and accumulation of overtopping flow, the erosion gully continuously eroded and undercut longitudinally, eroding the gully bank and widening the gravity collapse horizontally. The sediment carried by the slope flow was fan-shaped deposition around the gully mouth at the toe of the slope, forming an alluvial fan, covering an area of 176.64 cm² (Figure 4f). The erosion gully further developed and constantly degraded and widened. Due to the difference in the density of terraces and the non-uniformity of the filling materials, the velocities of anti-erosion of the terraces differed. The weak position started easily, and erosion occurred first, forming a scouring pit.

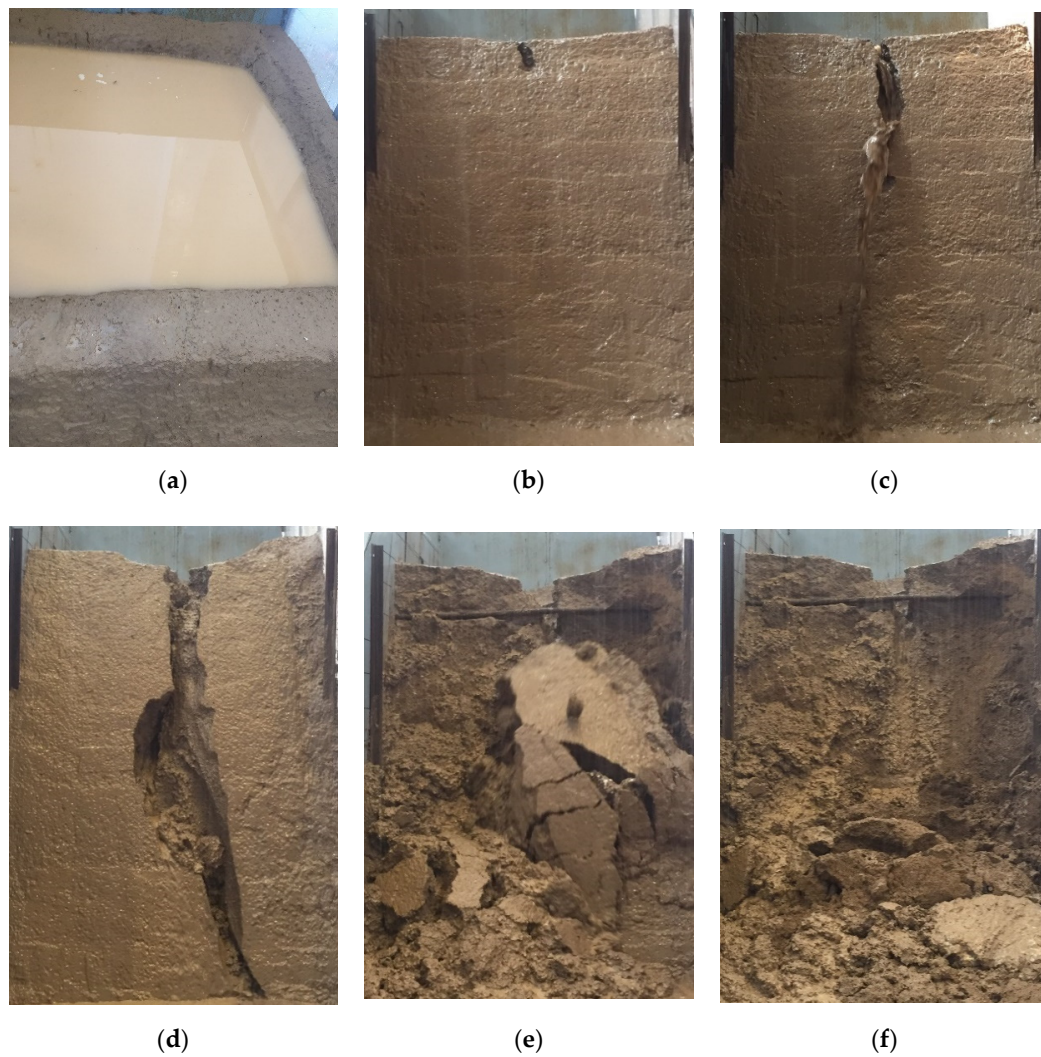
Figure 5. Shallow landslide process in terraces. (a) First stage, (b) Second stage, (c) Third stage, (d) Fourth stage, (e) Fifth stage, (f) Sixth stage.

According to a series of deformation characteristics of the side slope during the test, the mode of this kind of shallow landslide of terraces under rainfall conditions is summarized in this section. The deformation mode is shown in Figures 5 and 6 and can be described as follows: (i) The stage of water accumulation on terraced fields: As the rainfall continued, the soil of the terraces gradually became saturated, which reduced the infiltration capacity of the soil, while the rainfall gradually increased, resulting in water accumulated on the terraces. The height of stagnant water was 3.5 cm. (ii) The formation and development stage of the breach: After rainfall had been occurring for a period of time, the loess on the terrace surface and its slope surface reached saturation. The ponding on the field surface crossed the ridge, forming surface runoff and flowing down the slope. When the water flows through the ridge, the erosion of the ridge formed a breach with area of 706 cm². With the continuous erosion of water and rainfall, the erosion degree of the ridge increased and the breach expanded. (iii) The erosion of the waterfall nappe flow: The ponding flowed along the breach and formed plumes. Under the combined action of hydraulic forces and gravity, the discharge flow formed a multi-stage drop sill on the slope surface. The maximum discharge and maximum velocity of the breach occurred at this stage, and the ponding on the terrace surface dropped rapidly. (iv) The formation and development stage of the erosion gully: With continuous rainfall, the multi-level drop sill was connected by the water flow, forming an erosion ditch, and the width and depth of the erosion ditch gradually increased along the slope shoulder to the slope toe, finally forming the alluvial fan at the slope toe. The average erosion gully width was 17.8 cm. (v) The stage of superficial-layer shallow landslides of the terraces: With increases in the width and depth of the erosion gully, the soil on both sides of the slope was suspended. In addition, the soil is constantly saturated with water, the gravity increased and the cohesion decreased, resulting in superficial-layer shallow landslides of the terraces, and the soil volume of the landslide was about 0.24 m³. (vi) The terraces tend to be stable: After the superficial-layer shallow landslides of the terraces, the side slope grade of the residual slope was very small; even if the soil was in a saturated state, it would not easily collapse.

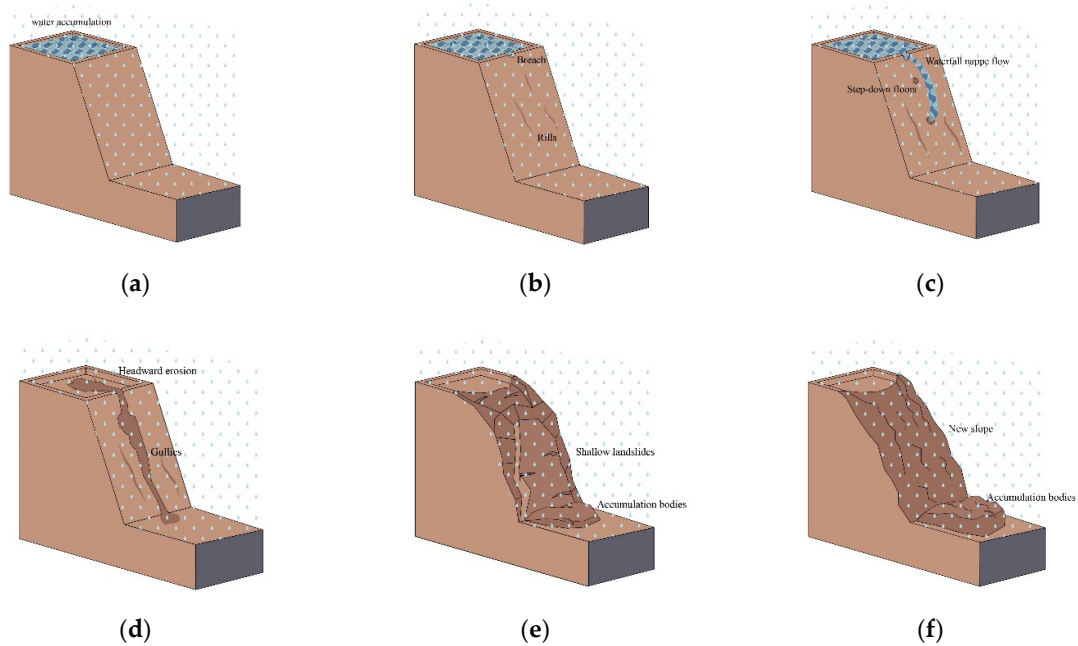
Figure 6. Three-dimensional diagram of shallow landslide process in terraces. (a) First stage, (b) Second stage, (c) Third stage, (d) Fourth stage, (e) Fifth stage, (f) Sixth stage.

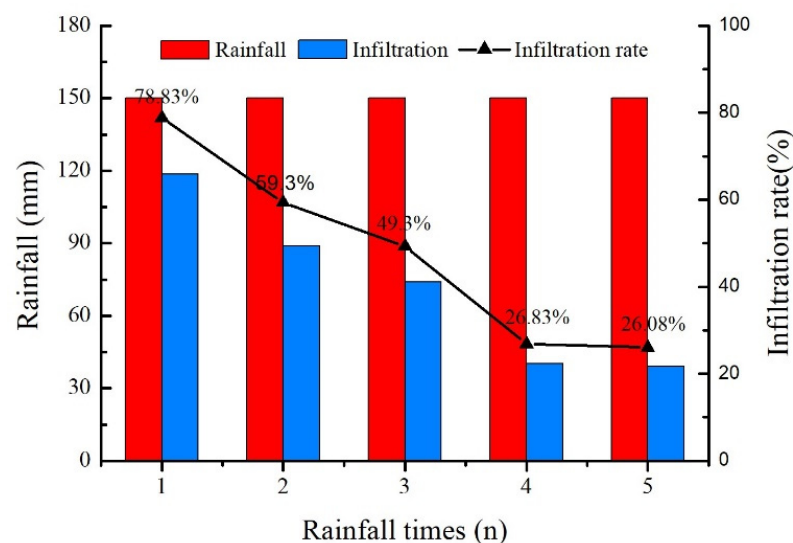
Figure 7. Rainfall amounts and percentage of infiltration.

The curve in Figure 7 shows the relationship between average rainfall (infiltration), infiltration percentage, and rainfall frequency. The infiltration rate was 79%, and the infiltration rate gradually decreased with the increase in surface runoff. In the third rainfall event, the infiltration rate decreased to 49.3% and then remained steady at approximately 26.14%. More than half of the rainfall turned into surface runoff, causing soil erosion and rain erosion on the slope's surface and formed rills. The infiltration of rainwater from the slope surface to the slope was an unsaturated-to-saturated seepage process, and the change in infiltration rate with time was related not only to the original humidity and matrix suction of unsaturated soil, but also to the physical characteristics and structure of the soil from the side slope. Generally, at the early stage of infiltration, infiltration capacity is greater than rainfall intensity and the infiltration rate is higher, so infiltration is pressureless. After a period of time, the soil begins to saturate, the gradient of soil moisture content decreases, the matrix suction reduces, and the infiltration capacity lowers. When rainfall intensity is greater than the soil's infiltration capacity, slope runoff occurs, which is pressure infiltration. Finally, with rainfall, the infiltration rate gradually decreases until it tends to be constant, reaching the stable infiltration stage. Figure 8a shows the relationship curve between infiltration rate and rainfall time for five rainfall events, and Figure 8b provides partial enlarged view; the figure shows, the infiltration rate generally presents the same decreasing trend. The steady infiltration rate ranged from 0.74 mm/min to 0.77 mm/min, and the results are similar to those in the literature [51]. This is because with progressing rainfall, the infiltrating rainwater continuously increased the soil moisture content, which saturated the surface soil causing the infiltration rate to gradually decrease. However, the infiltration rate of the topsoil was relatively low and stable after saturation, and the infiltration rate of rainwater was further reduced due to the small amount of rainwater infiltration inside. For the third and fourth rainfall events, the infiltration rate first increased and then decreased. The reason for the increase in the third rainfall's infiltration rate was that cracks appeared on the terrace surface and the infiltrated rainwater could speedily travel deep through the cracks; on the other hand, due to the water-retaining effect of the ridge, ponding formed on the horizontal surface, which accelerated the infiltration rate. The reason for the increase in the infiltration rate in the fourth rainfall was that the superficial layer of the terrace collapsed and the rainwater rapidly entered into the soil along the gully.

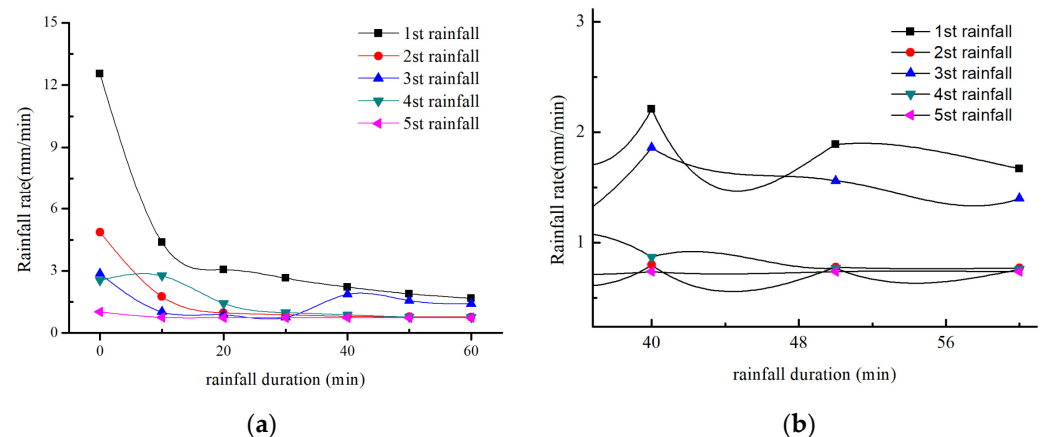
Figure 8. Relationship between infiltration rate and rainfall time in five rainfalls; (a) The relationship curve between infiltration rate and rainfall time for five rainfall events, (b) partial enlarged view of the Figure 8a.

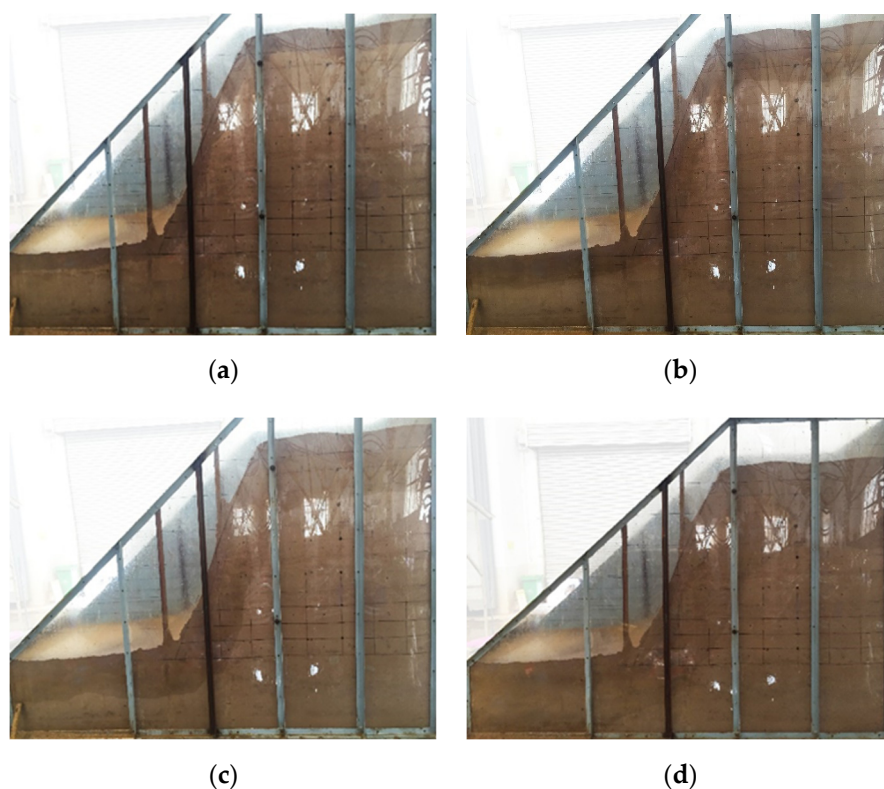
Figure 9. Infiltration peaks at different rainfall time; (a) $T = 10$ min, (b) $T = 60$ min, (c) $T = 180$ min, (d) $T = 300$ min.

Figure 9 depicts the wetting front from different rainfall time points: when the rainfall duration was 10 min, the downward depth of the wet front was 9.7 cm; when the rainfall duration was 60 min, the downward depth of the wet front was 28.8 cm; and when the rainfall duration was 180 min, the downward depth of the wet front was 35.5 cm. The wet front was basically linear with the rainfall time. The wetting front moved downward with increasing duration of rainfall and the migration rate of the horizontal wetting front was faster than that of the side slope surface. The reason for this finding is that the horizontal plane could effectively intercepted the rainwater, and the ponding accelerated the infiltration rate of the horizontal surface [54]. However, for the inclined slope, most of the rainwater formed runoff along the side slope surface, and only a small part of the rainwater infiltrated. Figure 10 shows that with continuous rainfall, a proportion of the rainwater on the terrace surface infiltrated, another part formed slope runoff, and some of it infiltrated along the back wall of the model box, where collapse deformation occurred. Due to the different materials of the back wall and the soil, the infiltration speed was faster than that of the soil; thus, the wetting front moved rapidly in the back wall.

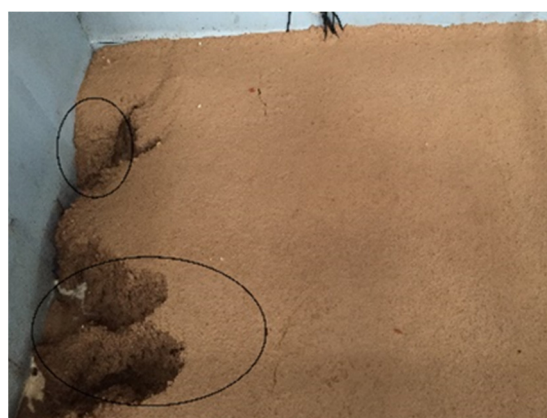
Figure 10. Collapsible deformation on the posterior wall.

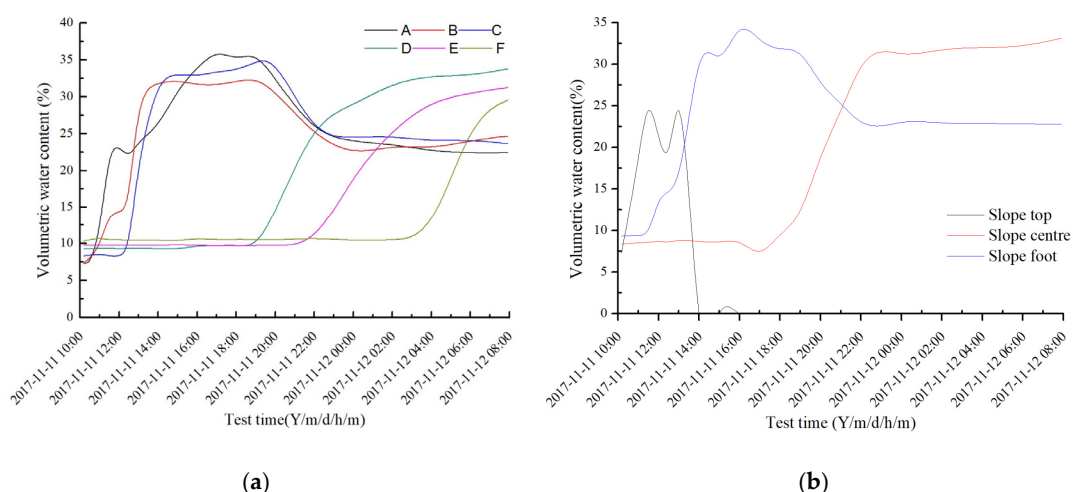
Figure 11. Variation of volumetric water content of soil layers and feature points with time; (a) The moisture content of each soil layer at different depths of slope varied with rainfall duration, (b) The moisture content at the top, center, and foot of the slope.

In accordance with the monitored data from the slope moisture sensor, the change in slope moisture content in the whole process can be understood. Figure 11a shows that the moisture content of each soil layer at different depths of slope varied with rainfall duration

and post-rain duration. Within 0.5 h of the beginning of rainfall, the moisture content of layers A, B, and C of the slope increased to 0.83%/h, and the change was obvious, while the moisture content of soil in layers D, E, and F changed very little, due to the infiltration of rainwater going from shallow to deep. With the increase in rainfall time, rainwater infiltrated and the moisture content of the whole slope increased continuously. The increased rate of moisture content of the upper soil was about 2~2.83%/h, which is higher than the previous value of 0.83%/h, due to the continuous increase in soil moisture content, the decrease in matrix suction, and the increase in the permeability coefficient. For D, E, and F, there is an obvious break point in the curve, and the moisture content suddenly increased at about 4:00 p.m., which indicated that there were violent activities in the soil; deep cracks appeared in the soil, the soil began to lose stability and the sliding surface formed. Thus, the change in moisture content strongly influenced soil failure. First, the increase in moisture content led to an increase in pore water pressure and a decrease in effective stress, thus resulting in a decrease in soil shear strength; second, the increase in moisture content increased the permeability of the water, which led to a decrease in side slope stability. The dual effect of rainfall infiltration leading to water content variation may be an important reason for the side slope's rainfall-induced instability. Figure 11b shows that the moisture content at the top of the slope rose the fastest and had the largest change range. At around 1:00 p.m. on 11 November, due to the shallow landslides of the slope body, the moisture content of the slope rapidly dropped to 0%, followed by the toe of the slope, with the smallest change and the smallest range in the middle of the slope.

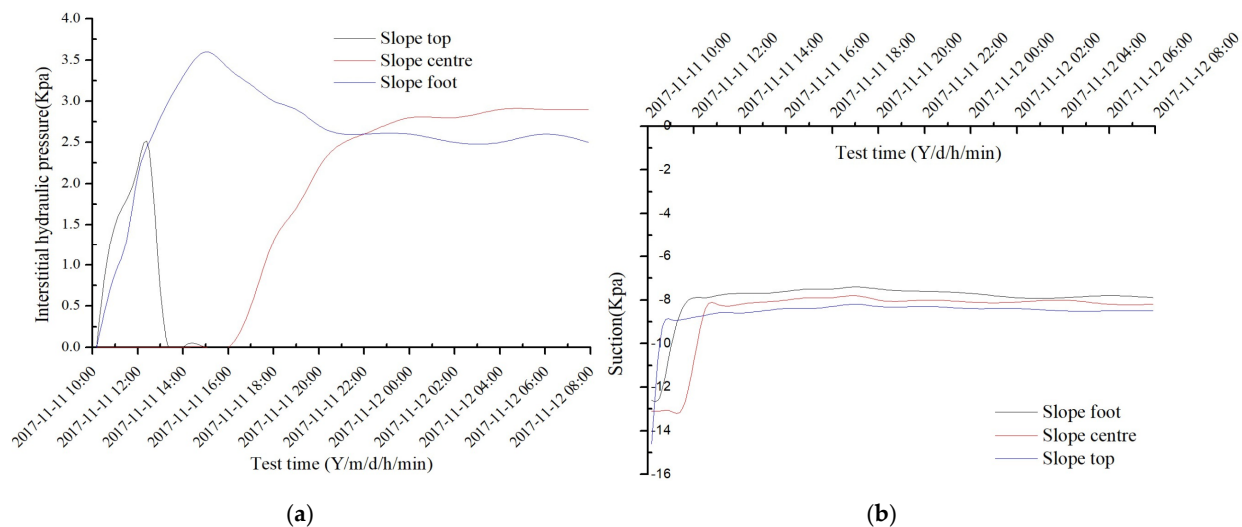
Figure 12. Variation of pore water pressure and soil water suction of feature points with time; (a) Variation of pore water pressure at top, center, and foot of slope, (b) soil water suction at top, center, and foot of slope.

Figure 12 shows the variation in pore water pressure and suction with rainfall. Figure 12a shows that the pore water pressure first increased and then tended to be stable with the rainfall duration. The variation in pore water pressure at the top of the slope ranged most before the shallow landslides of the slope, and the maximum value was 2.4 kPa. Since the sensor was exposed outside the slope after shallow landslides, it rapidly dropped to 0 kPa. The change in pore water pressure at the measuring point at the toe of slope was slightly later than that at the top of slope, with a maximum value of 3.6 kPa. At the end of the rainfall event, the pore water pressure gradually decreased and finally tended to be stable around 2.5 kPa. The change in pore water pressure at the measuring point in the middle of the slope changed later than at the measuring points at the top and toe of the slope, with the water infiltration reaching the measuring point at around 4:00 p.m., then increasing gradually, and finally tending to be about 2.8 kPa. As Figure 12b

shows, the suction (negative pore water pressure) varied from 7.4 to 14.6 kPa, showing a sharp decrease at first and then a stable trend. The reason for this finding is that with rainfall infiltration, the moisture content of each measuring point increased, and the suction decreased sharply. After the rainfall, the moisture content of each measuring point decreased slowly due to evaporation, so the suction increased slowly and finally tended to be stable. Notably, the Campbell 257 soil suction sensor uses an indirect-method suction sensor (with a measuring range of 200 kPa), but the air intake value of soil material is small, so when the suction of the soil sample is lower than 10 kPa, the measurement accuracy of the sensor is poor.

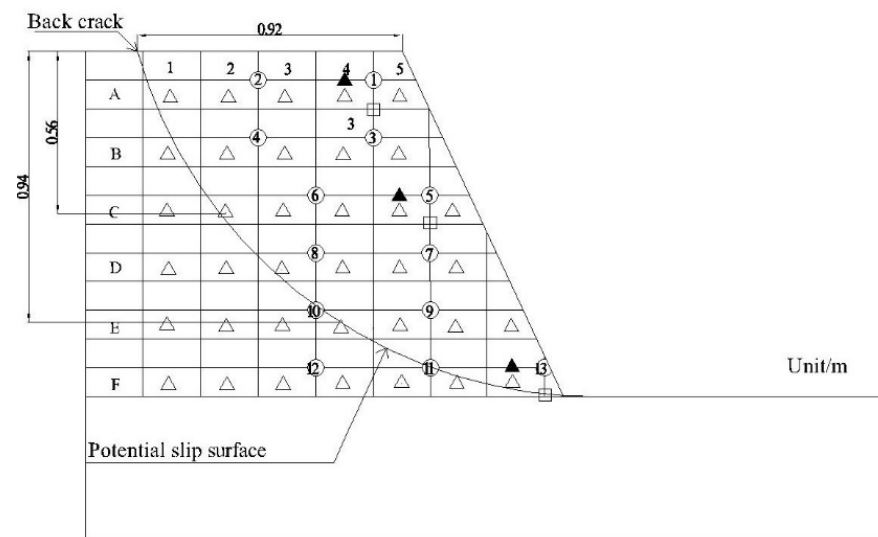
Figure 13. The deep shape of sliding surface. Different letters indicate soil layers; Numbers indicate soil columns; ○ indicates soil water content sensor; □ indicates pore water pressure sensor; △ indicates monitor point of displacement; ▲ indicates soil water suction sensor.

The displacement of measuring points near the top of slope (A1, A2, A3, A4, and A5) was 0.5–40 mm and the direction was 40–50° to the horizontal; the displacement of measuring points near the slope surface (B5, C6, and D6) was 2.5–15.6 mm and the direction was 60–70° to the horizontal; the displacement of measuring points (E7 and F7) near the slope toe was 1.2–6.0 mm and the direction was 80–85° to the horizontal. The displacement of the deepest measuring points (C1, D1, D2, E1, E2, E3, F1, F2, F3, F4, and F5) was almost 0 mm. Through analysis of the above measurements, we found that the movement of the soil near the slope was the most intense; the displacement was the largest here, as was the displacement change rate, as it was the main active area of soil. With increasing depth of the measuring points, the displacement of the soil became increasingly small. When the depth reached the deepest points, there was no displacement. With the increase in depth, the angle between the displacement of each measuring point and the horizontal direction was increasingly large, and some points were close to 90°. This shows that both horizontal and vertical movements occurred in the soil landslides, but with the increase in depth, the horizontal movement transformed into vertical movement, and finally, at a certain depth, the soil movement was close to vertical movement. The approximate depth of the deep slip surface can be determined from the tracer point with no displacement. If the displacement of B1, D2, and F5 points is 0 mm, the depth of the deep slip surface is approximately 0.35, 0.75, and 1.15 m, respectively. Combining the depth of the deep slip surface obtained by each tracing point moving to 0 mm and the staggered fracture at the trailing edge of the landslide, the position of the deep slip surface can be determined; the slip surface radius was 1.43 m. The shape of the deep slip surface is shown in Figure 13.

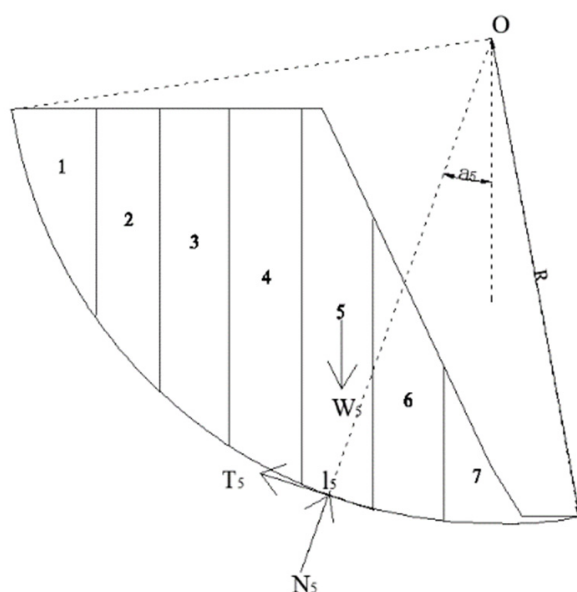
Figure 14. Analysis of the forces of the Swedish slice method.

To study the mechanism and process of deep sliding surfaces in terraces under extreme rainfall, the safety factor of sliding surfaces in terraces was calculated using the Swedish slice method. This method divides the soil above the slip surface into several strips to analyze the force and moment equilibrium on each strip, and to obtain the safety factor of soil stability under the limit equilibrium state [59]. In this experiment, the soil strips above the sliding surface are divided into seven vertical strips according to the location of the sensors. Before solving the safety factor, the following assumptions are made: (i) the force between the strips has little effect on the overall stability, which can be ignored; (ii) the moisture content of each soil strip is the average value of all moisture content sensors on the soil strip; (iii) the cohesive force and internal friction angle of each soil block are used from [60], namely, $c_i = \alpha w_i^{-\beta}$. As shown in Figure 14, according to the equilibrium condition of radial force

here α_i is the bottom slope angle of the strip i ; W_i is the sum of the self-weight of strip i and the upper load; N_i is the total normal force at the bottom of strip i ; T_i is the total tangential resistance of strip i at the bottom; F_s is the safety factor of the sliding arc; c_i is the cohesion of block i ; l_i is the bottom length of the block i ; φ_i is the internal friction angle of block i ; R is the arc radius of the sliding surface; w_i is the soil water content, ($\times 100$) α and β can be obtained by linear interpolation in Tables 2 and 3.

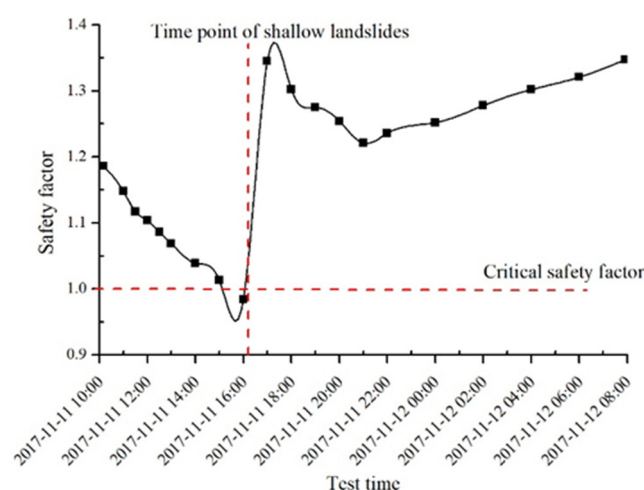
Figure 15. The changes of safety factor of terraces with test time.

Figure 15 shows the variation law of terraces' safety factor with test time. The safety factor first decreased, then increased, and finally slowly increased and tended to be stable. From 10:00 a.m. to 3:00 p.m., with the continuous infiltration of rainfall, the self-weight of the upper soil on the sliding surface increased, which increased the sliding torque. The decrease in cohesion led to the decrease in anti-sliding torque, which was the reason for the decrease in the safety factor. From 3:00 p.m. to 4:00 p.m., due to the sliding torque being greater than the anti-sliding torque, the sliding surface gradually formed, and the time of deep sliding surface began to form earlier than the terraced shallow landslides; 4:00 p.m. to 5:00 p.m., due to the terraces forming a new stable state; the slope was slowed down and the safety factor was larger than the initial stage. From 5:00 p.m. to 9:00 p.m., the change law was similar to that of the initial rainfall, which also showed that rainfall infiltration was the dominant factor leading to safety factor; after 9:00 p.m., the safety factor increased slowly and tended to be stable, because after the rainfall, the soil inside the terraces slowly dried and evaporated naturally, so that the soil moisture content decreased slowly and tended to be stable. The mechanical mechanism of deep slip surfaces in terraces was that through the sliding moment of the sliding body being greater than the anti-sliding moment. The formation of a deep sliding surface in a terraced slope was mainly the result of the interaction of hydraulic erosion and gravity erosion, due to rainfall infiltration, soil moisture content increase, pore water pressure increase, and suction decrease. It increased the bulk density of the sliding body, thereby increasing the sliding torque; however, rainfall infiltration reducing the cohesion and internal friction angle of the sliding body, thereby reduced the anti-sliding torque. With the continuous rainfall, the anti-sliding torque was equal to the sliding torque at a certain time, and the terraced slope was in the limit equilibrium state. The sliding surface began to develop and form from this moment, and the development of the erosion gully accelerated the formation process of the sliding surface. In this study, the rainfall threshold for deep landslides in terraces was 500 mm, which is similar to the results of Zhuang et al. [3], and provides data support for landslides in loess hilly and gully areas.

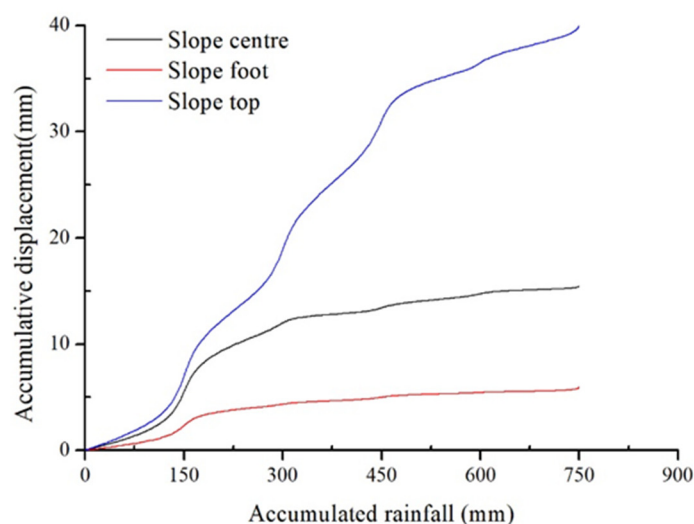
Figure 16. Displacement of characteristic points and its comparison with accumulative rainfall.

Figure 16 shows the relation curve between the displacement of three characteristic monitoring points (A5, C6, and F7) and the accumulated rainfall. With the increase in accumulated rainfall, the soil displacement gradually increased, with the largest displacement occurring at the top of the slope, the second largest at the slope center, and the smallest at the foot of the slope. At around 2:00 p.m. on 11 November, the displacement increased sharply. After the collapse, the displacement increased slowly and remained unchanged at 8:00 a.m. on 12 November. The displacements of the top, center and foot of the slope were 40.3 mm, 15.6 mm, and 6.0 mm, respectively.
