Coastal Erosion of Arctic Cultural Heritage in Danger: A Case Study from Svalbard, Norway

Keywords: coastal erosion; cultural heritage; high arctic; monitoring; Svalbard; DSAS

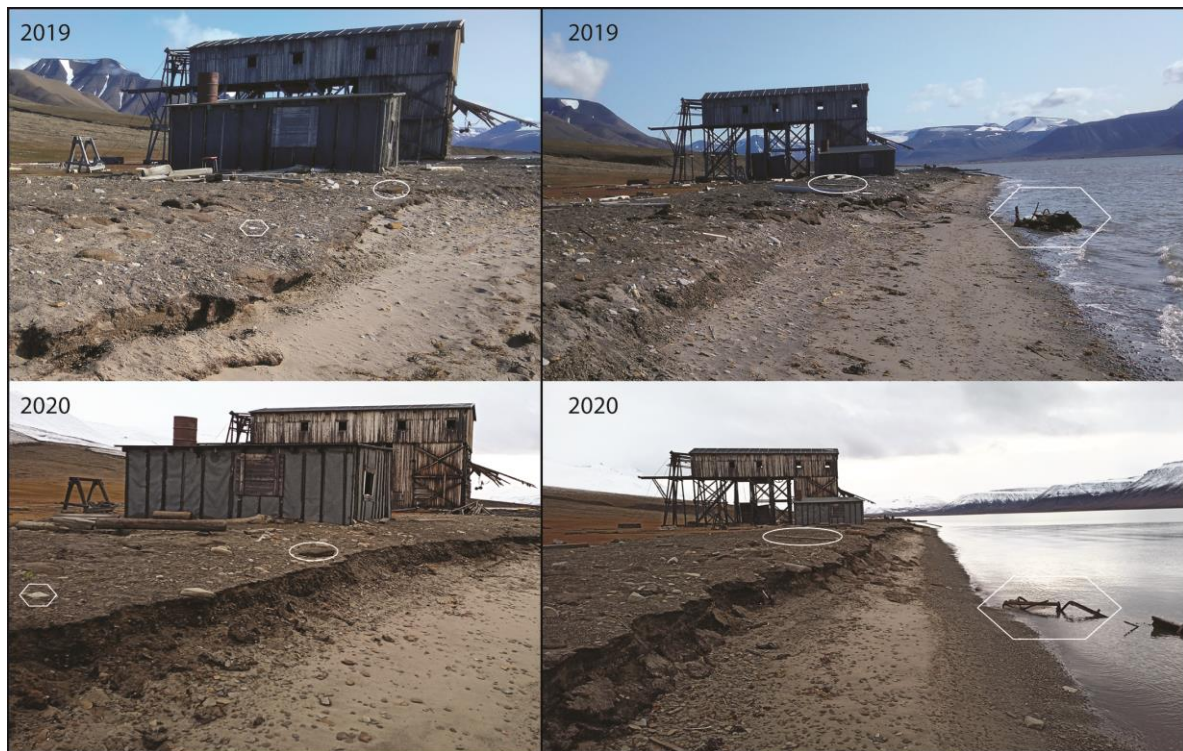
Figure 4. Comparison of shoreline position and morphology between 2019 and 2020 around some of the most important cultural heritage buildings and remnants along the sea in Sector 1 (no. 4 and no. 7). White ellipses and hexagons represent identical objects in the respective photographs.

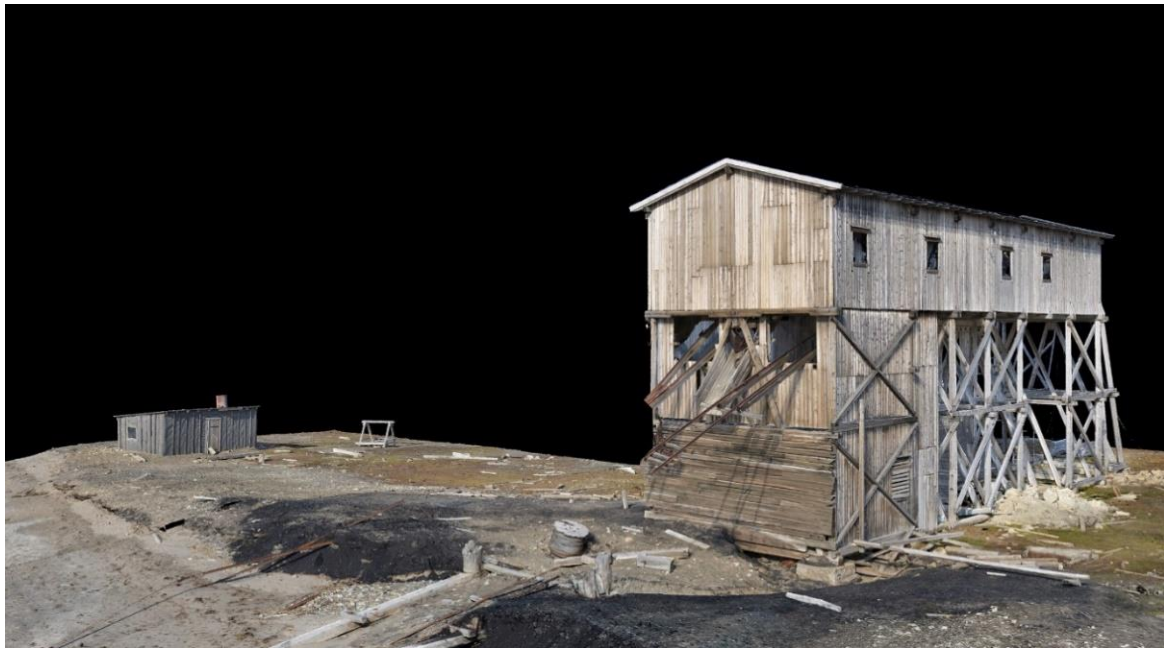
Figure 5. Textured 3D mesh model of the cultural heritage objects no. 1–7. The photogrammetric model was created using a combination of 3D laser scans and a series of single images. Geometry of the model is mainly based on laser scans, and photorealistic colour is derived from single images.

The results of the 3D scans are shown in Figure 5 and Supplementary Materials (short movie). Having a better image of the shoreline dynamics would be of great help for the local authorities in identifying and prioritizing future mitigation measures for the most
