# Failure Process Analysis of Landslide Triggered by Rainfall at Volcanic Area: Fangshan Landslide Case Study

**Abstract:** The Fangshan landslide was a rainfall-induced landslide that occurred in a volcanic area in the Fangshan scenic spot, Nanjing, Jiangsu, China. On 25 October 2016, after approximately 10 days of continuous rainfall, a shallow landslide rapidly developed, which triggered slow movement of deep mudstone rock. According to the characteristics of the landslide body, measures such as anti-slide piles, anchor cables and drainage were used to reinforce the landslide. Active drainage measures included arranging plant growth zones at the trailing edge of the landslide, and passive drainage measures included arranging pumping wells at the trailing edge of the landslide. It is worth emphasizing that the Fangshan landslide was the first example of a landslide in Jiangsu Province, China that was treated by actively lowering the water pressure. After landslide treatment from 16 May 2017 to 21 January 2018, the Fangshan landslide tended to be stable. However, the stable landslide was reactivated by the rise in groundwater level caused by rainfall and pumping well damage and u

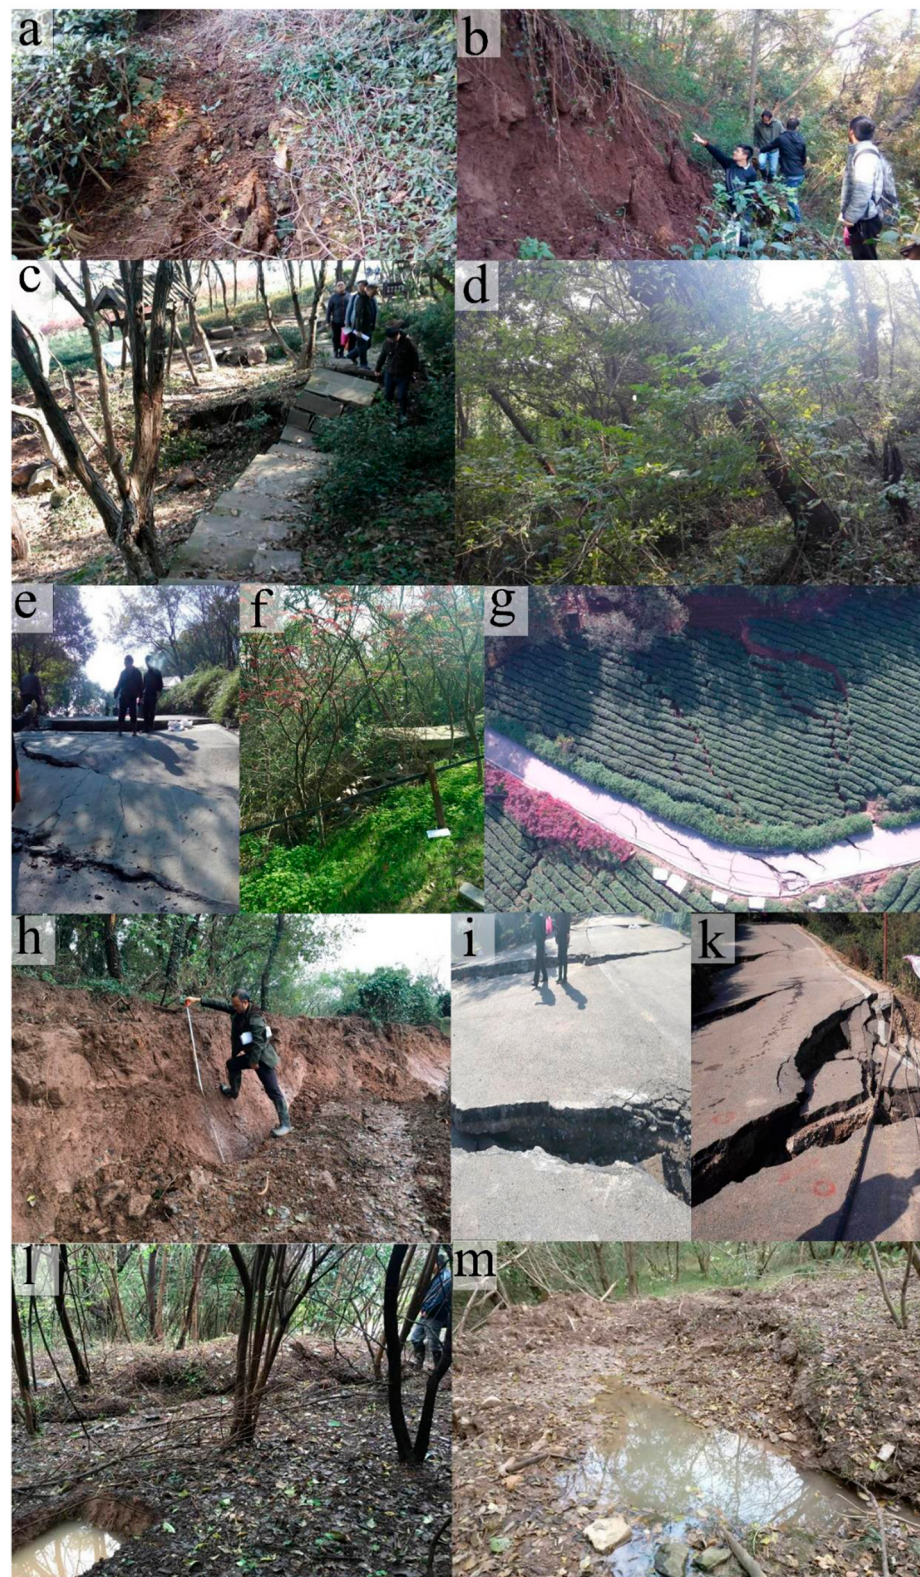
**Figure 4.** (a) Scarp on the trailing edge of landslide, photographed 23 September 2016; (b) scarp on the trailing edge of landslide, photographed 3 November 2016; (c) broken mountain road; (d) toppled trees; (e) cracks on Dlinglin Road; (f) deformation of retaining wall; (g) groove on the northwest side of landslide; (h) subsidence of groove [16]; (i) cracks on Zulong Road; (k) cracks on Dinglin Road; (l) front shear outlet; (m) groundwater flowing out of the surface, their positions are shown in Figure 5.

The boundary of region I is clear. At the trailing edge, a 0.5 m scarp was found on 23 September 2016, and the scarp height increased to 3.5 m (Figure 4b) after the shallow soil landslide formed. The mountain road fractured (Figure 4c), and the mountain trees toppled (Figure 4d). On the southeast side, a large number of tensile and shear cracks occurred in Dinglin Road. The maximum height difference of the road is 1.5 m (Figure 4e), and the retaining wall on the side of the road was uplifted by extrusion (Figure 4f). On the northwest side, a groove (Figure 4g) with a width of approximately 20 m formed, and the subsidence depth was 2 m (Figure 4h). In the middle of region I, cracks and deformation were observed in many places along Zulong Road (Figure 4i) and Dinglin Road (Figure 4k). At the leading edge of region I, several front shear exits were observed, accompanied by soil and road uplift (0.3–1.2 m), and a large number of swelling cracks were observed (Figure 4i). The soil at the leading edge was saturated, and groundwater flowed on the surface (Figure 4m). According to the geophysical profile (Figures 8–10) and the data from the deep displacement monitoring points of the landslide before treatment (P1–P6), it was concluded that the sliding surface of the shallow surface soil landslide was mainly developed in the layer of gravelly soil or at the interface between the gravelly soil and strongly weathered mudstone, at a depth of 8–15 m. The sliding surface of the deep mudstone rock landslide was mainly developed at the interface between the strongly weathered mudstone and moderately weathered mudstone or in the layer of strongly weathered glutenite, which is an interlayer of the strongly weathered mudstone.

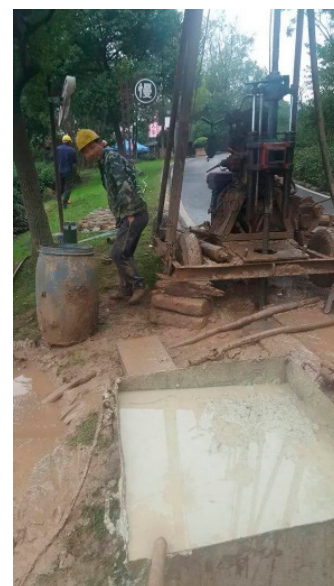
**Figure 7.** Drilling construction site.

The geological features of the landslide were obtained from drilling holes (Figure 7), field surveys, and geophysical sections, whose locations are shown in Figure 5. Figures 8–10 show the apparent resistivity maps of section 1-1, section 2-2, and section 3-3, measured by the high-density electrical method and audio-frequency magnetotelluric method. According to the geological profiles (Figure 11) obtained from the geophysical prospecting and borehole measurements, from surface to underground, the lithologies of the landslide were as follows:

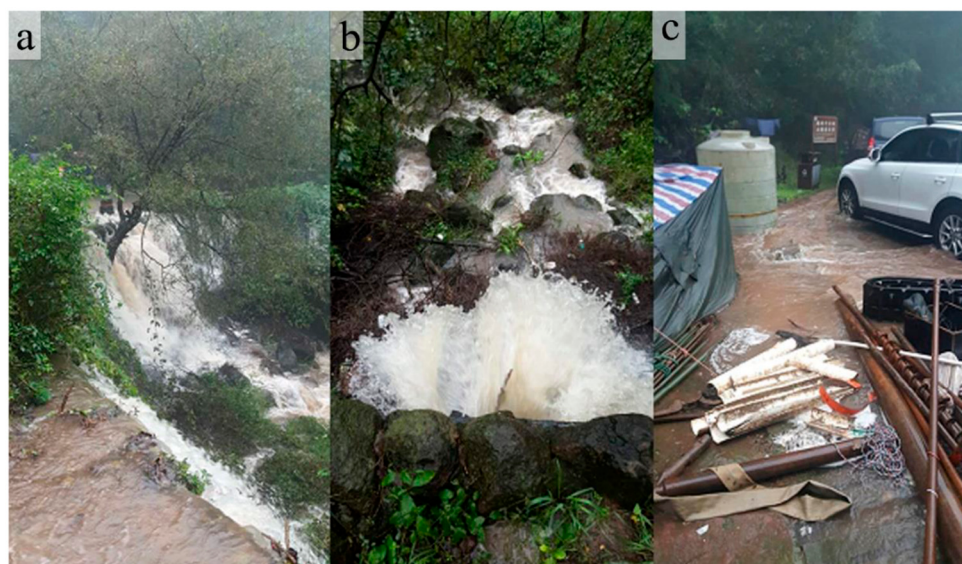
Figure 12. (a–c) were surface floods taken during the rainy season.

Surface floods often occurred in the study area during the rainy season (Figure 12), and it is meaningful to investigate the hydrogeological conditions of each layer to examine the failure process of such rainfall-induced landslides that occur in volcanic areas. The samples for variable head permeability test were sampled perpendicular to the soil sample level, some from drilling holes (Figure 7), some from the same type of layer exposed. Combined with experience from surrounding projects and previous studies [16] and water pressure testing drilling holes, Table 1 shows the results of permeability coefficients used in the design of landslide treatments, which showed that the hydraulic conductivity of each rock layer in the study area varied greatly, up to four orders of magnitude. Specifically, gravelly soil and strongly weathered basalt (sandy and gravelly) formed by the volcanic eruption have high permeability, and clay and mudstone formed by natural deposition have poor permeability, which corresponds to aquifers and relative aquicludes. From surface to underground, the layers include the following: (1) Clay: low permeability, relative aquiclude; (2) Gravelly soil: high permeability, aquifer. (3) Clay: low permeability, relative aquiclude. (4) Strongly weathered basalt (sandy): high permeability, aquifer. (5) Strongly weathered basalt (gravelly): high permeability, aquifer. (6) Strongly weathered mudstone: low permeability, relative aquiclude. (7) Strongly weathered glutenite: high permeability, aquifer. (8) Moderately weathered mudstone: low permeability, relative aquiclude.
