# Design of Cost-Effective and Sustainable Treatments of Old Landslides Adapted to the Moroccan Road Network: A Case Study of Regional Road R410 Crossing the Rifan Structural Domain

**Abstract:** The Moroccan road network is susceptible to multiple landslides annually, particularly in the northern regions due to high rainfall and specific geology. These events result in significant economic and social negative consequences, highlighting the need for sustainable and cost-effective solutions for network maintenance. This study outlines the methodology employed in addressing the issues within the RR410 regional road (Rifain region of Morocco), which entailed a thorough examination of the malfunctions, specific surveys, laboratory testing, and problem modeling. By incorporating long-term test-derived shear strength parameters, the model indicated that the road platform was stable, and back analysis using TALREN 4 software allows for model calibration. At kilometric point 23, using earthwork-based solutions (e.g., purging and replacing the base layer, employing granular water-insensitive substitution material) was found to provide a sustainable alternative to the expensive reinforced c

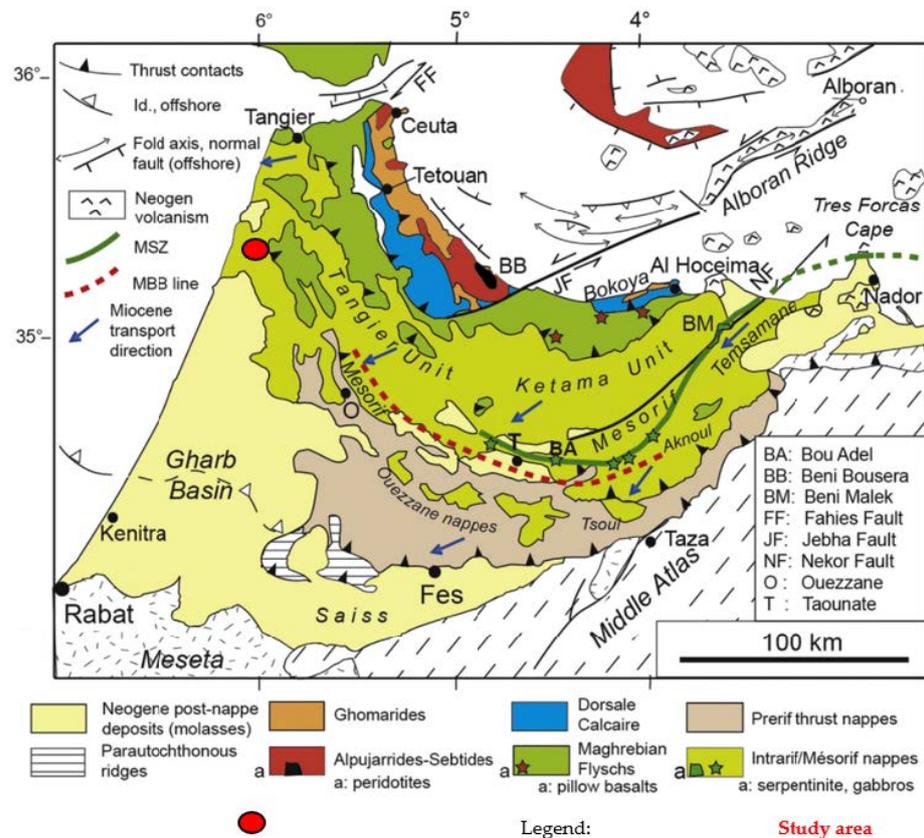
Figure 2. Simplified geological map of the Rif belt [35].

From a geological point of view, the region of Ksar Kbir belongs to the basin of the lower Lakkous (Figure 2), which is located at the limit of the meso-Rifan zone and constitutes the entirety of its eastern and northeastern edge. The structuring of the region is part of the Alpine tectonic evolution that marks the Rif range, the dominant Meso–Cenozoic and Mio–Plio–Quaternary lands record the different structures that mark the major Alpine phase: folds, thrust layers, overlaps, and fracturing [33,34]. In this area, a relatively calm structure is found, consisting of gray marls of the Upper Cretaceous (Senonian mainly), white marls and marl limestones from Eocene, and gray marls with sandstone banks of the Oligo–Miocene (sandstone “Larachian”). Shreds of “Numidian” sandstones associated with their clay base can be found locally.

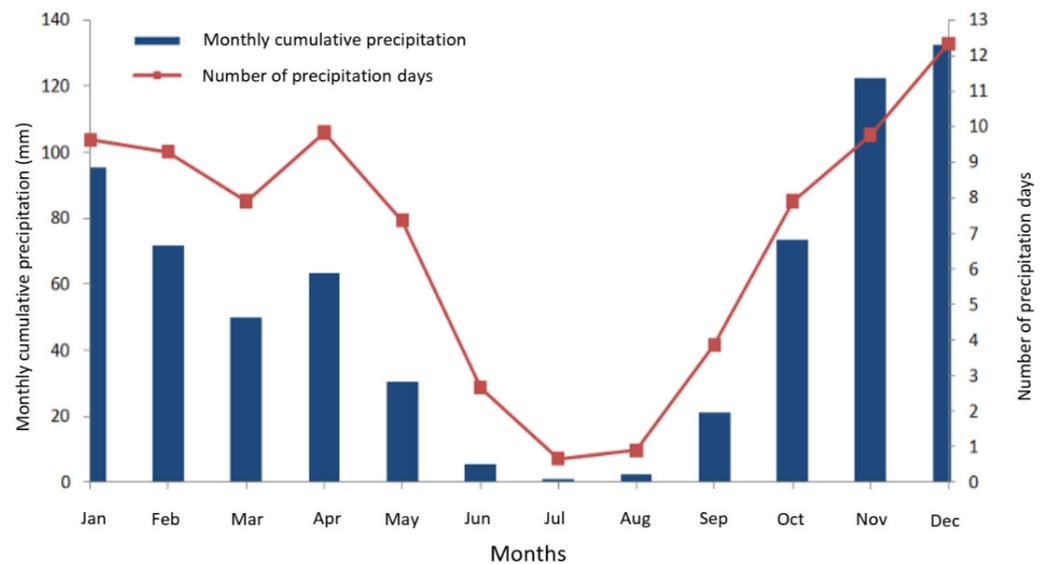
**Figure 3.** Monthly precipitation at Larache station (from 1980 to 2009).

This figure shows that the wettest seasons are from October to April, where the number of days ranges from 5 to 12. This shows the important rainfall during autumn and winter in this region. The rainfall data used came from the analysis of the Larache station provided by the National Meteorological Services. The parameters provided below (Table 1) come from the statistical analysis of a sample of around thirty years (1980 to 2009).

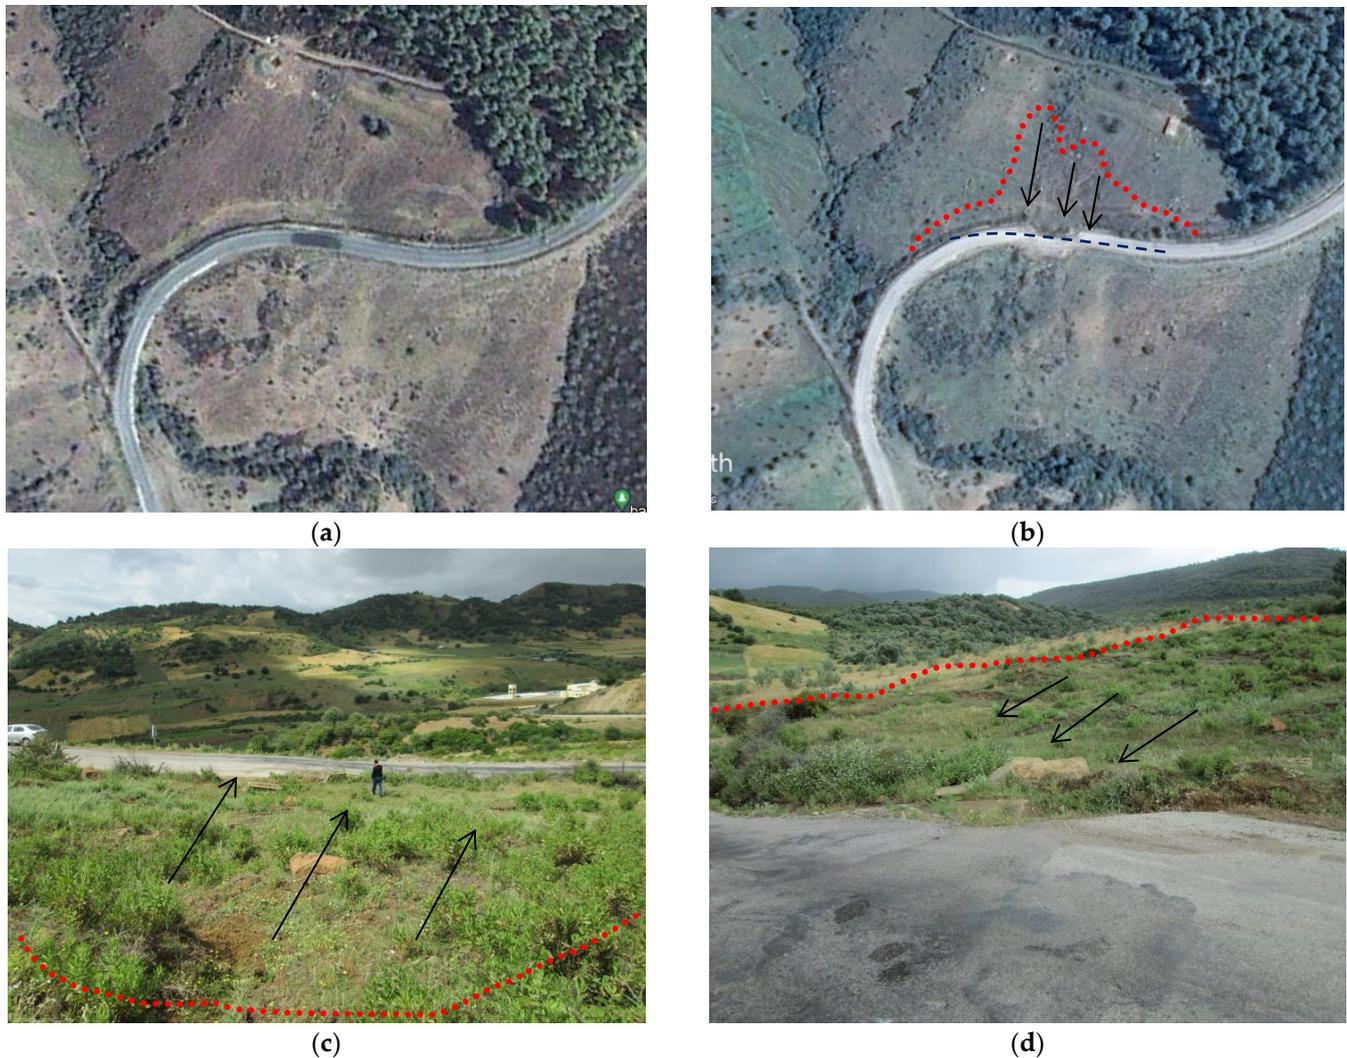
**Figure 4.** Illustration of the disorders observed at kilometric point 23: (a) Google Earth view of the road taken in October 2011; (b) Google Earth view of the departure of the platform taken in February 2014; (c) image taken from upstream (May 2014); (d) picture taken on the platform (May 2014).

The road, as shown in Figure 4c,d, is located on a natural slope, which is relatively low (Around 15°).

A landslide occurred on the platform for about 140 linear meters (Figure 4a,b). This caused its departure downstream as well as its subsidence. On the upstream side (Figure 4c), several marked flows (leaving significant traces on the slope) were observed. These arrivals infiltrate through the voids created by the digging of the ground by runoff water and affect the platform, especially in the absence of drainage devices. The deposits of solid matter resulting from the gully of the ground are seated at the bottom of the drainage ditch. On the platform (Figure 4d), the observed subsidence reached a depth of 3 m. The repetitive collapses were at the origin of the cut of the circulation on several occasions. Previous interventions have consisted of regularly reloading the platform to maintain traffic.

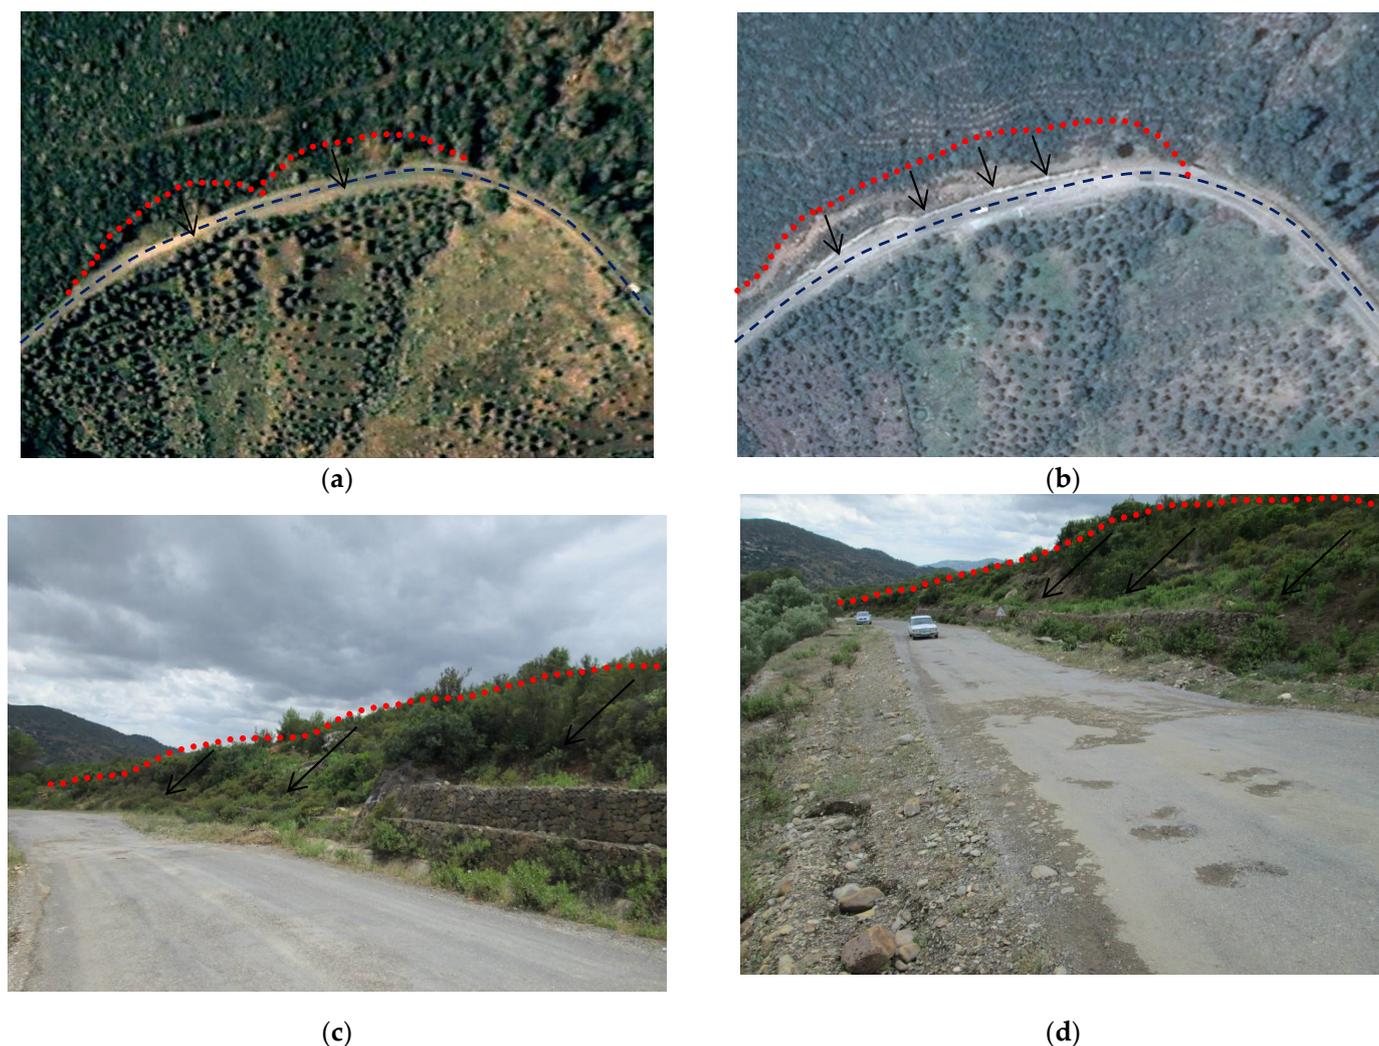
**Figure 5.** Illustration of the disorders observed at kilometric point 48: (a) Google Earth view of the disorder observed taken in January 2003; (b) Google Earth view of the departure of the platform taken in March 2014; (c) picture taken from upstream (May 2014); (d) picture taken on the platform (May 2014).

The road, as shown in Figure 5c,d is in mixed profile. The section affected by the disorders totals a linear of approximately 300 m (Figure 5a,b).

At the excavated side (Figure 5c), setbacks associated with a fall of blocks and stones were visible. This was treated using a gabion wall, without any intervention on the slope. The bottom ditches are blocked by solid deposits from the gullies of the upstream slope. On the platform (Figure 5d), the observed subsidence reached a depth of 3 m. This corresponds to talweg zones, where the existing hydraulic structures (culvert type), were diagnosed as insufficient. Also, the two existing hydraulic structures are partly blocked by solid transport. In the absence of drainage, runoff water therefore infiltrates through the body of the road embankment and causes deterioration of the road. On the downstream side, a major crack affected the shoulder and caused the start of its departure. Part of the embankment was reinforced by a gabion wall, the other part by a masonry wall, which was broken in places by the force of the interstitial pressures. The repetitive collapses were at the origin of the cut of the circulation on several occasions.

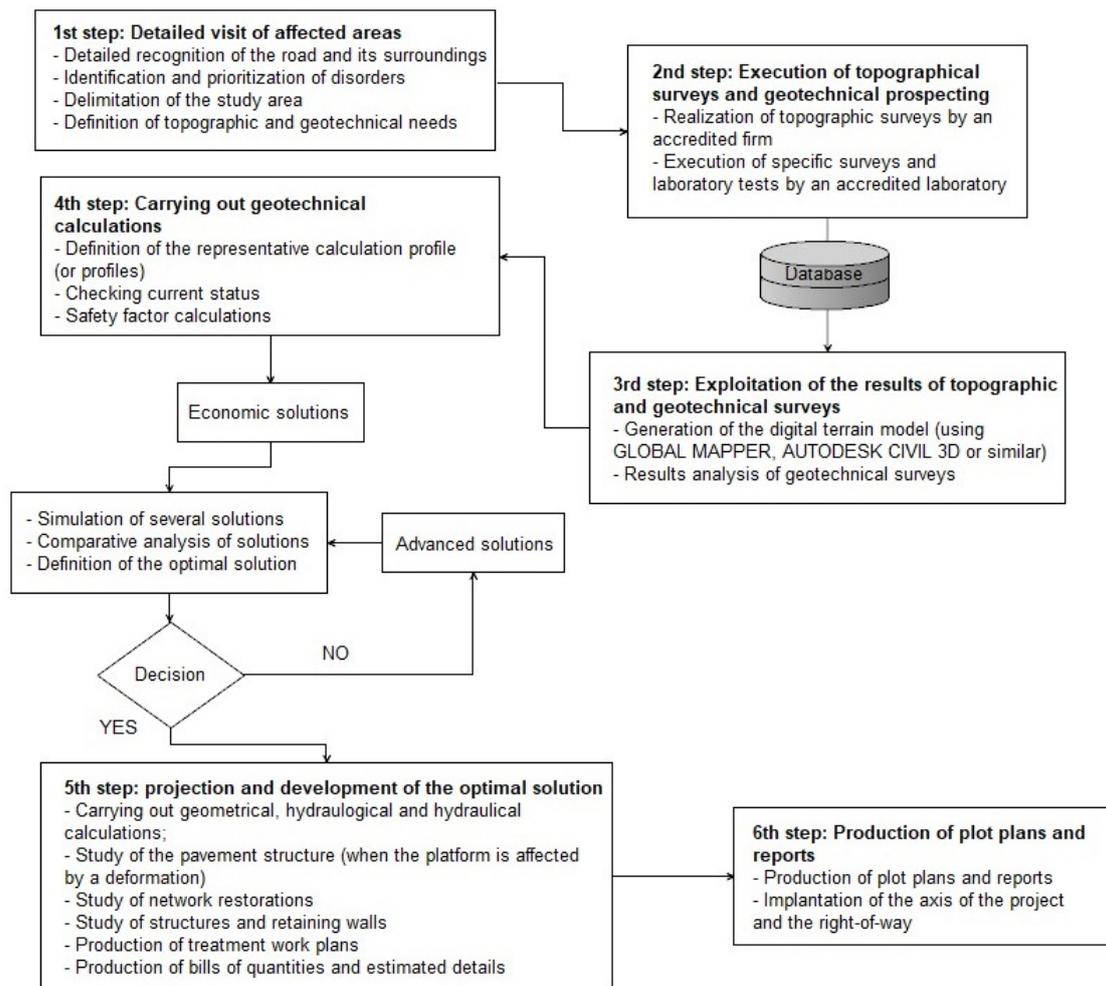
**Figure 6.** Flowchart of the detailed methodology followed to carry out this study.

The methodology followed, as shown in Figure 6, consisted of carrying out various tasks, according to thoughtful steps, to identify the problem and provide suitable solutions for the resolution of the disorders and the rehabilitation of the road. In order to optimize costs of repair work as much as possible, “earthmoving” type solutions are generally preferred. If these do not provide the desired stability, heavier solutions are then necessary. In addition, computer-aided drafting is of major importance because it makes it possible to rapidly project solutions and proceed with the necessary iterations to converge towards the final solution.

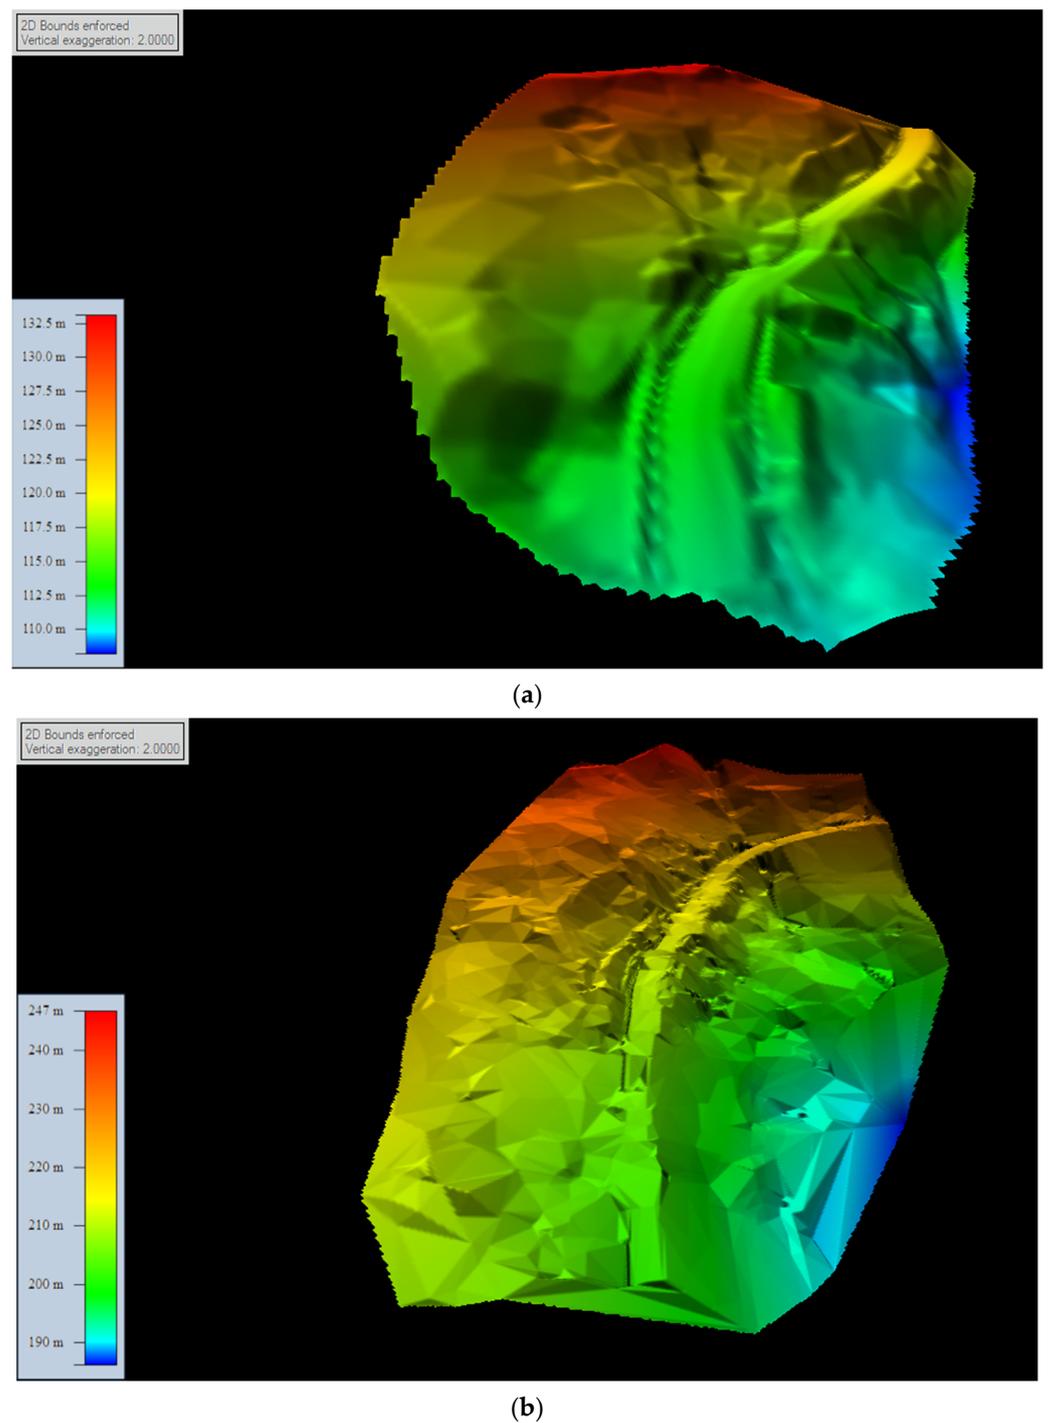
**Figure 7.** Digital terrain model of the two study areas, developed from topographic survey data: (a) kilometric point 23; (b) kilometric point 48.

Topographic ground surveys were used to establish digital terrain models related to the two study areas (Figure 7).

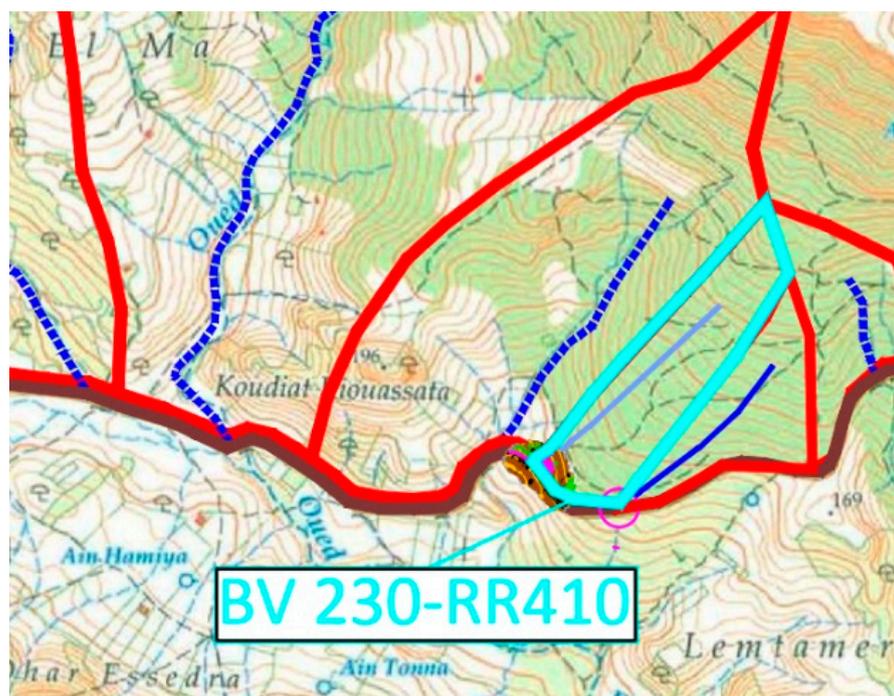
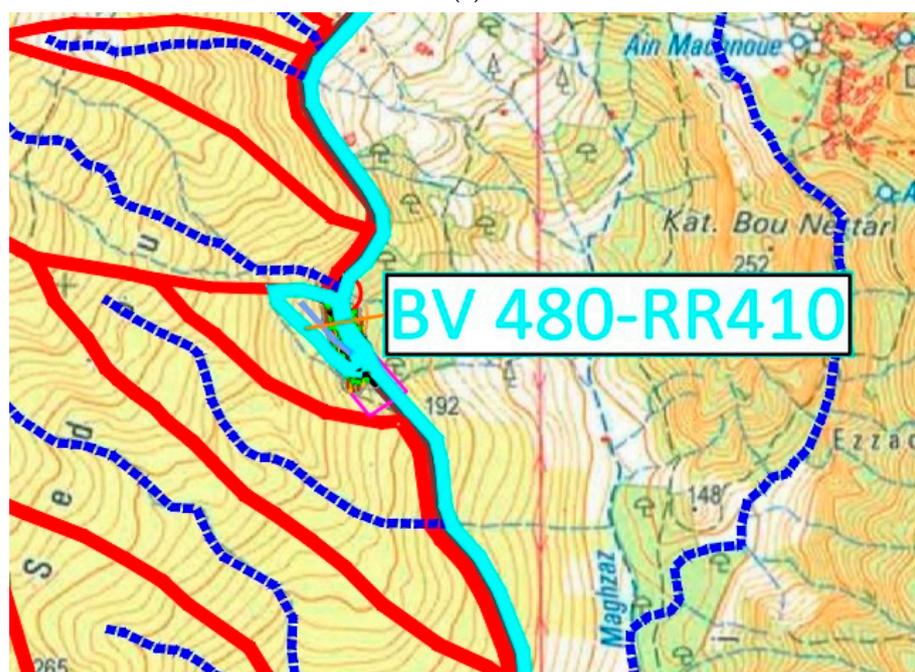
**Figure 8.** Illustration of watershed delineation on a topographic map at a scale of 1/50,000: (a) kilometeric point 23; (b) kilometeric point 48.

Several runoff flows derived from exterior watersheds intercept the road. Based on the 1/50.000 topographic maps, the watersheds were delineated and the corresponding boundaries are shown in the Figure 8. These flows correspond to small and medium-sized watersheds (less than 10 km<sup>2</sup>). They are restored by hydraulic structures such as gutters or intercepted by ditches.

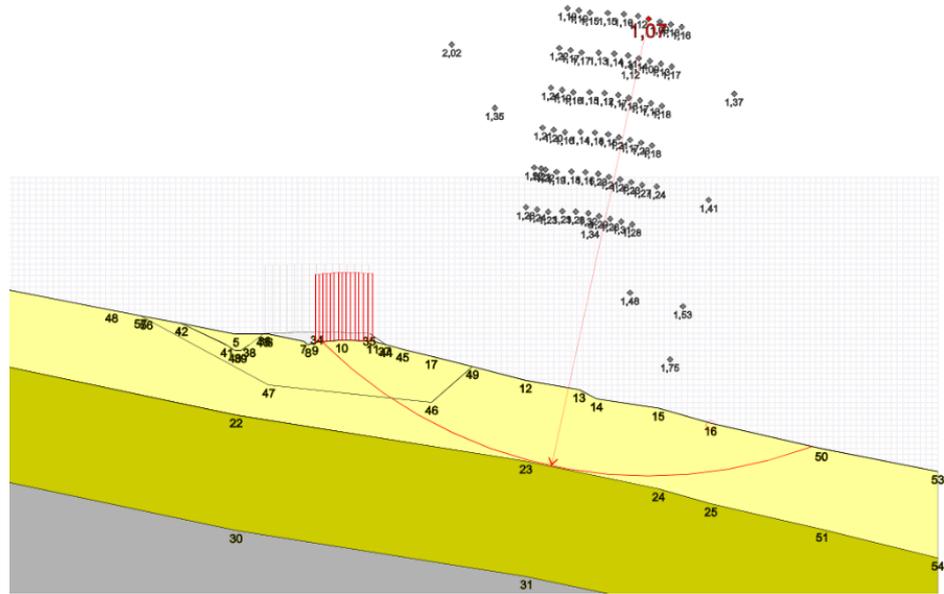
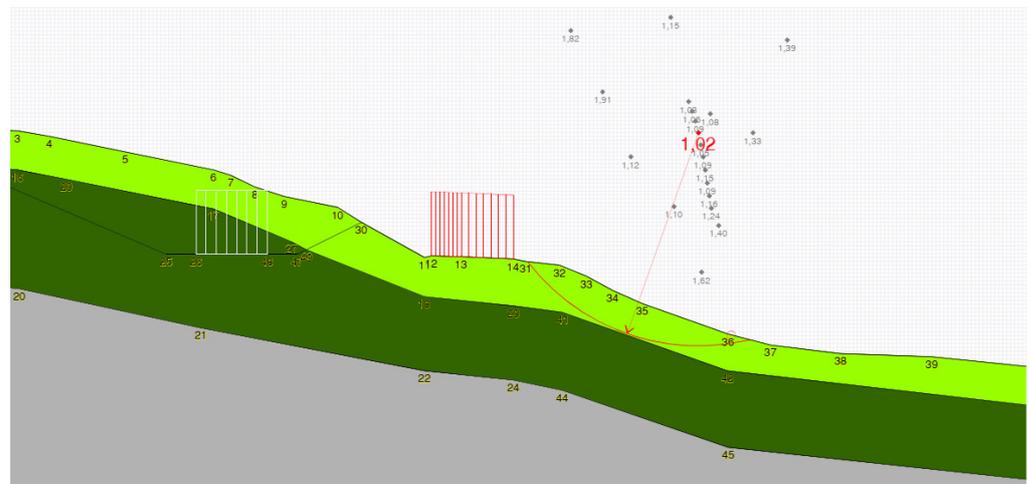
**Figure 9.** Calibration of geotechnical parameters: (a) kilometric point 23; (b) kilometric point 48.

These parameters are indeed lower than those measured in the laboratory. This is probably due to the sample disturbance during sample recovery or during the setting for the shear tests. Also, the non-representativeness of the recovered samples could also be the origin of this problem. It should be noted that a 60% saturation was introduced in the first layer to consider the insufficiency of the existing hydraulic structure. In fact, the estimated capacity flow of the current hydraulic structure is  $0.7 \text{ m}^3/\text{s}$ , whereas the project flow for a return period of 25 years is equal to  $2.5 \text{ m}^3/\text{s}$ .

At kilometric point 48 of the RR410 road, the same problem was found. The mechanical parameters of the subgrade were also calibrated, using a back analysis, in order to have a safety coefficient close to or equal to 1 ( $F \approx 1$ ). Figure 9b shows the results of the initial state calibration. Those parameters, as shown in Table 4, are also lower than those measured in the laboratory. As explained above, this situation may be due to sample disturbance during sample recovery or during setting of the shear tests. In addition, the

non-representativeness of the recovered samples could also be at the origin of this problem. A 50% saturation was also introduced in the first layer to reflect the stagnation of water upstream of the platform, which infiltrates into the surface layers causing saturation of the latter. These are visible on the reinforcement wall located downstream of the road platform.

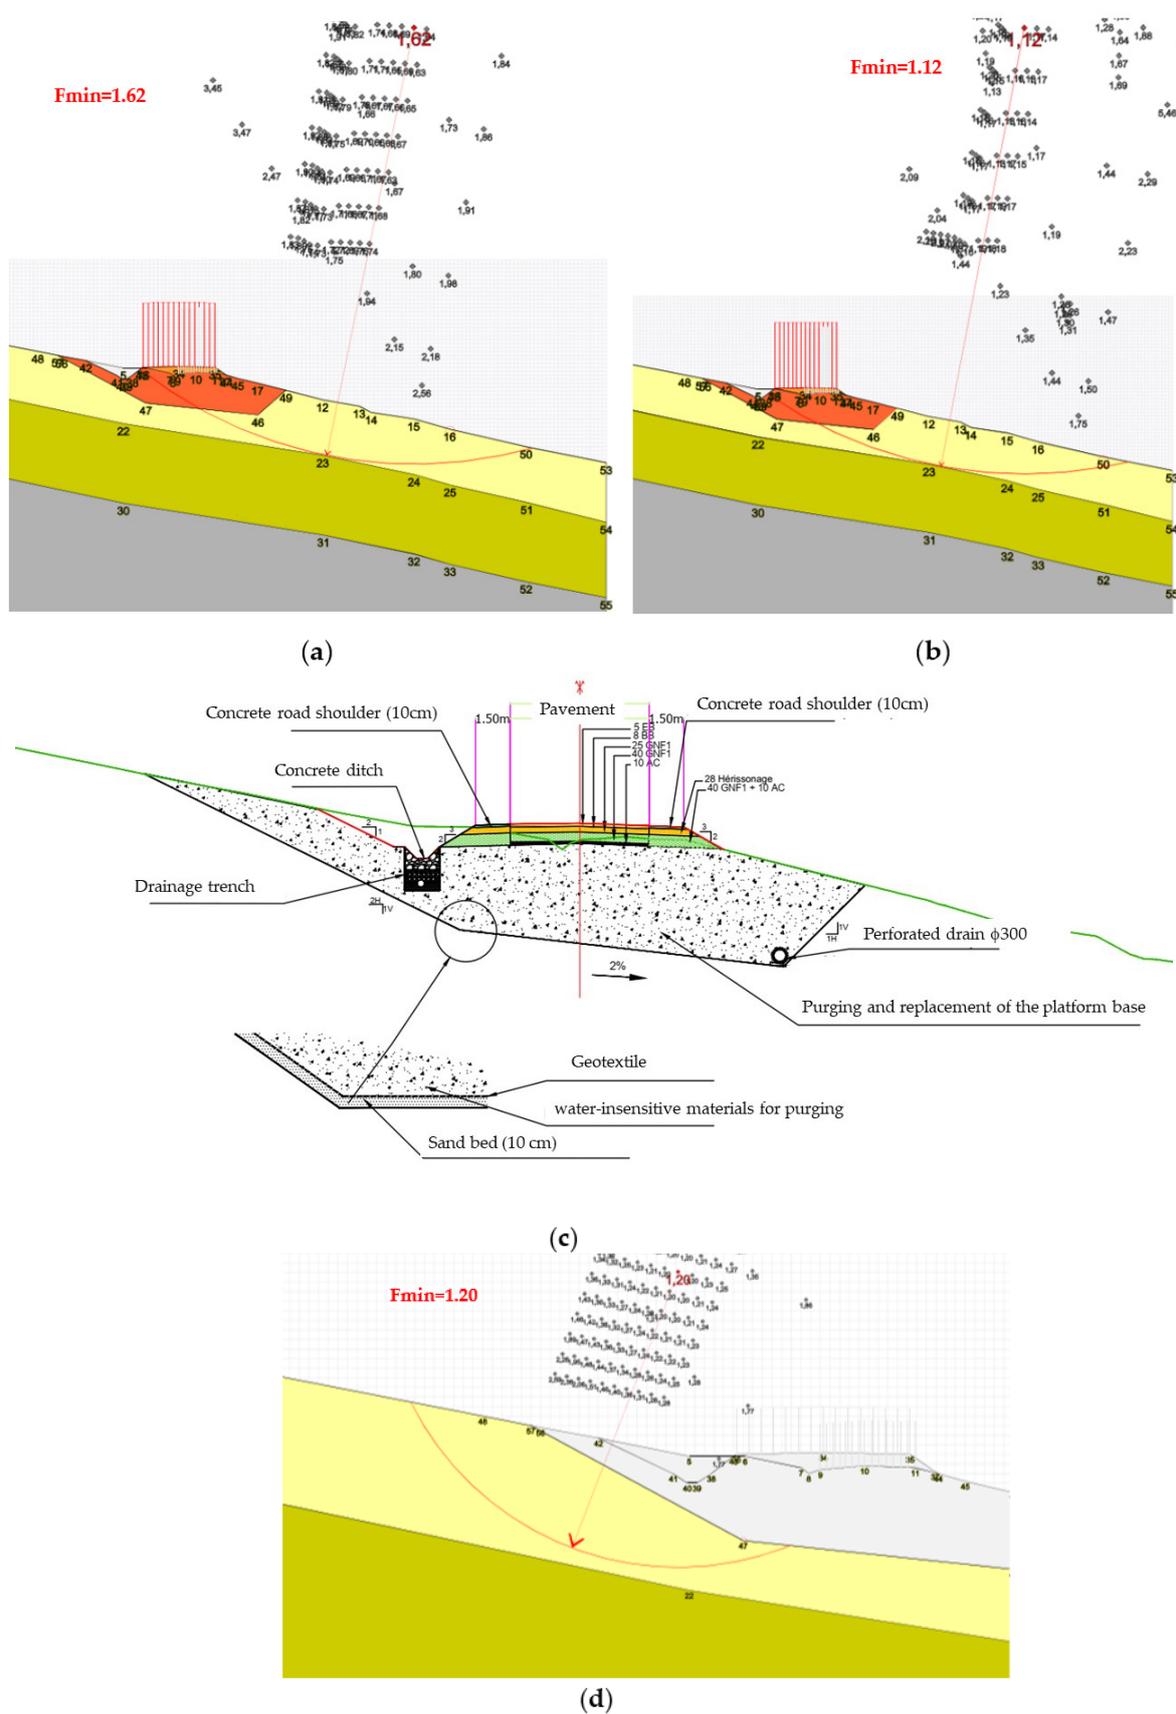
**Figure 10.** Results of the stability simulation at kilometeric point 23: (a) static condition; (b) dynamic condition; (c) typical cross-section of the adopted solution; (d) simulation of the temporary excavation stability.

For kilometric point 23, the mode of damage caused involved the purging and replacement of the platform, as shown on Figure 10a,b, over the entire damaged area. The restoration of the original road geometry, involving the respect of the original red line, was necessary to rehabilitate in sustainable way the road.

To stabilize the road, calculations were used to determine several necessary actions, including reconstructing the platform to its initial geometry, selecting a 4.5 m thick embankment for the purge with a minimum friction angle of  $33^\circ$  and a density of  $20 \text{ KN/m}^3$  that is insensitive to water and has a very low percentage of fine particles. The purge and substitution inclination must be set according to the natural ground slope and oriented outside the degraded area. Additionally, a drainage trench and several drainage spurs spaced 10 m apart on the upstream side of the platform were constructed to collect infiltration water, and a draining base was installed for the platform to relieve interstitial pressures and drain possible water from the upstream side. The shoulders were concreted to limit water infiltration towards the embankment's body, and drainage outside the landslide area must be upgraded by increasing the opening of the existing upstream hydraulic structure. The actions considered essential are presented in a typical cross-section provided in Figure 10c. In addition, the excavation scheduled under the platform required the detour of traffic during the works. Since the geometry of the excavation determines the temporary deviation, a stability calculation was carried out. It shows a safety coefficient  $F = 1.2$  in the temporary phase, for a slope of the excavation equal to  $2H/1V$ , as shown in Figure 10d. With a view to limiting possible complications during the works, it was recommended to realize the excavation and replacement of the subgrade outside the rainy period.

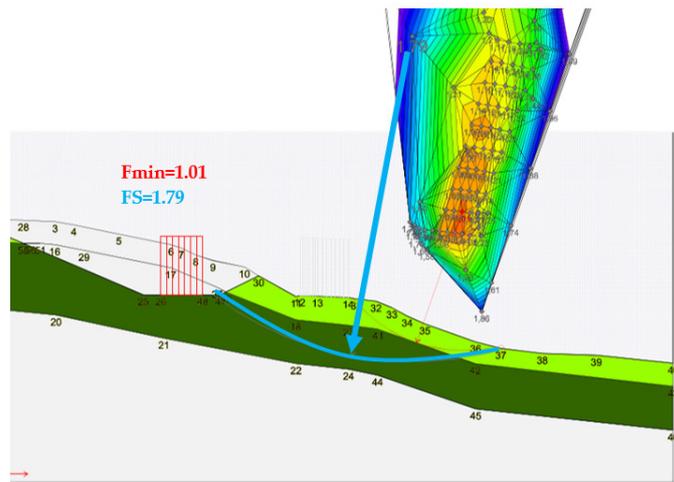
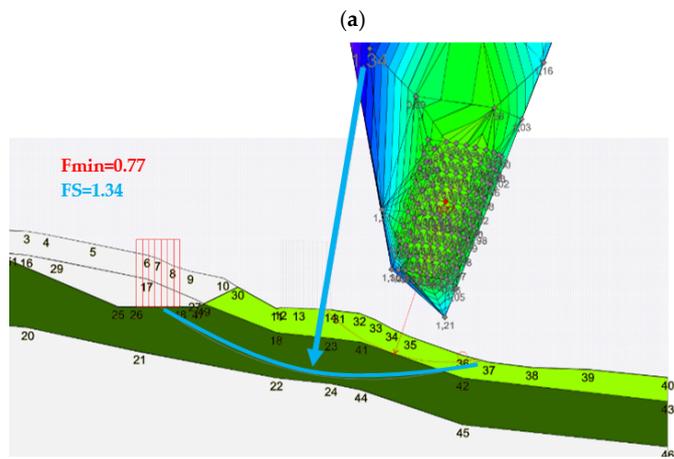
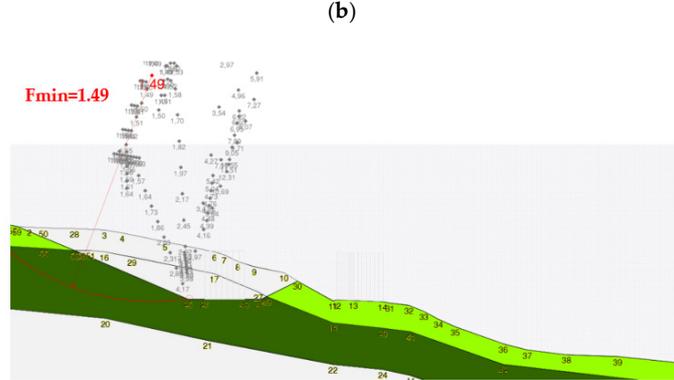
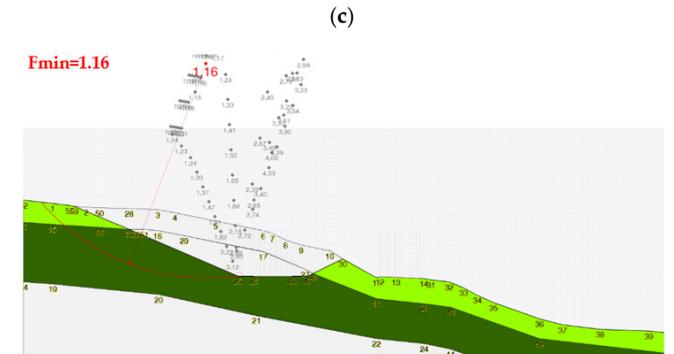
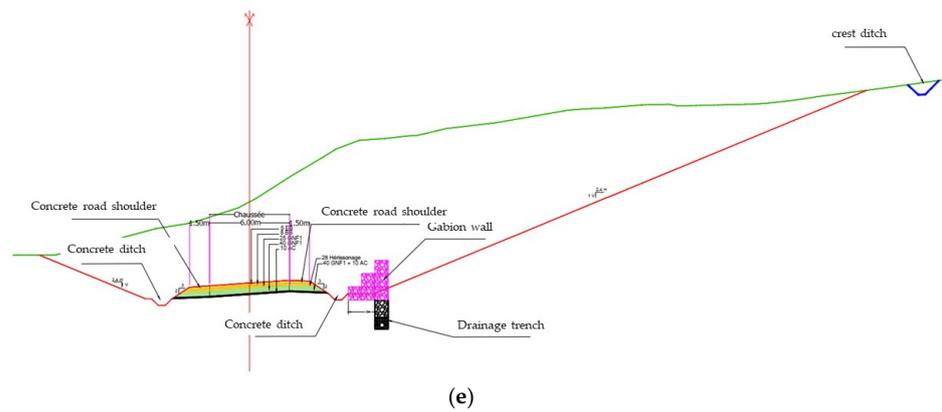
**Figure 11.** Results of the stability simulation at kilometric point 48: (a) static condition; (b) dynamic condition; (c) static condition of the excavated side; (d) dynamic condition of the excavated side; (e) typical cross-section of the adopted solution.

At kilometric point 48, the optimal and sustainable solution that emerged from the analysis of the topographical, geometrical, and geotechnical constraints was to deviate the route, anchoring the platform in cuttings, under the same conditions of ground saturation. Circular slide stability calculations have shown that the road deviation is stable when the platform is anchored at 25 m from the current road axis. In fact, although the worst-case safety coefficient does not meet the stability requirements, the first slip circle that passes through the new platform has a safety coefficient of  $F_s > 1.5$  (Figure 11a,b). The old platform acts as a foot stop for the new one. A second stability calculation was also carried out to define the slope of the cuttings. The safety coefficient obtained is acceptable ( $F_s = 1.5$ ). The slope necessary for stability, as shown at Figure 11c,d, must be equal to  $2.5H/1V$ . Various measures were implemented to ensure stability and prevent landslides. These measures include realigning the road to anchor the new platform in the cuttings, constructing a three-bed gabion wall to act as a pebble trap and prevent erosion and falling debris, and implementing measures to collect and drain runoff and infiltration. These included concreting the shoulders, channeling pavement flow with beads, and installing water chutes, drainage trenches on the upstream side, and draining spurs spaced at 10 m intervals to collect infiltration water. Additionally, the hydraulic structure at the beginning of the rectification project was replaced with a new one capable of recovering runoff water, water collected by the draining spurs, and water from the drainage trench. These provisions aimed to enhance stability, promote proper drainage, and prevent future landslides as summarized in Figure 11e.

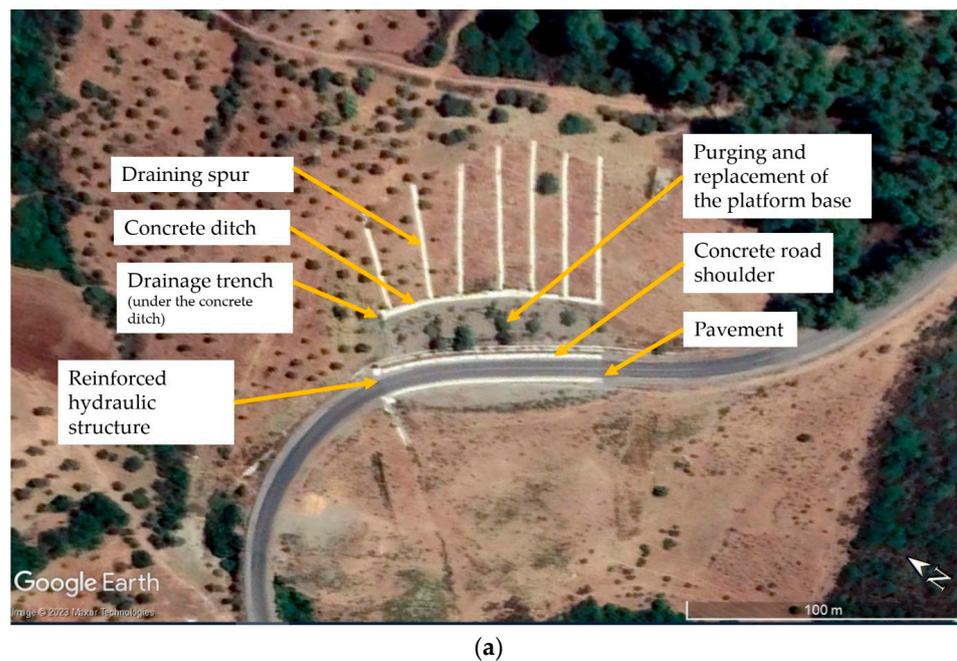
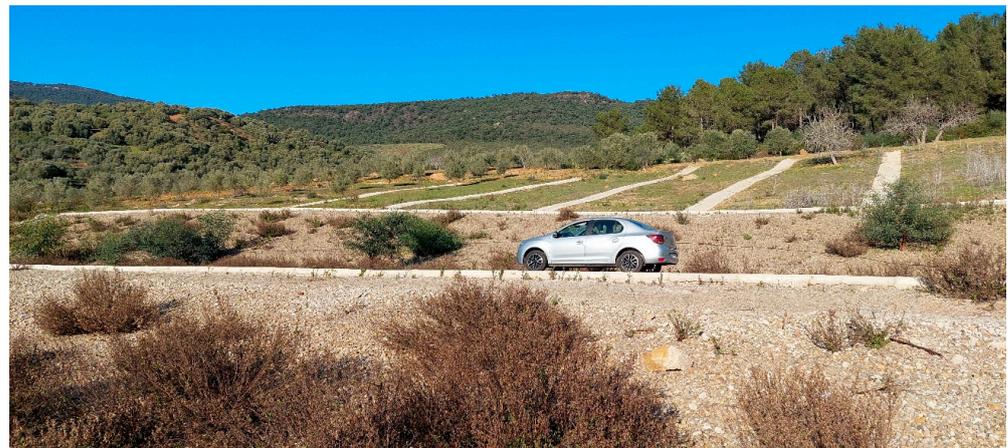
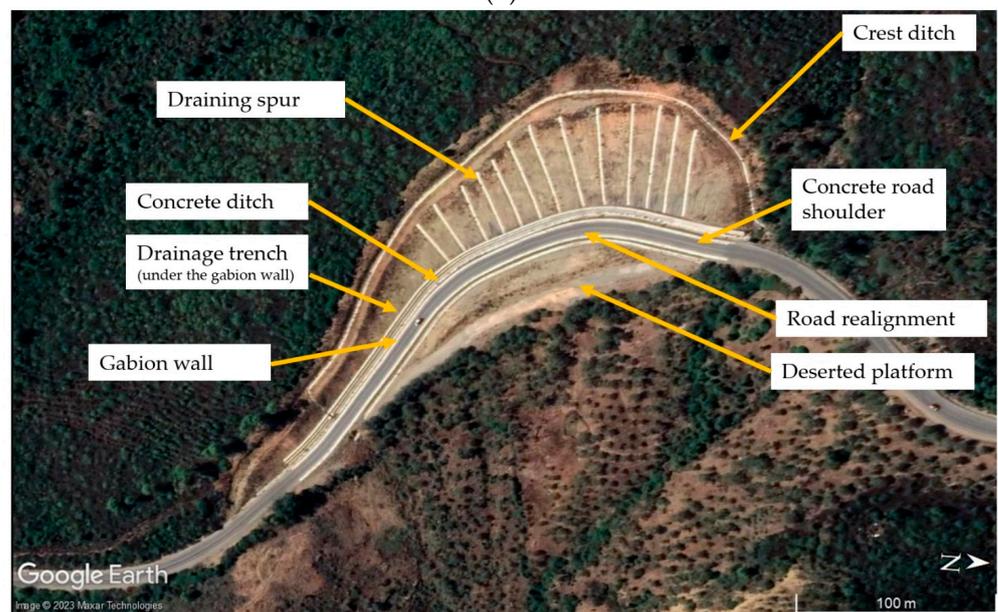
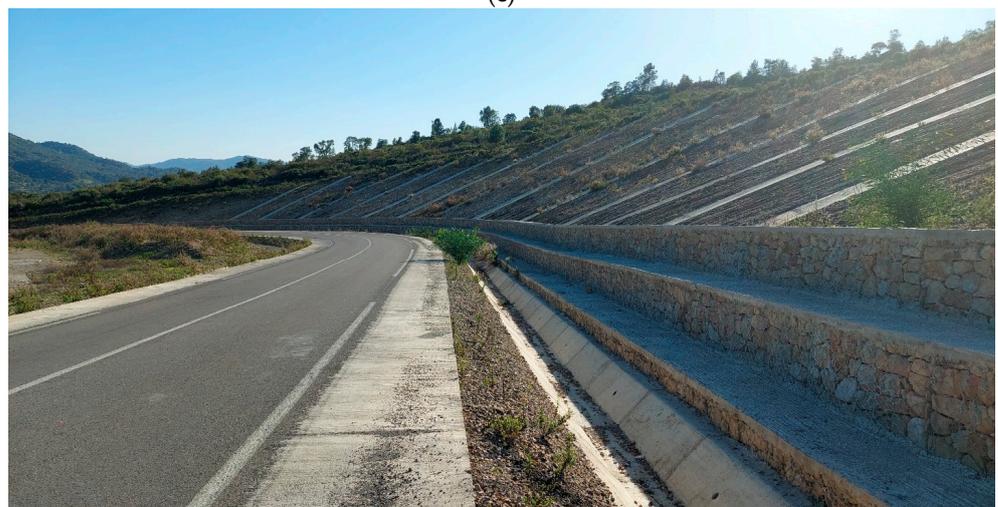
**Figure 12.** Situation after completion of works: (a) Google Earth view of the kilometric point 23, taken in July 2022; (b) picture of kilometric point 23 taken in January 2022; (c) Google Earth view of the kilometric point 48, taken in January 2022; (d) picture of kilometric point 48, taken in January 2022.

If the road has not experienced any problems since the completion works in 2018 (Figure 12a–d), this is hard evidence that the mitigation measures were effective.
