# Failure Prevention in Large-Diameter Water Pipelines Using Reliability-Centered Maintenance

**Abstract:** The consequences of failures from large-diameter water pipelines can be severe. Results can include significant property damage, adjacent damage to infrastructure such as roads and bridges resulting in transportation delays or shutdowns, adjacent structural damage to buildings resulting in loss of business, service disruption to a significant number of customers, loss of water, costly emergency repairs, and even loss of life. The Washington Suburban Sanitary Commission (WSSC) in the United States found that flooding was the greatest concern due to its potential duration, the potential for broad geographic impact, and its role in crater creation. Public safety, property damage, social and economic consequences, and loss of water service and for how long is also of paramount concern. The American Water Works Association's (AWWA) 2020 "State of the Water Industry" report states that the top issue facing the water industry since 2016 is aging infrastructure, with the second being financing for improvements. The industry needs to find novel ways of extending asset life and reduci

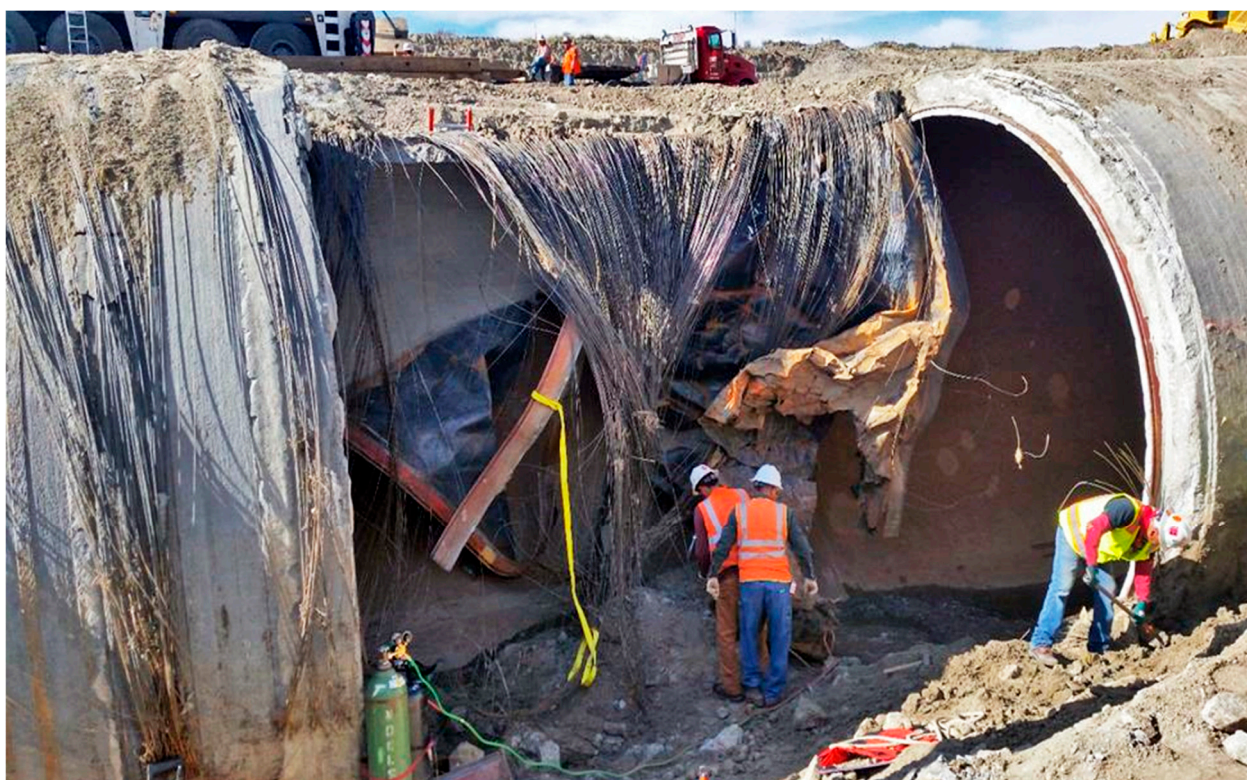
In 2016, a large irrigation pipeline failed in a farming area in New Mexico. Figure 2 shows a 5.33 m (210 inch) prestressed concrete pipe that failed due to corroded prestressing wires. Two pieces of pipe failed resulting in the pipeline being out of service for several weeks due to the unplanned outage to perform the repairs. While the estimated water loss was only about one million gallons because the pipeline was able to be isolated quickly, the estimated impact cost was almost USD 20 million. This included the cost to repair and the loss of revenue from crop loss.

**Figure 2.** Failed 5.33 m (210 inch) Prestressed Concrete Cylinder Pipe (Photo Courtesy of C. Duke).

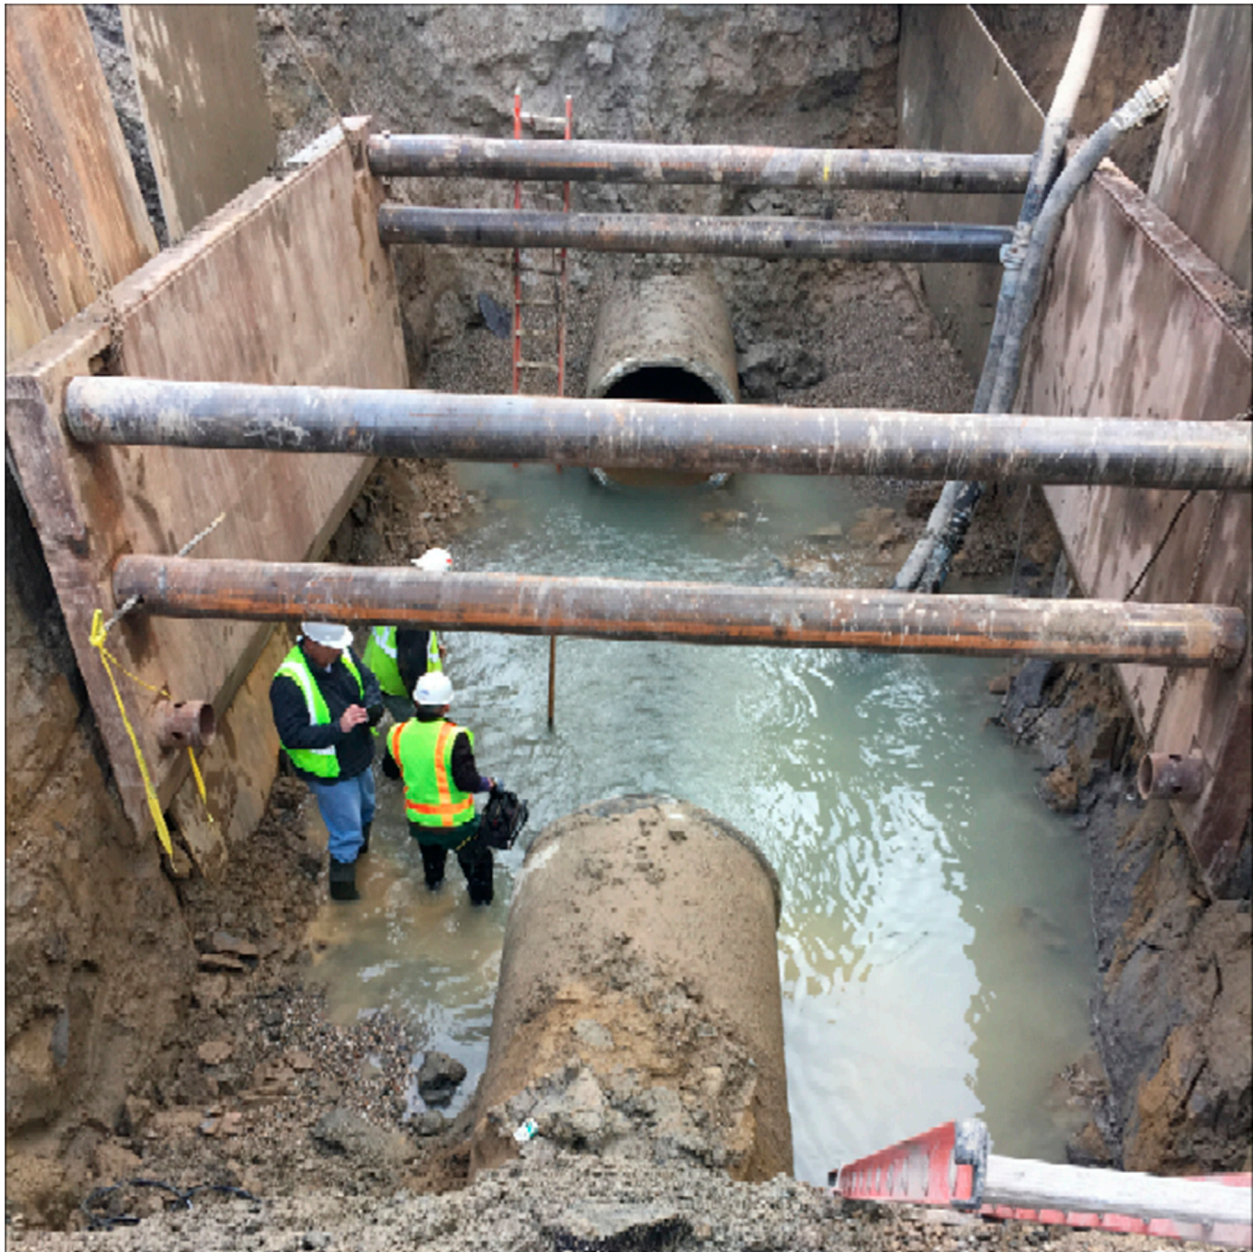
In October 2017, a 1.2 m (48 inch) PCCP failed in Oakland County, Michigan, sending 75.7 million liters of water down a busy street, disrupting traffic as well as water service to over 300,000 residents and three nearby hospitals. The drop in pressure caused by the failure resulted in reduced pressure, boiling water advisories, and losses of service. Repairs took five days before service was resumed. Figure 3 shows the excavated failed pipe in anticipation of repair activity.

**Figure 3.** Excavation for Repairing Failed 1.2 m (48-inch) Water Pipeline (Photo Courtesy of GLWA).

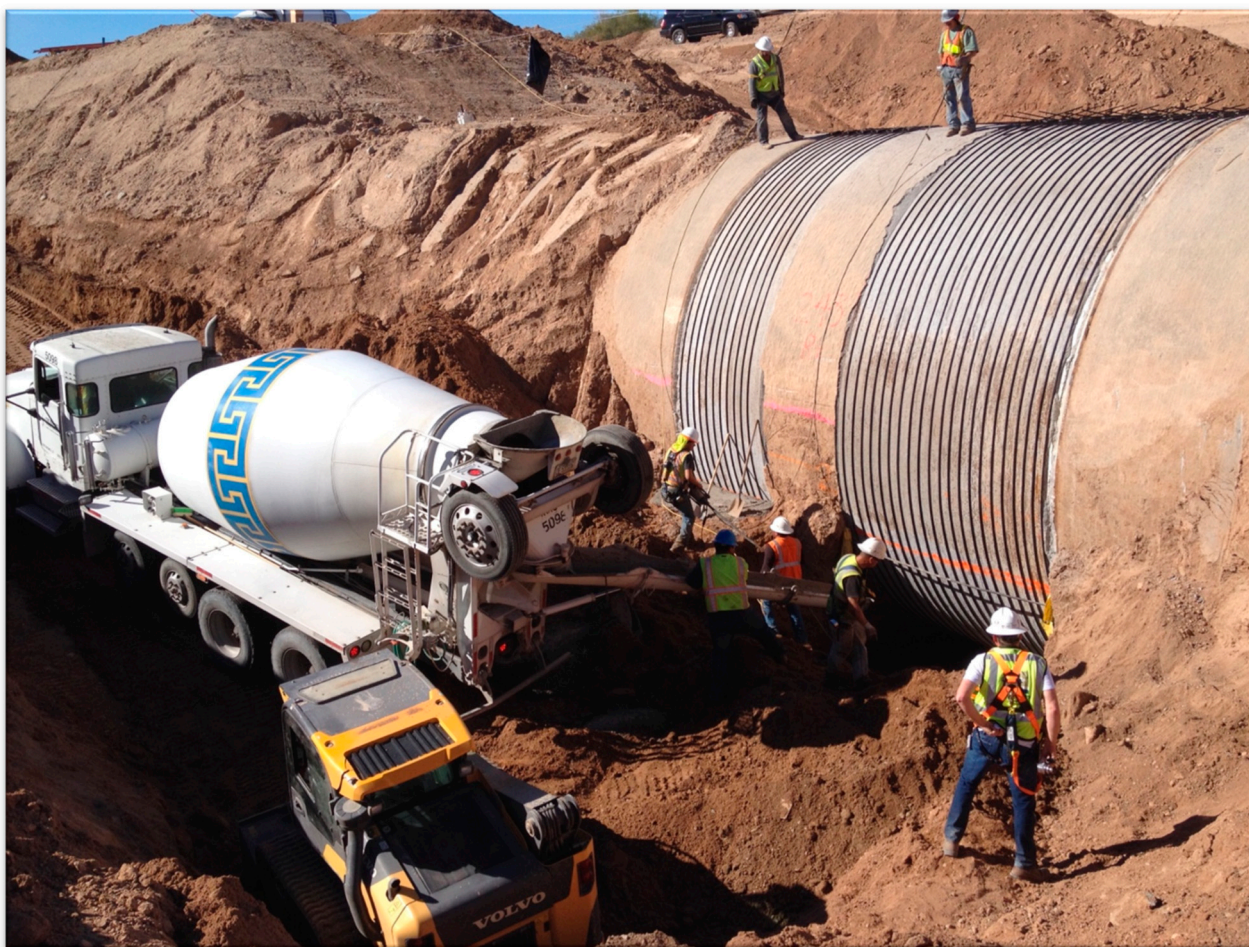
While proactive pipeline maintenance will not always prevent a failure, the relative cost of maintenance compared to the cost of a failure must be considered. In 2014, CAP decided to perform proactive maintenance on a large diameter prestressed concrete pipeline that had several pieces of pipe with a large number of distressed wires. Due to the location of the pipeline (a rural setting under a normally dry wash), a containment failure would not have resulted in adjacent property damage, but it would have resulted in loss of conveyance capability, putting at risk diverting Arizona's water allotment from the Colorado River, as well as the inability to provide customers with water. Figure 4 shows planned maintenance activities for a 6.4 m (252 inch) prestressed concrete pipe. This pipeline was intentionally removed from service for repair of nine pieces of pipe and was returned to service in less than two weeks because the agency had been able to plan for repairs based on condition assessment maintenance models, resulting from condition-based monitoring maintenance strategies.

**Figure 4.** Planned Maintenance Activities on a 6.4 m (252 inch) Prestressed Concrete Pipe (Photo by J. Geisbush).
