# Application and Automatic Monitoring and Analysis of Hybrid Support Structure in Ultra-DEEP Foundation Pit Engineering in the Lanzhou Area under Complex Environmental Conditions

**Abstract:** This paper takes the deep foundation pit project of Lanzhou Hospital of Traditional Chinese Medicine as the background. The design and construction of the foundation pit is relatively difficult due to the complex environment around the pit, the dense surrounding buildings, the complex underground soil layer and the influence of groundwater on the pit. In order to detect problems in the construction process, the pit was monitored in real time through an automated monitoring system for the whole process of excavation and backfilling of the pit. The analysis of the actual monitoring data shows that: (i) the support scheme of bored pile + prestressed anchor cable support combined with concrete corner bracing can meet the design of this type of foundation pit without causing disturbance to the surrounding buildings; (ii) combined with the actual case of the influence of groundwater on the excavation process of the foundation pit, it proves that the real-time measurement by the robot can timely d

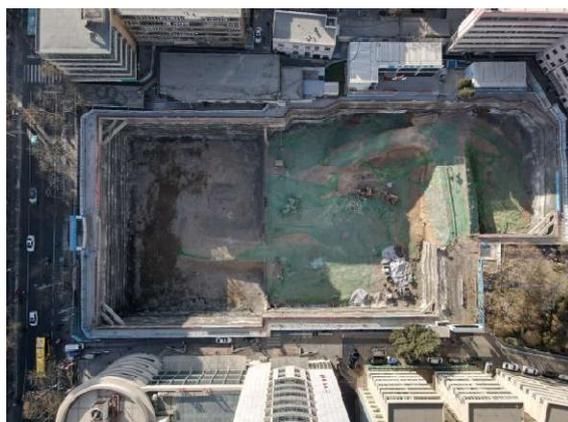
**Figure 1.** Map of the surrounding environment of the foundation pit.

The Northwest Regional Medical Center Project of Gansu Provincial Hospital of Traditional Chinese Medicine is located in Qilihe District, Lanzhou City, and the project is close to urban roads. The ground elevation of the site is 1528.88~1528.35 m, considering the thickness of 0.1 m cushion + 0.1 m waterproof layer, the depth of the podium pit of the medical part on the north side is 12.0~12.5 m, the depth of the foundation pit of the main building of the medical interest on the north side is 13.1 m. The depth of the foundation pit of the three-dimensional garage on the south side is 22.3 m. The surrounding environment of the foundation pit is complex and there are many buildings. Part: (1) a medical area, (2) an underground garage, the surrounding environment as shown in Figure 1.

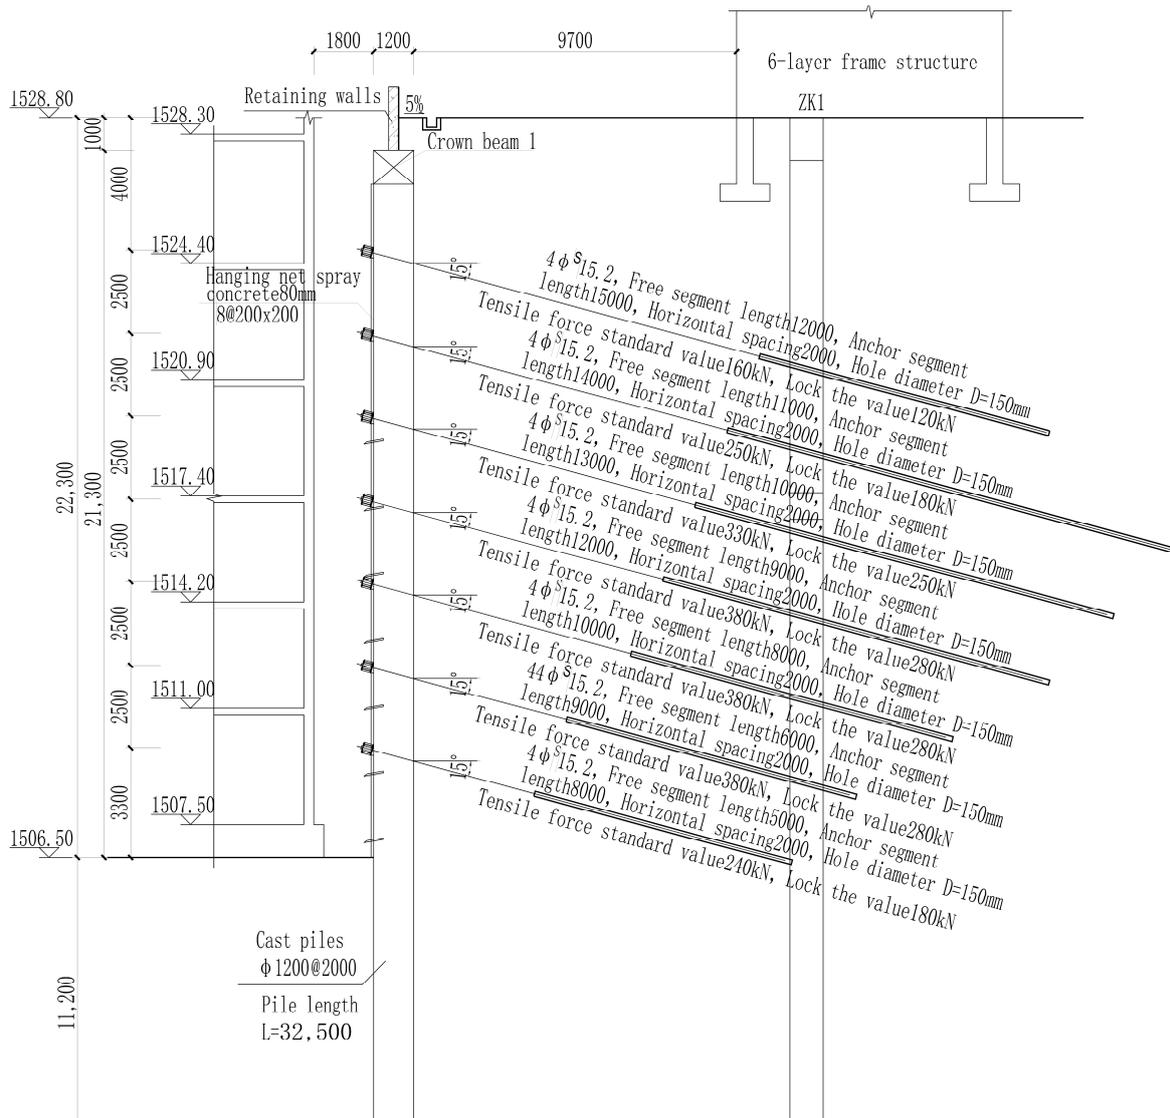
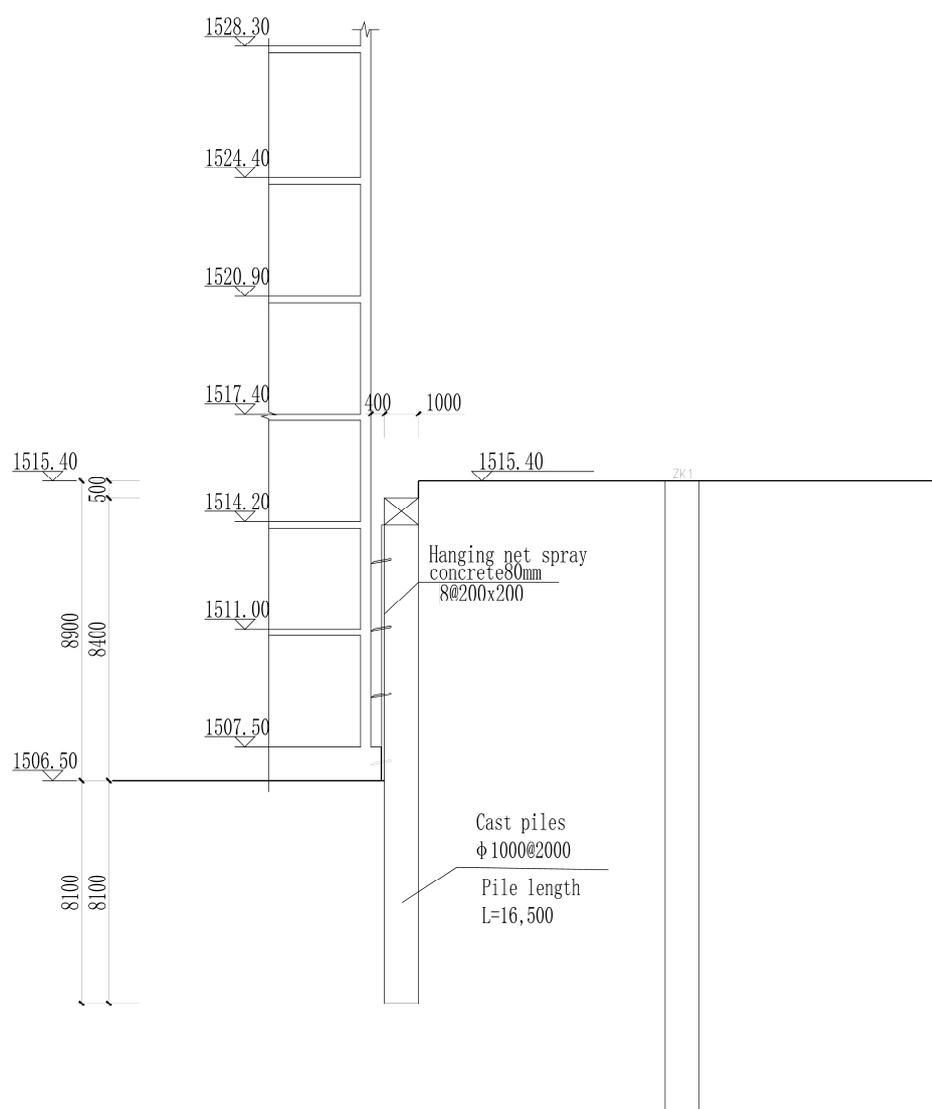
**Figure 2.** Profile view of a typical support structure.

(a) Pile anchor support structure

(b) Cantilever pile + concrete diagonal brace support structure

A~B, B~C, D~E section, C~D section, E~F section, F~G section, G~H~I section, I~J, J~K section, K~L section and L~A section adopt bored pile + prestressed anchor foundation pit support scheme, and area A~E adopts cantilever pile + concrete diagonal brace foundation pit support form. A typical profile is shown in Figure 2. According to the geological survey report, the groundwater level around the foundation pit is buried at a depth of about 10 m. The precipitation scheme of the tube well outside the hole + catchment well in the hole is adopted.

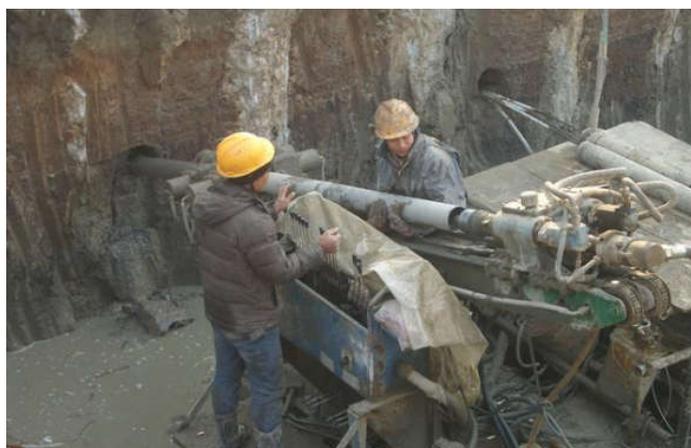
**Figure 3.** Drilling construction of anchor cable.

In this foundation pit project, the combination of prestressed anchor cable and supporting pile produces a more effective supporting effect for the foundation pit project. In this foundation pit project, the anchor cable adopts a 15.2 mm diameter steel strand, and the hole diameter is 150 mm. When applying to prestress to the anchor cable, it is necessary to wait for the strength of the grouting consolidation body of the anchor section to reach 20 MPa or reach more than 80% of the design strength and for the supporting pile gets more than 80% of the design strength, and the anchor cable can be tensioned and locked, and the five-stage tension is carried out according to the locking value, and the specific construction process is shown in Figure 3.

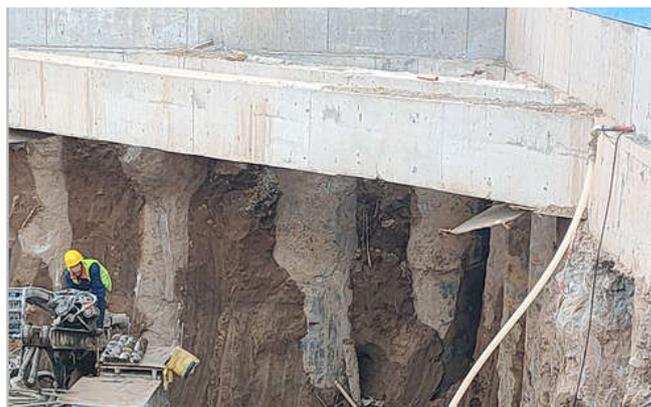
**Figure 4.** On-site construction of corner braces.

Considering the safety, economy, and stability of the foundation pit, the A-E sections are connected by an angle brace, and Figure 4 is the construction drawing of the corner brace site. The primary function of the crown beam is to communicate between stressed members and structure's integrity, and the node connection is shown in Figure 5.

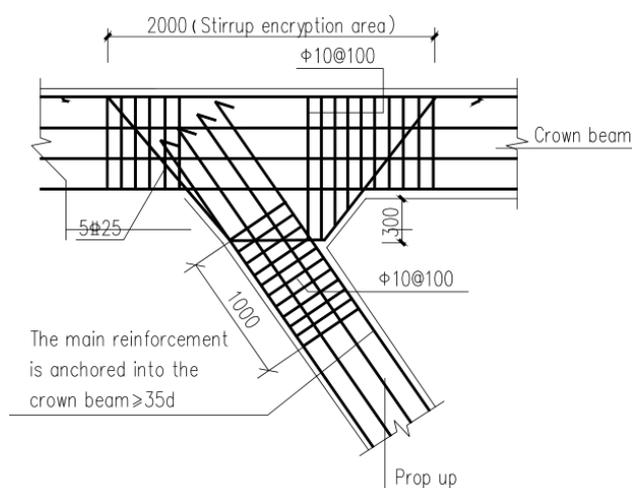
**Figure 5.** Construction drawings of angular braces/diagonal braces and crown joints.

The crown beam and angle brace of the foundation pit project are made of reinforced concrete material, and the bottom elevation position of the support beam is first excavated during its construction; the foundation is rammed, the bottom mold of the support beam is installed, and then the steel bar is installed on the bottom mold, and when the steel bar is installed, the support beam and the waist beam node should be connected as a whole, and the concrete is poured as a whole. For concrete braces, arching is used during construction, and the arching height is  $L/400$ .

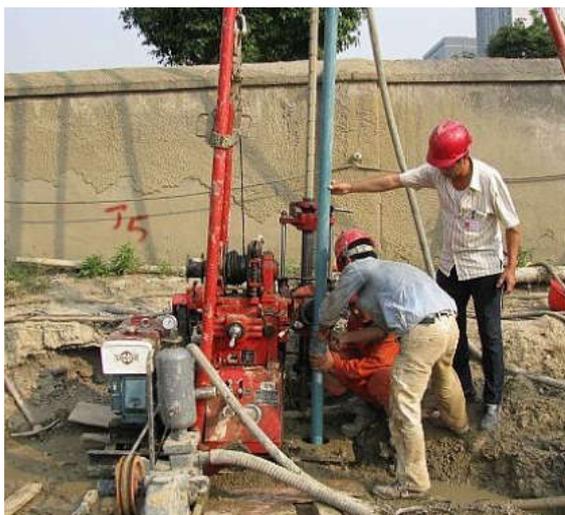
Figure 6. Borehole downpipe-buried.

The garage on the south side of the foundation pit of Gansu Provincial Hospital of Traditional Chinese Medicine is about 22.3 m deep, so the garage foundation pit needs to be designed for precipitation; after the rain of the foundation pit on the south side, the medical area on the north side does not need rain, so no precipitation wells are set up, and the medical room on the north side only sets up blind ditches and catchment wells in the space of the fertilizer trough, and Figures 6 and 7 are the effect drawings of the construction process and the completion of construction. The tube well precipitation + open drainage scheme in the foundation pit of this project is adopted, and the catchment wells need to be laid at a distance of 30 m around the bottom of the hole. The precipitation cycle of the foundation pit is determined according to the construction progress, and the precipitation well near the post-pouring belt is considered according to the specific situation after the excavation of the foundation. The well is sealed after the post-pouring belt is poured, and waterproof measures such as waterproof rings should be set up. After the precipitation outside the pit, the lower part is backfilled with graded sand and gravel to prevent the formation of groundwater channels and cause the foundation of surrounding buildings to collapse.

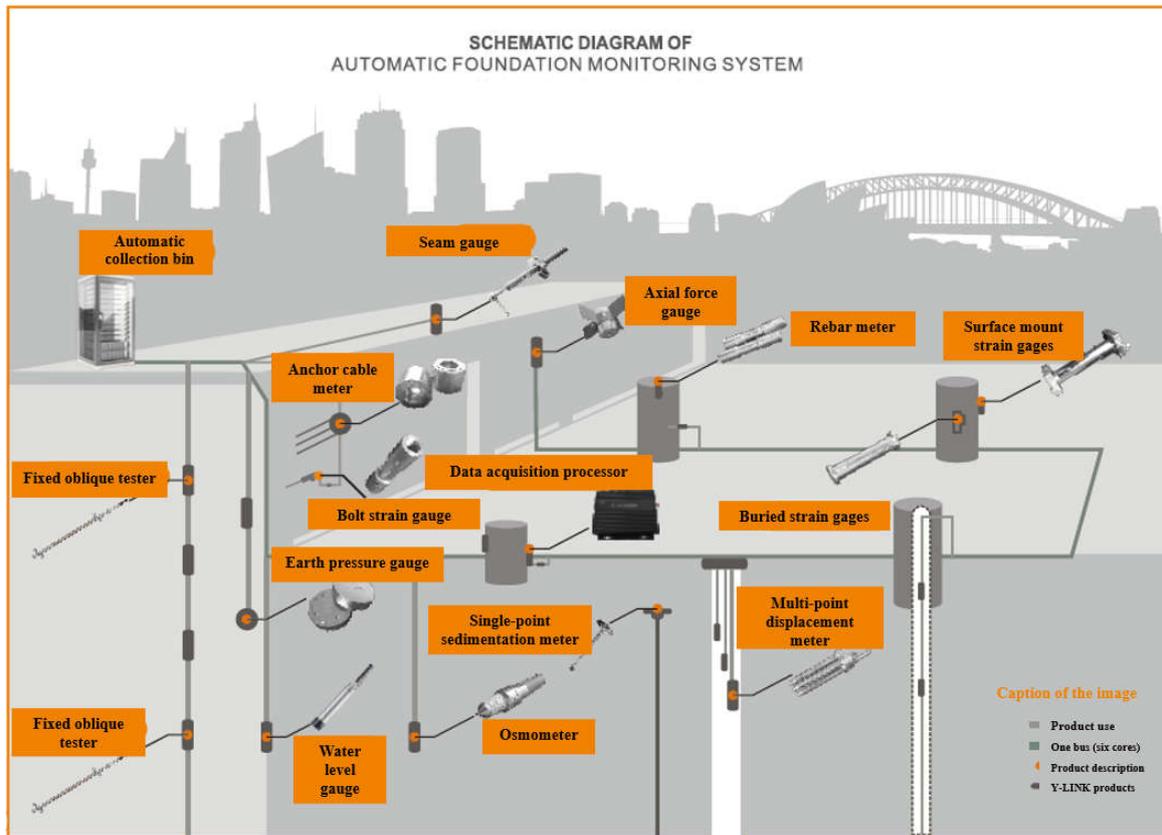
Figure 8. Schematic diagram of foundation pit online monitoring system.

Considering the density of surrounding buildings and their low water level, the horizontal displacement of deep soil, water level change, horizontal removal of supporting piles, vertical displacement of supporting banks, settlement of surrounding buildings, settlement of surrounding pipelines, the axial force of anchor cables, and monitoring of cracks at the top and around the supporting structure were monitored in this foundation pit project. To ensure the accuracy of monitoring, the foundation pit monitoring adopts automatic monitoring instruments and quantitative equipment monitoring (see Figure 8 for the work schematic diagram), the manual patrol inspection is qualitatively combined, and the selected measuring robot meets the accuracy requirements of the polar coordinate method for the total station, and the distance between the on-site work base station and the monitoring point is controlled within 150 m. Set up a data automatic collection base station at the site; the monitoring cycle of the foundation pit project starts on 1 September 2020, a period of 25 months of monitoring; the whole monitoring process adopts automatic reading, uploading, recording, alarm, the layout plan of the foundation pit monitoring point is shown in Figure 9, and the number of monitoring points is detailed in Table 3.

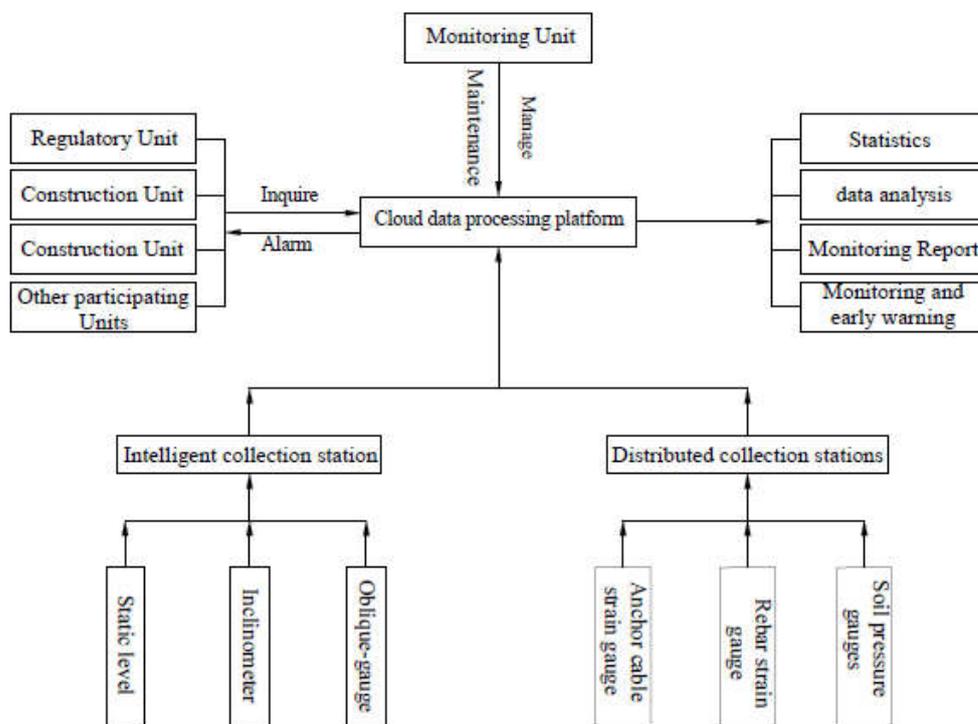
**Figure 10.** Function structure diagram of the automatic monitoring system.

The data of each monitoring point can be obtained by measuring the robot monitoring foundation pit, and the data processing center has a variety of functional requirements

according to its object orientation. Its available composition structure is shown in Figure 10. The data of each monitoring point can be summarized to plot the change curve of the monitoring point quickly.

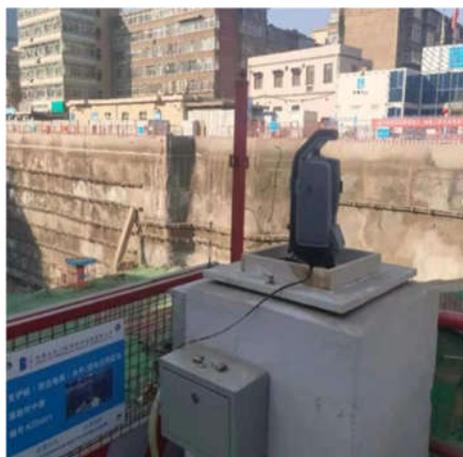
Figure 11. Ten Pao S9 measuring robot.

The settlement and horizontal displacement monitoring of the supporting structure were monitored by the Tianbao S9 measurement robot. Due to the significant disturbance and more changes in the excavation process of the foundation pit, the measurement robot can monitor the foundation pit in an all-around and full-time real-time manner to ensure a timely and effective discovery, and the robot details are shown in Figure 11.

The measuring robot is based on the principle of establishing a planar control network within the pit, establishing a corresponding planar coordinate system and setting up control points in undisturbed areas around the pit. The measuring robot will set up the corresponding stations and monitor the monitoring points in the pit one by one, obtaining distances and angles, back-calculating the corresponding coordinates  $X, Y, H$  as the initial measurement values and comparing them with the data taken at a later stage to see if there are any changes in the data and whether the pit has settled or not.

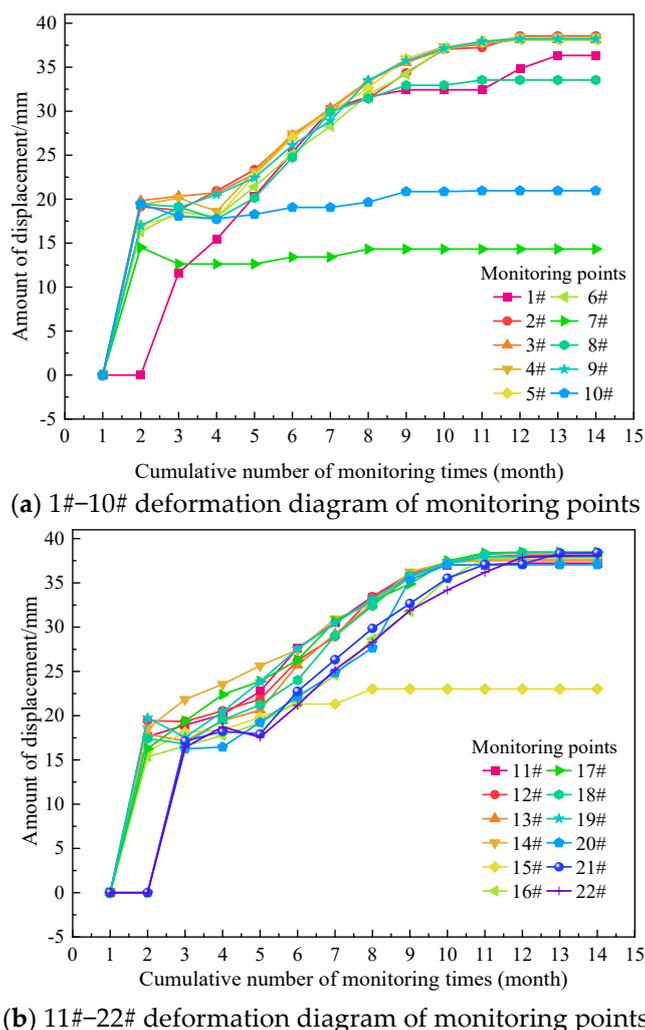
Figure 12. Horizontal displacement monitoring results of supporting structures.

When the horizontal displacement of the supporting structure is carried out, a total of 22 displacement monitoring points are arranged, and the  $XY$  value measured by the robot is further converted into horizontal displacement. Combined with the monitoring data analysis, it can be seen that the main distribution range of the cumulative change of horizontal displacement is 0.000 mm~38.54 mm, the cumulative value of the early warning value of horizontal displacement is 25 mm, and the change rate is 2 mm/d, so it can be concluded that the incremental change obtained by the flat displacement monitoring point of the supporting structure during the entire monitoring period exceeds the range of the allowable early warning value of the specification.

Through data observation, the horizontal displacement of the supporting structure mainly occurred in the excavation stage of the foundation pit, during which the cumulative value of the horizontal displacement of each monitoring point was 14.52~19.83 mm, and its deformation accounted for about 60% of the entire monitoring cycle. After the foundation pit is excavated to the foundation, a certain amount of horizontal displacement is continuously generated in adjusting the internal force of the supporting structure system. After the cumulative deformation value of each monitoring point exceeds the early warning range, the staff of the project department encrypts the monitoring point and strengthens the on-site inspection frequency; according to the monitoring data and inspection results, the side wall of the foundation pit is not abnormal in the subsequent construction until the foundation pit is backfilled, the deformation rate of each monitoring point is less than 2 mm/d, and the monitored deformation data converges until the horizontal displacement of the supporting structure is stable (see Figure 12 for the specific change of monitoring point).

- (1) Although the vertical and horizontal displacements of the support structure exceeded the specified warning values, the pit side walls were not continuously deformed and the surrounding cracks were not continuously developed through the later encrypted monitoring and on-site inspection by the site personnel, and the pit could be safely carried out. Therefore, it is suggested that the construction process of the foundation pit needs to focus on monitoring the displacement of the supporting structure to ensure the safety of the foundation pit.

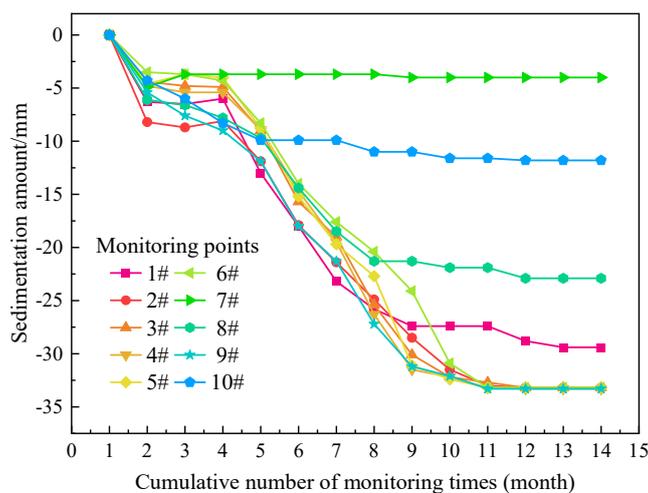
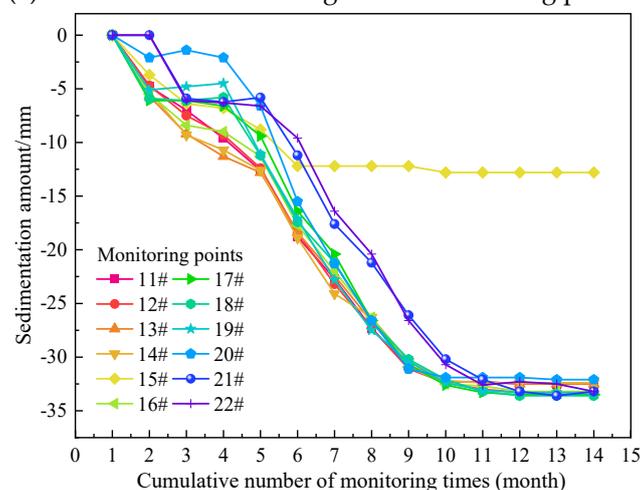
Figure 13. Monitoring results of vertical displacement of supporting structures.

Figure 13 shows the change curve of the vertical displacement monitoring point of the supporting structure. A total of 22 vertical displacement monitoring points at the top of the foundation pit support structure were arranged. The vertical displacement measured by the static level sensor was combined with the H value measured by the measuring robot, which was converted into vertical displacement for comparative analysis.

By measuring the value obtained by the robot for analysis, the cumulative value of settlement displacement of each monitoring point is 4.00 mm–33.600 mm; according to the requirements of the specification, the vertical displacement early warning value is a cumulative value of 15 mm, and the change rate is 2 mm/d, which can be judged that the incremental change of some monitoring points of all monitoring points in the foundation pit during the entire settlement displacement monitoring period exceeds the allowable warning value range of the specification. After the cumulative deformation value exceeds the scope of the early warning value, the on-site monitoring point is encrypted monitoring, and the on-site inspection is strengthened; the side wall of the foundation pit has not been continuously deformed, and the surrounding cracks have not continued to develop, and the monitoring points with large vertical deformation after analysis are all at the edge road and passage, there are edge loads and vehicle vibrations, and the construction unit removes the edge load, eliminating the potential safety hazards around the foundation pit and the foundation pit.

- (3) All monitoring points have been vertically displaced, and some displacement values exceed the early warning value. However, the foundation pit is still in a stable state, which does not affect the safety of the foundation pit.

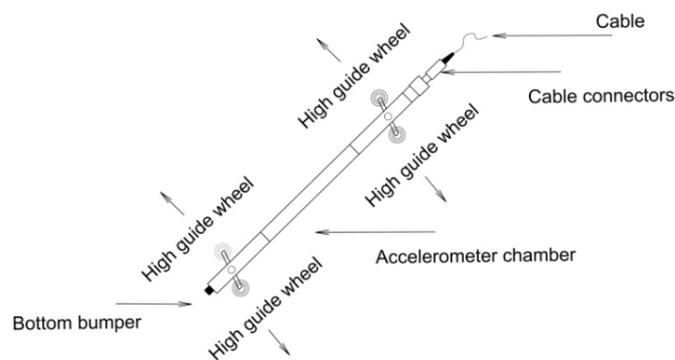
Figure 14. Oblique-gauge.

When monitoring the horizontal displacement of the soil mass of the foundation pit, a total of 6 flat displacement monitoring points of the bottomless foundation pit were arranged (three groups of horizontal displacement of deep soil and three groups of horizontal displacement of the deep pile), and the sinusoidal function of the inclination angle on the standard spacing  $L$  of the upper and lower guide wheels of the inclinometer was converted into horizontal displacement.

As shown in Figures 14 and 15, when the sensitive axis of the accelerometer is on a horizontal plane, the projection of the vector  $g$  on the sensitive axis is zero and the output of the accelerometer is zero. When there is a tilt angle  $\theta$  between the sensitive axis of the accelerometer and the horizontal plane, the accelerometer outputs a voltage signal.

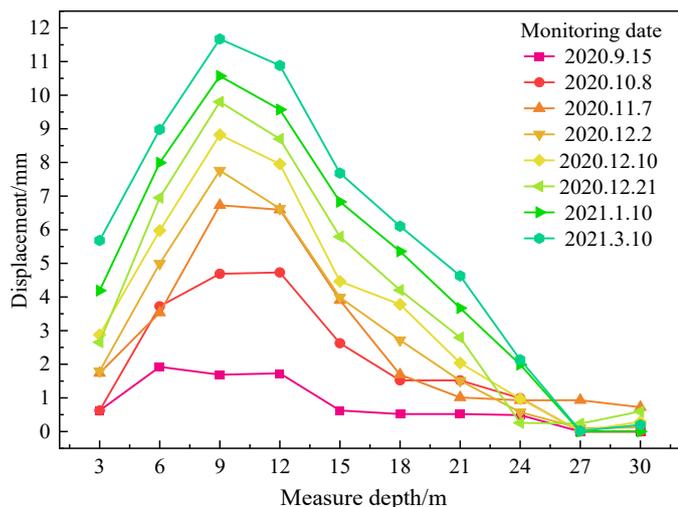
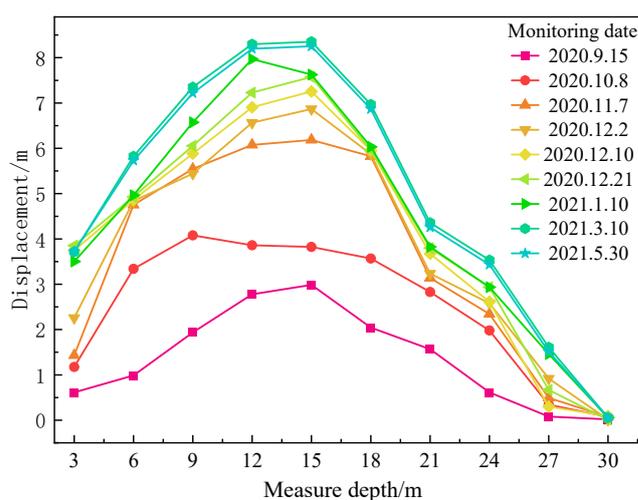
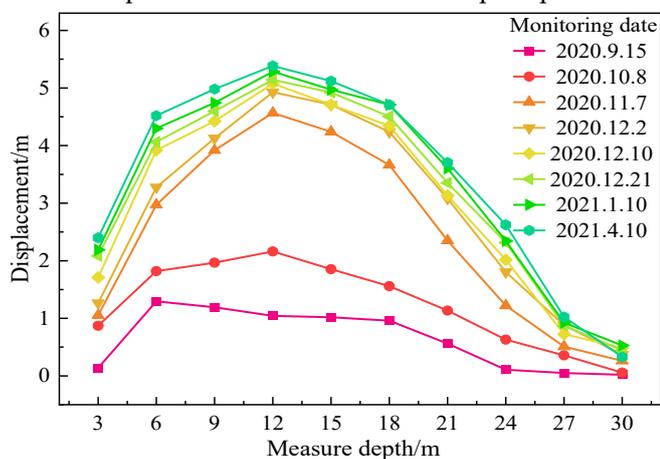
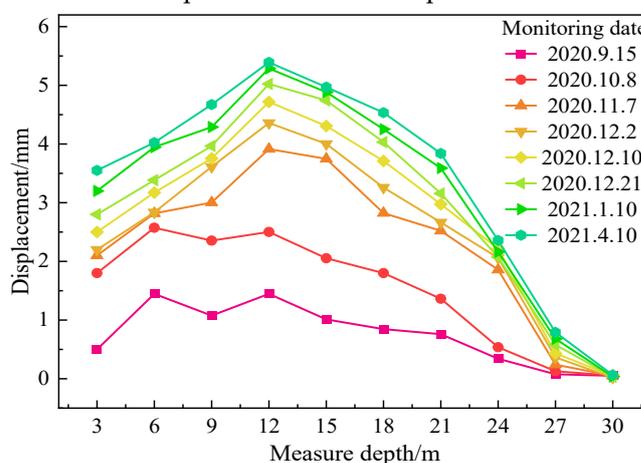
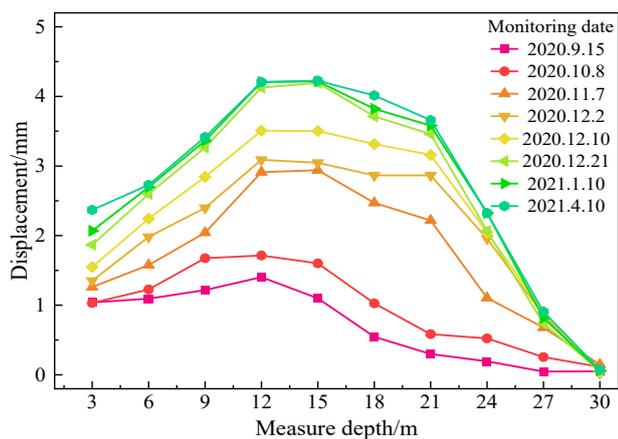
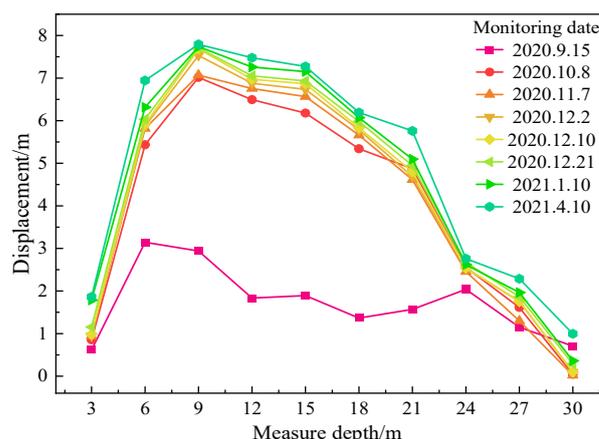
Figure 16. Deep horizontal displacement plot.

By observing the monitoring data, it can be seen that the cumulative change of deep horizontal displacement is mainly distributed in 0.000 mm~11.876 mm, and the flat displacement changes occur at all monitoring points. According to the existing specifications, the early warning value of the deep horizontal displacement of the foundation pit is 0.3% h~0.4% h, and h is the excavation depth of the foundation pit. The rate of change is 2 mm/d~3 mm/d. Through the monitoring data, it can be judged that the amount of change, individual change rate, and an individual cumulative change of all monitoring points of the foundation pit during the monitoring period are beyond the range of the allowable warning value of the specification. Still alarm value is not reached, which does not affect the safety of the foundation pit.

In the process of on-site monitoring, according to the apparent findings of the monitoring data, the deep horizontal displacement has no influence on the external environment during the monitoring process, the on-site data changes are more sensitive, and the data provided are more timely and accurate; Moreover, the deep horizontal displacement of the three groups of piles is relatively stable, and there is no huge fluctuation, but the change of the flat displacement data of the three groups of soil is slightly more significant than that of the horizontal displacement of the pile body. Still, they are all within the safe and controllable range of the foundation pit. The deep horizontal removal of the pile and the horizontal displacement of the soil are shown in Figure 16.

- (2) The deep horizontal displacement monitoring point of the foundation pit partially exceeds the early warning value, but does not reach the alarm value, which does not affect the safety of the foundation pit and the safety of the foundation pit, and the impact of the water pipeline rupture on the horizontal displacement of the foundation pit is found in time through the early warning of the online monitoring system. It can be proved that the real-time monitoring system can timely discover the influence of external unfavourable factors on the foundation pit.

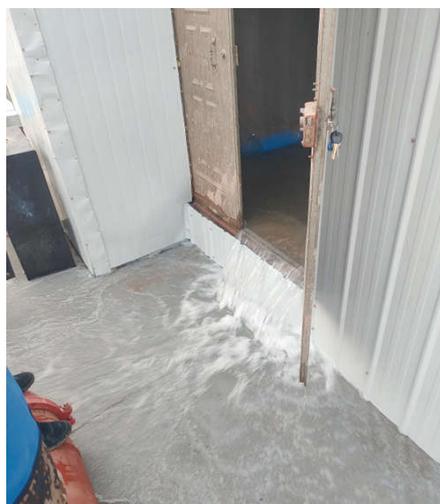
Figure 17. Ruptured pipe on site.

According to the automatic early warning system of the monitoring system, it was found that on 17 December 2020, the water pipeline of the pump room on the west side of the site foundation pit ruptured, resulting in a change in the horizontal displacement data at this location (Figures 17 and 18). Through the timely warning of the monitoring system, the relevant units immediately take corresponding treatment measures to eliminate the risk of the foundation pit in time.

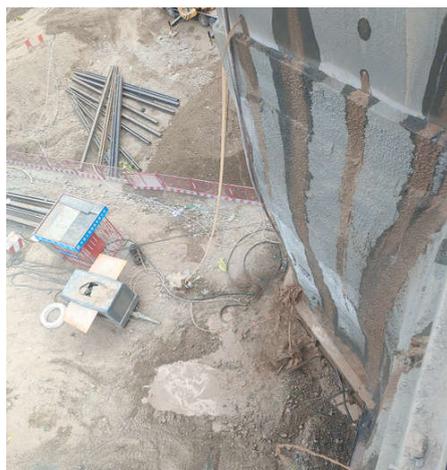
**Figure 18.** Pit site conditions.

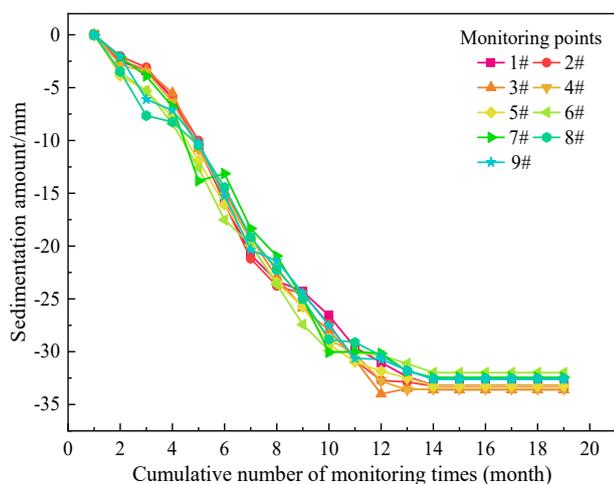
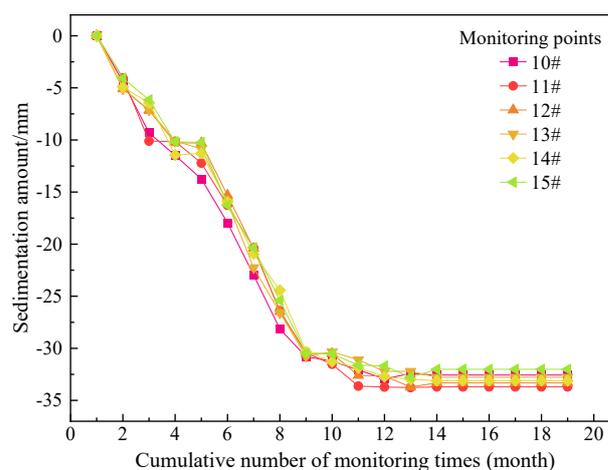
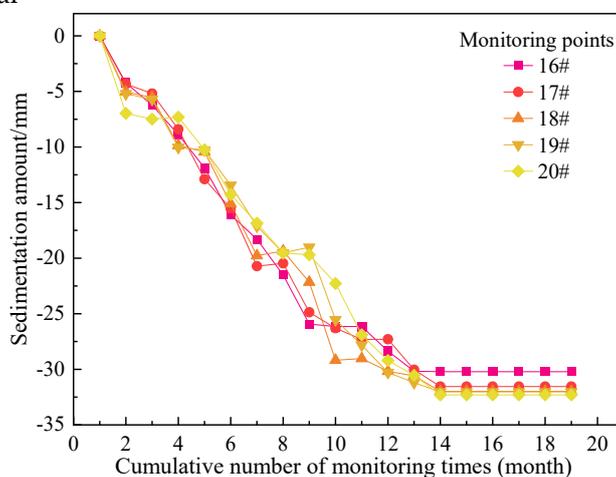
Figure 19. Static graph.

This time, a total of 22 foundation pit static level displacement monitoring points were arranged, of which Figure 19 is the static curve of the foundation pit, and it can be seen from data observation: 1. The cumulative change of vertical displacement of static level in all monitoring points is mainly distributed in 0.000 mm~−32.297 mm. The existing specifications stipulate that the early warning value is 0.4%h~0.6%h, and h is the excavation depth of the foundation pit; The rate of change is 2 mm/d~3 mm/d. It can be judged that the amount of change, individual change rate, and an individual cumulative change of all monitoring points of the foundation pit during the whole monitoring period are beyond the allowable alarm value range of the specification. After data analysis according to the site situation, it was judged that the cumulative change exceeded the capacity, and corresponding measures were taken on the site in time, and the data change was mainly concentrated in the early excavation process, and the data change in the later excavation process was stable, which did not affect the safety of the foundation pit, and the foundation pit as a whole was in a steady state.

After the pit raft has been poured, the elevation of the datum points monitored by the static level around the pit is in a stable state and the elevation measured by the static level is compared with the real-time monitoring data from the measurement robot in the direction H of each monitoring point. The monitoring data obtained by two different monitoring methods can see that the two sets of monitoring data change are the same, which has been verified with each other, indicating that there are indeed changes in the excavation process of the foundation pit. Still, the amount of change is within the controllable range, which does not affect the safe use of the foundation pit.

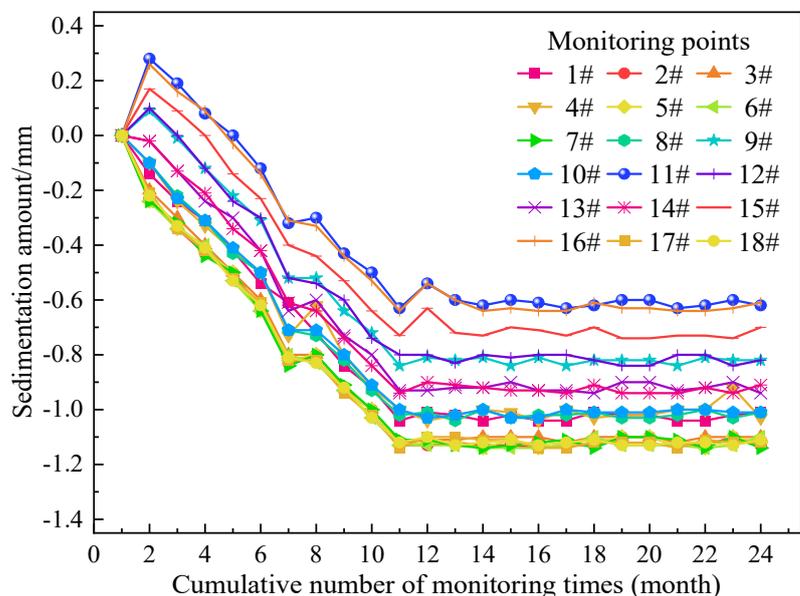
Figure 20. Perimeter pipeline monitoring diagram.

Figure 20 shows the pipeline monitoring map around the foundation pit, and a total of 18 pipeline monitoring points around the foundation pit are arranged in this foundation pit. The elevation of the measurement point can be calculated by measuring the height of the reference point.

Through the observation data, the cumulative changes of pipeline monitoring around the foundation pit were mainly distributed in 0.000 mm~−1.140 mm, and vertical displacement changes occurred in all monitoring points. According to the existing specifications, the surrounding pipeline monitoring alarm value can be known: the cumulative settlement is 10 mm, and the settlement rate is continuously greater than 1 mm/d. It can be judged that the amount of change, individual change rate, and an individual cumulative change of all monitoring points of the foundation pit during the whole monitoring period have not exceeded the range of the allowable alarm value of the specification; After data analysis according to the site situation, it was judged that the cumulative data change was mainly concentrated in the early excavation process, and the data change was stable during the later excavation process, which did not affect the safety of the pipelines around the foundation pit. The channels around the foundation pit were in a stable state as a whole.

After the pouring of the foundation pit raft slab, the pipeline monitoring data around the foundation pit is in a stable and safe state, and the construction in the foundation pit

at that time does not affect the safety of the pipeline around the foundation pit, through the means of manual patrol and the monitoring data comparison, the surrounding channel does not have displacement and damage, although there is a slight vibration caused by a tiny settlement, the settlement change is within the controllable range, does not affect the safe use of the pipeline around the foundation pit.

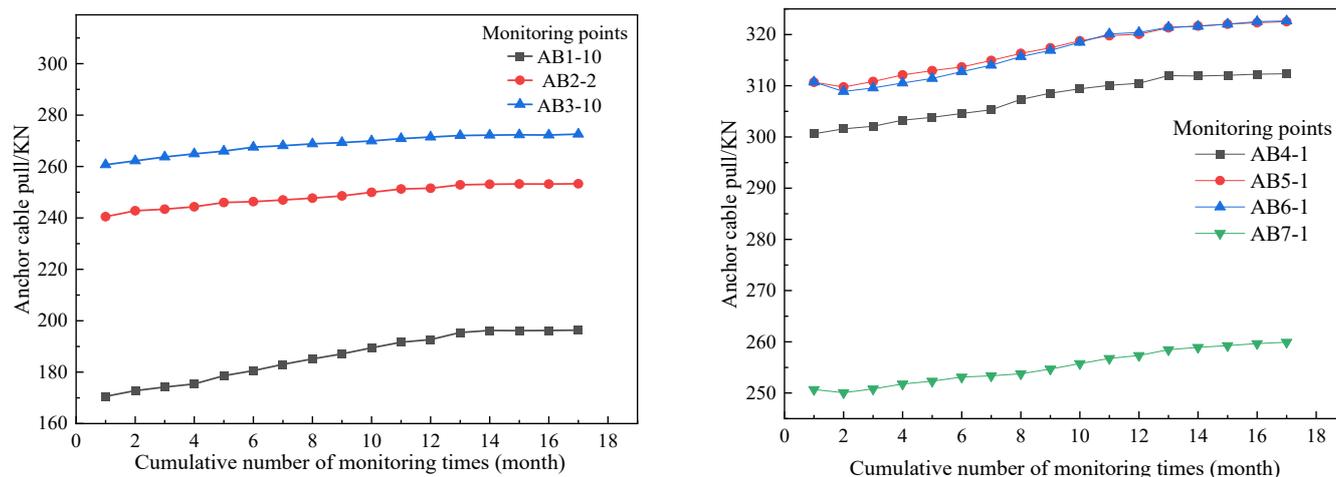
**Figure 21.** Anchor cable internal force monitoring curve.

Through the observation and monitoring data, the cumulative change of internal force of the anchor cable is mainly distributed in 0.00 kN~25.77 kN; according to the existing specifications, it can be seen that the early warning value of the internal force detection value of anchor cable in the foundation pit is the cumulative value (60%~80%), the maximum value  $f_2$ , and  $f_2$  is the load design value. Rate of change (70%~80%) $f_2$ . It can be judged that the amount of change, change rate, and a cumulative change of all monitoring points of the foundation pit during the entire internal force monitoring period does not exceed the allowable alarm value range of the specification.

In the early monitoring process, it was found that the locking value of all anchor cables did not reach the design locking value, and there would be an inevitable loss of internal force during the pressure relief process after closing, which was preliminarily judged to be the loss of internal power generated at the lock and clamp. Therefore, in the later stage of monitoring, the tensile force value is increased to offset the internal force loss caused in the last stage in the process of pressure relief, so that the final locking value can reach the designed locking value.

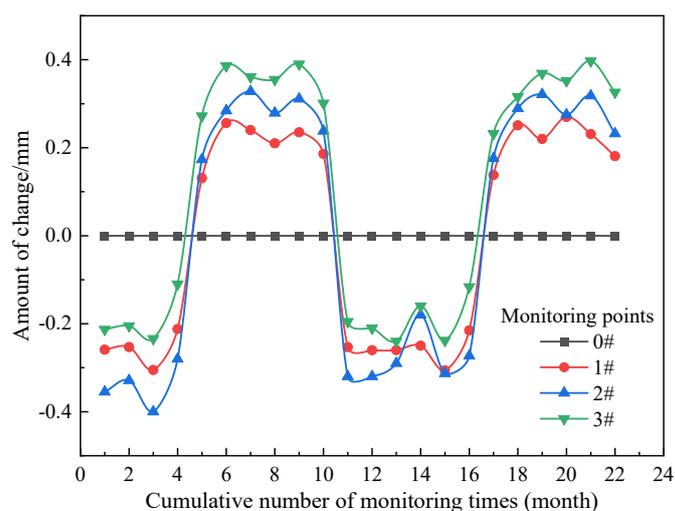
**Figure 22.** Curve of water level change in foundation pit.

Figure 22 is the analysis chart of the water level monitoring of the foundation pit, and a total of 3 groups of monitoring points are arranged during the water level monitoring of the foundation pit. Advanced isolated diffused silicon sensitive elements or ceramic capacitive pressure sensing sensors are used for monitoring. The static pressure is converted into an electrical signal using a sensor. Then temperature compensation and linear correction are carried out to convert it into a standard electrical signal, based on the principle that the water pressure is proportional to the height of the water.

Taking point 0 as the precipitation reference point, through observing the monitoring data, the cumulative change of the water level gauge is mainly distributed in 0.00 mm~0.386 mm; according to the existing specifications, it can be known that the incremental change early warning value of water level is 1000~2000 mm, the change rate is 500 mm/d, all monitoring points have water level changes, and the amount of change, change rate and a cumulative change of all monitoring points in the foundation pit during the entire water level monitoring period individually exceed the range of allowable alarm values of the specification.

As can be seen from Figure 20, the water level at point 3 of water level monitoring has a significant change, with a maximum variation of 3.718 m. The most significant groundwater increase occurred on 29 March 2021, 1.749 m higher than the designed scheduled water level, due to damage to the pumping pump in the local precipitation well, and the pumping volume was less than the recharge, resulting in the site being flooded with groundwater. In the later stage, the construction party strengthened the pumping capacity of the pump, reduced the water level to 0.5 m below the design foundation elevation, and the water level changed steadily.

- (5) By comparing the precipitation reference points, it is found that the individual monitoring data exceeded the warning range during the water level monitoring period, which

was due to the damage of the pumping pump in the local precipitation well. The pumping pump collection and drainage capacity was strengthened in time in the later stage to stabilize the water level change.

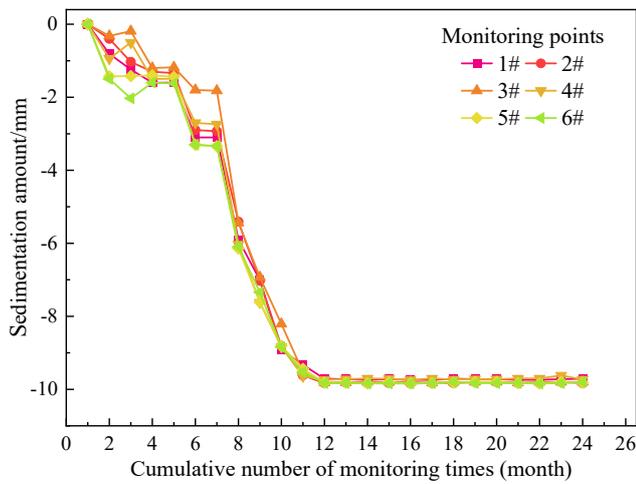
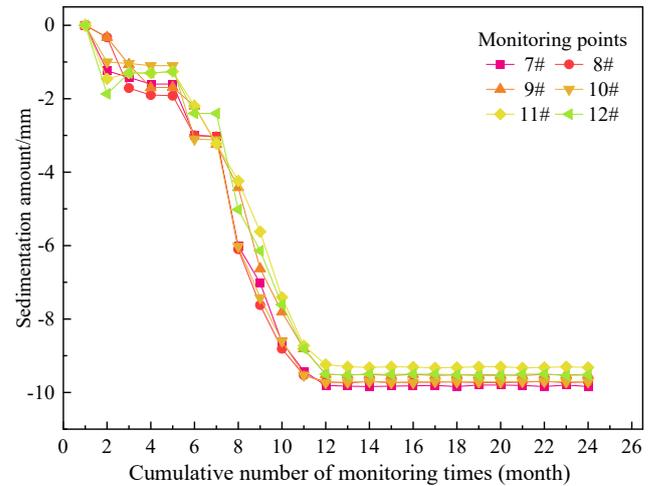
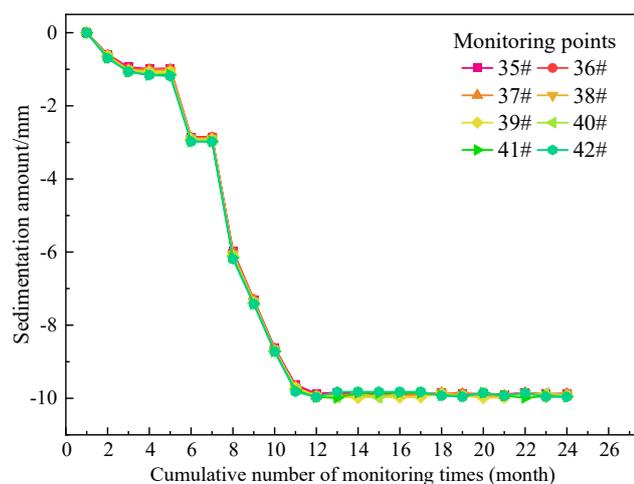
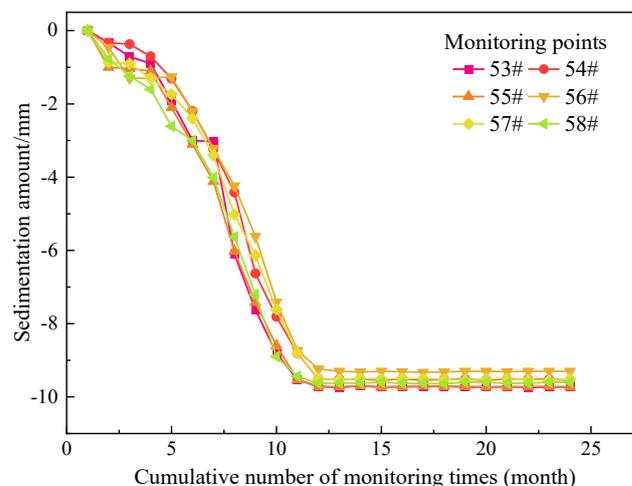
**Figure 23.** Curve of settlement of surrounding buildings.

By observing the settlement data of surrounding buildings, it can be seen that the settlement generated by every single building is relatively uniform, and its difference value and cumulative value do not exceed the specification. Combined with the results of the wall crack survey of surrounding buildings, the excavation of the foundation pit did not have a significant impact on the surrounding buildings, and the whole was in a stable state.

For monitoring different buildings, the monitoring results are shown in Table 4, and the maximum cumulative settlement is displayed for different measurement results of the same building; see Figure 23 for details. Due to the large area of the family hospital on the west side of the foundation pit, has a significant impact on the foundation pit, so it is divided into 6 groups of different location measurement points for monitoring. The inpatient building on the north side of the foundation pit is monitored in two groups of varying location measurement points.

(6) During the excavation of the foundation pit, the surrounding pipelines, and surrounding buildings have obvious impacts, and the settlement occurs within the controllable range to ensure that the whole is in a stable state.
