# Proposed Countermeasures against Woody Debris Damage Considering Runoff Characteristics

**Abstract:** In recent years, a combination of forestry decline and global climate change has led to heavy rains and landslides in Japan that have caused extensive forest damage through woody debris outflow. The current configuration of impermeable sabo dams has insufficient capacity to capture woody debris under these conditions; therefore, improvements to permeable sabo dams, which have a high woody debris capture capacity, are underway; these sometimes involve the addition of steel fittings. In this study, we examined the effectiveness of such measures in consideration of the factors affecting woody debris flow. After reviewing a woody debris outflow that occurred during a heavy rain disaster in northern Kyushu, Japan, we propose woody debris countermeasures that consider basin and runoff characteristics. Our results indicate that woody debris flow occurs later than sediment flow. Therefore, we performed experiments to test the effectiveness of various methods to slow water flow using the terrain conditions at the nearest valley outflow point. Finally, we propose woody debris countermeasu

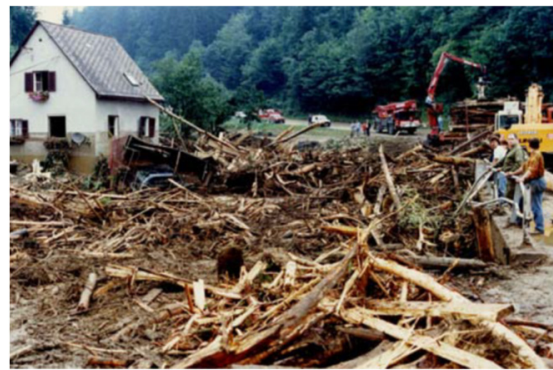
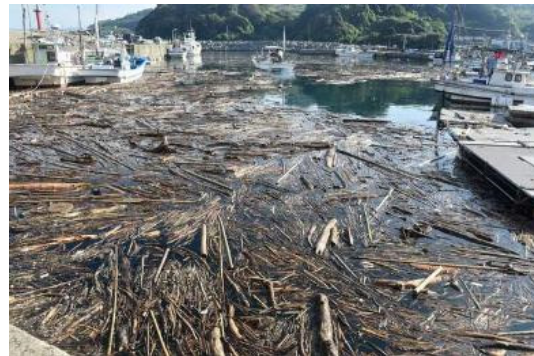
**Figure 1.** Damage caused by woody debris flows. (a) Mountainous area [2]. (b) Coastal area.

In recent years, extensive forest deforestation has been caused by woody debris outflows (Figure 1a) following landslides triggered by global warming-related heavy rain events [1,2]. Approximately 75% of Japan's land area is mountainous, most of which is covered by forests; thus, there are concerns regarding the occurrence and hazards of large amounts of woody debris produced through landslides and bank collapses [3], particularly along mountain streams and around reservoirs [4,5]. Past disasters have revealed that woody debris and sediment blockages can damage bridges and culverts, leading to significant outflow and/or flooding upstream of the blockage [6–9]. Woody debris flows also tend to create problems in coastal areas (Figure 1b). However, previous studies mainly examined woody debris damage at individual sites, and comprehensive studies of woody debris flows in entire basins are lacking.

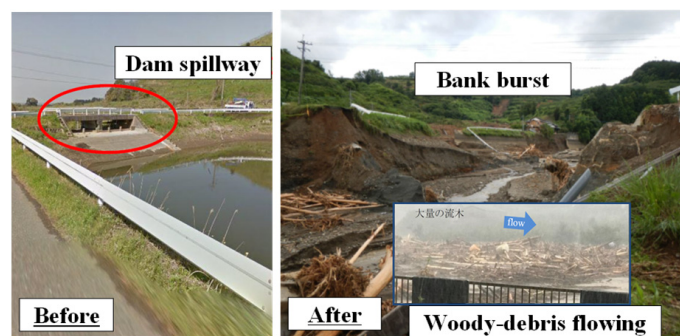
**Figure 2.** Woody debris damage following the July 2017 heavy rain disaster in northern Kyushu, Japan. (a) Yamanokami agricultural pond on the Naragaya River before and after the disaster [8,9]. (b) Woody debris capture by the impermeable Myoken River sabo dam after the disaster [16].

During the disaster, large amounts of woody debris were not captured by impermeable sabo dams, and flowed into downstream agricultural ponds (Figure 2a). The pond embankments eroded and overflowed, ultimately collapsing due to spillway blockage, which inhibited proper drainage. These collapses led to significant damage downstream [8,9]. By contrast, the impermeable Sugawa sabo dam I (Figure 2b) exhibited robust woody debris capture [16]. Thus, the woody debris capture capacity of impermeable sabo dams requires further study. In response to this 2017 heavy rain disaster, emergency countermeasures were proposed, including mountain streams and downstream areas in the basin [17]. However, the mechanism underlying the extensive woody debris damage that occurred during this event remains to be clarified.

To understand the runoff characteristics and capture functions of sabo dams, we will discuss the results with respect to the Northern Kyushu heavy rain disaster, in which a large amount of woody debris caused heavy damage (Figure 2a,b).

We examined woody debris damage in the Myoken River basin (Figure 7), where woody debris was captured by the impermeable sabo dam shown in Figure 2b. We also examined damage that occurred in the Naragaya River basin, where large amounts of woody debris escaped an impermeable sabo dam and flowed into a downstream agricultural pond (Figure 2a), leading to considerable damage.

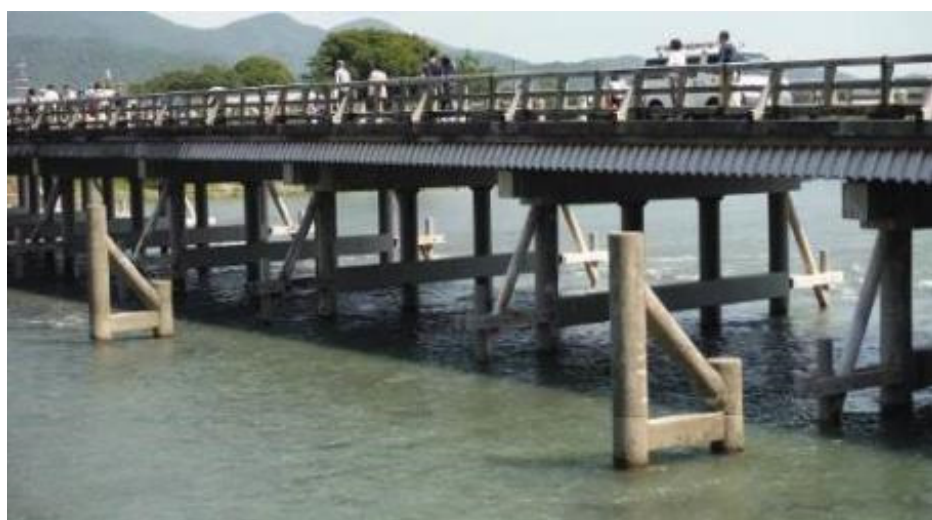
**Figure 3.** Stakes installed to prevent blockages at Togetsukyo Bridge in Kyoto-Arashiyama, Japan.

Stakes have been installed to prevent bridge blockages by woody debris in Japan since ancient times [22]. This conventional measure exploits the tendency of floating woody debris to rotate around an obstacle, slowing the debris flow upstream of the bridge and allowing the debris to re-orient to pass between its piers, providing some degree of control over the debris flow direction (Figures 3 and 16).

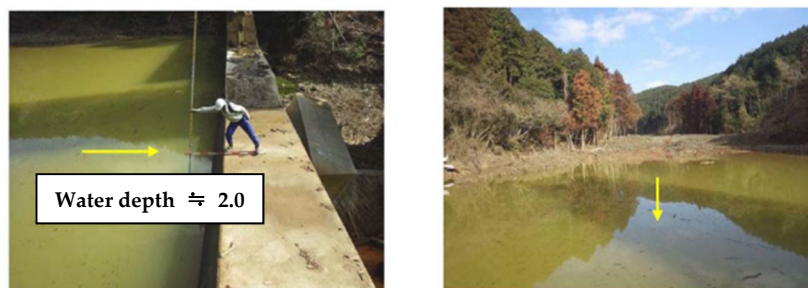
**Figure 8.** Flooding at Sugawa sabo dam I.

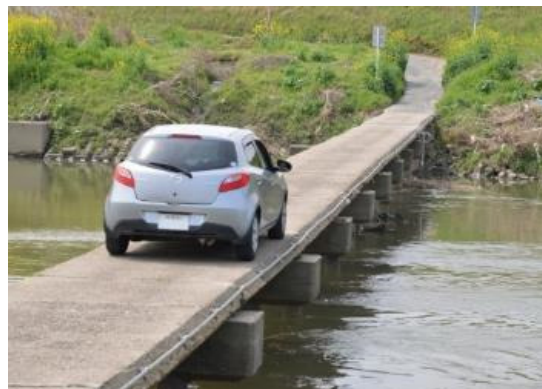
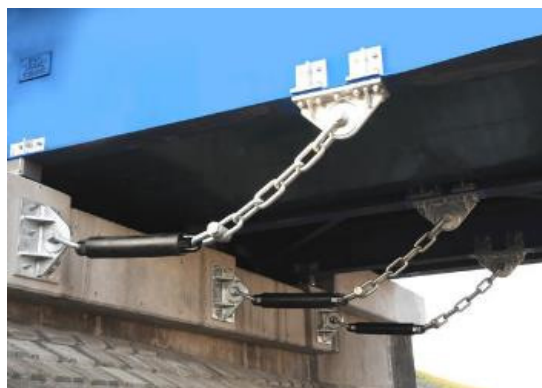
(a) Subsidence bridge.

(b) Girder chains to prevent bridge movement.

**Figure 15.** Japanese bridge collapse prevention measures.

Additionally, bridge collapse prevention devices (Figure 15b) such as girder chains are important in regions where rivers are blocked by woody debris [33].
