Article

Stability Analysis of a Rocky Slope with a Weak Interbedded Layer under Rainfall Infiltration Conditions

Citation: Zhuang, Y.; Hu, X.; He, W.; Shen, D.; Zhu, Y. Stability Analysis of a Rocky Slope with a Weak Interbedded Layer under Rainfall Infiltration Conditions. *Water* **2024**, *16*, 604. <https://doi.org/10.3390/w16040604>

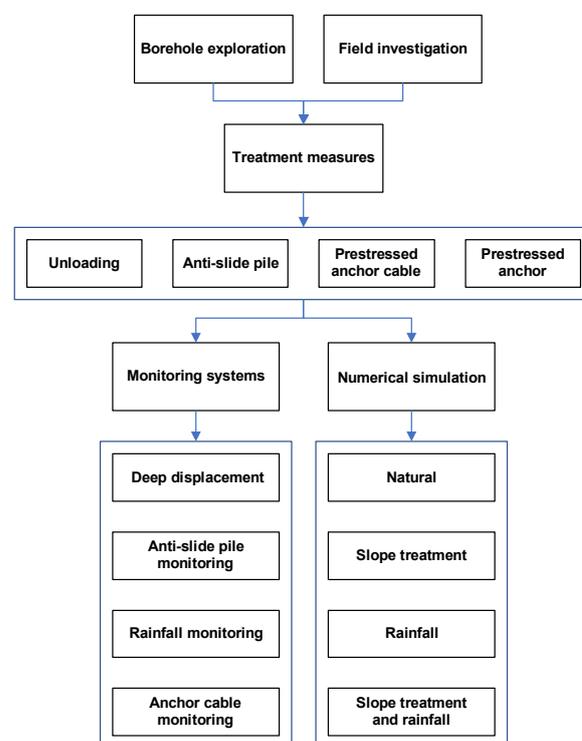
Figure 1. The overall workflow.

In this paper, a stability study of the landslide on the right side of the G104 Jinglan Line was carried out. The overall workflow is shown in Figure 1. Firstly, the geological information of the slope and the mechanical properties of the rock body were determined through on-site investigation and borehole tests, and the causes of the landslide were analyzed. On this basis, the management scheme of “excavation unloading” and “prestressed anchor + prestressed anchor cable + anti-slide pile” was determined. Then, the effect of rainfall on complex geologic rocky slopes was studied by monitoring the deep displacement, rainfall, axial force of anti-slip piles, and pre-stressing of pre-stressing anchor cables. Finally, considering the influence of rainfall infiltration on the slope, the finite difference software FLAC^{3D} was used to simulate the G104 landslide. The safety coefficients of the slope under natural and extreme rainstorm conditions were calculated based on the intensity discount method, and the stability of the slope before and after the treatment was compared, which was combined with the monitoring data to verify the effectiveness of the landslide management measures. The results of the study can provide a reference for the prediction of the instability mode and deformation evolution pattern of rocky slopes with similar complex geological conditions under extreme rainfall conditions, as well as management schemes of rocky high slope projects under complex geological conditions.

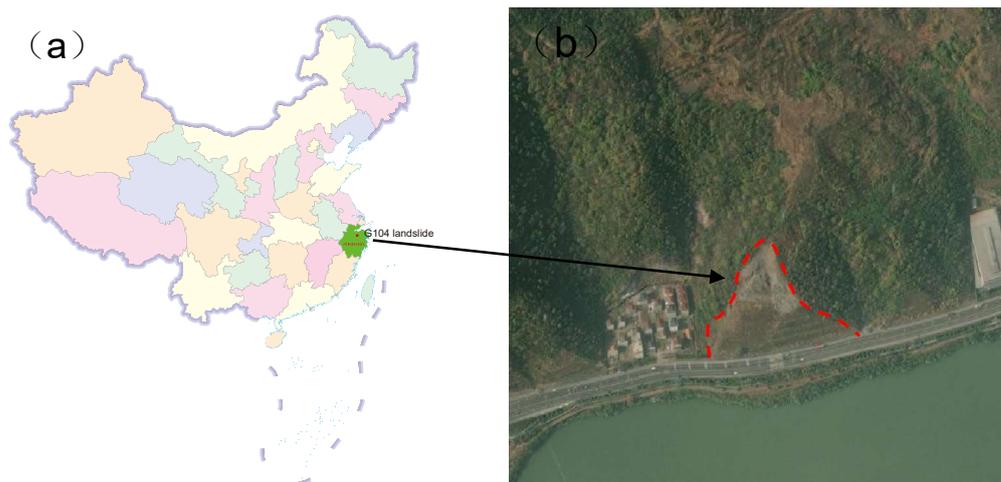
Figure 2. Study area and landslide: (a) location of the study area; (b) photo of the slope.

The landslide on the right side of G104 Jinglan Line is located on the north side of Sanjutan Village, Pukou Street, Shengzhou City, Shaoxing City, Zhejiang Province ($29^{\circ}39'43''$ N, $120^{\circ}49'19''$ E), with the station number range K1610 + 850~K1611 + 100 (Figure 2). The natural terrain of the landslide features a slope angle ranging from 25° to 30° , and the section with an elevation of 70 to 90 m resembles a gentle platform, with a terrain slope angle of 8° to 10° . Factory buildings and villages are more common at the foot of the slope around the mountain. The rock body of the slope is significantly influenced by tectonic structures, with developed joint fissures and small fracture structures.

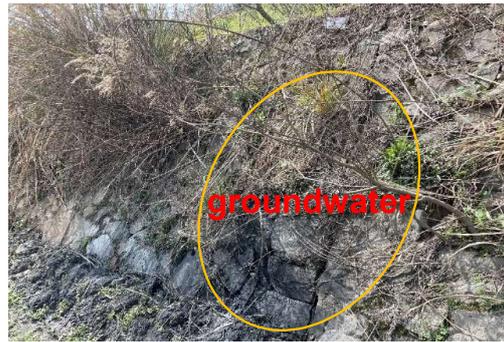
Figure 3. A small amount of groundwater seeps from the retaining wall.

Groundwater in this region is controlled by atmospheric precipitation and can be divided into loose rock pore water and weathered bedrock fracture water. Loose rock pore water is found in the Quaternary residual slope accumulation sub-clay, which is thinly distributed due to terrain constraints, with limited water permeability. It has the characteristics of local recharge and drainage, mainly influenced by seasonal rainfall. Weathered bedrock fracture water is present in the weathered fractures of the tuff, using the well-developed weathering fractures and small fissures of the tuff as an effective storage and migration channel for groundwater. A field investigation revealed minor groundwater seepage in the central and lower parts of the retaining wall at pile K1610 + 967. As the top of the retaining wall was partially exposed to the landslide shear outlet, it is hypothesized that groundwater seeped along the sliding surface to the retaining wall (Figure 3).

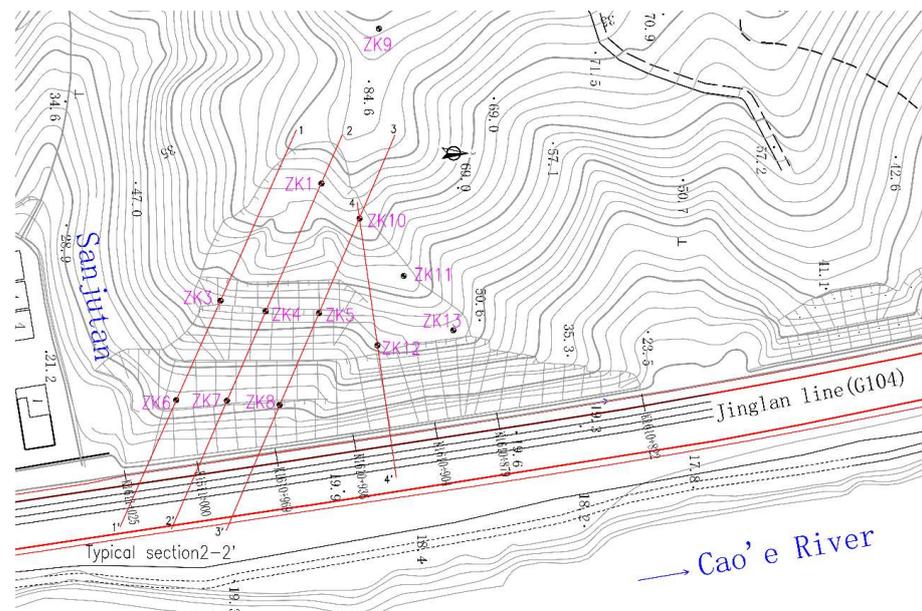
Figure 4. Plan view of slope drilling location.

A total of 12 boreholes were drilled to obtain the slope profile (Figure 4). Six boreholes were positioned within the sliding area of the landslide, with three each along the Level Two and Level Four platforms. In addition, six boreholes were positioned in the non-sliding area, one at the back edge of the slope, one on the top terrace of the slope, and four on the platform of the un-sliding area. A typical section is shown in Figure 5. According to the investigation data, the lithology of the slope is predominantly Quaternary residual slope deposits with gravelly sub-clay and Jurassic tuff, occasionally interbedded with sedimentary rocks. The surface of the Jurassic tuff is light and dark grey, characterized by a relatively hard rock quality, and the rock body has developed fractures influenced by the geological structure. The landslide is predominantly composed of strongly weathered, highly fragmented tuff, with a structural surface rich in ferromanganese and susceptible to softening by water. At the base of the extensive road cut, there is an intermediate layer of sedimentary rock consisting mainly of dark grey carbonaceous mudstone and shale, interspersed with coal lithologies. This layer is black-grey, soft, easily weathered, thinly bedded, and has a gentle dip. The rock layer is subject to distortion and deformation due to structural influences.

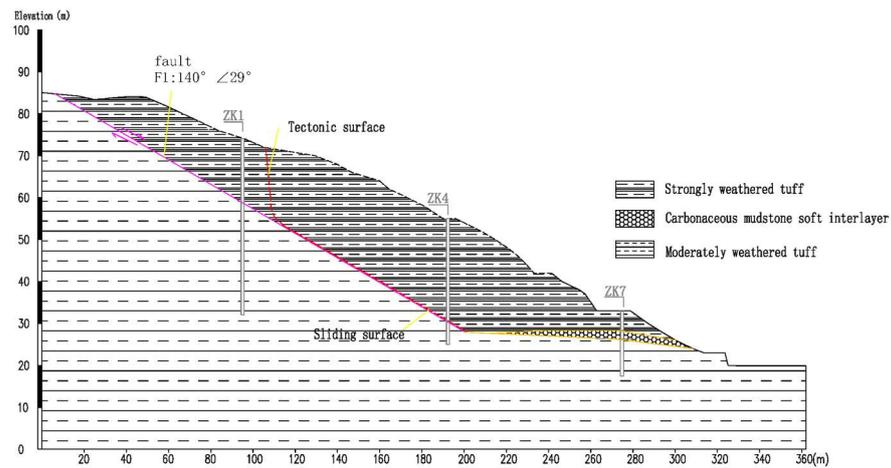
Figure 5. Schematic diagram of a typical engineering geological section.

The slope includes severe deformation area I and no deformation area II. A fault F1 (dip direction: 140°, dip angle: 29°) is developed along the original cut-off ditch of the slope, extending diagonally from the top of the retaining wall to the top of the slope (Figure 6). Influenced by the F1 fault, the upper plate of the fault is composed of strongly weathered tuff characterized by extremely fractured rock quality, extensive fractures, highly weathered fracture surfaces, and localized mud deposition. The lower plate is of hard rock quality with a reasonably complete rock body. Apart from the F1 fault, the dip has three sets of developed structural planes (Table 1): (1) dip direction: 68°, dip angle: 39°; (2) dip direction: 169°, dip angle: 50° (trailing edge tectonic plane); (3) dip direction: 68°, dip angle: 88° (trailing edge tectonic plane). A stereographic projection shows that the combination of structural planes adversely affects slope stability, with the fault having the greatest influence, resulting in a bedding landslide (Figure 7). The fault acts as the sliding surface of the landslide and represents the primary structural plane affecting landslide stability. At the base of the slope is a weak interlayer of carbonaceous mudstone and coal beds, which is a relatively weak interlayer. Under the combination of the carbonaceous mudstone weak interlayer, fault F1, and the middle and back margin tectonic plane, a wedge shape along the slope is formed.

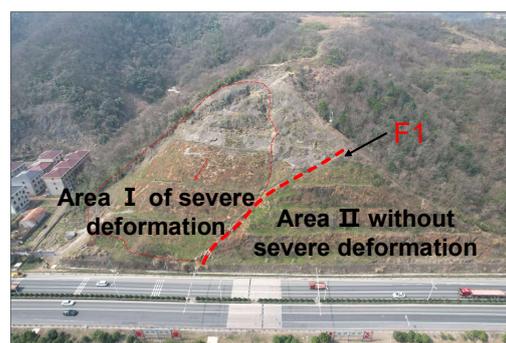
Figure 6. Landslide deformation area.

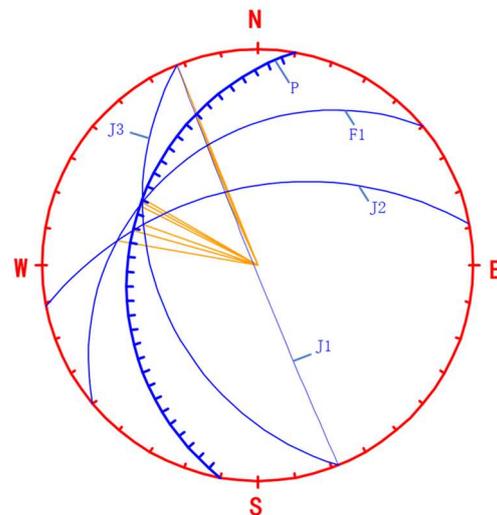
Figure 7. Equatorial projection.

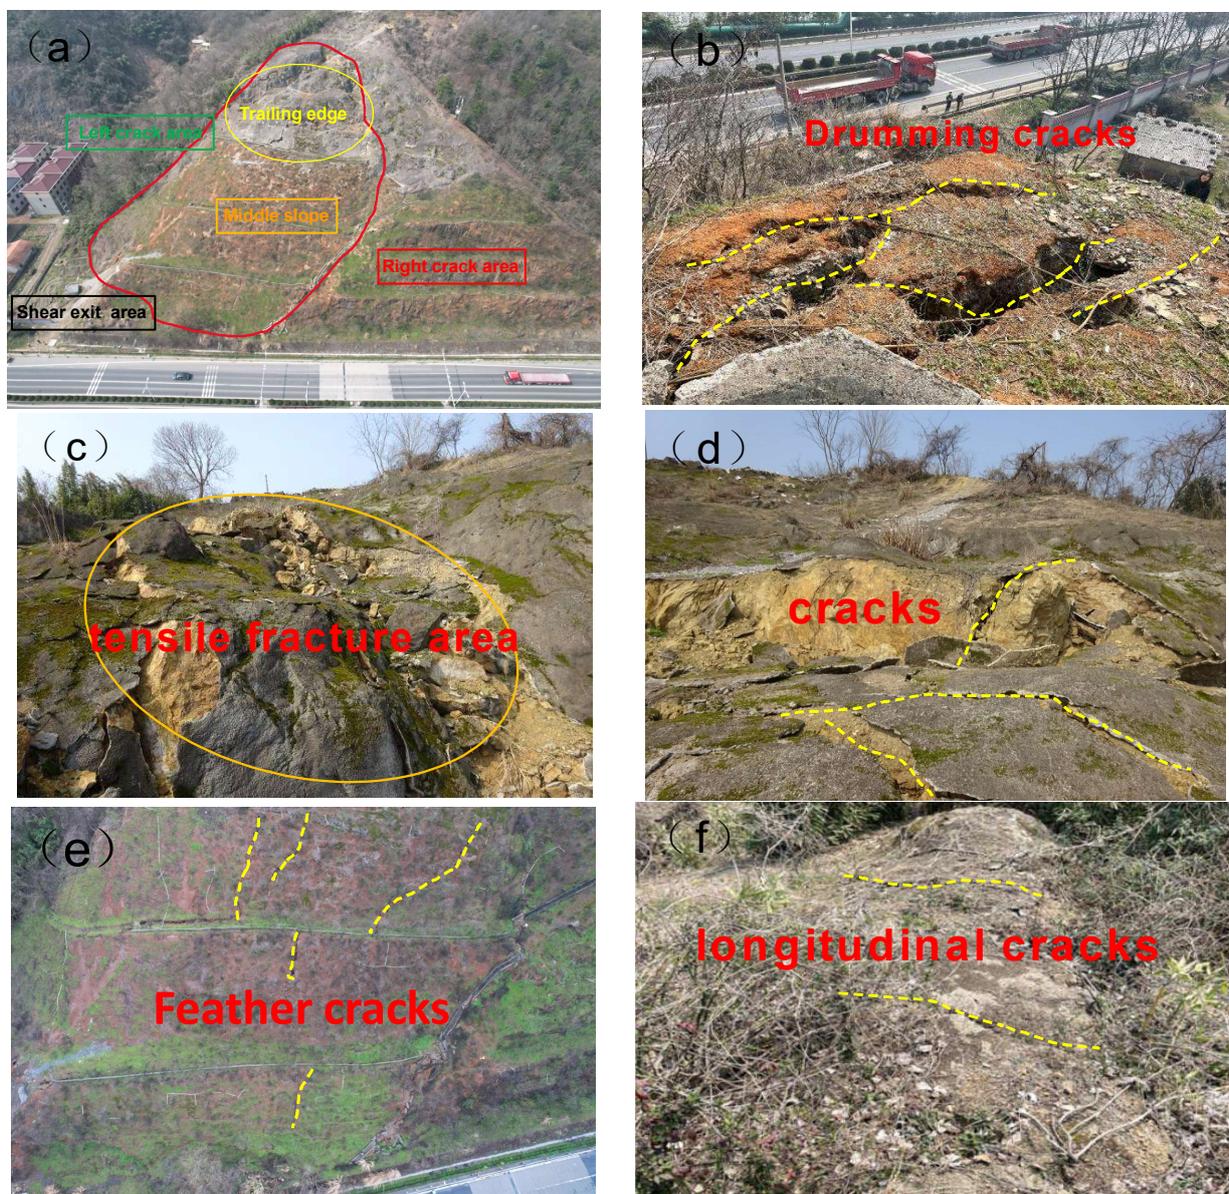
Figure 8. Slope deformation diagrams: (a) panoramic view of landslide deformation; (b) shear exit area; (c) right crack area; (d) back edge area; (e) mid-slope tensile crack area; (f) left crack area.

In February 2022, the high slope of the motorway underwent severe deformation due to prolonged rain and freezing snow conditions, resulting in the opening of longitudinal cracks on several slope platforms and the initial formation of an armchair landslide hazard. The perimeter of the landslide is well-defined and has a skip-shaped planform with a main slip direction of approximately 120° . The landslide is approximately 130 m long diagonally, approximately 60 m wide at the leading edge, 15–20 m wide at the trailing edge, and approximately 6–20 m thick. The estimated potential volume of the landslide is about $1.0 \times 10^5 \text{ m}^3$, classifying it as a medium-sized rocky landslide.

The landslide has numerous slope cracks and deformations in drainage channels. These can be categorized into different areas, namely the shear exit area, right crack area, back edge area, mid-slope tensile crack area, and left crack area. The deformation area is shown in Figure 8. In the shear exit area, pronounced extrusion deformation is observed at the leading edge. The shear exit extends from the slope foot to the first retaining wall. The left shear exit is located in the middle of the secondary slope and gradually extends to the right side to the top of the primary retaining wall. In addition, the middle and right shear exits are located at the middle of the top of the primary retaining wall, and bulging cracks were found at the front of the landslide. (Figure 8b). In the right crack zone, the

fracture ascends along the cut-off trench of the slope, diverging from the non-deformed zone II at the four-stage platform. As it progresses upwards, the fracture reaches the back edge of the slope. Subsequently, the slope cut-off trench shows extensive damage and deformation below the four-stage platform, resulting in downward sliding. The fracture is located above the F1 fault. In the right crack area, there is a tensile fracture area in the middle and upper part of the landslide (Figure 8c). A tension crack has developed at the back edge of the landslide, with a downward displacement of 1.0 to 2.0 m and a width of 30 to 50 cm. The maximum width of the transverse crack is approximately 2.0 m. The trailing edge has assumed an armchair configuration and the sliding mass manifests a triangular shape (Figure 8d). Within the mid-slope tensile crack zone, a large number of plume cracks are distributed across the central slope of the landslide. Transverse tension cracks are evident at the periphery of the platforms at each level, accompanied by localized longitudinal cracks of varying lengths within the slope (Figure 8e). In the left crack region, two locally identified longitudinal cracks cross the slope, measuring 10 to 15 m in length. There are also small cracks of 1 to 2 cm in width, but no prominent large cracks (Figure 8f).

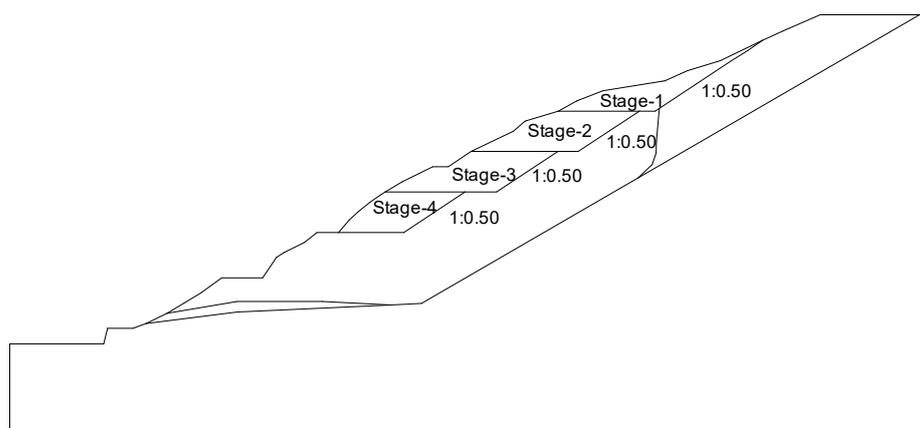
Figure 9. Excavation and unloading solution.

The initial slope was a grade six slope with slope ratios of 1:0.25, 1:1.0, 1:1.0, 1:1.25, 1:1.25, and 1:1.25, respectively. To mitigate the thrust exerted by the primary sliding section in the middle and upper regions of the landslide, excavation started from the third stage platform and proceeded in four stages (Figure 9). The first level of excavation had a slope height of 8 m, a slope ratio of 1:1.50, and a platform width of 6 m at the top of the slope. The next excavation level maintained a slope height of 8 m, a slope ratio of 1:1.50, and a platform width of 4 m at the top of the slope. The third level, also 8 m high, had a slope ratio of 1:1.50 and a platform width of 3 m at the top. The fourth level was excavated to its apex and had a slope ratio of 1:0.50. The total excavation volume was approximately 12,000 m³ (Table 3).

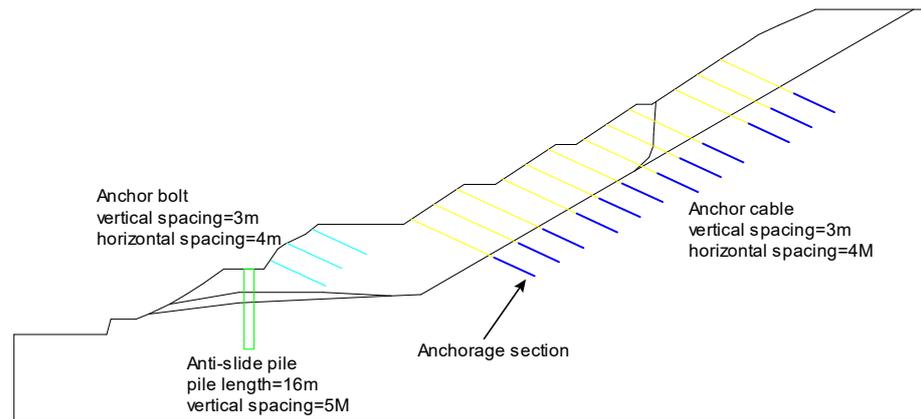
Figure 10. Slope reinforcement scheme.

The reinforcement scheme of “prestressed anchor + prestressed anchor cable + anti-slide pile” was adopted for the landslide, as shown in Figure 10. The slopes of the fourth to seventh levels were reinforced using pre-stressed anchor cables, each 25 m long, with a horizontal spacing of 4 m and a vertical spacing of 3 m. A total of 12 rows of anchor cables made from 6Φ_s15.2 stranded wire contributed to this reinforcement. The slope of the third stage was reinforced with 12 m-long 32 mm-diameter pre-stressed anchors, spaced horizontally at 4 m and vertically at 3 m, with three rows of anchors used systematically. A row of circular anti-slip piles with a diameter of 2 m, a pile length of 16 m, and a pile center distance of 5 m was installed on the inner side of the second stage platform, with a total of 15 piles (Figure 11).

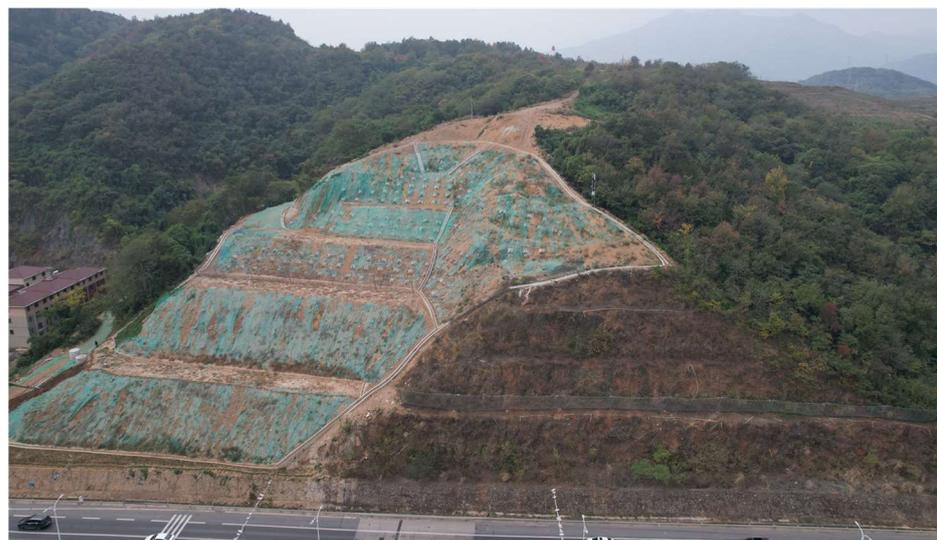
Figure 11. Photo of the slope after reinforcement.

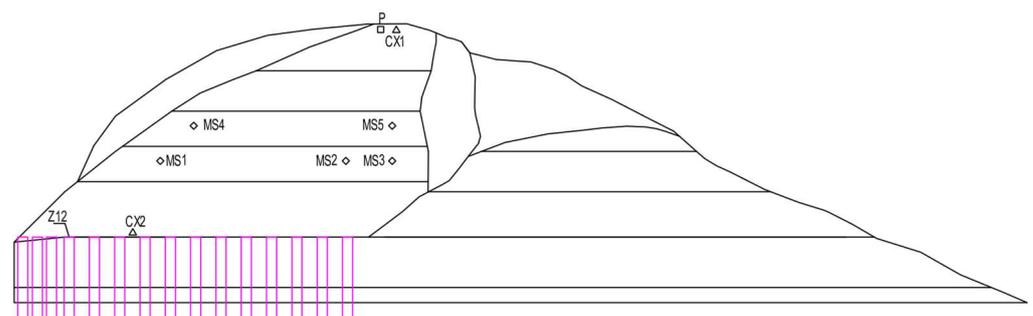
Figure 12. Detailed layout of monitoring instruments.

Field monitoring of the study area commenced in March 2022. The installed monitoring system consisted of two deep horizontal displacement monitors (CX1 and CX2) located on the second and seventh level platforms, five anchor cable monitors (MS1-MS5) located on the fifth and sixth level slopes, a rebar stress monitor (Z12) located on the second level platform, and a meteorological monitoring station (P) located on the seventh level platform to track real-time rainfall on the slope. The detailed arrangement of the monitoring instruments in the study area is shown in Figure 12.

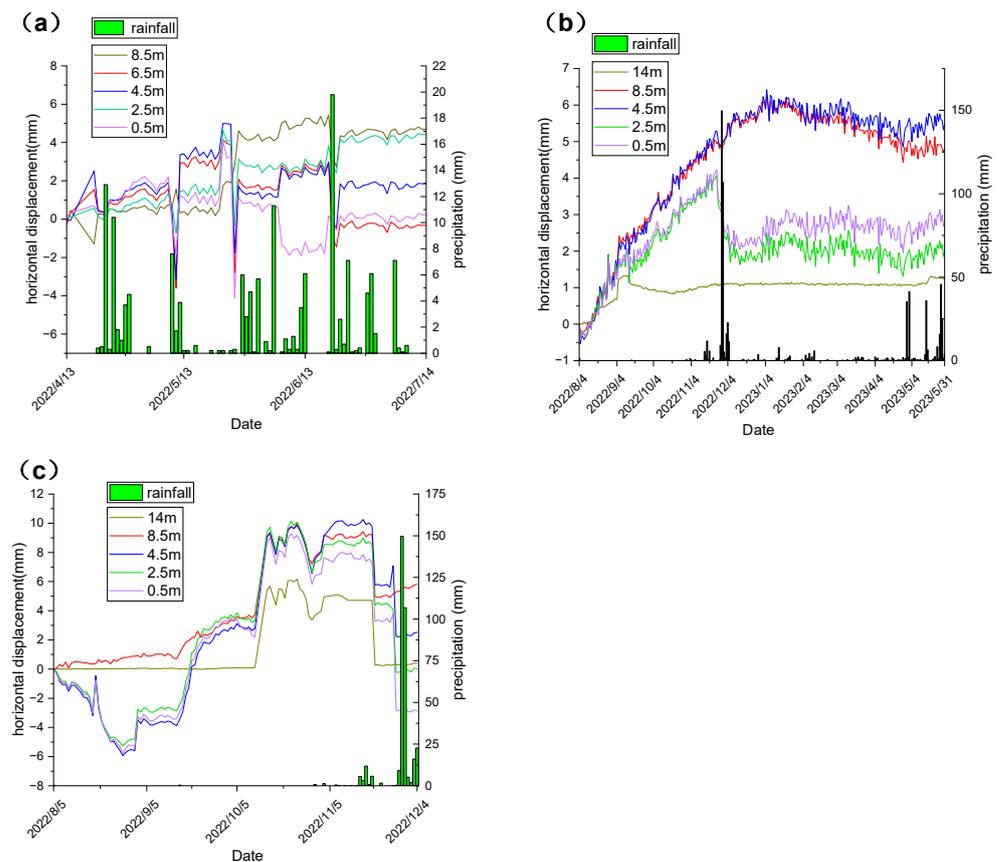
Figure 13. Deep displacement deformation time course curve: (a) inclinometer hole 1 from 13 April 2022 to 14 July 2022; (b) inclinometer hole 1 from 4 August 2022 to 31 May 2023; (c) inclinometer hole 2.

To monitor the fault, CX1 conducted displacement measurements at hole depths of 0.5 m, 2.5 m, 4.5 m, 6.5 m, and 8.5 m, spanning from 13 April 2022 to 14 July 2022 (Figure 13a). Deep displacement was influenced by on-site excavation construction and rainfall. Notably, significant sudden changes in displacement occurred on 10 May, 5 June, and 20 June 2022, primarily attributed to increased rainfall. The infiltration of rainfall into the fault resulted in their softening, rendering the slip zones saturated. Consequently, the slopes experienced decreased stability, leading to larger deformations, with deeper displacements exhibiting a corresponding increase. The displacement at the 8.5 m hole depth underwent the most significant change, reaching 5.43 mm on 19 June 2022. As this hole depth was close to the fault governing slope sliding, its displacement was considerably influenced by the fault. Subsequently, to further assess the impact of the fault and enhance monitoring, hole depths were adjusted to 0.5 m, 2.5 m, 4.5 m, 8.5 m, and 14 m from 4 August 2022 to 31 May 2023 (Figure 13b). Following 2 days of heavy rain on 29 and 30 November 2022, noticeable changes occurred at each measurement point. Displacements at the 4.5 m and 8.5 m points continued to increase, while those at the 0.5 m and 2.5 m points significantly decreased. The 14.5 m depth, situated at the bottom of the fault in the medium-weathered tuff, experienced minimal overall change. The lower part, composed of weathered tuff rock, exhibited robust mechanical properties, was less susceptible to rainfall, and demonstrated greater stability.

To monitor the weak interlayer, CX2 conducted measurements at hole depths of 0.5 m, 2.5 m, 4.5 m, and 8.5 m from 4 August 2022 to 4 December 2022 (Figure 13c). The maximum relative displacement occurred at 4.5 m and reached 10.26 mm on 16 November. This heightened displacement was attributed to the proximity of the weak interlayer at 4.5 m, rendering it more susceptible. Following continuous rainfall from 15 to 19 December 2022, the displacement at each point experienced a sudden decline. Subsequently, after 28 November, due to 2 consecutive days of heavy rain, the displacement at each point continued to decline abruptly. Surface water infiltration into the weak interlayer softened it, saturating the weak interlayer zone and diminishing its resistance to shear, resulting in larger displacements.

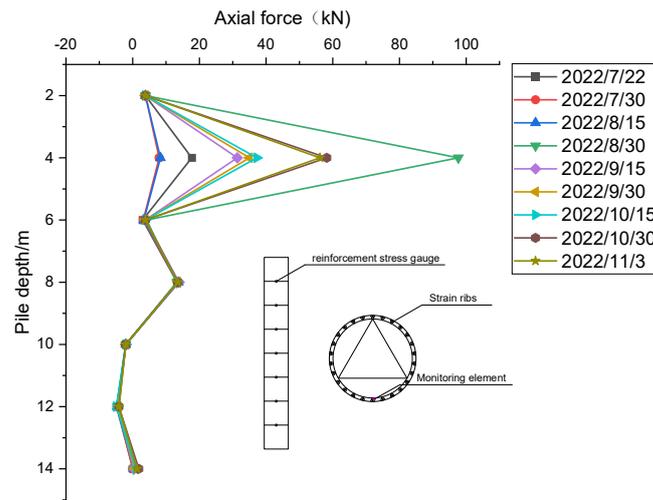
Figure 14. Curve of anti-slide pile force with depths.

At the third stage platform, the Z12 anti-slide pile was selected for internal force monitoring, and seven sensors were arranged along the direction of each pile from top to bottom for internal force monitoring (Figure 14).

The axial force within the pile body demonstrated overall stability, with no apparent abnormal mutations or consistent increases or decreases, except at points 12–2, where some fluctuations occurred. Given the presence of a weak interlayer at a depth of 4 m within the pile body, this section was particularly susceptible to changes in axial force. Throughout the monitoring period, the anti-slide pile experienced a maximum tensile force of 97.66 kN at a depth of 4 m, while the maximum compressive force reached -4.89 kN at 12 m. The stress levels within individual piles ranged from -6.08 MPa to 121.42 MPa, and the reinforcing bar did not reach the elastoplastic or plastic state; it remained in the elastic state. This observation indicated that the anti-slide pile did not fail, and the slope remained in stable condition.

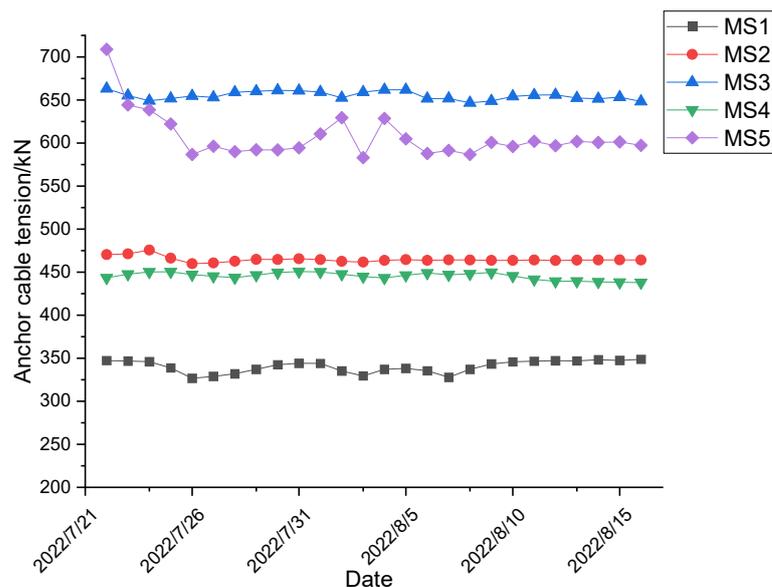
Figure 15. Cable tension variation diagram.

The monitoring of anchor cables employed a vibrating wire anchor cable dynamometer with a measurement range of 0 to 200 T, a sensitivity of < 0.5% F.S, and a temperature range of −20 to 80 °C. The manufacturer is Shanghai Geostar Sensing Technology Co., Ltd., located in Shanghai, China. The prestressed anchor cable could give full play to the bearing capacity of the rock mass and improve the stability of the slope. The monitoring results of the prestressed anchor cable could verify whether the anchor cable played a strengthening role. After the anchor cable tensioning was complete, the prestressing force of all anchor cables was lost to varying degrees (Figure 15). The anchorage force of MS5 was rapidly lost within 5 days, fluctuated greatly from 11 days to 15 days, and gradually stabilized after 15 days; the prestress loss reached 111.51 kN, and the loss rate was 15.73% (Table 4). The prestress of the other anchor cables slowly decreased, and the measured values did not change greatly. Vegetation spraying on the slope surface influenced the data during this period. The overall variation in anchor cable axial force meter readings remained within the early-warning control value, affirming that the slope was predominantly stable.

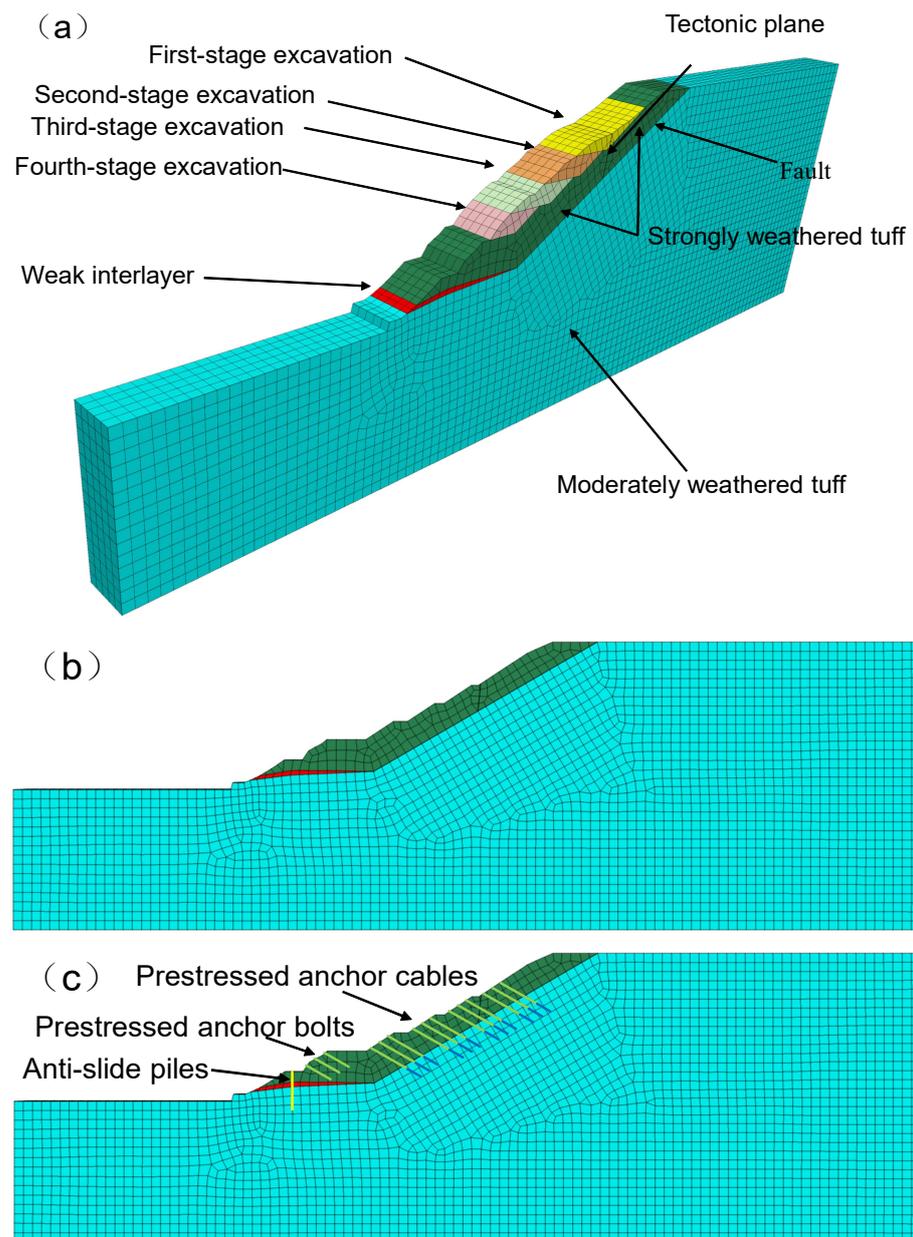
Figure 16. Calculation model: (a) original slope; (b) excavation; (c) support.

The typical profile 2-2 was selected for modeling based on FLAC^{3D}. To account for boundary effects, specific dimensions were considered: the distance from the slope foot to one side of the boundary was set to 1.5 times the slope height, the slope top to the other side of the boundary was set to 2.5 times the slope height, and the maximum height of the critical boundary above and below the model was greater than or equal to 2 times the slope height, ensuring optimal calculation accuracy [28]. Consequently, the model dimensions were established as 396 m (length) × 125 m (height) × 18 m (width). The model was configured with a fixed constraint at the bottom, normal constraints on the four sides, and a free boundary at the upper part (Figure 16). The anti-slip piles were modeled using a pile structural unit, while both prestressed anchors and prestressed anchor cables were simulated using a cable structural unit. The corresponding support parameters for these elements are provided in Tables 7 and 8.

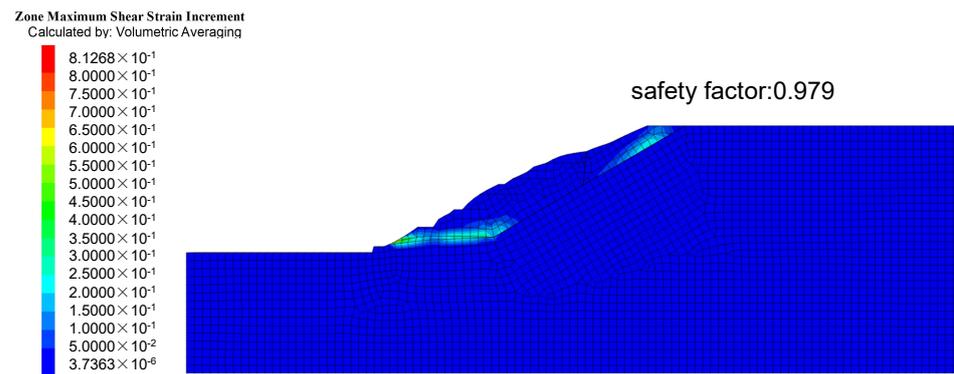
Figure 17. Maximum shear strain case under natural conditions.

The safety factor of the slope was 0.979 in the natural state, which was an unstable state and consistent with the field deformation (Figure 17). The rock properties were notably deficient, particularly the pronounced weathering of the tuff in the upper section, accompanied by crack development and the presence of weak charcoal mudstone interlayers at the slope base. The rock mass was fragmented, exhibiting soft qualities and an overall diminished strength. The interaction of the fault and the trailing edge of the tectonic surface formed a cutting combination, resulting in the formation of a wedge at the high side of the slope and contributing to the main thrust zone of the landslide. However, the collective strength of the rock and soil failed to withstand the downward force imposed by the slope's weight, leading to deformation and damage.

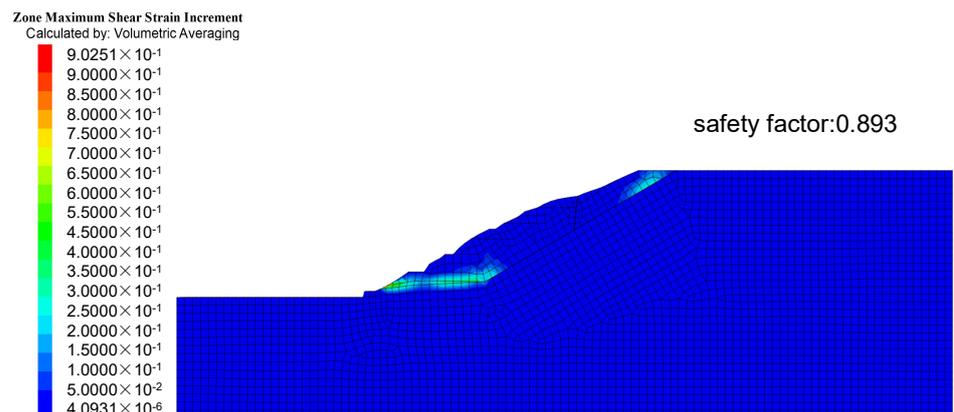
Figure 18. Maximum shear strain case under rainfall conditions.

Under the conditions of heavy rainfall, the slope stability was 0.893, which was an unstable state and more prone to collapse (Figure 18). As the slope was located at the ridge, the catchment area of the slope was small and cracks in the rock mass at the back edge developed, thus precipitation seeped down from the back edge of the slope. The carbonaceous mudstone soft interlayer exposed at the slope's base served as a partial water barrier. Groundwater permeated the slope along the contact surface between the upper strongly weathered layer and the underlying moderately weathered bedrock, flowing from topographic highs to lows. As the slope body accumulated more weight and approached saturation, the rock mass's strength decreased. Concurrently, the weak interlayer, the structural plane at the back edge, and the fault underwent softening, leading to a progressive decline in mechanical properties. This resulted in decreases in the c and ϕ values for the rock mass and each structural plane, ultimately reaching saturated parameters. With the rise in groundwater level, pore water pressure and dynamic water pressure greatly increased, increasing the sliding force and resulting in landslide deformation and failure. Tuff tends to soften and disintegrate upon contact with water, while high water content causes rocks to expand. Under rainstorm conditions, these factors contributed to significant reductions in the mechanical properties of the rock mass, posing a considerable threat to the slope's stability.

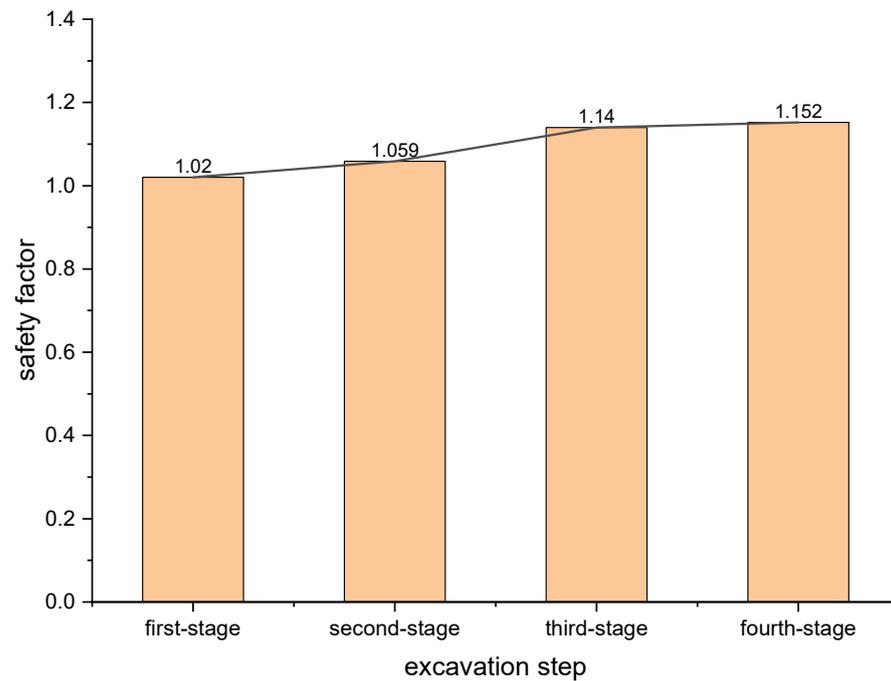
Figure 19. Safety factors for each step of excavation under natural conditions.

Through systematic excavation stages, the slope's stability experienced progressive enhancement. Upon completion of all excavation in the fourth step, the ultimate safety factor of the slope in its natural state reached 1.152 (Figure 19). The excavation process diminished the self-weight load of the slide, leading to a reduction in the downward sliding force. The stress level of the slope was significantly ameliorated compared to its natural

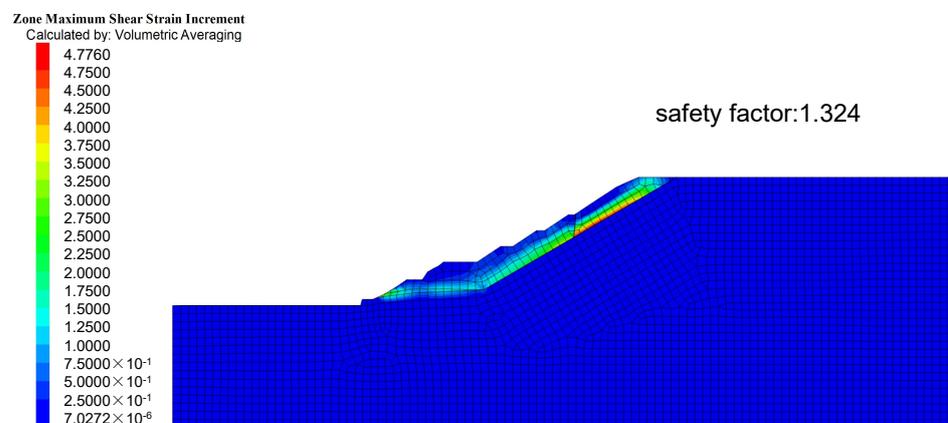
Figure 20. Maximum shear strain case under slope treatment conditions.

After excavation, the slope was supported by “anti-slip pile + prestressed anchor + prestressed anchor cable,” further improving the stability of the slope, and the coefficient of safety reached 1.324 under natural working conditions (Figure 20). This indicated that the support method of “anti-slip pile + prestressed anchor rod + prestressed anchor cable” had a good governing effect on wedge-shaped landslide composed of faults, trailing edge structural planes, and weak interlayers. The anti-slip effect of anti-slip piles was mainly to balance the landslide thrust by using the anchoring effect and passive resistance of the stable ground. The weak interlayer of the slope foot was easy to settle and deform, and anti-slide piles were used to strengthen the weak interlayer. The anchoring section of the prestressed anchor cable was anchored into the weathered tuff, and the sliding body and the stable bedrock were combined, thus changing the stress state of the rock mass of the slope and improving the integrity and strength of the unstable rock mass of the slope.

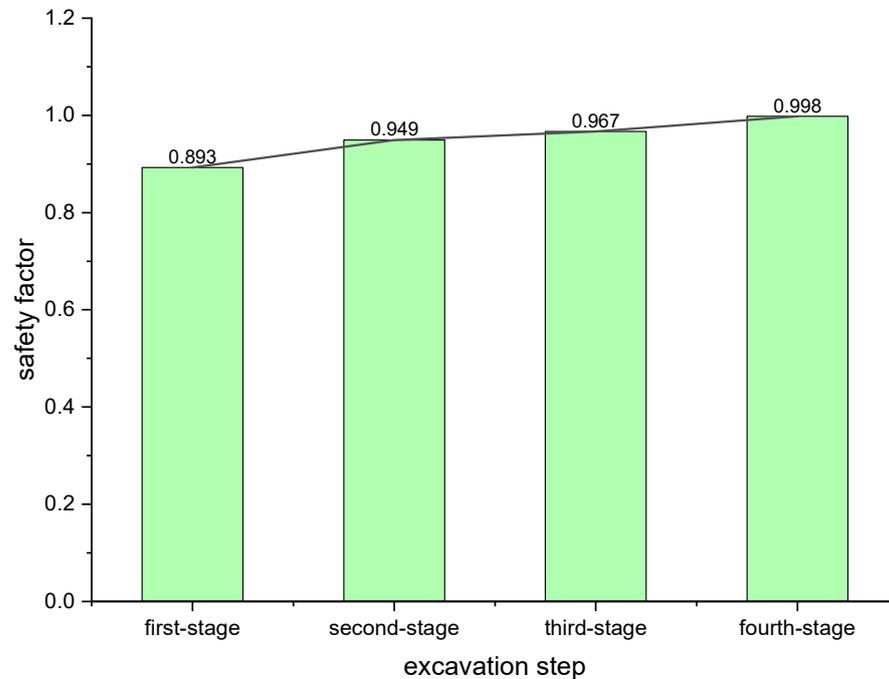
Figure 21. Safety factors for each step of excavation under rainstorm conditions.

Under rainstorm conditions, the stability of the excavation slope was gradually improved, and the safety factor after excavation finally reached 0.998, which was greatly improved compared with the original rainstorm conditions, but it was still not in a stable state (Figure 21). After support, the safety factor was improved to 1.191, and the slope was in a stable state (Figure 22).

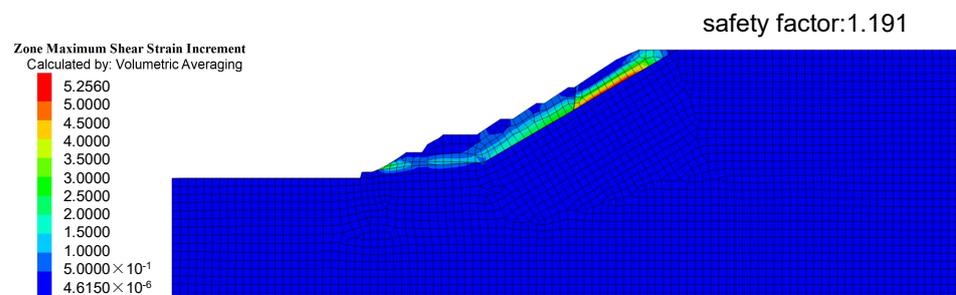
Figure 22. Maximum shear strain case under the combination of slope treatment and rainstorm conditions.

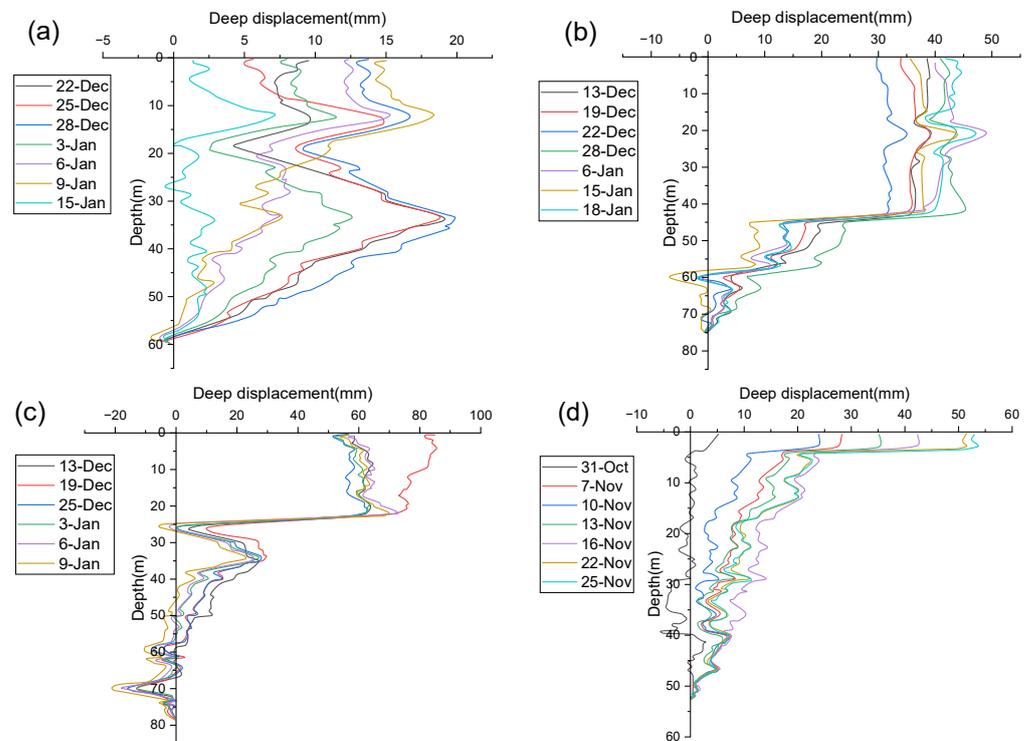
Figure 23. The deep displacement of each hole: (a) ZK4, (b) ZK7, (c) ZK5, (d) ZK6.

The existence of weak layers greatly affects the stability of slopes, and after rainfall, slopes are prone to landslides along the sliding surface of weak inclusions. Wang et al. analyzed the deformation of rock masses by monitoring the deep displacement of the slope and determined the location of weak layers on the slope [29]. The deep displacement curves of inclined holes ZK4, ZK7, ZK5, and ZK6 are shown in Figure 23, and the positions of weak interlayers are shown in Figure 24. From Figure 23a, it can be seen that the overall displacement had no obvious sudden changes in displacement, which showed that the whole depth of the oblique measurement was inside the slide, and the depth of the oblique hole had not yet reached the location of the key stratum controlling slope sliding, and the displacement was only affected by the movement of the slide. From Figure 23b, it can be seen that when the hole was located at a depth of about 42 m, the displacement value of each measurement had a sudden change compared with the initial value, indicating that the displacement of the rock body there had a large change, and it was the key stratum

controlling slope sliding. From Figure 23c, it can be seen that when the monitoring depth was about 21 m, each measured displacement value had a sudden change, indicating that this location was the key stratum to control slope sliding. From Figure 23d, it can be seen that when the monitoring depth was about 3.0 m, the relative displacement value of each curve had a sudden change, and the rock mass had large destabilizing activity, which was the key stratum to control slope sliding.

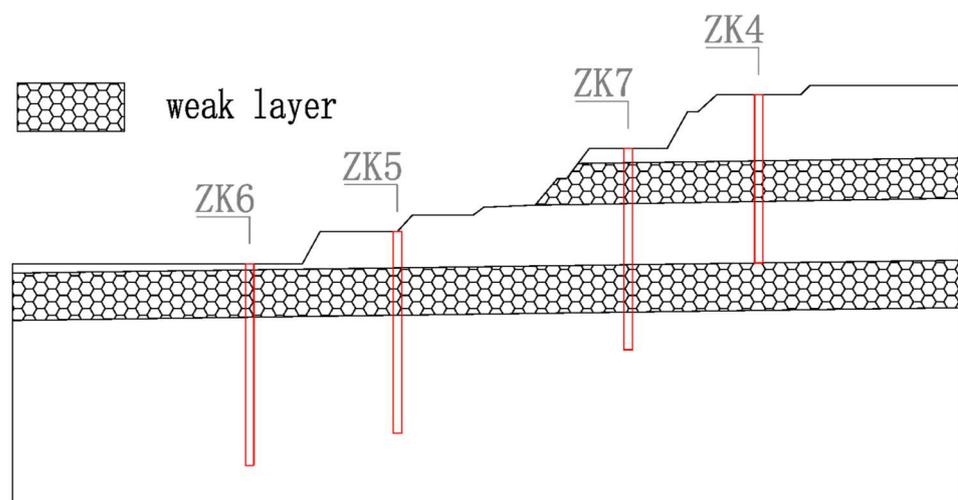
Figure 24. The weak layer location.

The study by Wang et al. [29] had some similarities with this paper. Close to the weak interlayer, the deep displacements abruptly increased, and the weak layer affected the sliding and stability of the slope. The difference lies in the combination analysis of deep displacement and rainfall in this study, and it was found that rainfall will increase the influence of the weak interlayer and the fault on the slope. In the vicinity of the weak interlayer and the fault, which themselves had large deep displacements and were
