# Failure Analysis of a Water Supply Pumping Pipeline System

Oscar Pozos-Estrada \*, Alejandro Sánchez-Huerta, José Agustín Breña-Naranjo and Adrián Pedrozo-Acuña

Instituto de Ingeniería, Department of Hydraulic Engineering, Universidad Nacional Autónoma de México, Cd. Universitaria, C.P. 04510 Mexico City, Mexico; ash@pumas.iingen.unam.mx (A.S.-H.); jbreñan@iingen.unam.mx (J.A.B.-N.); apedrozoa@iingen.unam.mx (A.P.-A.)

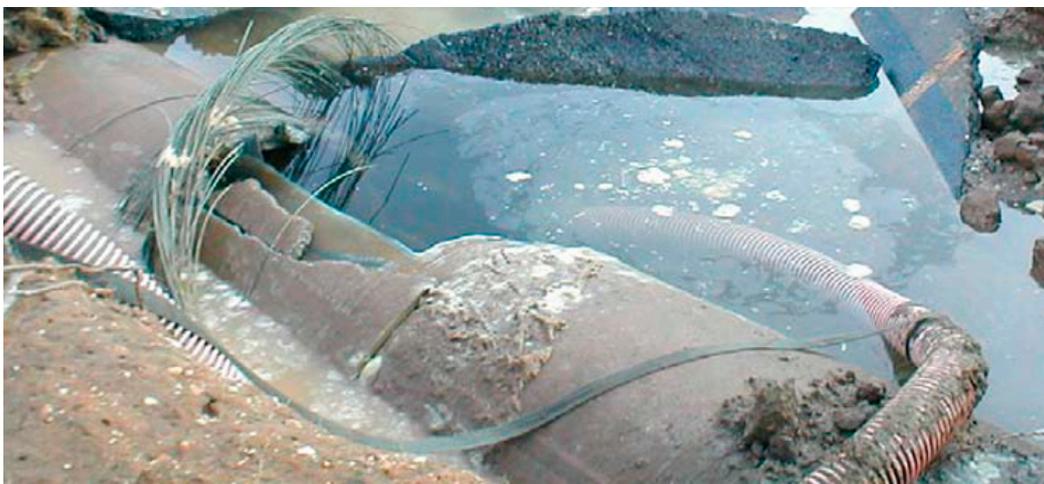
The pumping pipeline was constructed in 2000 and after 15 years of reliable operation, the pipeline experienced a serious rupture at chainage 0 + 465.80, followed by a shutdown of the four pumps. The fracture or longitudinal split occurred at the top of the PCCP, which indicates that it was caused by a severe positive peak pressure. Furthermore, most of the wires exhibited little corrosion whilst the cylinder showed only superficial corrosion, as shown in Figure 1.

**Figure 1.** Rupture of the PCC pipe at chainage 0 + 465.80.

There was significant structural damage to the adjacent dwellings, since a large quantity of water was released and flooded 20 homes located in a low lying area with poor drainage. In addition, four people were heavily injured by the rocks and debris transported with the current.

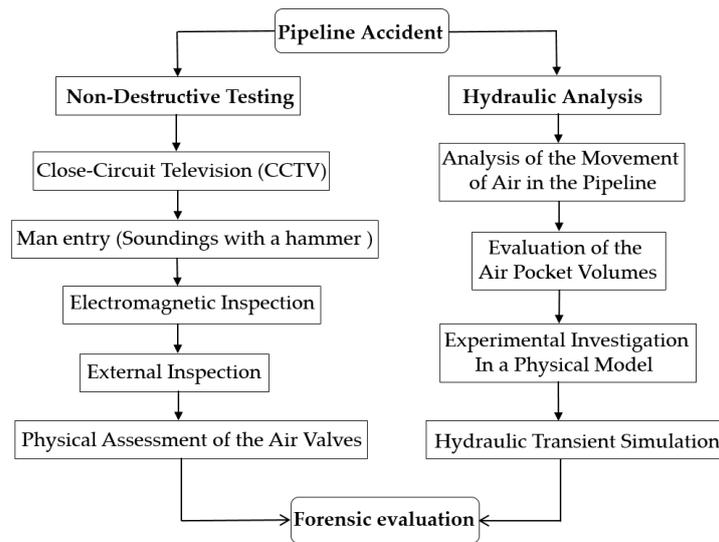
Figure 2 shows the summary of the investigations and simulations developed in order to find and identify the main causes of this incident. The actions conducted are explained within the next section.

**Figure 2.** Investigations and simulations developed to identify the causes of the incident.

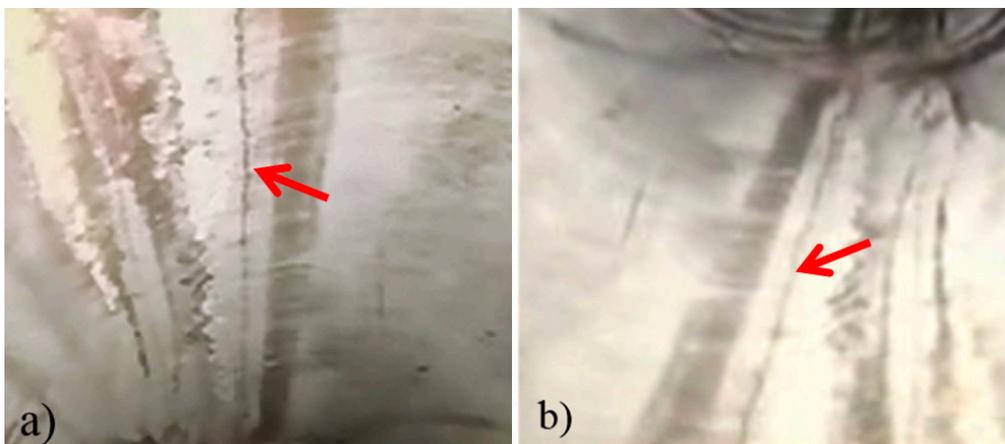
Immediately after the accident a detailed internal examination of pipeline was made. The inspection was conducted by close-circuit television (CCTV) and man entry. It revealed 37 PCC pipes with longitudinal cracks at the crown and invert. Figure 3 illustrates the longitudinal cracks. In addition to the visual inspection, soundings with a hammer were performed along the pipeline to verify it was in good condition. Most of the pipes showed a concrete wall surface hard and dense, only three pipes in the vicinity of the rupture (station 0 + 465.80 km) and two more near a damaged air valve (station 0 + 990.42 km) presented hollow areas indicative of delamination often associated with significant wire break damage [25].

**Figure 3.** Longitudinal cracks: (a) at the crown; and (b) at the invert.

core and mortar coating to generate the cracks at the pipeline. This could explain the longitudinal cracks found at crown and invert of some pipeline sections during the field survey.

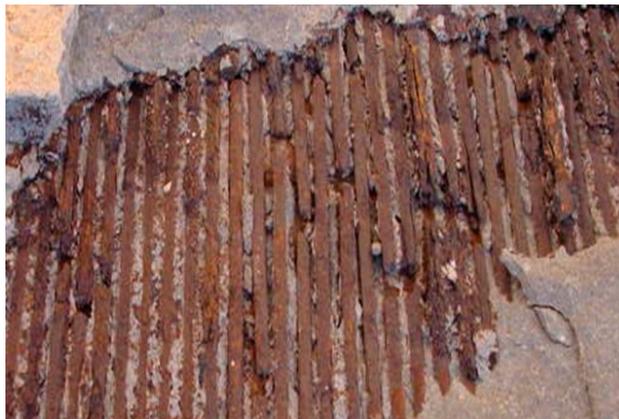
The external inspection of the five distressed pipes permitted to confirm the existence of delaminated mortar coating sections and as well as the number of corroded broken wires. The wire break estimates on individual pipe sections ranged from 18 to 37 wire breaks, all of them located at the upper half of the of the pipes. Figure 4 shows a distressed area with 20 wire breaks. The damage areas were located in the barrel of the pipes, from approximately the 10:00 o'clock to 2:00 o'clock positions. Four pipes showed longitudinal cracking of the mortar coating without distressed areas at top of the pipes with a maximum length of one meter.

**Figure 4.** Distressed area of a PCCP.

It is important to bring notice that the water authority decided to replace the five distressed pipes with new PCCP. Moreover, given the catastrophic failure and that, 22 other pipe sections have electromagnetic anomalies consistent with wire break damage, permanent acoustic fiber optic was installed along the invert of the aqueduct to continuously monitor the condition of the pipes and identify pipe sections experiencing ongoing wire break activity. The wire breaks recorded by the data acquisition system are now added to the assessed wire breaks detected by the electromagnetic survey and thus at any point in the future, water authority can estimate the total number of wire breaks and the risk associated with each pipe section can be anticipated. In case a pipe section deteriorates to an unacceptable level of risk, the water authority can initiate the complete rehabilitation of a pipe section to avoid pipe failure under normal operation and reduce any additional risk during an emergency maneuver.

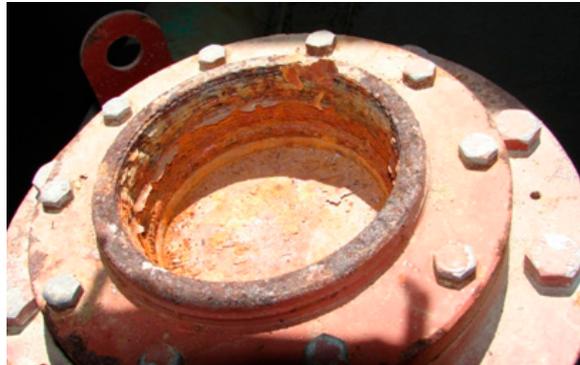
also discovered that the float of the air valve located at chainage 0 + 990.42 jammed into the discharge port, it might occur either in a previous hydraulic transient event or during a filling operation of the pipeline when the valve could experience dynamic closure. Figure 5 shows the damaged valve.

Figure 5. Damage air valve at station 0 + 990.42.

Following the authors' recommendation, the water authority replaced the actual air valves for advanced, innovative devices for preventing the accumulation of air pockets and for averting the above-mentioned damages. The new air valves were re-sized; they are air release and vacuum break valves and have a small precision orifice to vent air while the pipeline is operating. The components of these valves are in corrosion free materials, the large orifices diameters equal the nominal size of the valves to reduce the resistance to the intake of air and reducing considerably the possible negative pressure within the pipeline during a draining operation. In the same way, the valves design ensures the effective removal of all air without causing dynamic closure while eliminating the possibilities of water hammer on closure of the large orifice.

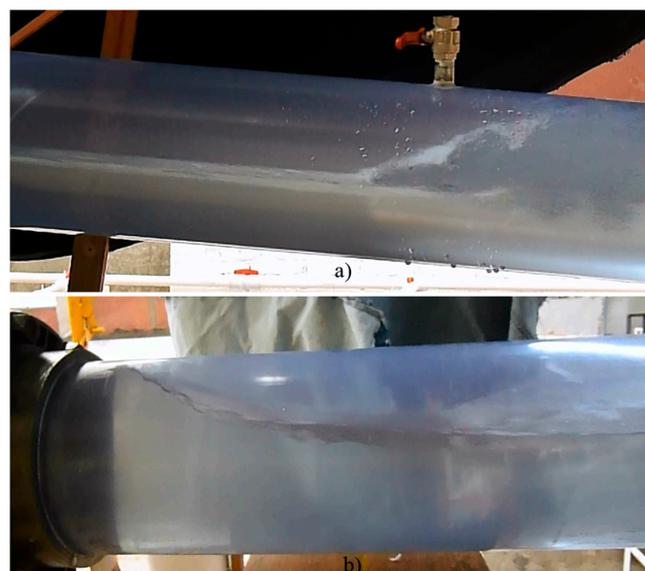
Figure 6 shows the flow profiles A2 ( $S_{\text{up}} = -0.141$ ) and S2 ( $S_{\text{down}} = 0.109$ ) simulated in the hydraulic model. Part of the results obtained during the tests is summarized in Table 1. It is important to highlight that the length of the air pocket profiles remain constant upstream of the control section and the pocket will continue growing only in the downstream direction when more air is injected as observed by Walski et al. [19] and Pozos et al. [20] during their investigations. In addition, the test section of the apparatus operated at pressures slightly higher than the atmospheric pressure in Mexico City ( $P_{\text{atm}} = 8.03 \text{ mH}_2\text{O}$ ).

**Figure 6.** Flow profiles underneath the air pocket: (a) S2 supercritical; and (b) A2 subcritical.

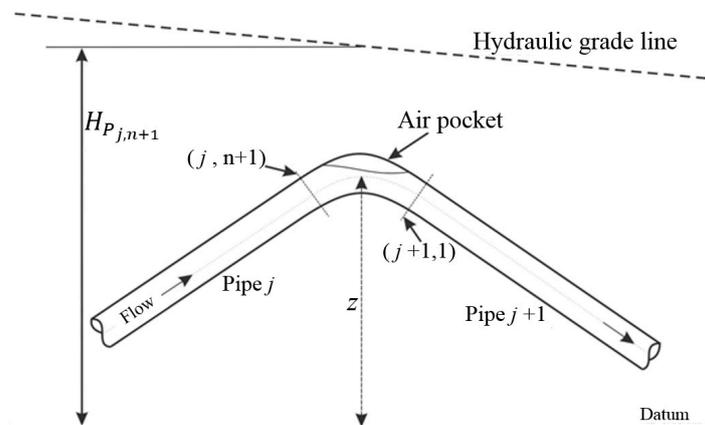
Figure 7. Notation for the air pocket.

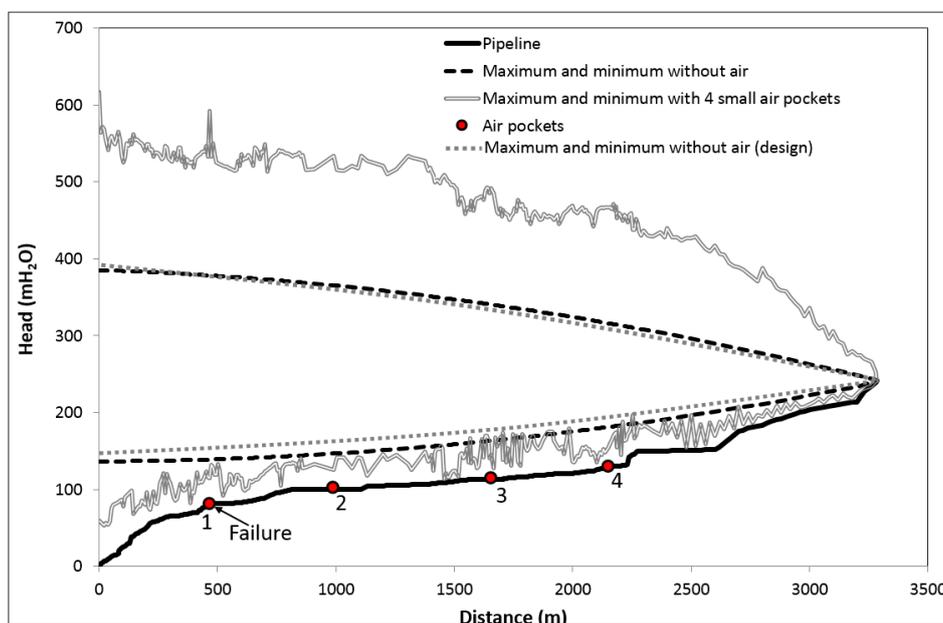
Because there were no pressure recorders in the failure area, a hydraulic transient analysis was performed to estimate the magnitude of the pressure increases that may have occurred near the failure location. The analysis started with a simulation of a transient event caused by power failure for the four pumps in the plant without considering air pockets. It is important to highlight that the results of the numerical simulation shows a suitable design of the pumping pipeline due to the highest pressures did not surpass the design pressure transients achieved for the same scenario in the length of line affected, as can be observed in Figure 8.

In contrast to the above mentioned, the presence of the four small air pocket volumes occasioned the worst consequence in the investigated pipeline, they caused a considerable heightening of the maximum and minimum head envelopes along the system (see Figure 8). The results show that these pockets absorbed only a part of the transient pressure wave and the rest is reflected and amplified towards the boundaries, the butterfly valves at the discharges of the pumps at upstream end and the constant head tank at downstream end of the pipeline.

Figure 8 also shows that the upstream air pocket location gives the highest transient pressures at the pump exit. This is possibly as a result of the effect of reflection of the transient wave by the small air pocket, since it suppresses only partially the energy of pressure waves, this contributes to an accumulation effect. In addition, the influence of the small pocket further downstream is that the

**Figure 8.** Comparison of maximum and minimum head envelopes with and without air in the investigated pipeline.

The severe pressure transients achieved by the hydraulic transient analysis with entrapped air appears to ratify the PCCP failure diagnostic and show that the small air pocket volumes located at points 1 to 4 (Figure 8) of the pumping pipeline have the potential harmful effect to exacerbate pressure transients that could lead to the pipeline rupture, since during the transient simulation of the
