# Spatial and Temporal Variability of Bank Erosion during the Period 1930–2016: Case Study—Kolubara River Basin (Serbia)

**Abstract:** The fluvial process is characterized by an intense meandering riverbed. The aim of this study was to perform a reconstruction of the lateral migration of a 15 km length of an active meandering river during the period 1930–2016. River morphological changes were analyzed and quantified from cadastral maps and aerial photographs as well as by geodetic survey and GIS. Hydrological characteristics and extreme hydrological events were evaluated in relation to bank erosion rate. The rate of bank erosion was markedly different from the long-term studied meanders, just like in the short-term period. During the 87 years of observation (from 1930 to 2016), the length of the Kolubara River was enlarged by 3.44 km. The average migration rate of the Kolubara River for monitored meanders in the period 1930–2010 was 1.9 m·year<sup>−1</sup>, while in the period 2010–2016, the average migration rate was 3.3 m·year<sup>−1</sup>. The rate of bank erosion was more intensive across the entire short-term period than during the longer period, and the maximum annual rate o

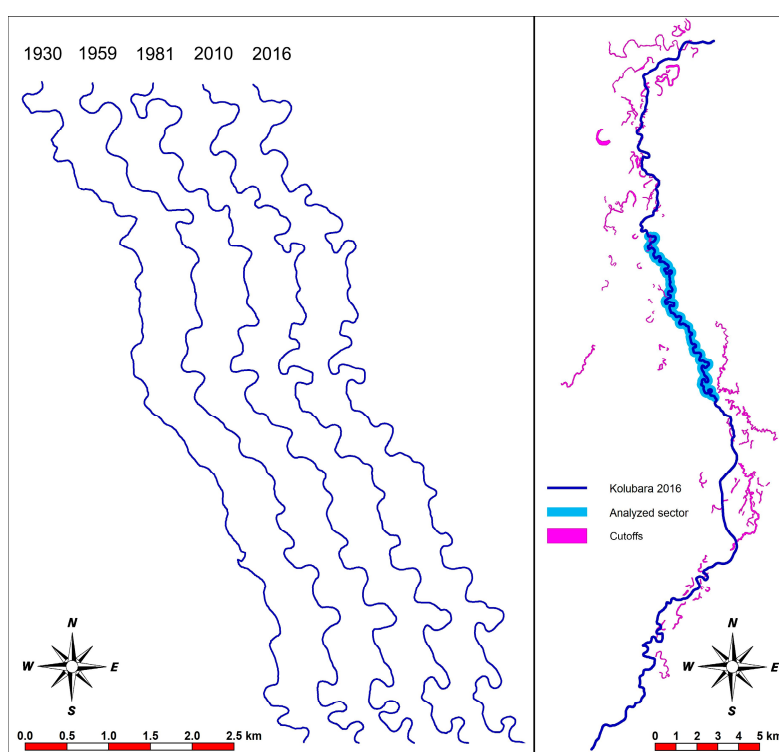
**Figure 2.** Successive channel planform changes for period 1930–2016 along the study area.

The bank erosion process influences river morphology changes. By monitoring this process in the most endangered areas (river meanders), we collected data which helped us determine the spatial and temporal variability of riverbank erosion and accretion in the study area. The length of the Kolubara River in the study area was 11.56 km in 1930, 12.89 km in 1959, 14.25 km in 1981, 14.63 km in 2010, and 15 km in 2016. During the 87 years of observation (from 1930 to 2016), the length of Kolubara River was enlarged by 3.44 km (Figure 2).

The most intensive change of the Kolubara River occurred during the period 1959–1981, when the riverbed extended by 1.36 km (an average of 62  $\text{m}\cdot\text{year}^{-1}$ ) in the study area. During the period 1930–1959, the length of the riverbed of the Kolubara increased by 45.9 m per year (1.33 km), during the period from 1981 to 2010, only 0.01  $\text{m}\cdot\text{year}^{-1}$ . However, it is important to note that during 2006, the Kolubara River cut the neck of the meander near the confluence of the Tamnava River, which caused the river course to the east. In this way, the length of Kolubara River is shorter by 1.12 km [27]. This would last for the period 1981–2010 with an increase in length of 1.51  $\text{m}\cdot\text{year}^{-1}$ , or an

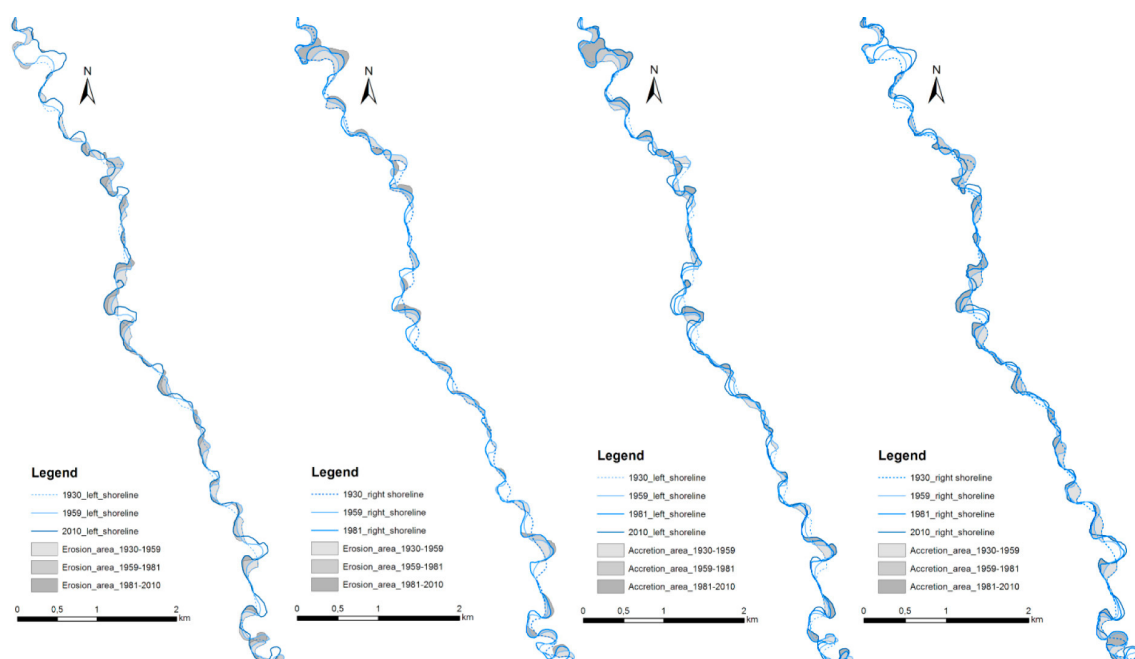
**Figure 3.** Bank erosion and accretion between 1930 and 2010.

In our analysis, we identified 96 erosion plots on the left and 95 erosion plots on the right banks of the Kolubara River. The total area of left bank erosion plots was 63.4 ha and the total area of right

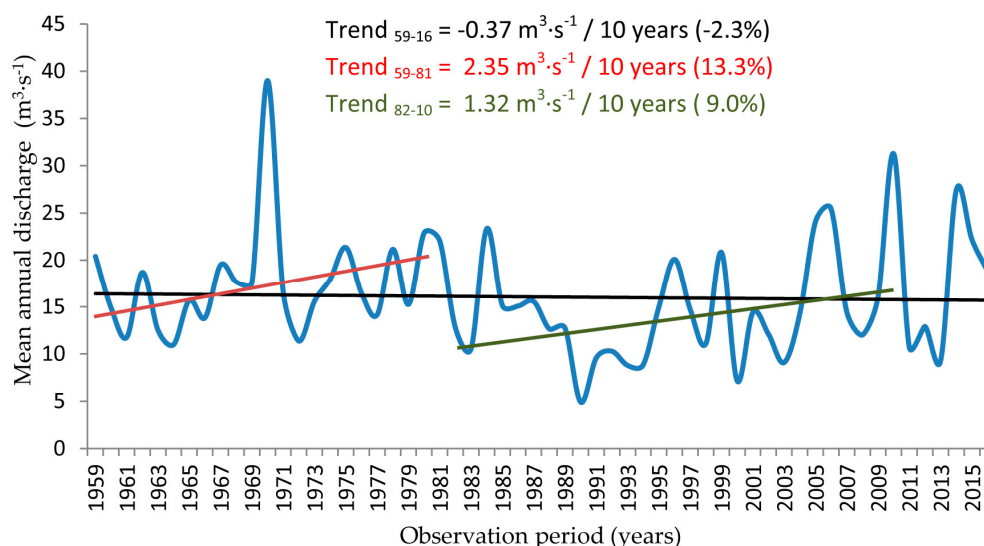
**Figure 4.** Trend of the mean annual discharge of the Kolubara River measured at the Beli Brod gauging station in the periods of 1959–2016, 1959–1981, and 1982–2010.

By dividing the observed period into two parts (1959–1981 and 1982–2010), the difference in discharge trends were significant. The first period had more waters and the trend of increasing discharge was  $2.35 \text{ m}^3 \cdot \text{s}^{-1}$  (13.3%) per decade, or a total increase per trend line of  $5.16 \text{ m}^3 \cdot \text{s}^{-1}$  (29.1%/23 years). The second period was dryer: only six years had discharges above the average value. During this period, the trend of increasing discharge was  $1.32 \text{ m}^3 \cdot \text{s}^{-1}$  (9%) per decade, or a total increase per trend line of  $3.70 \text{ m}^3 \cdot \text{s}^{-1}$  (25.3%/29 years). In the period 1959–1981, there was significantly more water than in the period 1982–2010, so the trend line (1959–2016) decreased overall. The variations of annual discharges of the second period were more significant when compared to the first period, and the extreme values occurred more often. In most cases, the mean annual discharge was in the range of usual fluctuations, which indicated that nothing unusual happened with the mean annual discharge in the period from 1959 to 2016.

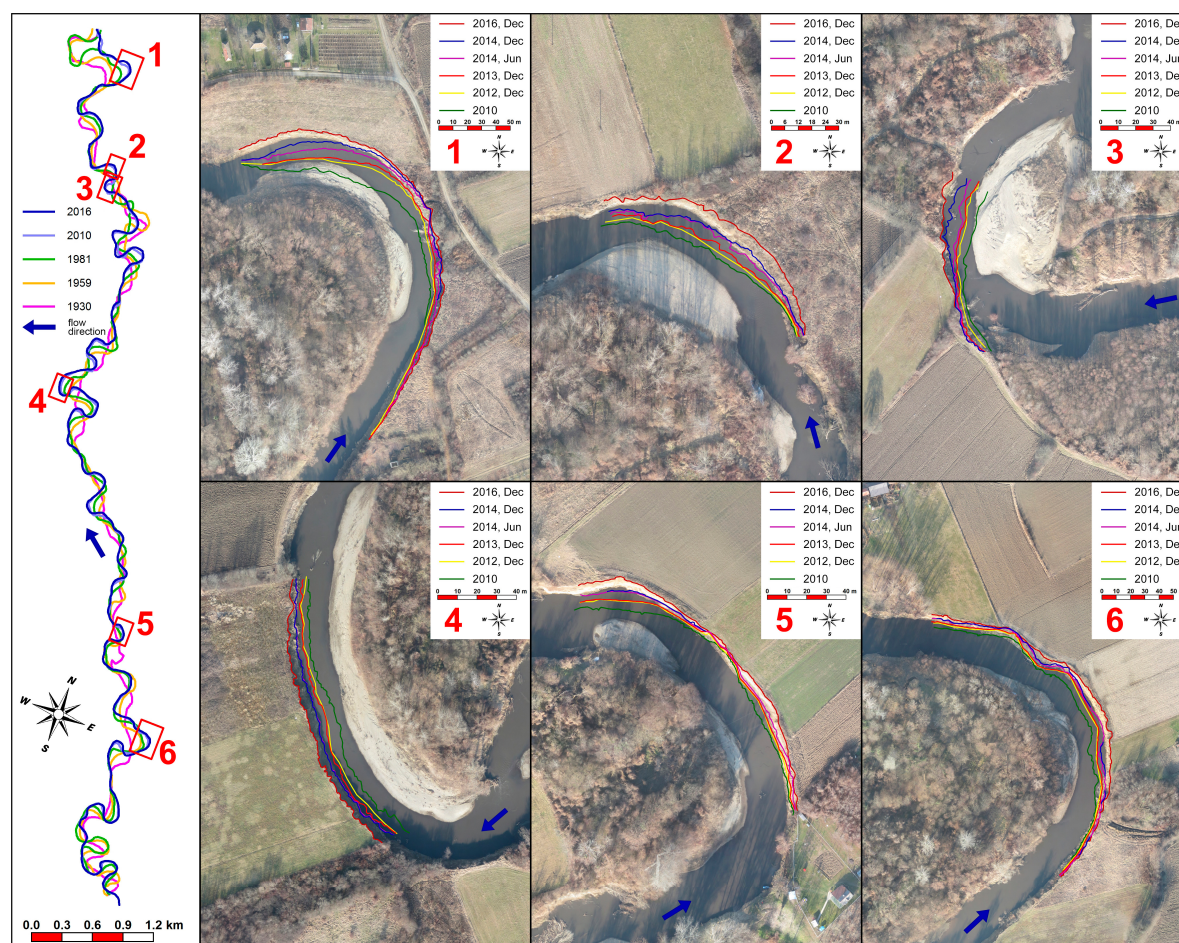
Figure 5. Bank erosion on six meanders in between 2010 and 2016.

The long-term rate of bank erosion was markedly different at the studied meanders, just like in the short-term period. In 1930 and 2010, bank erosion was the most intensive on meanders 1, 6, and 4. The maximum annual rate of bank erosion during the studied period 2010–2016 varied between 0.3 and 11.5 m. It was the highest in meander 1 (28.3 m) during the whole monitoring period (as a long-term analysis) than in meander 3 (23.1 m), meander 2 (18.1 m), etc. The largest bank erosion in one year was observed in 2014, and the least in 2013. Across the entire short-term period, the rate of bank erosion was more intensive than in the longer period. The average migration rate of the Kolubara River for monitored meanders between 1930 and 2010 was 1.9 m·year<sup>−1</sup>, while between 2010 and 2016 the average migration rate was 3.3 m·year<sup>−1</sup>. In meander 1, the average rate of bank erosion was 2.76 m·year<sup>−1</sup> between 1930 and 2010, while in the last period (2010–2016) it increased by 4.72 m·year<sup>−1</sup>. In meanders 2, 3 and 4 the average increased to almost double of the previous period (Figure 5).

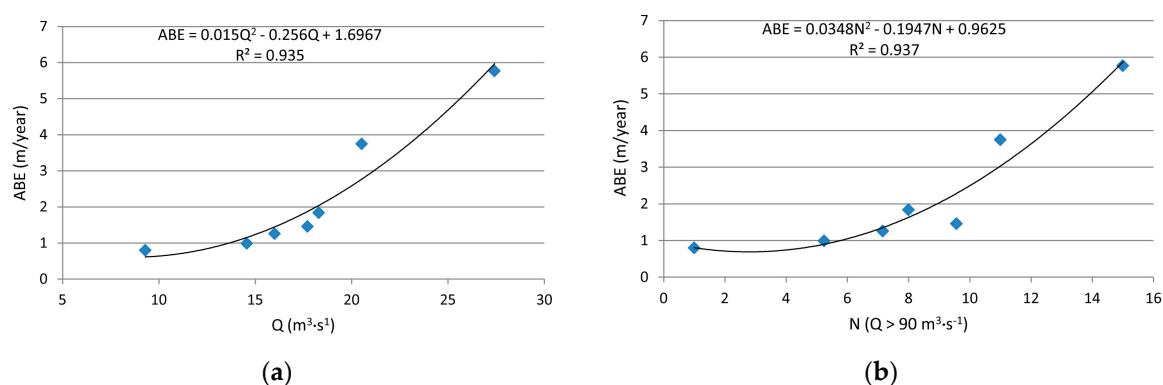
**Figure 6.** Estimation of average annual riverbank erosion ABE ( $\text{m}/\text{year}$ ) using the mean annual discharge ( $\text{m}^3\cdot\text{s}^{-1}$ ) (a) and the number of annual discharges which exceed the value of  $90 \text{ m}^3\cdot\text{s}^{-1}$  (N) (b).

Both models (Figure 6) have their practical uses, although they must consider the small number of observations (7). Our results revealed that the annual bank erosion rate increased exponentially by increasing the mean annual discharge (adj.  $R^2 = 0.935$ ). Analysis of the first graph (Figure 6a) indicated that the intensity of riverbank movement remained in the range of one meter per year when the mean annual discharge did not exceed the value of the average annual water ( $16 \text{ m}^3\cdot\text{s}^{-1}$ ). With further increase of the mean annual discharge, erosion progressed faster, and when the discharge as greater than  $20 \text{ m}^3\cdot\text{s}^{-1}$ , it reached a value of more than three meters. This discharge had an occurrence probability of 24% (an empirical value), which meant that it occurred approximately once in every four years. Unfortunately, between that value and the largest one in a series ( $27 \text{ m}^3\cdot\text{s}^{-1}$ ), there was no measurement of bank movements, so we had to rely on the theoretical estimates.

According to another dependence (Figure 6b), the riverbank will move up to one meter per year if a daily discharge of  $90 \text{ m}^3\cdot\text{s}^{-1}$  or more occurs no more than five times per year. With higher frequency, riverbanks become more erodible, and a case from 2014 showed that this threshold may exceed 15 times and thereby move the riverbank almost six meters. Comparing these two dependencies, one can conclude that the second might be more practical. The first reason is that the mean annual discharge only indirectly applies to frequent water, like bank-full discharge and that extrapolations are actualize very rare (only the 1970s and 2010 in the whole series). On the other hand, the number of overcoming bank-full discharge are data that directly affects the vulnerability of riverbanks. Although the maximum value observed in the series was 15 (2014), the number of occurrences over the threshold for 58 years is five.
