# Rehabilitation and Continuing Management of an Urban Lake Shoreline in Southeastern Minnesota, USA

**Abstract:** Lake Winona is a 129-hectare urban lake which occupies part of an old side channel of the Mississippi River and has been modified significantly over the past 125 years. The entire shoreline (>8 km) is publicly owned, with current shorelines created mostly during two periods of lake dredging and filling of fringe wetlands 70 and 110 years ago, respectively. Since then, some sections were allowed to revegetate naturally with trees and shrubs, some were armored with riprap, and others have been maintained mostly as turfgrass parklands. Shoreline vegetation assessments and tree stand surveys were completed prior to beginning targeted shoreline rehabilitation in 2017. These rehabilitation activities (encompassing the majority of shoreline) include the following: (1) repeated removal and chemical treatment of woody invasive shrubs/trees (primarily common buckthorn *Rhamnus cathartica* and nonnative bush honeysuckles *Lonicera* spp.) by contractors and volunteers; (2) chemical spraying and hand pulling of nonnative invasive ornamental grasses (*Miscanthus* spp.) and forbs (J

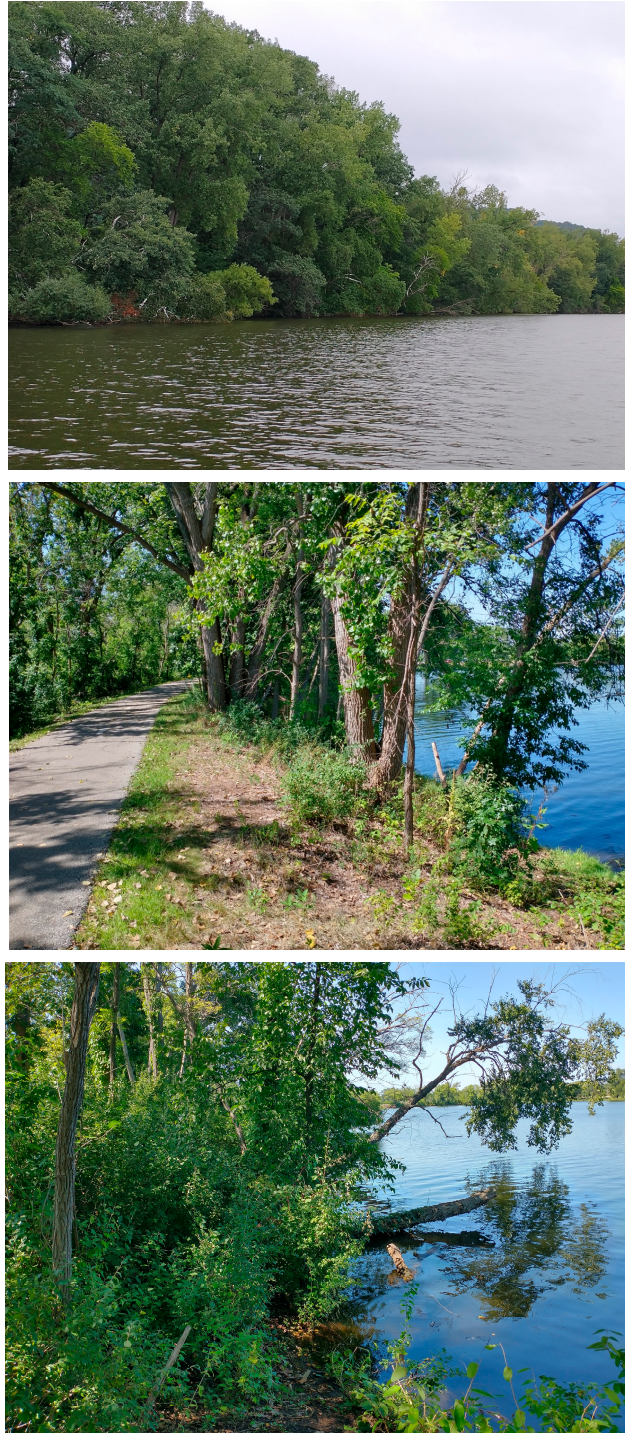
**Figure 1.** The wooded southern shoreline of the eastern basin of Lake Winona as viewed from the lake (**top panel**), the paved multi-use pathway along that same shoreline (**middle panel**), and a section of shoreline overrun with invasive buckthorn and honeysuckle (**bottom panel**).

Along the southern shore of the eastern basin, buckthorn and other woody invasives were first cut and treated in August 2017. Large buckthorns along one section were cut by a youth crew from the Conservation Corps of Minnesota and Iowa. Stumps were treated to prevent regrowth, and the cut brush was transported by City of Winona staff to another portion of the lake, where it was used in another shoreline project (see Section 4.5 below). More extensive buckthorn removal and treatment efforts by adult crews of the Conservation Corps of Minnesota and Iowa occurred along most of the southern shore (nearly 2 km) from July 2019 to January 2020, and again in August 2020. The removal focused on both the lake and wetland sides of the paved pathway, primarily to remove large berry-and-seed producing buckthorn. The retreatment of the southern shoreline and initial removal around the southeastern bay (sections 30–33) took place in June and September/October 2021 and September/October 2022, working section by section to target new plants germinating from the seedbank plus any stump resprouts. This removal and treatment process will continue along the southern shoreline until the buckthorn seedbank becomes depleted (Figure 1).

After the buckthorn removal along the east basin's southern shoreline (Figure 1), several efforts were directed at planting native shrubs, tree saplings, and native woodland seeds (forbs and grasses). Shrubs and trees were planted during the spring of 2020 and 2021, including the American elm, eastern cottonwood, river birch, and peachleaf willow (*Salix amygdaloides*). Additional plantings of these species occurred along the eastern bays (sections 20–31; Figure 2) of the eastern basin during spring 2022. Over 1900 seedlings and 100 trees 1.2 m or taller have been planted along shorelines of the eastern basin.

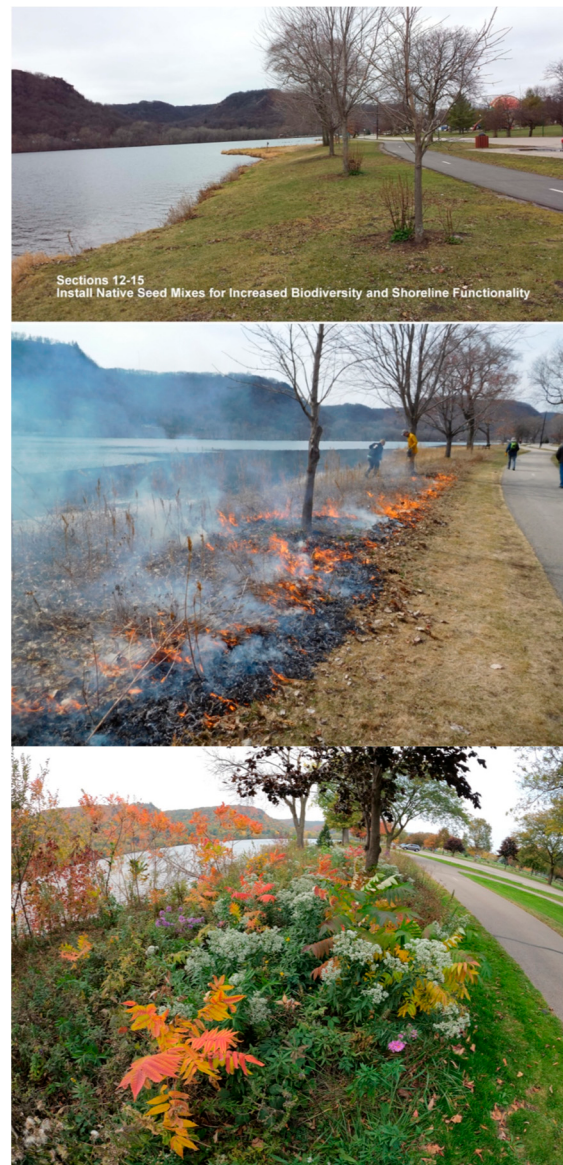
**Figure 4.** Replacement of sections of shoreline turfgrass with native prairie plantings, northern shoreline of eastern basin of Lake Winona. (**Top panel**): Turfgrass section of shoreline. (**Middle panel**): Prescribed burn of native prairie planting after third growing season. (**Bottom panel**): Native prairie planting after several growing seasons.

During early July 2017, two sections of turfgrass (approximately 0.1 ha total area) within the “research area” along the eastern basin’s northern shoreline (Figure 2, sections 12–15; Figure 4) were killed via two glyphosate herbicide applications. Based on soil characteristics, different sections were then overseeded during early November 2017 with five different, site-specific seed mixes (prairie mix, sand prairie mix, wet meadow mix, understory mix, and riprap mix; Figure 4). Plots were surrounded by temporary fencing to exclude waterfowl and to delineate areas from adjacent mowed turfgrass.

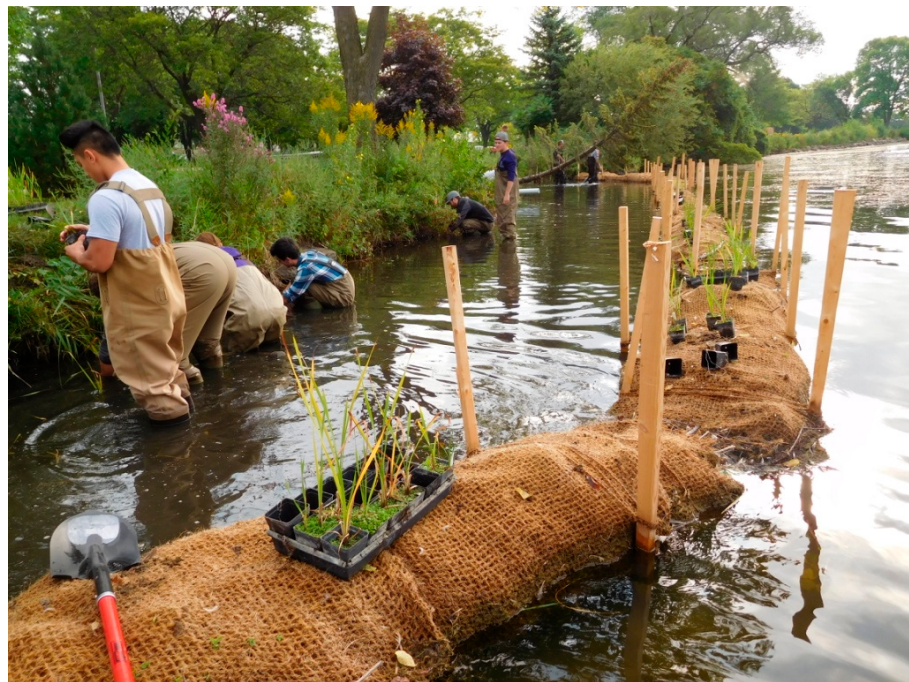
**Figure 5.** Brush bundle wave barriers (buckthorn wrapped in coir fabric) in place along the northern shore of the eastern basin of Lake Winona, anchored in place with wooden stakes (stakes were shortened later). Volunteers are shown planting emergent aquatic macrophytes to stabilize the shoreline.

The large buckthorn and honeysuckle cut from the southern lake shoreline was used to create wave barriers in 2017 for installation along a portion of the northern shoreline where wave action was causing severe erosion of the sandy shore. Quantities of the cut woody invasives were wrapped in mesh coir fabric to create brush bundles (approximately 0.75 m in diameter, 4.5 m long) onshore adjacent to the shorelines. Bundles were secured with jute rope, rolled into the water and placed 3 to 4 m from the shore, and anchored to the lake bottom with 1.5 m-long wooden stakes. Barriers extended from the lake bottom to approximately 30 cm above lake level. A total of 16 barrier units (10 in one group, six in another) were placed end-to-end parallel to the shoreline, with end barriers angled toward shore to protect two areas of eroding shoreline, separated by about 15 m (Figure 5). Wave barriers were intended for only short-term use (approximately 2 years), allowing time for the planted macrophytes to become established and for shorelines to stabilize.

The brush bundle wave barriers (also referred to previously as brush mattresses [20]) created from large buckthorn and honeysuckle proved very effective in eliminating wave action against shorelines with newly planted emergent macrophytes. Brush bundles also accumulated sand being carried along shore by wave action, helping to build a new shoreline for most of their 2-year lifespan. These types of wave barriers would prove useful when placed along several other sections of Lake Winona's shoreline, especially in the

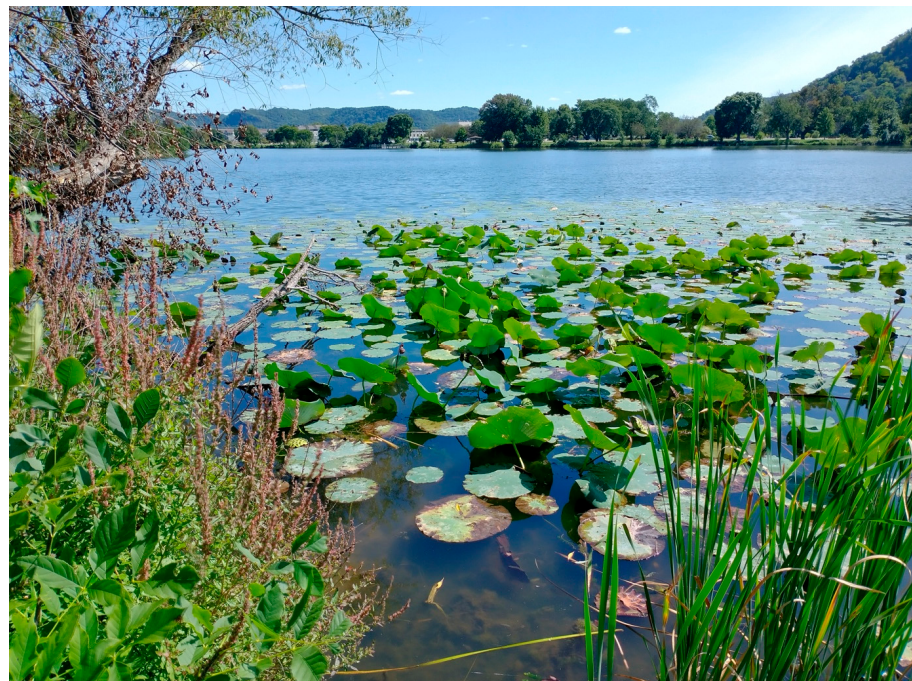
**Figure 6.** Bed of American lotus (*Nelumbo lutea*) established along the northern shore of Lake Winona's eastern basin.
