Article

Determinants of the Performance of Bat Gantries Installed to Carry Bat Commuting Routes over the S3 Expressway in Poland

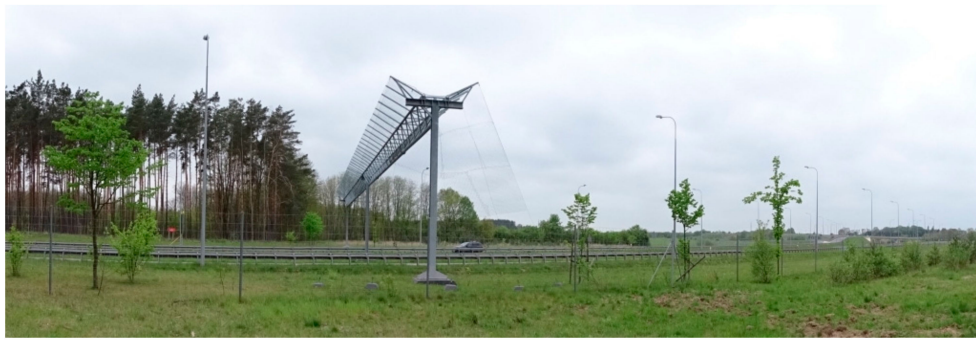
Figure 4. Bat gantry No. 1 over the S3 expressway built in the course of the flyway along the edge of forest near the interchange connecting A6 motorway and S3 expressway (the three-level interchange is visible in the background).

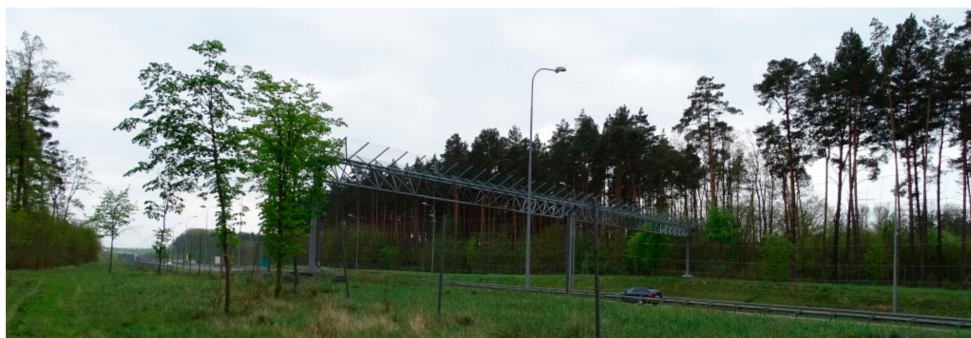
Figure 5. Bat gantry No. 2 over the S3 expressway built in the course of the flyway crossing the forest opening area.

The symmetric layout of landscape features along the S3 expressway and along the planned commuting route is ensured only at gantry No. 2 (Figures 5 and 7). At gantry No. 3, which is aligned with the forest edge, the landscape features are symmetric along the S3 expressway only in the summer and autumn (Figures 6 and 7). The big wooded area near gantry No. 3 planted with deciduous trees,

one because bats flew between pine trees dropping onto the road right in front of the cars. This called for sealing the gaps between the naturally growing trees with fast growing tree species, as shown in Figure 5.

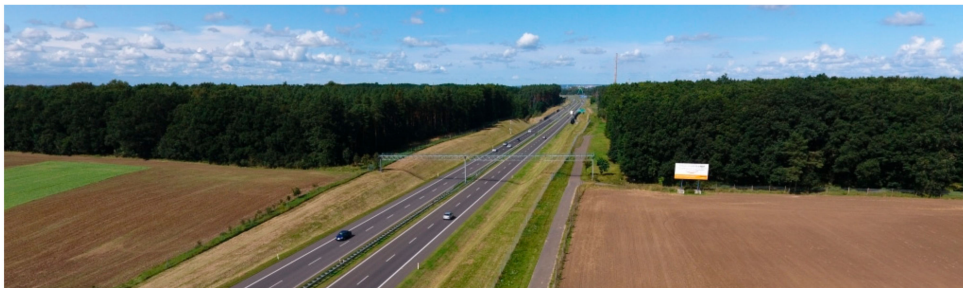
Figure 6. Bat gantry No. 3 over the S3 expressway built in the course of the flyway along the forest edge.

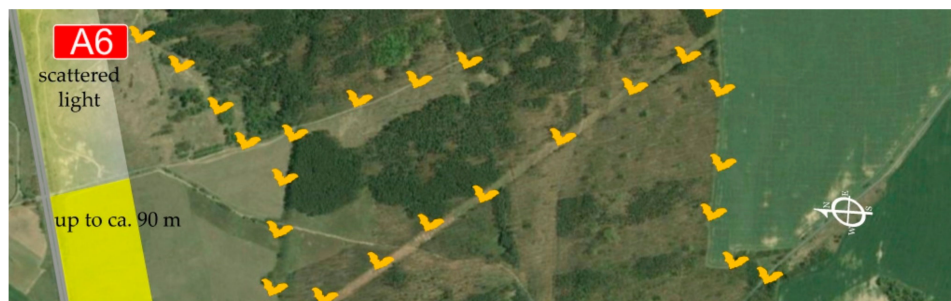
Figure 11. The impact of artificial lighting on the bat commuting routes in the Puszcza Bukowa forest before S3 construction (plotted on a Google Earth satellite image from 2004) [28]).

Considering the above facts, in analyzing the performance of gantries built over the S3 expressway, the author paid particular attention to symmetric or non-symmetric layout of land features about the axis of the road section in the Puszcza Bukowa forest area. The conditions related to the commuting of bats before construction of the S3 expressway are presented in Figure 11. At that time, the impact of the road lighting was noted only along the existing A6 motorway, especially on its western part, which runs in the open area. The eastern part of A6 runs in a road cut, surrounded by an area with randomly distributed patches of vegetation, which scatters the headlight beams.

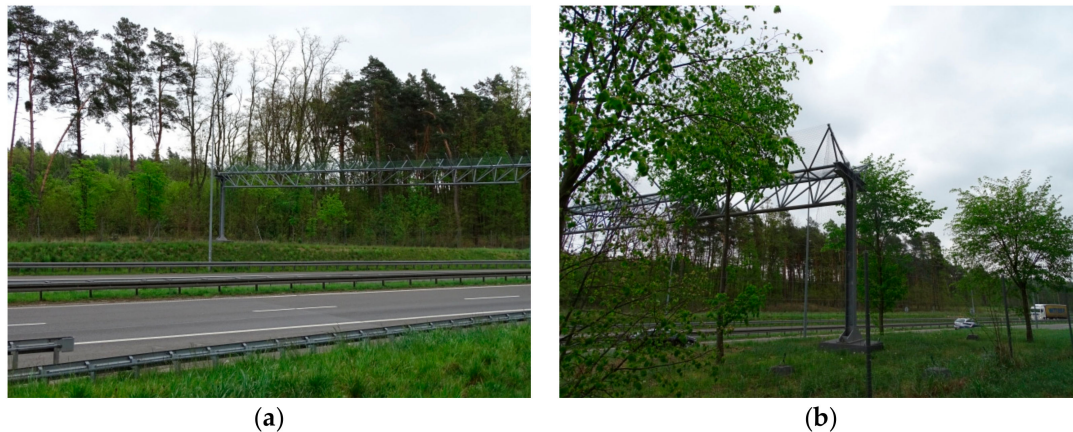
Figure 18. Plantings at gantry No. 2: (a) guiding and gap-filling vegetation in the forest opening area to the east of the S3 expressway, and (b) guiding vegetation to the west of the S3 expressway.

The V-shaped vegetation corridors were actually planted only at gantry No. 2 in 2010. The plants have established themselves and have overtopped the structure by now (Figure 18). However, the gaps between the lime-trees were not filled by shrubs. Instead, considering the local conditions, various shrubs and trees were planted in thinly vegetated parts of forest openings in order to seal the corridor and make bats increase their flight height (Figure 19). This crossing was the most problematic

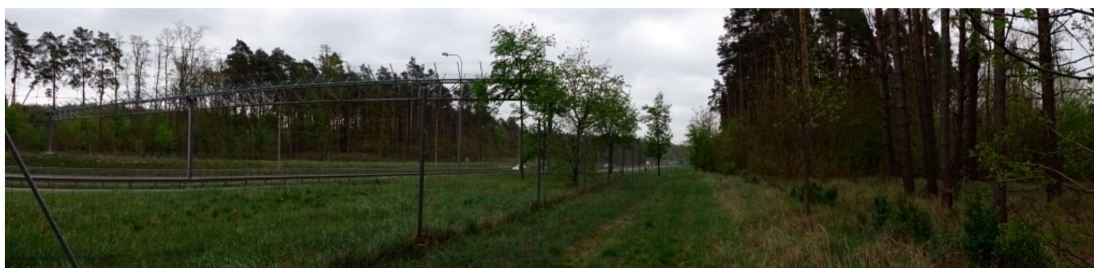
Figure 19. Gap-filling vegetation, planted to seal the gaps in thinly wooded, wide forest opening, and encourage bats to increase their flight height at gantry No. 2.

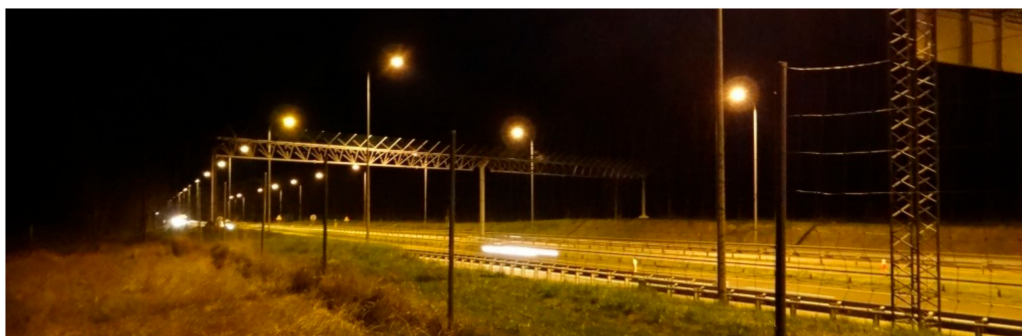
Figure 20. Artificial lighting during the night near gantry No. 2.

Effectiveness of gantry No. 2 is confirmed by the results of the 2010 to 2012 bat activity surveys, as presented in Figure 8. Filling and guiding vegetation has most likely contributed to this success. The trees and shrubs grew year by year and overtopped the gantry structure in 2019 (Figures 18b and 19). The artificial vegetation planted to seal the gaps in forest openings on both sides of the expressway has also contributed to rising the height of the flight of bats on the approach to gantry No. 2 (Figure 18a) and, together with the slopes of a 2-meter deep cut, considerably mitigated the negative impacts of light and noise pollution. In the analyzed case, light from the nearby road lamps will not attract insects, which would make bats stop in order to forage or would disturb their flight (Figures 15 and 20).

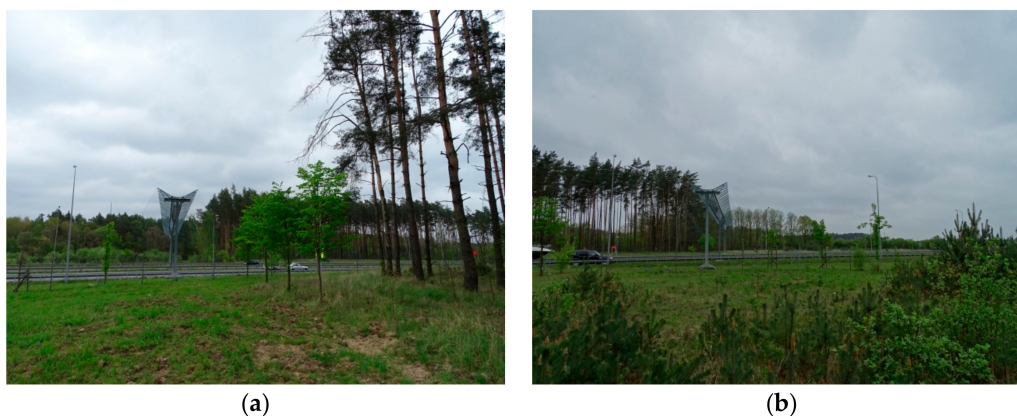
Figure 21. Plantings at gantry No. 1: (a) guiding bats from the area to the west of the S3 expressway and (b) guiding bats from the area to the east of the S3 expressway.

At gantry No. 1, the V-shaped vegetation corridor was actually planted only to the east of the road (Figure 21). However, the plants have established themselves poorly (Figure 21b) and, after nine years, they fulfill neither orientation nor a guiding role. To the west of the road, four lime-trees were planted in line with the forest edge (Figure 21a), which, however, did not grow as expected after nine years. This reached only half way up the structure height. Additionally, these plants do not serve the orientation or guiding purposes. The performance of gantry No. 1 is further compromised by the asymmetric arrangement of landscape features (Figures 21 and 22) due to the open area at this location. With a lack of well-developed guiding vegetation, gaps in the approach corridor and open area, which does not mitigate the negative impacts of traffic noise and light pollution from the interchange lamps (Figure 17) and headlight beams, the conditions cannot be considered favorable for successful performance of gantry No. 1.

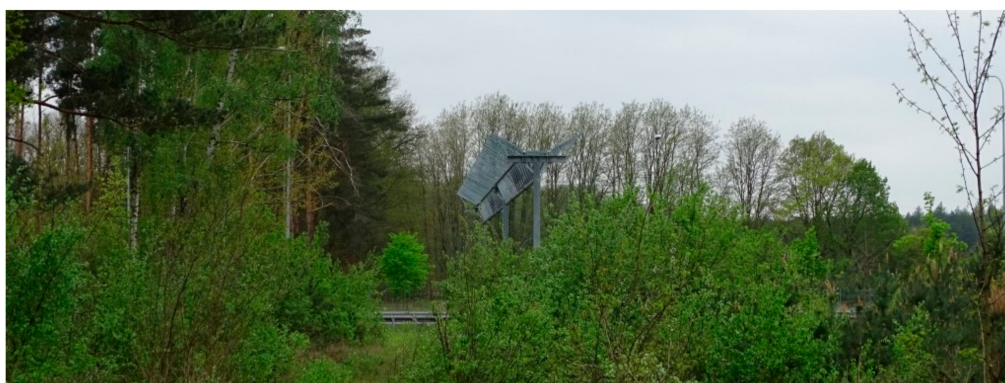
Figure 22. Landscape features and thin groves at gantry No. 1.

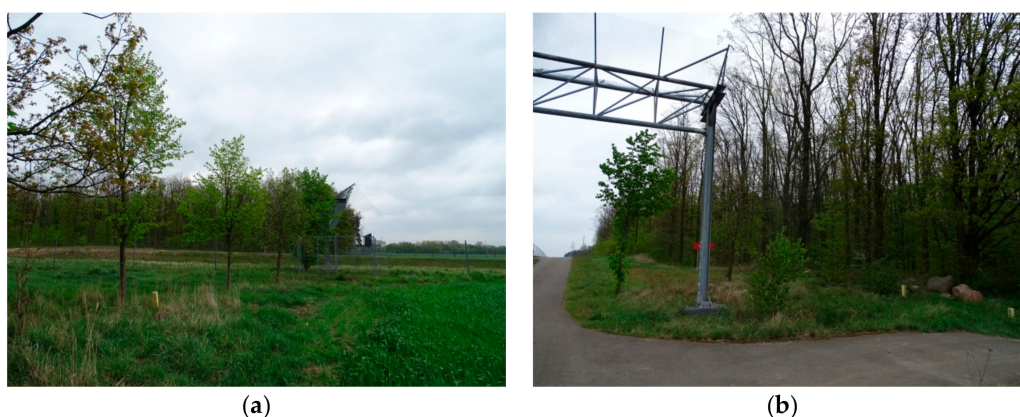
Figure 23. Plantings at gantry No. 3: (a) guiding bats from the area to the west of the S3 expressway and (b) poorly developed vegetation designed to guide bats from the area to the east of the S3 expressway.

In addition, at gantry No. 3, a row of four trees were planted in line with the forest edge (Figure 23). On the western side, the trees have developed well and are almost as high as the structure. The plants on the eastern side are set back from the structure and forest edge lines by ca. 2 m. Only three trees have developed and are currently ca. 5 m tall. Moreover, on the eastern side of the road, the forest edge is closer to the structure due to the service road location (Figure 23b). With no light pollution from the road lamps, ca. 3-meter deep road cut, artificial vegetation, and keeping the pre-construction commuting route make this location very favorable to support bat movements. In addition, the farm fields located near the road make a foraging area for bats. It is likely the combined effect of the above-mentioned factors that resulted in increasing numbers of bat passes observed during bat activity surveys (Figure 8).

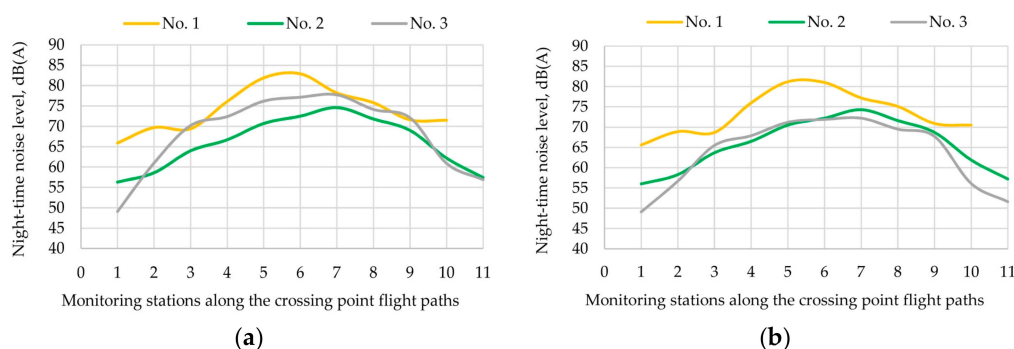
Figure 26. Comparison of the noise levels on the bat commuting routes over the installed crossing structures in spring: (a) at 6-meters above the ground and (b) at 8-meters above the ground.

For the purpose of analyzing the noise distribution in the area under analysis, more than one dozen monitoring stations were deployed on the established commuting routes at 6-meter and 8-meter heights along the installed crossing structures. The output noise data are presented in the comparative diagrams below (Figures 26 and 27).

According to the spring survey data, the most favorable conditions for bat movements are over gantry No. 2 at both heights and over gantry No. 3 at 8-meters in height. This is a likely cause of the highest number of passes recorded in the spring over gantry No. 3, which is located on the pre-construction route, in a place without any road lamps in the vicinity and with the surrounding fields used by bats as a foraging site. Considering the conclusions of the relevant studies [19,20], we can propose a hypothesis that, after noticing adverse changes on their established commuting routes, the bats switched to the route in the forest opening and through the underpasses and tested the new route along gantry No. 2. The results in favor of this hypothesis are the increasing numbers of passes over gantry No. 2 in the subsequent years of monitoring (Figure 8). The high noise level over gantry No. 1, illumination of the nearby interchange, penetration of headlight beams into the surrounding area (particularly disadvantageous in the case of cars travelling on the highest-level exit ramp), and the lack of mitigating vegetation created the most unfavorable conditions, which deterred the bats from using their established route. It is likely the combined effect of all the above-mentioned factors that discouraged bats from using this route regularly (Figure 8), which results in poor performance of gantry No. 1.

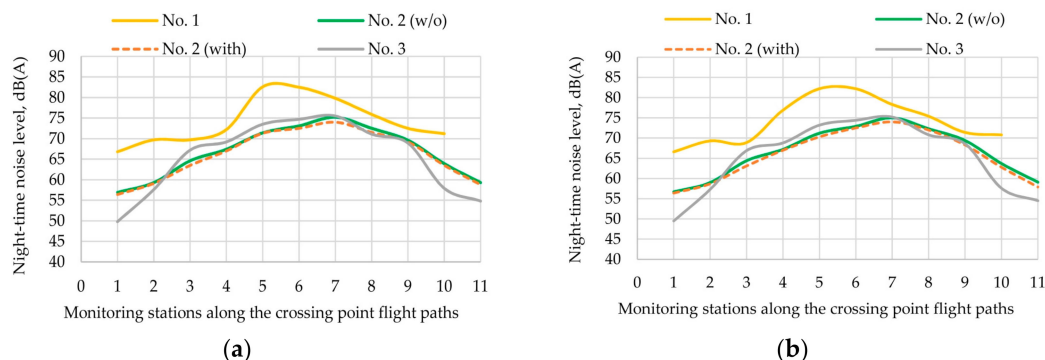
Figure 27. Comparison of the noise levels on the bat commuting routes over the installed crossing structures in summer: (a) at 6-meters above the ground and (b) at 8-meters above the ground.

Similar conclusions can be derived in relation to the summer survey data (Figure 27). For the purpose of the current analysis, the noise levels were additionally estimated for the situation after planting of filling and guiding vegetation in the wide forest opening on both sides of the S3 expressway and on both sides of the flyway over gantry No. 2 (broken line in Figure 27). Moreover, the results show that additional plantings to seal the forest opening area and encourage bats to increase their flight height and guiding vegetation leading the bats over gantry No. 2 reduced the noise level on the bat flyway by 0.5–1 dB (see comparison in Figure 27. No. 2 (w/o)—solid line, representing noise levels without additional or guiding vegetation in the forest opening, No. 2 (with)—broken line, representing noise levels with the additional and filling vegetation already in place). According to the noise data, the most favorable conditions for bat movements are over gantries No. 2 and No. 3 with

the maximum recorded noise levels not exceeding 75 dB (A). On the other hand, noise levels in excess of 80 dB (A) was recorded over gantry No. 1, right over the carriageway (monitoring stations No. 5–7).
