# The Use of Precise Survey Techniques to Find the Connection between Discontinuities and Surface Morphologic Features in the Laže Quarry in Slovenia

**Abstract:** This paper addresses a stability evaluation of artificial slopes in a quarry located in Slovenia that was affected by a rockslide in March 2019. In order to ensure the safety of further production, measures were taken to restore the slopes. A stability assessment of the remaining parts of the quarry was conducted. To ensure quality spatial data, an upgraded study based on terrain mapping and aerial photogrammetric imaging using an unmanned aircraft was carried out, in addition to a traditional field survey of the quarry. So that the data were qualitatively useful, a digital terrain and discontinuity model was developed. Projections of the discontinuities occurring in the quarry and in the wider area were determined. The focus of the modeling was finding the main systems of discontinuities and projecting these systems onto the unexcavated parts of the quarry.

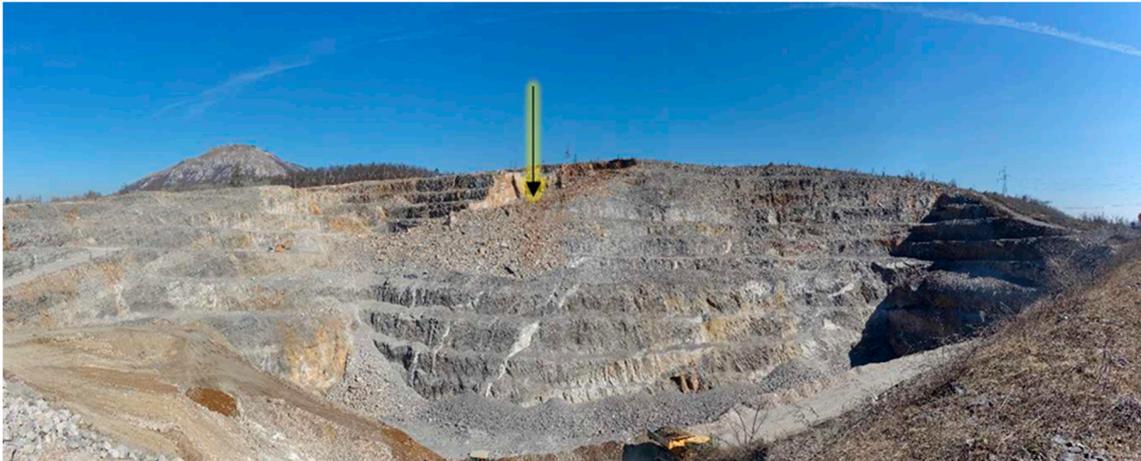
**Figure 1.** View toward the north. The collapsed area is marked with an arrow.

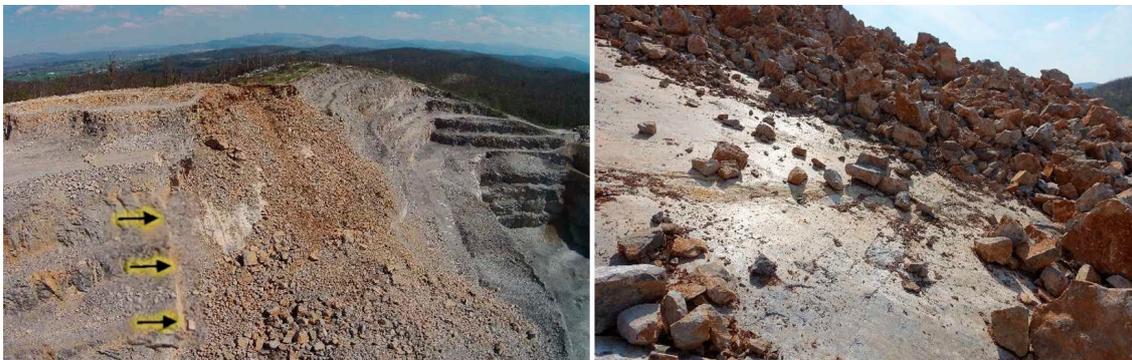
On 13 March 2019, a rockslide occurred during blasting operations when 1000 kg of explosive material was used 20 m away from where the rockslide began (see Figure 2). No falling material was observed previous to this.

**Figure 2.** Left: view of the rockslide toward the southeast. A fault plane is clearly visible. Vertical cracks on the west side are noted with arrows. Right: the flat sliding surface in the rockslide area, facing east.

On 13 March 2019, during a blasting operation, a rockslide of about 47,800 m<sup>3</sup> with a mean width of about 60 m occurred, affecting all quarry benches from the top bench to the bench at 700 a.s.l. The landslide debris slid down to the lower benches, reaching the quarry bottom (at about 672 m a.s.l.). A portion of the landslide debris stopped in the upper parts of the quarry. At the northern and eastern flanks of the excavated area, vertical cracks clearly delimited the landslide debris, whereas along the eastern and western flanks, the slopes, which had not yet collapsed, showed the presence of vertical cracks. A straight sliding surface was also clearly visible.

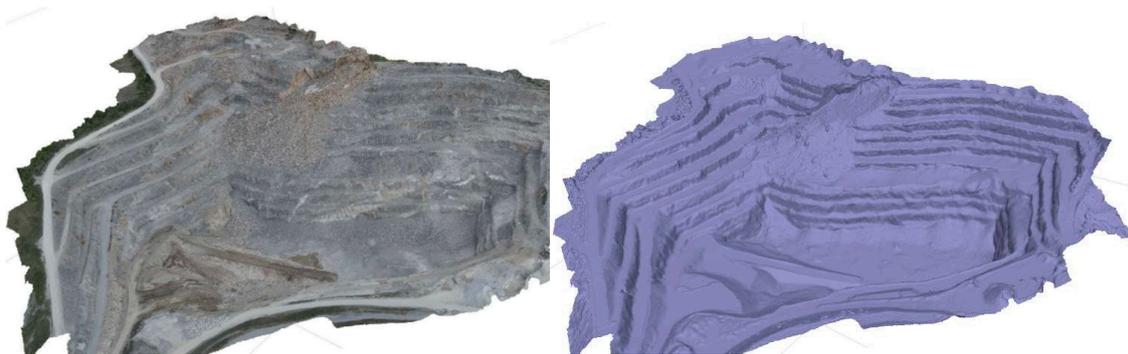
On 8 May 2019, we performed an aero-photogrammetrical survey of the entire quarry surface using an unmanned aircraft. A total of 422 aerial photographs were taken. The photos had an 80% overlap with each other and a 70% overlap with the bands. The measurements were integrated into the D96/TM (ETRS 89) national coordinate system using the RTK GNSS method. Eight control points were measured with centimetric accuracy with a Leica GS18T receiver. A  $10 \times 10$  cm grid was also constructed (see Figure 4).

**Figure 4.** Laže 1 quarry, 3D view toward the north. The terrain model was created using unmanned aircraft photography. Left: the model is covered with photos. Right: a digital relief model with a  $10 \times 10$  cm grid.

In carrying out each process, we searched for a model 3D image of the quarry and gradually implemented a model to verify it (both computationally and from an engineering perspective) and project it onto the rest of the quarry (see Figure 4).

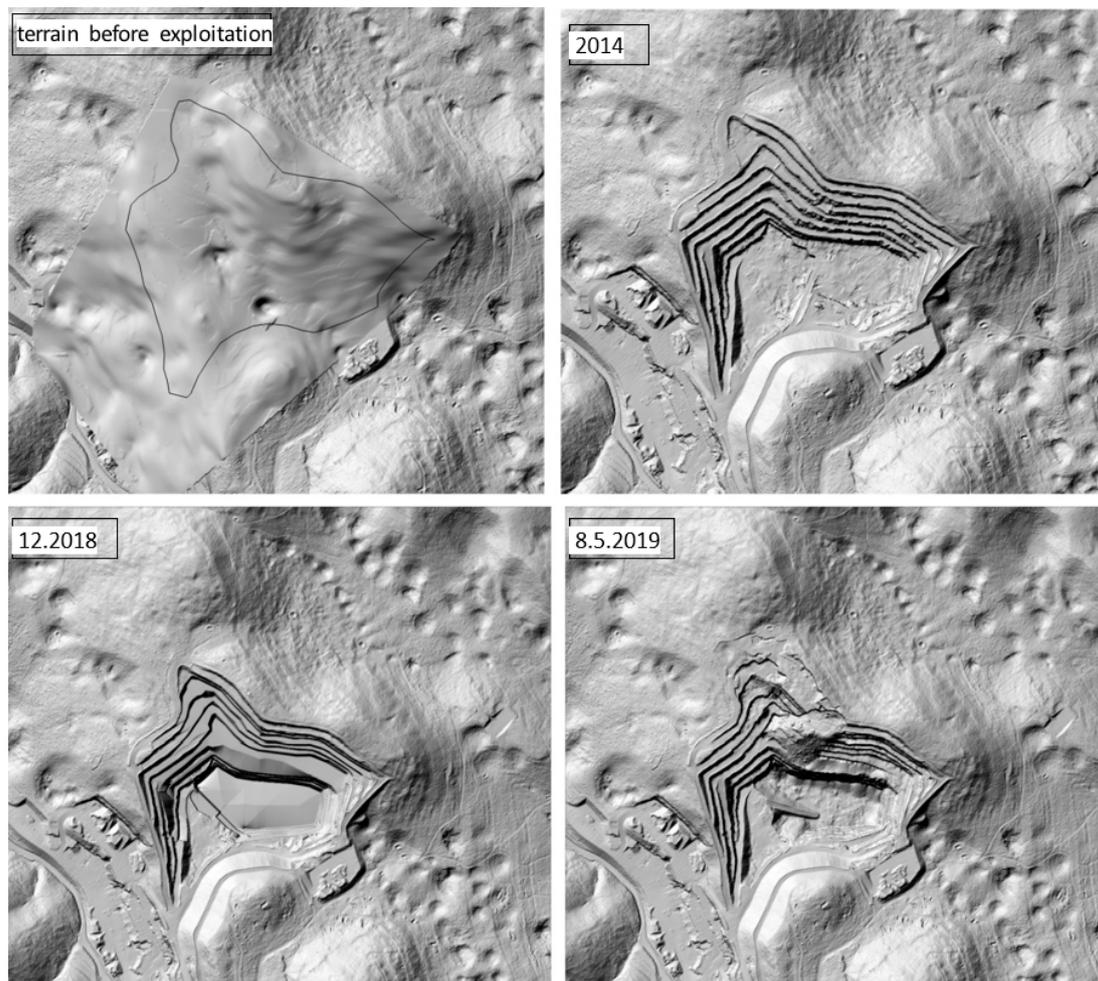
In this way, the digitized data we created were integrated into the LIDAR terrain mesh. We obtained four products for use and interpretation (see Figure 5):

- a terrain model of the quarry before exploitation;
- a quarry model using 2014 LIDAR data;
- a model of the quarry from December 2018; and
- a quarry model with data from 8 May 2019, i.e., after the rockslide.

**Figure 5.** Shaded models of quarry relief in the four phases of the Laže 1 quarry operation.

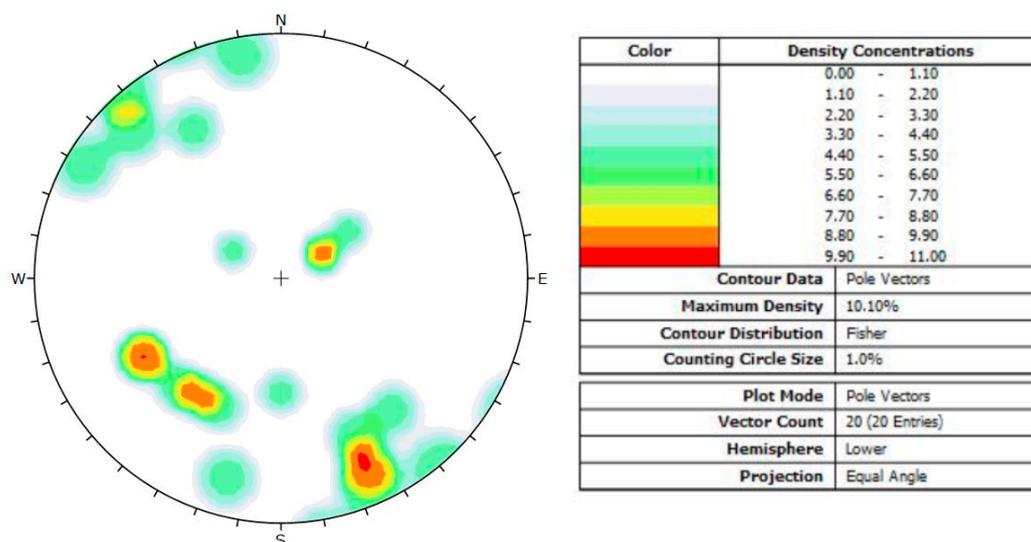
The joint systems affecting the rock mass were mapped and classified into several groups (according to their importance for slope stability) as follows (see Figure 6):

- Cracks facing southwest at 20°–40°. These included the major discontinuity due to the rockslide (245/21). This crack was perfectly straight and was the main crack (see Figure 2). This also included a crack that was parallel to the main crack (9.57 m), right above it. On the benches at 730 and 700 a.s.l., tension cracks spread from these benches to several other benches (234/23). In the eastern part of the quarry, the cracks were filled with calcite. Along these cracks, we noticed major sliding;
- Cracks perpendicular to the main crack system 40–60/60–65: these cracks occurred throughout the quarry and were clearly visible in the area of the rockslide;
- Vertical and subvertical cracks with a strike running from northeast–southwest;
- Other crack systems that did not belong to any of the above crack systems.

**Figure 6.** Schmidt diagram poles of cracks (discontinuities) in the Laže 1 quarry.

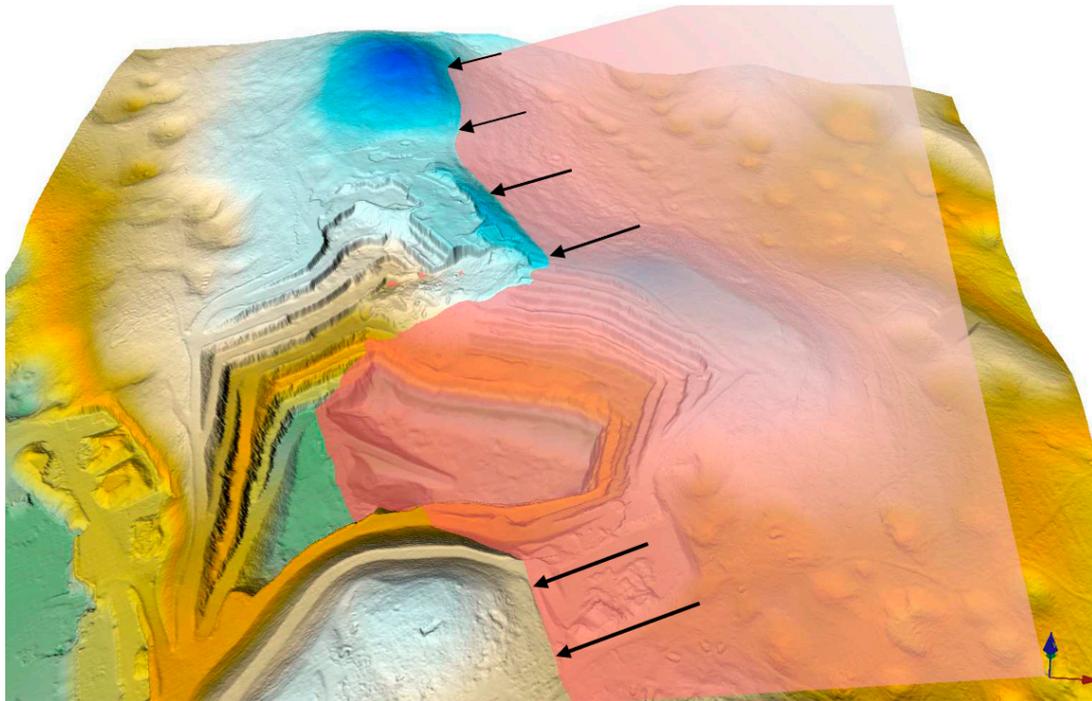
During the quarry mapping, it was difficult to connect cracks throughout the quarry due to the inaccessibility of individual benches and the inability to check individual benches. For this purpose, a digital model was used to map existing cracks. These connected cracks were imaged using a structural map of the quarry, and we constructed a map of the plane and the intersection between the regular quarry surface and the sliding surface. A spatial representation of this process is shown in Figure 7.

**Figure 7.** The Laže 1 quarry (a view to the north). Using the mapping data, the plane of the main crack (red surface) was constructed and put into a digital relief model. This gave us a spatially visible and determinable projection of the still-unexcavated areas and the entire surface (arrows).

The spatial orientation of a sliding surface is defined by the direction of the normal vector, which here was  $[-0.324150, -0.150404, 0.933973]$ . From this, the slope ( $21^\circ$ ) and azimuth ( $245^\circ$ ) of the sliding surface were calculated.

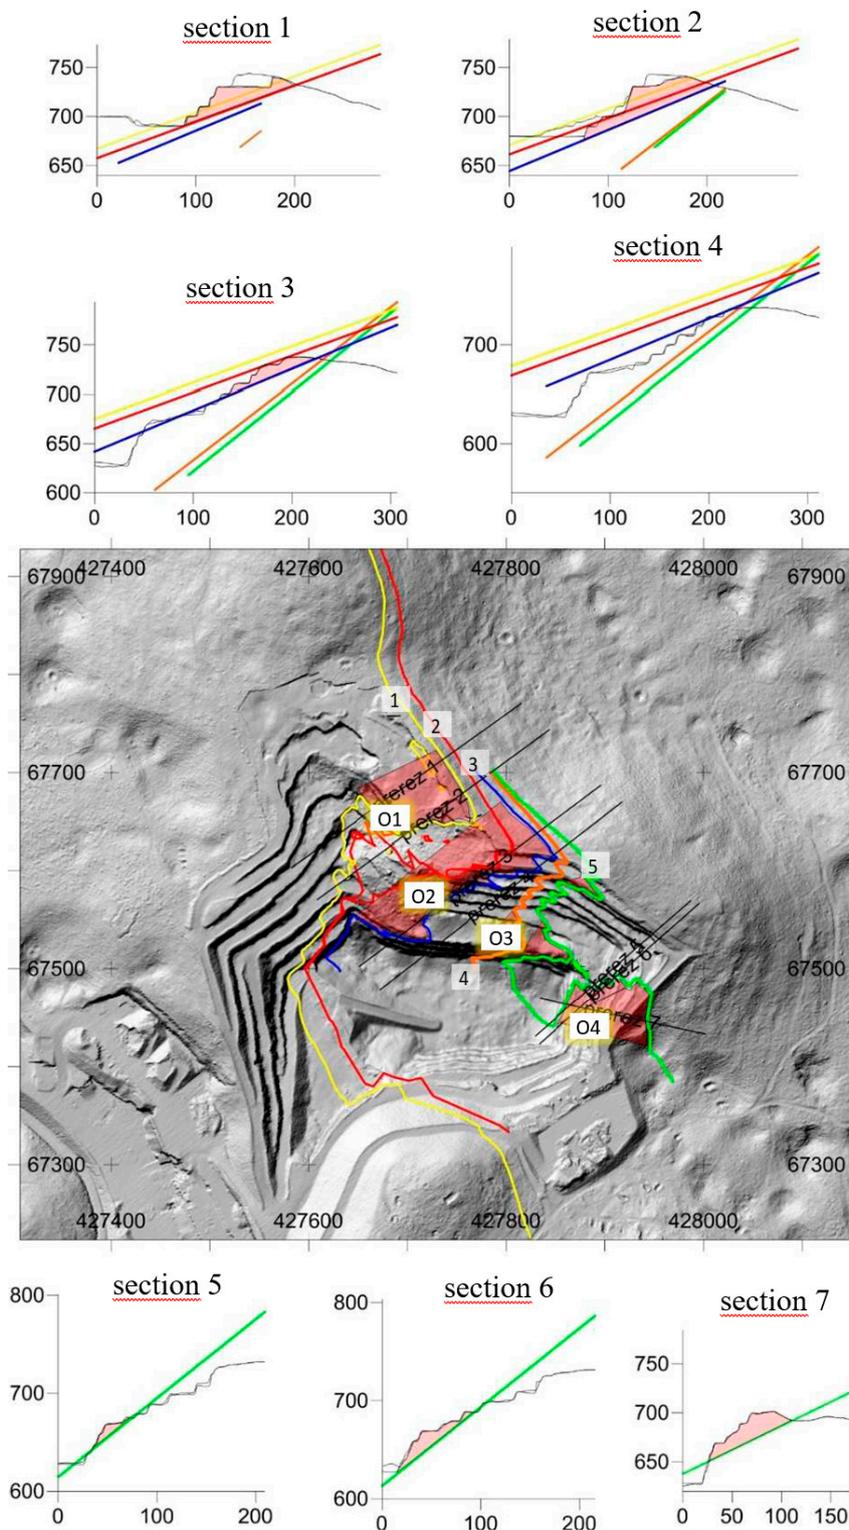
Through the stability analysis, potential paths for the system of major cracks were identified: by major cracks, we mean those with a south–west incidence and a low angle. After detailed research that included connecting benches and a visual assessment of the cracks in the Laže 1 quarry, five cracks were identified (Figure 8). We numbered them from west to east:

- A crack that was visible in the collapsed area in the vertical wall was parallel to the crack that led to the rockslide. It was 9.72 m away (height-wise) and is indicated as Number 1 (pictured in yellow) below;
- The crack that caused the collapse was by far the most susceptible to sliding. It was completely flat and extended over a large portion of the open quarry. We refer to it here as the main crack (Number 2, shown in red). This crack was clearly visible in surface anomalies;
- On the benches at 720 and 710 a.s.l., an intense crack from the same system was observed. It presented over several benches (234/23) and was clearly parallel to cracks a1 and a2 (Number 3, pictured in blue);

- A steeper crack that ran across multiple benches (235/37, pictured in orange, Number 4);
- In the eastern part of the quarry, on bench 680 (a.s.l.), more calcite-filled cracks were found (230/38). Along these cracks, the banks of the benches were falling off. The projections were dragged along the benches for analysis (pictured in green, Number 5).

**Figure 8.** The locations of major discontinuities (numbers 1 to 5) and critical areas in the quarry (numbers O1–O4) are marked in red.

All of these cracks were projected onto the slopes (the quarry benches). We were looking for free paths, or rather, a situation that was similar or identical to the situation prior to the March 2019 slide: a faulty crack on the slope combined with a vertical crack, forming a structural wedge. Therefore, four areas were determined to be critical areas:

- The first area, in the western part of the quarry, was due to cracks 1 and 2. One slide had already occurred at crack number 2, but the cracks were clearly still spreading westward in such a way that a similar situation could occur again. The likelihood of collapse is high;
- The second area was at crack number 3. This crack had the same free path as the first two cracks;
- The third area was by crack number 4, which had a larger vertical drop than the first three cracks did. The vertical crack, which was observed to run through all of the quarry benches on this slope, created a wedge between benches 680 and 622 (a.s.l.);
- The fourth area, which was in the eastern part of the quarry, had the same combination of cracks as did crack number 5 in area number 3.

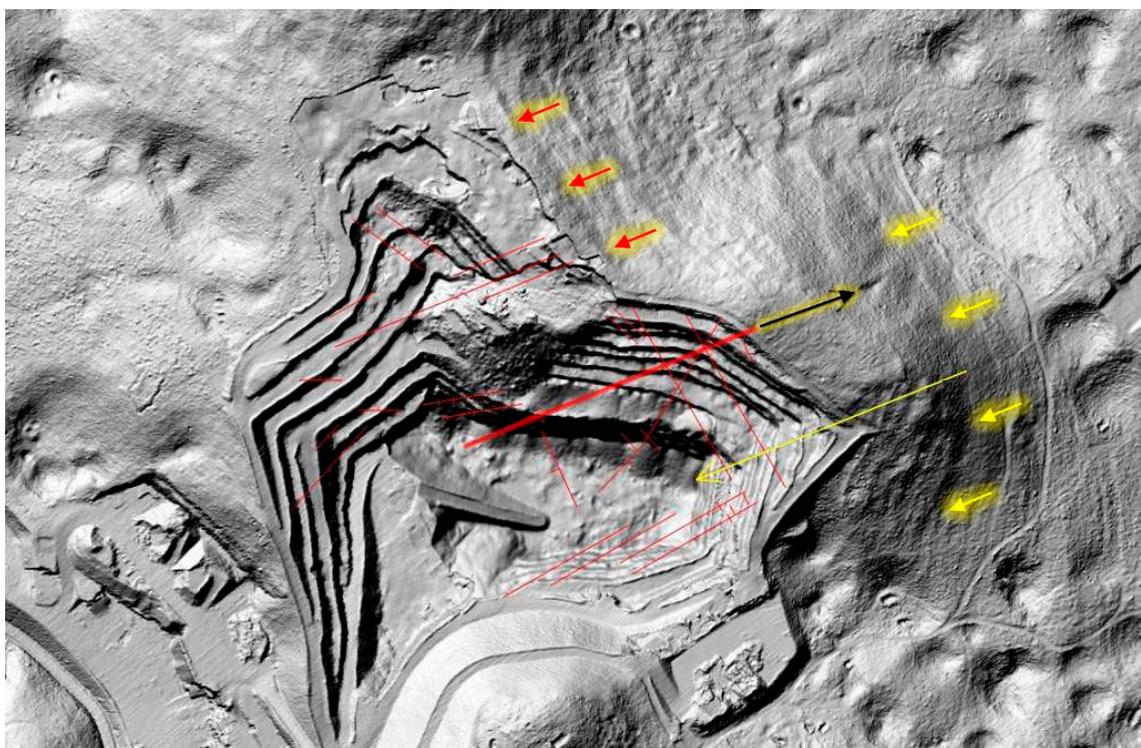
Figure 9 shows the terrain surrounding the Laže 1 quarry, which was constructed from aerial laser scanning data (LIDAR 2014). The red arrows indicate an anomaly on the surface due to a connection to the crack that led to the collapse.

**Figure 9.** The morphological peculiarities of the quarry were also reflected on the surface: the red arrows indicate a groove in the surface, which indicates a connection with the crack where the collapse took place. The yellow arrows mark recesses, which are spread throughout quarry due to plane construction. The vertical fracture in the quarry is expressed through a morphological irregularity on the surface (black arrow).

The yellow arrows mark irregularities, which spread throughout the quarry due to plane construction. The vertical fracture is expressed through a morphological groove on the surface (black arrow).
