# Geochemical State of Wilga River Environment in Kraków (Poland)—Historical Aspects and Existing Issues

**Citation:** Strzebońska, M.; Kostka, A. Geochemical State of Wilga River Environment in Kraków (Poland)—Historical Aspects and Existing Issues. *Minerals* **2021**, *11*, 908. <https://doi.org/10.3390/min11080908>

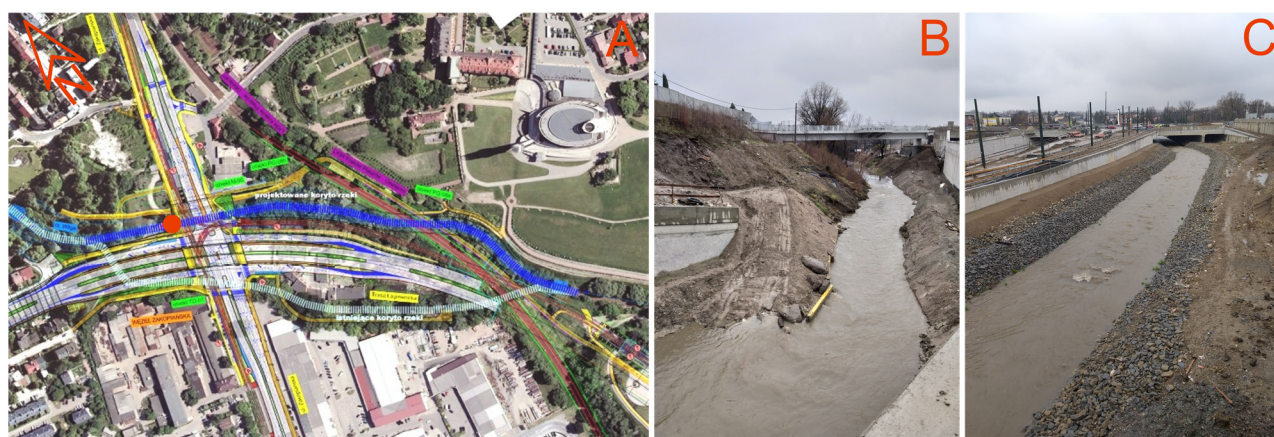
**Figure 2.** Relocated section of the Wilga River: (A)—photomap with the indication of the old river bed (light blue) and new river bed (dark blue) (obtained courtesy of Trasa Łagiewnicka S.A. [59]), as well as the location of sampling point No. 6 (red dot); (B)—section of old river bed seen from the vicinity of sampling point No. 6; (C)—section of new river bed seen from the vicinity of sampling point No. 6 (Figure 1).

The area which the Wilga runs through is currently affected by works connected with the construction of a section of the third ringway of Kraków, the “Łagiewnicka Route”, which required the relocation of a section of the river bed of the length of approx. 550 m (Figures 1 and 2), which was done on 29 February 2020. The new river bed was also designed to provide more protection against flooding [59]. The Wilga also runs across the area of the former “Solvay” Kraków Soda Works, which contains soda waste piles that have been partially recultivated and redeveloped [69] (Figures 1 and 3). Moreover, the Wilga basin was heavily affected for several decades by the chemical industry, being a source of toxic elements, among others. The most significant object in the Wilga River catchment area was the Kraków Tannery (pol. Krakowskie Zakłady Garbarskie). Its history started in 1885, when the Dłużyński brothers began production at a facility named (pol.) “Bracia Dłużyńscy, Garbarnia Ludwinów przy Krakowie”, and ended in 1990 when the old departments located in the city centre (Ludwinów) were closed down in view of environmental protection. That year saw the completion of the construction of the plant in Bieżanów, where the production of all departments of the Kraków Tannery were relocated. Modern production halls, a sewage treatment plant and an office building were built on an area of approx. 16 ha [70]. The remaining industrial facilities located in the Wilga catchment area are: Kraków Fur Processing Plant (pol. Krakowskie Zakłady Futrzarskie), active in the years 1951–1974; Kraków Metal Hardware Plant “Metaloplast” (pol. Wytwórnia Galanterii Metalowej “Metaloplast”), active in years 1951–1976 and the previously-mentioned “Solvay” Kraków Soda Works (pol. Krakowskie Zakłady Sodowe),

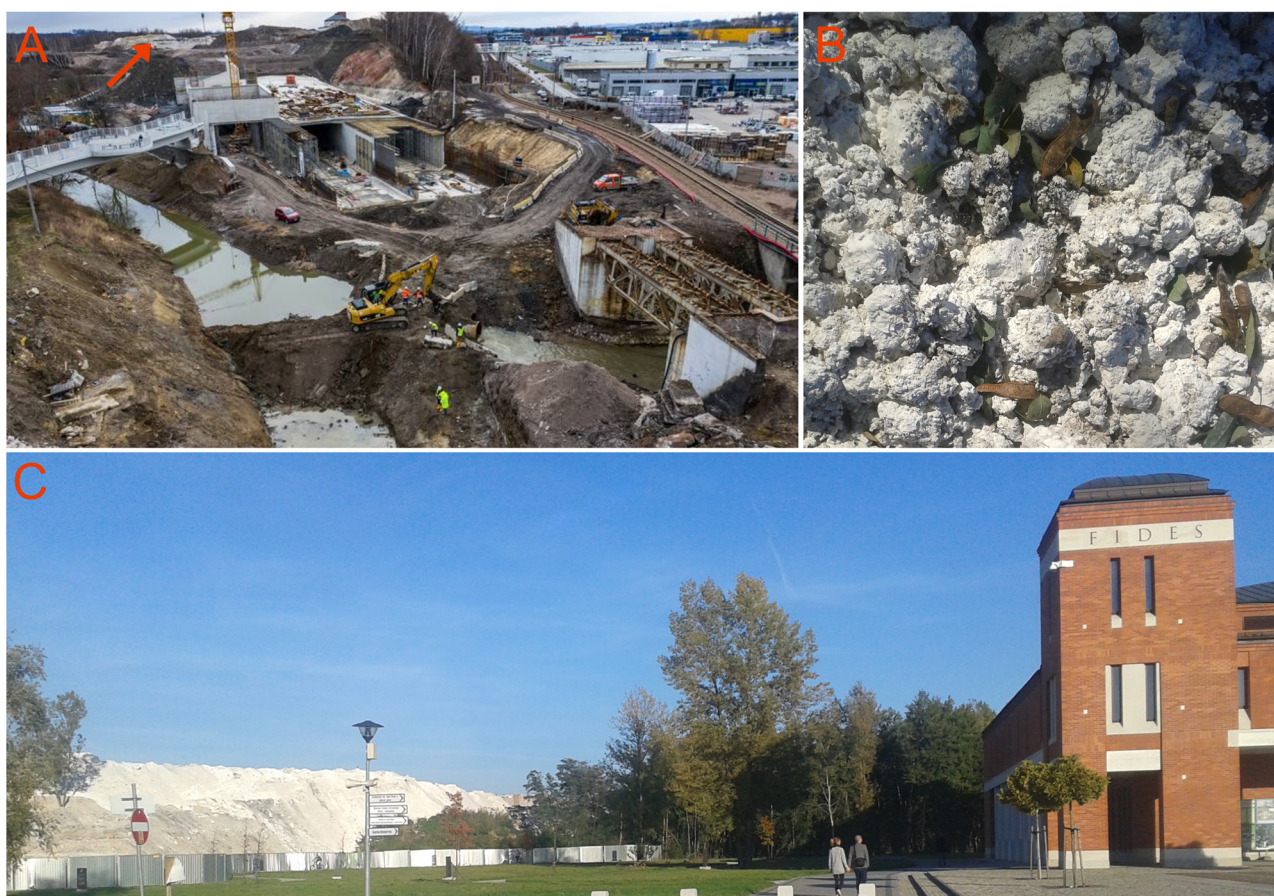
**Figure 3.** Wastes of former “Solvay” Kraków Soda Works, so-called “White Seas” (pol. Białe Morza): (A)—vicinity of sampling point No. 6 (Figure 1) during construction works and relocation of the Wilga River bed (obtained courtesy of Trasa Łagiewnicka S.A. [59]), with waste piles visible in the background (red arrow); (B)—soda waste up close; (C)—non-processed soda waste piles in the vicinity of the Wilga River, next to the recultivated and redeveloped area.

active in years 1906–1996 (Figure 1). Waste generated during the process of obtaining sodium carbonate using the Solvay method (Figure 3), consists of  $\text{CaCO}_3$  (approx. 70% of dry mass),  $\text{NaCl}$ ,  $\text{CaCl}_2$ ,  $\text{CaSO}_4$ ,  $\text{MgSO}_4$ ,  $\text{BaSO}_4$ ,  $\text{P}_2\text{O}_5$  and  $\text{SiO}_2$  [67].

The main ecological problem related to the presence of waste piles of former “Solvay” Kraków Soda Works in the drainage basin of the Wilga River is the leaching of salts into the surface water and presumably also groundwater in the area of Kraków. Such waters are present in this area in several aquifers, in Devonian, Jurassic, Cretaceous, Tertiary and Quaternary formations, of which the most important for the economy are Quaternary waters, then Tertiary and Jurassic waters. The chemical composition of groundwater is highly variable and related to the geological structure of respective aquifers. The chemical composition of the uppermost Quaternary waters is not natural, due to contamination infiltrating these waters from the air (via precipitation), from surface waters (via infiltration from the Vistula River and its distributaries) and the soil. However, the direct influence of the waste piles is not evident in the chemical composition of groundwaters and other factors also play a significant role here. These waters are somewhat variable in different areas of Kraków, but generally demonstrate a neutral pH and a relatively high level of hardness and mineralization. The most prevalent anions are sulphates and carbonates, whereas the most prevalent cations are calcium, magnesium and iron, and sometimes also manganese. Only the high concentration of iron is of partially natural origin and is related to the saturation of Pleistocene aquifers with iron [22,23].
