# Transverse Profiles of Belt Core Damage in the Analysis of the Correct Loading and Operation of Conveyors

**Abstract:** This article presents an analysis of the transverse profile of belt damage in the context of the proper loading and operation of conveyors. The aim of this study was to identify and understand the characteristic features of damage and their placement that may occur in conveyor belts during operation and indicate abnormalities in any of the components of the conveyor system, especially during loading at chutes. A total of seven different conveyors were examined, and the obtained results allowed for a thorough comparison and investigation of the distribution of belt damage on their cross-sectional profiles. This article discusses factors that may contribute to the occurrence of unevenly distributed belt damage. The conclusions from the conducted research can be of significant importance for conveyor owners and operators as they enable an effective assessment of the conveyor belt's condition, the correctness of the conveyors, and the chutes' designs as well as the implementation of necessary design changes, correct actions, and repairs. Through proper belt monitor

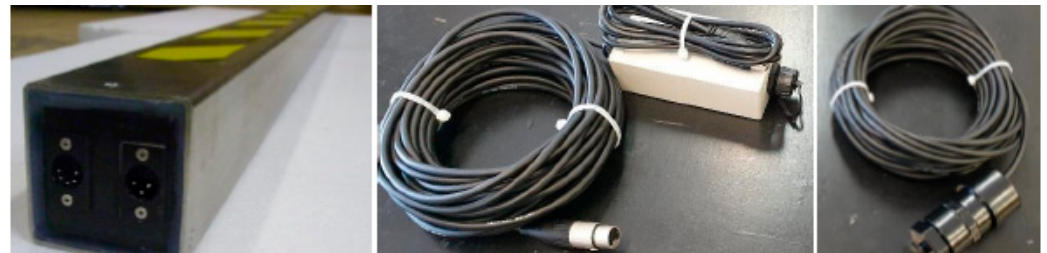
**Figure 3.** Components of the DiagBelt+ system (measuring head, data acquisition module with USB interface, tachometer).

Figure 3 presents the components of the DiagBelt+ diagnostic system, while Figure 4 shows the schematic of the device installation on the conveyor belt.

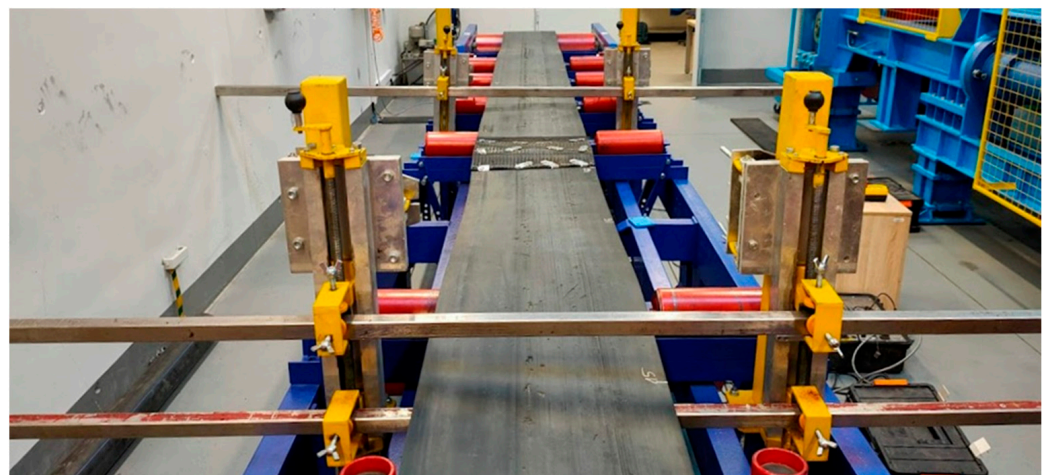
**Figure 5.** Installation of the DiagBelt system at the laboratory station in LTT.

In Figure 5, the installation method of the DiagBelt system on a conveyor belt in the Belt Transport Laboratory of Wrocław University of Science and Technology (LTT) is shown. The DiagBelt system can be mounted on both the upper and lower strands of the belt, providing flexibility and the ability to monitor the technical condition of the conveyor belt at various points along its path.

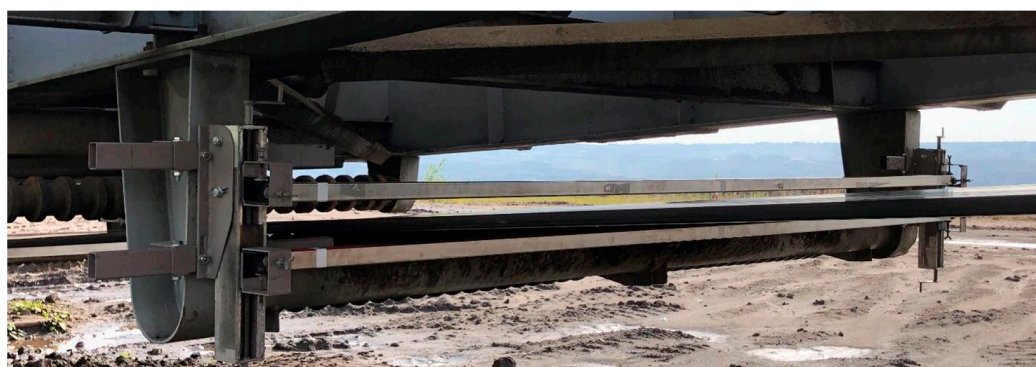
Figure 11. Two magnet heads attached to the conveyor structure.

Figures 11 and 12 depict the method of mounting the magnet and measuring heads of the DiagBelt+ diagnostic system during measurements.

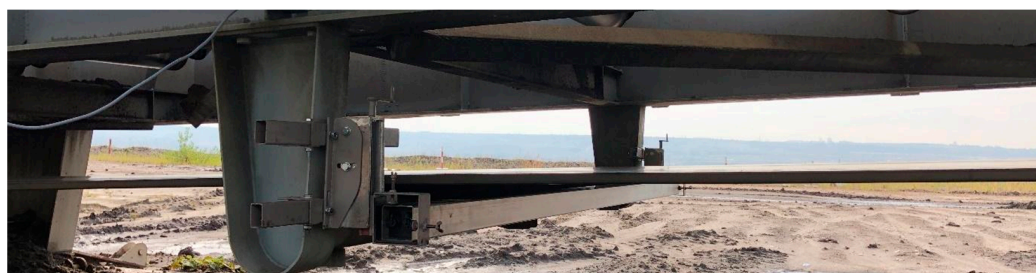
**Figure 12.** Measurement head placed on stands below the lower belt strand of the conveyor.
