# Fault Diagnosis in a 2 MW Wind Turbine Drive Train by Vibration Analysis: A Case Study

**Abstract:** This paper presents a vibration analysis method for detecting typical faults in gears of the drive train of a 2 MW wind turbine. The data were collected over a one-year period from an operating wind turbine with a gearbox composed of one planetary stage and two helical gear stages. Failures in two pairs of helical gears were identified: one involving pitting and wear in the gears connecting the intermediate-speed shaft to the low-speed shaft, and another one involving significant material detachment in the gears connecting the intermediate-speed shaft to the high-speed shaft. The continuous evaluation of time signals, frequency spectra, and amplitude modulations allowed the most sensitive sensors and frequencies for predicting surface damage on gear teeth in this type of turbine to be determined. A steady-state frequency analysis was performed, enabling the detection of the aforementioned surface faults. This approach is simpler compared with more complex transient-state techniques. By tracking vibration signals over time, the importance of analyzing gear mesh frequencies and the

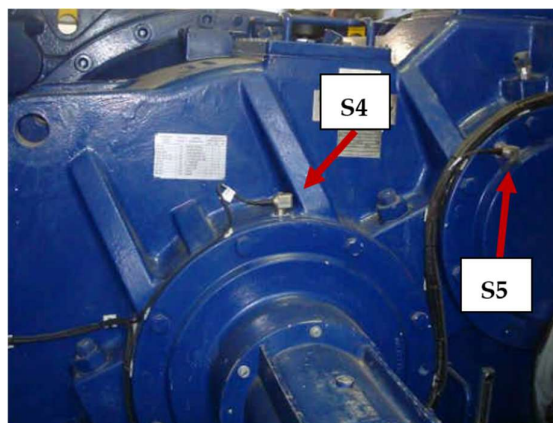
**Figure 3.** Photograph showing the location of the vertical accelerometer (S4) and axial accelerometer (S5) on the gearbox near the ISS and HSS, viewed from the generator.

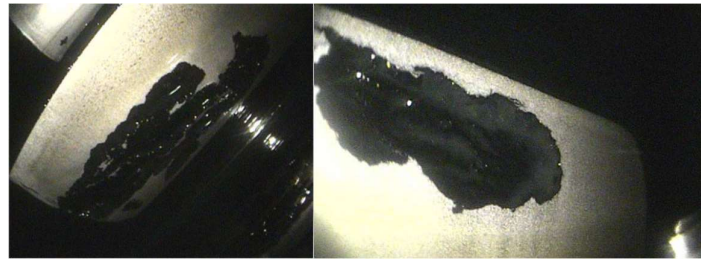
**Figure 4.** Pitting and spalling on the pinion gear mounted on the HSS.

The internal inspection of the gearbox using an endoscope revealed damage in the gear pair coupled to the HSS, which consisted of pitting and spalling on the pinion teeth, as can be seen in the photographs shown in Figure 4. Pitting is a type of damage caused by surface fatigue resulting from the repeated pulsed loading of gear teeth during mesh engagement. It manifests as small, localized craters. This initial form of surface fatigue can progress to a more severe stage, known as spalling, where the damage leads to the detachment of material fragments from the surface. This type of damage is usually expected to manifest at the GMF3 gear mesh frequency or its harmonics. For detection purposes, these frequencies were examined using data from sensors S4, S5, and S6.

Gear faults were first identified through vibration anomalies, then confirmed via endoscopic inspections during maintenance (Figures 4 and 5). Data from a replaced gearbox and historical signatures of healthy turbines [16] served as baselines. Due to the proximity of the sensors to the studied faults, accelerometers S4, S5, and S6 were analyzed in more detail. The different frequency bands stored by the acquisition system were examined to identify where a significant increase occurred and in which band the damage progression could be observed. For those identified frequencies that showed a progressive increase in acceleration values, a regression model was proposed for each of the time intervals studied. This model was developed using an analysis of variance (ANOVA), and its statistical validity has been demonstrated for the operating ranges considered. Since power output appears to be a more direct indicator of drive-train loading than wind speed, we focused

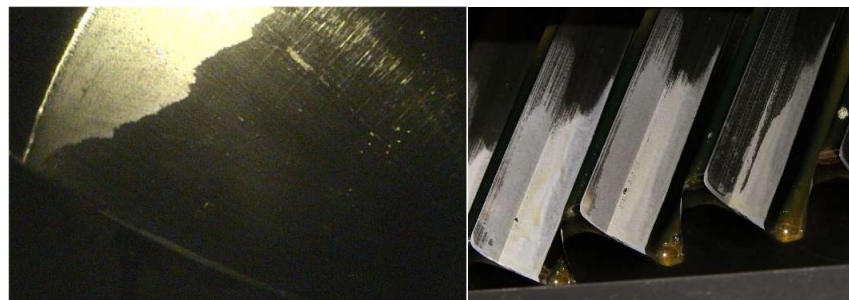
**Figure 5.** Pitting (left) and wear (right) on the pinion gear mounted on the ISS.

Upon inspection, pitting and wear were found on the pinion teeth of the gear pair connecting the ISS to the LSS., as shown in Figure 5. The frequencies of interest for detecting these faults are GMF2 and its multiples. Data recorded by sensors S4 and S5 were analyzed in this case. In addition, sensor S6 was also checked for validation purposes. The coexistence of pitting and wear in the ISS-LSS gear pair suggests a multi-stage failure process: initial pitting from contact fatigue (under adequate lubrication), followed by wear accelerated by micro-pitting-induced surface roughness, and transient lubrication breakdowns at high loads. This is consistent with the harmonic-specific vibration trends observed in S5 (Figures 11–14) as will be shown.
