# Return to the Roots—Experimental Work on Water-Lubricated Bearings with Lignum Vitae Wood Bearing Bushes and Comparison with Other Similar Solutions

## Abstract

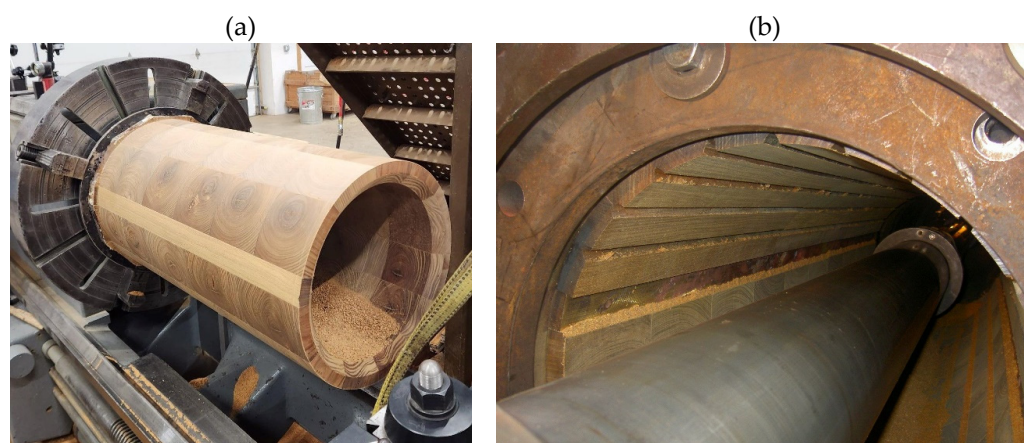
**Figure 2.** Manufacturing a wooden bearing bush: (a) a bush ready for installation during final turning; (b) machining of the bush after installation in the stern tube (authors' archive).

All bearings were machined before installation in the steel housing. This method has some advantages and disadvantages. The manufacturing process was conducted by a specialist in a professional workshop (Figure 2a), although in this case, the bearing has to be press-fitted into a precisely prepared housing, and any imperfection in the housing is likely to be transferred to the bush sliding surface [37]. The new generation of machining tools can help to achieve a high quality for the sliding surface when the final process is conducted after installation of the wooden bush in the steel housing (Figure 2b).

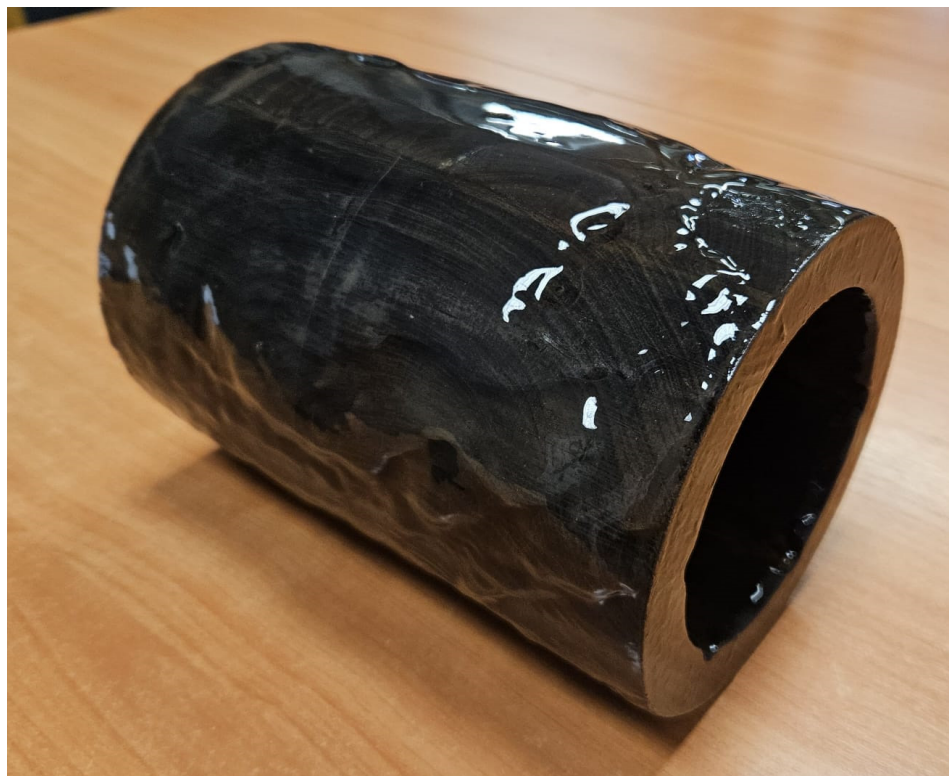
**Figure 12.** Substance formed on the bearing bush after two months of immersion in water.

The visible effect of load change on the transition point for the bearing with a composite bush results from the rough surface of the bush, which, despite many hours of running-in, was not ideal. It can be assumed that as the wear process progresses, the sliding surface will eventually smooth and the resistance to movement will decrease. The significant errors in the shape of the bush and the differences in the bearing clearance are worth noting. Despite the shape defects, it was possible to confirm the occurrence of hydrodynamic phenomena in five of the six bearings tested (Table 3). This is important information because it is often anticipated that the geometry of the sliding couple is practically ideal, while in practice, manufacturing limitations, specific assembly methods, or properties of the polymer bush, such as water absorption, make it practically impossible. The lowest starting resistance is demonstrated by the 3-layer bearing with a sliding surface made of PTFE. An interesting phenomenon is shown in Figure 12: after keeping the bushes immersed in water, a unique gel-like substance is formed around the bush, which is slick and well attached to the surface. This is likely to influence the performance of the lignum vitae bearing, as it adheres to the surface quite strongly and is not easy to remove.
