Article

Early Detection and Identification of Fatigue Damage in Thrust Ball Bearings by an Acoustic Emission Technique

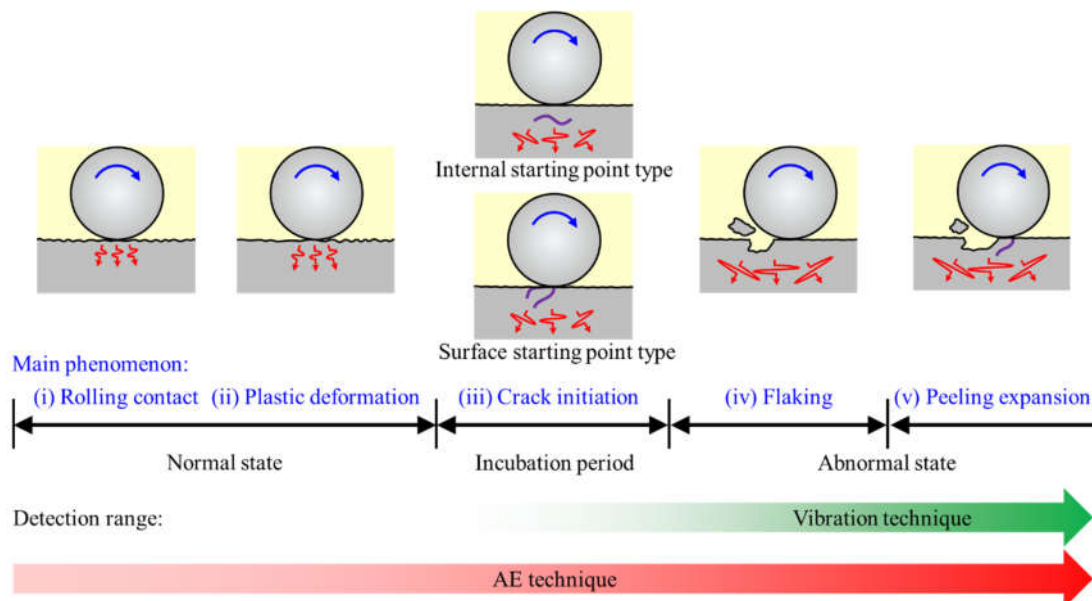
Figure 1. Differences in the detection range between the acoustic emission (AE) technique and the vibration technique.

A technique based on vibration has conventionally been used to detect and diagnose damage to bearings [2]. However, this technique does not provide enough information to permit damage prediction, because it can only detect problems at a terminal stage such as when flaking or peel expansion occurs, as shown in Figure 1. On the other hand, an acoustic emission (AE) technique, which can directly evaluate friction and wear, is considered to be very effective in diagnosing the lifetimes of bearings. The AE technique is a diagnostic technique for detecting potential wear that involves analysis of elastic stress waves that occur when strain energy stored in a material is released as the material is deformed or fractured. Unlike the vibration technique, the AE technique can detect plastic deformations of surfaces and crack initiation during their incubation periods. The AE technique is therefore suitable for predicting the fatigue of bearings and for evaluating the mode of damage. Several studies have been conducted on the diagnosis of abnormalities in rolling bearings and in bearing steels by using the AE technique [3–9]. However, most of these were based on a comparison between the operating time of the rolling bearing and changes in AE signals. As a result, it is difficult to clearly understand the cause of the abnormalities that occurred in the rolling bearings during the fatigue process.

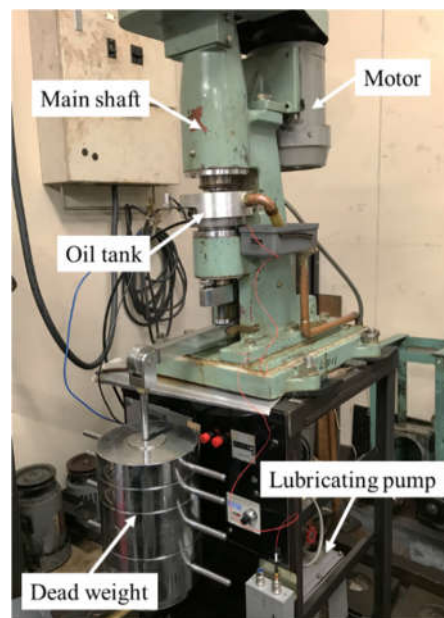
Figure 2. Appearance of the experimental setup for the bearing fatigue test.

Figure 2 is a photograph of the bearing fatigue tester that was used in the bearing fatigue test. Figure 3 is a schematic representation of the bearing fatigue tester and the measuring system. A small wideband-type AE sensor (AE-900M-WB: NF Corp., Yokohama, Japan) was used in this study. The AE sensor was installed onto the holder near the bearing-installation section, so that elastic waves generated by rolling friction could be detected with high sensitivity. The AE amplification factor was set to 70 dB by a preamplifier (AE-912: NF Corp., Yokohama, Japan) and a main amplifier, and the background noise was eliminated by using a 20 kHz high-pass filter with a discriminator (AE9922: NF Corp.). A vibration sensor (GH-313A: Keyence Corp., Osaka, Japan) with a minimum detected acceleration of 0.98 m/s^2 was installed near the AE sensor. Changes in amplitude of the AE signal were evaluated by using the envelope detection waveform from which the amplitude of the background noise component was subtracted. To examine changes in the frequency spectrum of the AE signal waveforms during the fatigue process in the rolling bearing, the AE signal waveforms were recorded by using a high-speed waveform digitizer and subjected to a fast Fourier transform.

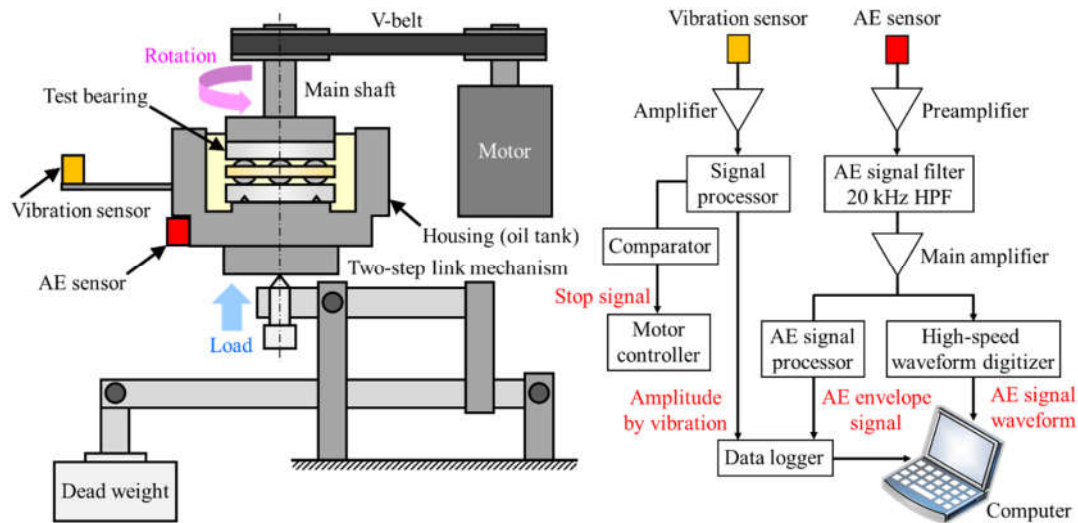
Figure 3. Schematic representations of the experimental setup and the measurement system for the bearing fatigue test.

In the indentation test, a Vickers hardness tester was used to analyze the AE signal measured when an indentation was artificially created on the bearing raceway. The AE sensor was installed behind the bearing raceway. The AE measuring system had the same configuration as that shown in Figure 3. The AE amplification factor was set to 90 dB, and noise was eliminated by using a 20 kHz high-pass filter. Here, the indenter indentation load was 9.8 N or 98 N, and the holding time was 30 s. The lubricating oil present between the indenter and the bearing raceway surface was the same as that used during the fatigue test.

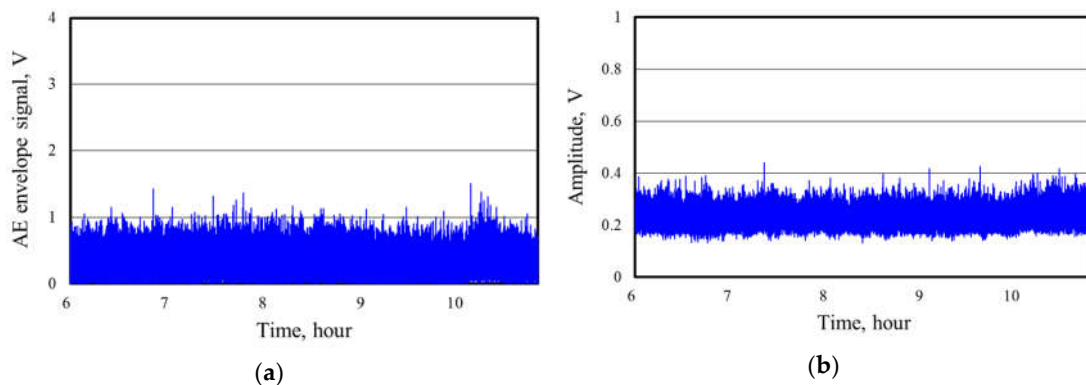
Figure 4. Changes in the AE signal and the vibrational acceleration up to 10 h from the start of the rolling fatigue test: (a) AE envelope signal; (b) amplitude of vibration.

As the experiment required a long time, of the order of 400 h, only the experimental results identified as noteworthy are described below. Figure 4 shows the changes in amplitude of the AE signal (envelope detection waveform) and the vibration signal during the period from 6 to 10 h after the start of the bearing fatigue test. During this initial stage, there were no significant changes in the amplitude of either the AE signal or the vibration signal. Therefore, the lubrication conditions were ideal and no damage occurred. Figure 5 shows a typical AE signal waveform detected during this time period, together with the results of a frequency analysis. In the frequency analysis, a primary frequency peak appeared below 0.1 MHz. Since such a periodic wave of low frequency without distortion, as shown in Figure 5a, can be observed when a material surface is hit by hammering, it can be said that pure rolling contact and friction occurred between the surfaces. Throughout the

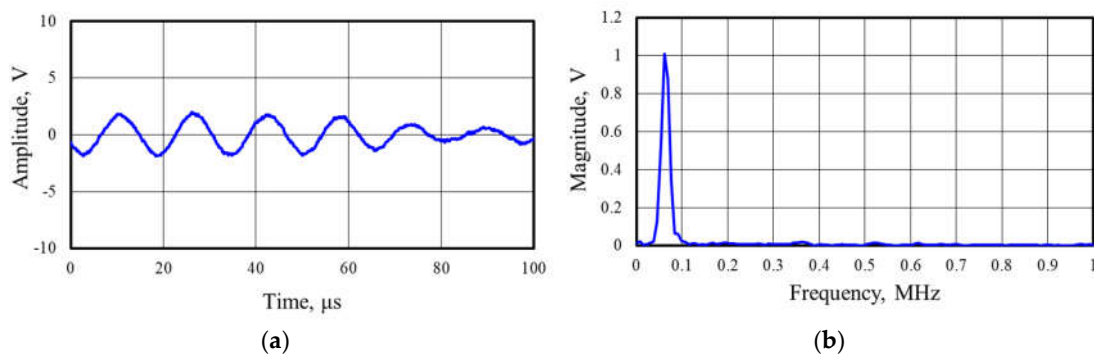
Figure 5. Typical AE signal waveform detected at about 8 h and its frequency spectrum: (a) AE signal waveform; (b) frequency spectrum.

experiments, as shown in Figure 5b, only the frequency peak below 0.1 MHz was observed during the initial stages of the tests, corresponding to the normal operating state.

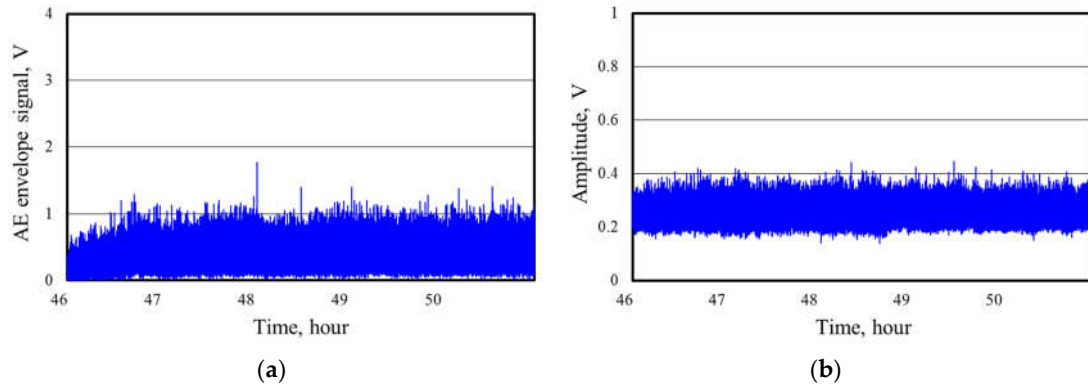
Figure 6. Changes in the AE signal and the vibrational acceleration at about 50 h from the start of the rolling fatigue test: (a) AE envelope signal; (b) amplitude of vibration.

Next, Figures 6 and 7 show the results recorded around 50 h after the start of the bearing fatigue test. Although no significant changes were observed in the vibration measurements, the amplitude of the AE signal showed a slight increase when compared with its initial value. This is considered to be the result of a decrease in the viscosity and thickness of the oil film as its temperature increased, and the consequent change in the contact state. This trend was observed several times during the test. Both amplitudes of the AE signal and vibration signal were slightly larger than those in Figure 4. It especially seems from Figure 6a that small burst-type AE signals were frequently detected. Additionally, the AE signal waveform in Figure 7a was distorted compared with that in Figure 5a. In the frequency analysis results shown in Figure 7, a primary peak appeared at a frequency below 0.1 MHz, similar to that seen in the experimental results shown in Figure 5b. Moreover, small peaks were also observed at frequencies between 0.15 and 0.35 MHz.

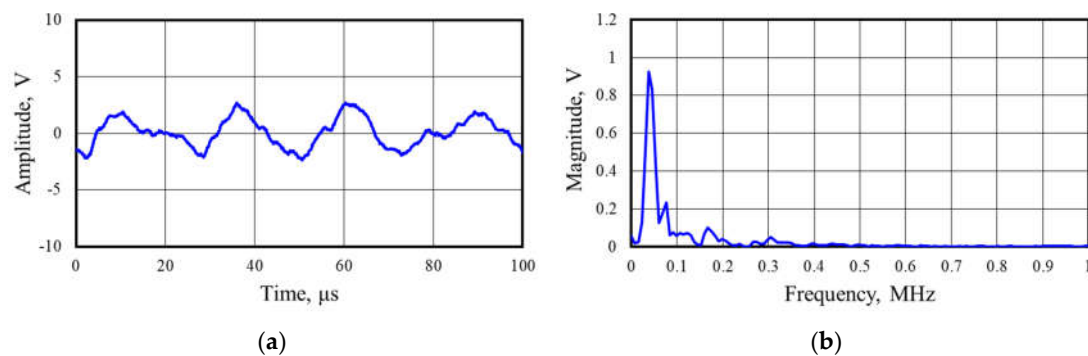
Figure 7. Typical AE signal waveform detected at about 50 h and its frequency spectrum: (a) AE signal waveform; (b) frequency spectrum.

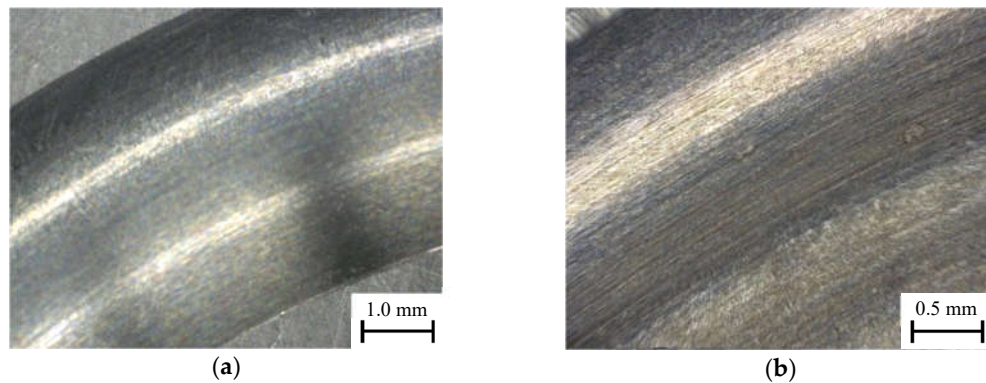
Figure 8. Micrographs of the raceway surface of the bearing (shaft washer): (a) before the test; (b) after 50 h.

Figure 8 shows micrographs of the raceway surface of the thrust ball bearing before the test and after 50 h of testing. A track deformed by rolling friction with the balls could be observed on the bearing raceway surface after 50 h of testing. Therefore, the large peak below a frequency of 0.1 MHz is considered to be due to a pure rolling contact without damage (i.e., contact and plastic flow of surface asperities during the running-in process of the bearing raceway surface). The small peaks observed at frequencies between 0.15 and 0.35 MHz were considered to be due to the formation of microscopic defects beneath the bearing raceway surface.

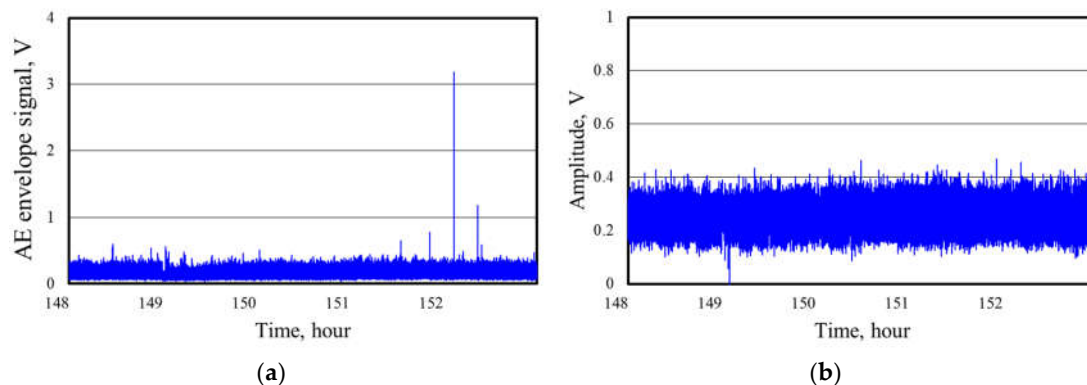
Figure 9. Changes in the AE signal and the vibrational acceleration about 150 h after the start of the rolling fatigue test: (a) AE envelope signal; (b) amplitude of vibration.

Figure 9 shows the changes in amplitudes of the AE signal and vibrations at about 150 h after the start of the bearing fatigue test. The fluctuation in the amplitude of the AE signals appeared to be smaller than that in the initial stages; this was caused by progression of plastic deformation on the bearing raceway surface, as shown in Figure 4, because the fluctuation in the amplitude of the AE signals was related to the surface roughness [10]. Large burst-type AE signals were detected infrequently after about 152 h. However, no marked change in vibration occurred at this point. Figure 10 shows a typical AE signal waveform obtained after 152 h, together with its frequency spectrum. From the results of this frequency analysis, it was confirmed that large peaks appear not only at

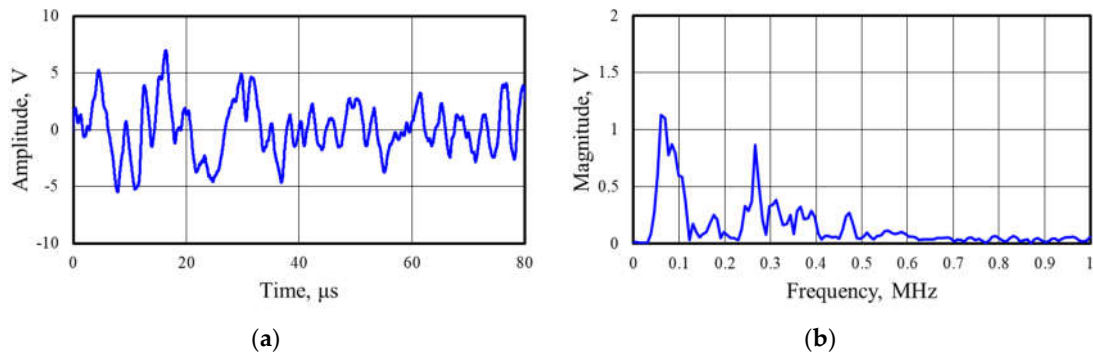
Figure 10. Typical AE signal waveform detected at around 152 h and its frequency spectrum: (a) AE signal waveform; (b) frequency spectrum.

frequencies below 0.1 MHz, but also at about 0.3 MHz. It is likely that this peak at a frequency of around 0.3 MHz was caused by crack initiation on the bearing raceway surface.

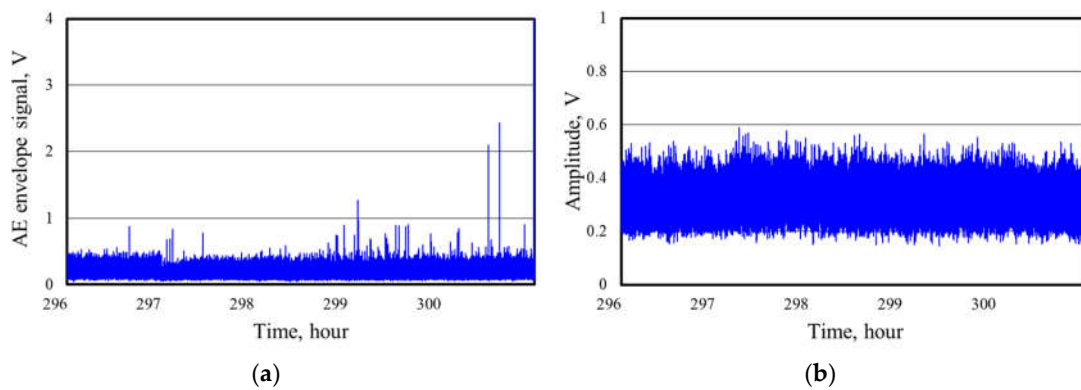
Figure 11. Changes in the AE signal and the vibrational acceleration about 300 h after the start of the rolling fatigue test: (a) AE envelope signal; (b) amplitude of vibration.

Figure 11 shows changes in the amplitudes of the AE signal and vibrations about 300 h after the start of the bearing fatigue test. Although large burst-type AE signals were frequently detected after about 299 h, the vibration signal still did not change markedly. Figure 12 shows a typical AE signal waveform obtained after 300 h, together with its frequency spectrum. The results of this frequency analysis confirmed that large peaks appeared at frequencies of about 0.15 to 0.4 MHz, which were not present at the beginning of the test. Furthermore, the magnitudes of the peaks at about 0.15 to 0.4 MHz were larger than those in Figure 10.

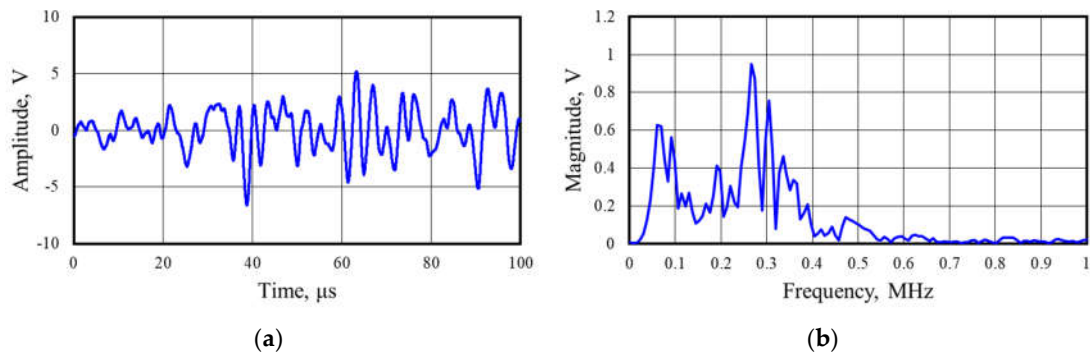
Figure 12. Typical AE signal waveform detected at around 300 h and its frequency spectrum: (a) AE signal waveform; (b) frequency spectrum.

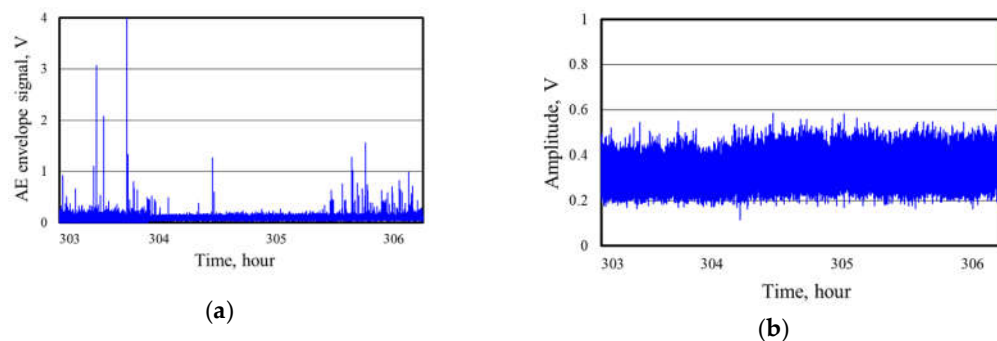
Figure 13. Changes in the AE signal and the vibrational acceleration about 306 h after the start of the rolling fatigue test: (a) AE envelope signal; (b) amplitude of vibration.

Approximately 306 h after the start of the test, upon detection of a large vibration, the machine's stopping device was activated and operation was stopped. Removal of the shaft washer and examination of the raceway surface confirmed the presence of flaking on the surface of the bearing raceway. Figure 13 shows the changes in amplitudes of the AE signal and vibration signal at about this time. Large burst-type AE signals with an amplitude of more than 1.5 V were detected between 303 and 304 h and immediately before the stop, but a vibration signal was detected only immediately before the stop. Figure 14 shows a typical AE signal waveform corresponding to a large burst-type AE signal at around 303 h, together with its frequency spectrum. This frequency analysis confirmed that peaks appeared not only at a frequency of around 0.1 MHz, but also at about 0.15 to 0.4 MHz. Moreover, in a study on the detection of rolling fatigue of the coating film of a rolling bearing by using the AE technique, the presence of a frequency component at around 0.35 MHz caused by fracture and peeling of the surface coating has been previously confirmed [11].

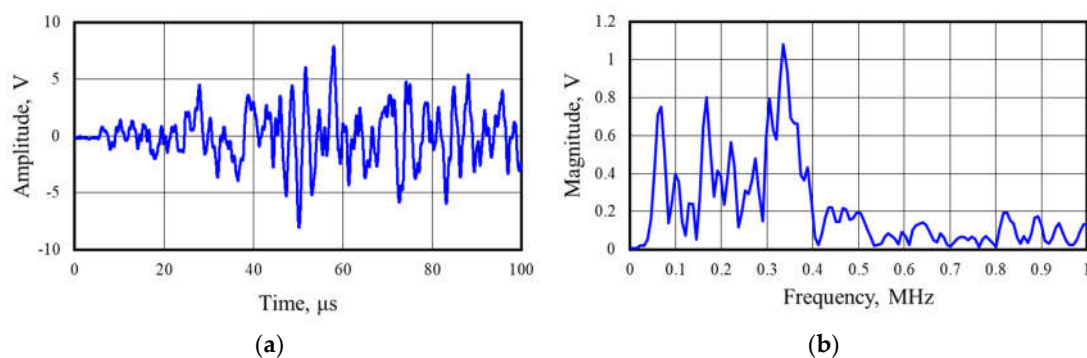
Figure 14. Typical AE signal waveform detected at around 306 h and its frequency spectrum: (a) AE signal waveform; (b) frequency spectrum.

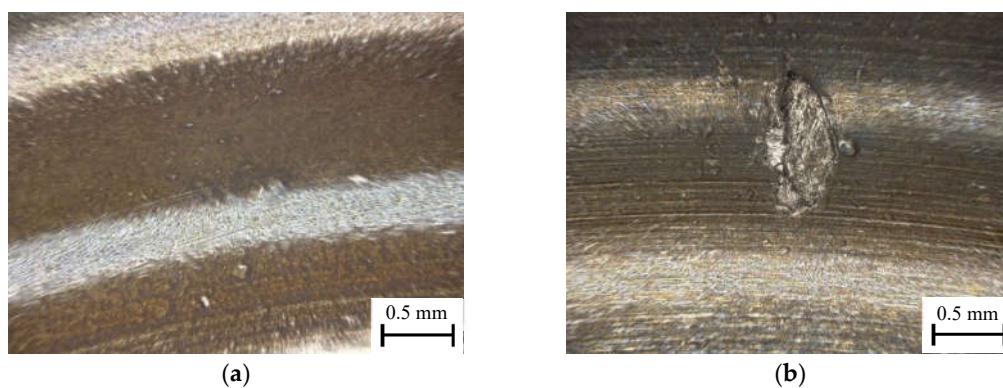
Figure 15. Micrographs of the raceway surface of the bearing (shaft washer): (a) after 300 h; (b) after 306 h.

Figure 15 shows micrographs of the bearing raceway surface before (at about 300 h) and after (at about 306 h) the appearance of flaking on the shaft washer of the thrust ball bearing. The micrograph of the raceway surface presented in Figure 15a showed no significant change compared with the previous raceway surface, indicating that a satin-finished surface was formed over the entire friction track. On the other hand, in Figure 15b, flaking can be observed to have occurred at the center of the raceway surface.

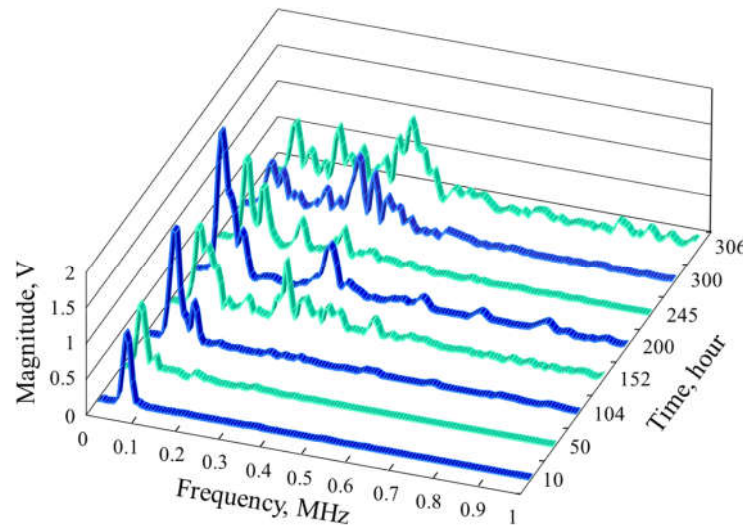
Figure 16. Change in the frequencies of the AE signal waveforms at various times until flaking occurred in the shaft washer.

Figure 16 shows the change in the frequencies of the AE signal waveforms at various times until flaking occurred in the shaft washer. A frequency peak at around 0.1 MHz, generated due to pure rolling contact, is apparent from the initial stages. The magnitude of frequency peaks at about 0.15 to 0.4 MHz gradually became large as the fatigue damage progressed. A shift in the primary frequency to around 0.3 MHz occurred from 300 h. It is considered that a low frequency AE signal is effective for the evaluation of the running-in process and a high frequency AE signal is effective for the early detection of fatigue damage.

Figure 20 shows the change in the frequencies of the AE signal waveforms at various times until flaking occurred in the housing washer. As for when flaking occurred in the housing washer, the change in the frequencies was basically the same as that in the shaft washer, as shown in Figure 16. However, the magnitude of frequency peaked at about 0.3 MHz. A shift in the primary frequency, not to 0.3 MHz but to around 0.2 MHz, occurred from 370 h, although a large frequency peak at about 0.3 MHz also existed. Comparing the surface observations after flaking in Figures 15 and 19, the difference in the high frequency peak may be related to the mode of crack initiation and its size. As discussed above, with the bearing damage, high frequency peaks started to appear in the AE spectra. Since various secondary AE events are generated during crack propagation [12], the frequency spectrum may be complicated. Nevertheless, it is considered to be related to the nucleation of small defects whose size is proportional to the frequency because the AE spectra are accurate against deformation and fracture phenomena. In order to yield any findings about the frequency spectra, further experiments and consideration will be needed to interpret the numerical data obtained from this study.

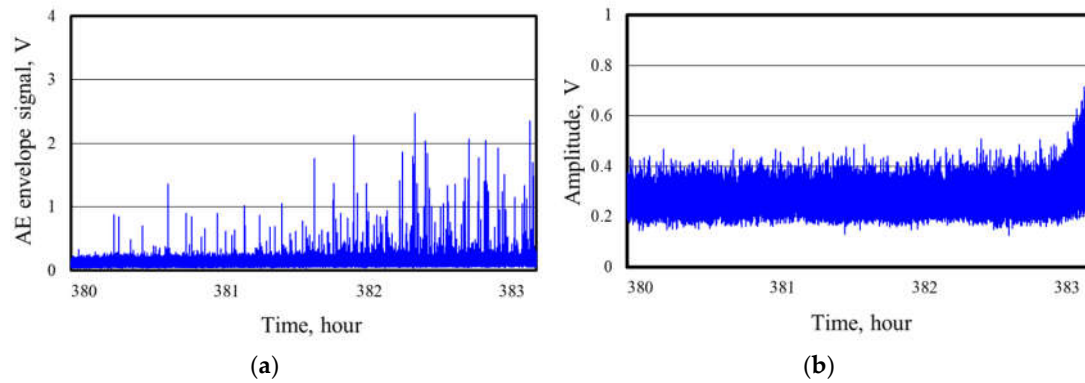
Figure 17. Changes in the AE signal and the vibrational acceleration about 383 h later from the start of the rolling fatigue test: (a) AE envelope signal; (b) amplitude of vibration.

Figure 17 shows the changes in amplitudes of the AE signal and the vibration signal immediately before the bearing fatigue tester stopped. Large burst-type AE signals were detected shortly after 380 h, but the amplitude of the vibration greatly increased at 383 h, immediately before stopping. Figure 18 shows a typical AE signal waveform obtained just before the test stopped at 383 h, together with its frequency spectrum. This frequency analysis confirmed that large peaks appeared at around 0.2 MHz.

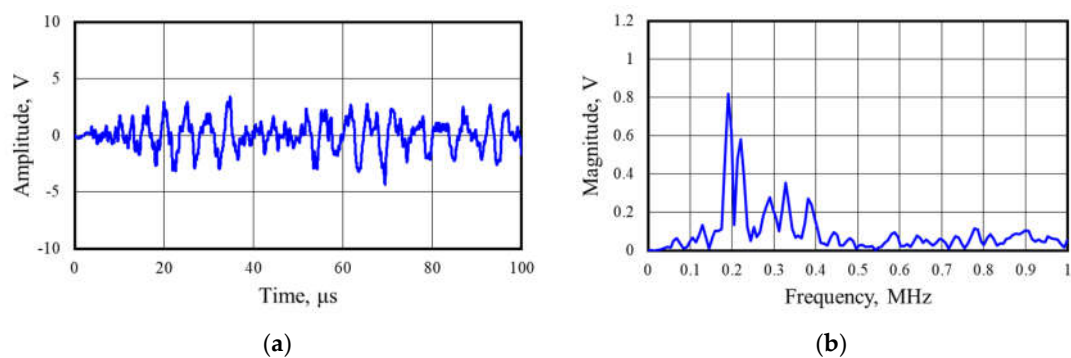
Figure 18. Typical AE signal waveform detected at around 383 h and its frequency spectrum: (a) AE signal waveform; (b) frequency spectrum.

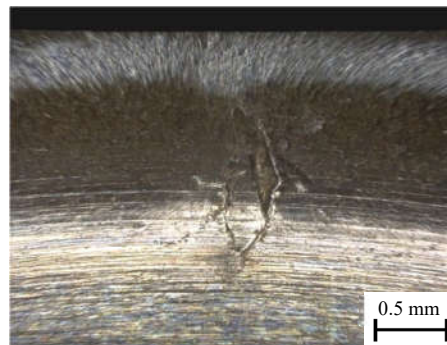
Figure 19. Micrograph of the raceway surface of the bearing (housing washer) after the test.

Figure 19 shows micrographs of the housing washer of the thrust ball bearing. Flaking and consequent peeling off the surface layer can be observed at the center of the friction track. Therefore, the peaks in the frequency region of about 0.15 to 0.4 MHz were considered to be due to the occurrence of flaking.

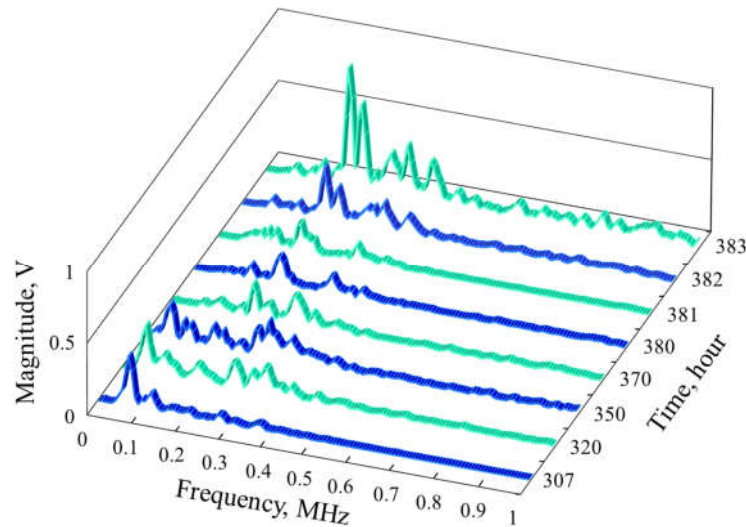
Figure 20. Change in the frequencies of the AE signal waveforms at various times until flaking occurred in the housing washer.

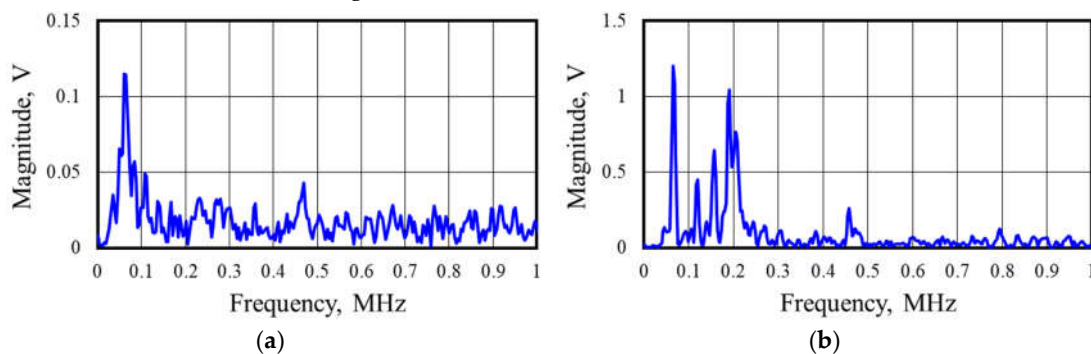
Figure 21. Frequency spectrum of the AE signal waveform detected in the indentation test: (a) at 9.8 N; (b) at 98 N.

Figure 21 shows the frequency spectrum of the AE signal waveforms obtained from indentation tests performed at two different applied loads. As shown in Figure 21a, when a low load was applied, a primary peak appeared at a frequency below 0.1 MHz; however, as shown in Figure 21b, when a high load was applied, in addition to the peak at a frequency below 0.1 MHz, another peak appeared at around 0.2 MHz. In both cases, the peak at about 0.1 MHz was considered to be related to plastic flow due to contact and friction between the indenter and the bearing race surface. This is similar to the feature in the AE frequency observed in the initial stages (normal state) of the bearing-fatigue test, as described in Section 3.1. This is because the collision (contact) and plastic flow of surface asperities also occur in the running-in process. A peak with a similar frequency has been confirmed to occur during sliding friction without wear [13,14]. In addition, microcracks might form at the corners of the indentation under a high applied load, so the peaks in the 0.2 to 0.3 MHz frequency region can be attributed to the generation and propagation of cracks in bearings. Similar features have been observed in other fatigue tests [15].

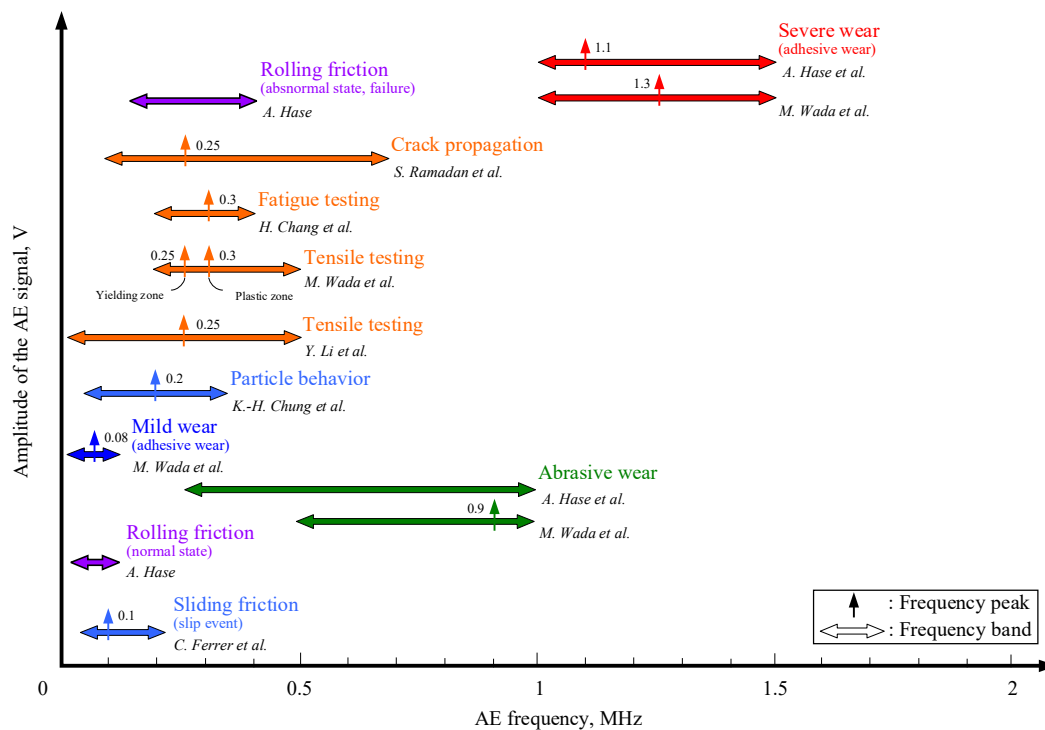
Figure 22. Correlation map between the frequency spectra of AE signals and deformation and fracture phenomena (friction and wear modes).

As proposed in a previous study [16], the correlation map between the frequency spectra of AE signals and deformation and fracture phenomena (friction and wear modes) provides a very powerful tool for identifying and evaluating complex tribological phenomena. Consequently, the correlation map was updated to include the results of the present study, as shown in Figure 22. Here, the amplitude of the AE signal shown on the vertical axis is not an absolute value because many factors such as the AE measuring system and measurement conditions affect the sensitivity of detection. However, the trends in the frequency spectrum of the AE signal waveform are markedly dependent on the deformation and fracture phenomena rather than on the experimental conditions, because the velocity and scale of the phenomena chiefly decide the shape of the AE waveform (i.e., the feature of the frequency spectrum) [17,18]. Although the position of a peak in the frequency spectrum of the AE signals was slightly shifted, similar trends in the frequency spectrum to those observed in this study have been confirmed in an experimental study using a deep-groove ball bearing [19].

It follows from the above that fatigue damage in rolling bearings can be evaluated and identified from the AE signal component that corresponds to each deformation and fracture phenomenon. With regard to the early detection of fatigue damage by using the AE technique, it is possible to detect the occurrence of fatigue damage in a bearing raceway surface from measurements of the AE signal component between 0.15 to 0.4 MHz. Additionally, it might be possible to evaluate the running-in process of a bearing raceway surface by measuring the AE signal component below 0.1 MHz. Moreover, since the oil film thickness and the reaction film formation by additives can be identified using the AE technique [20,21], the lubrication performance of lubricants for the fatigue damage could be evaluated from the frequency component of the AE signals, its magnitude, and the detection time.
