# Response of an Existing Two-Storey RC Frame Designed for Gravity Loads: In Situ Pushover Tests and Numerical Analyses

Simone Peloso, Chiara Casarotti \*

Centro Europeo di Ricerca e Formazione in Ingegneria Sismica, 27100 Pavia, Italy; simone.peloso@eucentre.it (S.P.); filippo.dacarro@eucentre.it (F.D.); giuseppe.sinopoli@eucentre.it (G.S.)

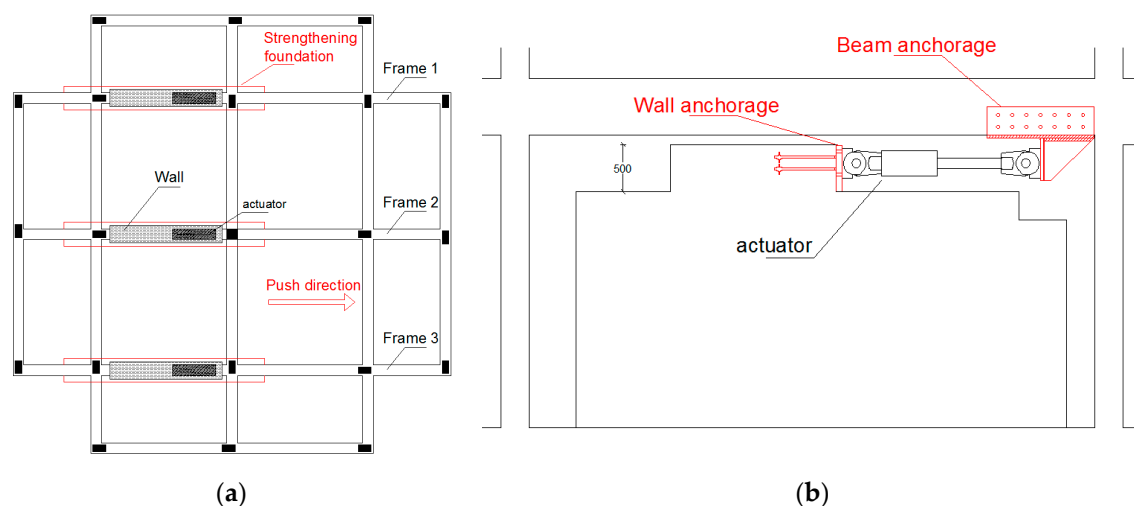
Figure 1. Test setup: Top view (a) and front view (b).

The pseudo-static test, described in this article, consisted of the application of push–pull cycles to a real frame building to study the response of a structure designed in the '80s for gravity loads only. The design was done according to out-of-date regulations that did not properly consider the seismic demand either at the input level or in the building detailing. Three walls were built inside the structure and connected with the existing foundation (Figure 1a) in order to counteract the forces applied to the beams of the first floor (Figure 1b). To predict the response and design the test setup, a number of numerical models and pushover analysis of the structure have been carried out, in order to account for the uncertainties related to the mechanical characteristics of the materials, to the deformable/rigid floor response, and to the contribution of the infill panels. The numerical analyses were finalized to obtain the capacity of the structure in terms of both force and displacement, the ductility reserve, and the most likely sequence of formation of plastic hinges.

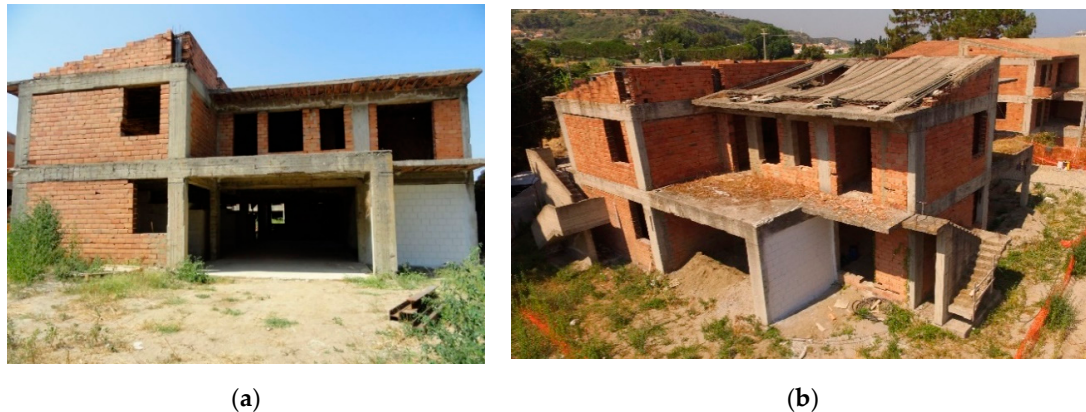
**Figure 2.** South (a) and north-west (b) building views.

As evident in Figure 2, the building was in a state of total abandonment. The building is a two-story RC structure, about 8 m high, with an inter-story height of 3.70 and 3.20 m at the first and second floors, respectively.

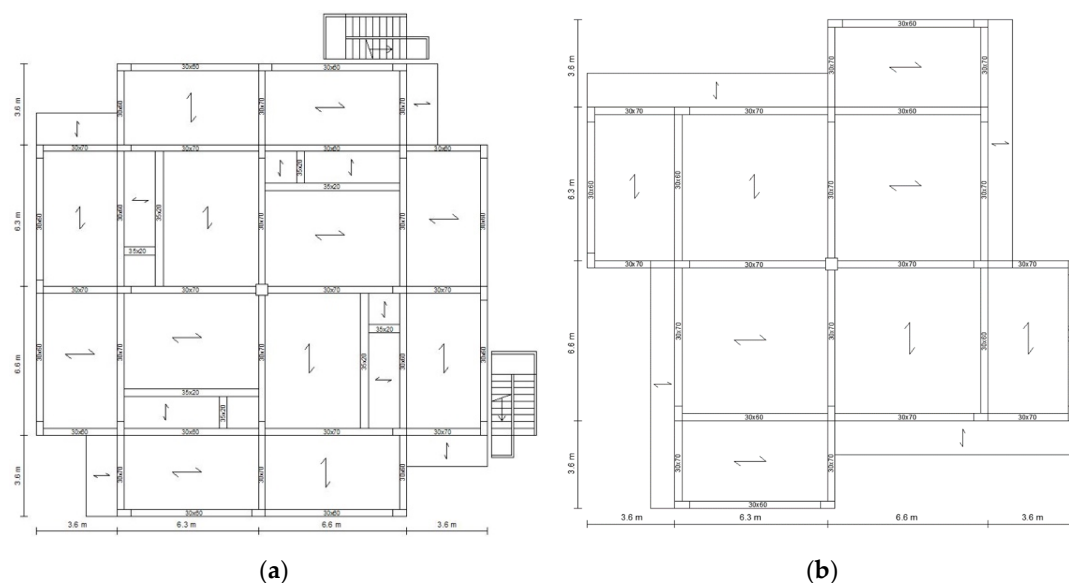
**Figure 3.** First floor (a) and roof (b) plans.

The building's plan is fairly regular, about 20 by 20 m, for a gross floor area of approximately 350 m<sup>2</sup> (Figure 3). Slabs on the first floor and roof, which were in a state of advanced degradation, were ordinary casted RC and hollow block clay elements with a total thickness of 0.2 m. Stairs were external and not connected to the building.

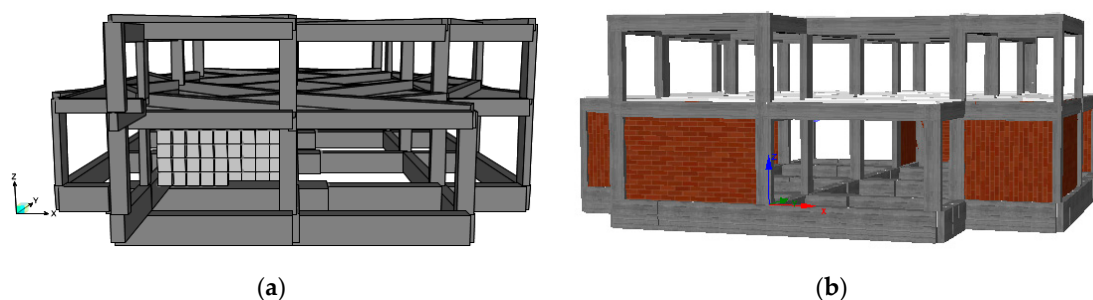
**Figure 4.** Structure modeled with SAP2000 (a) and SeismoStruct (b).

The whole structure-reaction system was modeled by means of two analysis software (Figure 4): SAP2000 v22.1.0 [22] and SeismoStruct v2020 [23]. Double modeling, elastic and non-linear, respectively, considered several hypotheses and different combinations of those variables affecting the structural behavior, in order to study various critical aspects. In this way, it was possible to optimize the design of the test, balancing costs and feasibility issues, accounting for the estimated building capacity and the interaction with the reaction system.

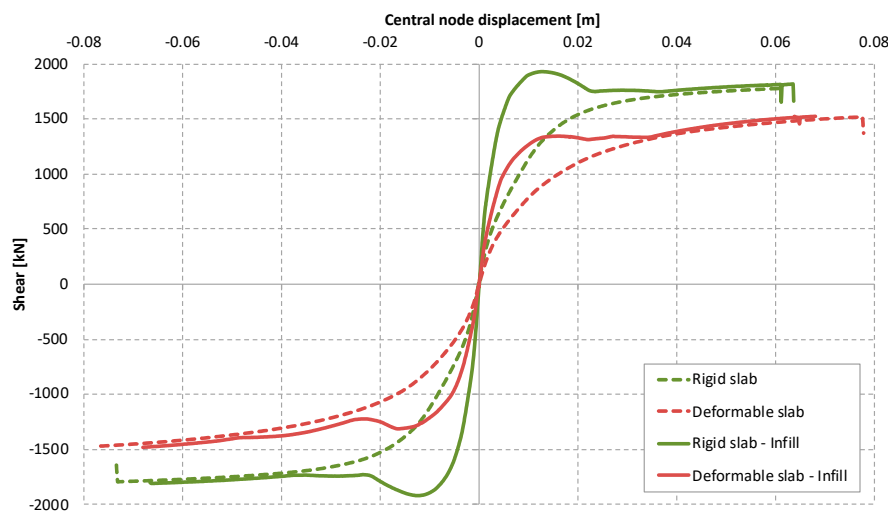
Figure 5. Pushover curves.

Figure 5 shows the pushover curves of the different models in both push and pull directions. Table 2 shows the numerical results obtained from the analyses, in terms of maximum base shear and maximum displacement measured at the central node of the first slab. In all cases, the target displacement of 0.12 m was not reached. The model with deformable slabs and infills reached the maximum displacement of about 0.08 m. As expected, the presence of infills significantly influenced the structural response, stiffening the elastic part of the capacity curve, up to the reaching of the breakout limit value of the infills themselves, beyond which the two curves obviously coincide progressively. In the model with rigid slabs, the presence of infills had a great influence on the maximum reached shear value, occurring at the infills breakdown limit value.

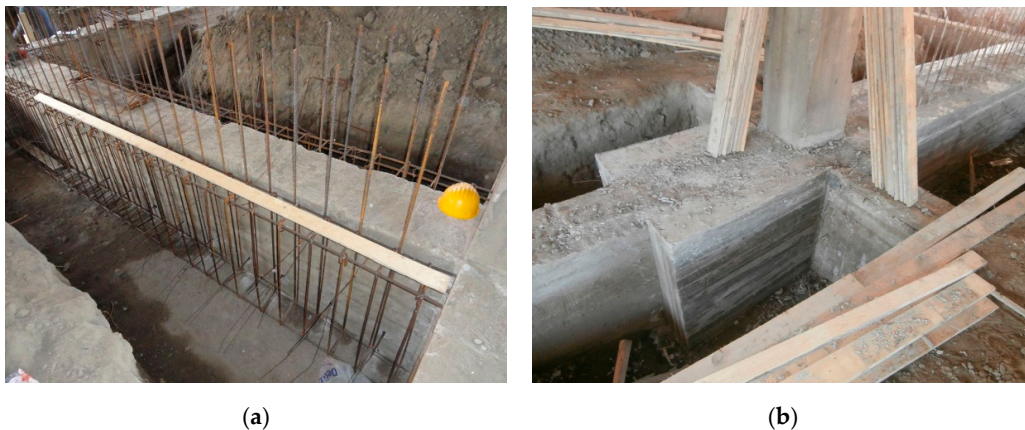
**Figure 6.** Footings retrofit: Steel reinforcement (a) and section enlargement (b).

The retaining walls were built on the existing foundation beams, which have been reinforced to withstand the expected base shear: The original section of 0.50 by 1.10 m (base and height, respectively) was extended to 1.10 by 1.10 m. Such intervention on the foundation beams was extended beyond the columns close to the walls, as shown in Figure 6, in order to reduce the stresses nearby foundation beams. The reinforcement sections were integrated with the existing section by means of connectors passing through holes created in the original foundation. Figure 7 shows the steel reinforcement of the retaining walls and a completely casted wall. It is possible to notice a squat tooth cantilever on top of the wall, where the actuator was connected through a vertical steel plate (Figure 8a). At the other end, the connection to the building was realized by means of steel plates fixed to the intrados of the first slab beam through passing connectors (Figure 8b).

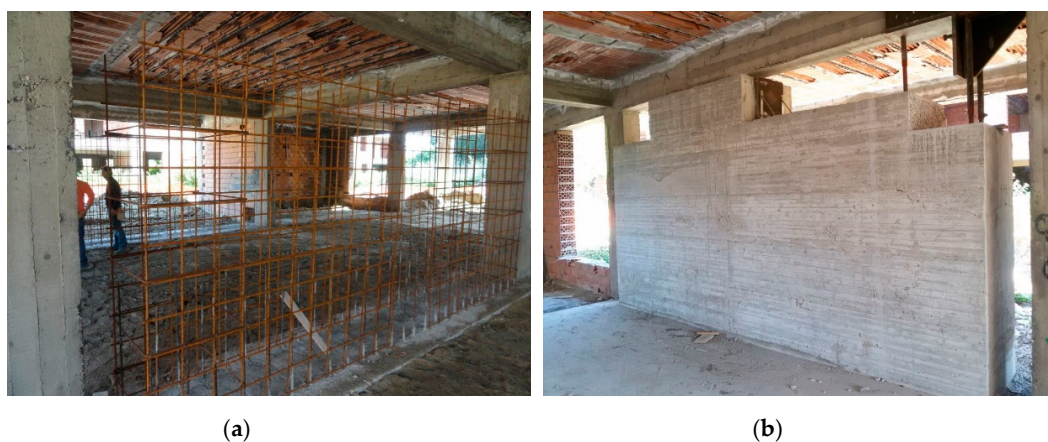
**Figure 7.** Reaction walls: Steel reinforcement (a) and fully casted wall (b).

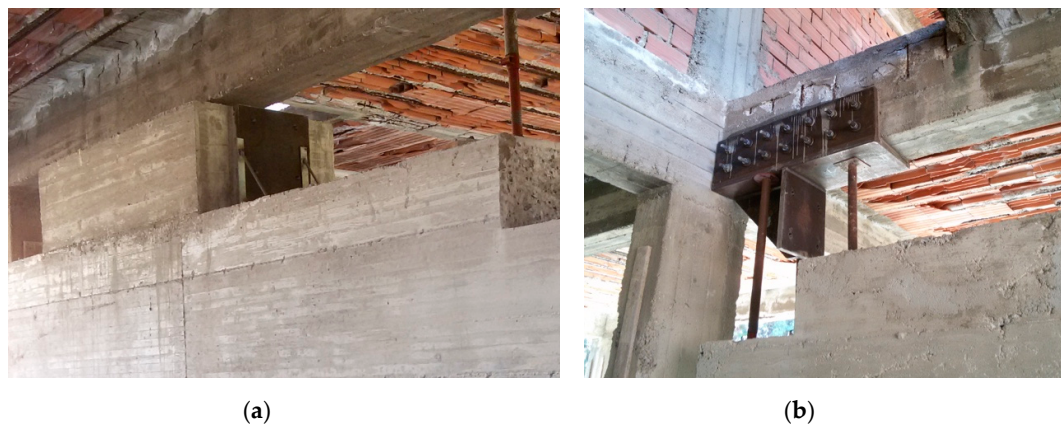
**Figure 8.** Steel element connections for the actuators: On the reaction wall (a) and on the frame first floor beam (b).

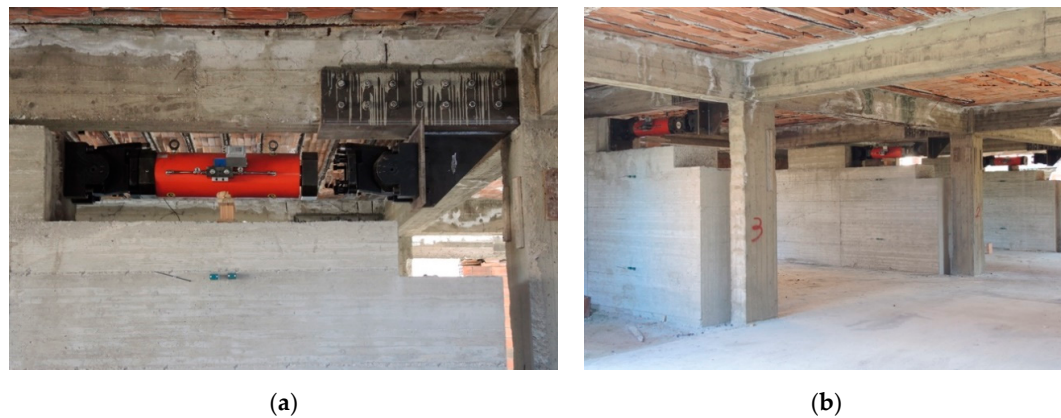
**Figure 9.** Actuation detail (a) and overview of the test setup (b).

The actuation system designed based on the test to be carried out included three double-acting hydraulic actuators, shown in Figure 9.

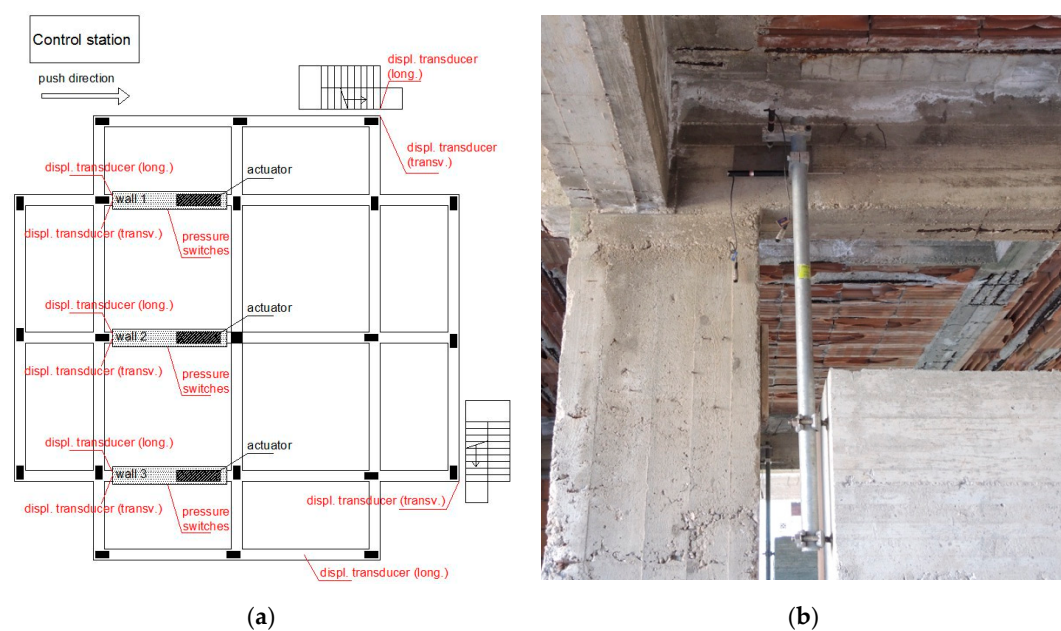
**Figure 10.** Measurement equipment layout (a) and detail of the displacement transducers (b).

In Figure 10, it is possible to observe the measurement equipment layout used to monitor the structural response during the test: (i) Potentiometers with 250 mm stroke to measure the displacement along the testing direction, (ii) displacement transducers with 100 mm stroke for the displacements in the orthogonal direction, and (iii) pressure sensors to measure the force of the actuators. In addition,

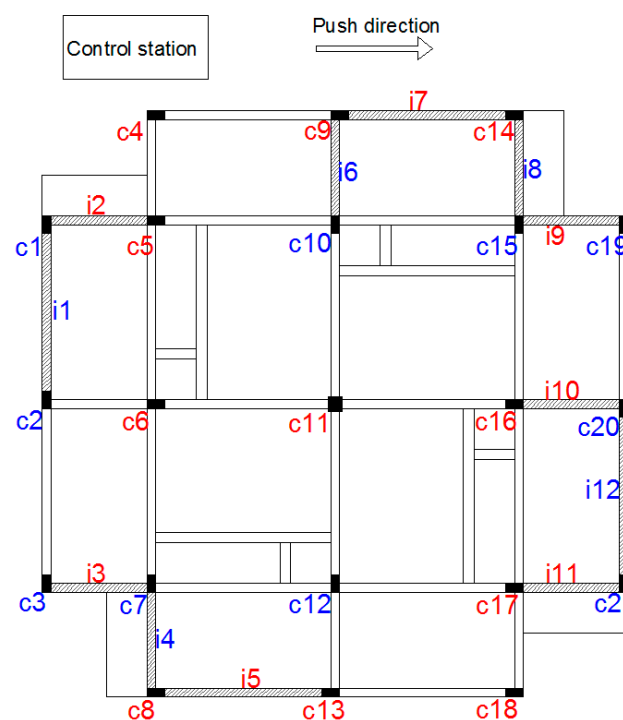
**Figure 11.** Column (“c”) and infill (“i”) labels.

Figure 11 shows the plan view with the numbering of the columns (prefix “c”) and the infills (prefix “i”), useful to locate the elements in what follows. Elements were divided into two categories, i.e., those aligned to the test direction (stronger resistance, red color) and those aligned perpendicularly (blue color). After each run, damages were checked on both structural and non-structural elements, that is, on whitened infills, where the evolution of the cracking pattern is shown as an example in Figure 12.

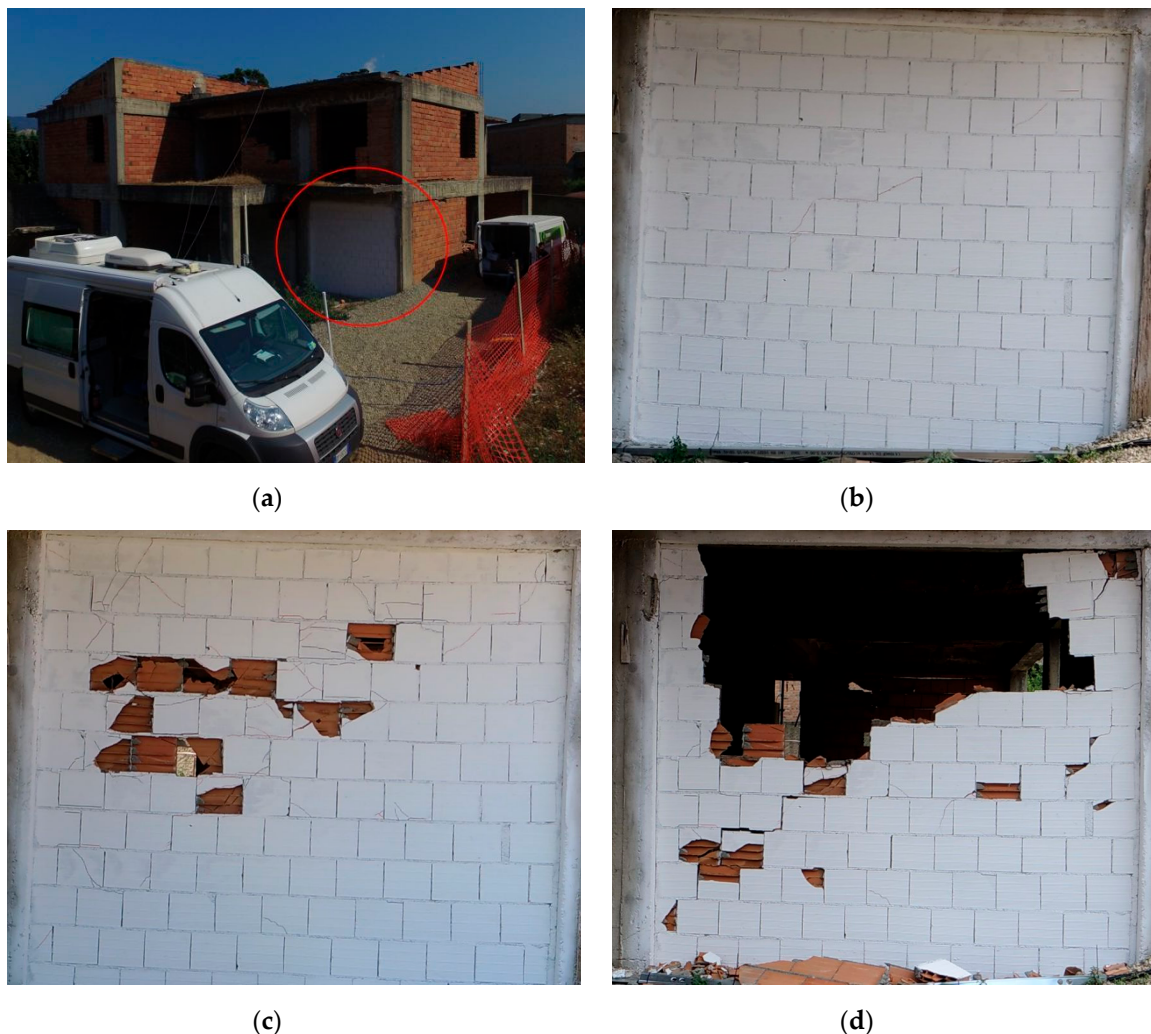
**Figure 12.** Infill panel i2 (a), cracking pattern at: run #2—4.3 mm/0.12% (b), run #5—12.9 mm/0.35% (c), run #8—52.6 mm/1.42% (d).

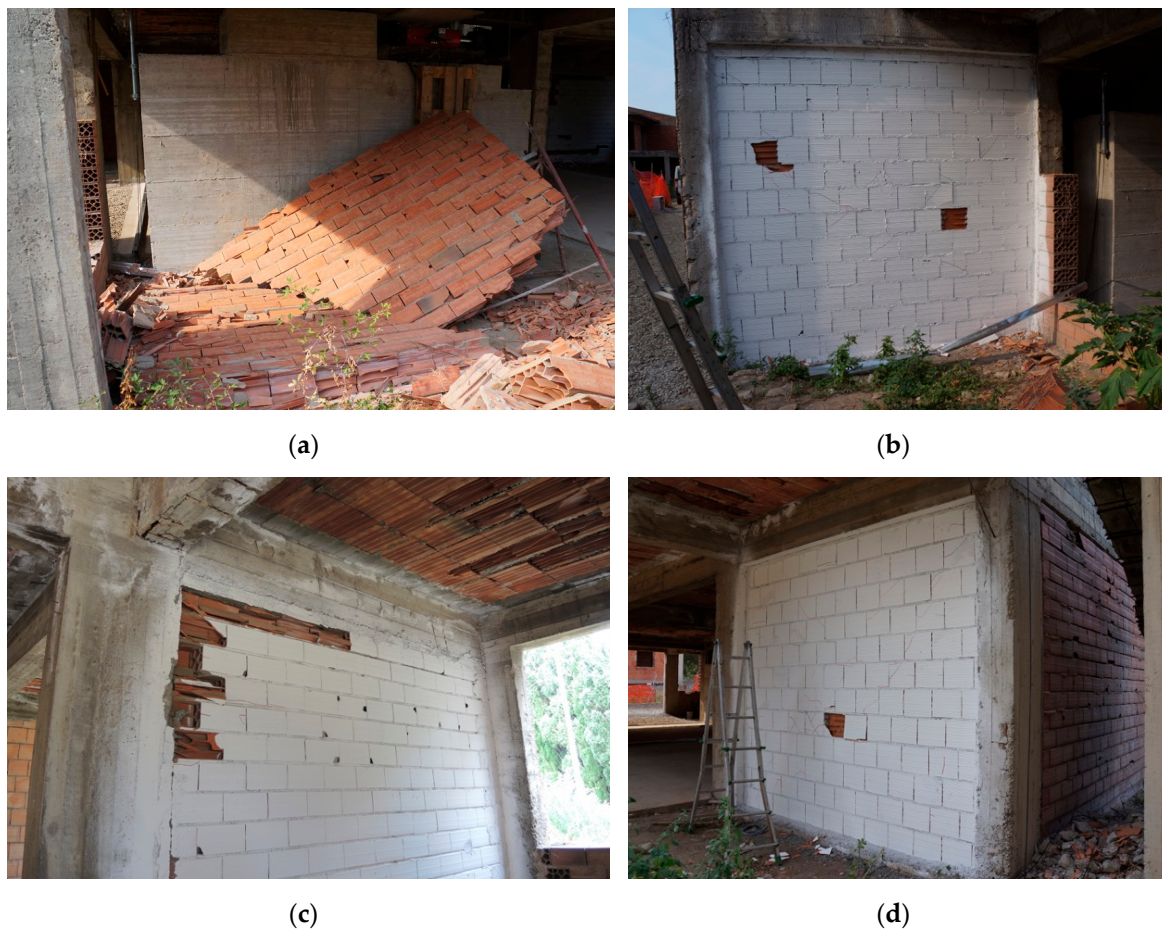
**Figure 13.** Infill damage at run #4, 9.6 mm—0.26%: Infill i5 (a); infill i3 (b); infill i10 (c); infill i11 (d).

At run test #4, the infill i5 overturned unexpectedly, probably due to bad connection with the frame, while the other infills panels reported minor damages (Figure 13), and no damage to structural elements was detected. After run #4, the infills began to be progressively damaged. It should be noticed that the current Italian code [25] sets a limit of 0.2%, 0.5%, and 0.75% for the damage limit state of ordinary bearing masonry, brittle, and ductile infills, respectively, and that recent experimental studies ([26,27]) showed that a reasonable damage limit for poor quality or weak infills (e.g., horizontal holes laying) is in the order of magnitude of 0.3%.

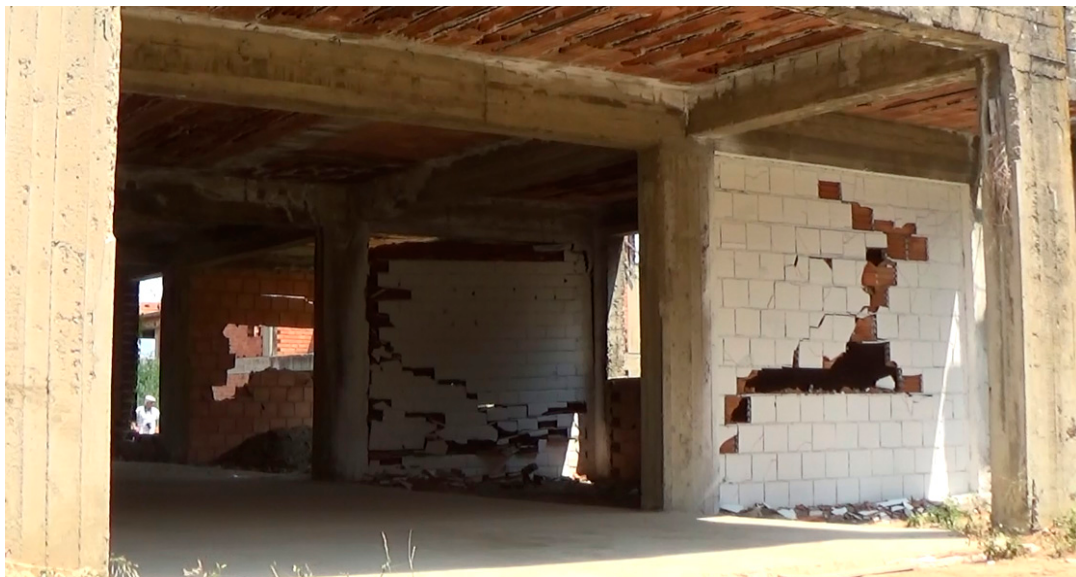
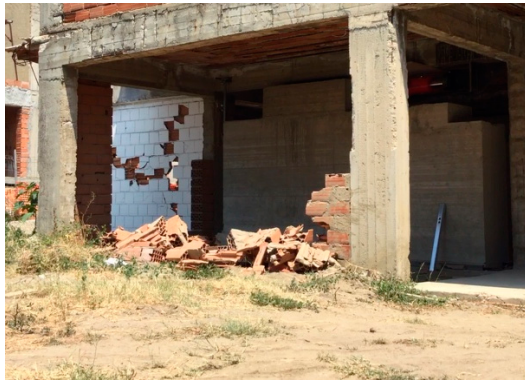
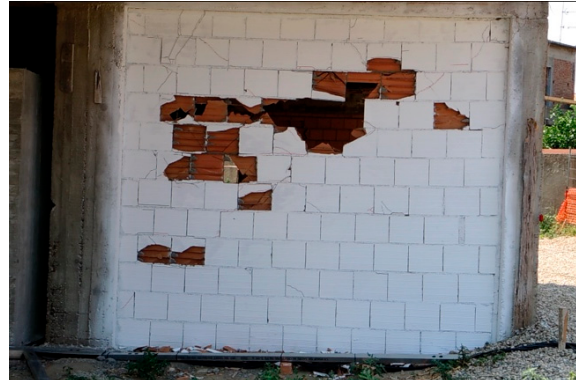
**Figure 14.** Infill damage at run #6, 21.6 mm—0.58%: From left to right, infills i9, i10, i11 (a); infill i3 (b); infill i2 (c).

Figure 14 shows the main damage that occurred at run test #6 (21.6 mm, 0.58%). No critical cracks were observed along beams and columns, but the damage at the infills increased, with some partial collapse. Obviously, as the damage increased, the strength and stiffness contribution offered by the infills decreased progressively. It is expected that at the larger drift levels, the bare frame strength reserves would be activated, i.e., damages would be extended to the structural elements.

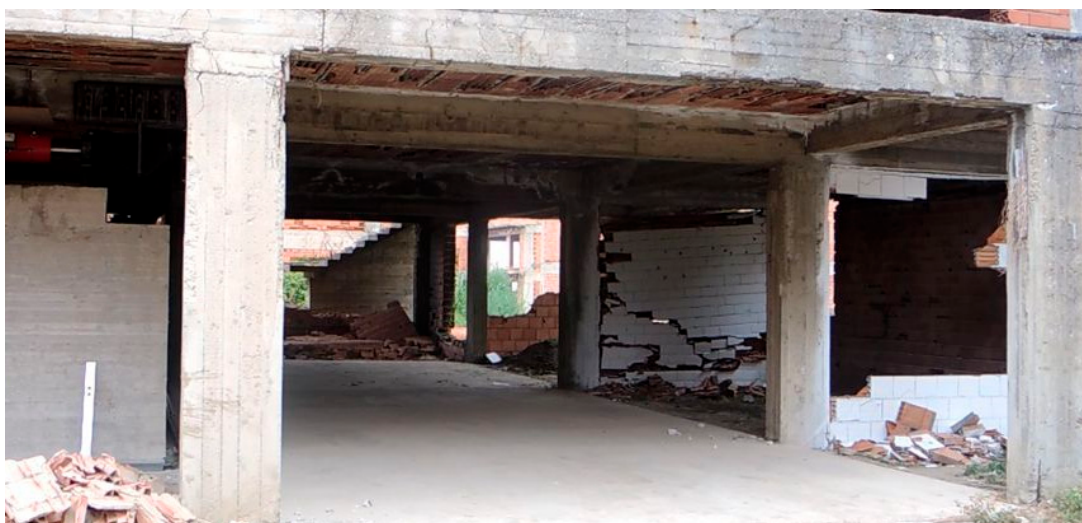
**Figure 15.** Run #9, 62.4 mm—1.69%: Infills parallel to the test direction fully collapsed.

Figures 15–21 show the major damages that occurred at the end of the last test, run #9 (62.4 mm, 1.69%). As expected, beams did not show significant damage, while all the infills along the push direction, heavily damaged by the previous tests, collapsed completely (Figure 15). The most damaged columns were those with the larger size parallel to the push direction, since they attracted larger forces. Most of these elements featured mixed shear and flexural failures at the base and at the top, with concrete spalling and longitudinal rebars buckling (e.g., Figures 16 and 17). The same applies to the central column c11 (Figure 18). A particularly severe shear failure occurred at column c9 (Figure 20, right). Failure modes connected to bending behavior occurred mainly at the base of the columns c4 and c18 (Figure 19): The lower axial load probably shifted the strength hierarchy in favor of the flexural collapse mode. Less damage, in general, was found on the perimeter columns (#3, 4, 18, 19), whose bays were not directly pushed by actuators, and by the columns aligned perpendicularly to the test direction, with an exception done for columns c20 and c3 which showed some shear and flexural cracks, respectively. Some of the not fully confined joints, i.e., those on the perimeter, showed shear failure (Figure 21).

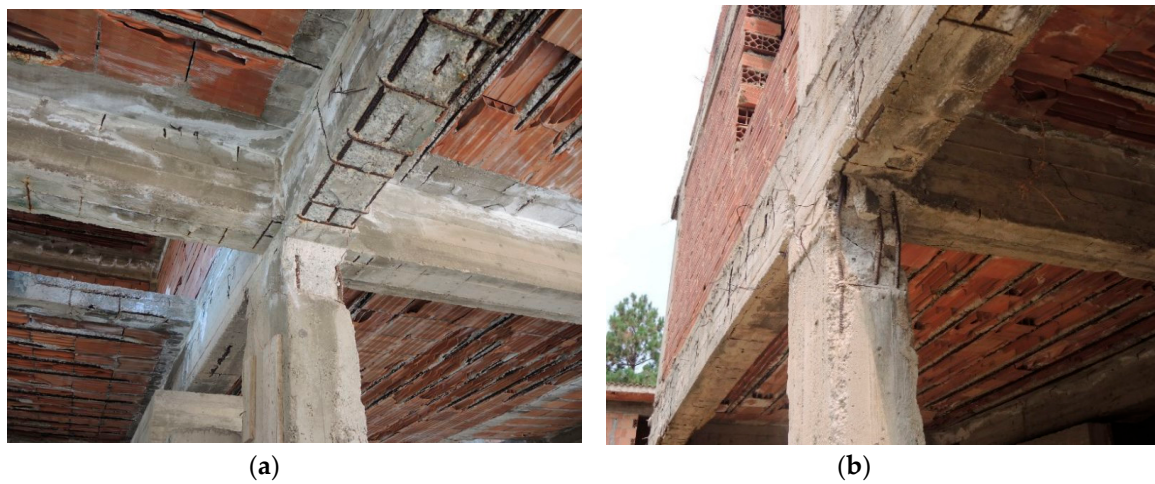
**Figure 16.** Run #9, 62.4 mm—1.69%: Concrete spalling, core crushing, and reinforcement buckling at the top of column c6 (a) and c13 (b).

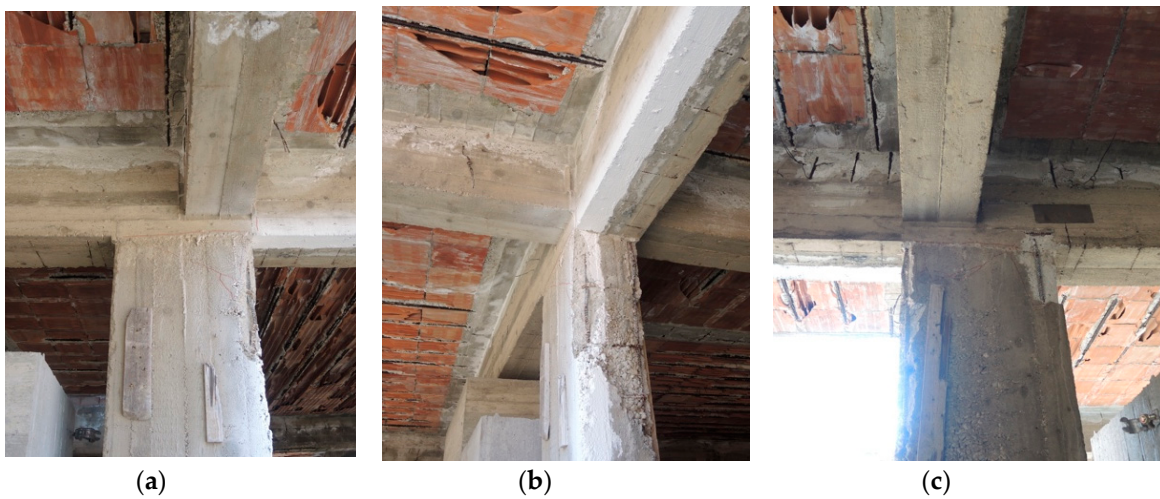
**Figure 17.** Run #9, 62.4 mm—1.69%: Damage at the top of column c5. Front (a), side (b) and back (c) view.

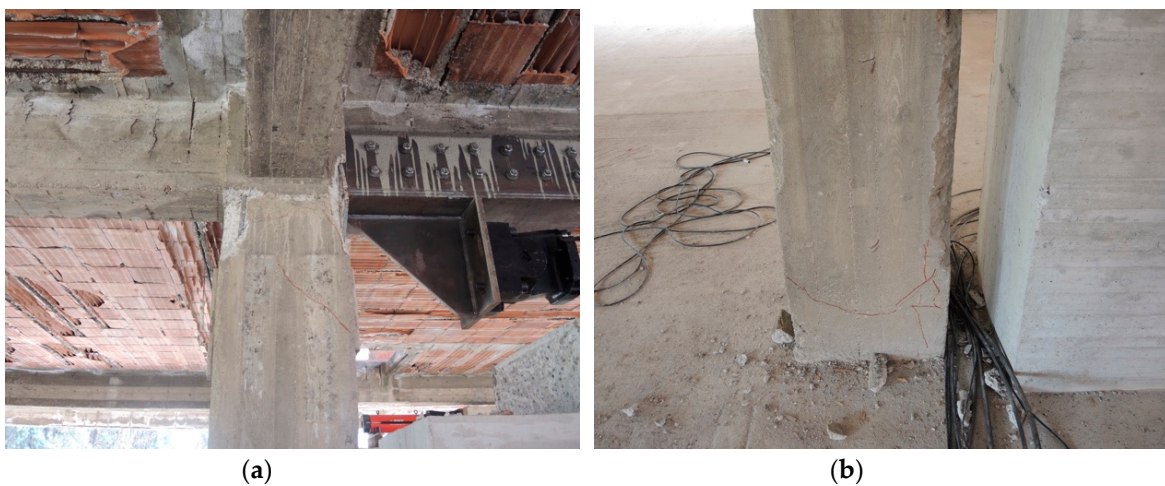
**Figure 18.** Run #9, 62.4 mm—1.69%: Damage at the top (a) and at the base (b) of column c11.

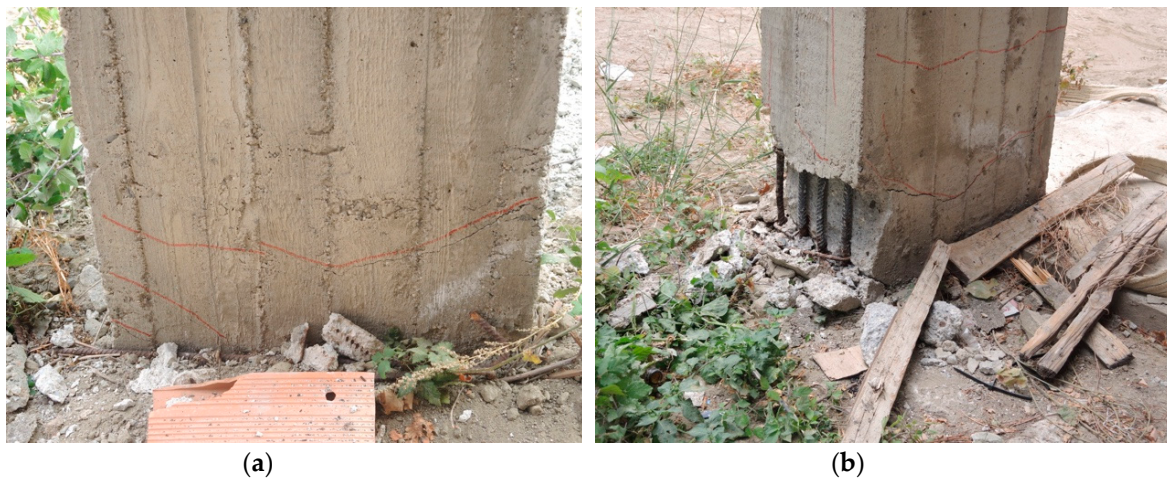
**Figure 19.** Run #9, 62.4 mm—1.69%: Flexural cracking pattern and failures at the base of columns c4 (a) and c18 (b).

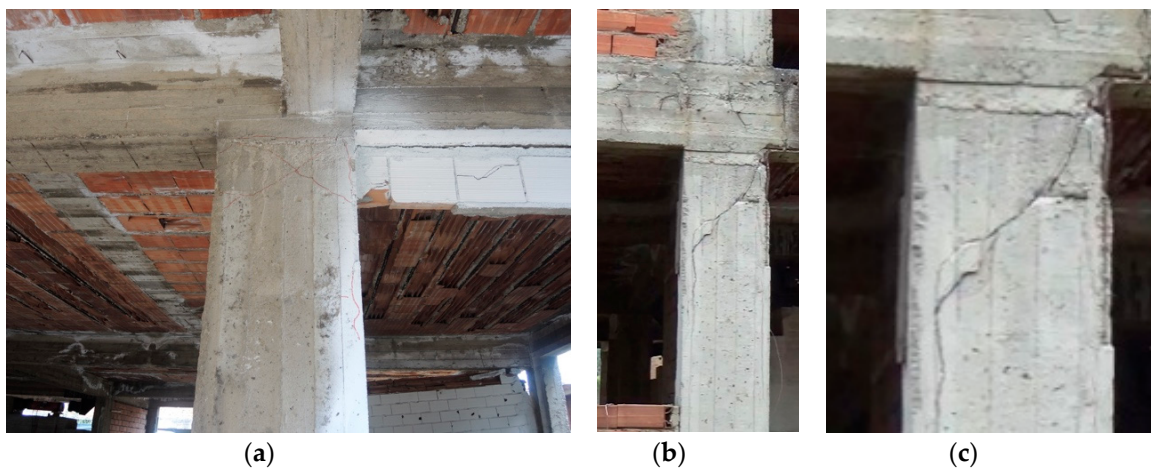
**Figure 20.** Run #9, 62.4 mm—1.69%: Shear failures, columns c17 (a) and c9 (b) and (c).

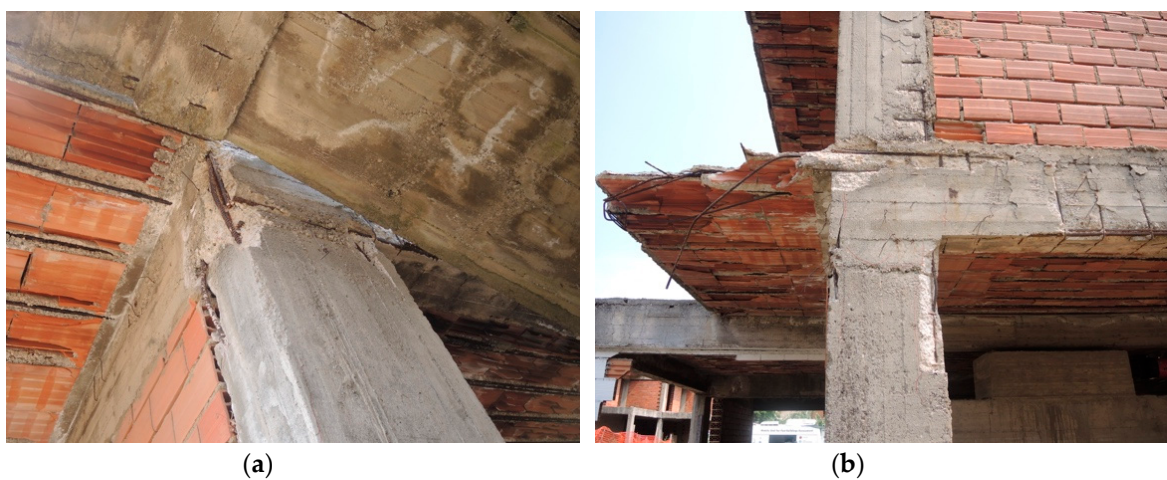
**Figure 21.** Run #9, 62.4 mm—1.69%: Joint damage at the top of column c14 (a) and c8 (b).

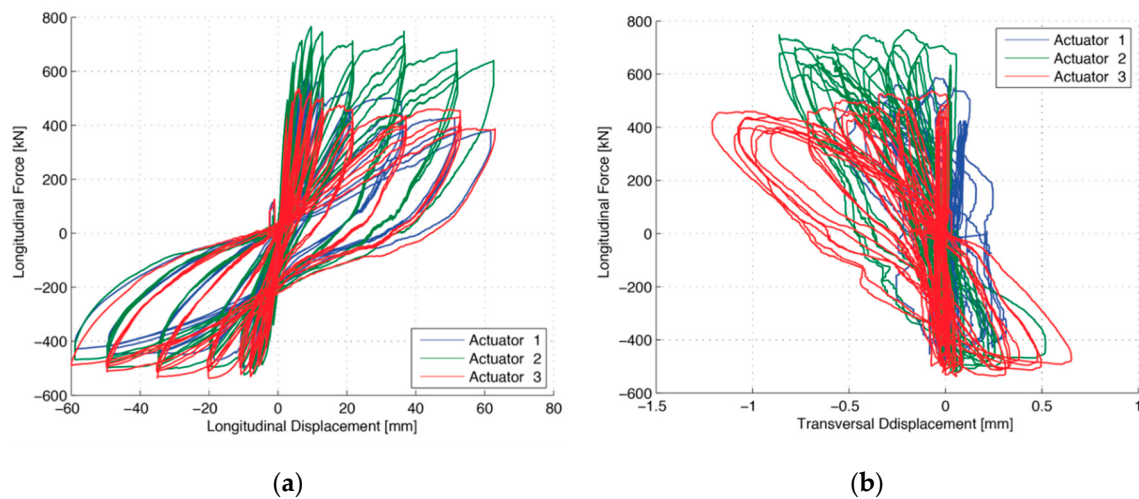
**Figure 22.** Force-displacement loop of individual actuators. Force is in the test direction, displacement is parallel (a) and orthogonal to the test direction (b).

Figure 22 shows the force record of the individual actuators, plotted versus displacement along the test direction (a) and orthogonal to the test direction (b). In Figure 23, the total force-average displacement loops are shown together with the skeleton curve, on which the energy balanced bilinear approximation is plotted. Finally, Figure 24 shows the relation between displacement and equivalent viscous damping: One point for each cycle at every displacement amplitude. These values were evaluated using the well-known Jacobsen's approach on the basis of the hysteretic energy of each cycle. Considering that, due to damages, the equivalent viscous damping was mainly due to the hysteretic contribution, the calculated values appeared to be reasonable.

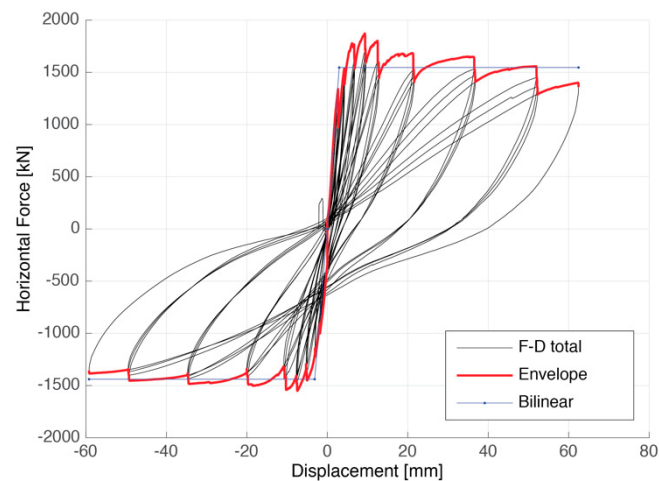
**Figure 23.** Force-displacement loop of the structure, envelope curve, and bilinear approximation.

The analysis of the recorded data substantially confirms what was previously observed on structural damage. The maximum force is achieved at a displacement equal to 9.6 mm. Beyond this threshold, infills began to show significant damages, the maximum force decreased, and the damping increased. When infills were completely damaged, beyond 22 mm displacement, the damping increased considerably because of the increasing hysteretic contribution of the RC frame. Consistently with the progress of the damage, even within the same run, the damping was higher at the first cycle and decreased in the following two cycles of the same amplitude. At the last single-cycle run, the damping did not increase any longer, likely due to the brittle failure of the RC elements, implying the possibility of an incipient global collapse.

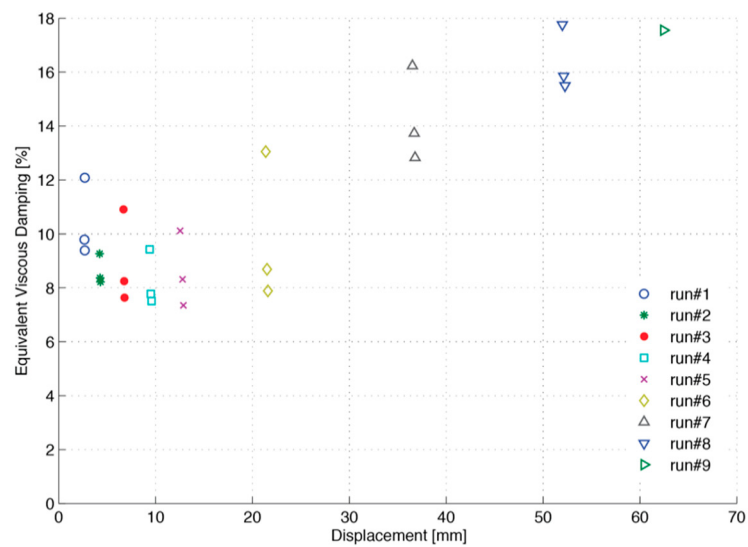
**Figure 24.** Equivalent viscous damping for the three cycles of each run.

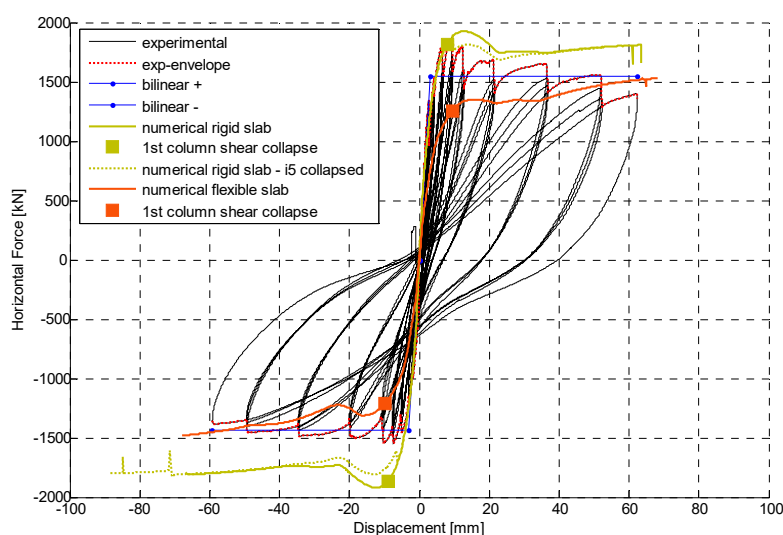
Figure 25. Capacity curves numerical and experimental.

Figure 25 shows the comparison between the experimental skeleton curve the numerical capacity curves modeling infills, with and without the rigid slab assumption. The results of the numerical simulations are in fair agreement with the experimental response. The analytical curve closest to the actual behavior was the one modeling rigid slabs: The maximum base shear value was achieved at the infill break-down limit, and afterwards the base shear decreased until the full exhaustion of the infills' resistance. Henceforth, the resistance was completely entrusted to the structural elements. It was noted that in the experimental curve there was a more pronounced decay in structural capacity, probably due to the shear failures and joints damage, which were not modeled within the software. Markers on the numerical capacity curves indicated when the first column reached its shear resistance, i.e., the displacement level after which modeling was less accurate.

For the sake of completeness, the same figure shows, as a dashed green line, the simulation considering the out of the plane collapse of infill i5 which happened when applying a few millimeters of displacement. Such a failure mode, sudden and very different from the other failed infills, was likely due to the bad connection of the infill itself, and could not be foreseen by modeling; thus, it was introduced after the experimental evidence.

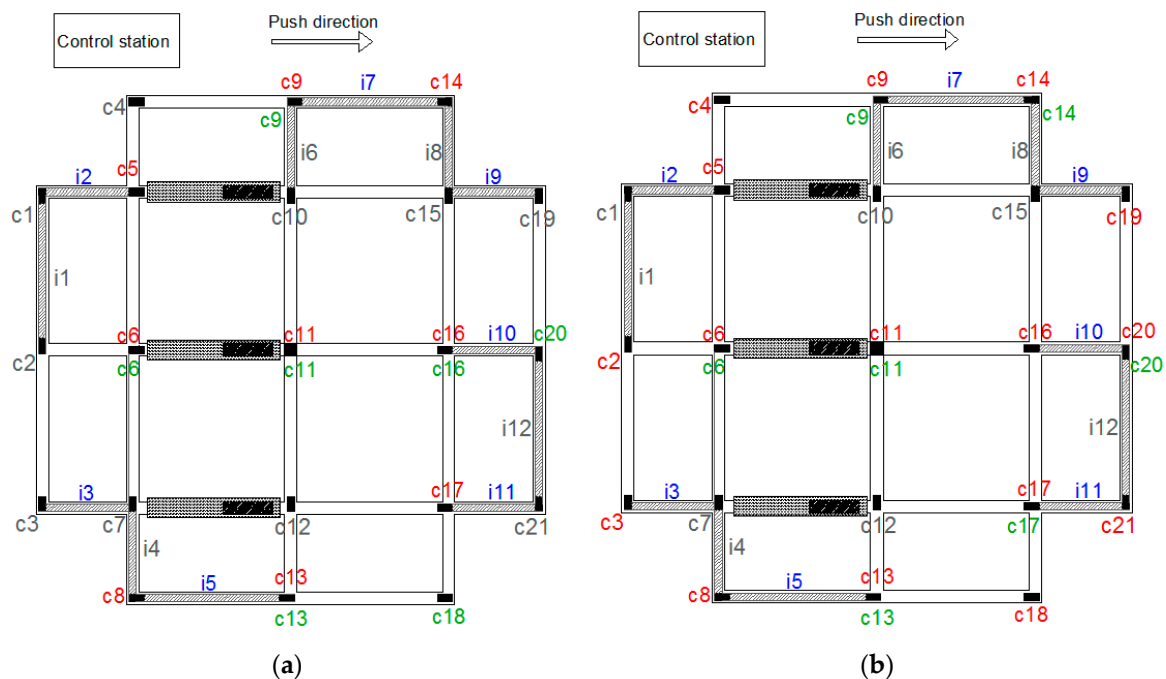
**Figure 26.** Element failure pattern in the numerical model (a) and in experimental results (b) (red—flexure, green—shear, blue—infills collapse).

Figure 26 shows the comparison of elements failure modes between this last model (a) and the experimental results (b): Red and green colors indicate structural elements failing for flexure and shear, respectively, while collapsed infills are marked in blue. The shear failure, not modeled at the element level, has only been included in the software as a performance criterion (achievement of the resistance value calculated according to the DM 2018 [25] using  $\Phi 5.5$  stirrups).

In the numerical model, the first infill (i10) began damaging at about 6 mm. At a displacement of 23 mm, five infill panels (i2, i3, i9, i10, i11) were collapsed, while at 37 mm all the infill panels along the push direction failed, substantially confirming experimental results. Concerning structural frame elements, beams did not show any shear or flexural failure, while columns aligned to the test direction developed plastic hinges, except for columns c4 and c18 (external and in the single floor portions of the building). Most of them also reached their shear resistance. The columns perpendicular to the push direction did not reach their strength or deformation limit, except for the column c20 failing for shear. In addition, for structural elements, such results were in fair agreement with the experimental ones.
